LOWMAN BEACH PARK

Feasibility Study Report

Prepared for
Seattle Parks & Recreation Department

December 7, 2017

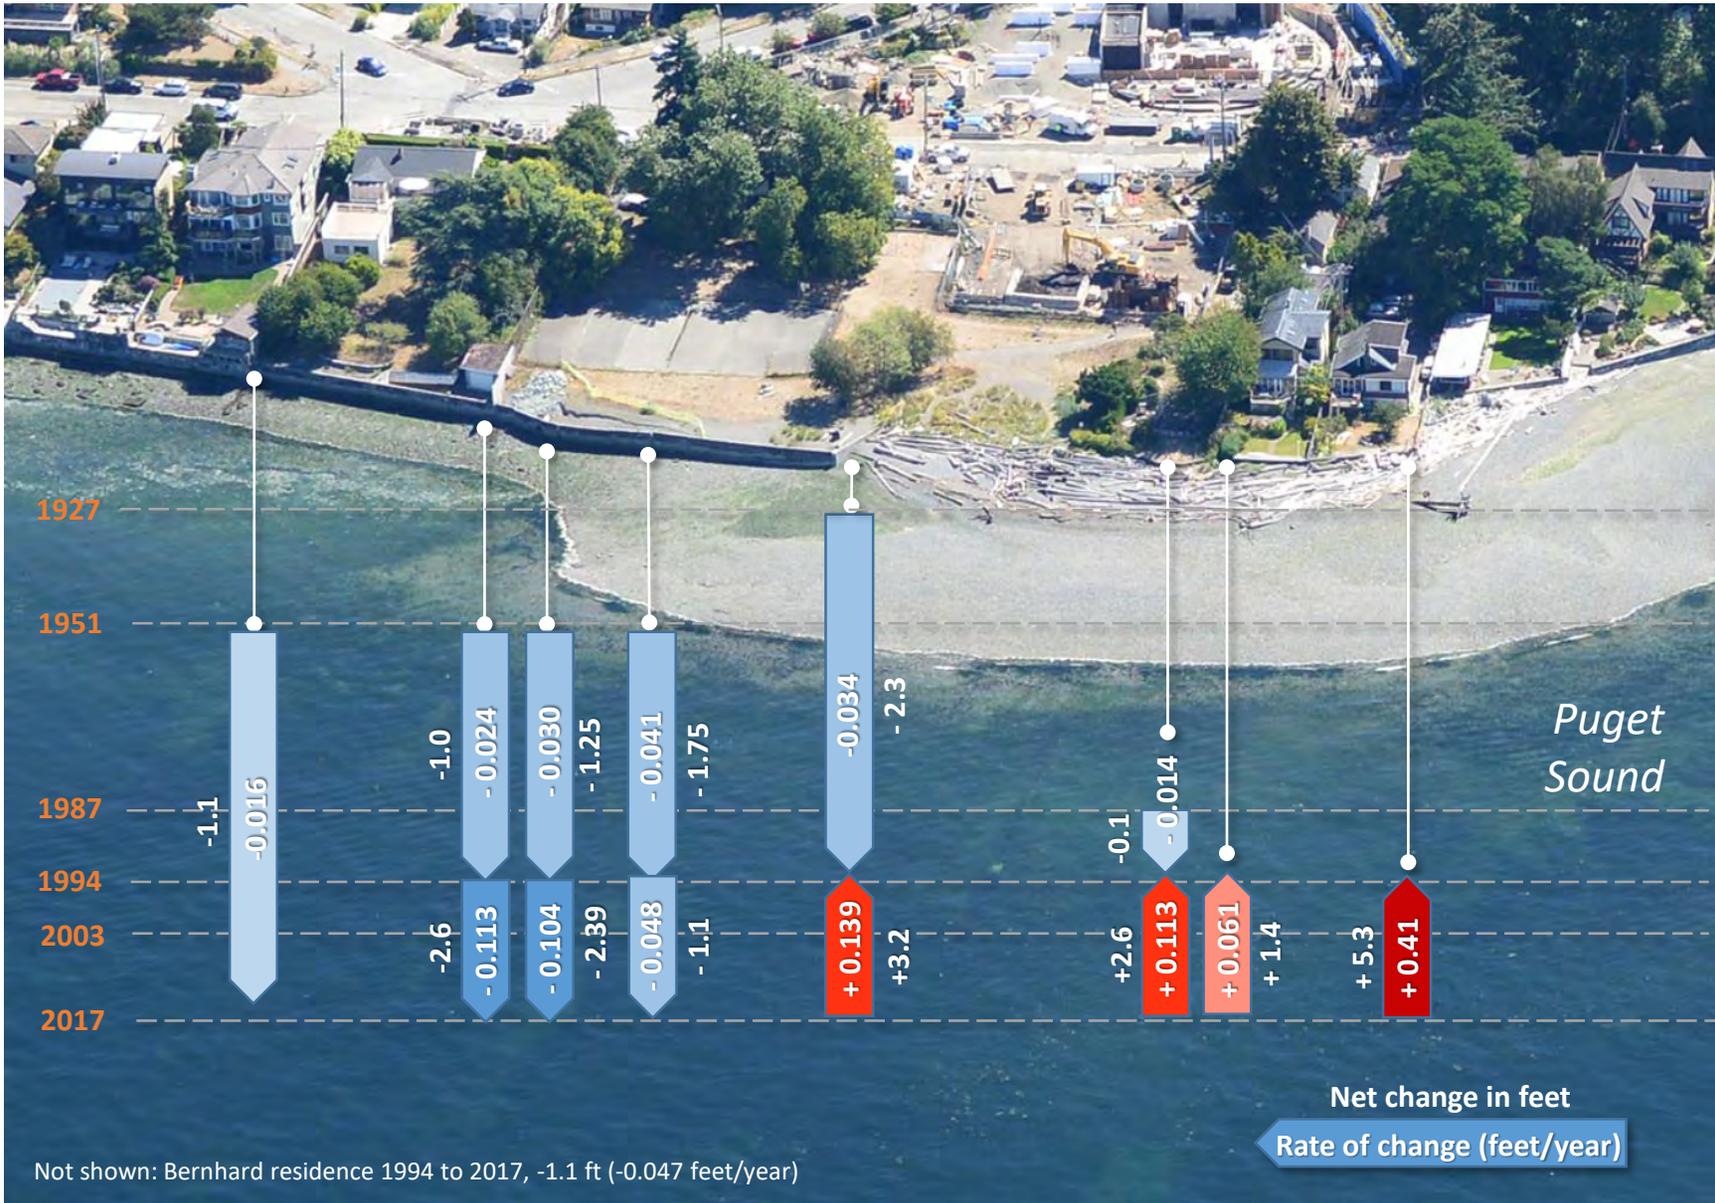
From 1994 to 2017 the beach grades at the north end of park lowered by almost 3 feet. At the middle point of the existing seawall, beaches grade lowered by about 1.5 feet. In the restored beach area, accretion (rising elevations) has occurred near the existing return wall and restored beach to the south of the seawall. Beaches immediately to the north of the park have continued to experience erosion from 1994 to 2017. Based on limited data, beach elevations at the toe of seawalls north of the park are estimated to have lowered by 1.0 to 2.5 feet during this period, with the most pronounced erosion occurring immediately north of the park and diminishing further to the north. Beaches to the north of the park have also lost the veneer of sand that was present near the toe of bulkheads in historical photos from 1993 and ground-level photos from 1994. Areas of grey clay are exposed at the surface, making fine sediment and small gravel deposition unlikely. Approximate beach elevation derived from LiDAR survey data near structure toes north of the park is depicted in Figure 21.

Figure 19
Beach Elevation Change Summary

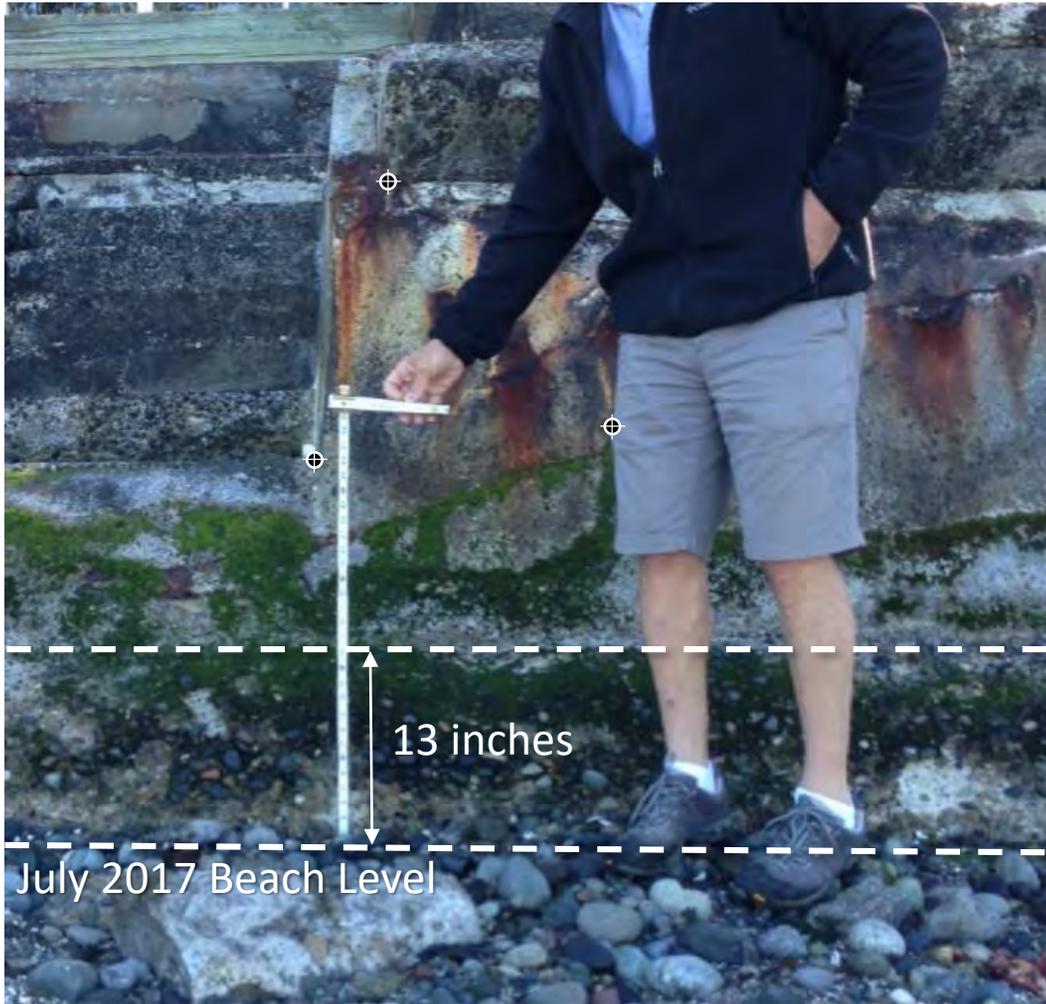
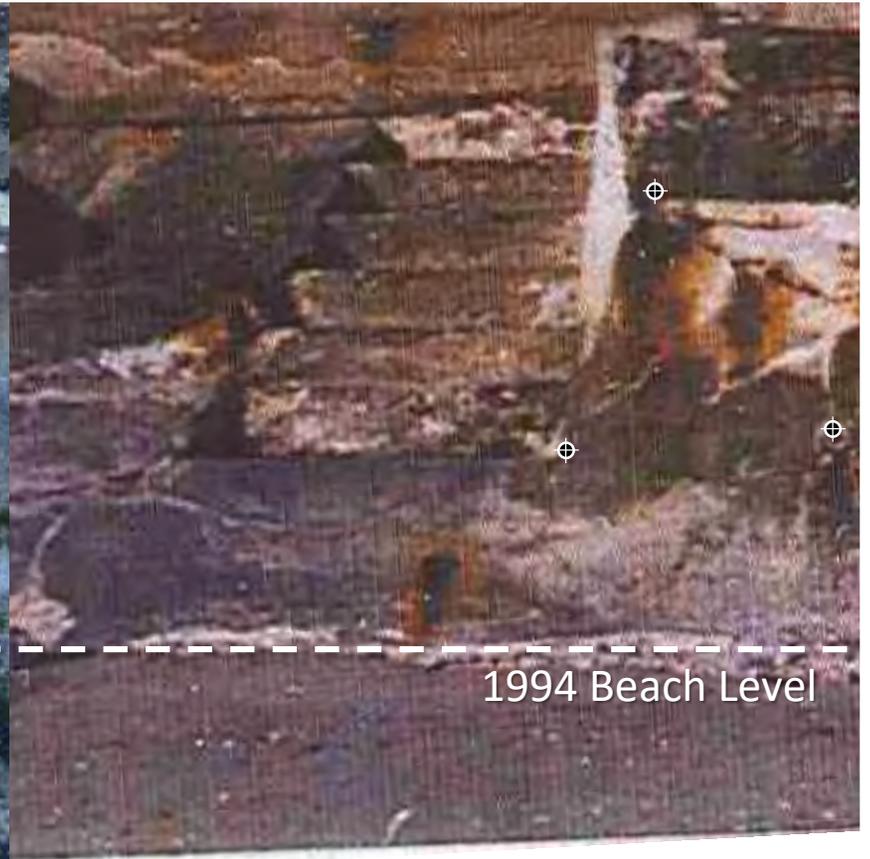
2017	City survey indicates murphy residence north property boundary of EL. 5.0 feet. At the north park property boundary, grades are approximately EL. 5.34 feet on top of spalls but actual beach grade about 1 foot lower, 85 feet south of north park boundary EL. 5.4 feet, south property boundary EL. 11.3 feet. Bernhard residence beach elevation dropped by approximately 13 inches from 1994 to 2017 based on photo comparisons.

Figure 20
Comparison of Ground Photos of Beach
Level at 6751 Beach Dr. SW

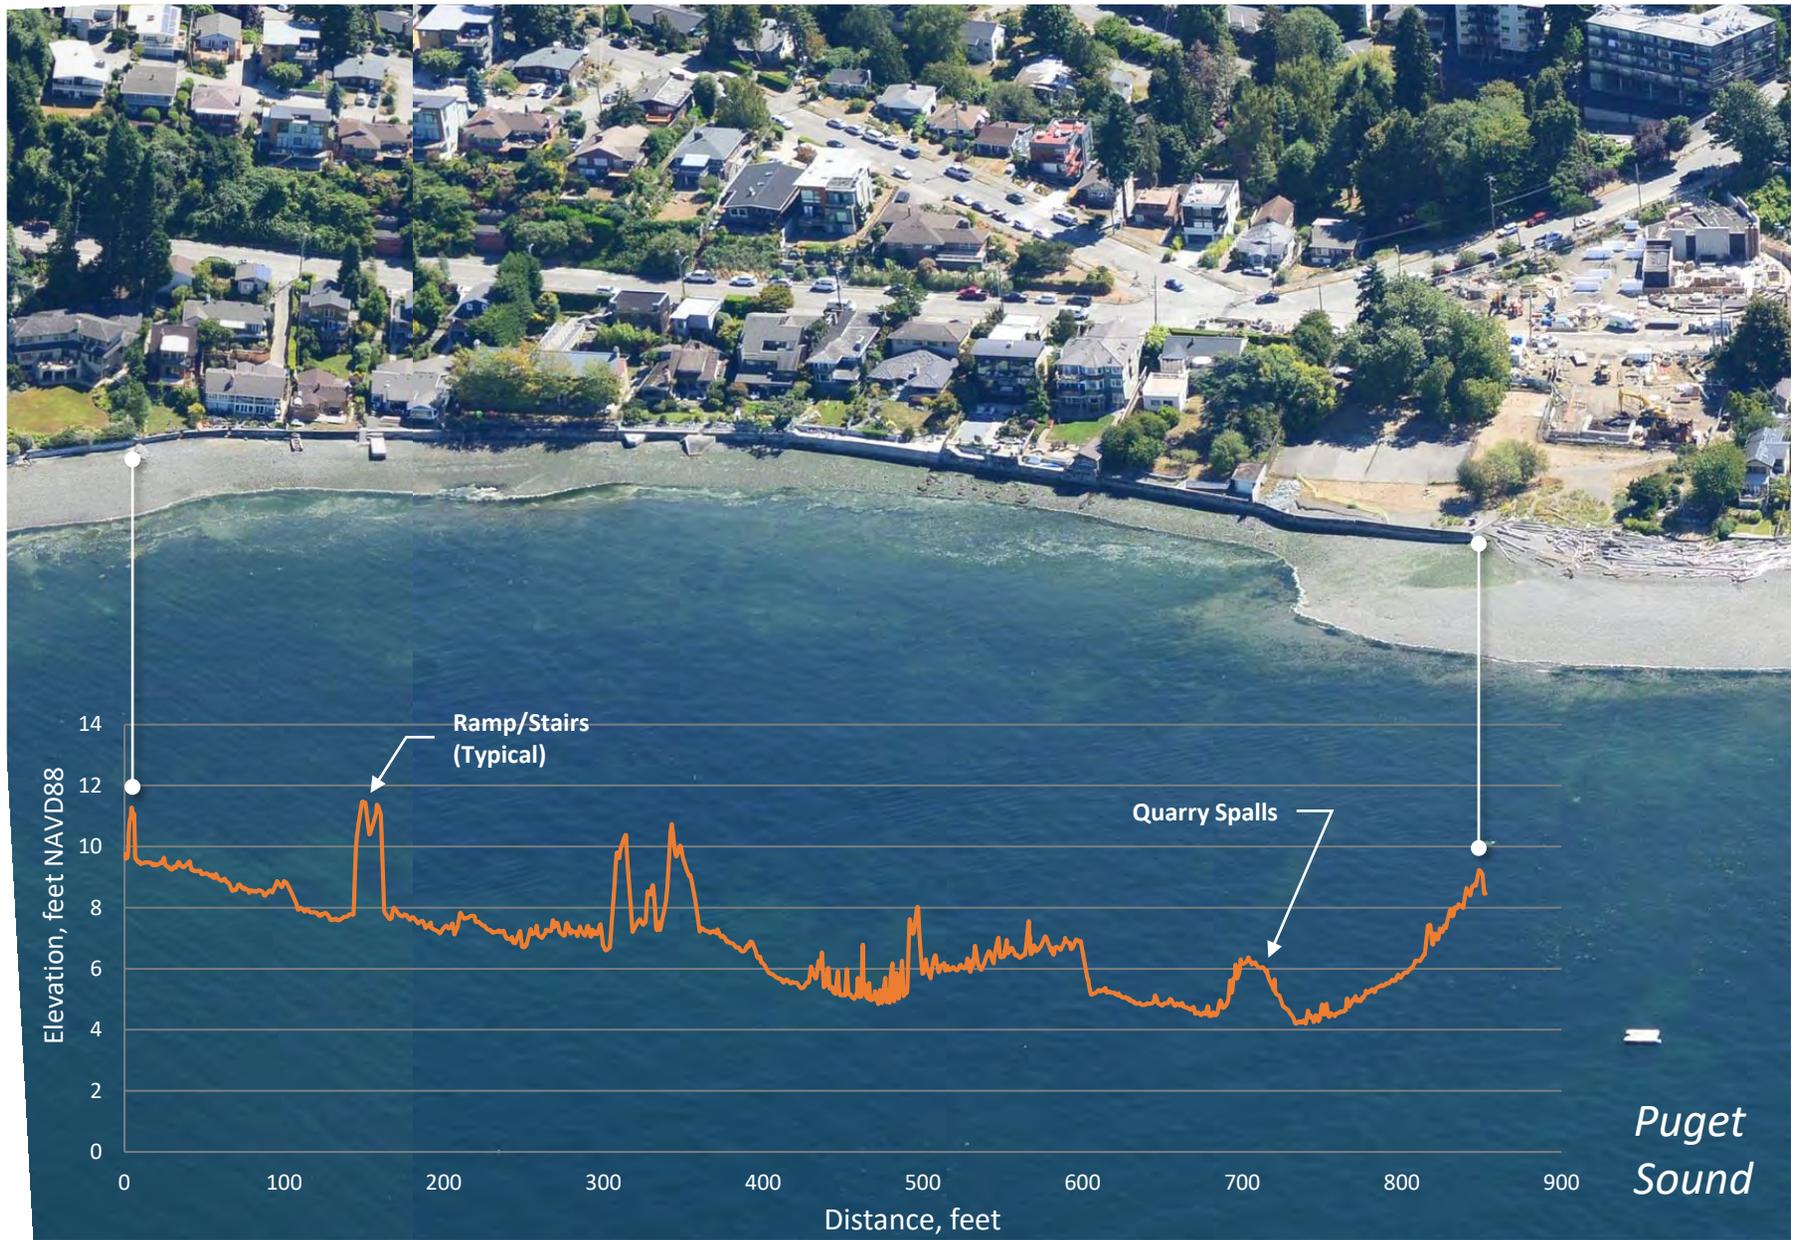
Figure 21
Beach Elevation Near Structure Toe
from 2016 King County LiDAR

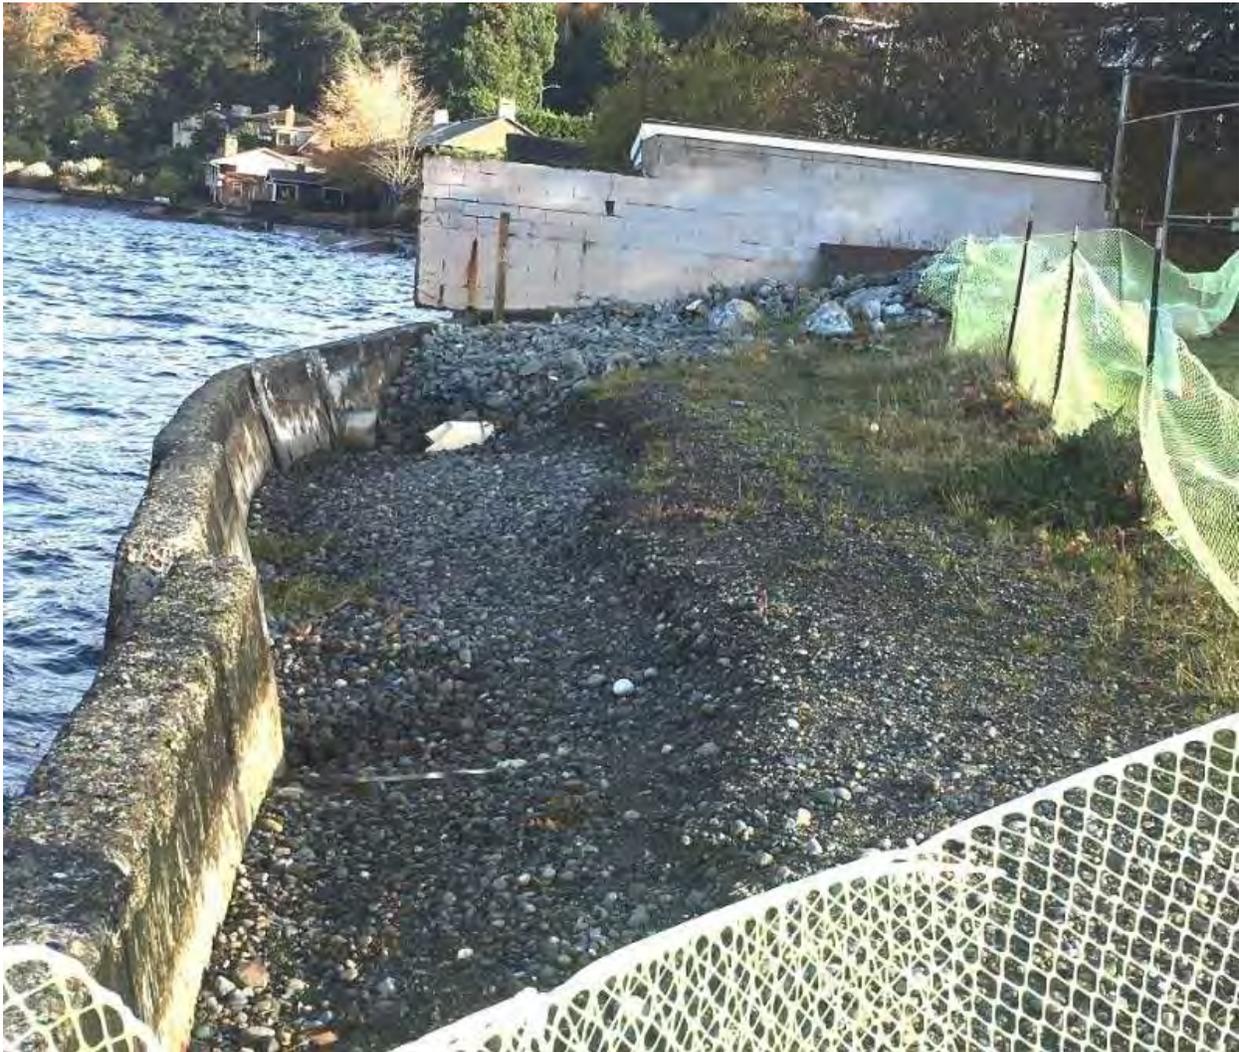
Figure 1. Failed Seawall (Photo taken on 10/18/2016).

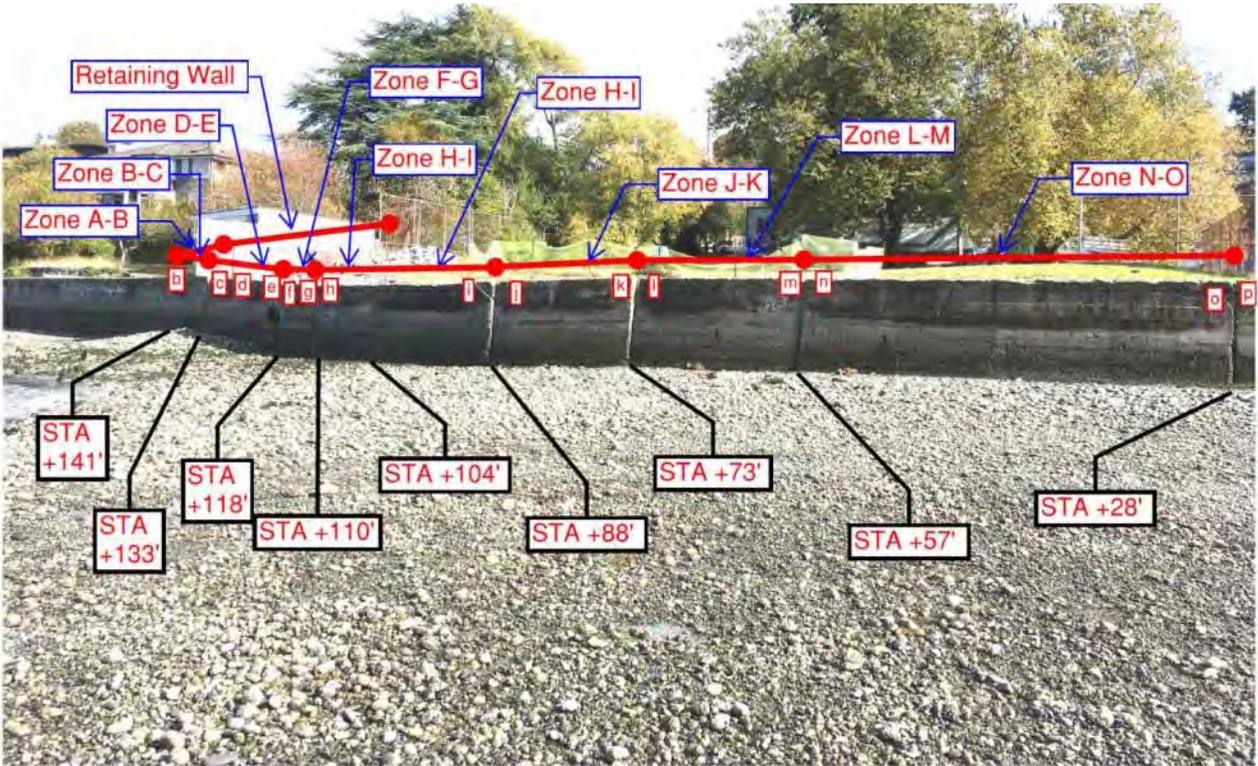
Photo 1. North Portion of Seawall.
 Source: Reid Middleton Site Visit 10/18/2016
 Note: Dimensions roughly field measured – for assessment purposes only.

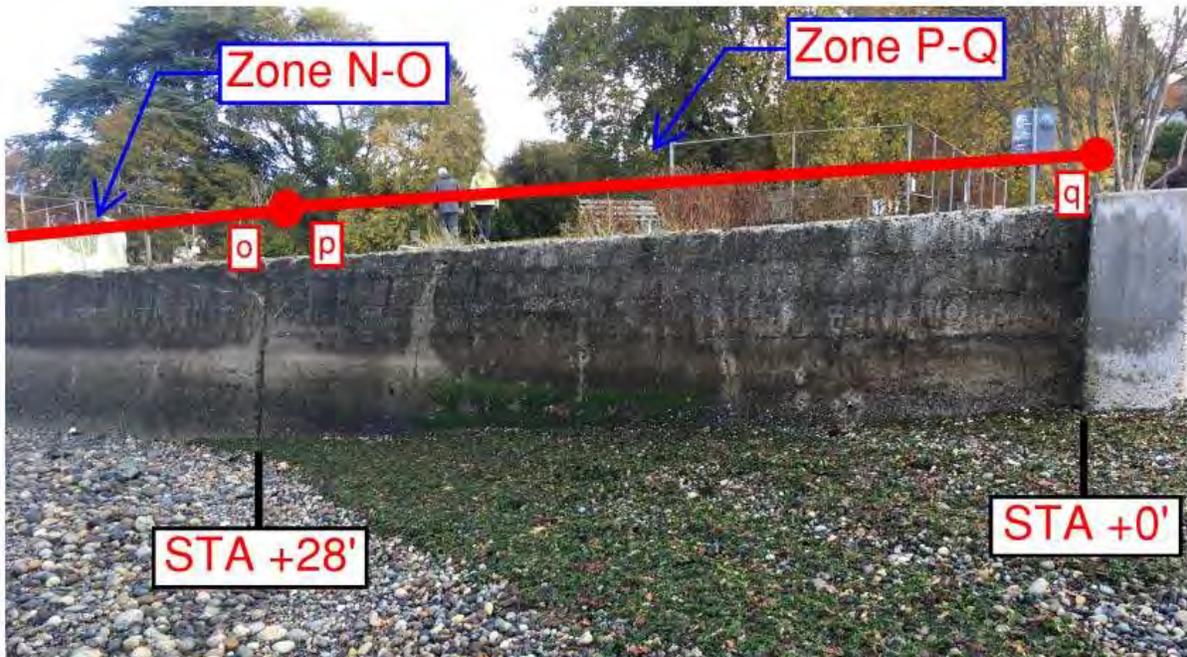
Photo 2. South Portion of Seawall.
 Source: Reid Middleton Site Visit 10/18/2016
 Note: Dimensions roughly field measured – for assessment purposes only.

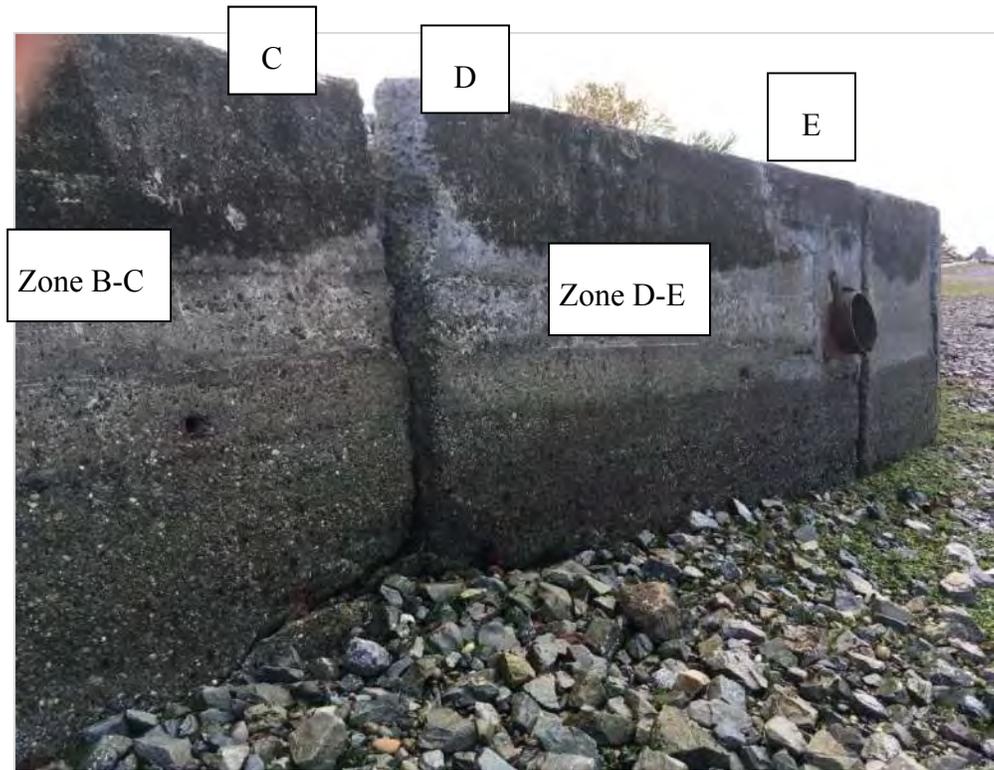
Photo 11. Zones B-C & D-E, Outfall.
Source: Reid Middleton Site Visit 10/18/2016

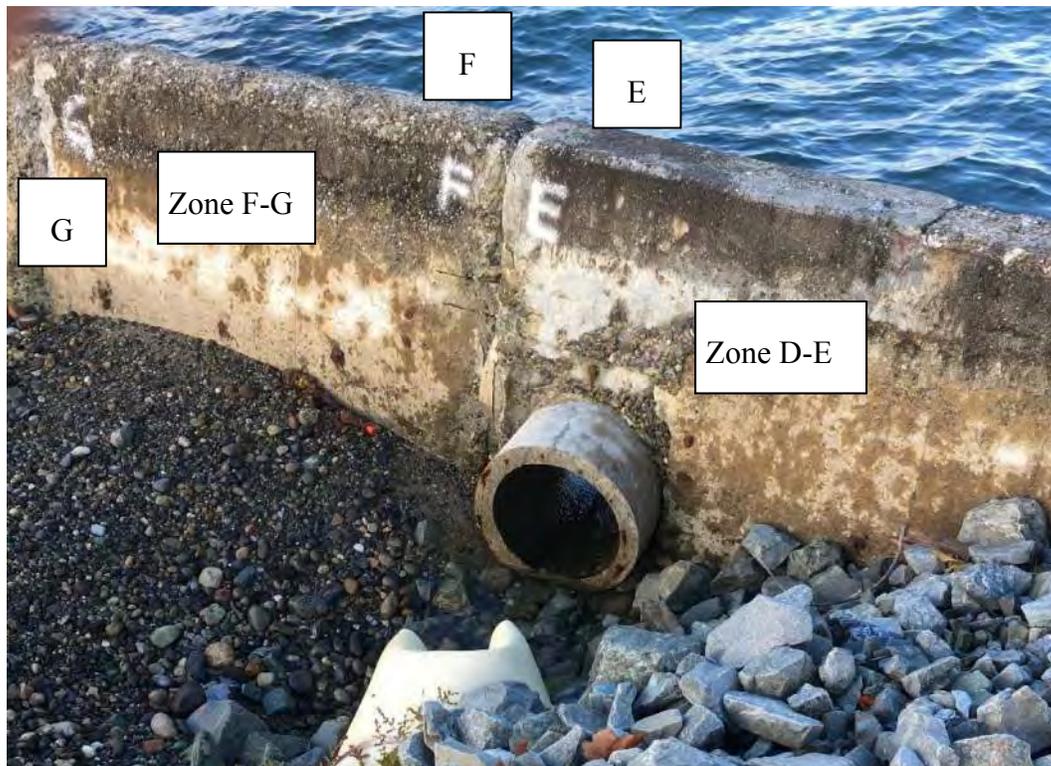
Photo 16. Zones D-E & F-G, Broken Outfall.
 Source: Reid Middleton Site Visit 10/18/2016

- Disconnect and divert the existing SPU outfall. Reconnection might further scour the seabed and exacerbate ongoing erosion, wall undermining, and accelerate wall movement.
- Coordinate with the property owner to the north to shore-up the cracked concrete block wall at the north property boundary.
- Isolate the existing seawall from public access, both above and below the seawall. As the wet season continues and soils become saturated wall failure is more likely and creates a potential life-safety risk for the public in the vicinity.
- Continue monitoring movement and condition of the seawall top and undermining at the toe. Be prepared to notify regulatory agencies of potential failure and need to implement emergency action. Conduct twice-yearly survey of beach topography in conjunction with ongoing wall monitoring.

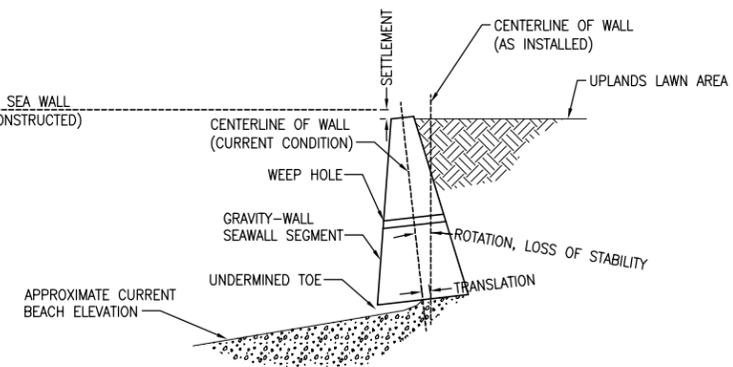
B SECTION - CURRENT SEAWALL CONDITION
SCALE: 1/4"=1'-0"
