January 18, 2019

To: Matthew Donahue - SDOT
From: Brett Commander - BDI
CC: Jamie O'Day - SDOT, Kyle Ramer - BDI
Re:

Attachments: West Seattle High Bridge Monitoring Summary

INTRODUCTION

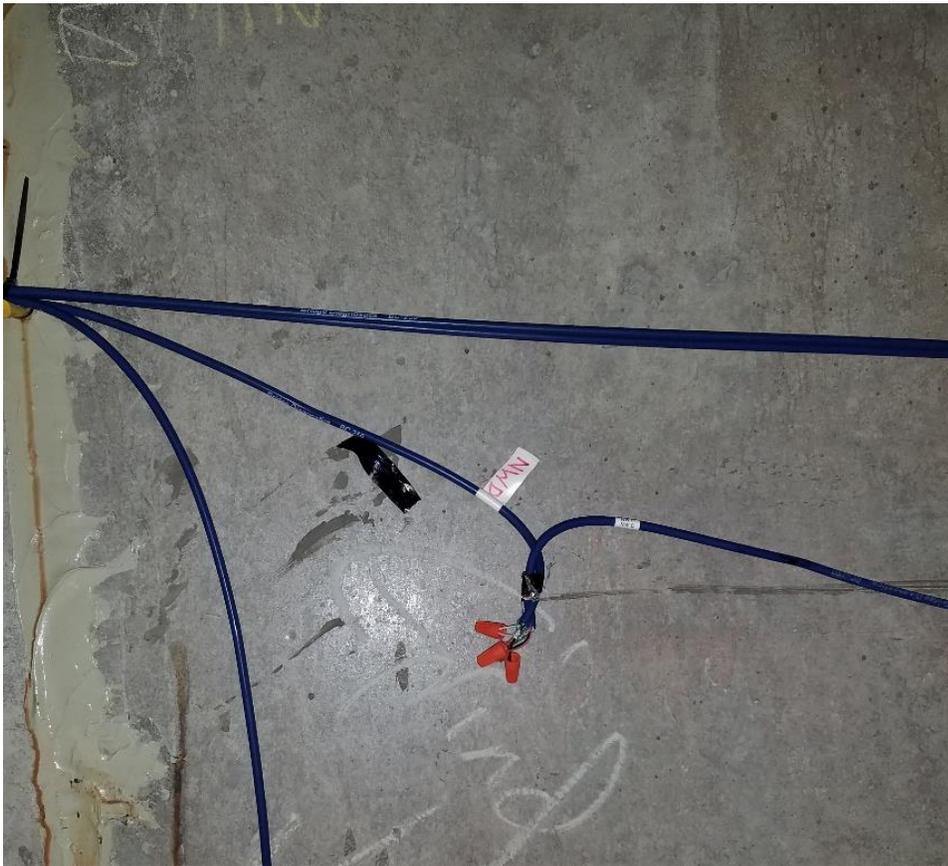
- Sensor wire field splices inside the boxes were of poor quality, consisting of twisted wires and wire nuts (Figure 1). These splices, although still functional, should be improved with crimped or soldered splice connections.

Figure 1 Sensor wire field splices

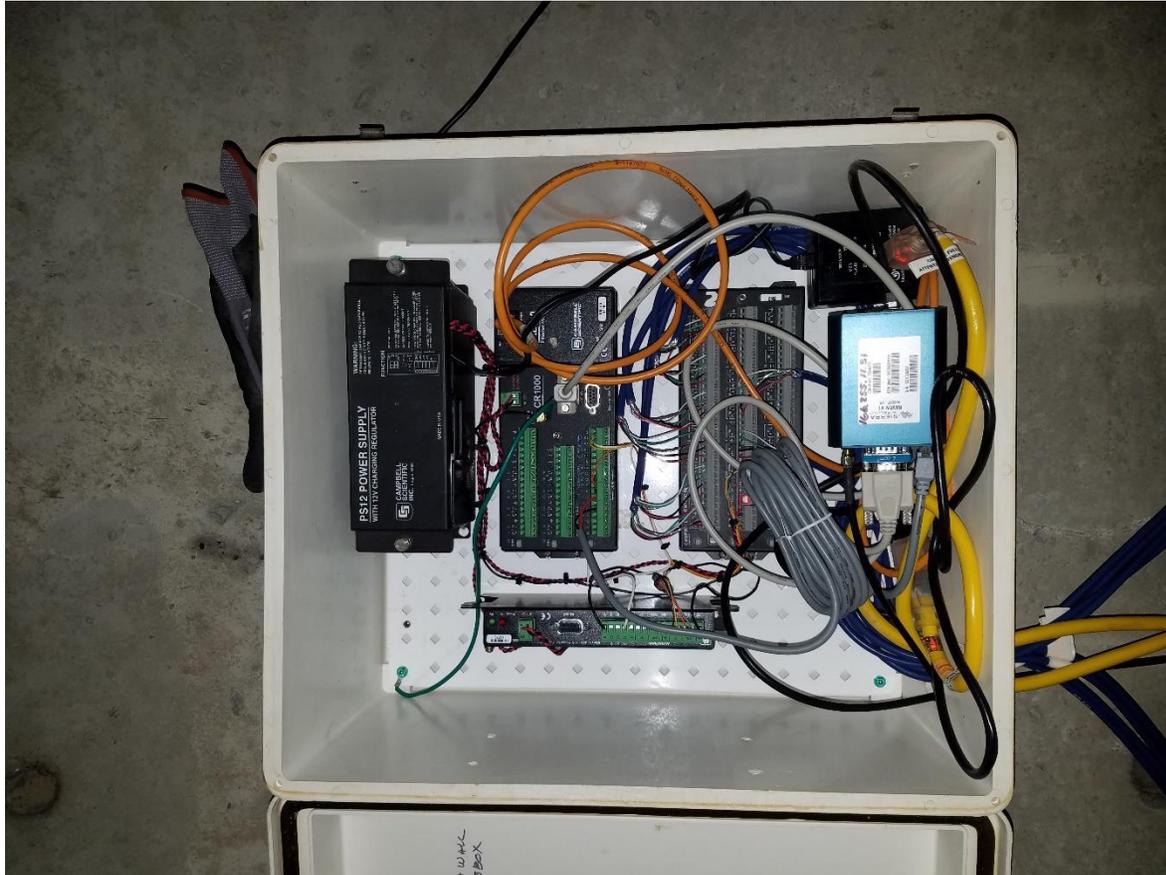
- The logger cabinet is at approximately midspan of the north girder. The logger cabinet consists of the following components (Figure 2):
 - CSI CR1000 logger

Figure 2 Existing logger cabinet consisting of CR1000 logger, AM16/32 multiplexer, RavenXT modem, AVW200 VW

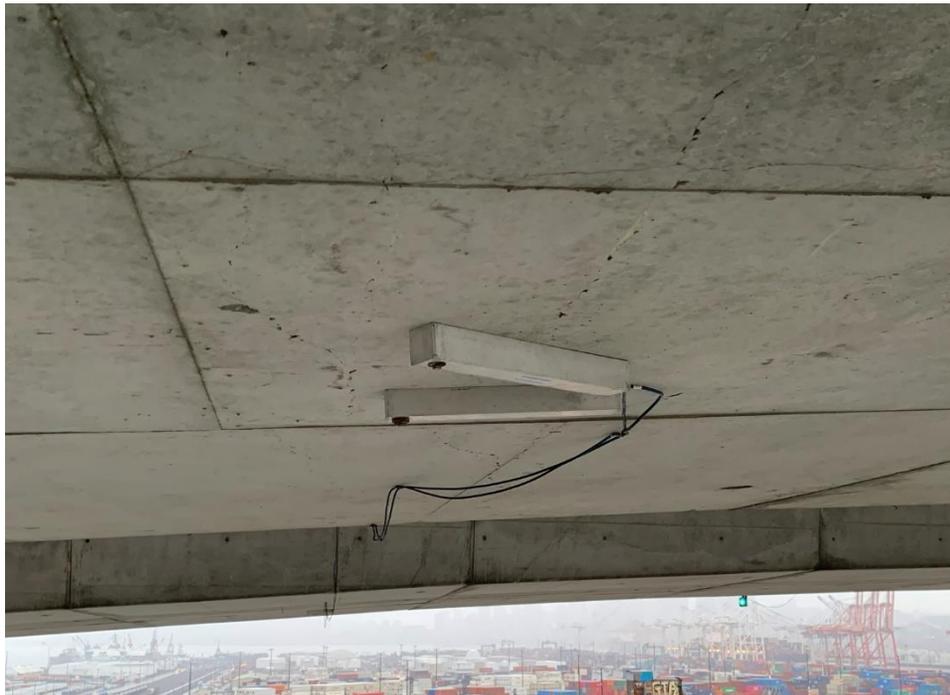
- The sensors themselves are mounted to the bottom surface of the box girders with 2 sensors on each of the 4 cracked segments. One crack gage crosses perpendicular to the crack and is oriented with the girder axis. The

other crack sensor crosses the same crack at a 45-degree angle (Figure 3). This was presumably done to determine if the crack movement was one directional.

Figure 3 Typical crack meter installation on soffit of box girders

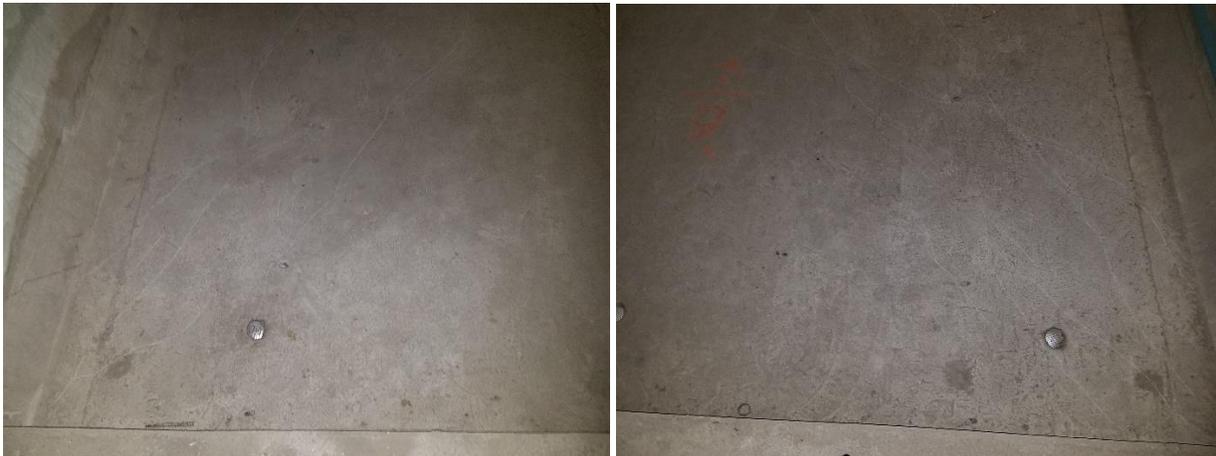
Cracks in the girder floor were observed in the 10th segment from the pier which was the first segment beyond the bottom flange main-span post tensioning. A peculiar observation was that cracks appeared to initiate from the web/flange interface and travel across the bottom flange at a 45-degree angle towards the pier and the center of the box. These cracks originated from both webs and met at the middle of the box which was also the interface with the adjacent segment. In general, bottom flange cracks did not appear to propagate into the adjacent (9th) segment as this was the point of intersection along the two diagonal crack lines. Several parallel lines of cracks existed and were at roughly 12-inch spaces. Figure 4 illustrates the formation of the bottom flange cracks as seen from inside the box.

Figure 4 Diagonal cracks across box floor originating from floor/web interface just beyond post tensioning anchorage

Hopefully the cracks do not present a concern from a load capacity or safety viewpoint, regardless the cracks do pose a threat to the long-term performance as they allow for the ingress of moisture, chlorides, and oxygen which can accelerate corrosion of the reinforcing steel. Therefore, it is recommended that all cracks in the bottom flange and the vertical webs be sealed with epoxy injection.

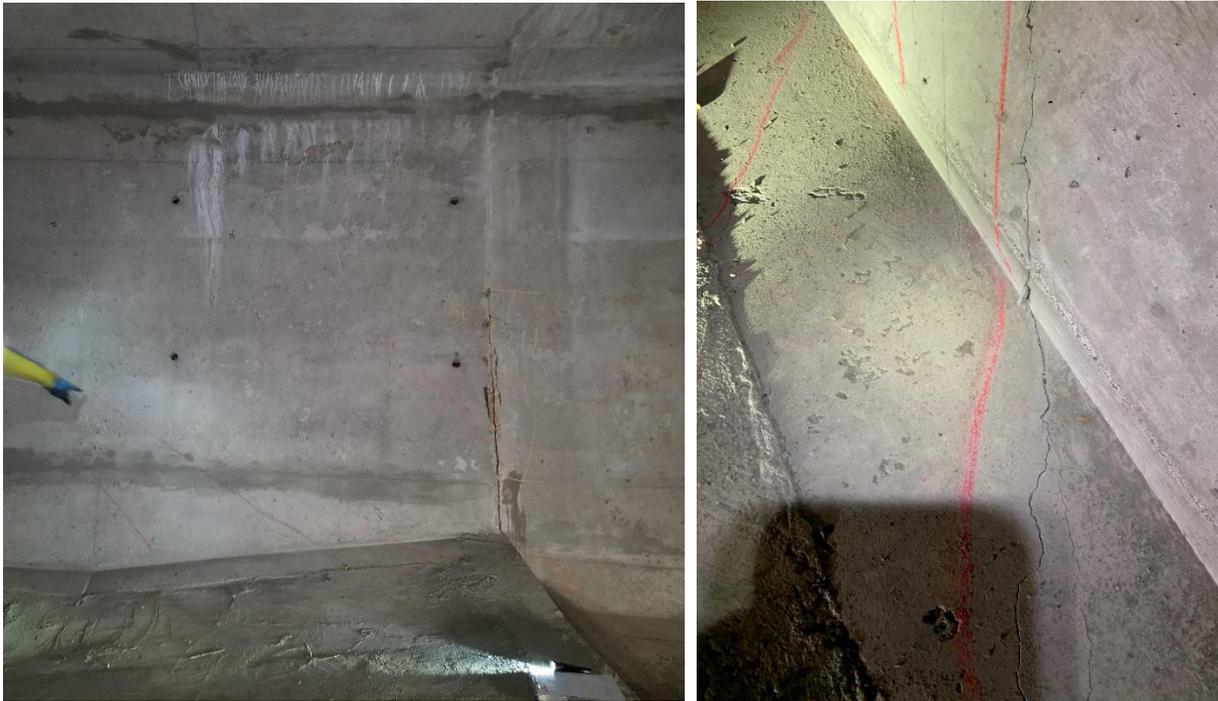
In addition to the bottom flange, cracks were observed in the box webs in the adjacent segments (11 and 12 from the piers). These cracks appeared to be classic shear cracks as they extended up the webs at a 45-degree angle. These cracks appeared to be extensions of the floor cracks as they originated at the same location along the flange/web interface. Figure 5 illustrate the location and pattern of the web cracks.

Figure 5 Diagonal shear cracks on box webs and at floor/web interface

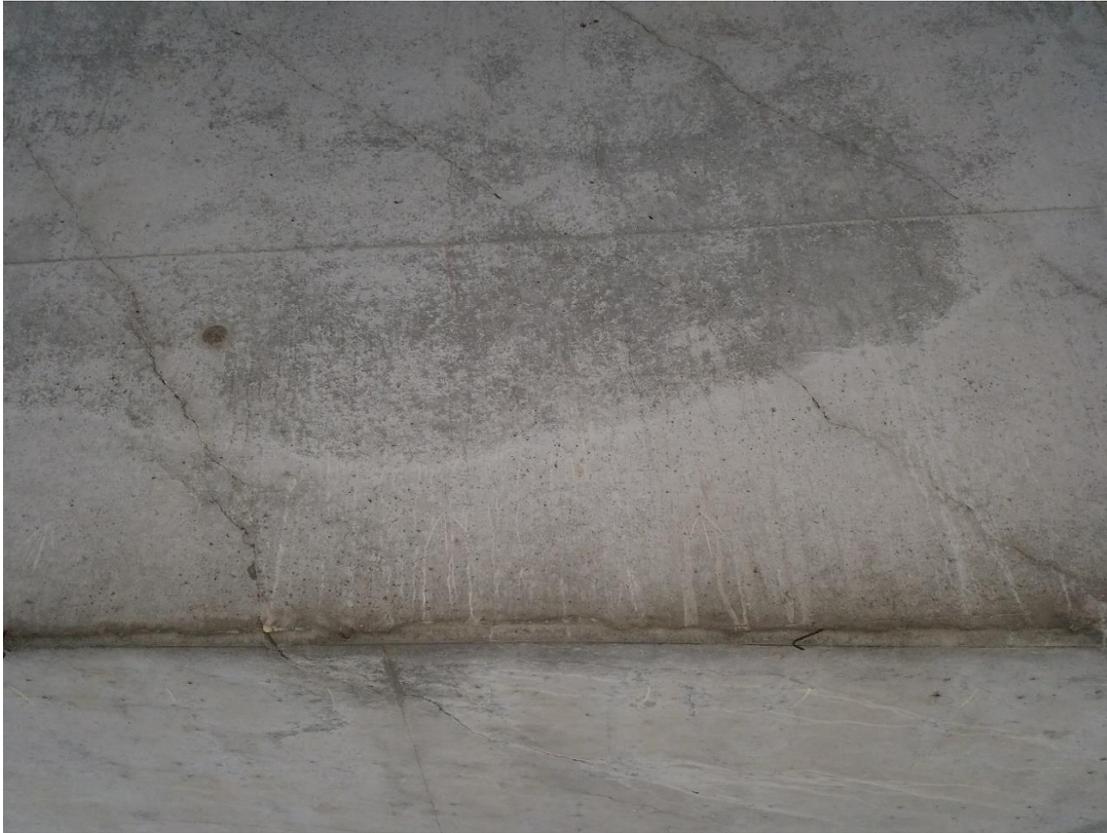
Crack formation observed from inside the box were essentially mirrored on the outside surface indicating they were all through cracks. Due to better lighting and a smoother concrete finish, cracks were much easier to see on the outer surfaces. As with the interior, the crack formation on the bottom flange was limited to the segment adjacent to the post-tensioning termination (10th seg from the pier). The web cracks appeared to extend from the bottom flange cracks and travel up the web at a 45-degree angle as shown in Figure 6. The web exterior web cracks were primarily visible in the 11th and 12th segment from the pier as shown in Figure 7.

Figure 6 Continuation of bottom flange diagonal cracks into web – exterior bottom flange / web interface.

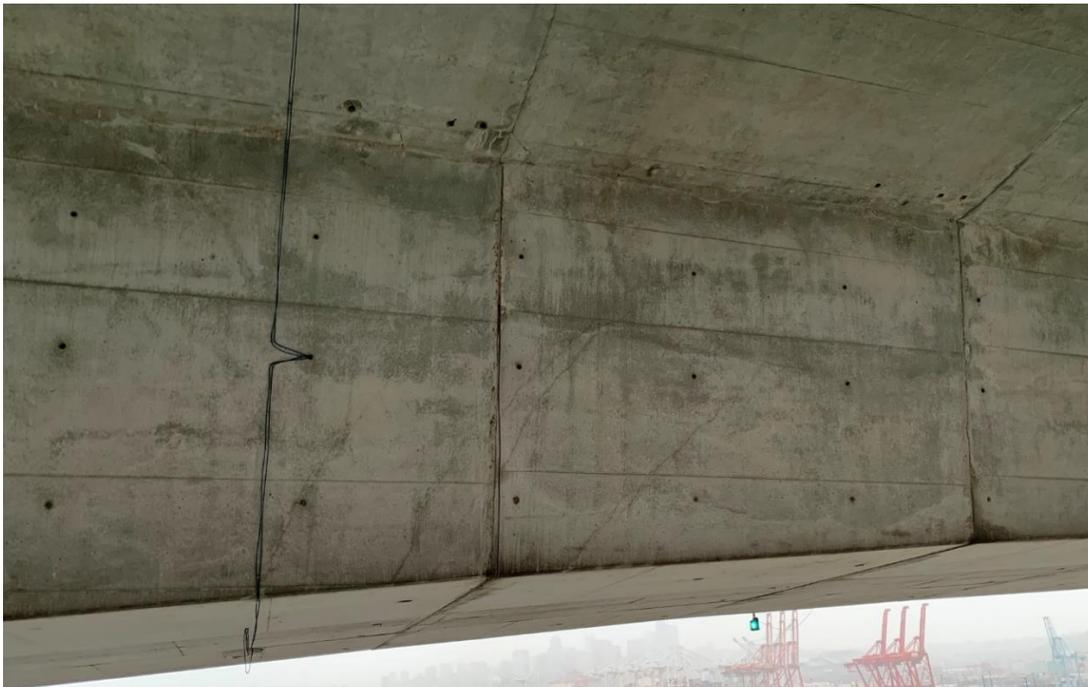
Figure 7 Diagonal shear cracks in exterior face of vertical web.

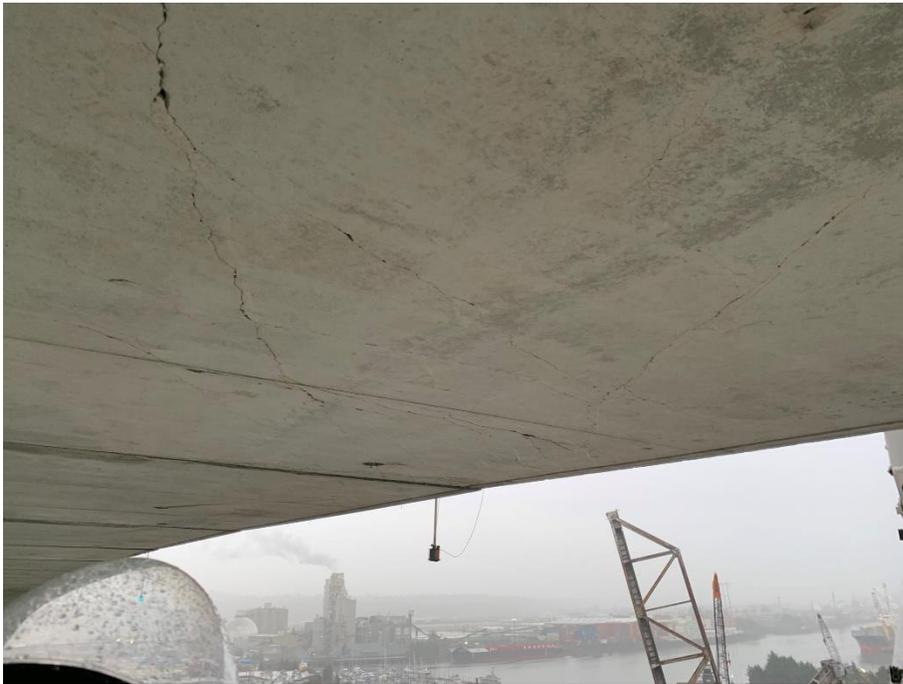
As was observed in the interior surfaces, the crack formation was very isolated to the same three segments (bottom flange @ Segment 10 and webs of segments 11 and 12) at each end of each box girder. One observation that was easier to detect from the outside, was a shift in orientation of the bottom flange cracks. Figure 8 shows bottom flange cracks which are oriented at a 45-degree angle near the edges of the girder tend to shift to a perpendicular orientation near the center of the box. From the outside, it was apparent that some bottom flange cracks did extend into the adjacent segment (#9 from the pier). Most of these were oriented across the girder indicating positive moment flexural activity (tension in the bottom flange).

Figure 8 Bottom flange diagonal cracks shifting to transverse cracks near middle of box girder.
