Special Bridge Inspection – August 26th, 2013

West Seattle High Level Bridge – BRG #131

Special Inspection of the cracks in the soffit of the main span box girder near segment 11 as counted from Pier 15 and Pier 16 in both the north and south box girders. The cracks were noted during the routine UBIT inspection earlier this year.

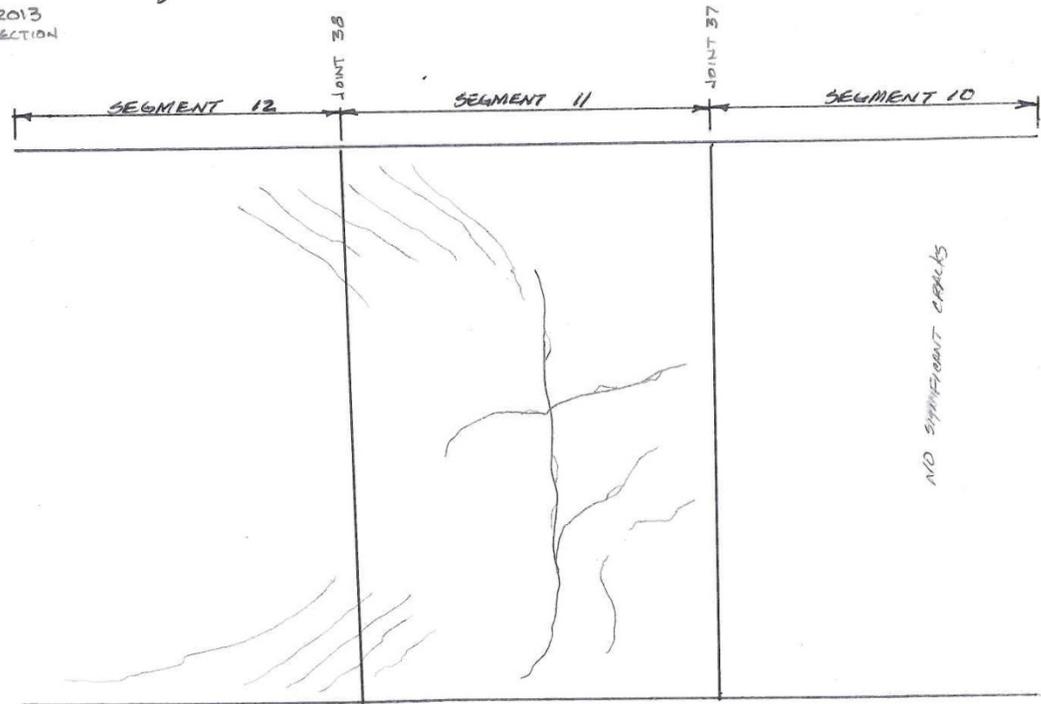
NORTHEAST BOX GIRDER SECTION

1. Segment 10 had no significant visible cracks.
2. Segment 11 had numerous cracks with the largest most predominant crack running in the transverse direction through the middle 2/3 of box girder width. Towards the north and south edges of the box girder bottom slab the cracks tended to become diagonal and in the direction of the center of the main span. Several cracks began as diagonal, originating near the north and south edges of the bottom slab and continuing into segment 12. The main transverse crack was located approximately 6' from the joint between seg. 11 and seg. 12. The most predominate longitudinal crack was located approximately 6 ½' from the south edge of seg. 11. Many of the cracks have signs of surface spalling with the largest spalls measuring 5" x 1" x ¾" deep. A feeler gage was used to approximate the surface opening of cracks that did not have surface spalls. Crack width measured up to 0.010". Magnification observation suggested that the cracks have significant depth. Previous inspection from inside the box girder did not detect significant cracks on the top surface of the bottom slab. Crack width varied from extremely tight to the measured widths up to 0.01. Spall areas were obviously wider. Faulting was observed across cracks. Although, minor, a detectable lip was observed in some locations, both visually and by rubbing your hand across the crack. Sounding of the concrete adjacent to cracks did not detect any delaminated areas. The concrete was sound. Bondo and a crack gage were installed at this segment location.

3. Segment 12 was relatively crack free except for the continuation of diagonal cracks originating from segment 11. A few of the diagonal cracks did originate in segment 12. All cracks were confined to the area near the north and south edges of the bottom slab.

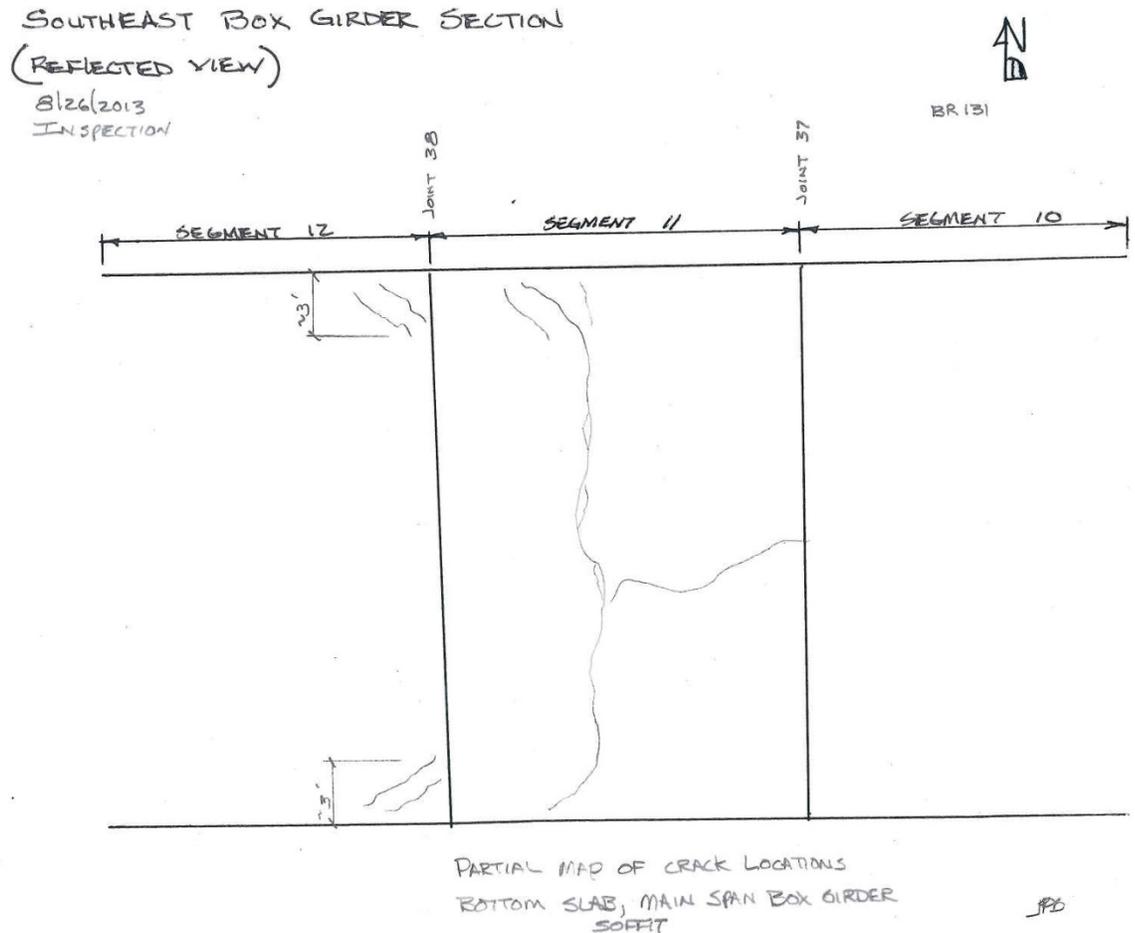
1. Segment 10 has no significant visible cracks.
2. Segment 11 has numerous cracks with one predominate crack that runs transverse. The crack patterns were similar to seg. 11 in the northeast section but significantly less severe in both number and apparent width. Due to the access limitation of the UBIT we were not able to reach segment 11, but observed the crack condition from approximately 10 feet. A monocular was used to magnify and inspect the cracks. The predominate transverse crack had two areas of spalling and transitioned from transverse to diagonal within approximately three feet of the north and south edges of the bottom slab. There was at least one longitudinal crack that was near the mid width of seg. 11.

- Segment 12 had no significant cracks noted except for diagonal cracks originating near the segment joint between seg. 11 and seg. 12 and confined to the approximately 3' from the north and south edges of the bottom slab.

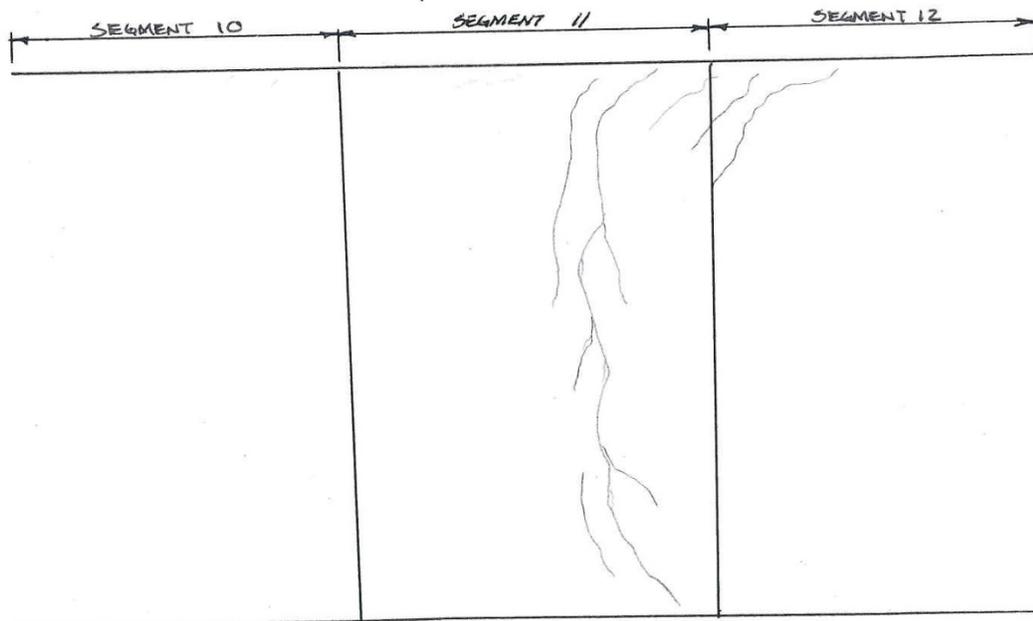
SOUTHWEST BOX GIRDER SECTION
(REFLECTED VIEW)
8/26/2013
INSPECTION

- Segment 10 had no significant visible cracks.
- Segment 11 had numerous cracks with one predominate crack that runs transverse. The crack patterns were similar to seg. 11 in the northeast section but significantly less severe in both number and apparent width. Due to the access limitation of the UBIT we were not able to reach segment 11, but observed the crack condition from approximately 10 feet. A monocular was used to magnify and inspect the cracks. The predominate transverse crack transitioned from transverse to diagonal within approximately three feet of the north and south edges of the bottom slab. The diagonal crack extended into seg. 12 and continued into the north web section. The web

diagonal cracks appeared as typical shear cracks and had an orientation of approximately 45 deg. to 60 deg. with the upper end towards the main span center. We did not have access to the south side of the box and could not verify that similar diagonal crack existed. A significant longitudinal crack was not observed.

3. Segment 12 had the continuation of diagonal cracks from seg. 11 in the approximately 3' near the north edge of the bottom slab. The south edge was not inspected due to access limitations.

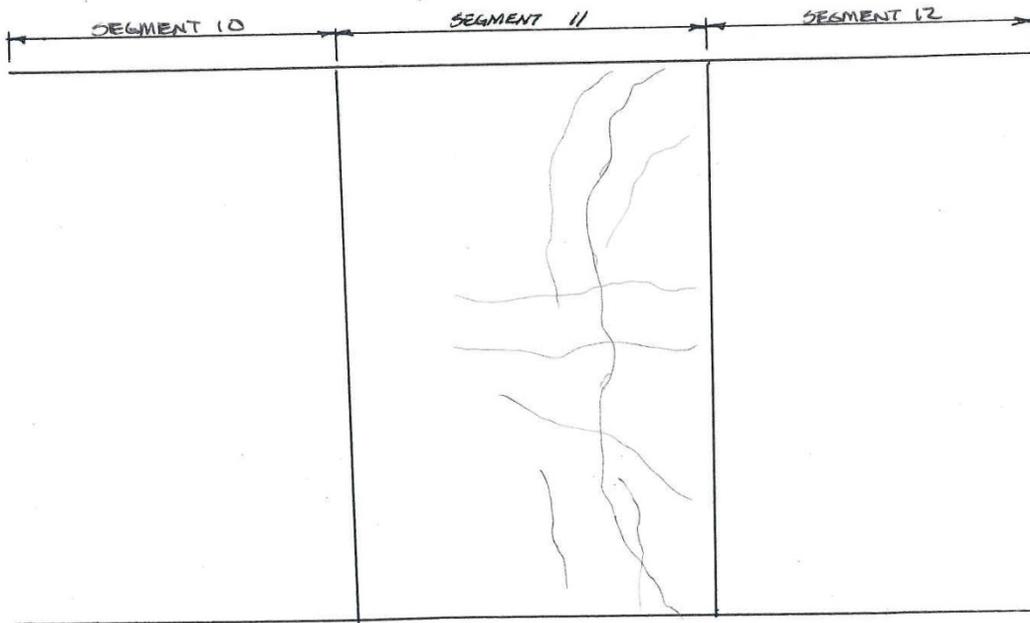
NORTHWEST BOX GIRDER SECTION
(REFLECTED VIEW)

1. Segment 10 had no significant visible cracks.
2. Segment 11 had numerous cracks with one prominent crack that ran transverse. The crack patterns were similar to seg. 11 in the northeast section but significantly less severe in both number and apparent width. Surfacing spalling of cracks is visible. Similar to other segments the transverse crack trends to a diagonal crack as it approaches the north and south edges of the bottom slab. The predominate transverse

crack is located 5'-5" from the joint between seg. 11 and seg. 12. Other diagonal cracks originate near the north and south edges. The diagonal cracks do not extend significantly into segment 12. There are approximately three longitudinal cracks that are near the mid-width of seg. 11.

- 3. Segment 12 did not have any significant visible cracks.

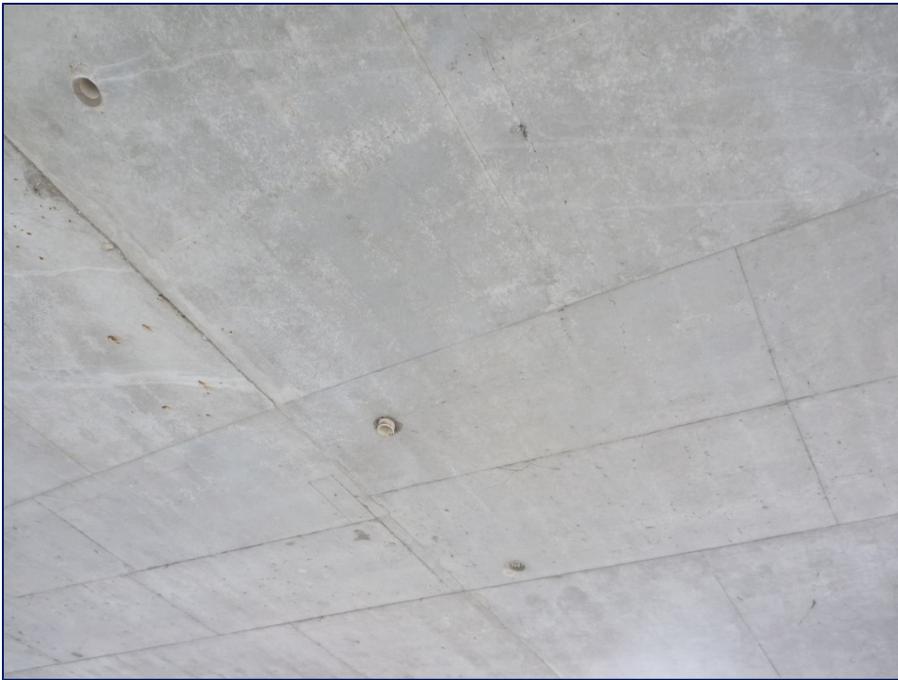
Photo #1 N/E Section - Prominent transverse crack

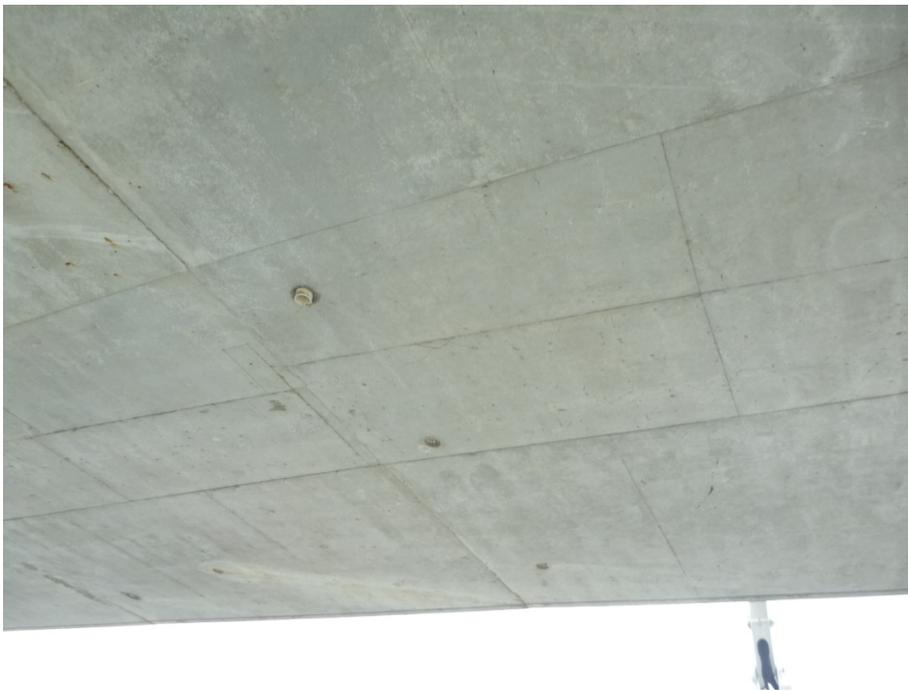
Photo #2 N/E Section, Segment 11 – transverse crack transitioning to diagonal

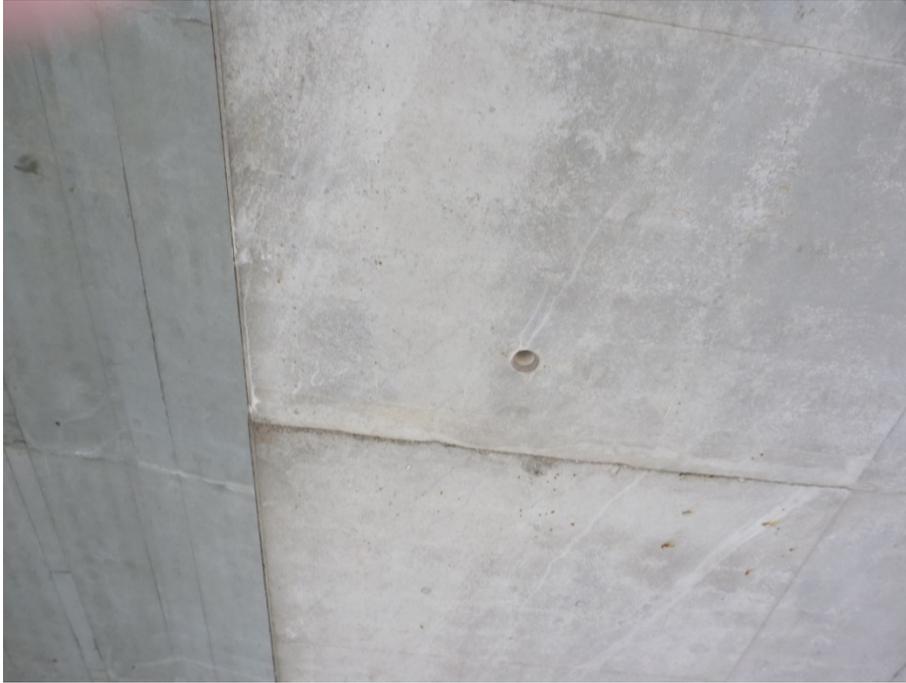
Photo #3 N/E Section, Segment 11 – diagonal cracks spanning into segment 12

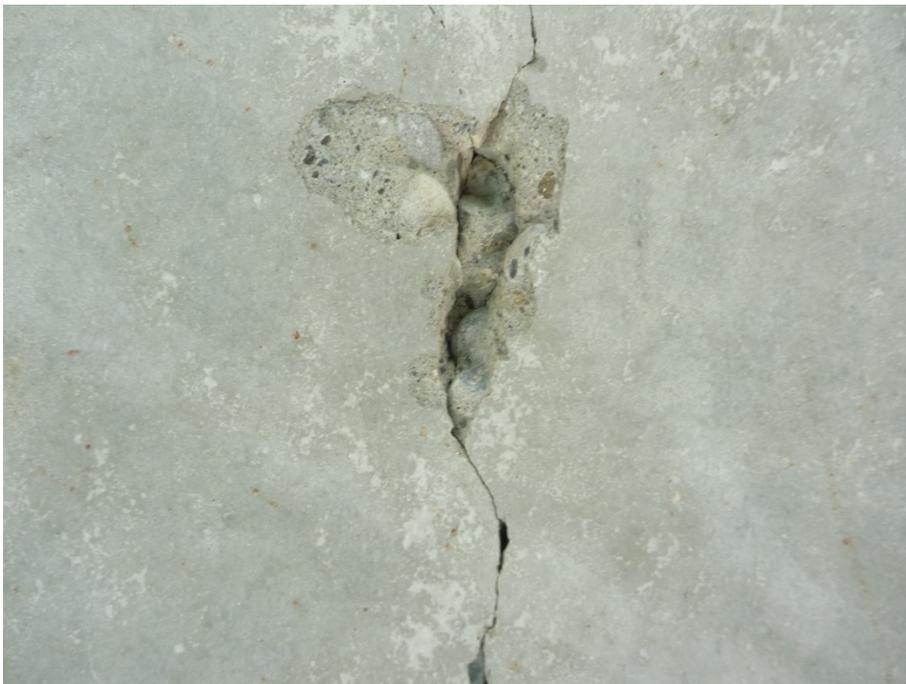
Photo #4 N/E Section, Segment 11 - close up on transverse crack with spalling, 5"x1"x3/4"

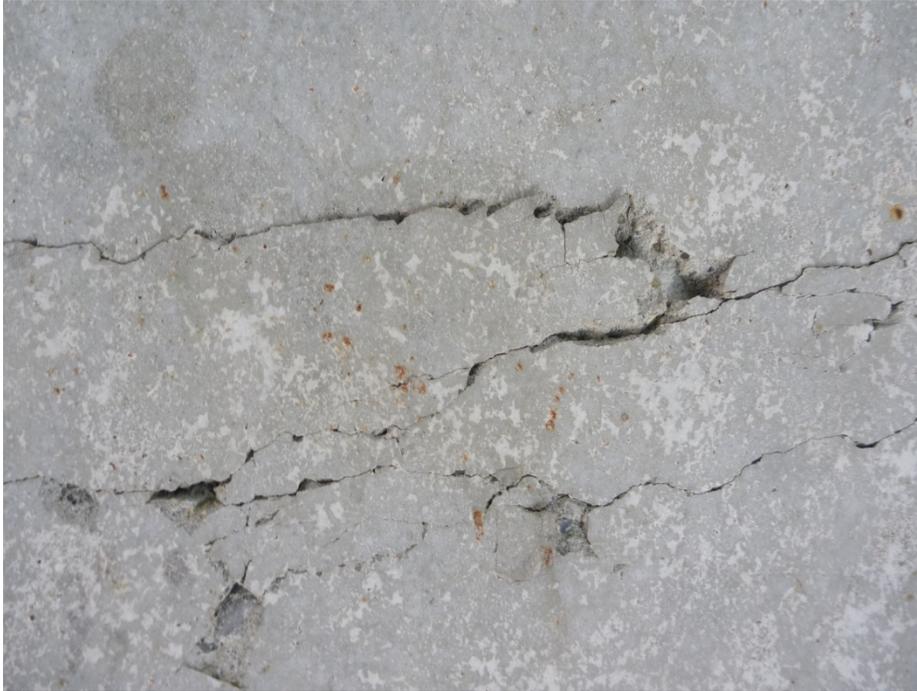
Photo #5 N/E Section, Segment 11, close up of transverse crack

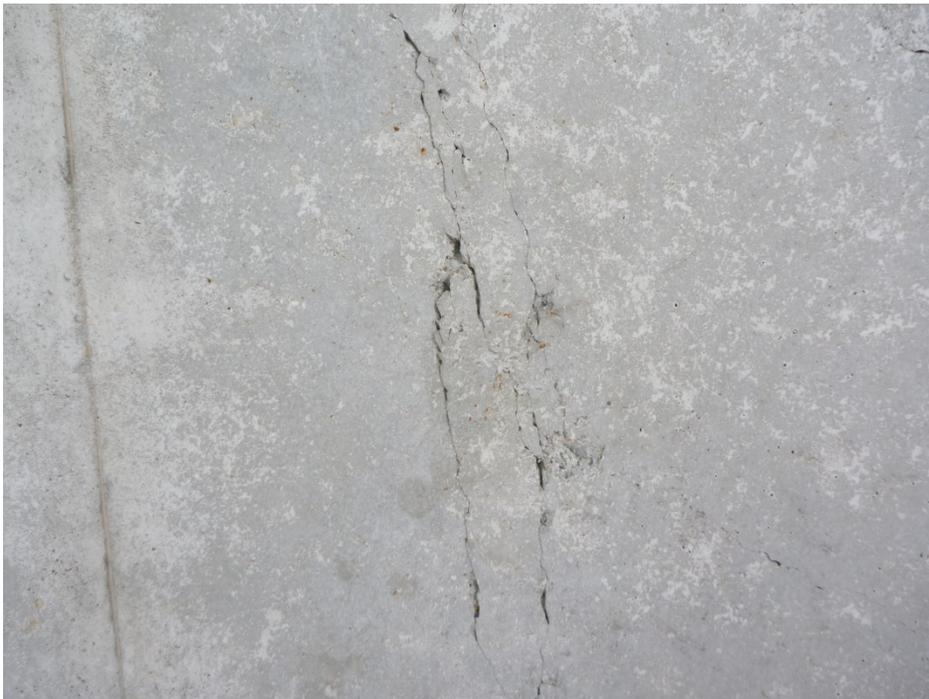
Photo #6 N/E Section, Segment 11, same location as Photo #5

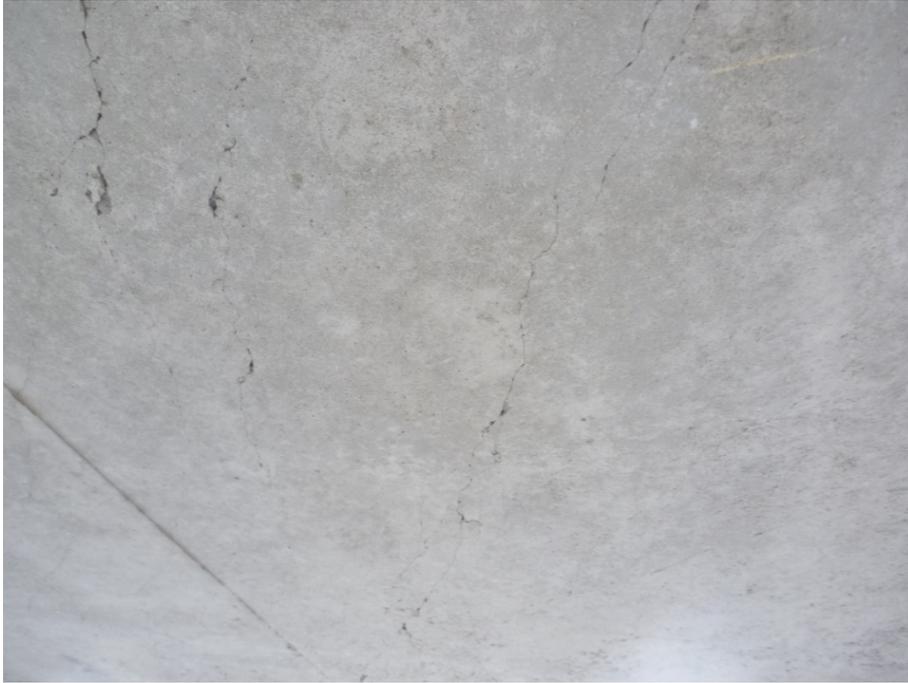
Photo #7 NE Section, Segment 11, typical cracks

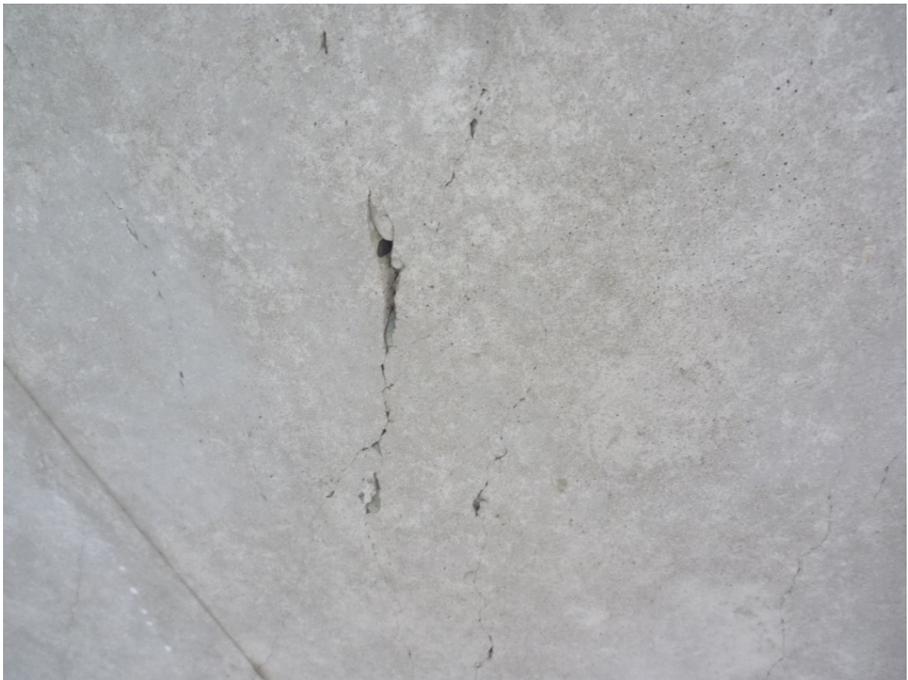
Photo #8 NE Section, Segment 11, typical cracks

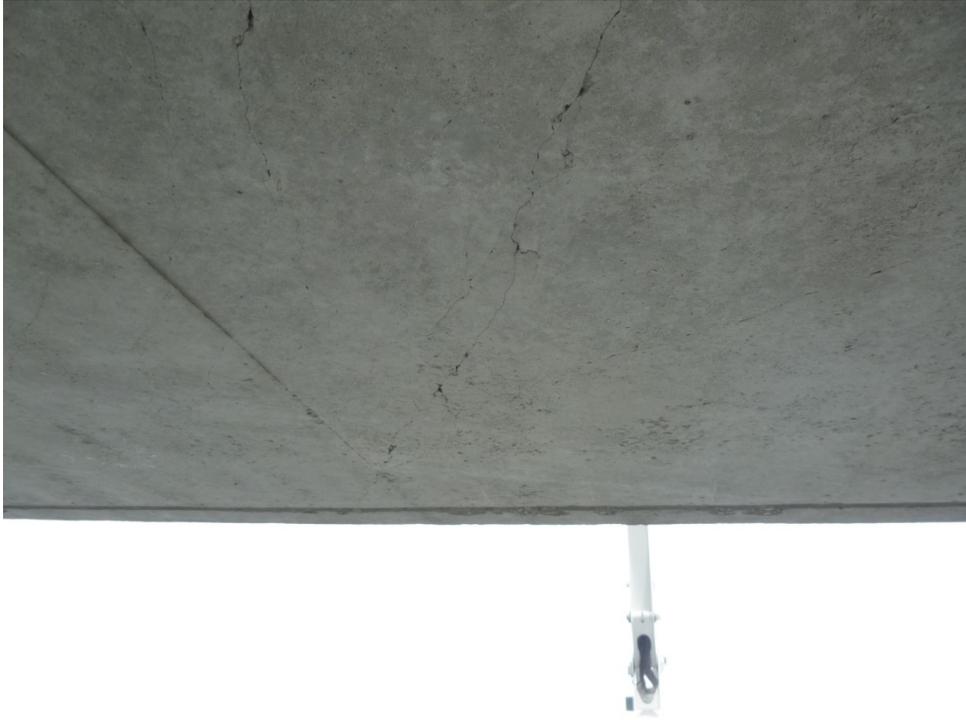
Photo #9 N/E Section, Segment 11, Cracks transitioning to diagonal near web.

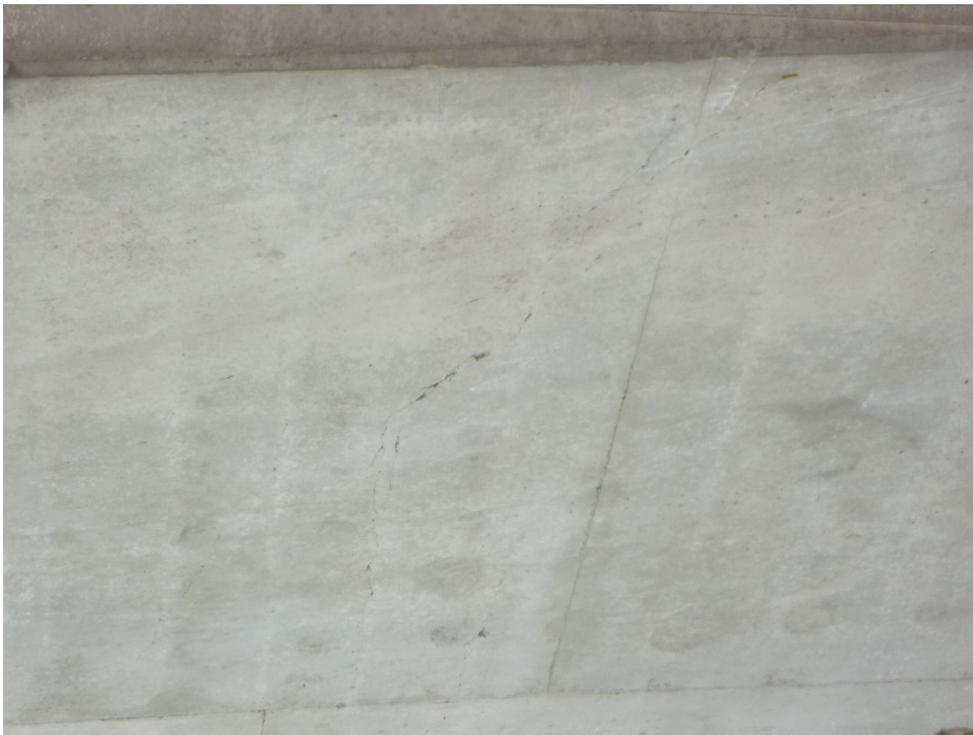
Photo #10 S/E Section, Segment 11, typical crack

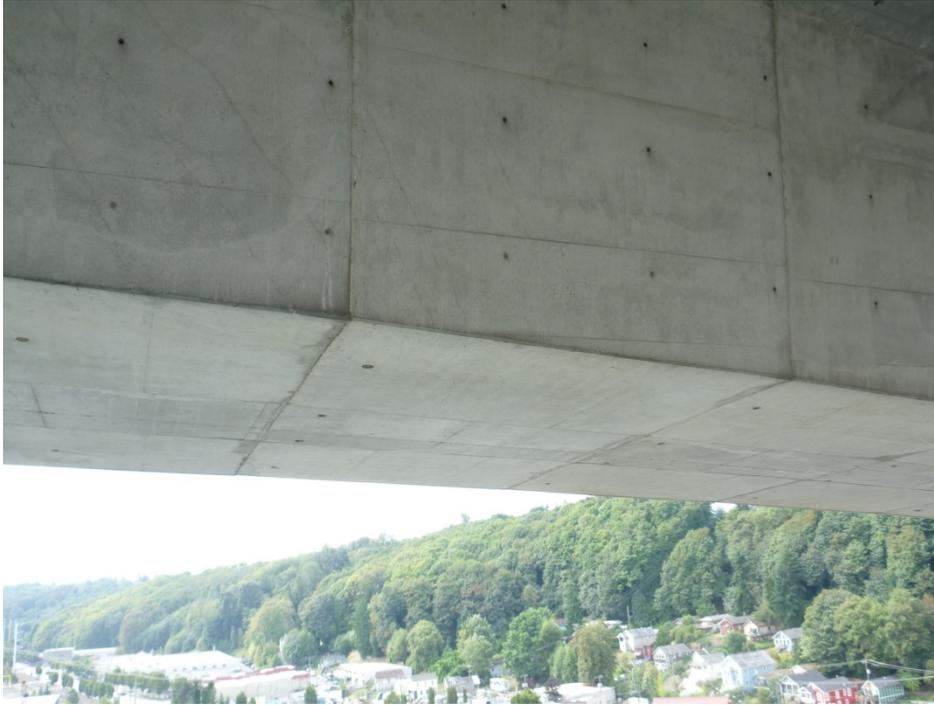
Photo #11 S/W Section, Segment 11/12, continuous cracks into web

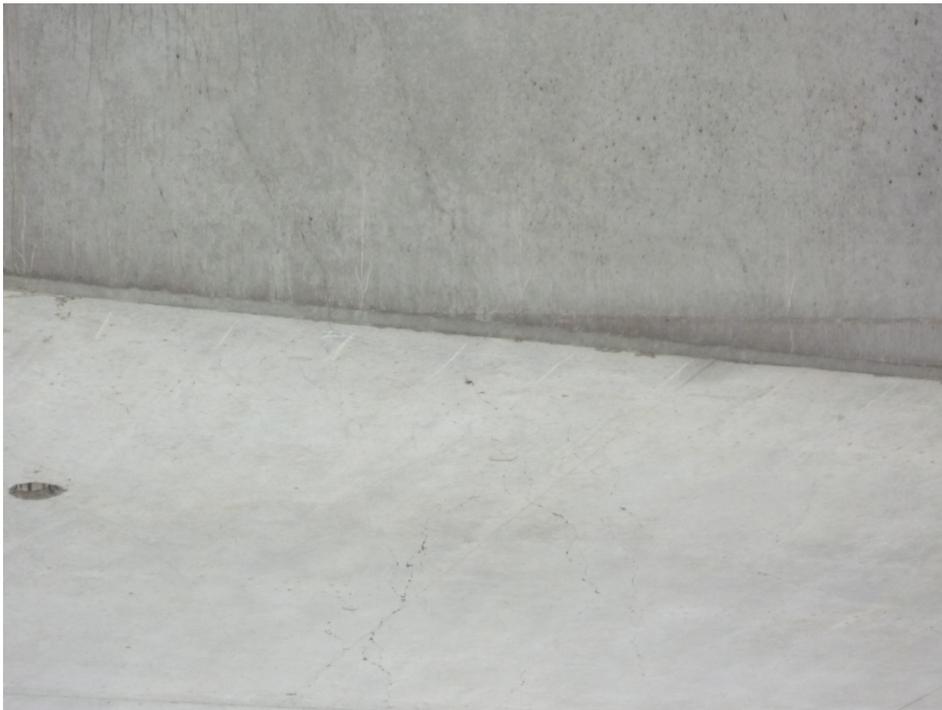
Photo #12 S/W Section, Segment 11, close up of continuous cracks into web

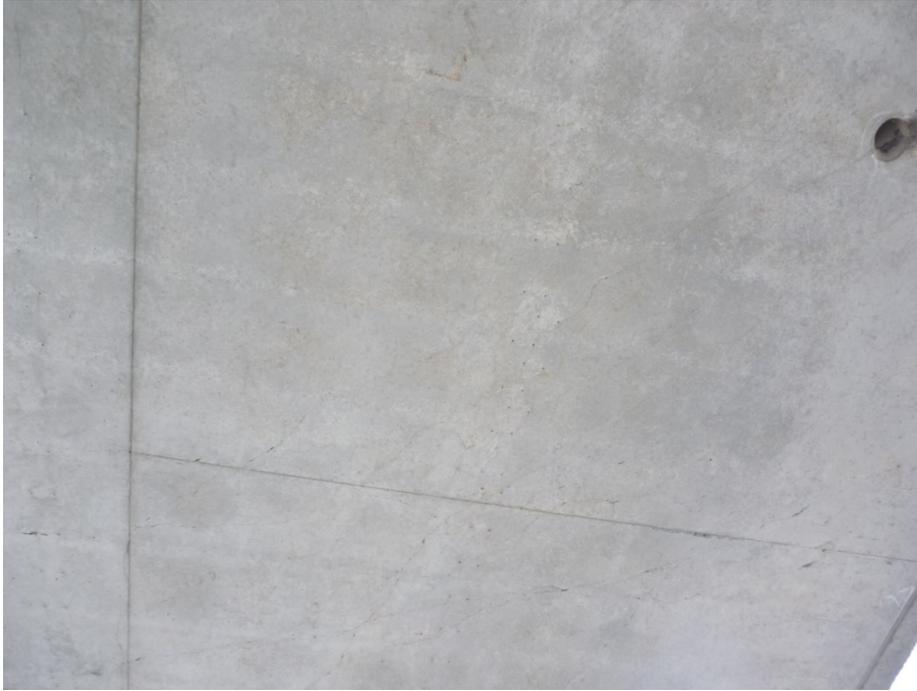
Photo #13 N/W Section, Segment 11, typical cracks

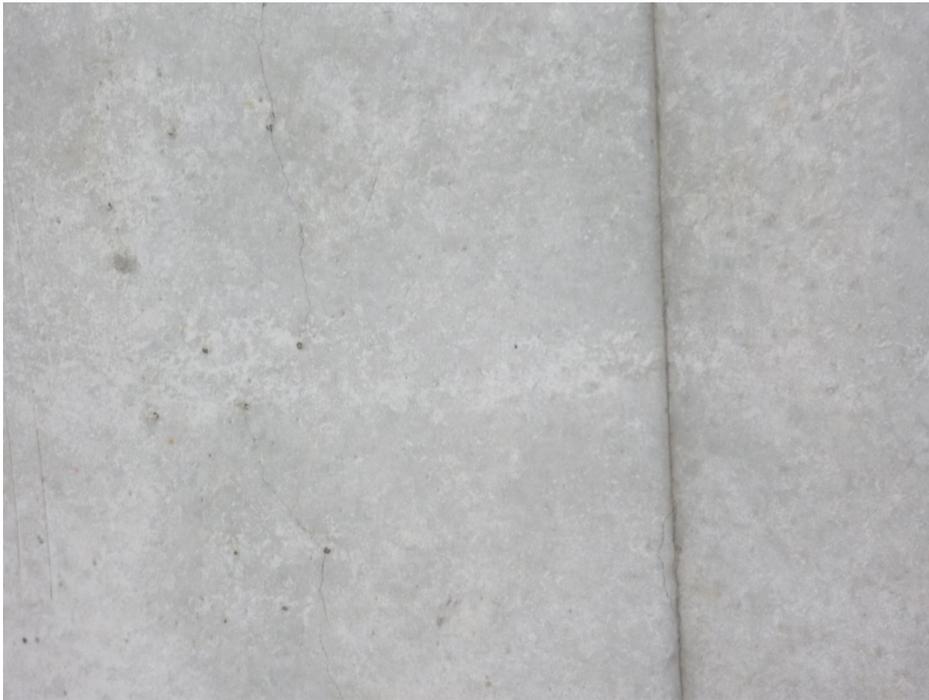
Photo #12, N/W Section, Segment 11, typical cracks
