City of Seattle Parks & Recreation Department

# LOWMAN BEACH PARK SEAWALL CONDITION ASSESSMENT

Seattle, Washington

Nov 30, 2017  
ESA # D160292.00

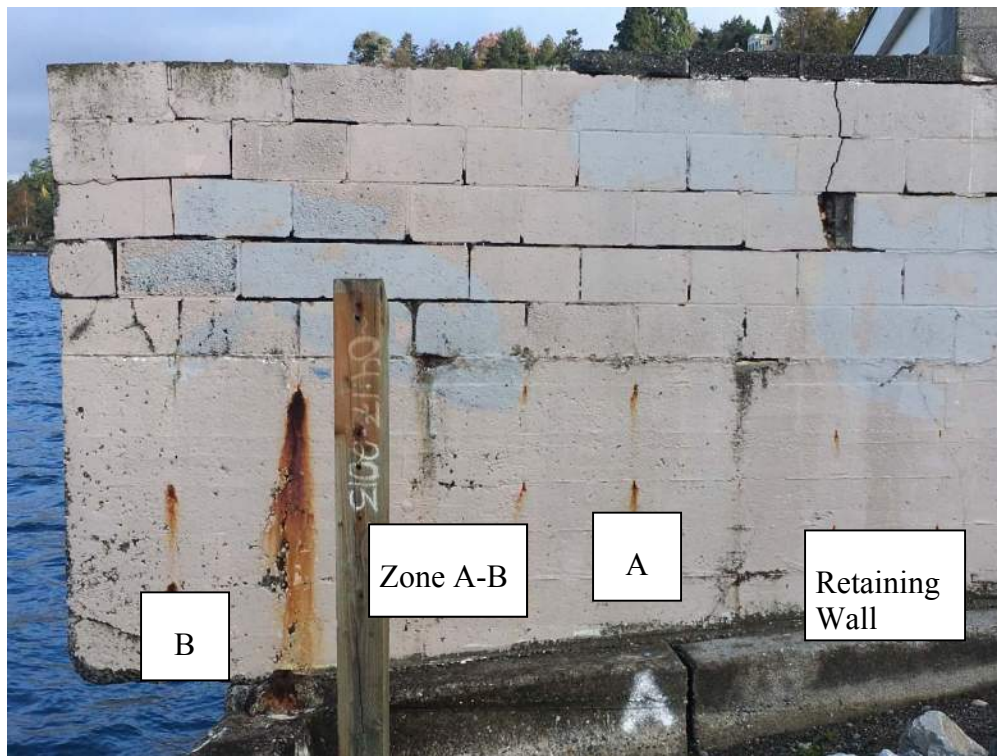
ITEM	PHOTO	RATING	EXISTING CONDITION
North Retaining Wall Origin: Unknown, likely 1950's	5, 6	Fair	Structural: Not much visible, no damage notes. CMU privacy wall on top of retaining wall in serious condition. Length unknown, wall terminates underground Toe: N/A Rotation & Settlement: N/A
Zone A-B Length = 5'  Origin: 1950's	5, 6, 7, 8	Fair	Structural: Some spalling <sup>1</sup> at mudline where intersects Zone B-C. Toe: Exposed, material loss beginning, not protected. Rotation & Settlement: Minimal, has return portion perpendicular to shoreline that adds stability.
Zone B-C (8') Zone D-E (15') Zone F-G (8') Zone H-I (22') Zone J-K (15') Origin: 1950's	10 - 24	Critical	Structural: Cracking and spalling <sup>1</sup> . Original seawall segments have broken full-height into smaller segments. Toe: Exposed, material loss below wall, not protected. Rotation & Settlement: Segments appear to have rotated outwards and translated away from shore. Multiple segments broken full-height due to differential settlement.

Photo 6. Zone A-B, Adjacent Property.  
 Source: Reid Middleton Site Visit 10/18/2016

4. Zone A-B (1950's era) of the existing seawall could likely be reused, though it should be secured to the concrete retaining wall running shoreward and the toe protected from further erosion.

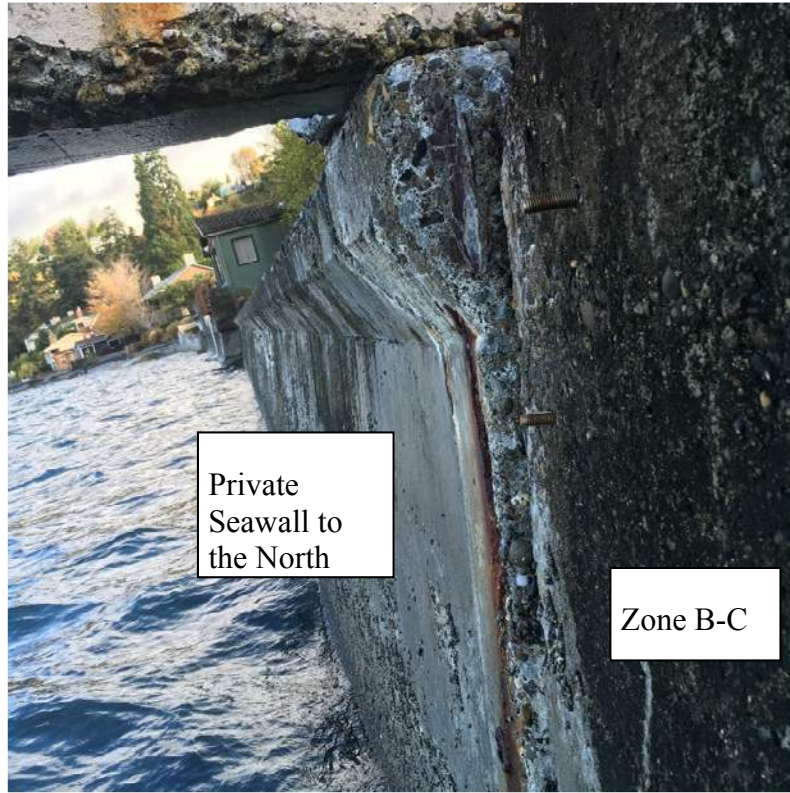
To the north of the Lowman Beach seawall is a private residence. There is a seawall protecting this private residence roughly in-line with the existing Lowman Beach Park seawall. This private seawall appears to be concrete construction, similar to the other walls in the vicinity and presumably subject to similar failure mechanisms as the Lowman Beach seawall.

Photo 9. Private Seawall to the North.  
 Source: Reid Middleton Site Visit 10/18/2016

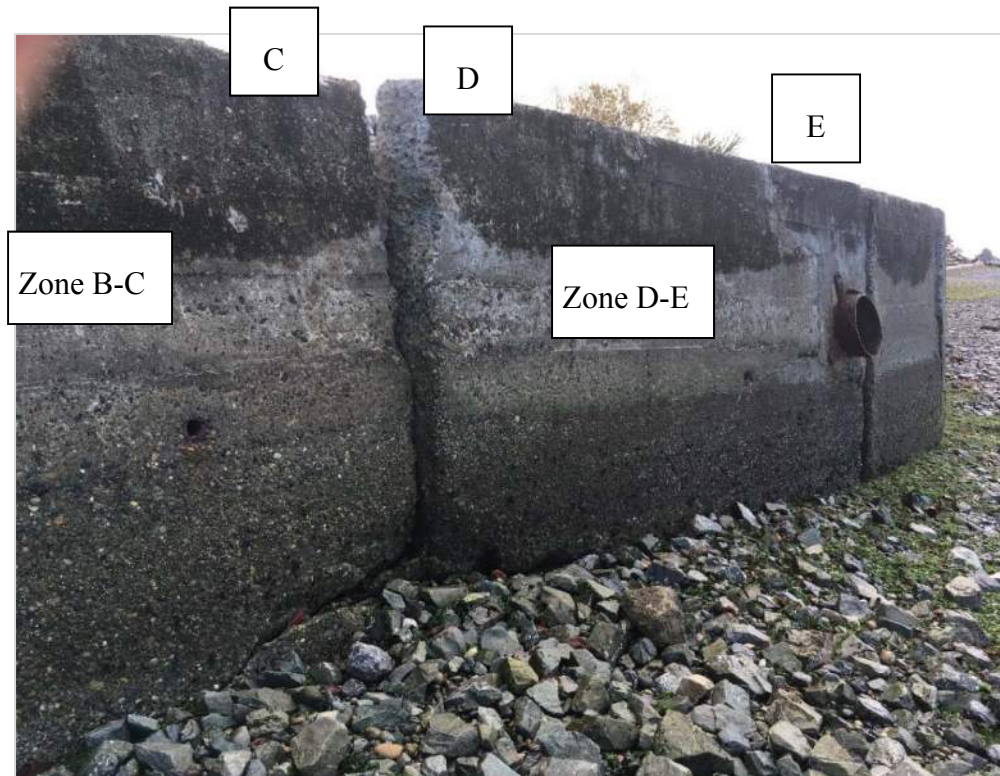
An existing storm outfall connection was disconnected within Zone D-E due to translation and rotation of the seawall. It is anticipated that soil will continue to be washed out from behind and below the existing seawall at the location of the disconnected storm outfall, accelerating the already occurring failure of the seawall.

Photo 11. Zones B-C & D-E, Outfall.  
Source: Reid Middleton Site Visit 10/18/2016

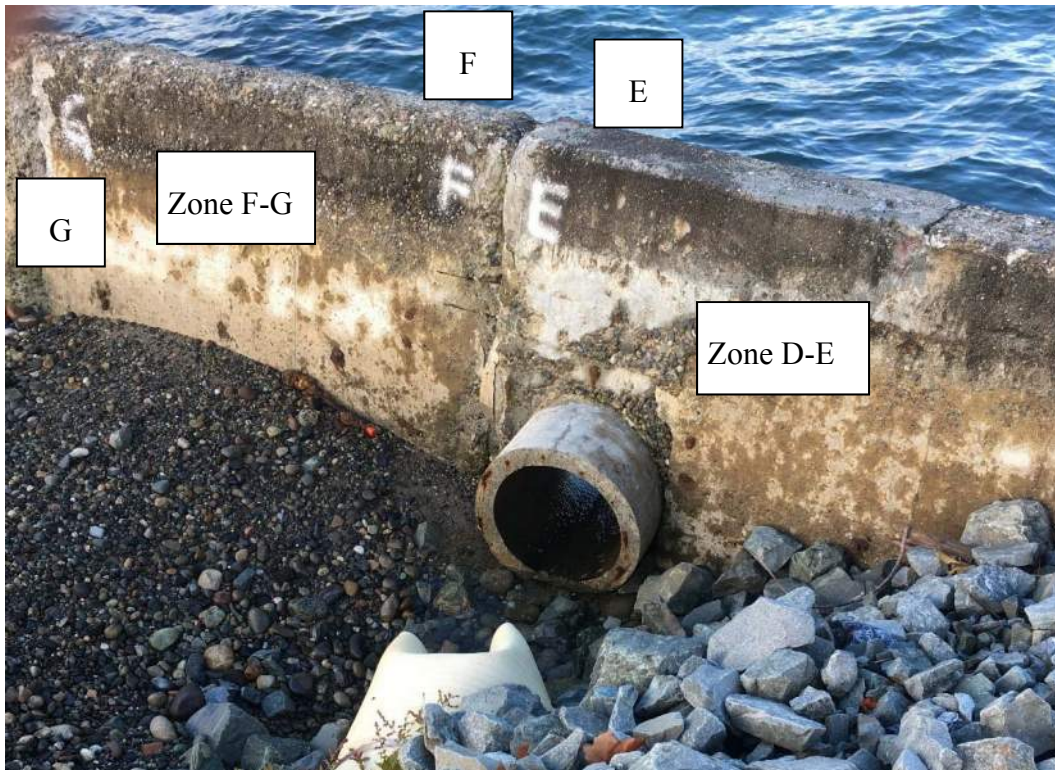
Photo 16. Zones D-E & F-G, Broken Outfall.  
Source: Reid Middleton Site Visit 10/18/2016

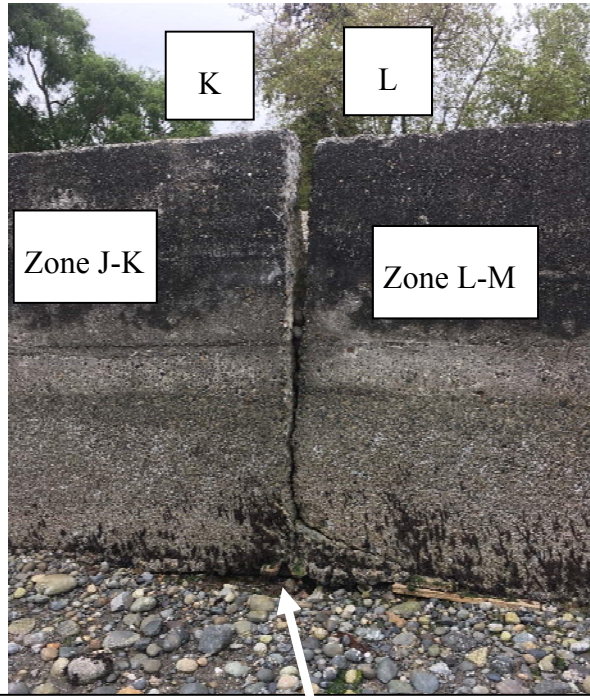
Additional undermining since 10/18/2016 visit

Photo 23. Zone J-K & L-M.  
Source: Reid Middleton Site Visit 5/31/2017

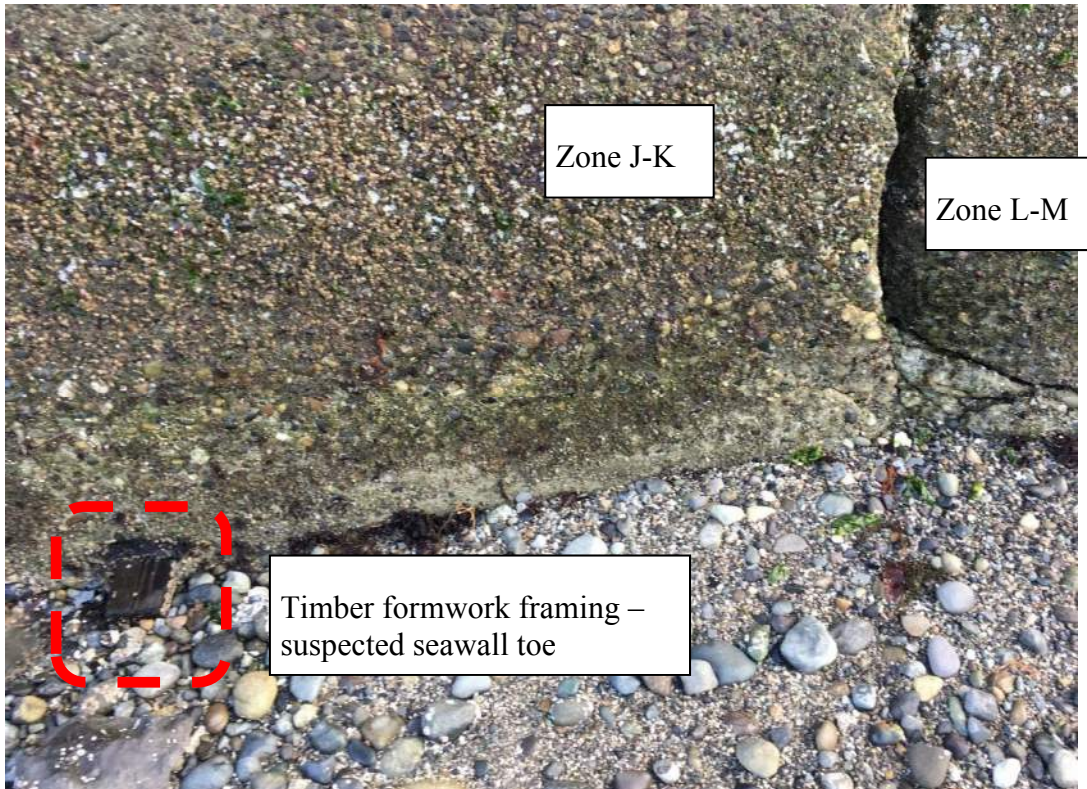
Zone L-M Length = 16'  Origin: 1950's	24, 25	Critical	Structural: Cracking and spalling <sup>1</sup> . Toe: Exposed, material loss below wall, not protected. Rotation & Settlement: Less than adjacent panels, but appears that some has occurred.
Zone N-O Length = 29'  Origin: 1950's	25, 26	Serious	Structural: Cracking and spalling <sup>1</sup> . Toe: Exposed, material loss below wall beginning, not protected. Rotation & Settlement: Appears to have slight rotation outwards and slight translation away from shore.
Zone P-Q Length = 28'  Origin: 1950's	26, 27, 28, 29	Serious	Structural: Cracking and spalling <sup>1</sup> . Multiple full-height cracks. Toe: Evidence of material loss below wall, not protected. Rotation & Settlement: Evidence of settlement observed, full-height cracking pattern.
Zone R-S Length = 50'± Origin: 1995	29, 31	Good	Structural: No visible damage. Toe: Buried, does not appear to be exposed. Rotation & Settlement: None visible.

<sup>1</sup>Cracking and spalling occurred where adjacent portions of seawall bear due to differential settlement and rotation.

Photo 24. Zone J-K & L-M.  
Source: Reid Middleton Site Visit 10/18/2016

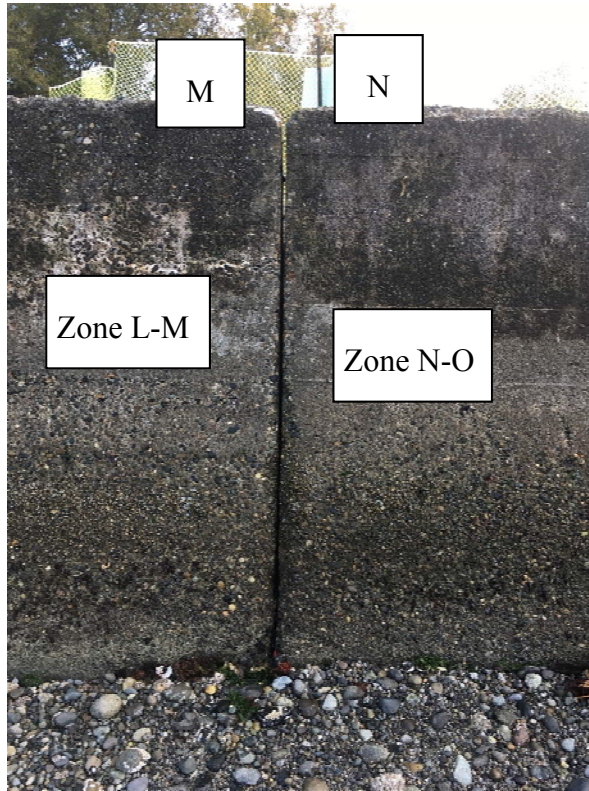
Photo 25. Zones L-M & N-O.  
Source: Reid Middleton Site Visit 10/18/2016

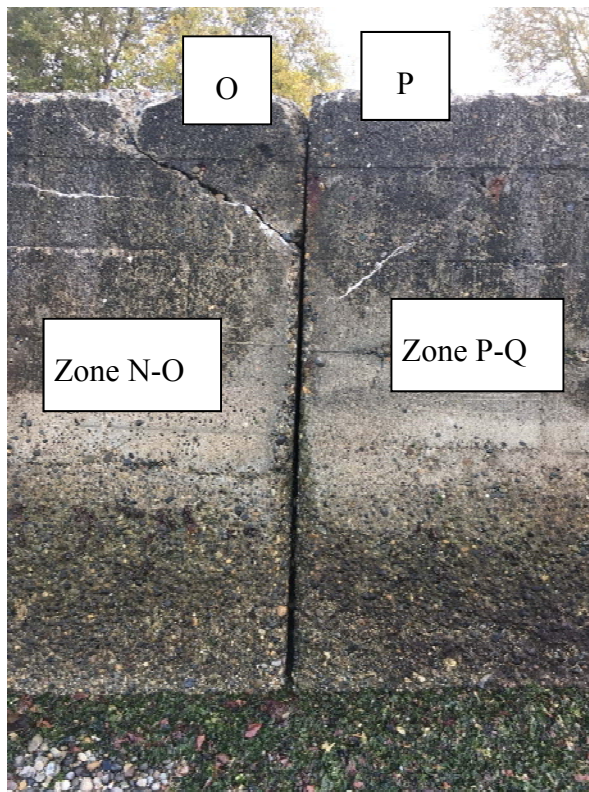
Photo 26. Zones N-O & P-Q.  
Source: Reid Middleton Site Visit 10/18/2016
