May 12, 2017

Re: Asbestos and lead survey.
 Lake City Community Center building, Seattle.

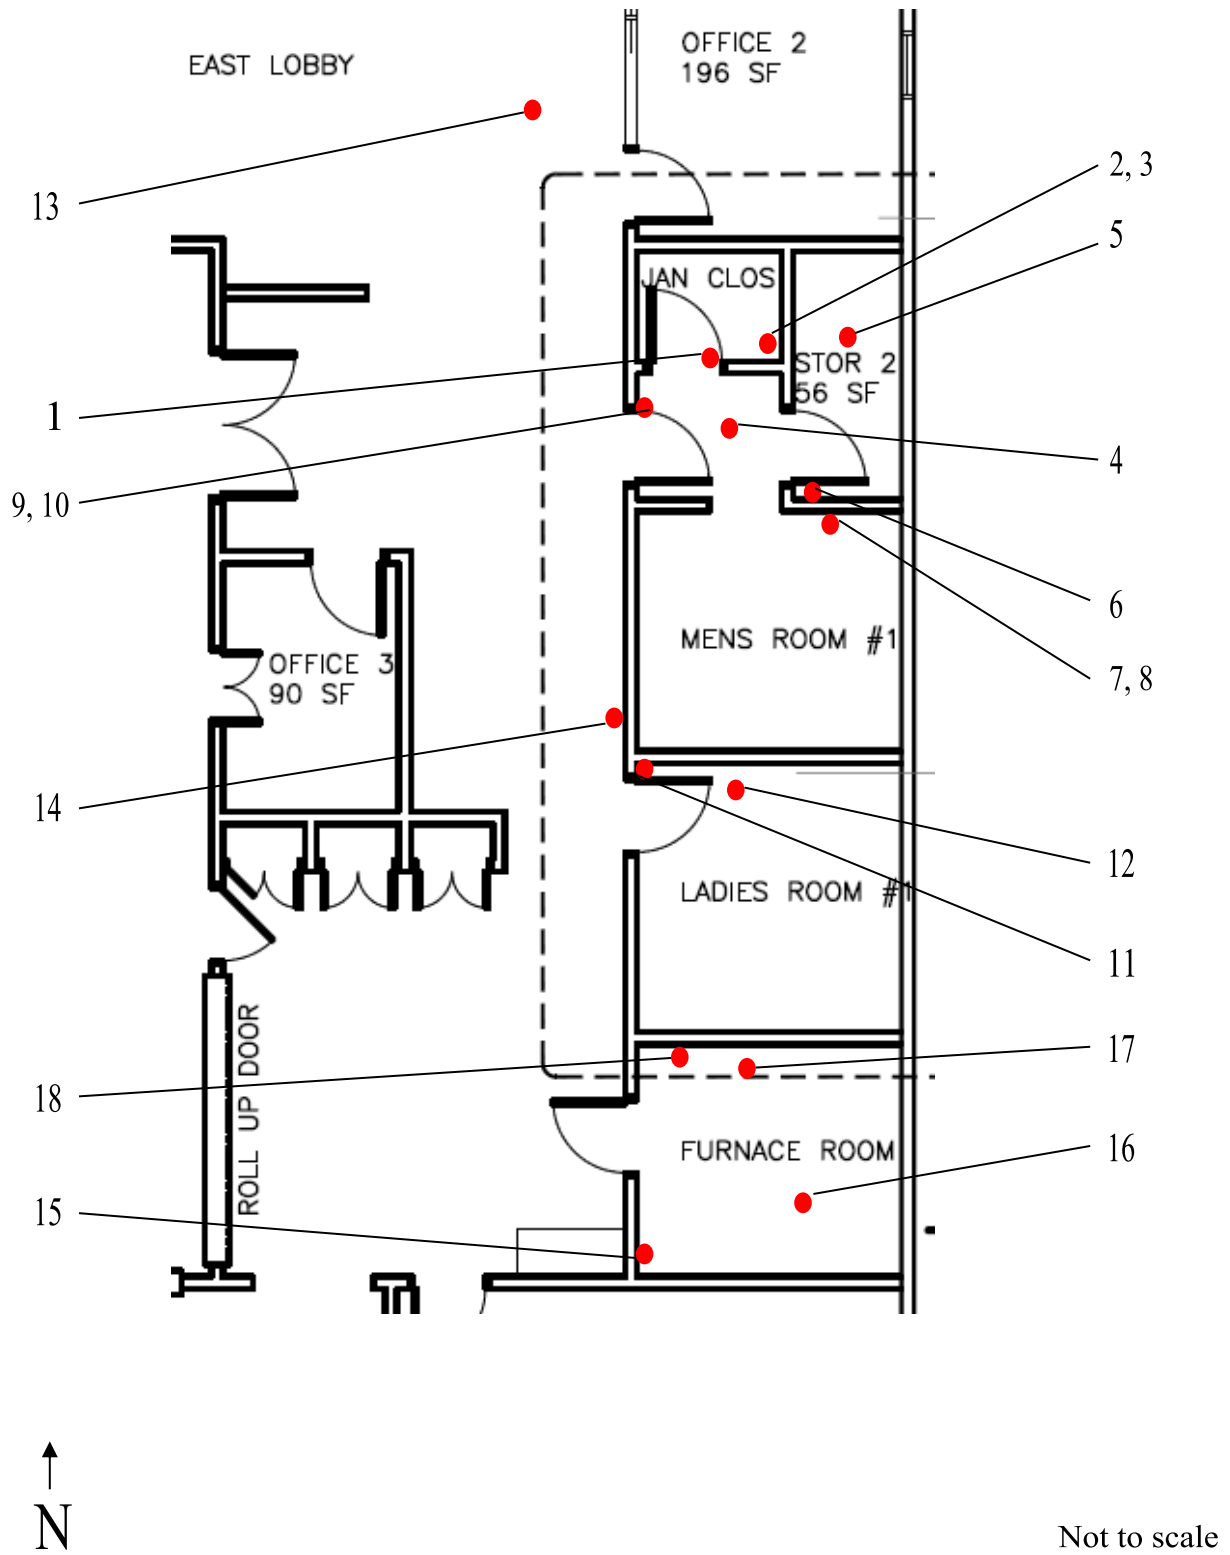
Figure 1. Approximate asbestos sampling locations. East area. Lake City Community Center building. May 2, 2017.

- Janitor's closet. Bottom layer of sheet vinyl flooring/mastic (not top layer of sheet vinyl/mastic) over a concrete floor (sample number 2). An estimated 24 square feet total in this area.

- Storage room. 9-by-9-inch floor tile (not tile mastic) over a concrete floor (sample number 5). An estimated 57 square feet total in this area.
- Hallway. 9-by-9-inch floor tile (not tile mastic) over a concrete floor (sample number 13). Throughout this hallway area.
- Furnace room. Boiler insulation material (sample number 16). An estimated 3.5-feet in diameter by 6 feet in height.
- Office #1. Floor tile (not tile mastic) over a concrete floor (sample number 27). All beneath carpet tiles and 2 layers of carpet (nailed). Throughout this office area.

The asbestos materials noted above must be properly removed and disposed of by a licensed asbestos abatement contractor prior to any demolition activity that may disturb the materials.

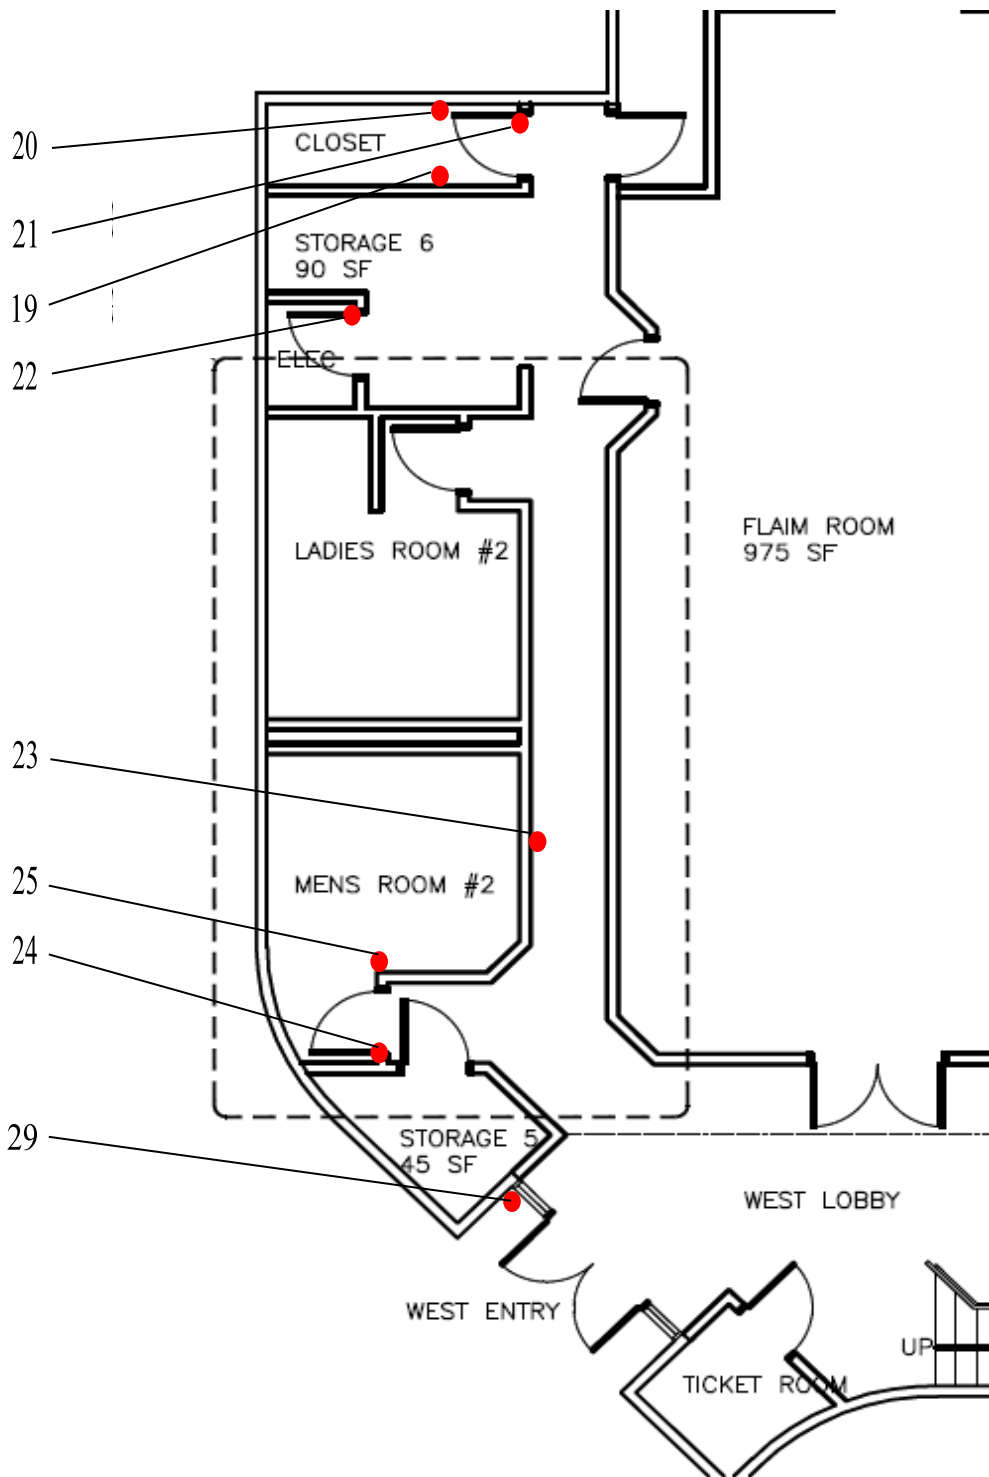
Figure 2. Approximate asbestos sampling locations. West area. Lake City Community Center building. May 2, 2017.

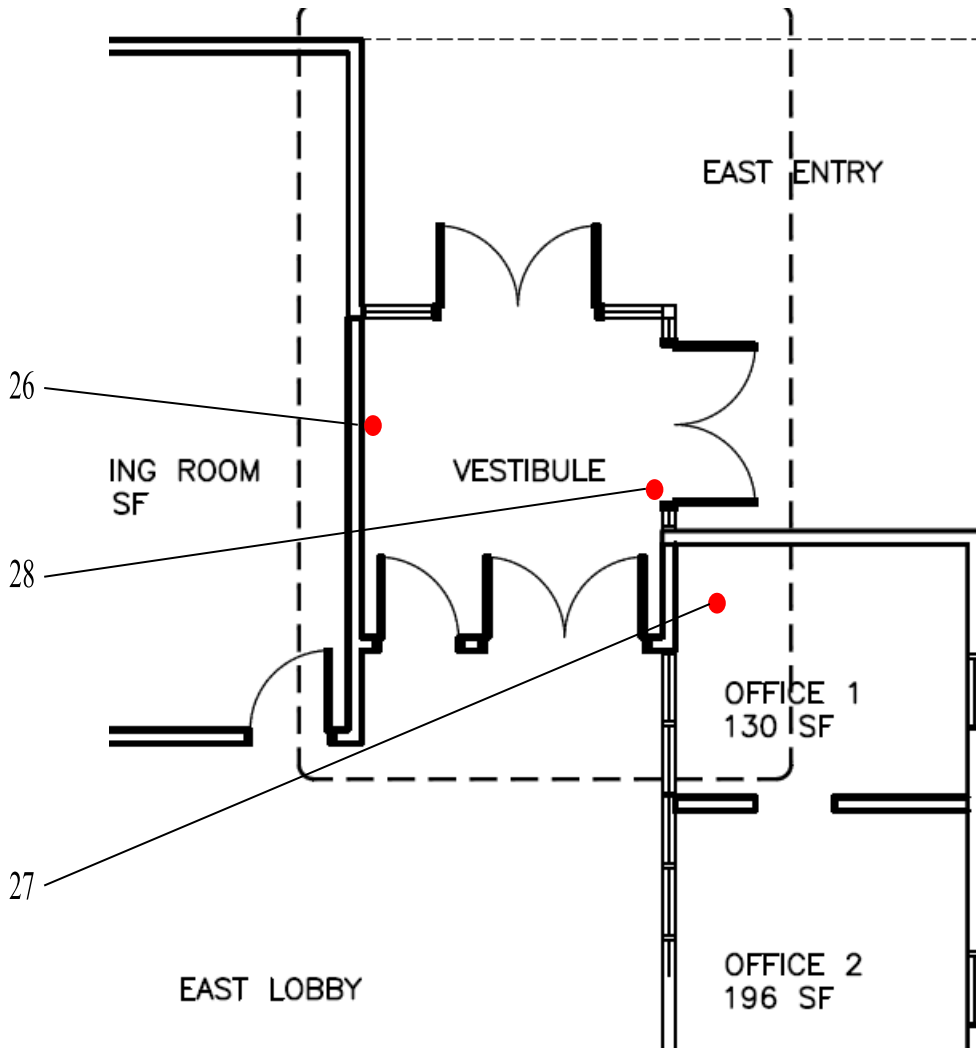
Figure 3. Approximate asbestos sampling locations. Northeast entry area. Lake City Community Center building. May 2, 2017.
