## **Kobe Park Building/Nippon Kan Theatre**

This narrative provides an overview of some of the work to be conducted to rehabilitate the Kobe Park Building (also known as the Nippon Kan Theatre). The building has multiple addresses including 633 Yesler Way, Seattle, WA 98104 and 628 So Washington Street; parcel 524780-2080. Related before and after photos are included in supporting materials.

The narrative below provides an overview of the observations of the due diligence process and the attendant work performed to address the findings.

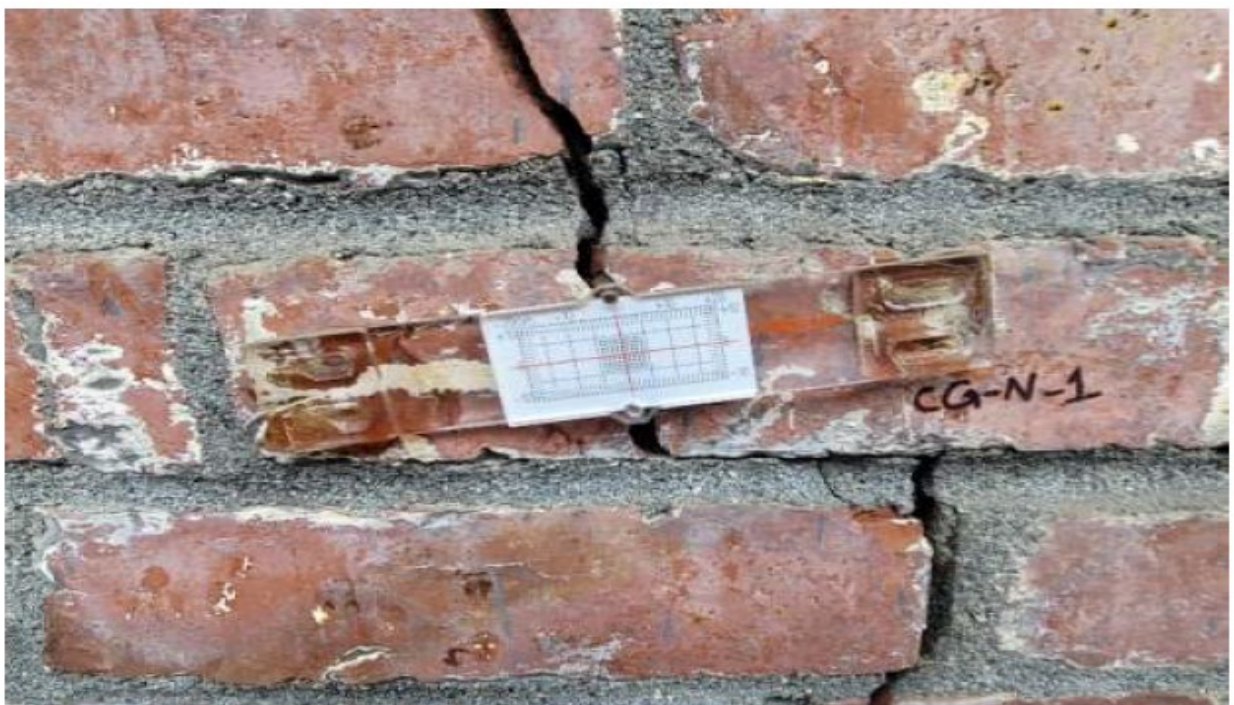
- Cracking at several locations telegraphing through the plaster at the interior of level one
- Soft mortar (aka fretting) at multiple interior and exterior locations
- Vertical mortar joints separating the historic masonry and contemporary brick below the storefront zone have separated, creating an unprotected opening at a critical juncture of the building envelope.
- Organic growth is present at the masonry rowlocks (window sills) project-wide and around the downspout at the west elevation.
- Efflorescence is common on the outer surface of the mortar joints and bricks near the finished grade plane.

2. North foundation wall, with crack monitor.

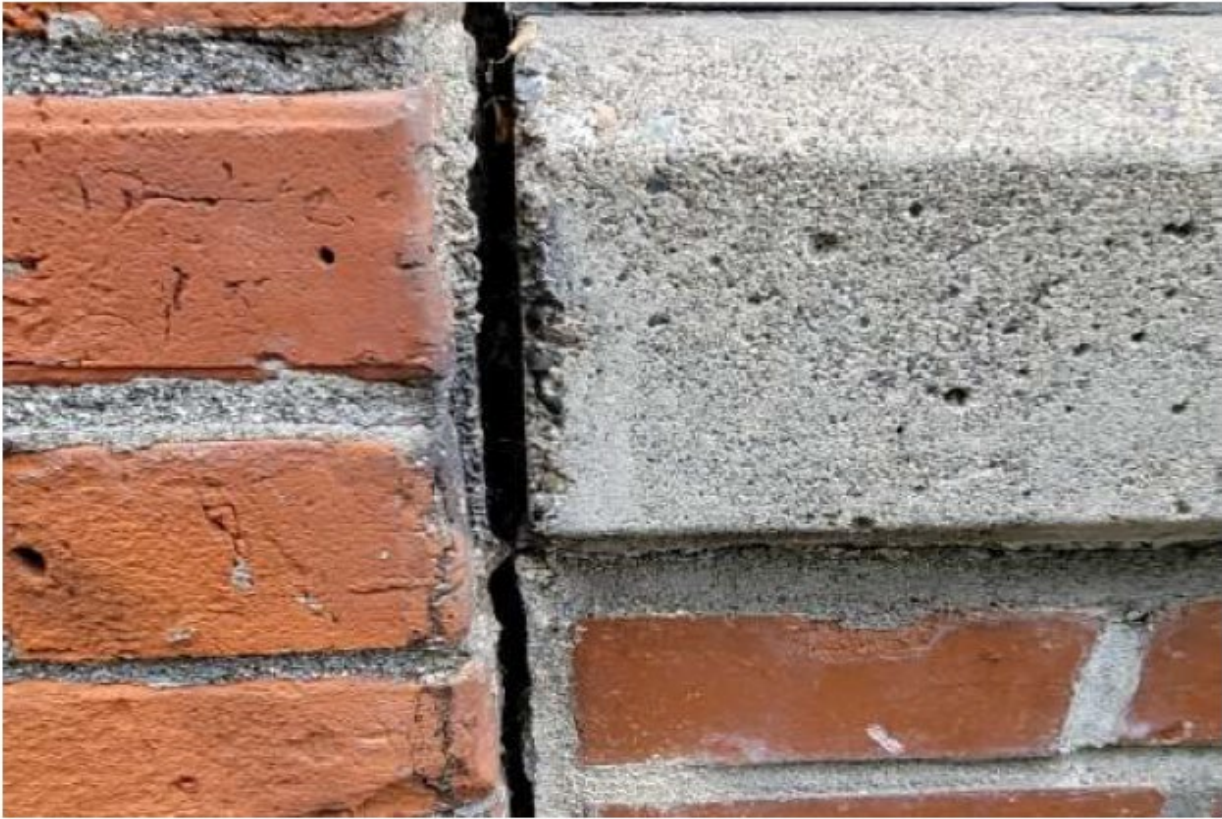
3. Southeast building corner, looking west. Gap in masonry.

- Route out all failed or otherwise compromised mortar joints
- Tuck point Type N mortar. Color and tooling to match existing.
- Install Dow Silicone sealant over all terra cotta sky facing joints.
- Pressure clean the entire elevation.
- Paint lower stucco area at the West elevation ground level.
- Scrape, prep, prime and paint the exterior roof trim, as well as the top floor belly band.
- Apply BSM 40 clear water repellent to all masonry areas. Wash windows
- Embed 1/4" stainless steel threaded rods in failing mortar joints

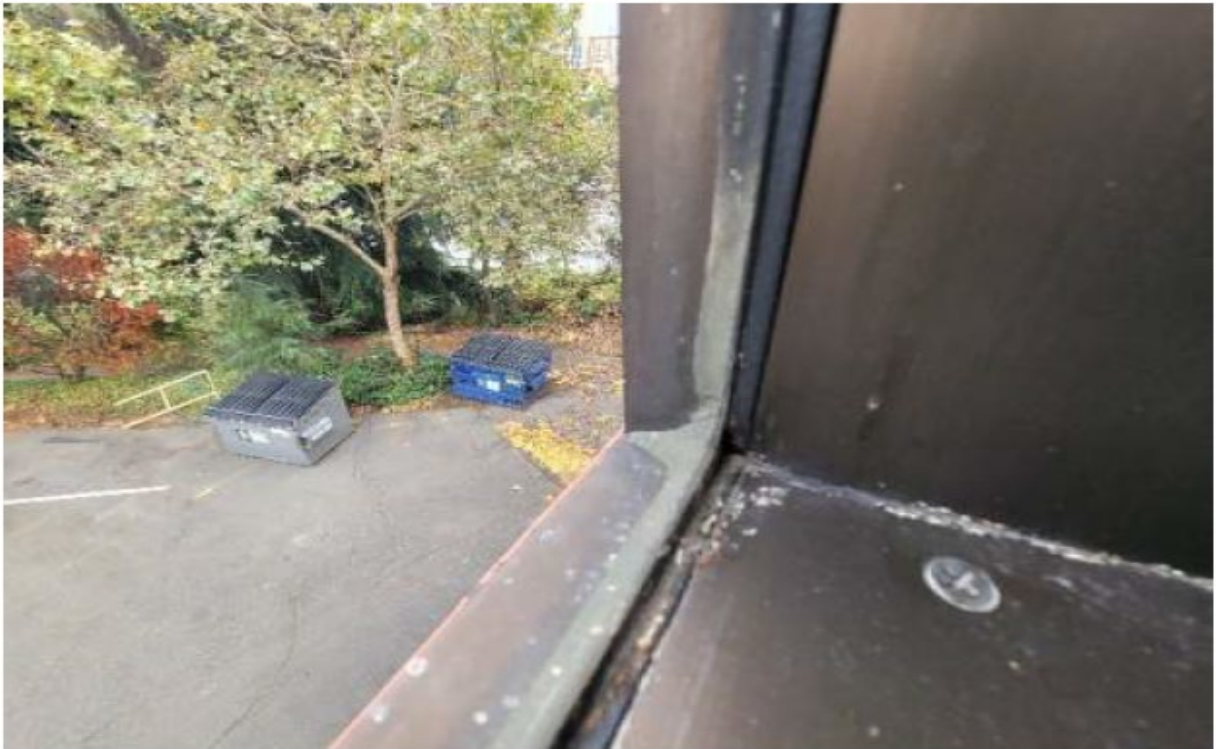
- Exterior wood paint is failing (i.e., flaking).
- The interior glazing gaskets are not set tight at corners, resulting in gaps in the gasket.
- The metal frame is corroded around the joinery where the vertical mullions interface the sill at the east end of the level 3 ribbon window, indicative of past water ingress.
- Black duct tape placed over the operable window joints, presumably in an attempt to prevent air infiltration.
- Inoperable (fixed) aluminum windows with dual-pane IGUs are provided at both the north addition as well as the penthouse structure. Field-applied sealant is provided at the window perimeters. The sealant is broken down and is ineffectual after years of exposure to UV and bulk moisture.
- Perimeter exterior sealant is weathered with surface crazing and is at the end of its useful service life.

4. Example of water ingress on a third floor windowsill.

To address the aforementioned issues, extensive repair work was performed by Pivotal Construction throughout the building including replacing failed IGUs with new energy-efficient units with argon gas fill and low emissivity coating on the #2 surface.

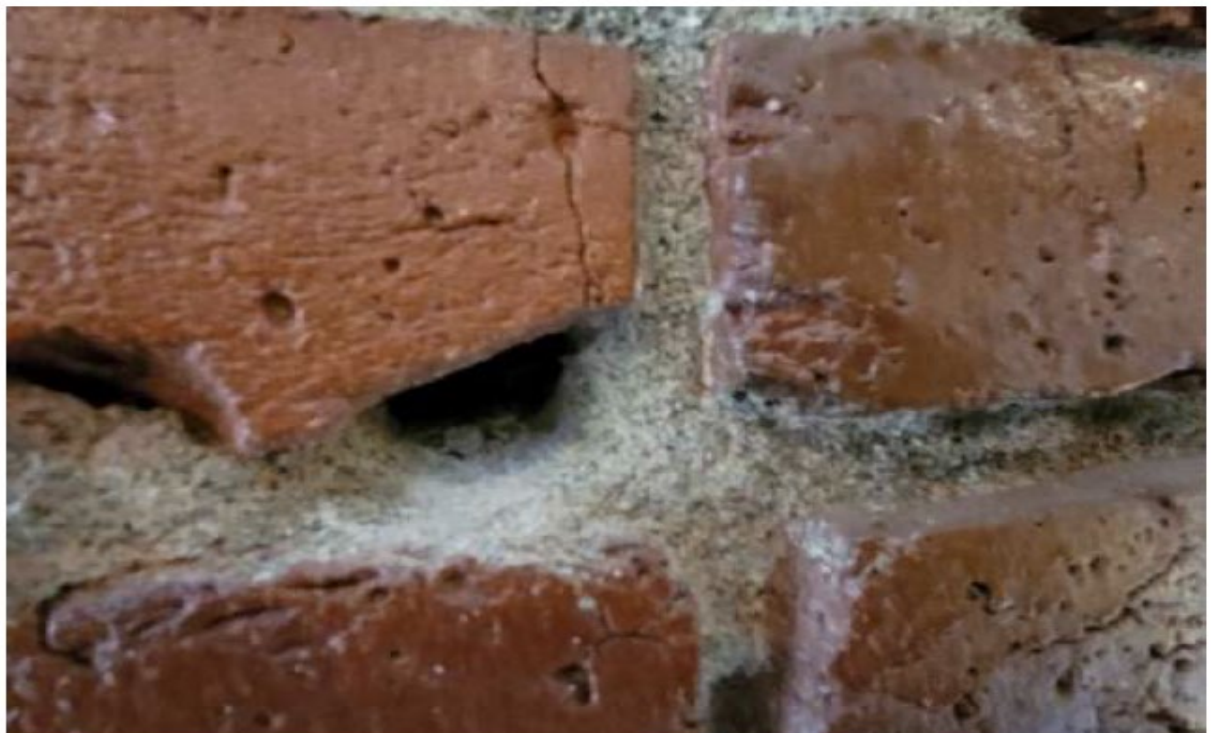
5. Example of a mortar joint gap on an interior wall.

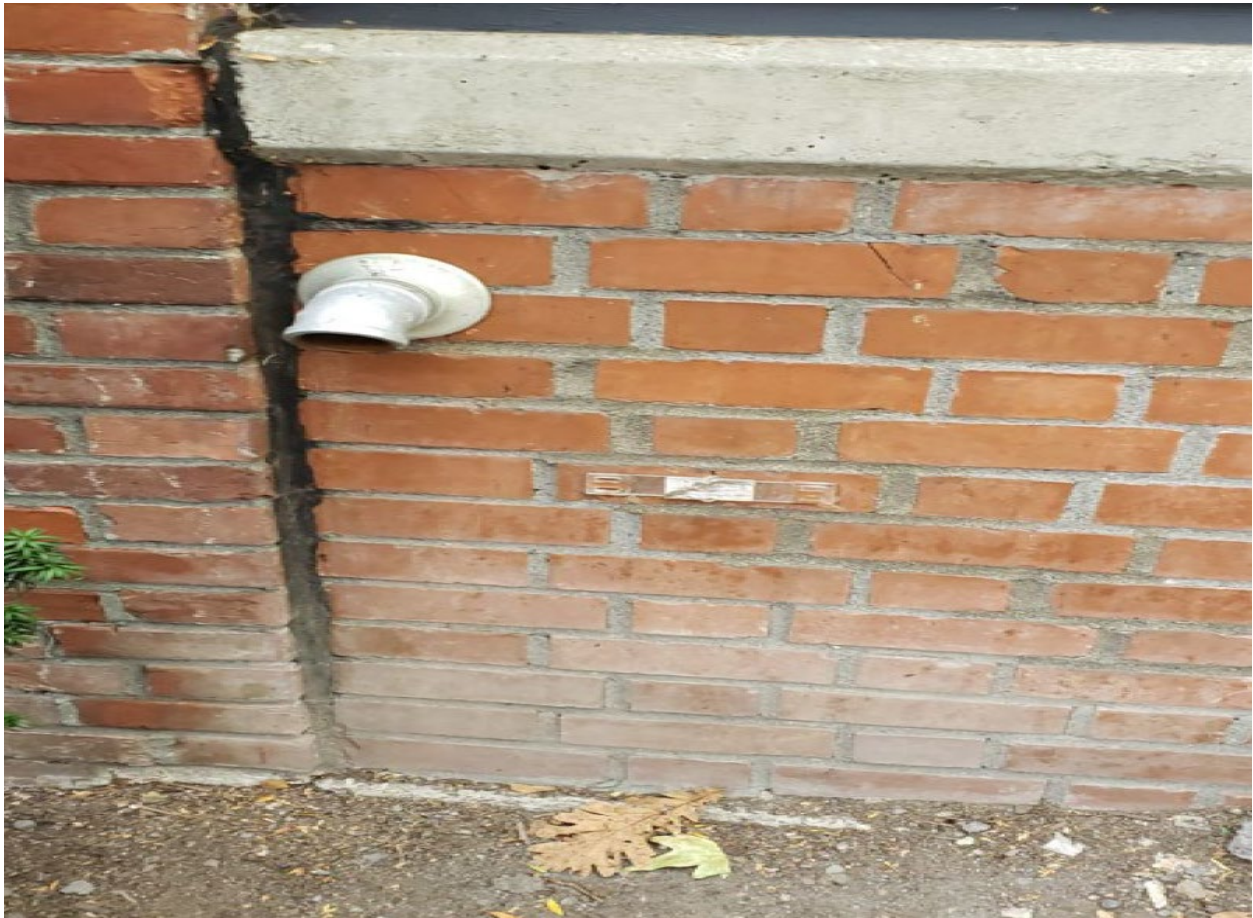
1. Exterior brick tuckpointing and masonry repair.

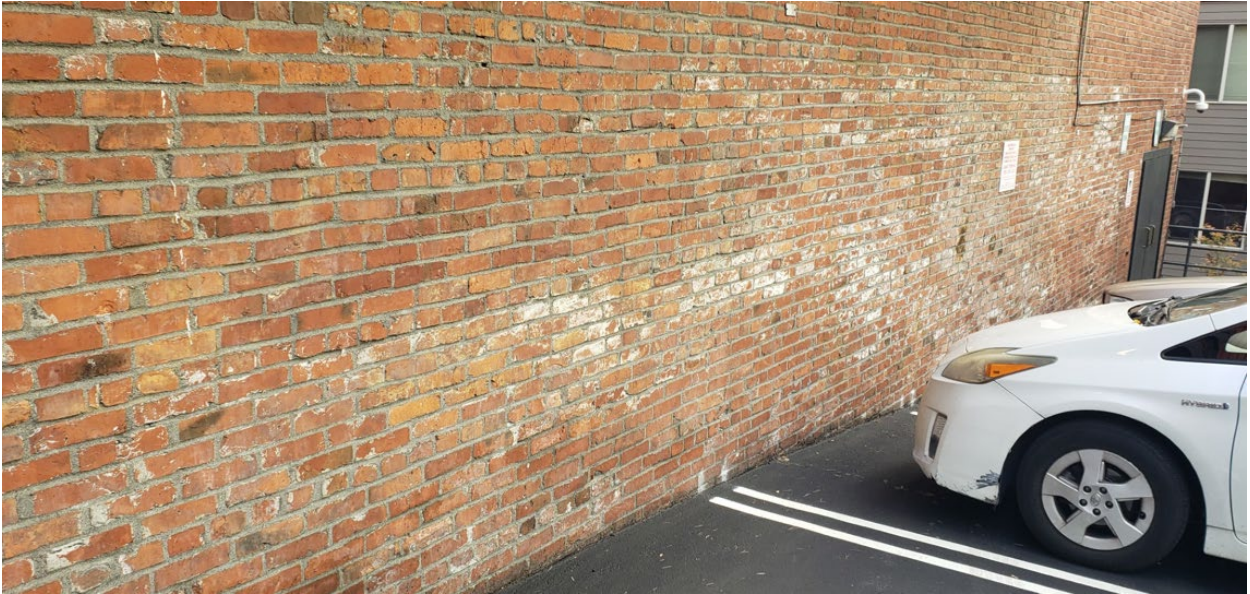
3. Parking lot wall, with tuckpointing.

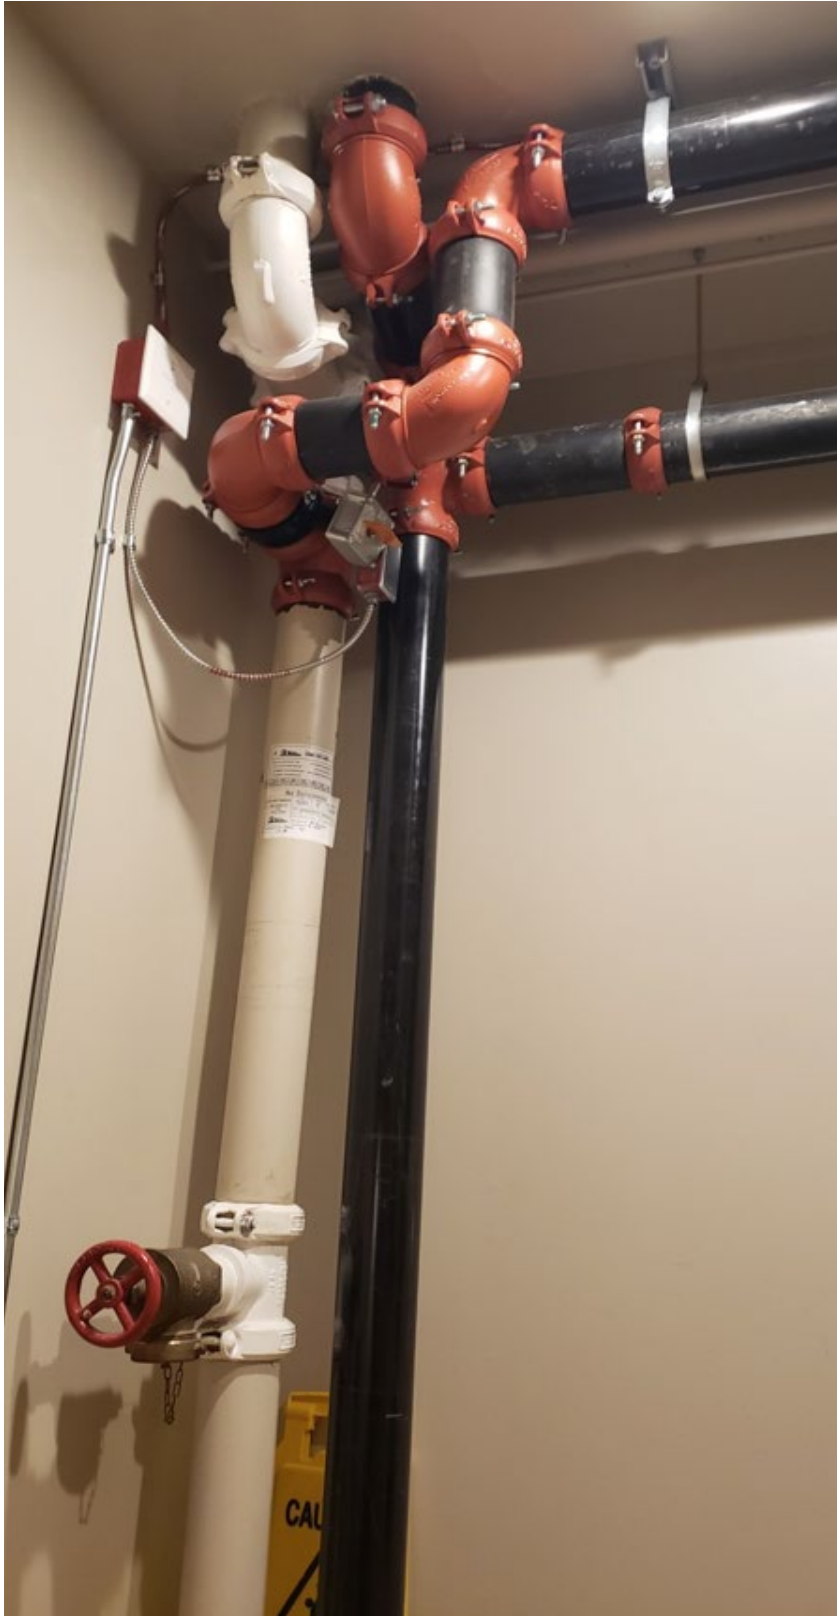
5. Sprinkler system main water intake.

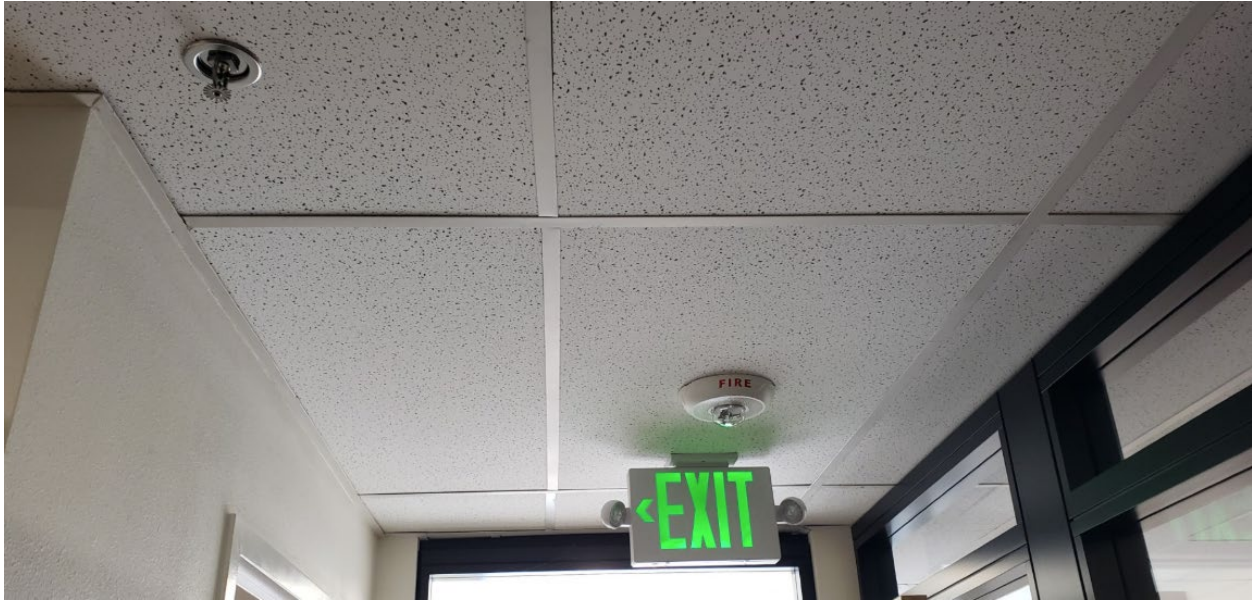
6. Sprinkler head and fire alarm.

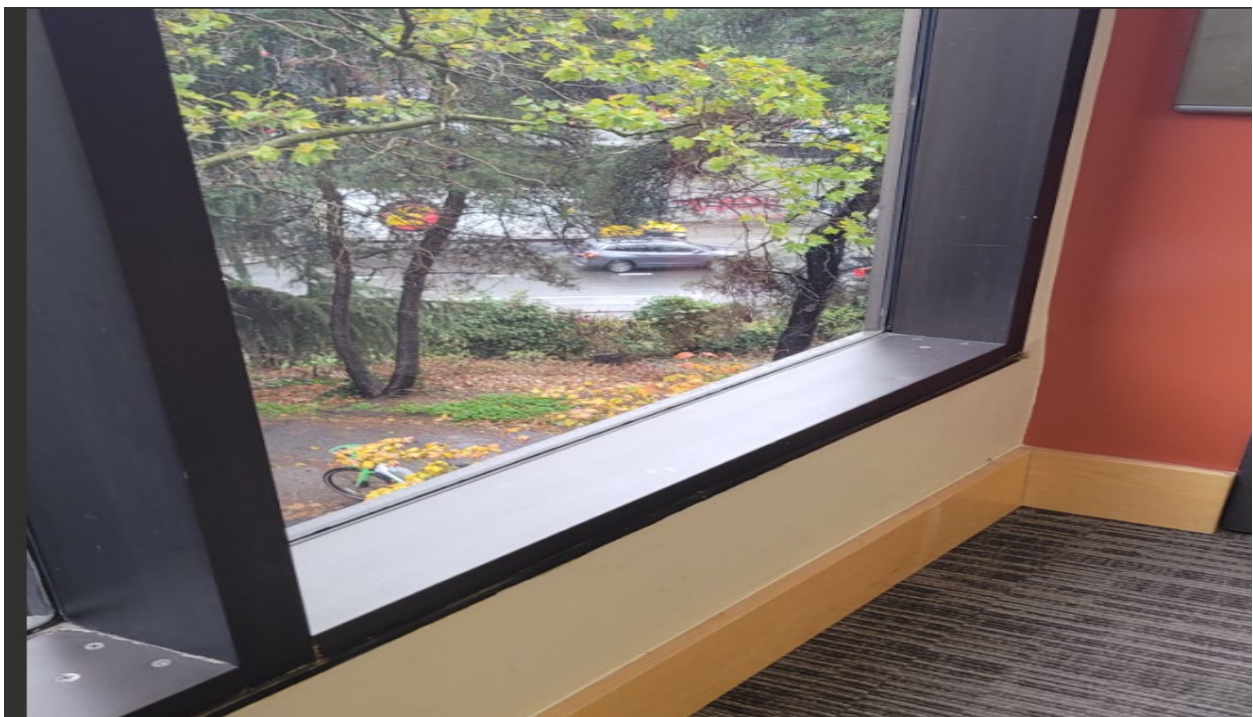
9. Example window, post repair. Match to pre-rehab photo #4.

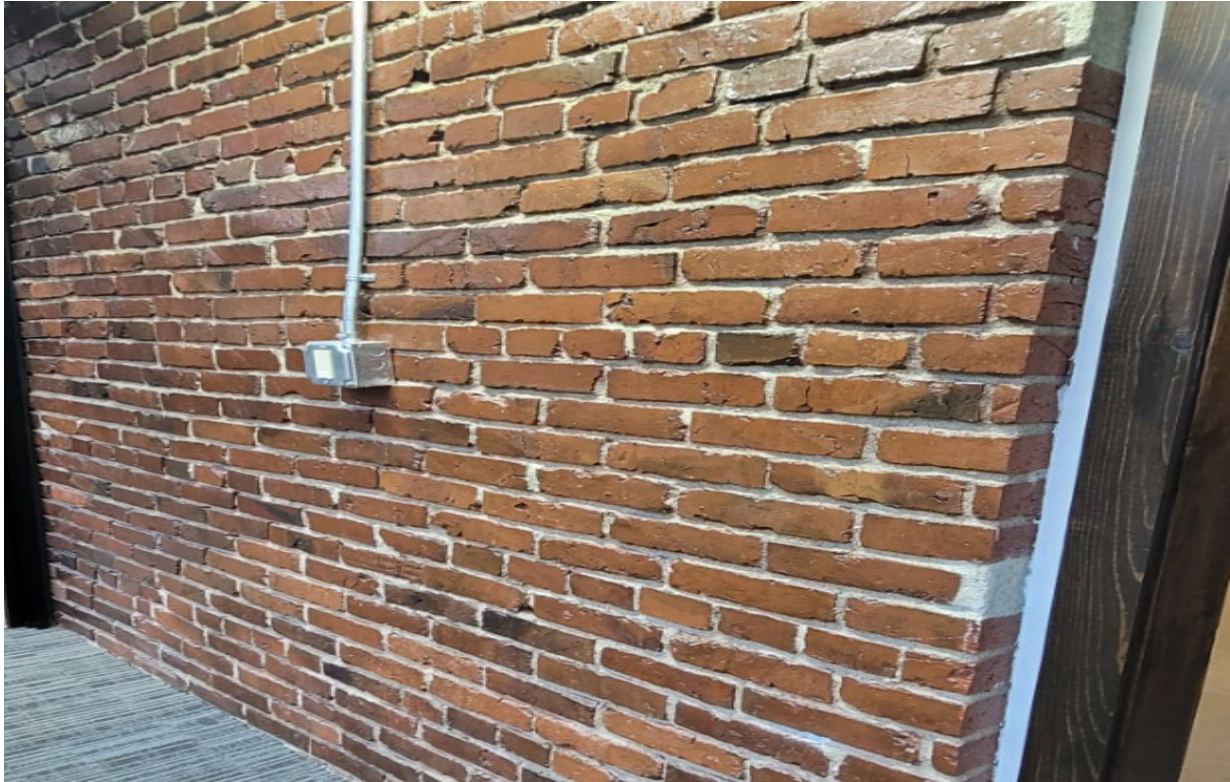
15. Example interior wall, post mortar repair.
