J&M HOTEL ANNEX DEMOLITION PACKET

Pioneer Square Preservation Board Briefing
July 10, 2025

Structural Engineer’s Report on the Condition of the Annex7

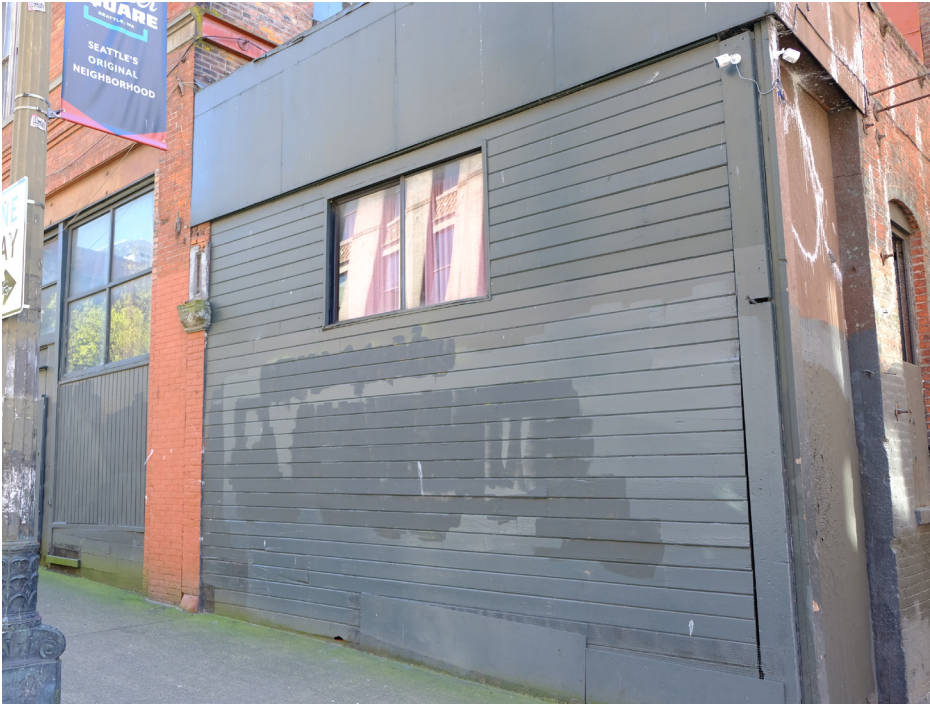
existing north annex, Washington street facade

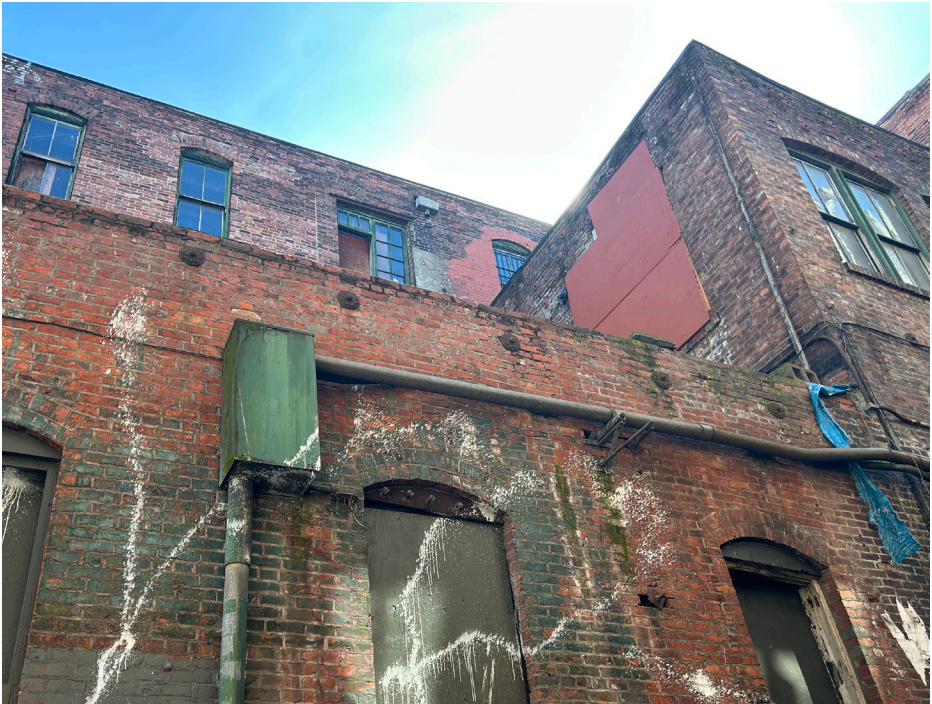
existing north annex in foreground with south annex to the right and the j&m building beyond

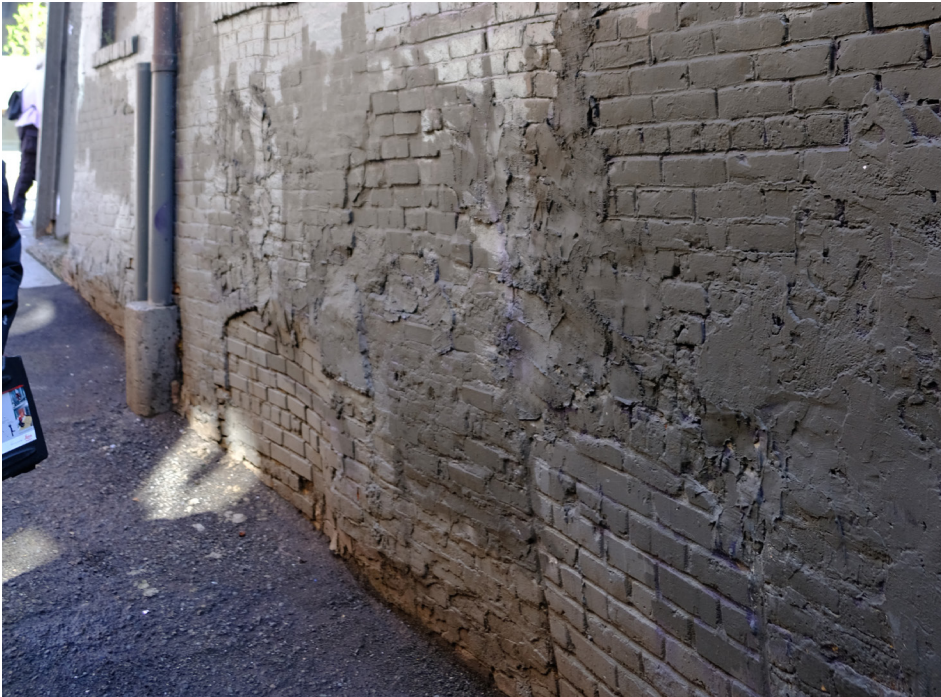
deformation of load-bearing west wall of north annex along the alley

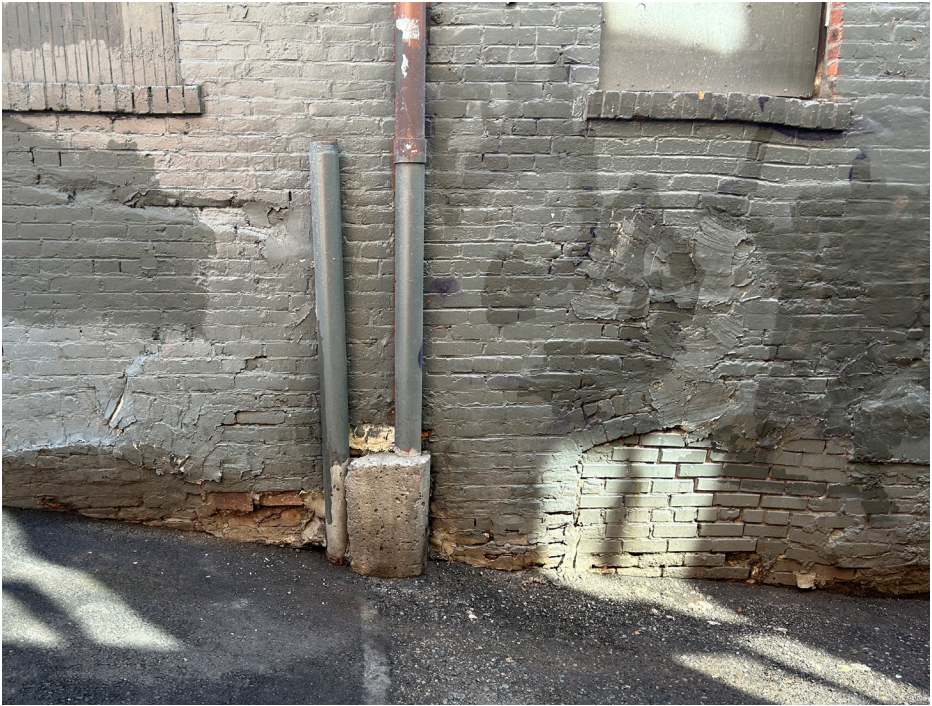
deformation of load-bearing brick at west wall of north annex

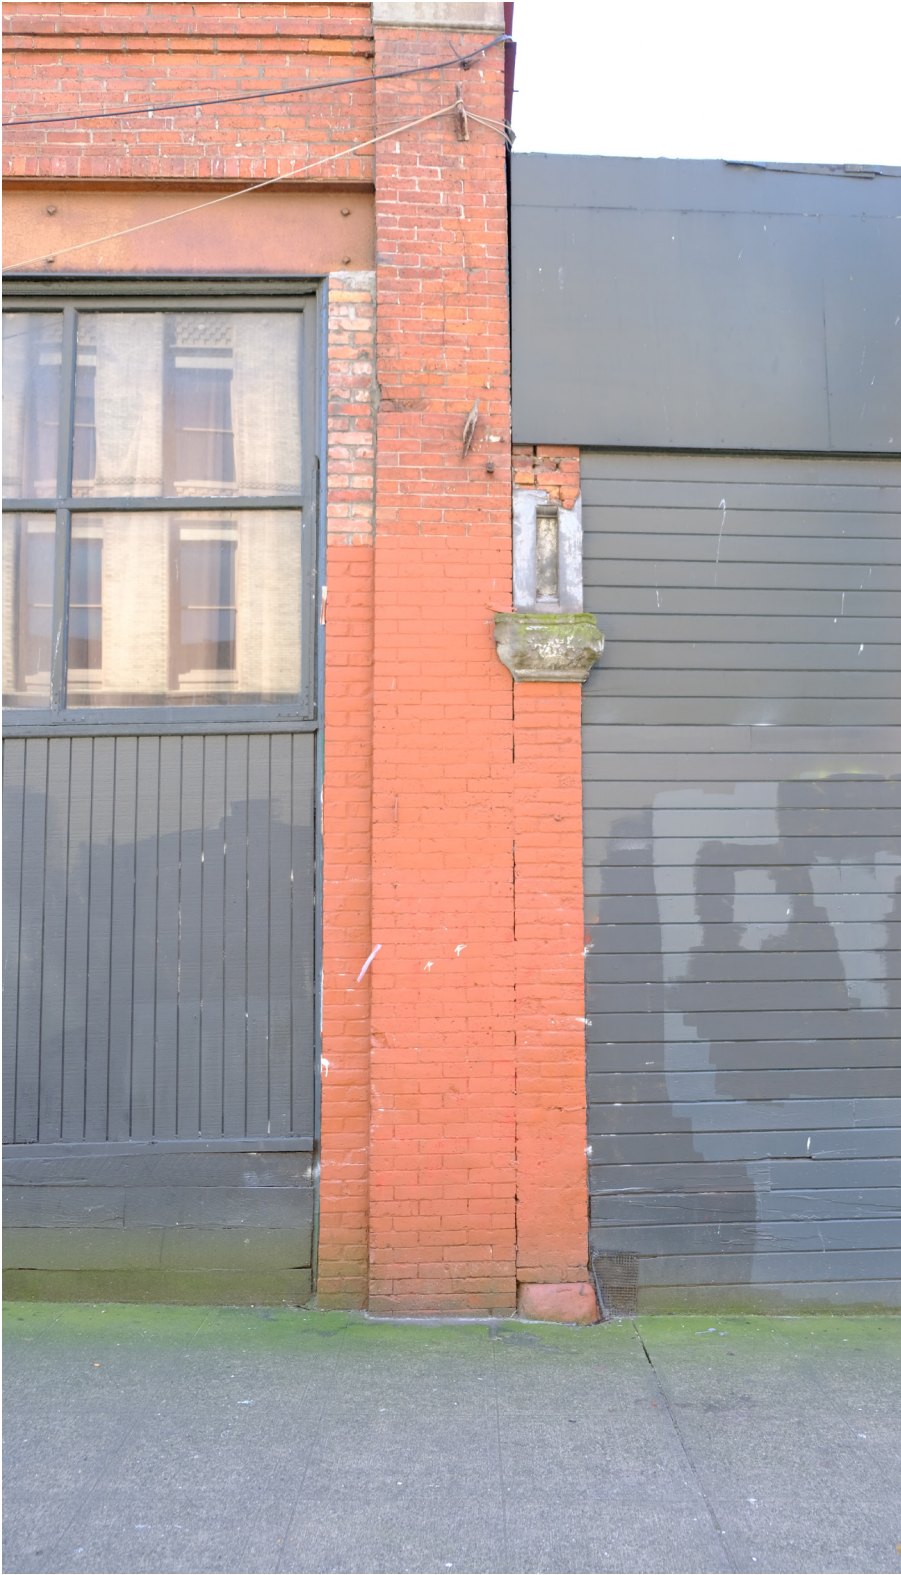
detail at joint between j&m base building and north annex

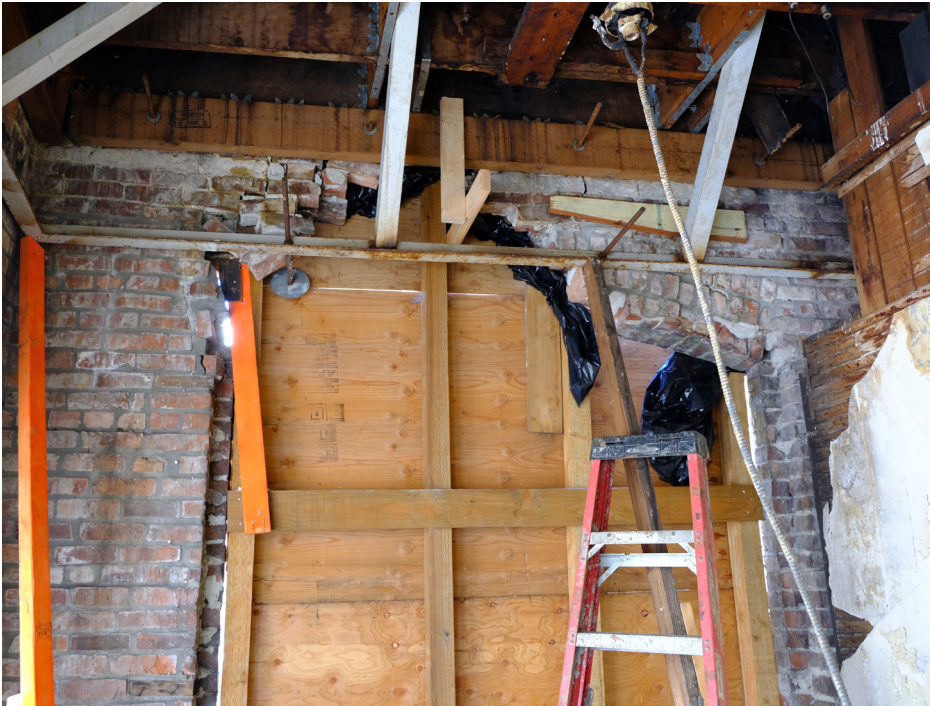
collapsing load-bearing brick wall at window in north wall of 2nd story of south annex

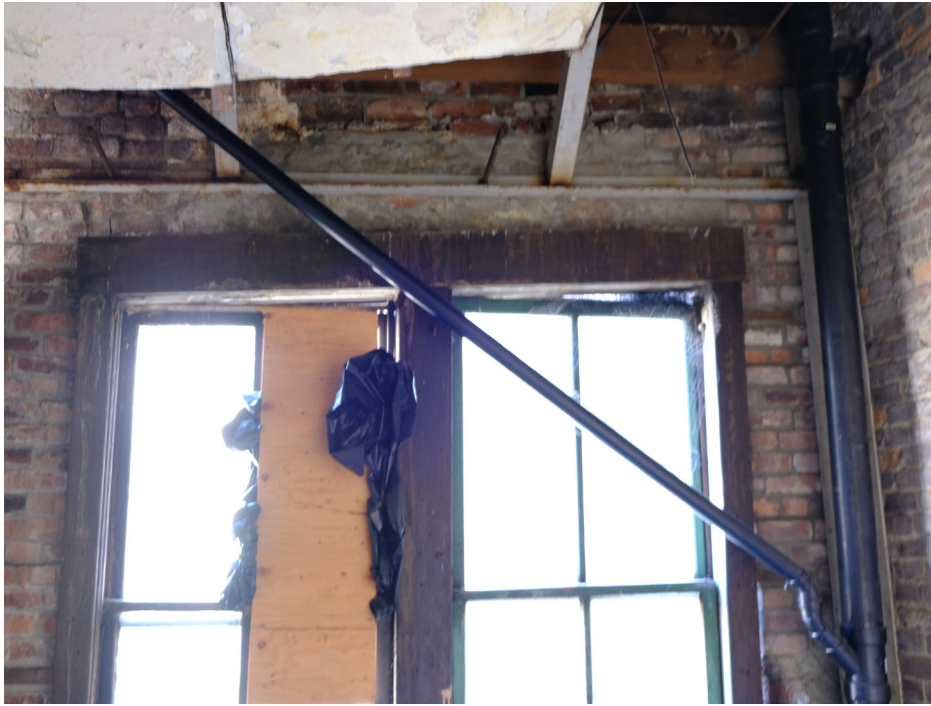
failing lintel at 2nd story window in south annex

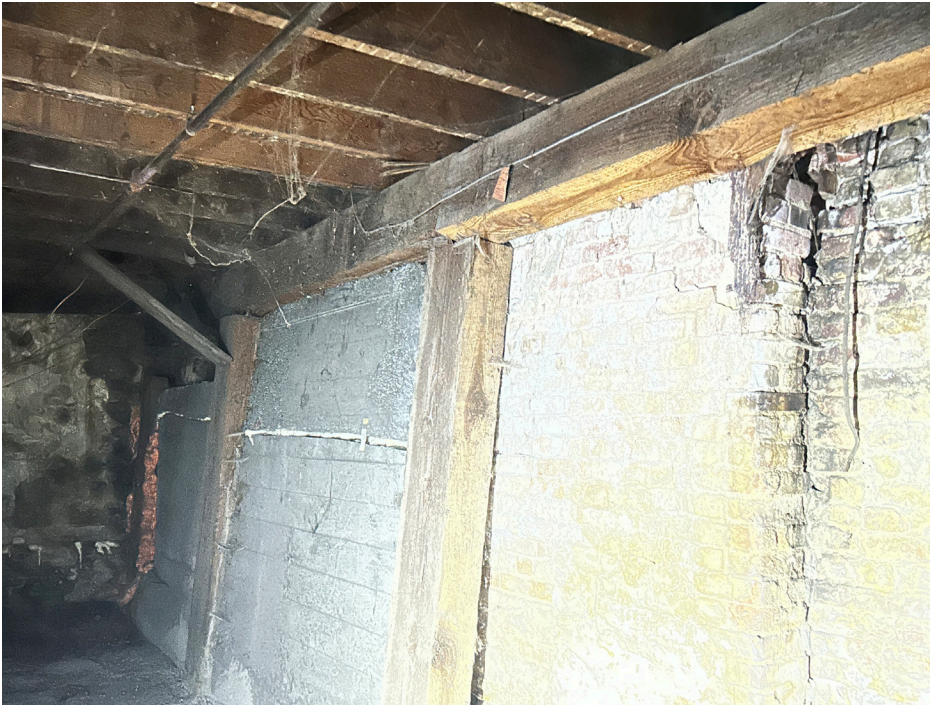
west wall of north annex at basement level is leaning away from building

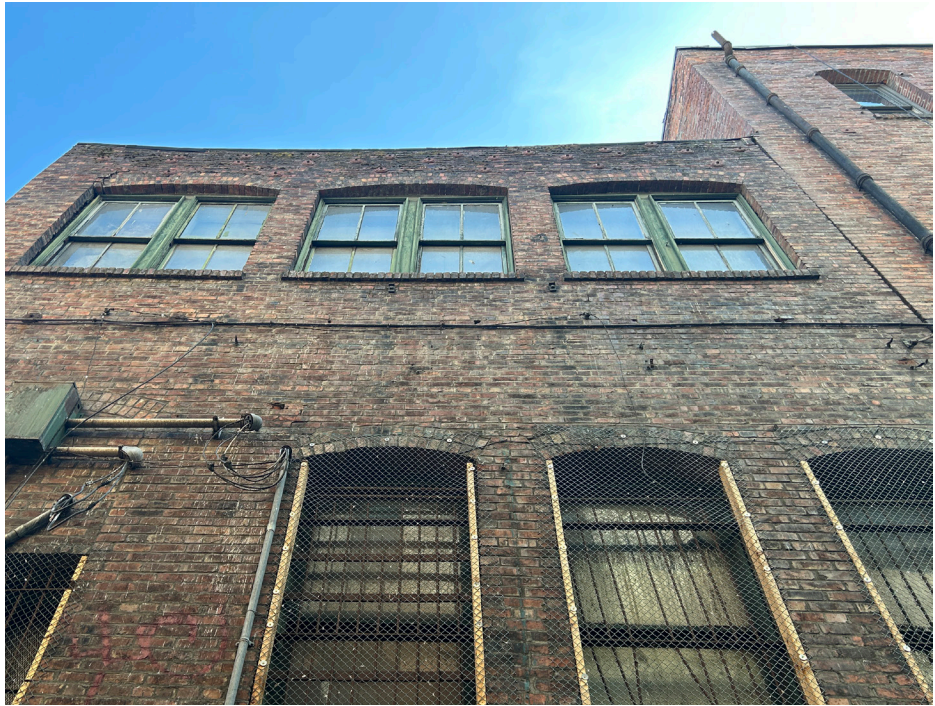
west wall of south annex

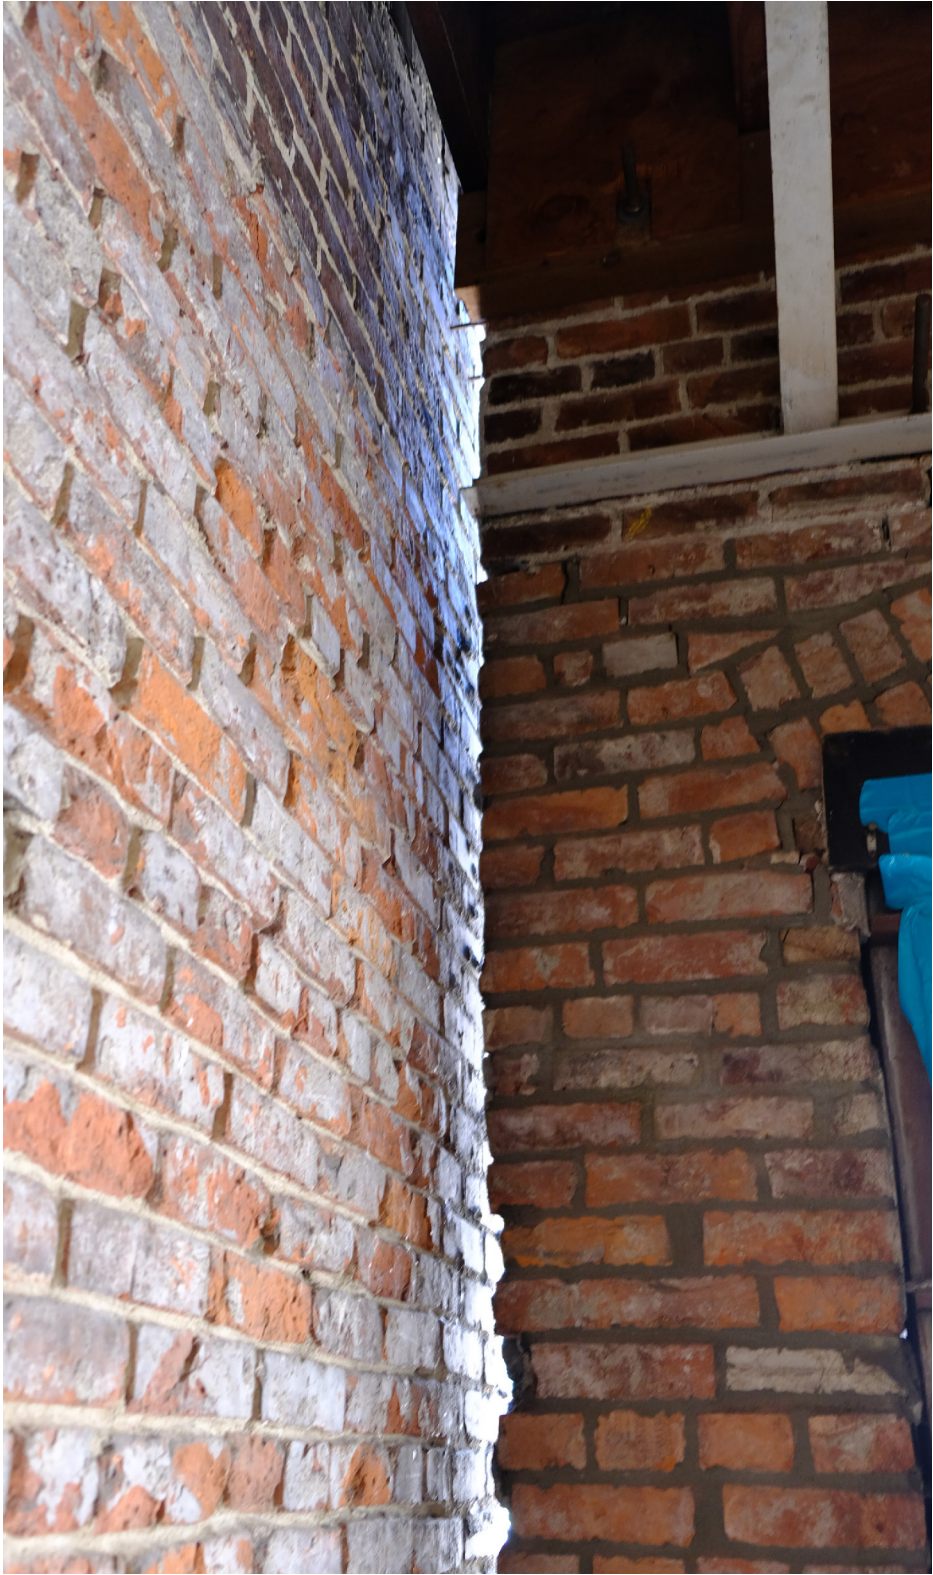
3" daylight gap between west wall of south annex and neighboring building to the south.

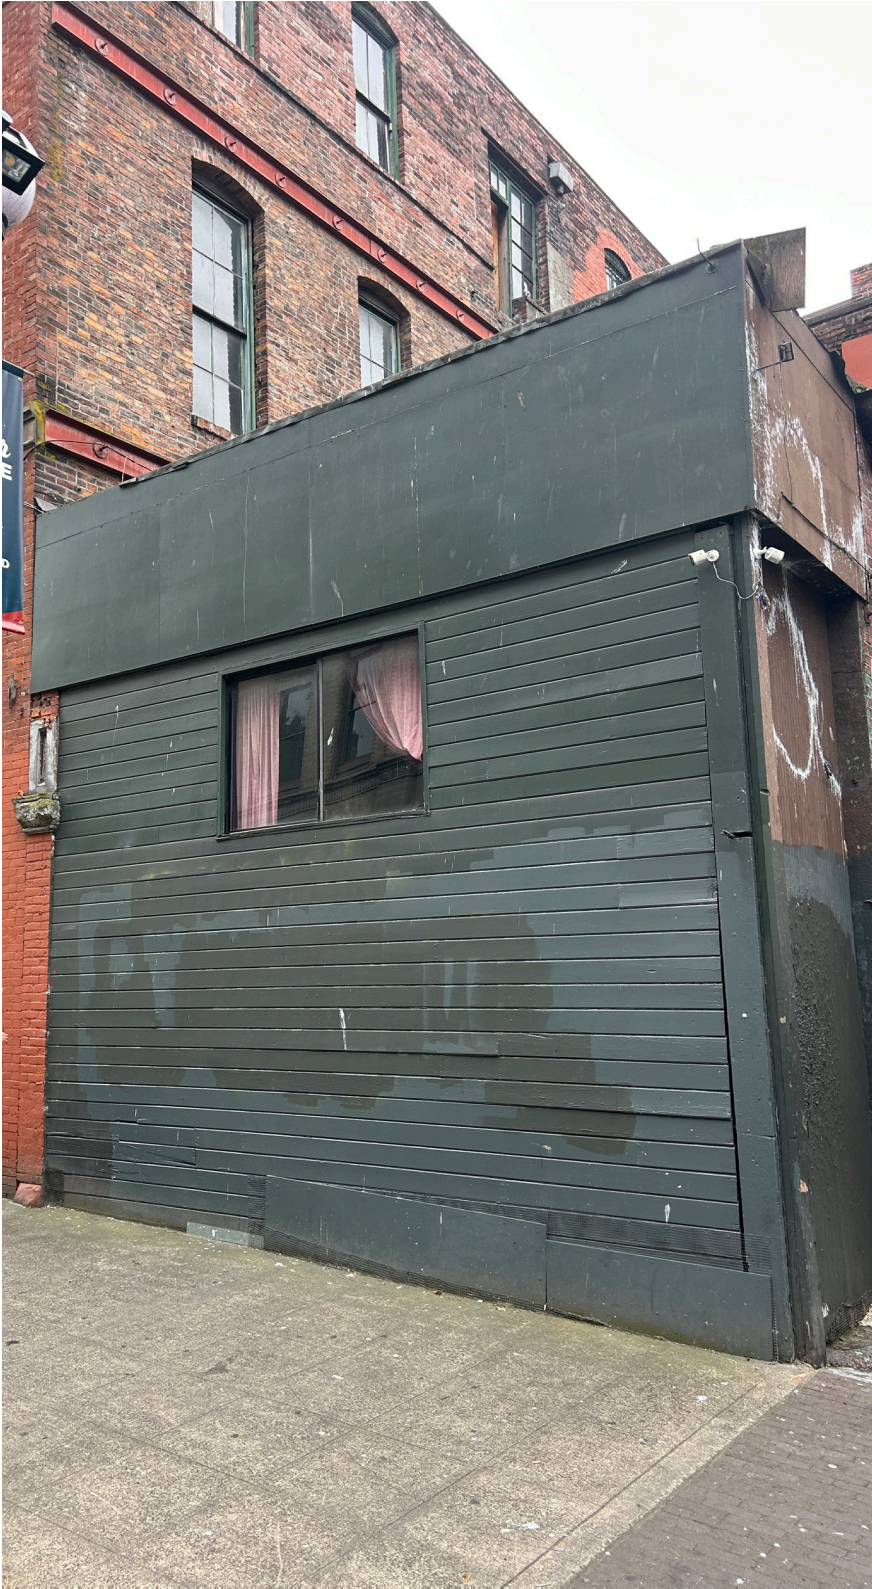
horizontal wood siding at annex, seen from exterior

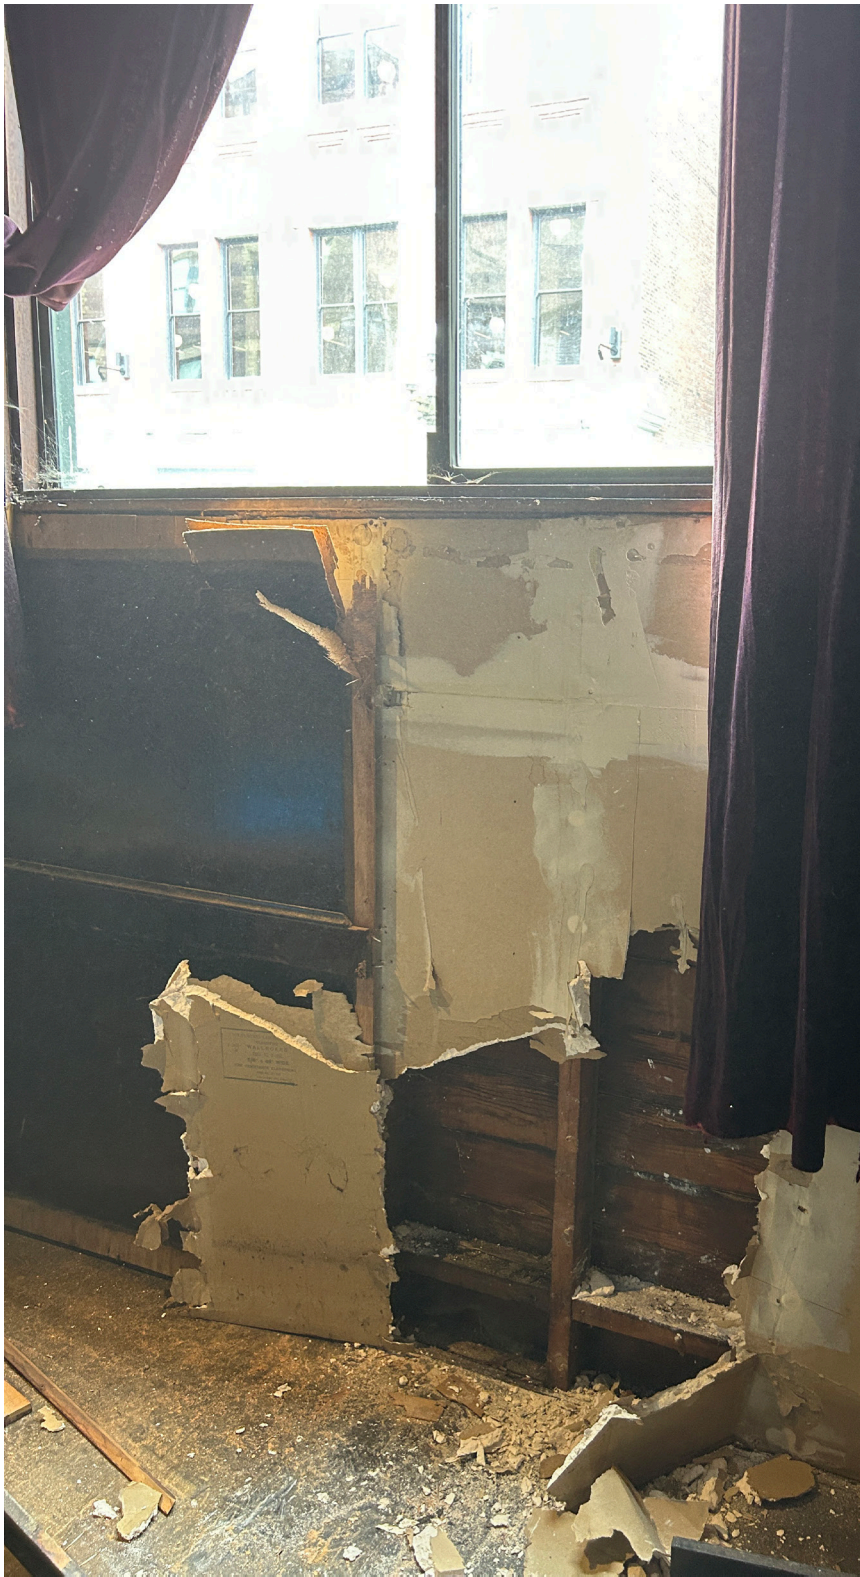
demolition of wall shows assembly of gwb, 2x4's and horizontal wood siding

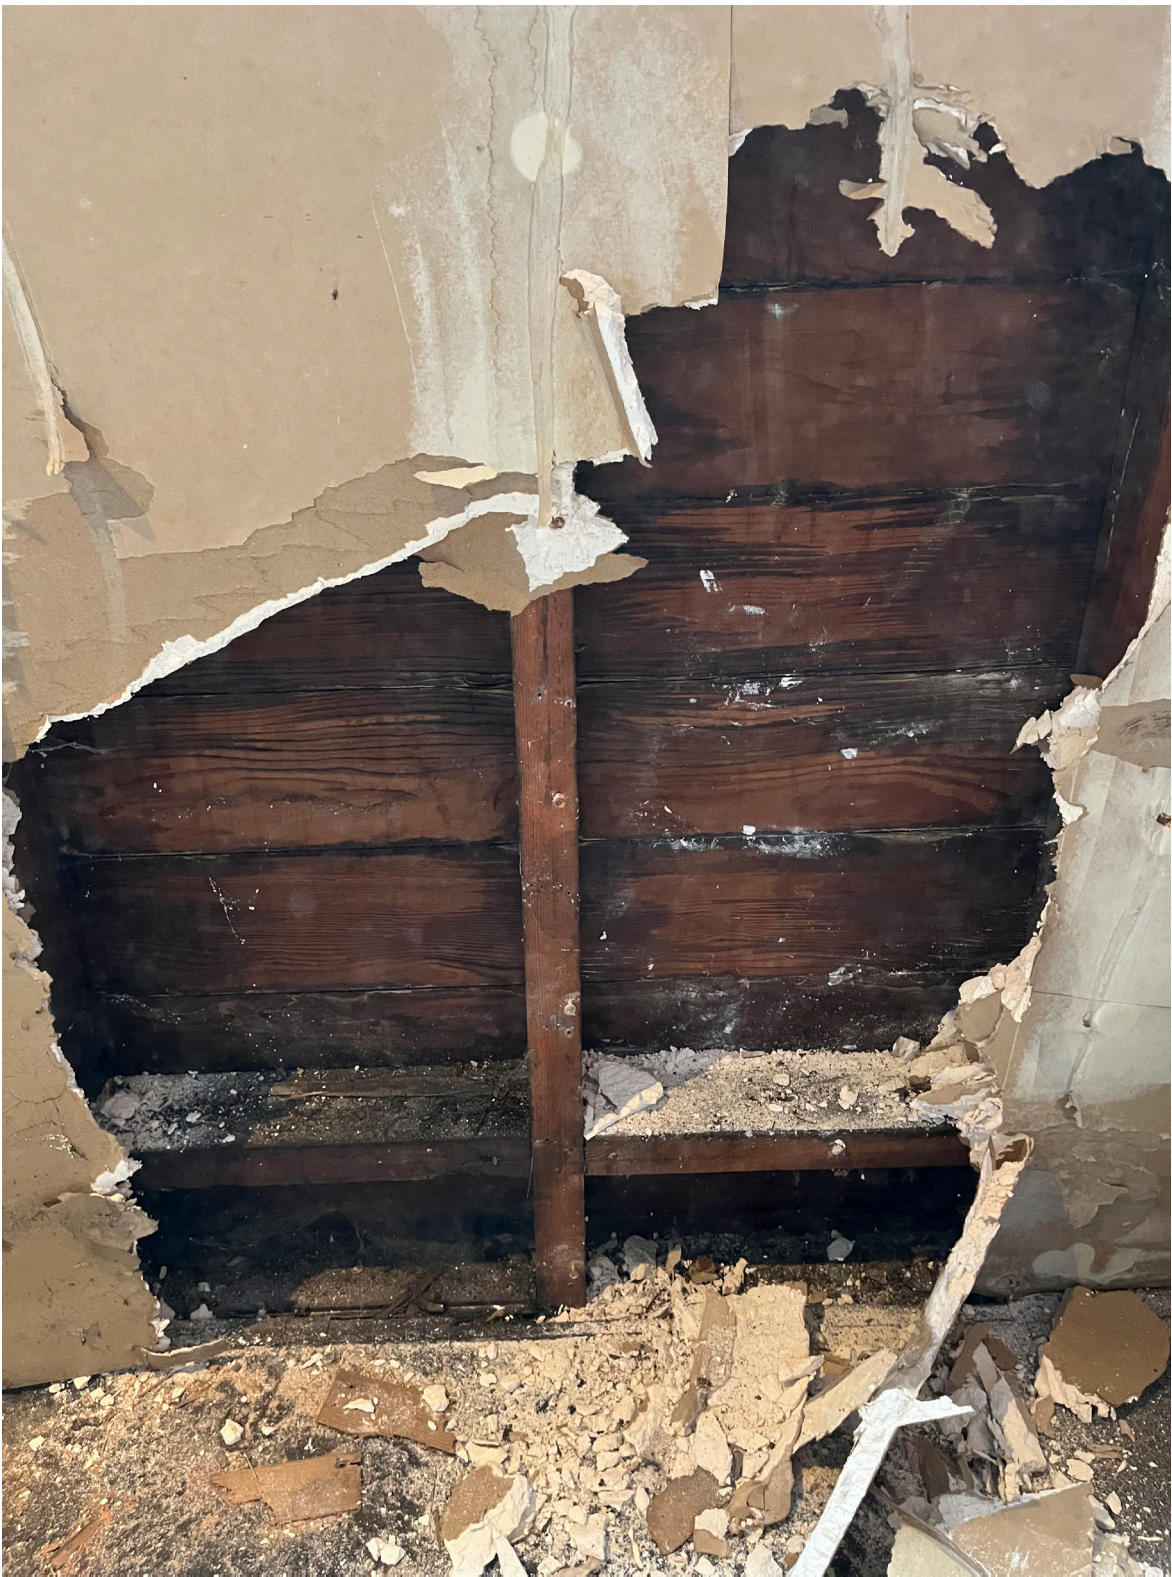
close-up of wall assembly shows no original building materials still exist

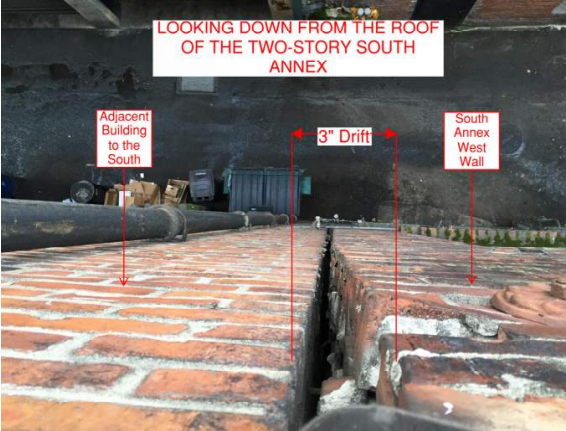
The annex additions have a permanent displacement to the north-west as evidenced by a separation of the annex walls from both the adjacent building to the south, and the main J&M building to the east. The separation opens near the 1st floor level and the gap increases over the building’s height. In 2015 we measured a gap between the annex and the adjacent building to the south of approximately 3” at the second floor, which was unchanged in April of 2025. See Figure 1. We also measured a gap of 2”-3” between the annex and main J&M building. Movement to the west is also evident in significant out-of-plane drift. See Figure 2. At the time of our site visits in 2015, the maximum westerly drift of the annex was 8” at the north annex and 4 ½” at the south annex. During our 2025 site visit, we found that the drift of the north annex had increase from 8” to 8 7/8”. The added 7/8” drift appears to be due to a bulge that has formed in the west wall 7’-4” above grade.

Figure 1: Northerly Drift- South End of Building

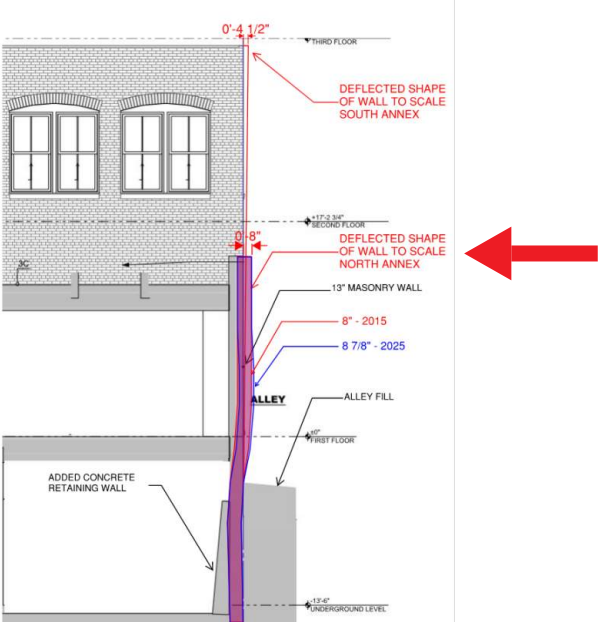
Figure 2: Alley Wall Displacement - West

Possible explanations for the drift and gaps are foundation settlement, deterioration of the brick and mortar, and racking due to earthquake damage. It is likely that the gaps are a result of combination of all three.

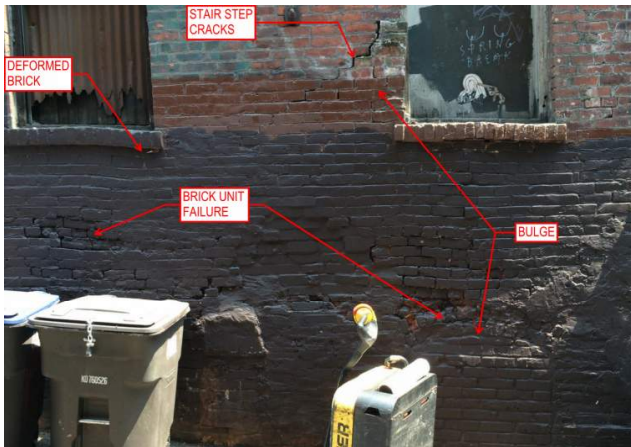
Sheets of plywood have been installed over windows and headers to cover the failing brick. Significant deterioration and damage has also occurred to the North Annex wall. The brick units have lost internal structural integrity resulting in visible deformation along the length of the units. The loss of integrity is likely the result of weathering, and overstresses cause by foundation settlement and settlement induced by deterioration and collapse of the below grade brickwork. Deformations were observed of ½” to ¾” over the length of some units, and a total of over 4” over a length of 24”. See Figure 3.

Figure 3: West Wall Localized Failures

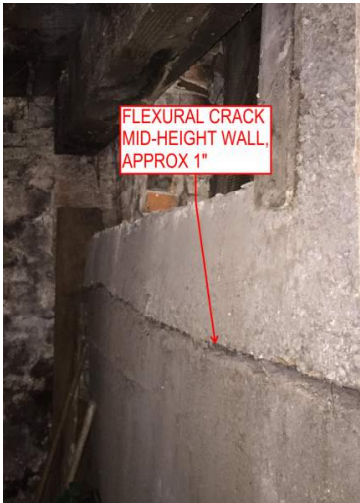
We found that the foundation wall of the annex is failing due to a combination of settlement, deterioration, and out-of-plane soil loads. As noted previously, the alley was regraded, and fill was placed against the annex’s west wall. The interior of the wall shows evidence of deteriorated brick units and severely degraded mortar, as well as heavy efflorescence consistent with deteriorated

or missing waterproofing facing the soil. No waterproofing was visible on the outside face of wall. The added soil pressure, in combination with the deterioration of the masonry from direct contact with the soil, has caused an out-of-plane failure of the west annex wall. The failure is most significant in the North Annex, where grade is highest. The failing North Annex wall had been reinforced with a concrete overlay wall, which has also failed in flexure due to the soil loads. See Figure 4. The west wall of the annex appears to have settled at least 6”, as measure in deformation of brick units and floor elevation measurements. See Figure 5 for settlement as measure on the annex floor. In our opinion, the foundation of the annex was found on fill material and has suffered from either consolidation settlement, liquefaction related settlement, or both.

Figure 4: Basement Wall Flexural Failure

We recommend deconstruction of the west, north, and mid annex walls to allow foundation replacement, followed by reconstruction in accordance with architectural and historical requirements.

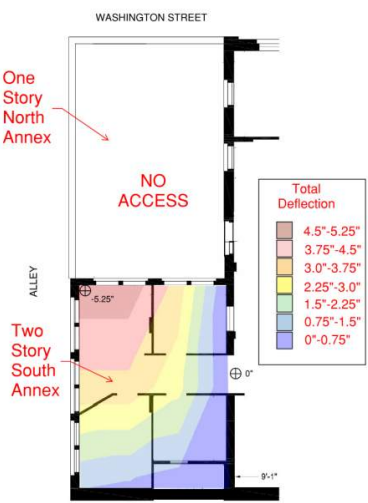
Figure 5: Floor out-of-Level
