J&M HOTEL ANNEX DEMOLITION PACKET

Pioneer Square Preservation Board Briefing
April 30, 2025

J&M Hotel Annex 2025 Condition Assessment

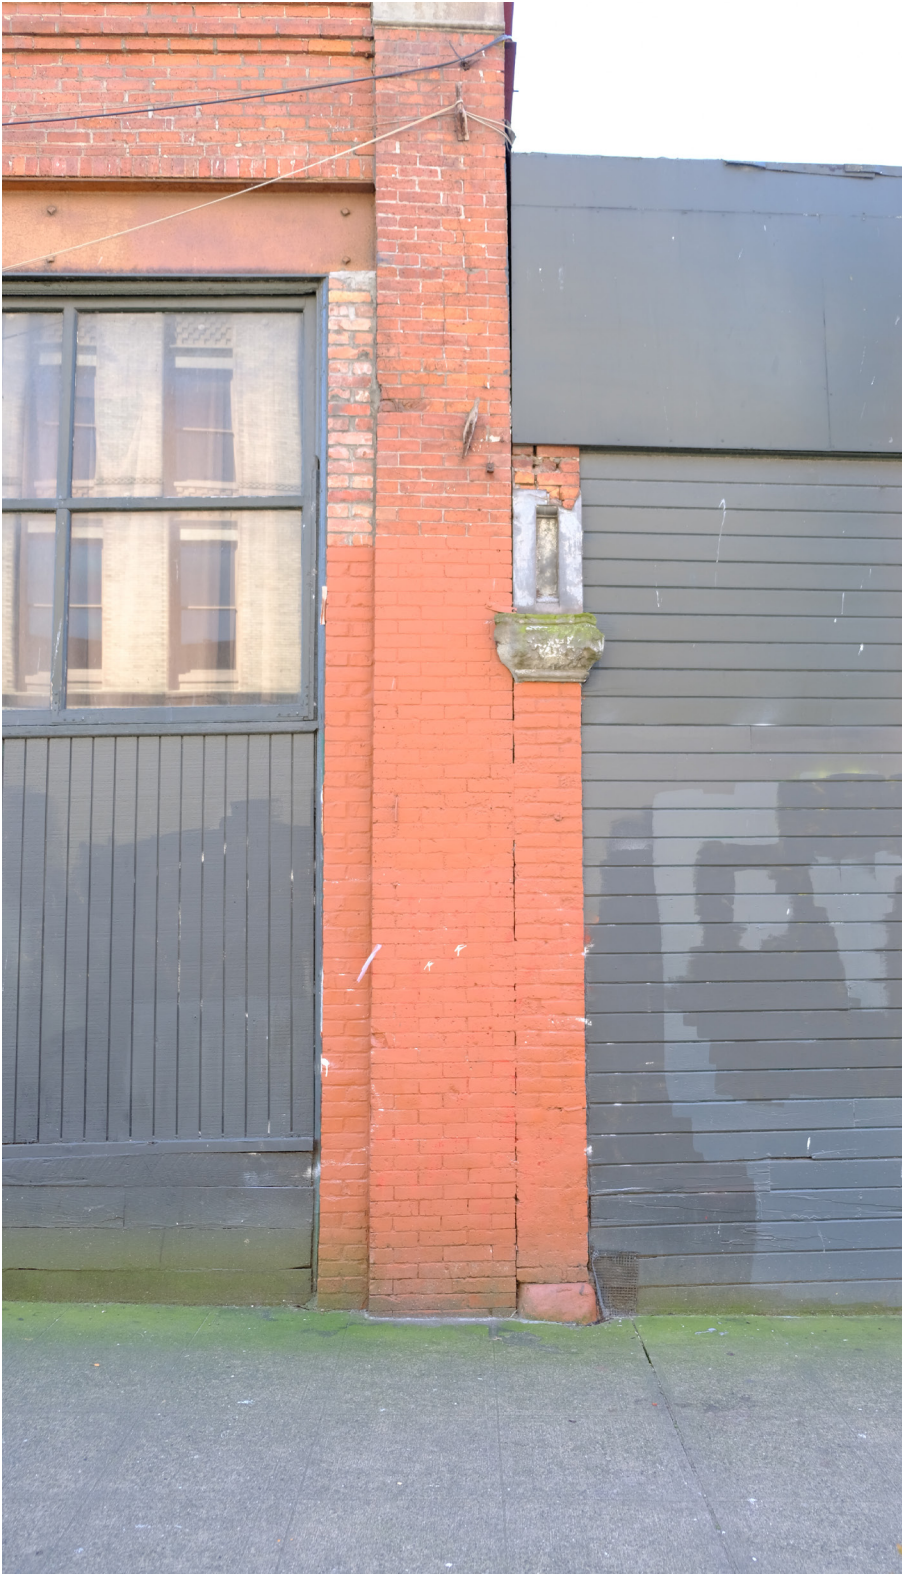
detail at joint between j&m base building and north annex

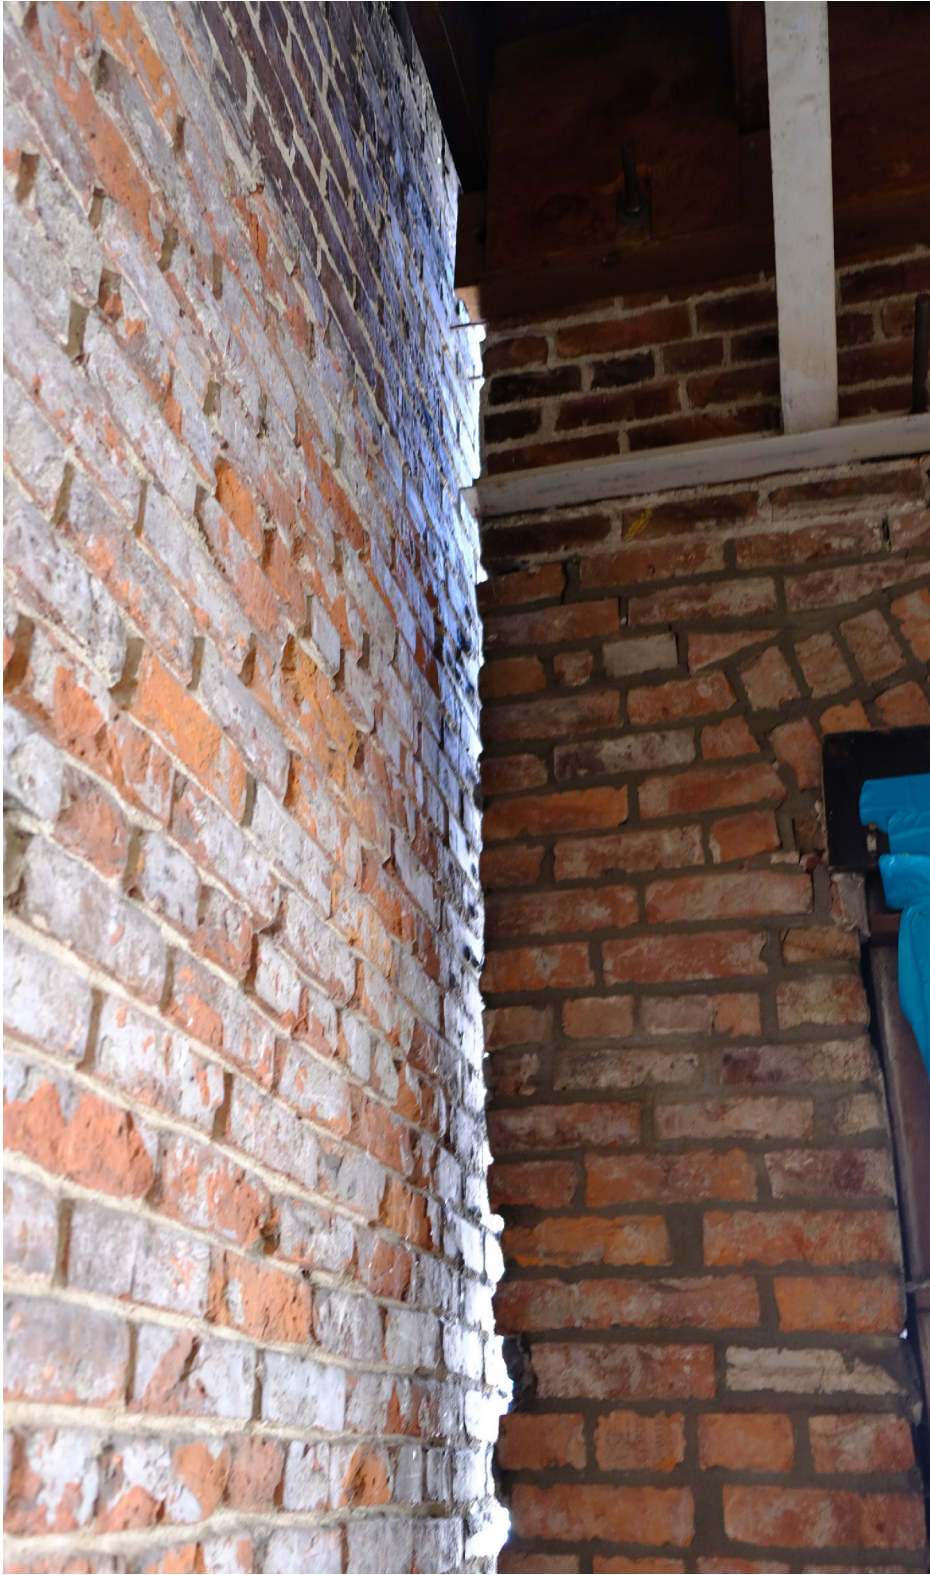
3" daylight gap between west wall of south annex and neighboring building to the south.

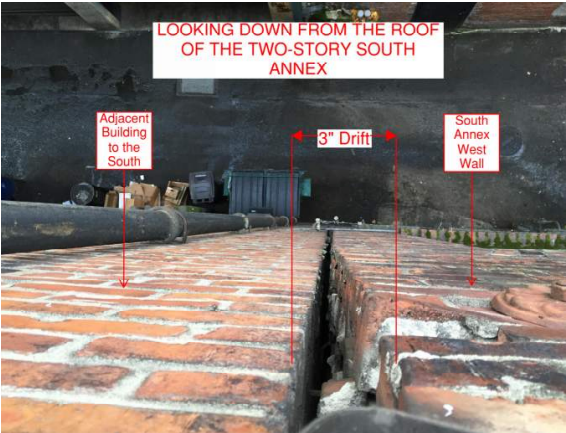
The annex additions have a permanent displacement to the north-west as evidenced by a separation of the annex walls from both the adjacent building to the south, and the main J&M building to the east. The separation opens near the 1st floor level and the gap increases over the building’s height. In 2015 we measured a gap between the annex and the adjacent building to the south of approximately 3” at the second floor, which was unchanged in April of 2025. See Figure 1. We also measured a gap of 2”-3” between the annex and main J&M building. Movement to the west is also evident in significant out-of-plane drift. See Figure 2. At the time of our site visits in 2015, the maximum westerly drift of the annex was 8” at the north annex and 4 ½” at the south annex. During our 2025 site visit, we found that the drift of the north annex had increase from 8” to 8 7/8”. The added 7/8” drift appears to be due to a bulge that has formed in the west wall 7’-4” above grade.

Figure 1: Northerly Drift- South End of Building

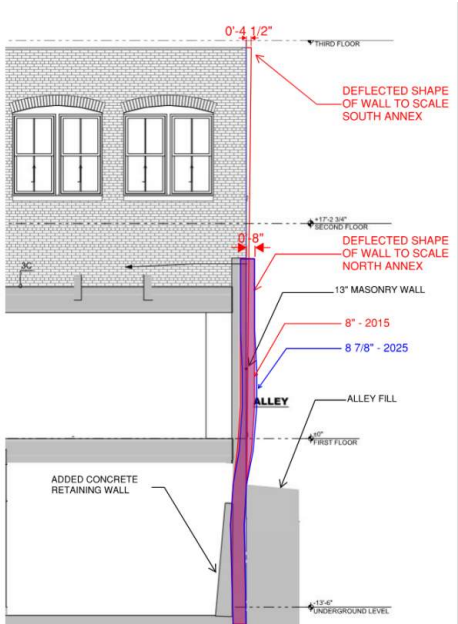
Figure 2: Alley Wall Displacement - West

Possible explanations for the drift and gaps are foundation settlement, deterioration of the brick and mortar, and racking due to earthquake damage. It is likely that the gaps are a result of combination of all three.

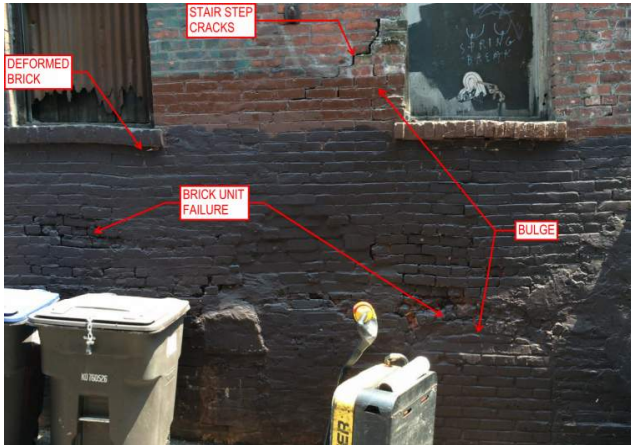
Sheets of plywood have been installed over windows and headers to cover the failing brick. Significant deterioration and damage has also occurred to the North Annex wall. The brick units have lost internal structural integrity resulting in visible deformation along the length of the units. The loss of integrity is likely the result of weathering, and overstresses cause by foundation settlement and settlement induced by deterioration and collapse of the below grade brickwork. Deformations were observed of ½” to ¾” over the length of some units, and a total of over 4” over a length of 24”. See Figure 3.

Figure 3: West Wall Localized Failures

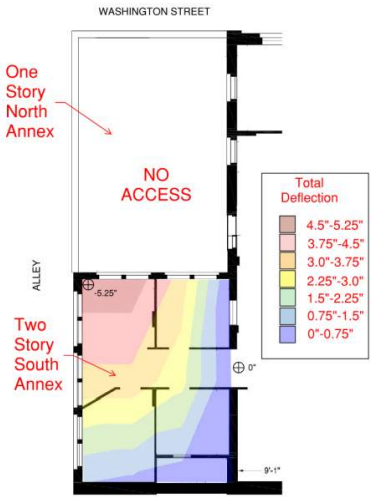
Figure 5: Floor out-of-Level
