**Name:** J&M Hotel

**Address:** 201 First Avenue

# STRUCTURAL REPORT

April 24<sup>th</sup>, 2025

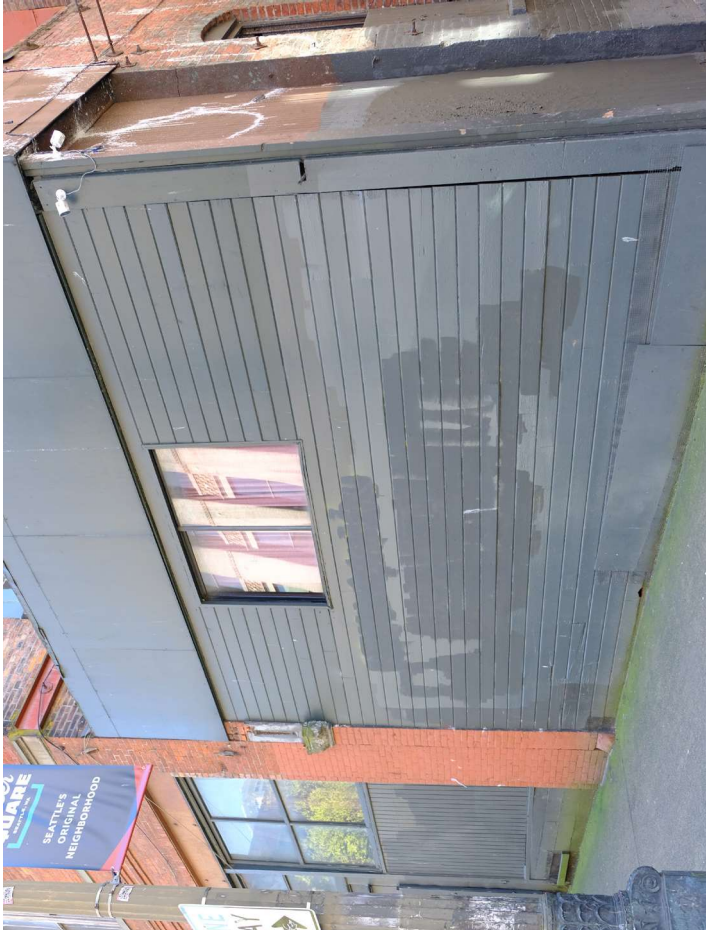
existing north annex, Washington street facade

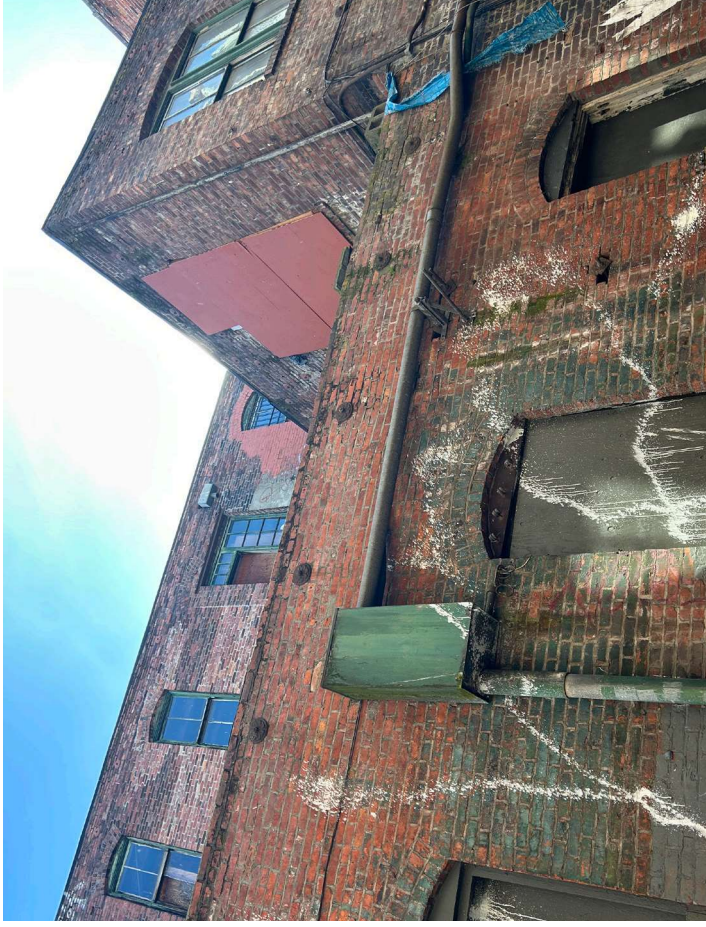
existing north annex in foreground with south annex to the right and the j&m building beyond

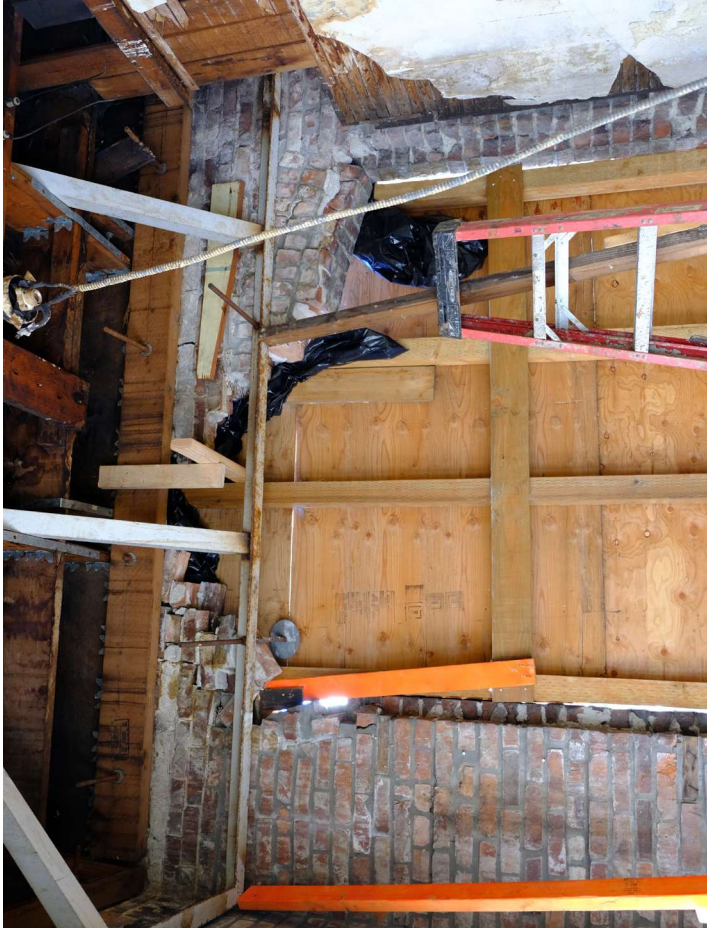
collapsing load-bearing brick wall at window in north wall of 2nd story of south annex

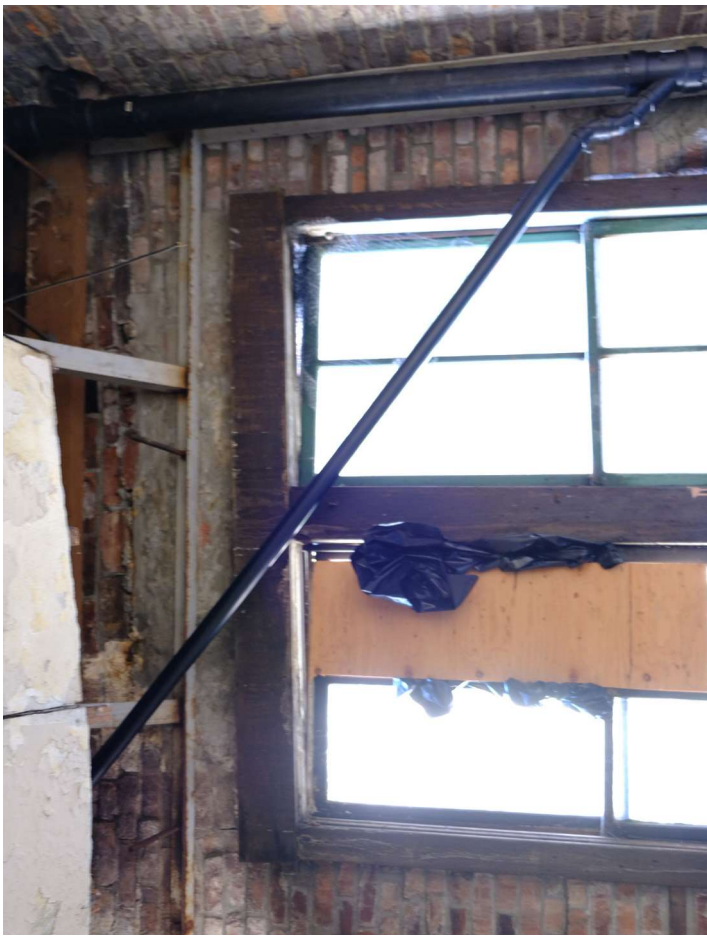
failing lintel at 2nd story window in south annex

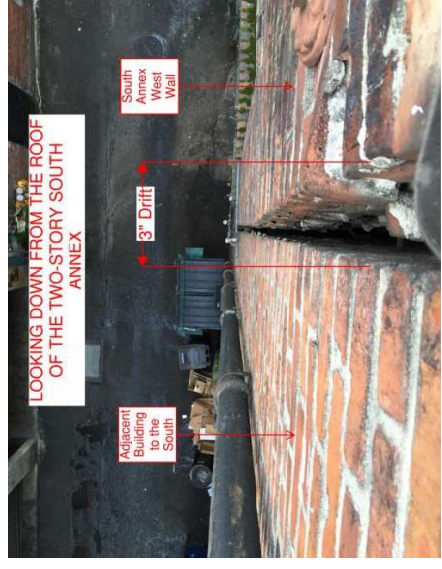
The annex additions have a permanent displacement to the north-west as evidenced by a separation of the annex walls from both the adjacent building to the south, and the main J&M building to the east. The separation opens near the 1<sup>st</sup> floor level and the gap increases over the building's height. In 2015 we measured a gap between the annex and the adjacent building to the south of approximately 3" at the second floor, which was unchanged in April of 2025. See Figure 1. We also measured a gap of 2"-3" between the annex and main J&M building. Movement to the west is also evident in significant out-of-plane drift. See Figure 2. At the time of our site visits in 2015, the maximum westerly drift of the annex was 8" at the north annex and 4 1/2" at the south annex. During our 2025 site visit, we found that the drift of the north annex had increased from 8" to 8 7/8". The added 7/8" drift appears to be due to a bulge that has formed in the west wall 7'-4" above grade.

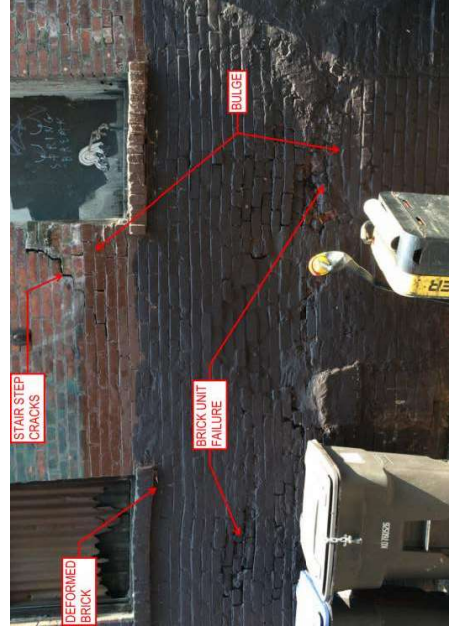
Figure 3: West Wall Localized Failures

Sheets of plywood have been installed over windows and headers to cover the failing brick. Significant deterioration and damage has also occurred to the North Annex wall. The brick units have lost internal structural integrity resulting in visible deformation along the length of the units. The loss of integrity is likely the result of weathering, and overstresses cause by foundation settlement and settlement induced by deterioration and collapse of the below grade brickwork. Deformations were observed of  $\frac{1}{2}$ " to  $\frac{3}{4}$ " over the length of some units, and a total of over 4" over a length of 24". See Figure 3.

Other areas of concern include the concrete block piers supporting the South Annex, which have shear cracks. In summary, the areas of wall with severe degradation include: the entirety of the west wall of the North Annex and South Annex from foundation to roof, the demising wall between the North Annex and South Annex from the second floor to the roof.

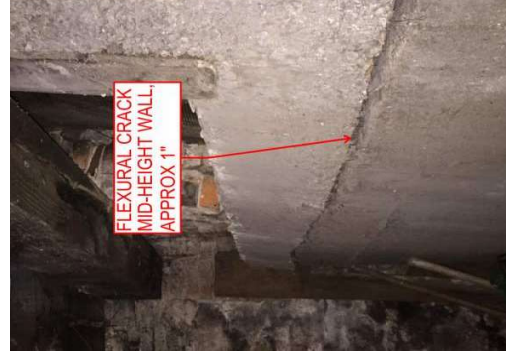
Figure 4: Basement Wall Flexural Failure

We found that the foundation wall of the annex is failing due to a combination of settlement, deterioration, and out-of-plane soil loads. As noted previously, the alley was regraded, and fill was placed against the annex's west wall. The interior of the wall shows evidence of deteriorated brick units and severely decayed mortar, as well as heavy efflorescence consistent with deteriorated

or missing waterproofing facing the soil. No waterproofing was visible on the outside face of wall. The added soil pressure, in combination with the deterioration of the masonry from direct contact with the soil, has caused an out-of-plane failure of the west annex wall. The failure is most significant in the North Annex, where grade is highest. The failing North Annex wall had been reinforced with a concrete overlay wall, which has also failed in flexure due to the soil loads. See Figure 4. The west wall of the annex appears to have settled at least 6", as measure in deformation of brick units and floor elevation measurements. See Figure 5 for settlement as measure on the annex floor. In our opinion, the foundation of the annex was found on fill material and has suffered from either consolidation settlement, liquefaction related settlement, or both.

The foundation of the annex has failed with significant vertical settlement and out-of-plane displacement. As a result, it must be replaced with a deep foundation system that has firm bearing on the glacial till approximately 20' below alley grade. To safely replace the foundation, the building above must maintain its structural integrity as the wall stresses are transferred between the existing foundation, to
