# Morrison Hotel

Certificate of Approval Application, Window Survey

509 Thrid Avenue South - Seattle, WA 98104

Survey conducted by SMR Architects in conjunction with DESC on the days of 07/09/2026, 07/10/2026, 7/23/2026.

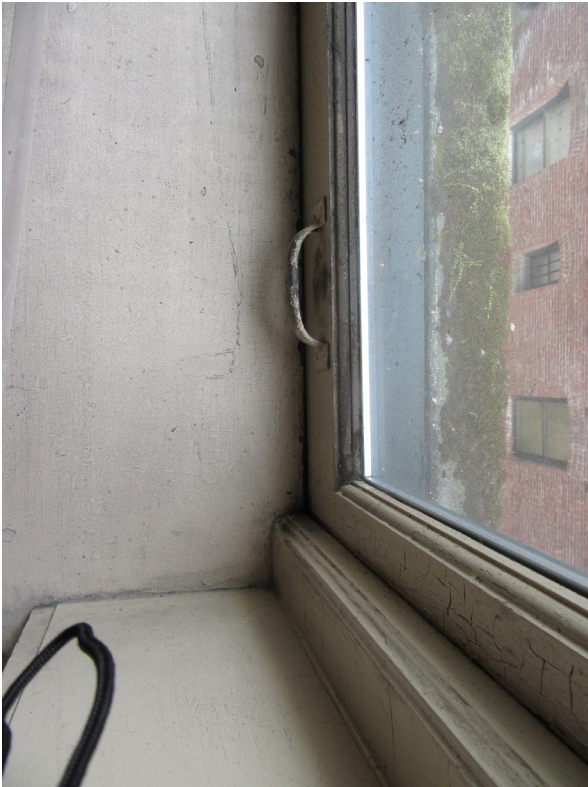
FAIR Sash & Stool

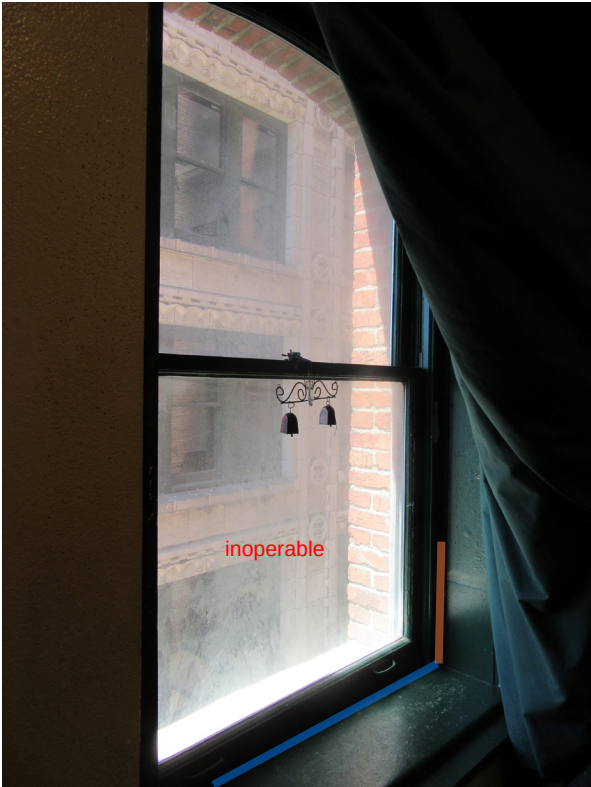
| Window Survey | | | | | | | | | | | | | | | |
|---|---|---|---|---|---|---|---|---|---|---|---|---|---|---|---|
| 301 | 301.1 | | | X | SH | | F | P | G | F | P | P | F | F | |

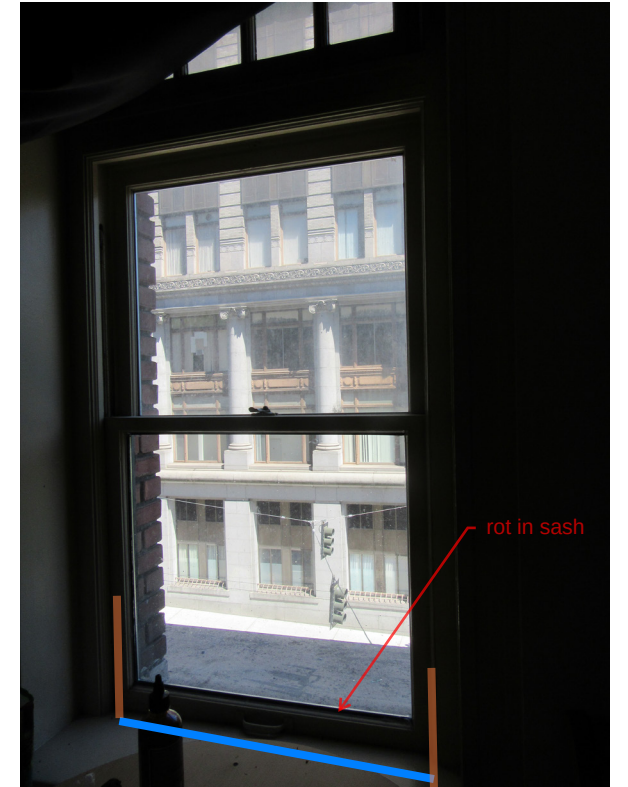
| Window Survey | | | | | | | | | | | | | | | |
|---|---|---|---|---|---|---|---|---|---|---|---|---|---|---|---|
| | 306.3 | | | X | SH | X | F | P | G | P | P | P | P | F | |

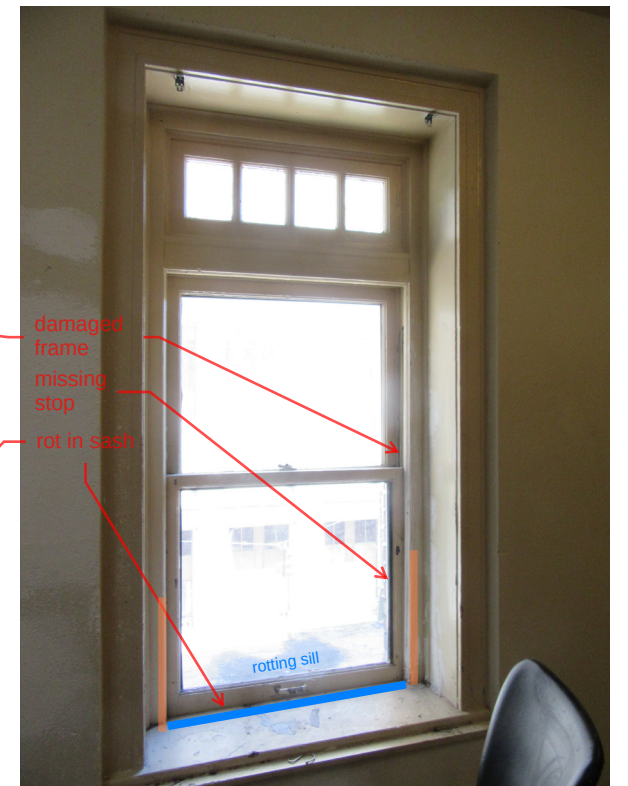
| Window Survey | | | | | | | | | | | | | | | |
|---|---|---|---|---|---|---|---|---|---|---|---|---|---|---|---|
| 308 | 308.1 | | | X | SH | X | F | P | G | F | P | F | P | F | |

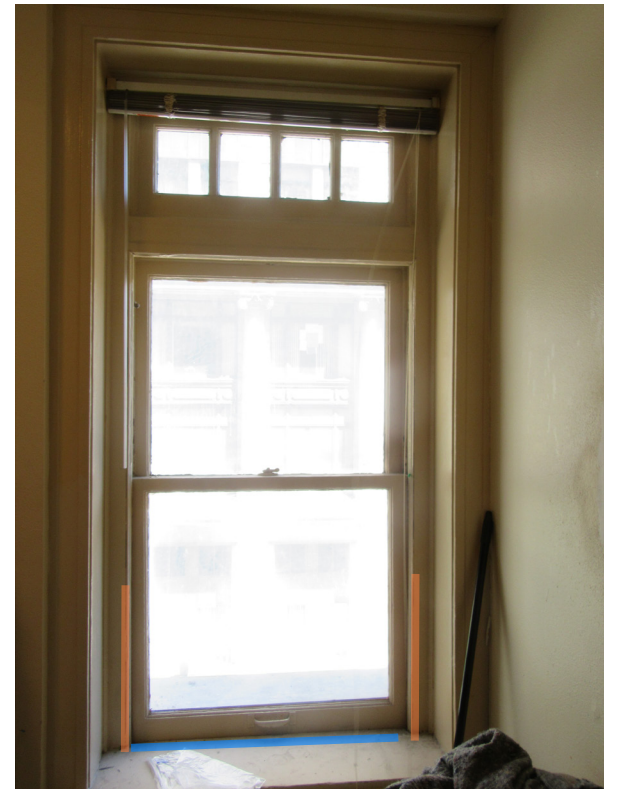
| Window Survey | | | | | | | | | | | | | | | |
|---|---|---|---|---|---|---|---|---|---|---|---|---|---|---|---|
| 310 | 310.1 | | | X | SH | X | F | P | G | F | P | P | F | F | |

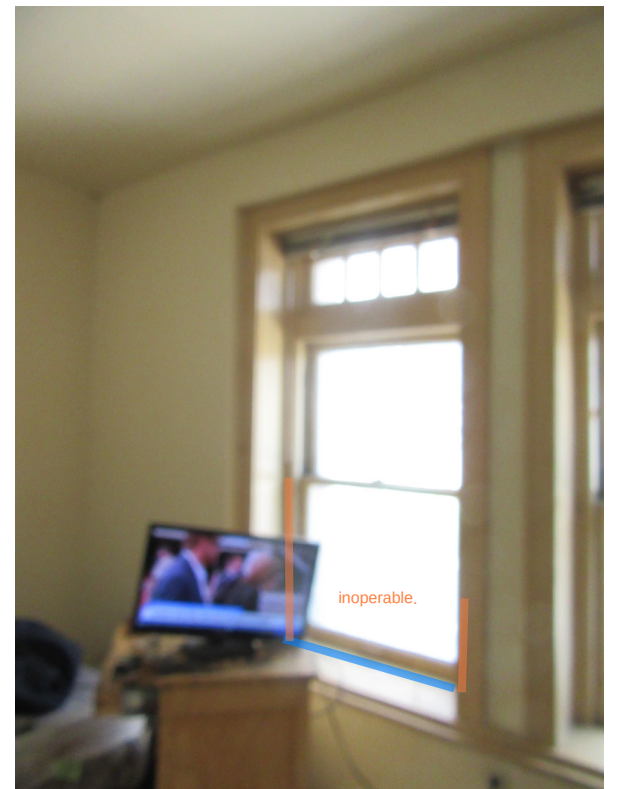
| Window Survey | | | | | | | | | | | | | | | |
|---|---|---|---|---|---|---|---|---|---|---|---|---|---|---|---|
| | 311.3 | | | X | SH | X | P | P | G | F | P | P | F | F | |

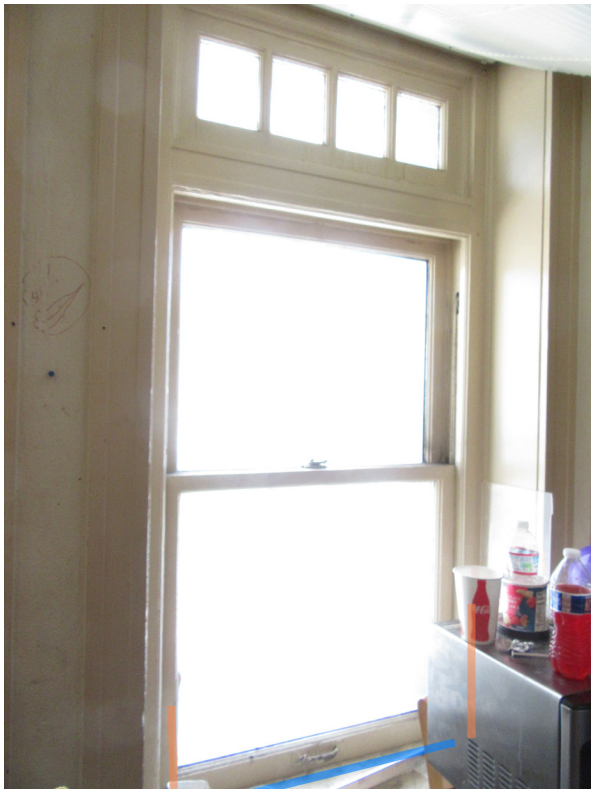
| Window Survey | | | | | | | | | | | | | | | |
|---|---|---|---|---|---|---|---|---|---|---|---|---|---|---|---|
| | 312.2 | | | X | SH | X | P | P | G | F | P | P | F | F | |

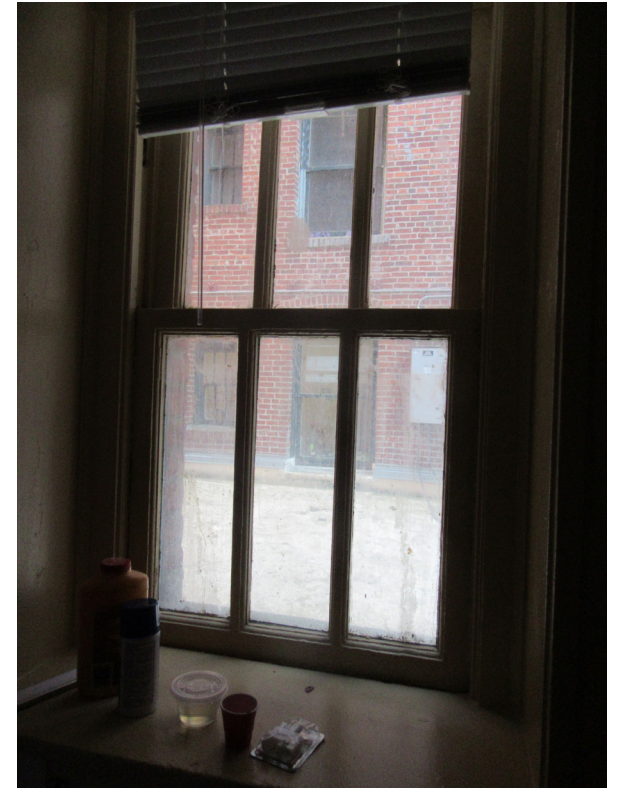
| Window Survey | | | | | | | | | | | | | | | |
|---|---|---|---|---|---|---|---|---|---|---|---|---|---|---|---|
| | 322.3 | | X | | SH/F | | F | F | NA | F | F | NA | F | | SINGLE PANE |

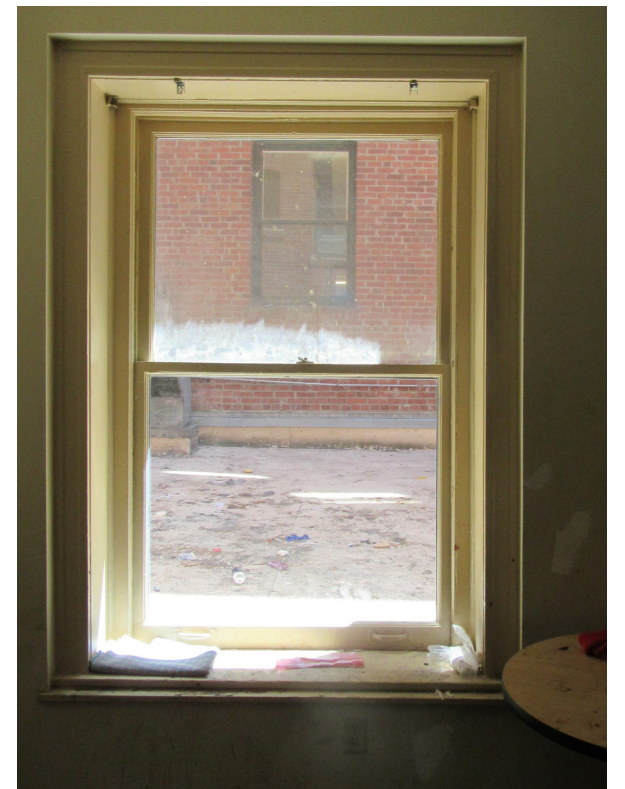
| Window Survey | | | | | | | | | | | | | | | |
|---|---|---|---|---|---|---|---|---|---|---|---|---|---|---|---|
| 325 | 325.1 | | | X | SH | | P | P | G | F | P | P | F | P | |

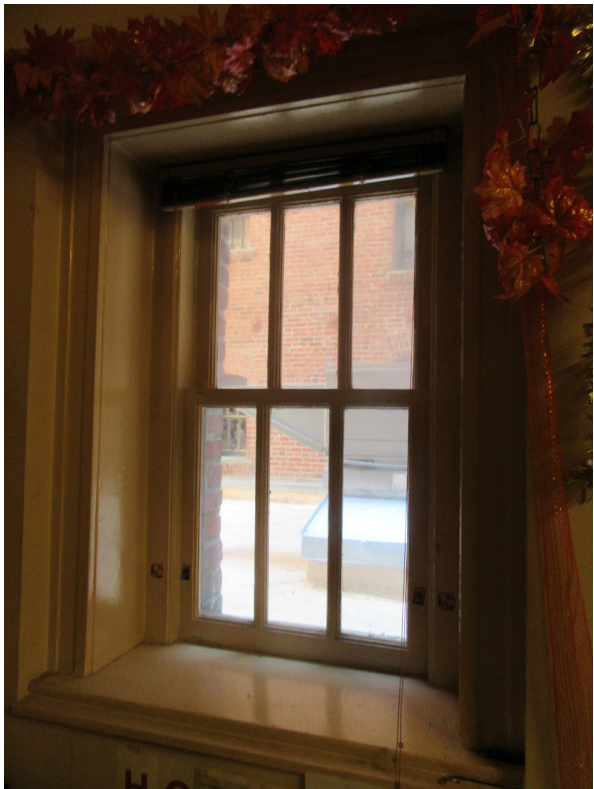
| Window Survey | | | | | | | | | | | | | | | |
|---|---|---|---|---|---|---|---|---|---|---|---|---|---|---|---|
| | 331.2 | | X | | SH/F | | F | F | NA | F | F | NA | F | | SINGLE PANE |

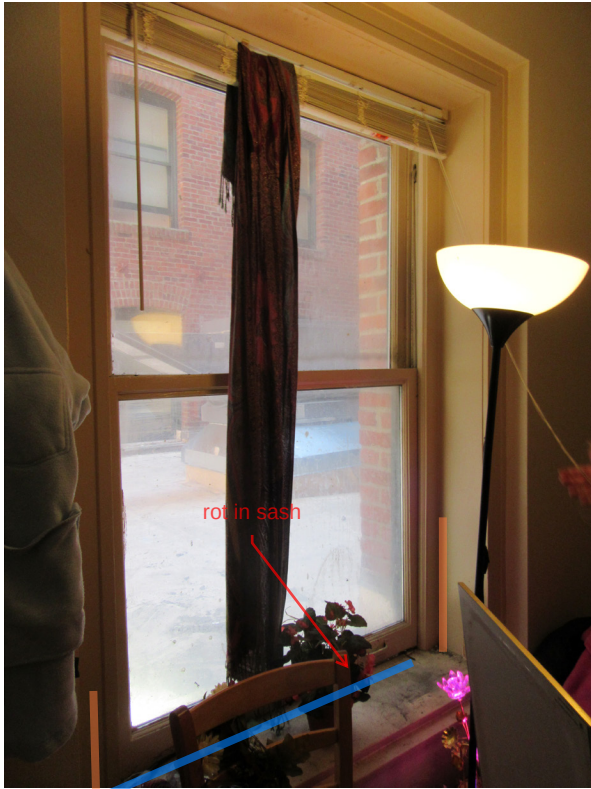
| Window Survey | | | | | | | | | | | | | | | |
|---|---|---|---|---|---|---|---|---|---|---|---|---|---|---|---|
| 332 | 332.1 | | | X | SH | | F | P | G | F | P | G | F | | |

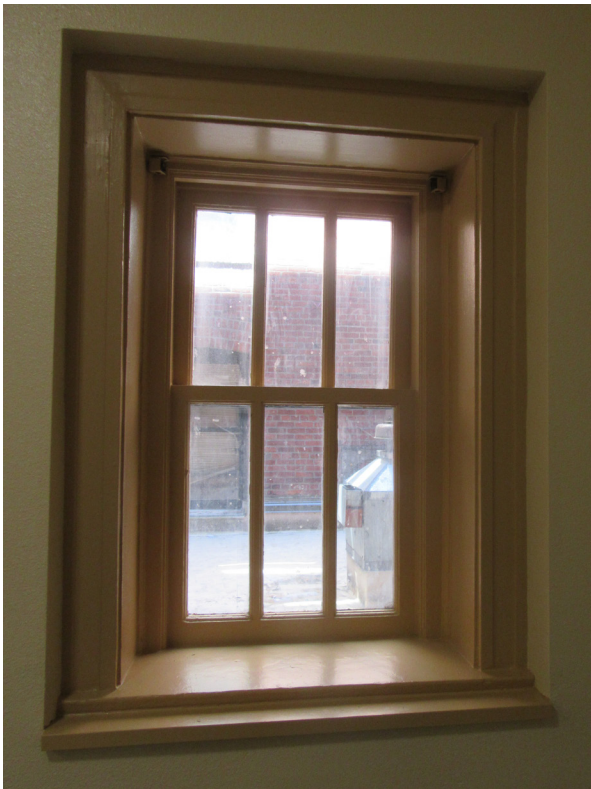
| Window Survey | | | | | | | | | | | | | | | |
|---|---|---|---|---|---|---|---|---|---|---|---|---|---|---|---|
| 338 | 338.1 | | X | | SH/F | | F | F | NA | G | F | NA | F | | SINGLE PANE |

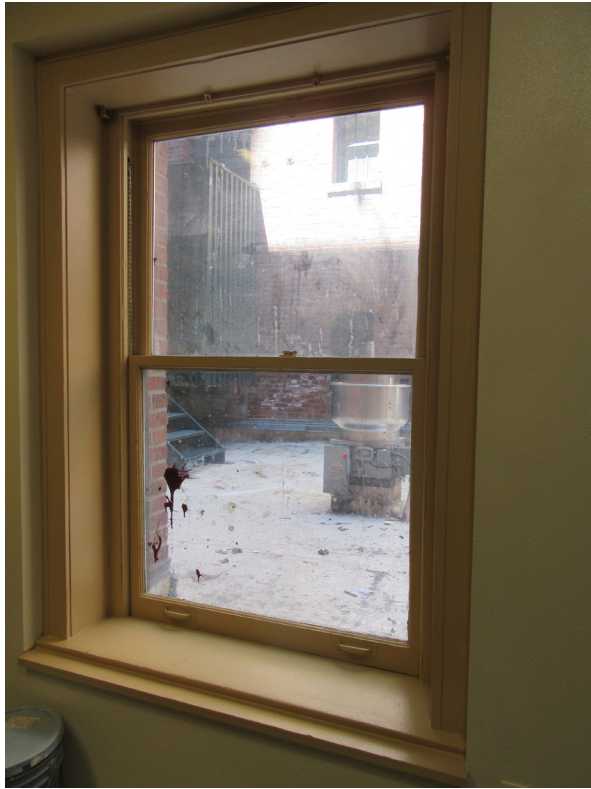
| Window Survey | | | | | | | | | | | | | | | |
|---|---|---|---|---|---|---|---|---|---|---|---|---|---|---|---|
| | 338.2 | | | X | SH | | F | P | P | F | P | P | P | F | |

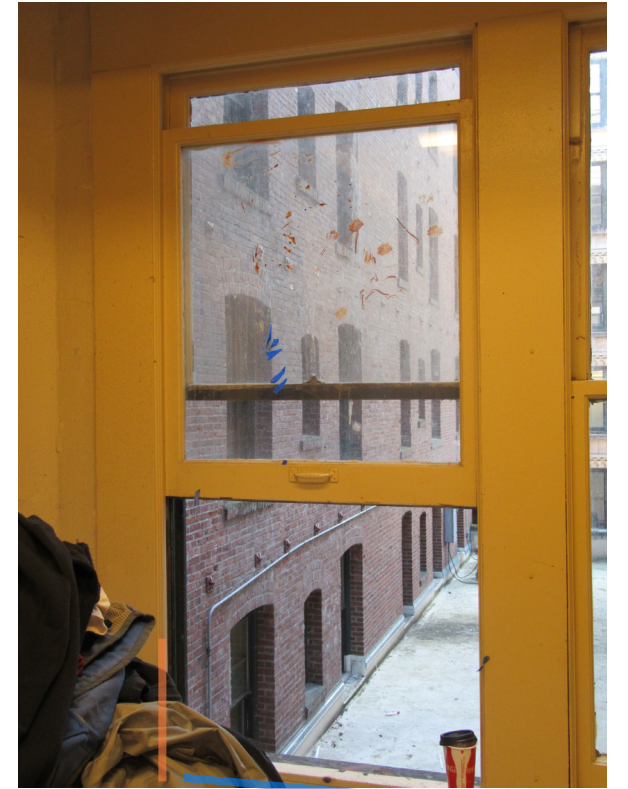
| Window Survey | | | | | | | | | | | | | | | |
|---|---|---|---|---|---|---|---|---|---|---|---|---|---|---|---|
| | 342.2 | | | X | SH | | P | P | F | F | F | F | P | F | SINGLE PANE |

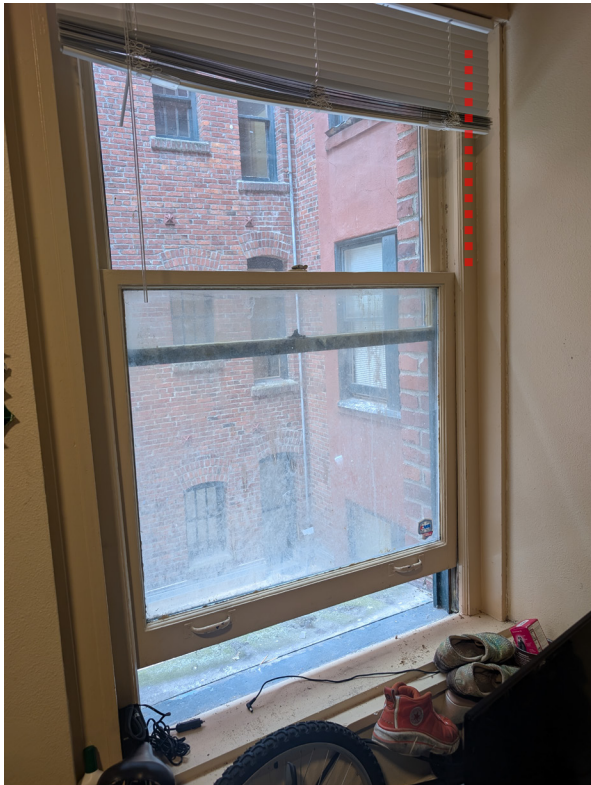
| Window Survey | | | | | | | | | | | | | | | |
|---|---|---|---|---|---|---|---|---|---|---|---|---|---|---|---|
| 436 | 436.1 | | X | | SH | | F | F | F | F | F | P | F | F | CORD MISSING, MISALIGNED |

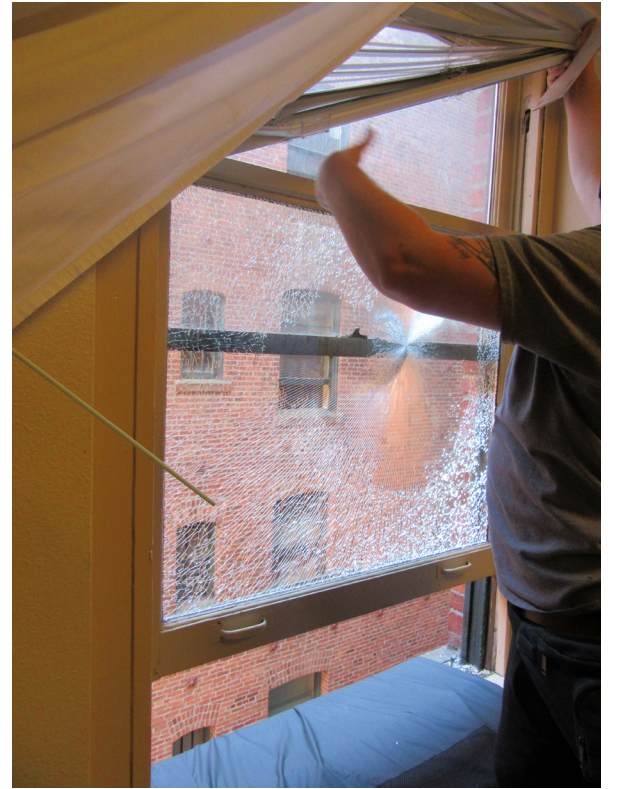
| Window Survey | | | | | | | | | | | | | | | |
|---|---|---|---|---|---|---|---|---|---|---|---|---|---|---|---|
| 631 | 631.1 | | | X | SH | | F | P | P | F | F | P | F | F | BROKEN GLAZING AND MISALIGNED |

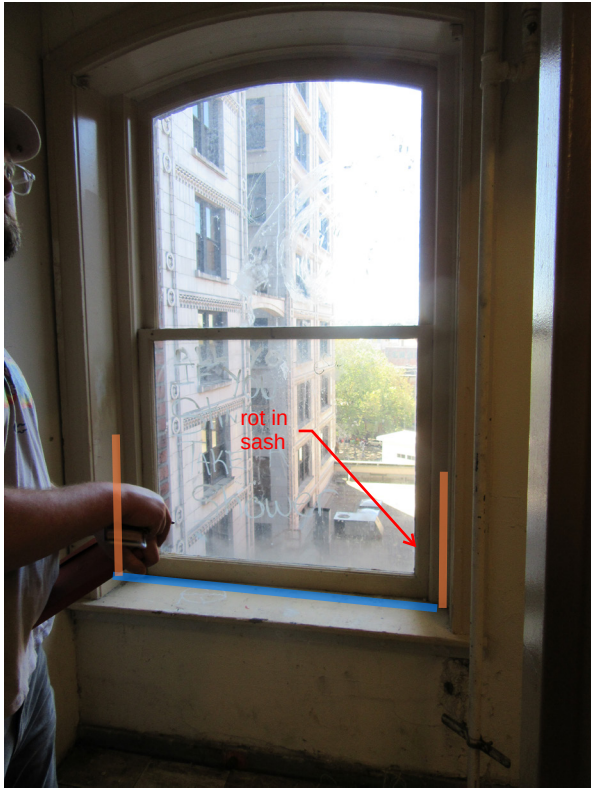
| Window Survey | | | | | | | | | | | | | | | |
|---|---|---|---|---|---|---|---|---|---|---|---|---|---|---|---|
| 300N | 300N.1 | | | X | SH/F | | P | P | P | F | P | NA | G | NA | NAILED CLOSED, SINGLE PANE |

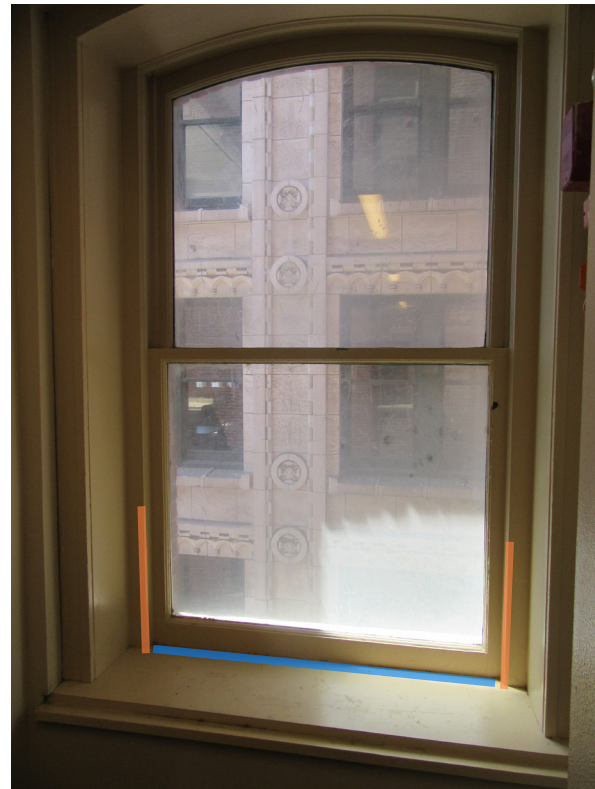
| Window Survey | | | | | | | | | | | | | | | |
|---|---|---|---|---|---|---|---|---|---|---|---|---|---|---|---|
| 300S | 300S.1 | | | X | SH/F | | F | P | G | F | P | NA | P | NA | NAILED CLOSED |
