Terry Denny Building Stair

Pioneer Square Preservation Board Briefing

July 28, 2023

Name: Terry Denny Stair Repair

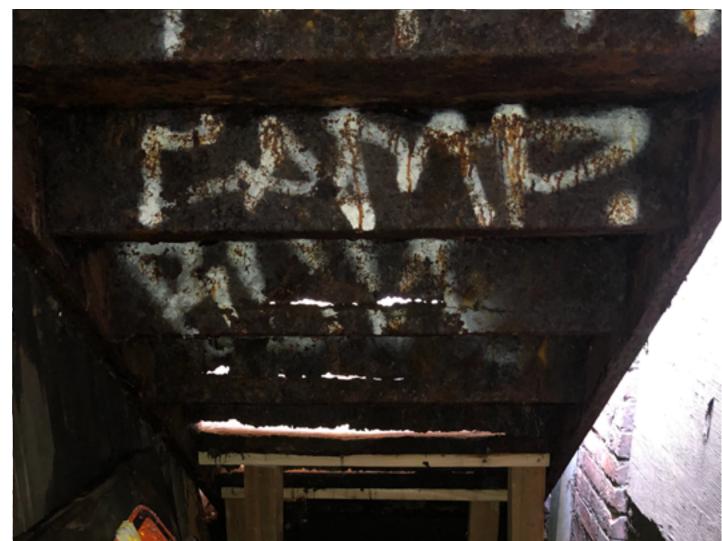
The rail at street level appears to be original while the actual stair structure appears to have been replaced at an unknown date. The current stair is comprised of concrete filled pan treads and steel stringers that likely date back to the bid 20th century at the earliest. The handrail along the building appears to have been added at an unknown date as well.

FROM BELOW STAIR SHOWING LEVEL OF DETERIORATION

The proposed project scope is the replacement of this badly deteriorated stair structure. The design includes new steel channel stringers and concrete filled metal pans with steel risers to match the existing structure. The existing handrail along the building and the rail around the opening at street level are to be painted to match existing but to remain as is. A new stair handrail on the street side of the stair is proposed for safety and accessibility to better align with current code and will also be painted to match existing adjacent rails. The existing walls at the areaway level are to remain and the gate near the bottom of the stair is to be re-installed following the installation of the new stair structure.

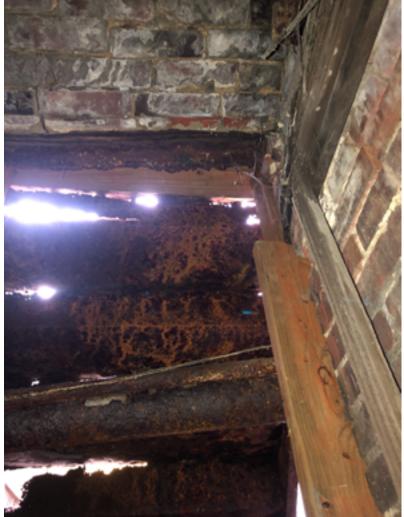
FROM BELOW STAIR SHOWING LEVEL OF DETERIORATION

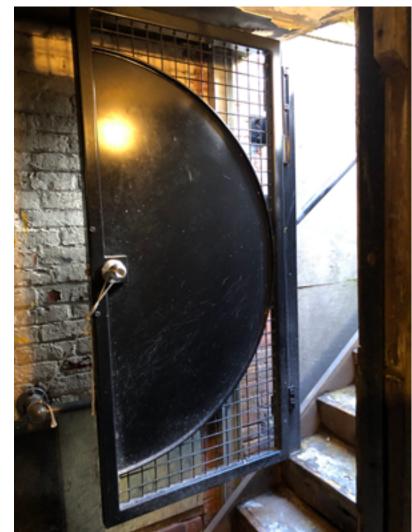
EXISTING GATE TO REMAIN
