Seattle City Light - Vault 22V-4 Repair and Transformer Installation 117 S. Main Street, Seattle

Existing Conditions for Vault 22V-4

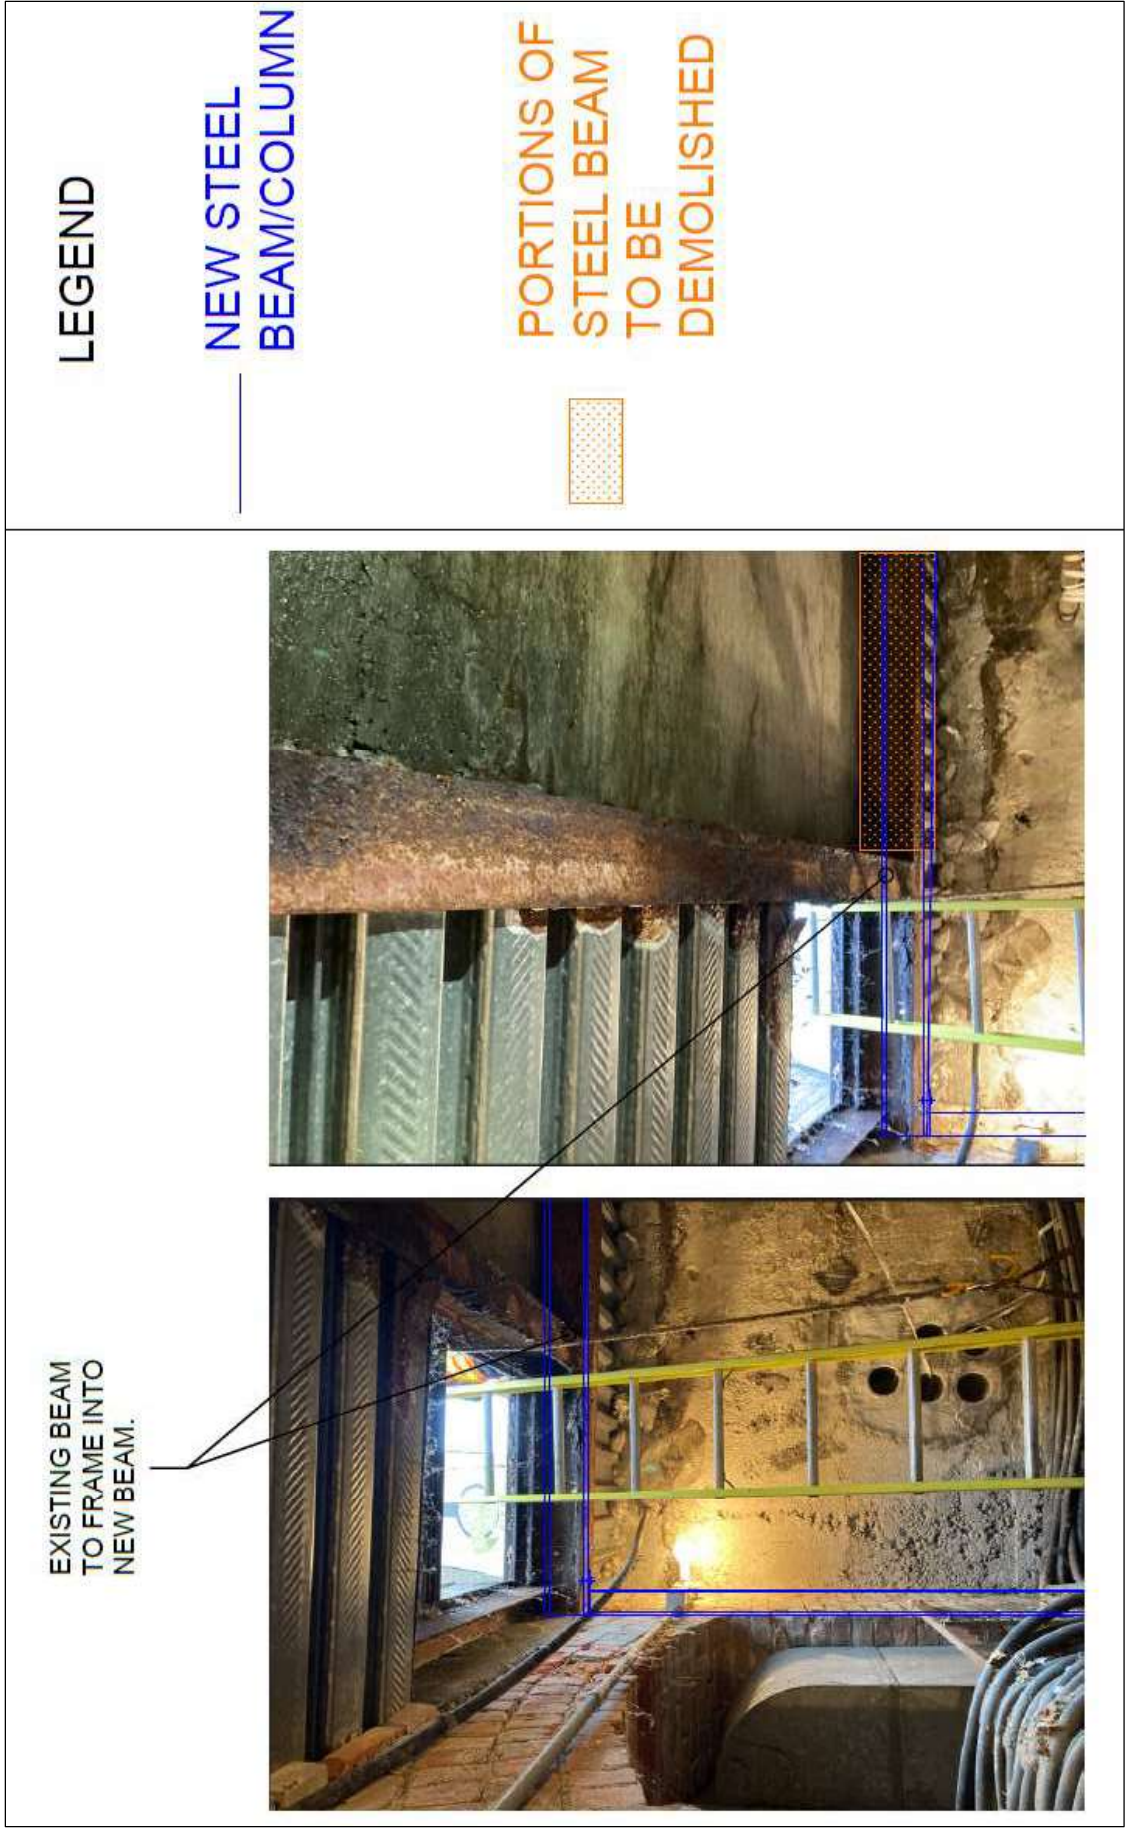
Figure 3 – Proposed placement of steel columns and beams within the vault using photos #5 and #6 as background. This is SK1 from figure 2. (Source: Seattle City Light, 2023.)

- Demolish the existing vault hatch cover on-site and remove debris.
- Remove portions of the steel beams within the vault.
- Install new steel beams where they have been removed, and new columns within the vault adjacent to the existing columns (e.g., to be left in place) and fasten the new into the concrete vault floor and wall surfaces.
- Install a transformer in the vault.
- Install a vault hatch cover composed of slip resistant steel grate panels (3) to provide ventilation and fire resistance.
- Avoid any work on or impacts to the brick arches in the southern side of the vault.
- Avoid any work on the sidewalk adjacent to the vault hatch opening and/or sidewalk curbs.

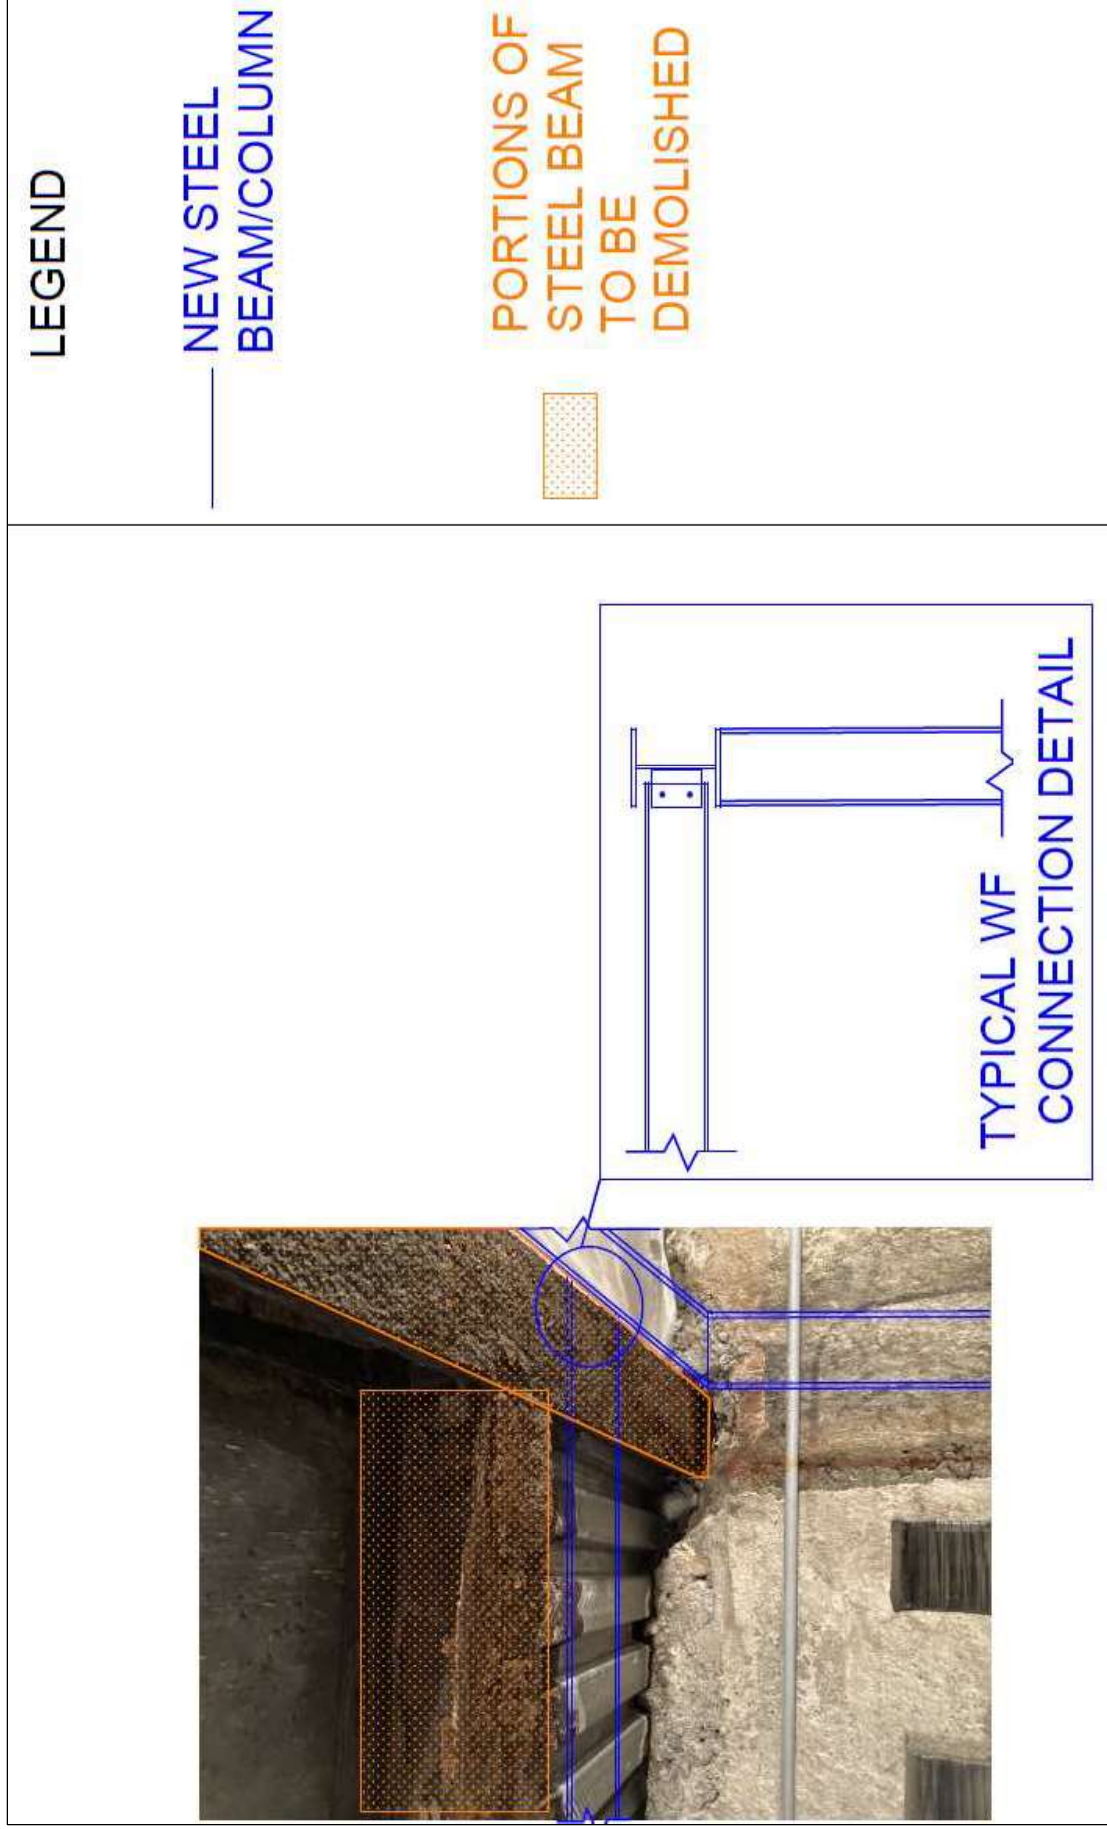
Figure 4 – Proposed installation using Photo #7 as background. This is SK2 from figure 2.
 (Source: Seattle City Light, 2023.)

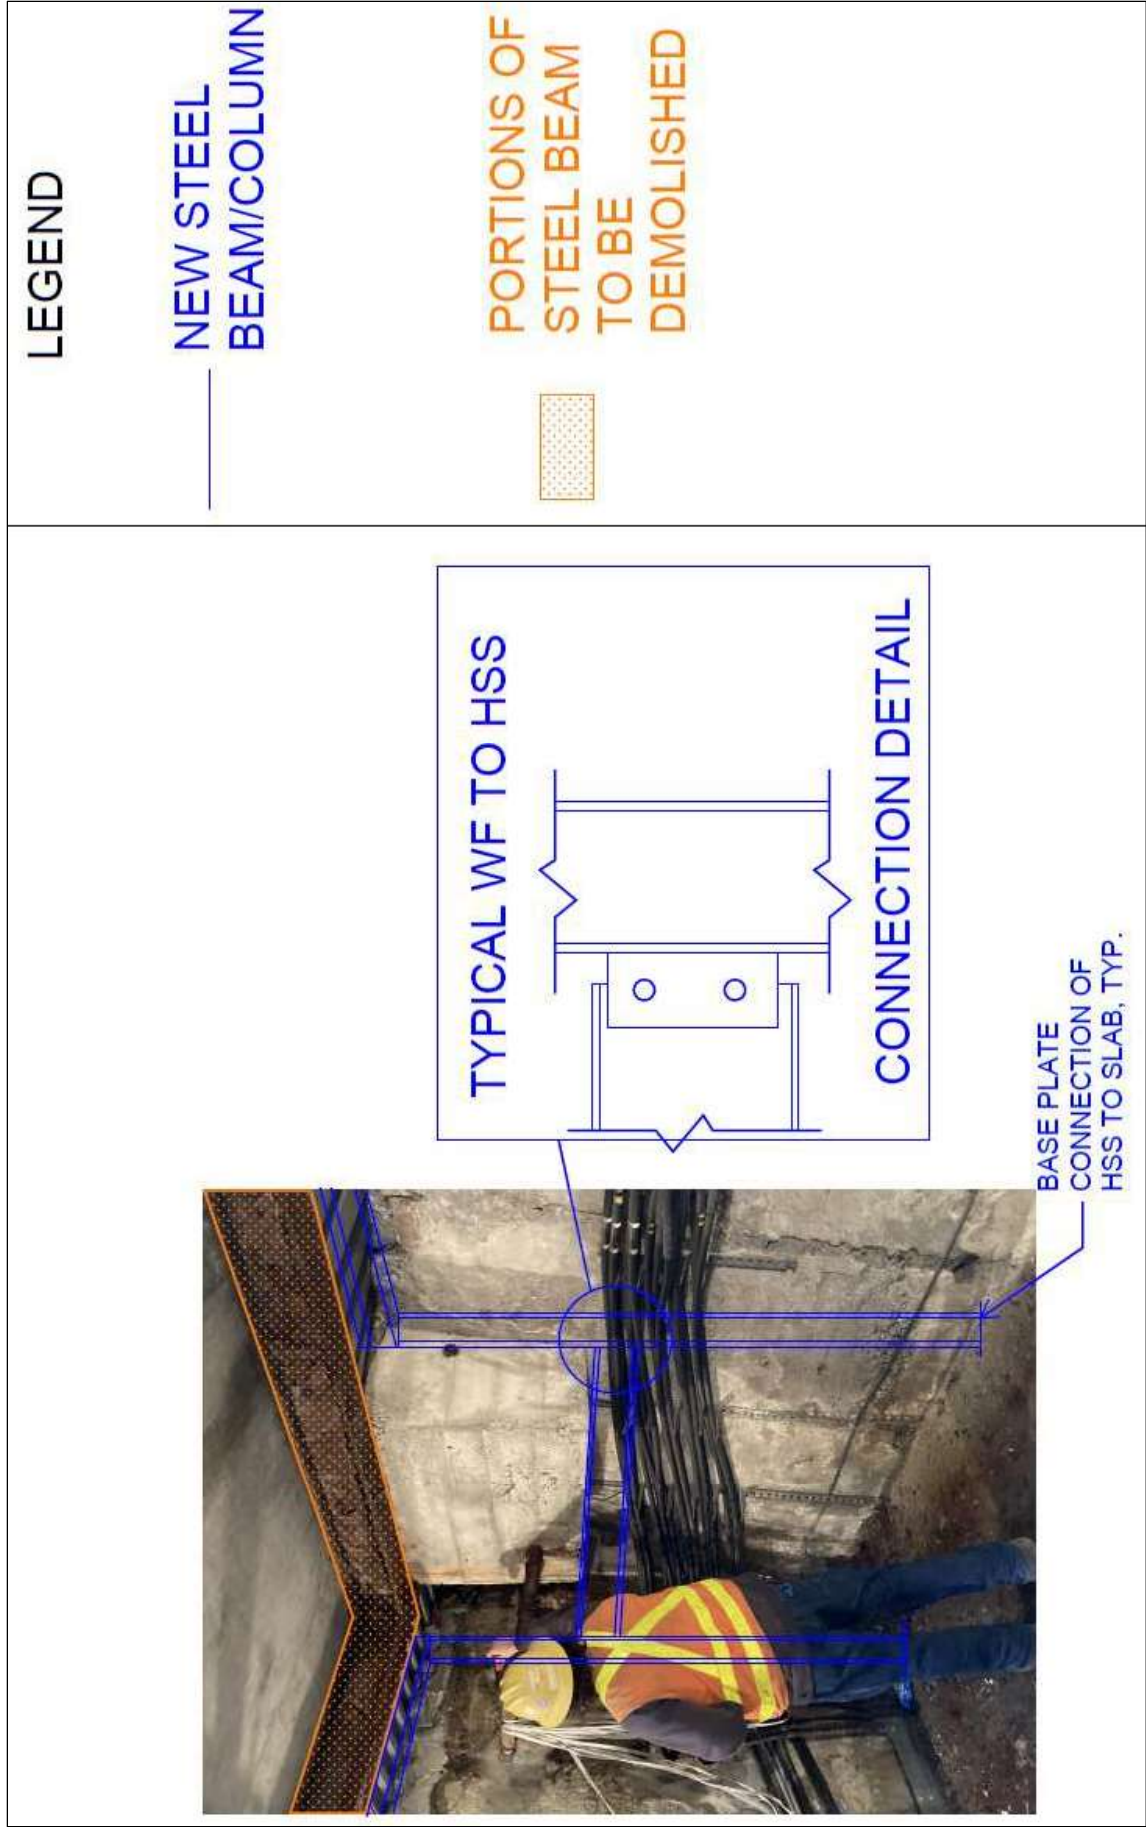
Figure 5 – Proposed installation using Photo #8 as background. This is SK3 from figure 2.
 (Source: Seattle City Light, 2023.)

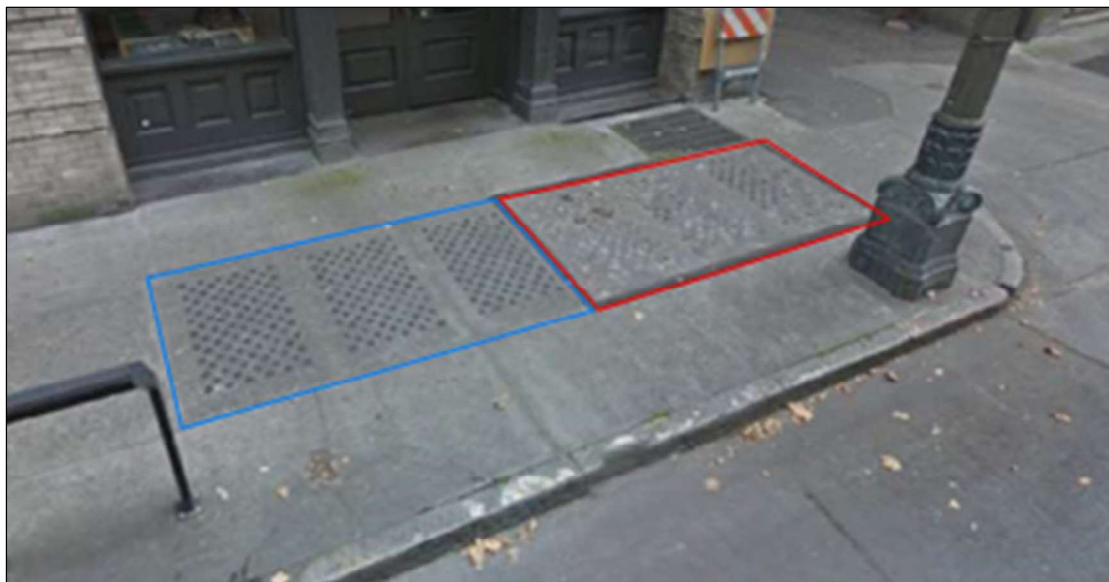
The existing cover as seen in figure 11 (outlined in red) and figure 13 (detail view of figure 11) has round glass pavers with a diameter of 2 inches. The east panel (outlined in blue in figure 11, detail view in figure 12) has round glass pavers that are 2-3/8 inches in diameter. Figure 14 is a partial view of the blue outlined area in figure 11, showing the dimensions of the panel, spacing between pavers and the existing pattern.

Figure 11 – Vault at 117 S. Main St. The blue outlined area shows the portion that will remain in place and will not be altered. The red outlined area shows the area we are proposing to change. (*) Note: The glass pavers here are not true prisms that allow light into the underground space. They are embedded in the upper portion of the concrete panel and do not extend through the depth (thickness) of the concrete panel. (Source: Seattle City Light, 2023.)

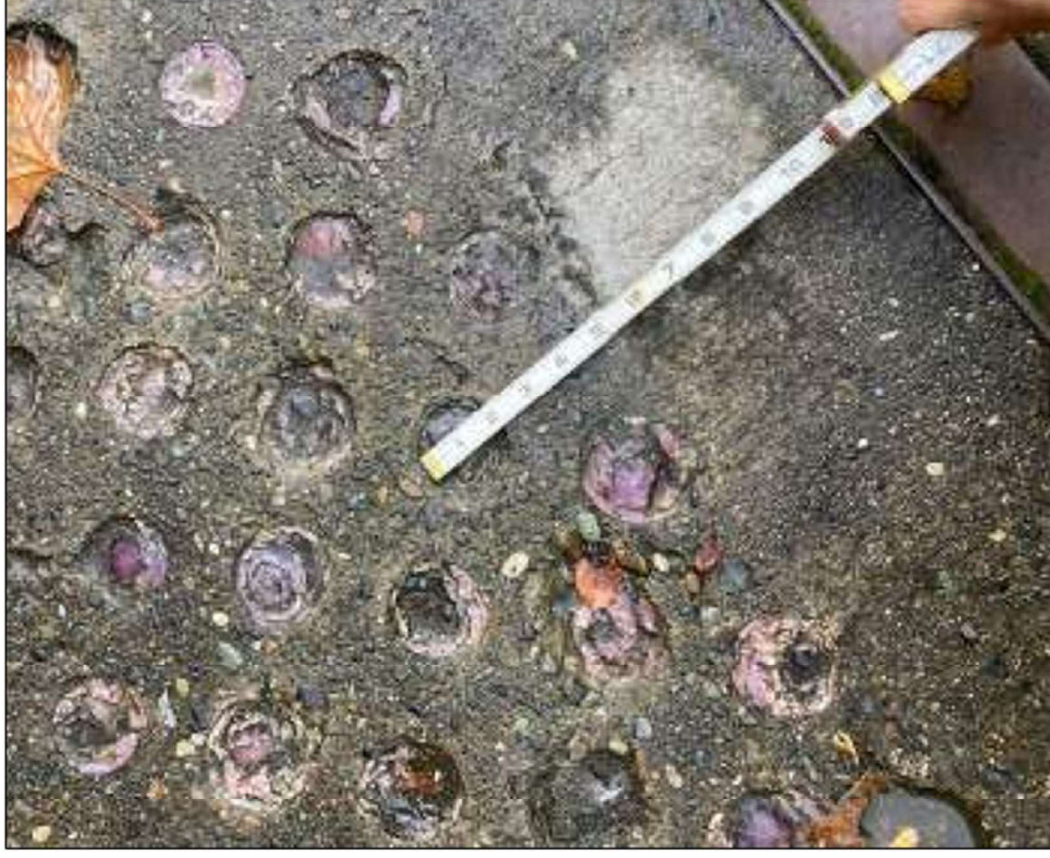
Figure 13 – Zoomed in view of the existing and deteriorated round glass pavers within the red outlined area in figure 11. The diameter is 2 inches. (Source: Seattle City Light, 2023.)

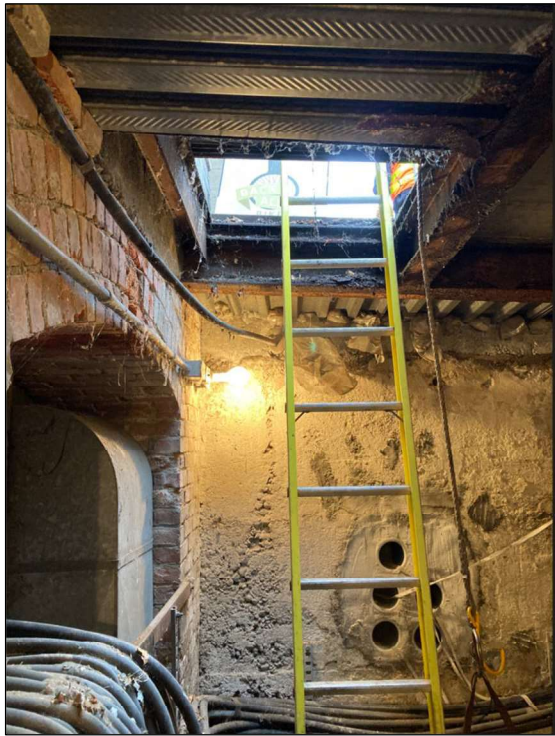
An inspection of Vault 22V-4 in 2022 observed that the exterior and interior steel framing and concrete hatch cover were showing signs of significant deterioration since their installation in 1977 (see photos 5-10). The outer surface of the cover (e.g., the "sidewalk" surface) is rusted, spalling, and missing pieces of concrete along with cracked and/or missing round glass pavers. Inside the vault, substantial rust was visible on the steel columns, beams, and ceiling decking. The conclusion was that emergency temporary wood supports would be needed in the vault; followed by new permanent steel structural framing, along with a new vault hatch cover before the transformer was installed. Further observation noted the lack of true prisms in the hatch cover and that the purple hued round glass pavers were 2-inches in diameter embedded on the surface and arranged in three rectangular groupings. Within each, the glass paver pattern consisted of 17 rows, alternating between 6 and 5 pavers per row. This treatment did not allow any light into the vault. Due to the clearances needed to install new steel beams and columns within the vault, the condition of the existing single concrete panel with pavers cover, and ventilation requirements for the new transformer, the existing vault hatch cover cannot be reused. A new vault hatch cover will be manufactured and designed as a three-panel hatch cover instead of a single panel due to the previously noted weight restrictions.

Photo 5 – Vault interior, view to the west showing existing conditions. Union Trust Annex brick arch to the left. (Source: SCL, 2022.)

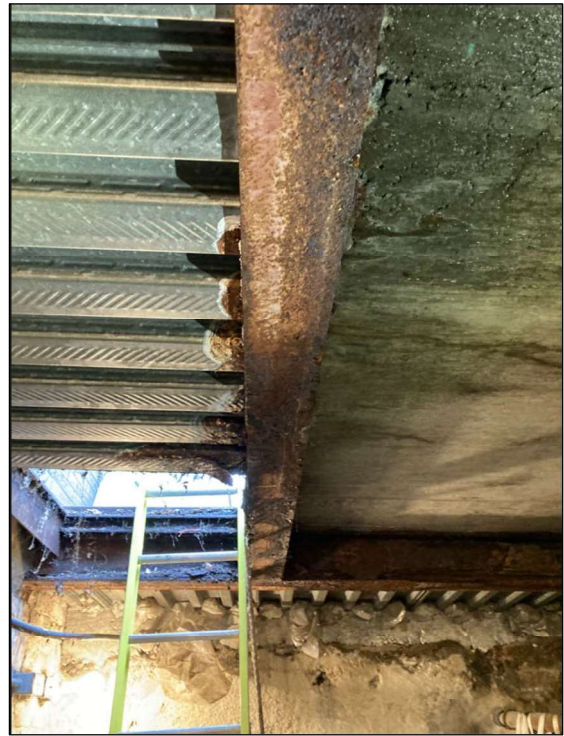
Photo 6 – Vault ceiling interior, west view showing rusted steel beams. Panel on right is sidewalk surface with glass pavers. (Source: SCL, 2022.)

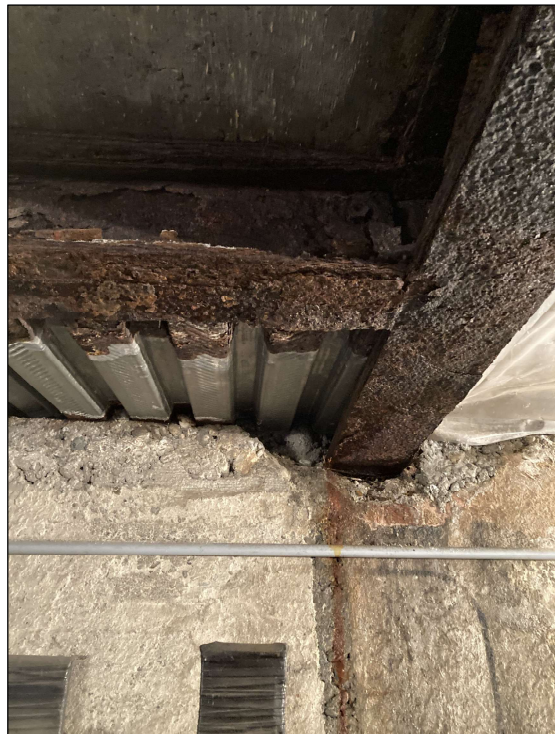
Photo 7 – Detail view showing general conditions of the steel beams and ceiling decking in the vault. (Source: SCL, 2022.)

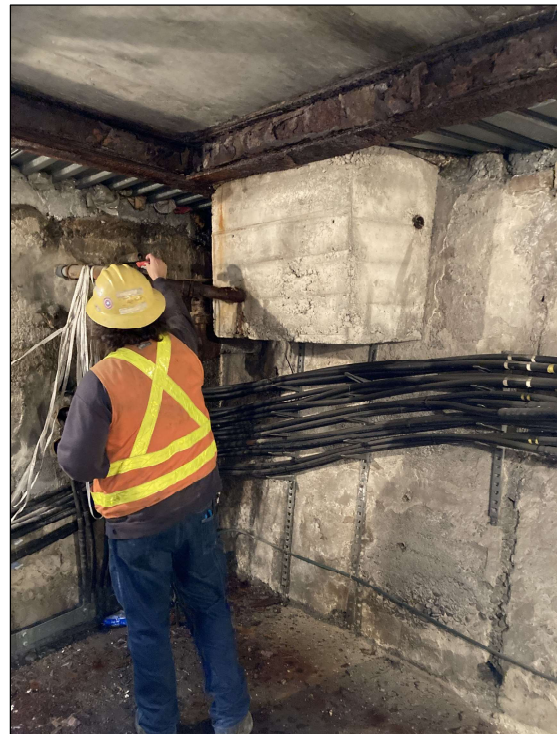
Photo 8 – Northwest corner detail. The ceiling concrete panel has on the exterior surface the small round glass pavers. (Source: SCL, 2022.)

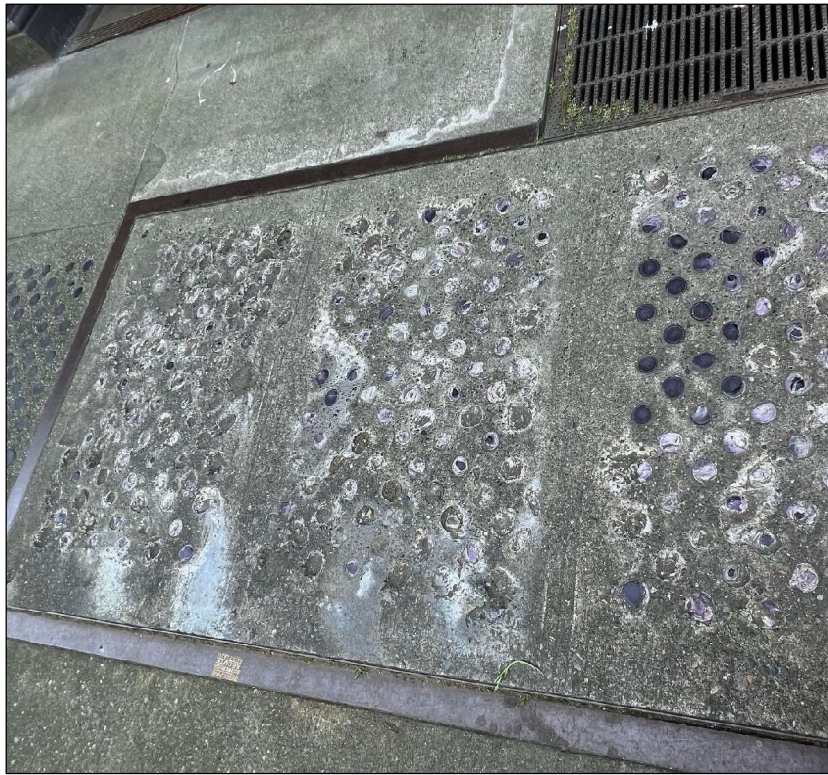
Photo 9 – Existing conditions on the exterior or sidewalk surface of the vault’s concrete hatch cover. Circular imprints are visible where glass pavers were once located in the concrete. (Source: Seattle City Light, 2022.)

Of the above, Option 4 rose to the top since it would accommodate City Light’s needs (e.g., increase ventilation since the size of the existing ladder access grate cover was insufficient, and would also provide fire resistance). This option could also provide for an appearance close to the existing concrete vault hatch cover with the surface embedded glass pavers, albeit reduced to one-third of what it was.

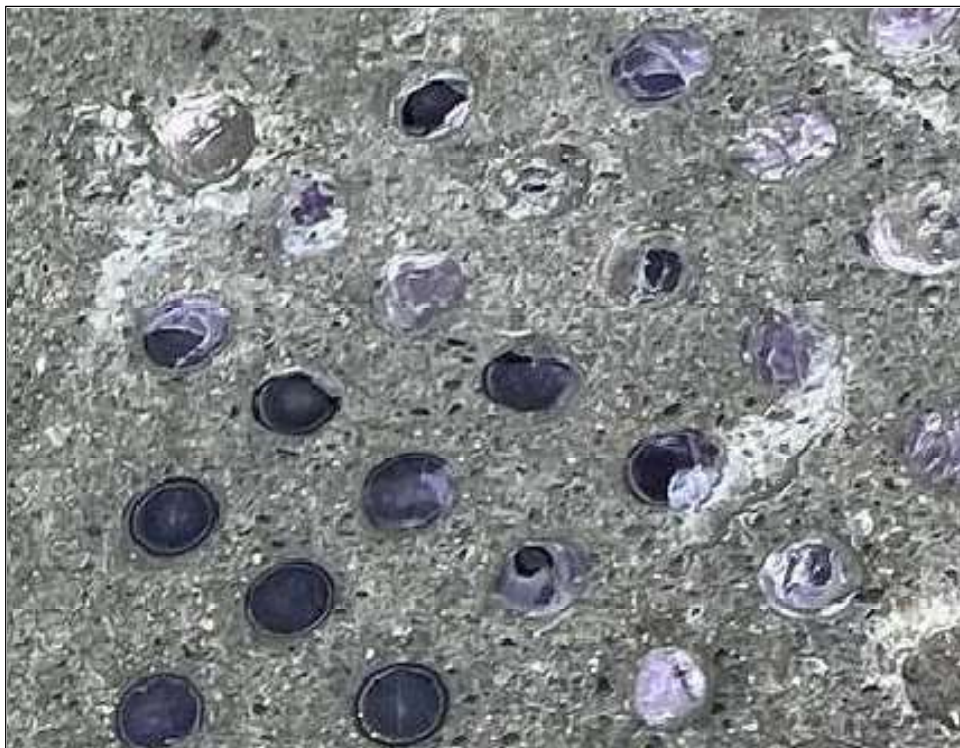
Photo 10 – Detail of upper right corner of photo #9. Glass pavers are embedded on the surface with many that are chipped, cracked, or missing. (Source: Seattle City Light, 2022.)
