210 THIRD AVENUE SOUTH - WEST UNIT WINDOW SURVEY- FLOORS 2-5 AND WEST STOREFRONT ADDENDUM - FLOOR 1

Cross 2 Design Group for True North Construction Management, Inc.

The Lofts Window Survey

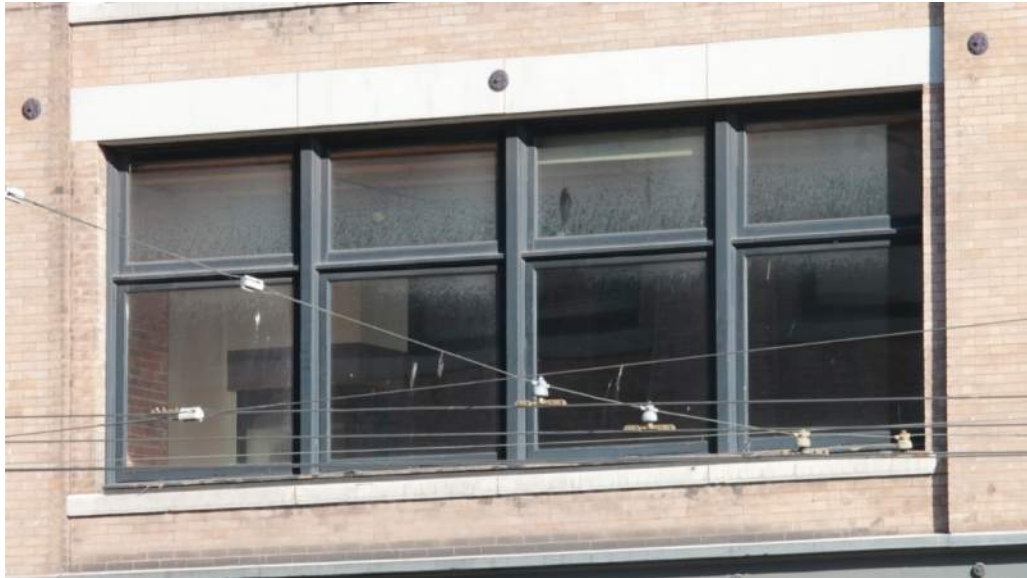
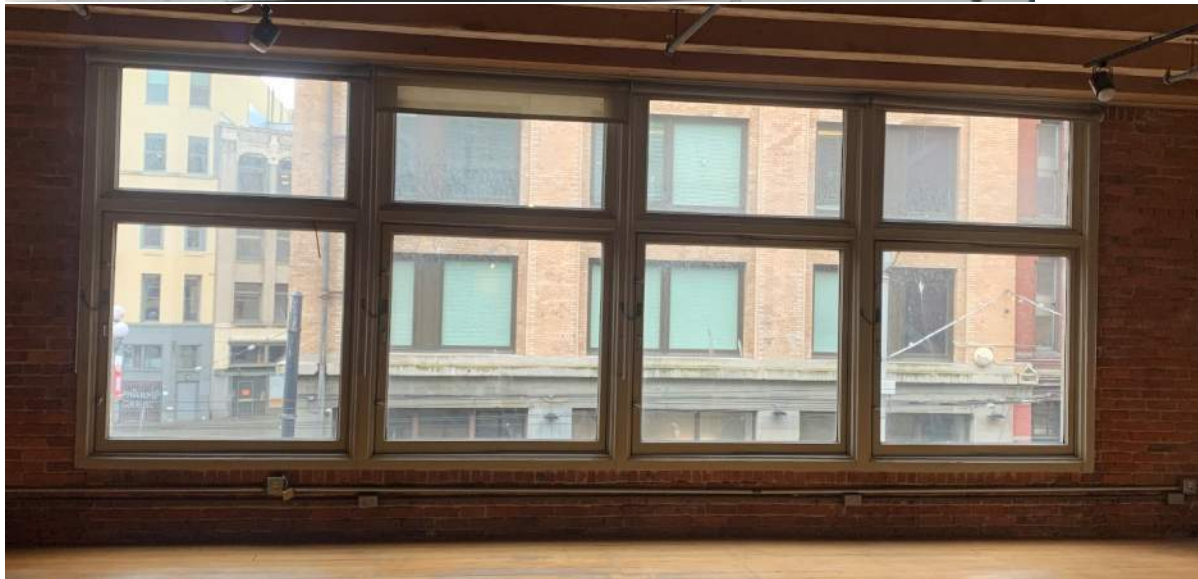
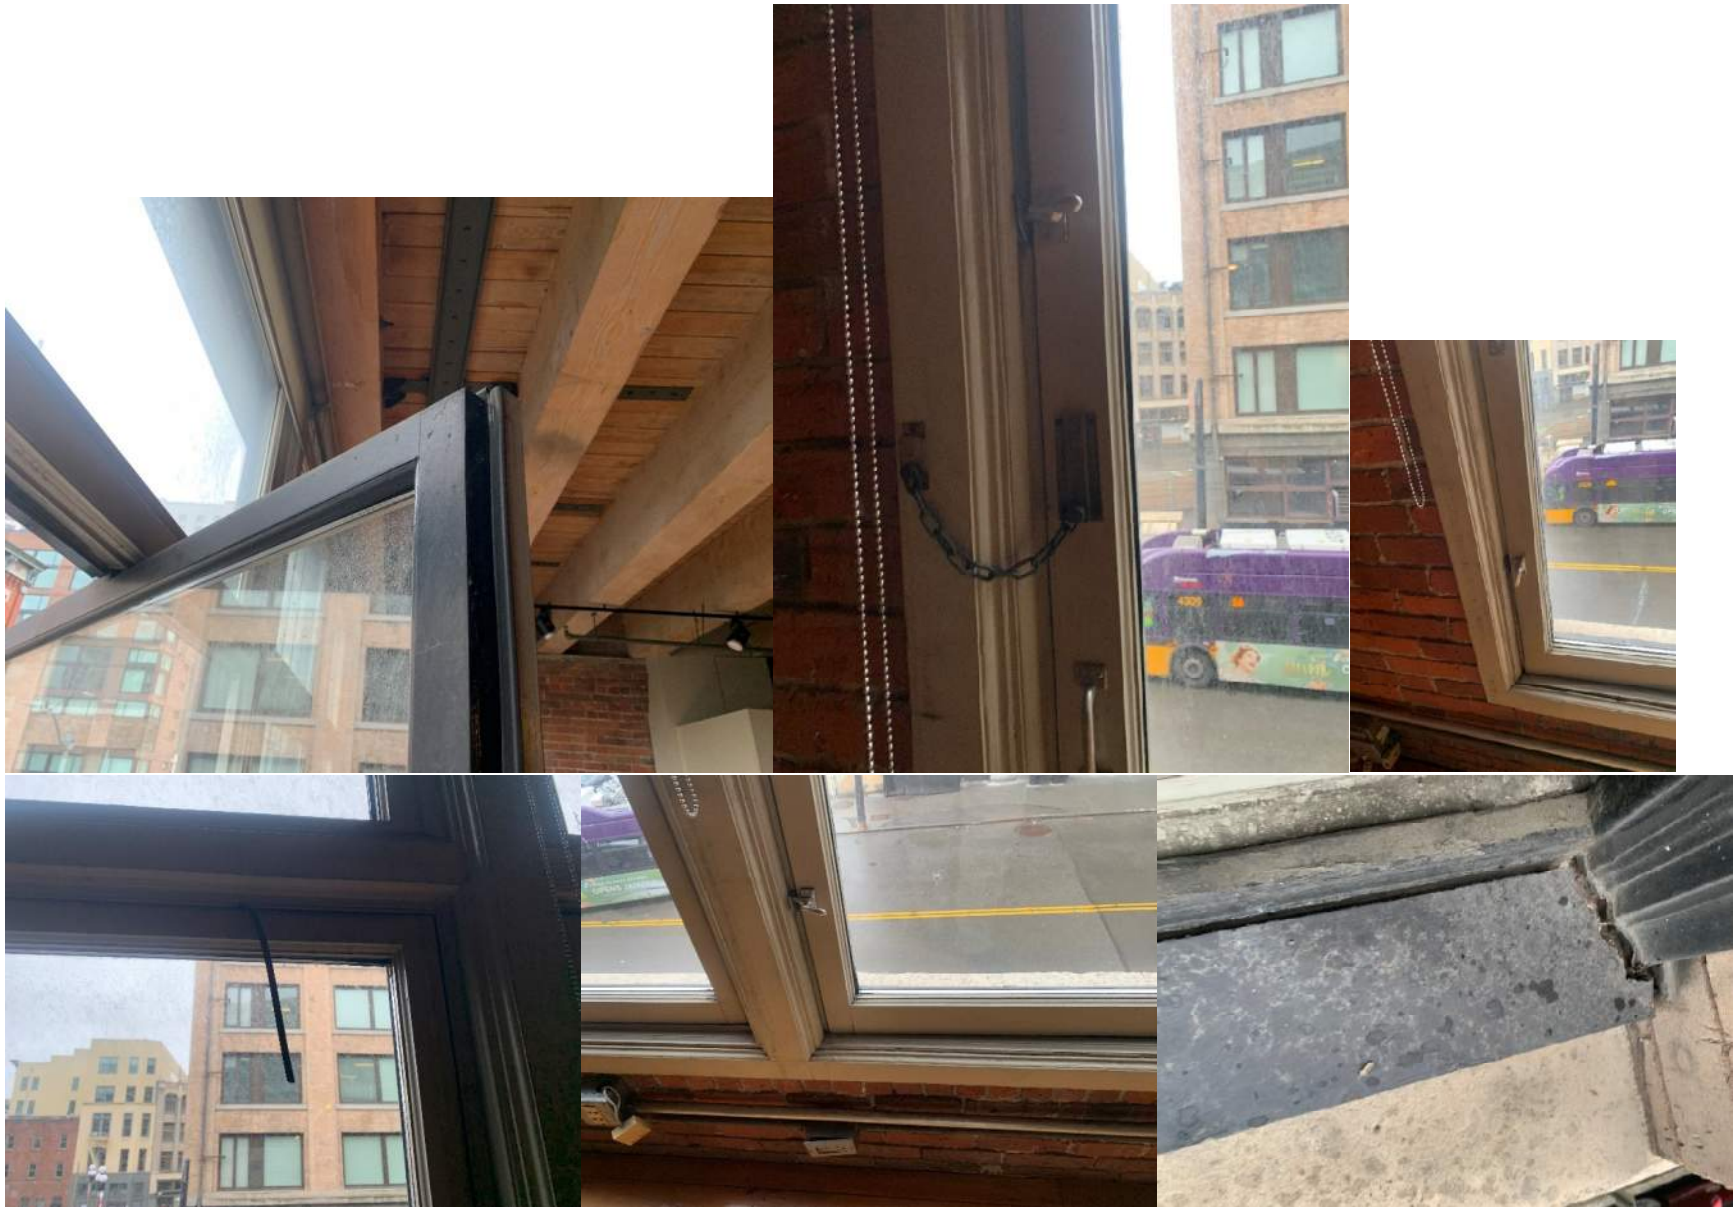
UNIT 2A

Unit	Window ID	Size	Type	Interior Frame	Exterior Frame	Interior Wood Sill	Exterior Wood Sill	Sash	Weatherstrip	Sash stop	Glazing Stop	Glazing	Remarks
2A	W2A	21'-4" x 8'-1"	F/PT	OR, P	OR, P	C, P	PR, P, C		PR	PR, C	P	NO	Weatherstripping damaged at several operable sashes. Open joints in most operable sash sill conditions. Small amount of rot at pivot.
2C	W2C	21'-4" x 8'-1"	F/PT	OR	OR	P	PR,C, D,P	P	PR	PR,C,D	PR, C, P	NO	No sealant and Rot and severe checking at exterior sill trim All visible fasteners philips head screws Rot / damage at sash stops and rot near pivot. Some open joints present at sash
3A	W3A	21'-4" x 8'-1"	F/PT	OR, P	OR, P, C	P	PR, C, D, P		PR	P	PR, C	NO	Jamb damage, loose joints and fasteners in operable sash, weatherstripping damaged on most sashes, water staining noted between sashes, checking and some rot at lower jambs, staining from upper sash onto window frame

Unit 2A: Upper photos showing typical conditions. Lower photos: showing damaged weatherstripping (L), (C) Interior view of vertical mullion and sill, (R) damaged to sill and exterior of window frame including weather checking and damage to sill trim.

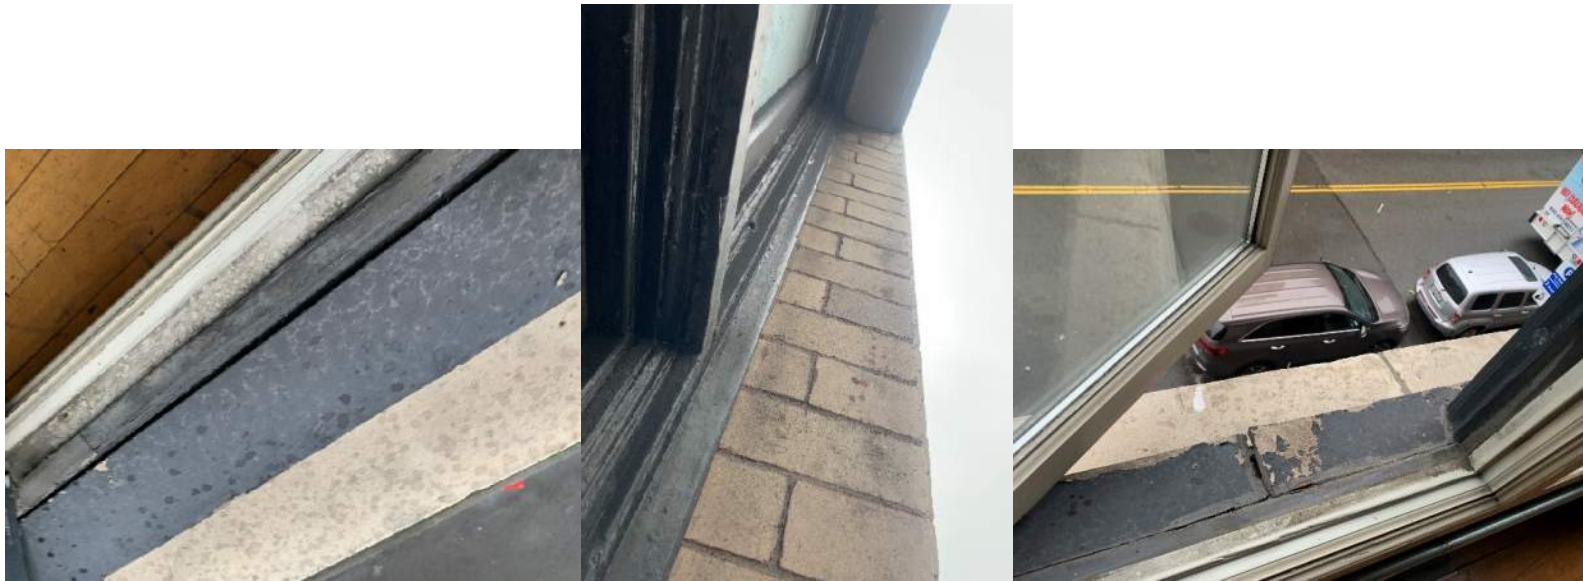
Unit 2A: (L) damaged to sill and exterior of window frame. (C) Exterior wear at jamb. (R) Damage to sill trim.

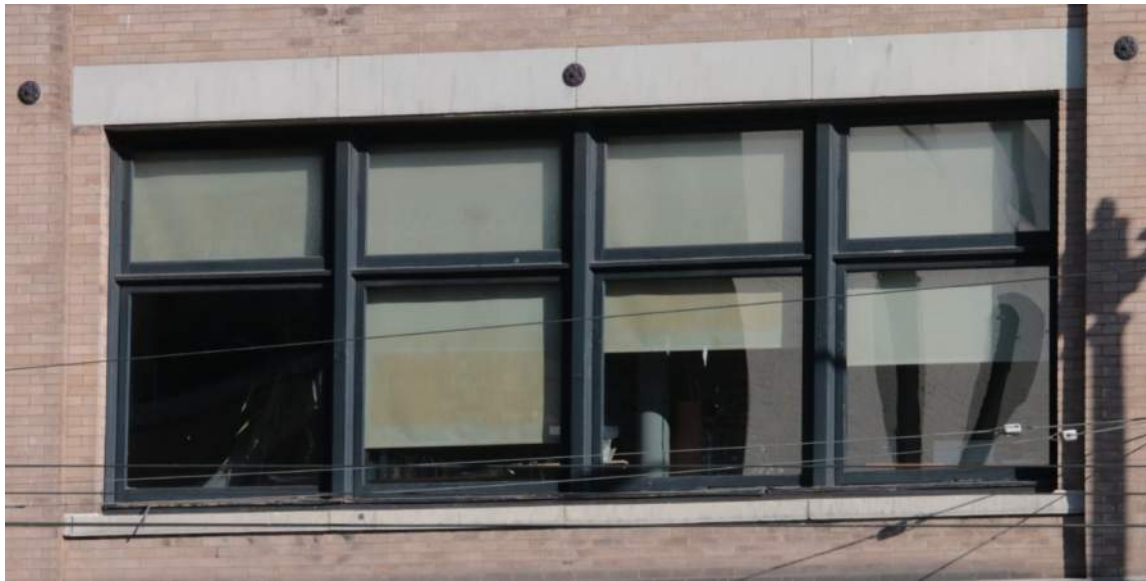
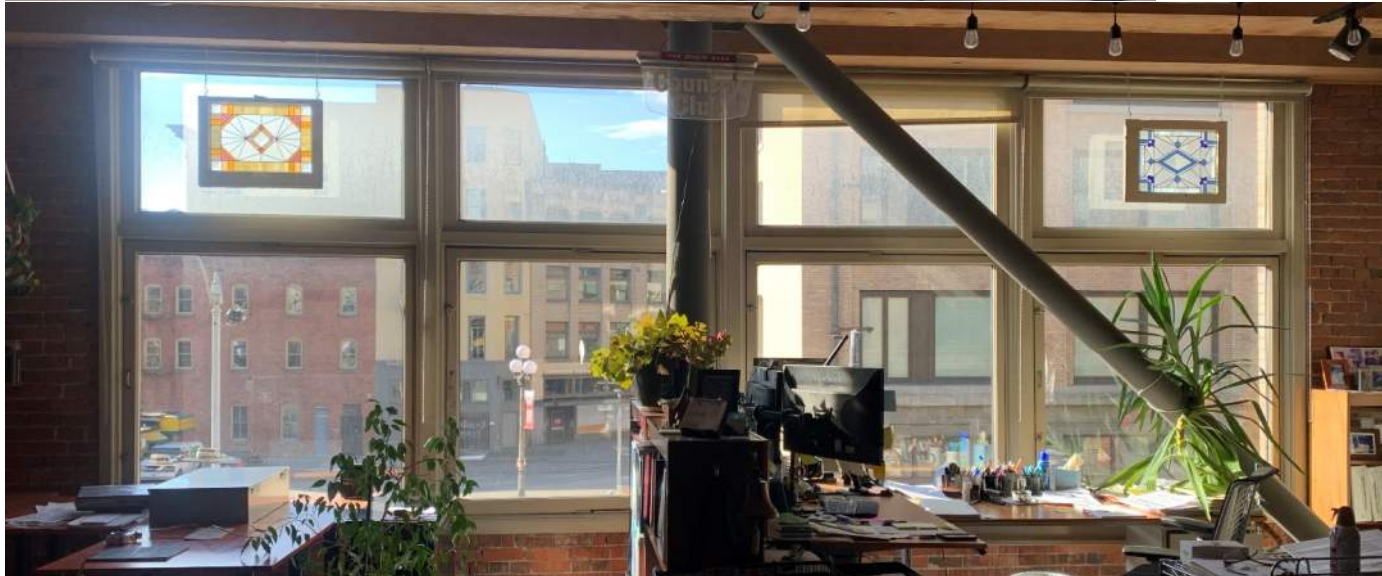
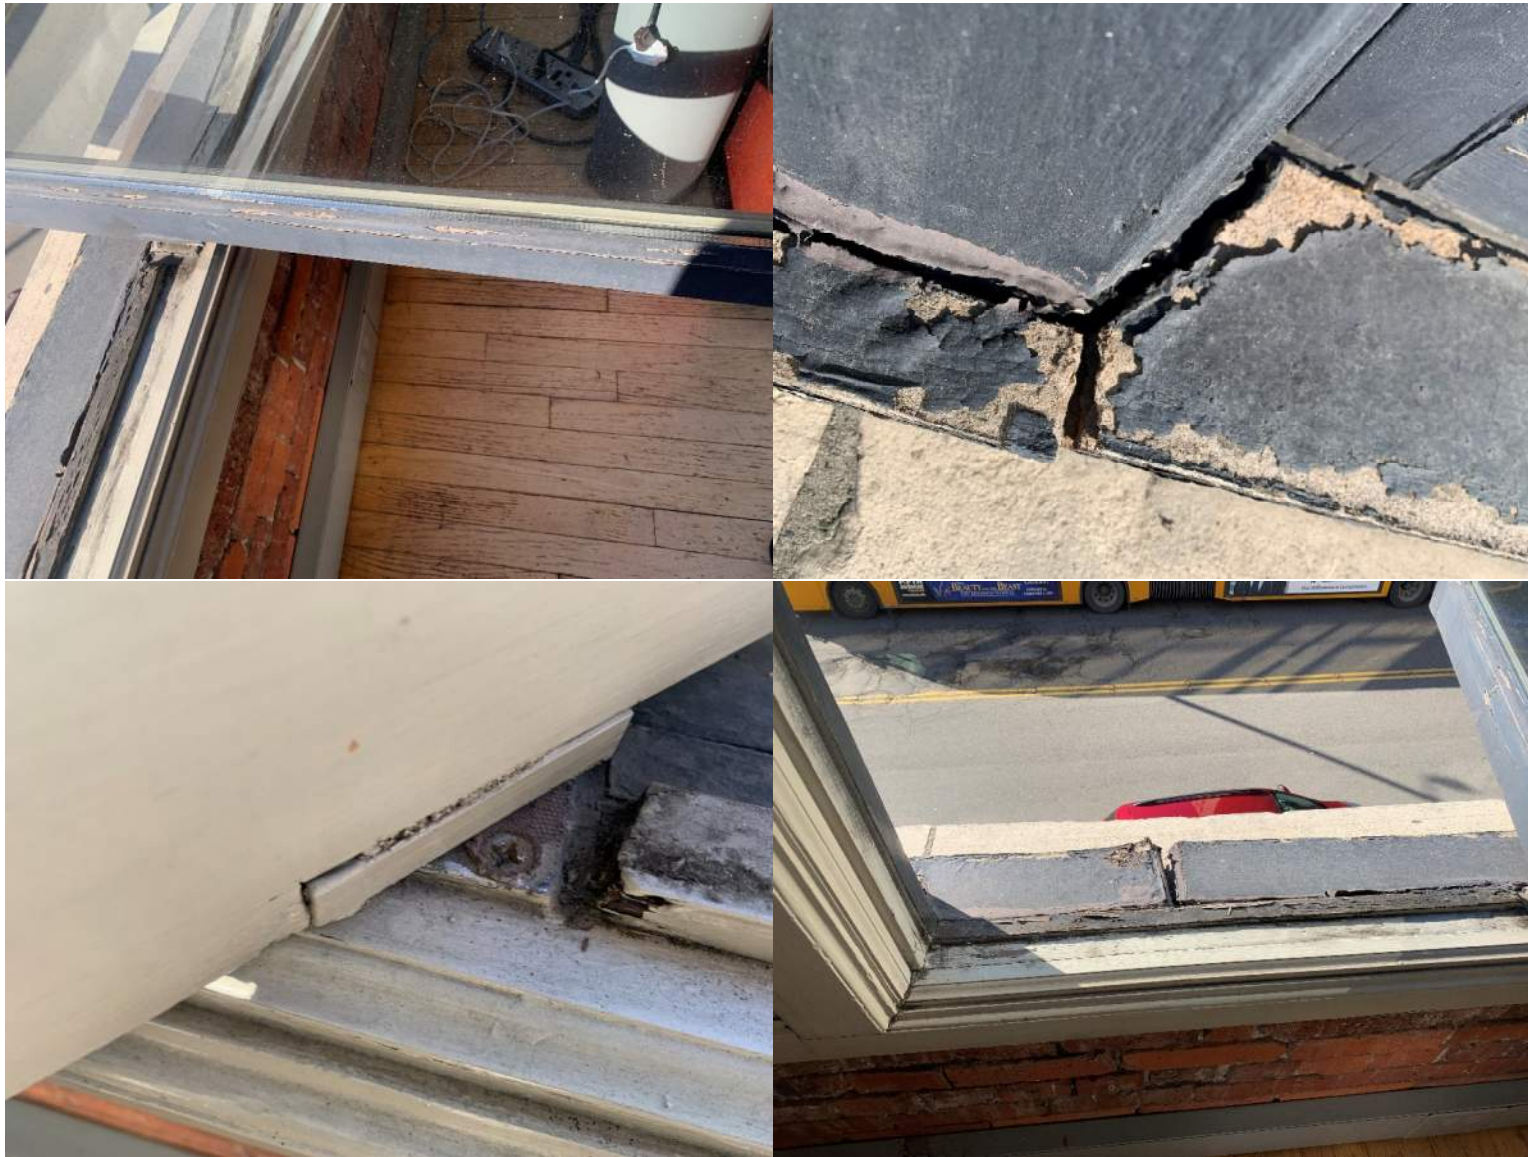
UNIT 2C

Unit 2C: Upper photos – (L) Damage at sill and sash. (R) Damage to frame, and sash. Lower photos – (L) Damage at pivot hardware, Right damage at sill and frame.

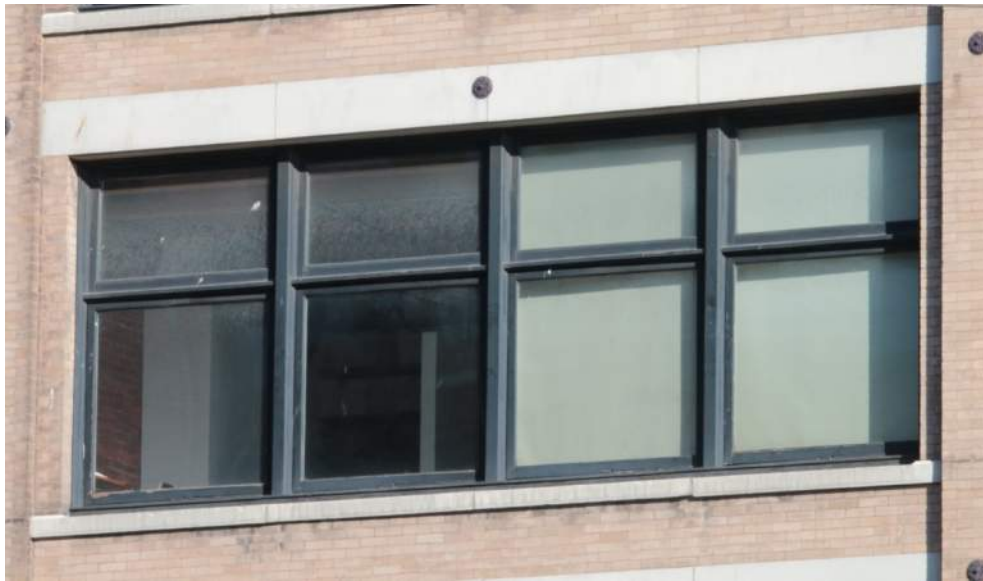
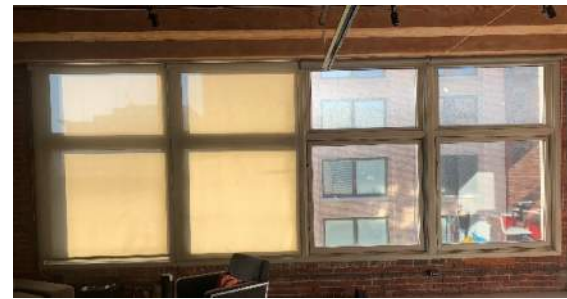
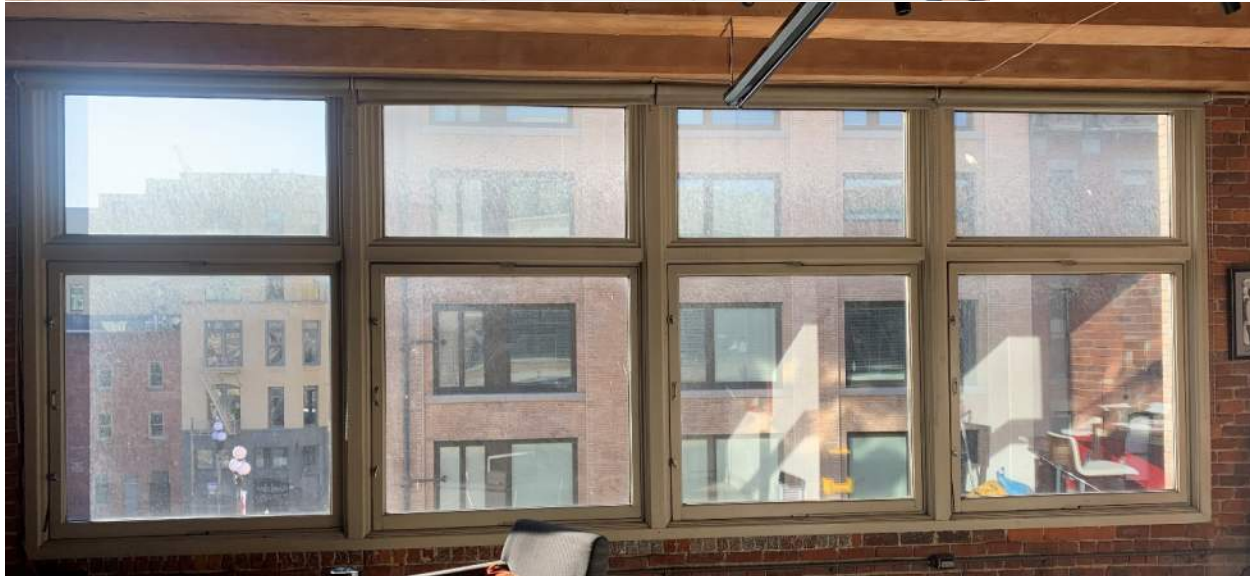
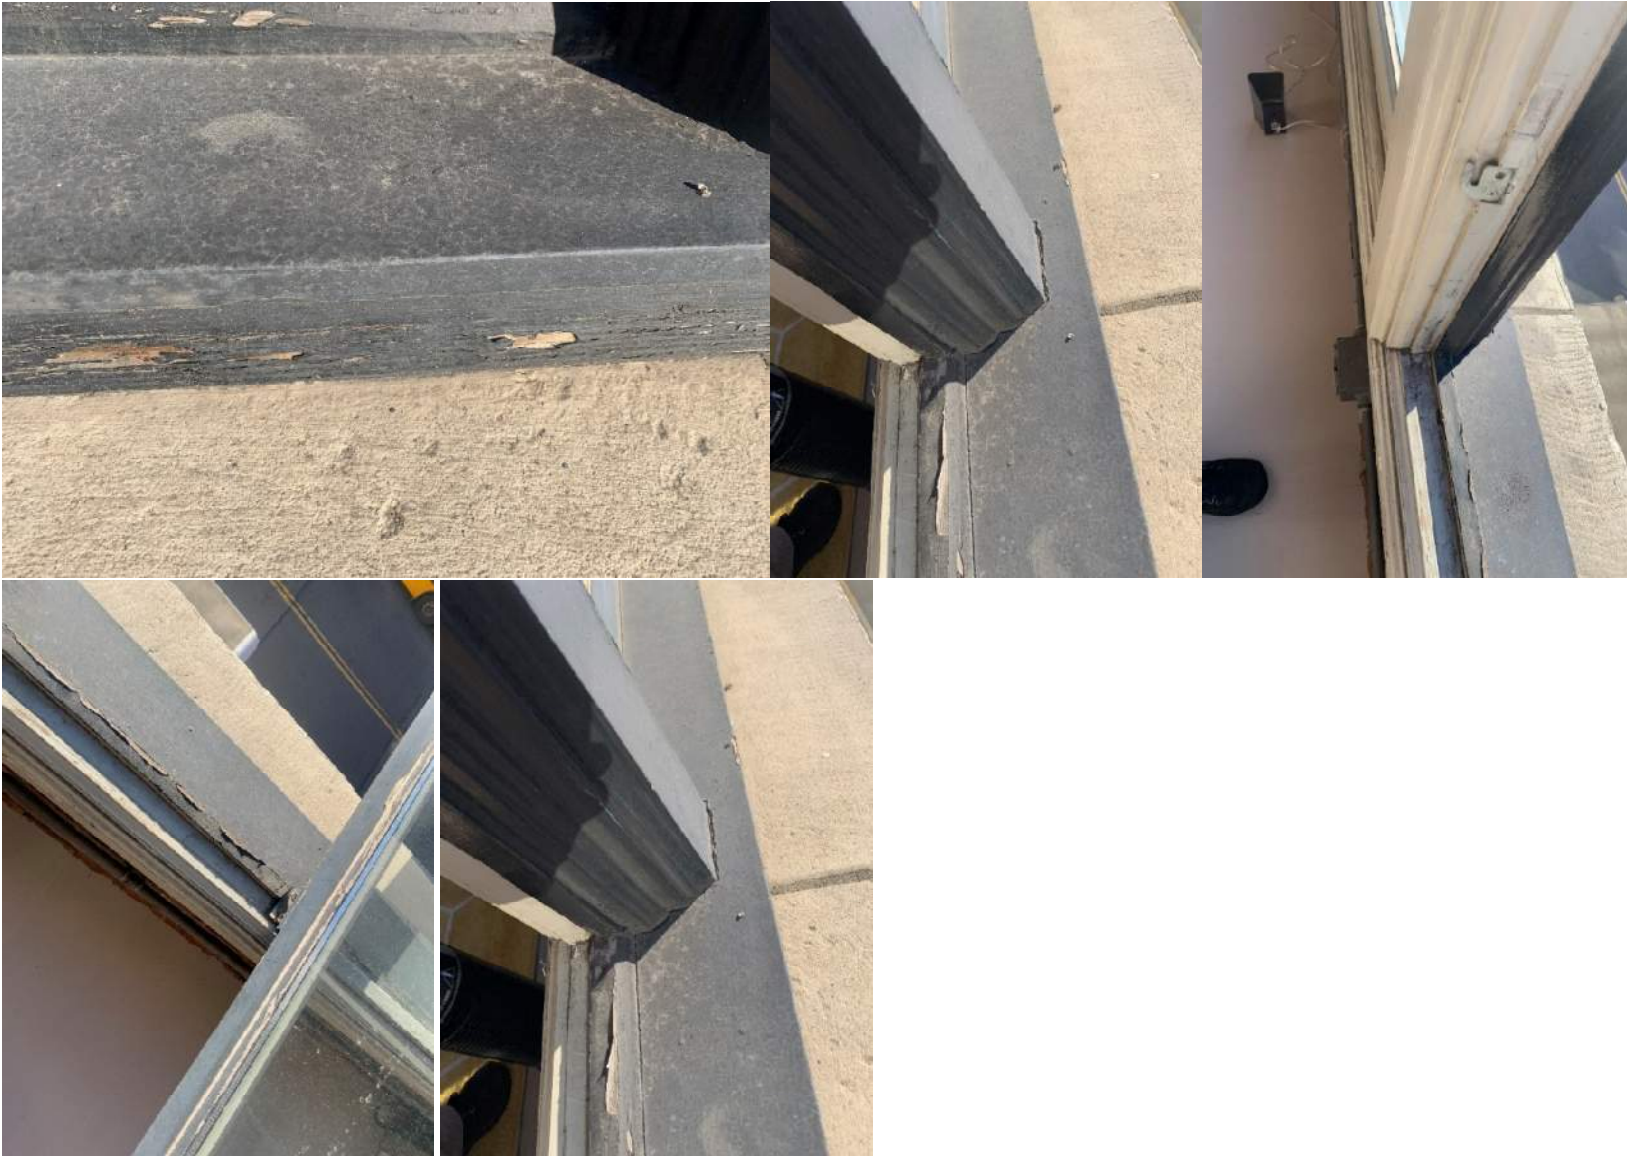
UNIT 3A

Unit 3A – Upper row (L) weatherchecking at sill. (C) weatherchecking and peeling paint at sill. (R) peeling paint and damage at frame and sill.

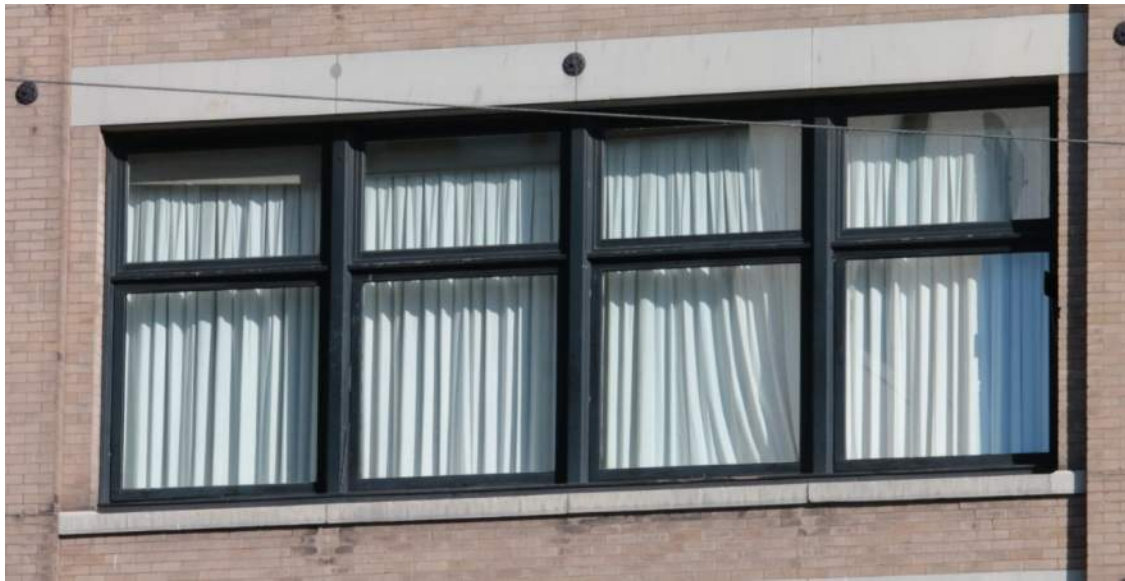
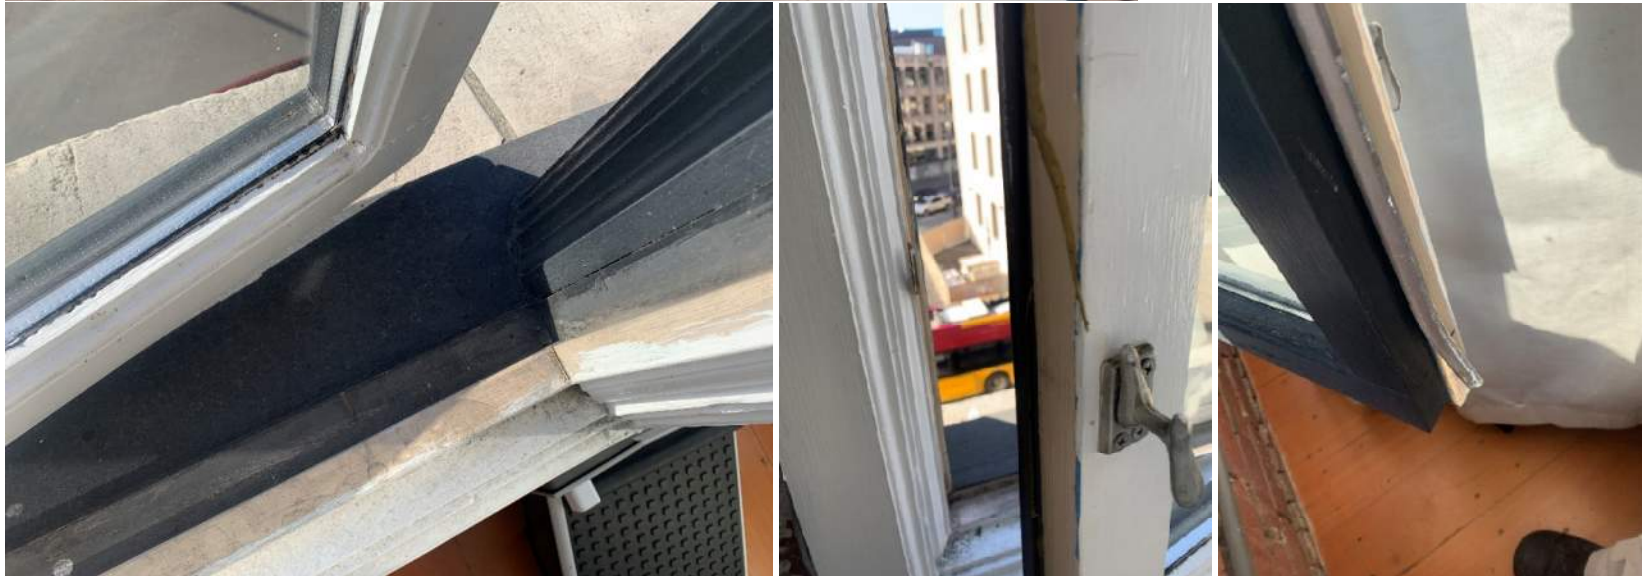
UNIT 3C

Unit	Window ID	Size	Type	Interior Frame	Exterior Frame	Interior Wood Sill	Exterior Wood Sill	Sash	Weatherstrip	Sash stop	Glazing Stop	Glazing	Remarks
3C	W3C	21'-4" x 8'-1"	F/PT	OR, P, C	OR, P,	P	PR, C, P	PR, C, P	PR		PR, C	NO	Overall photos of interior not accessible as drapery was not operable at the time of inspection. Weatherstripping damaged typically on the south and sill side of operable sashes. Checked sills. Rot at lower south portion of operable sashes.
4A	W4A	21'-4" x 8'-1"	F/PT	OR, P	OR, P	P	PR, C, P	PR, P	PR	PR, P	PR, P	NO	damaged sash stop on jambs, checked exterior wood sash damaged at multiple locations., damage mullion jambs
4C	W4C	21'-4" x 8'-1"	F/PT	OR, P	OR, P	P	PR, C, P	PR	PR	PR, C, D	PR, C, P	NO	exterior sill trim has some rot, heavily checked. Multiple sash stops heavily damaged.
5A	W5A	21'-4" x 8'-1"	F/PT	OR, P	OR, C, P	P	PR, C, P	P	PR	PR, C, P	PR, P, C	NO	Upper sash joints pulling apart. Trim, glazing and sash stops heavily weather checked. Minor damage at latch.

Unit 3C: Lower row – (L) open joints and paint damage, (C) paint damage (R) damage to weatherstripping.

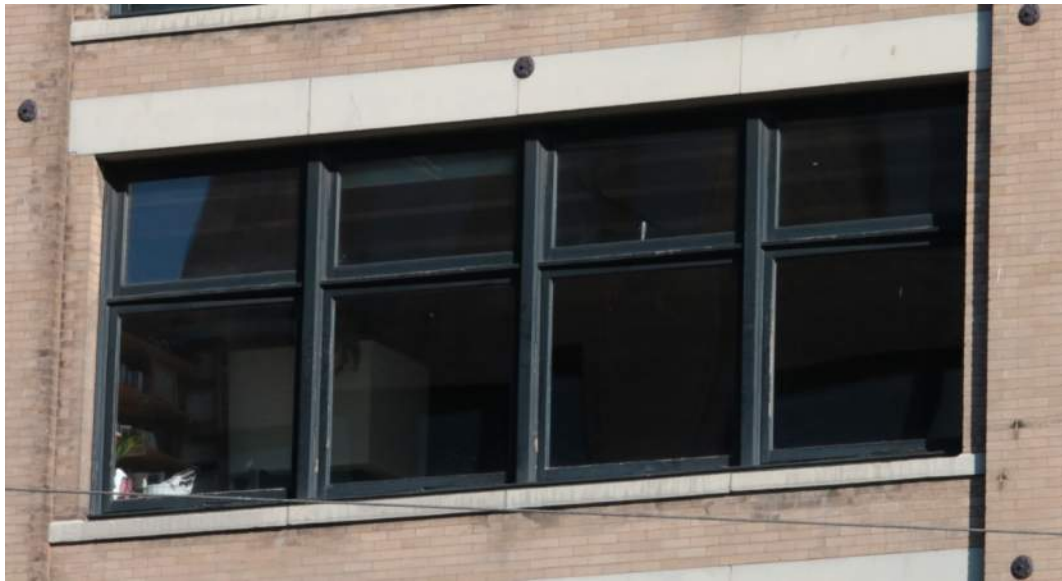
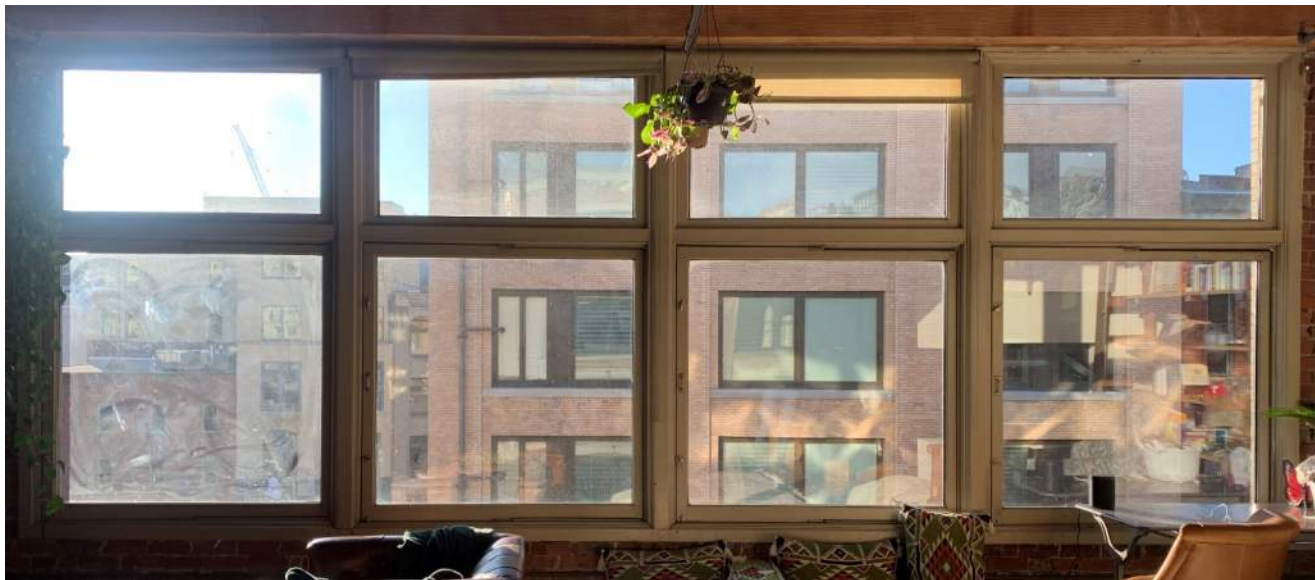
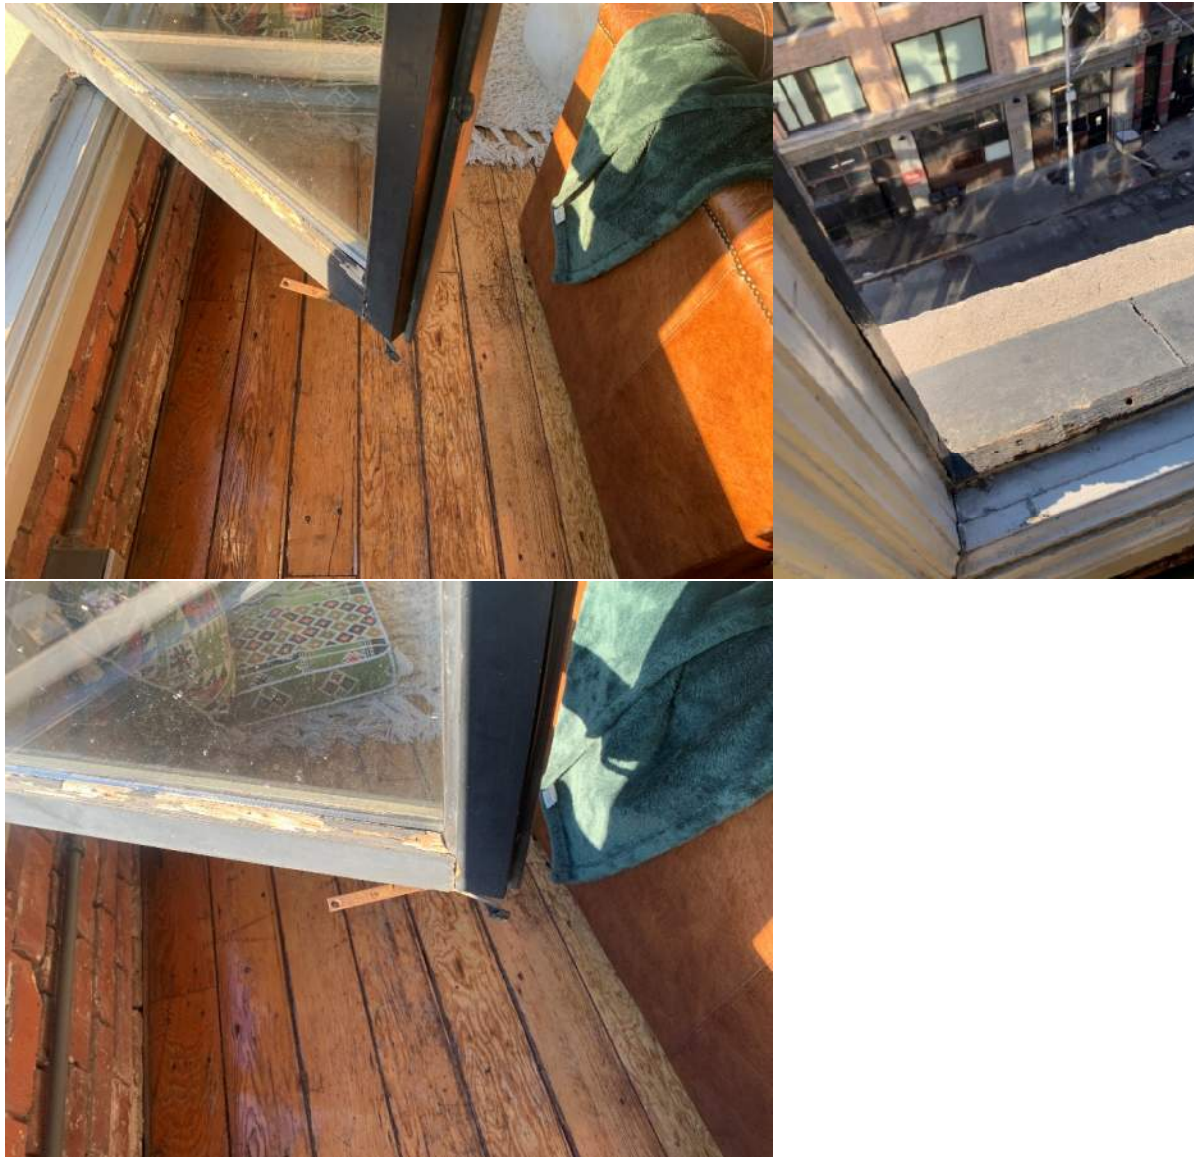
UNIT 4A

Unit 4A: (L) Upper and lower, loose joint in sash, damaged hardware, weatherchecking at sash and open joint (R) weatherchecking and damage / rot at sill.

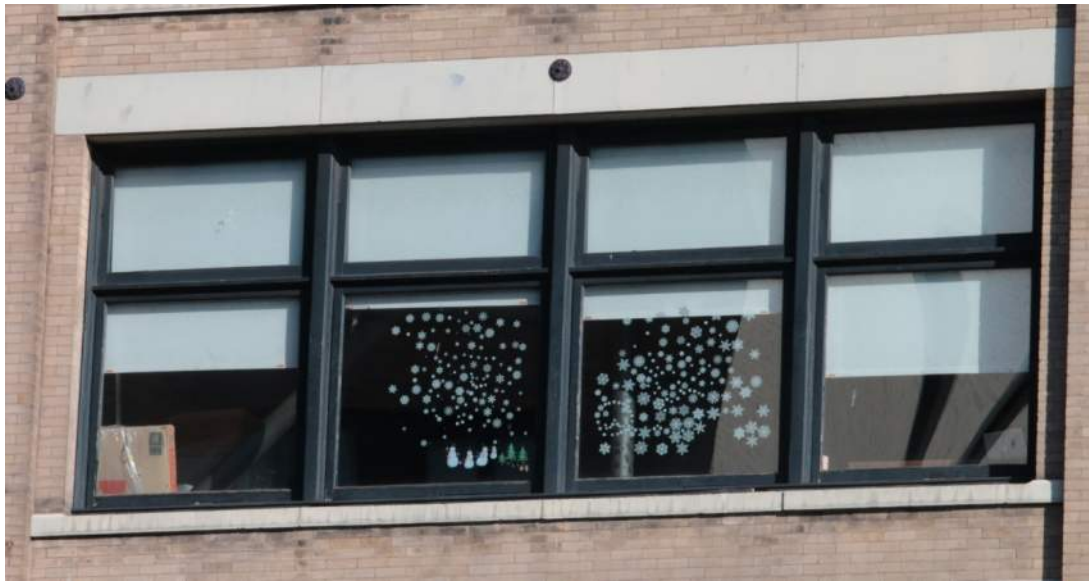
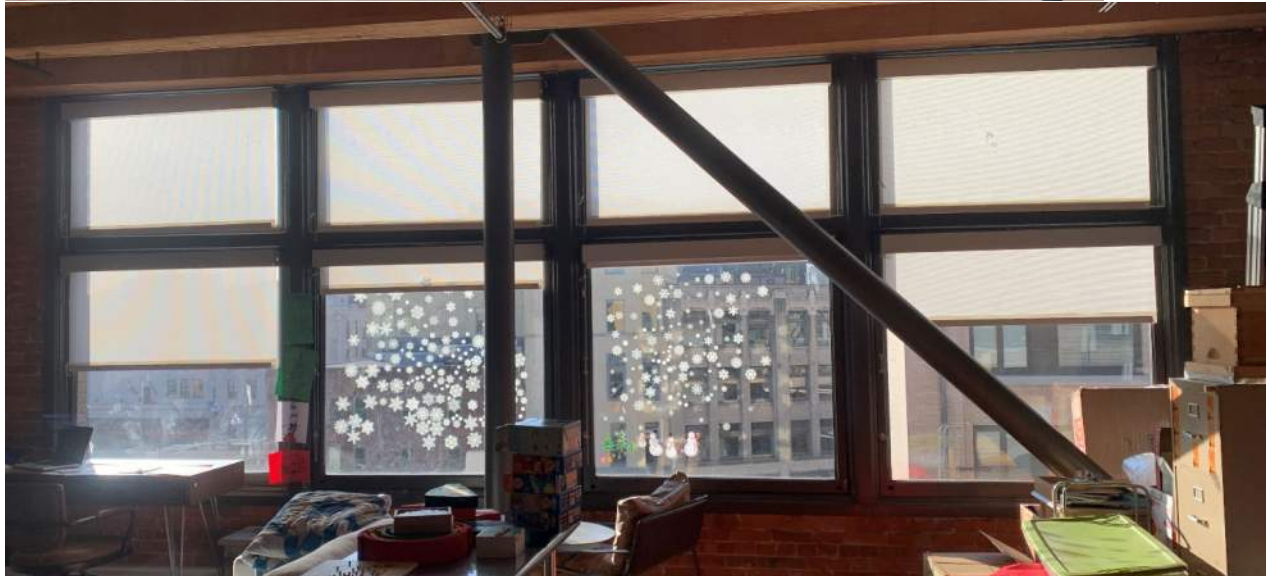
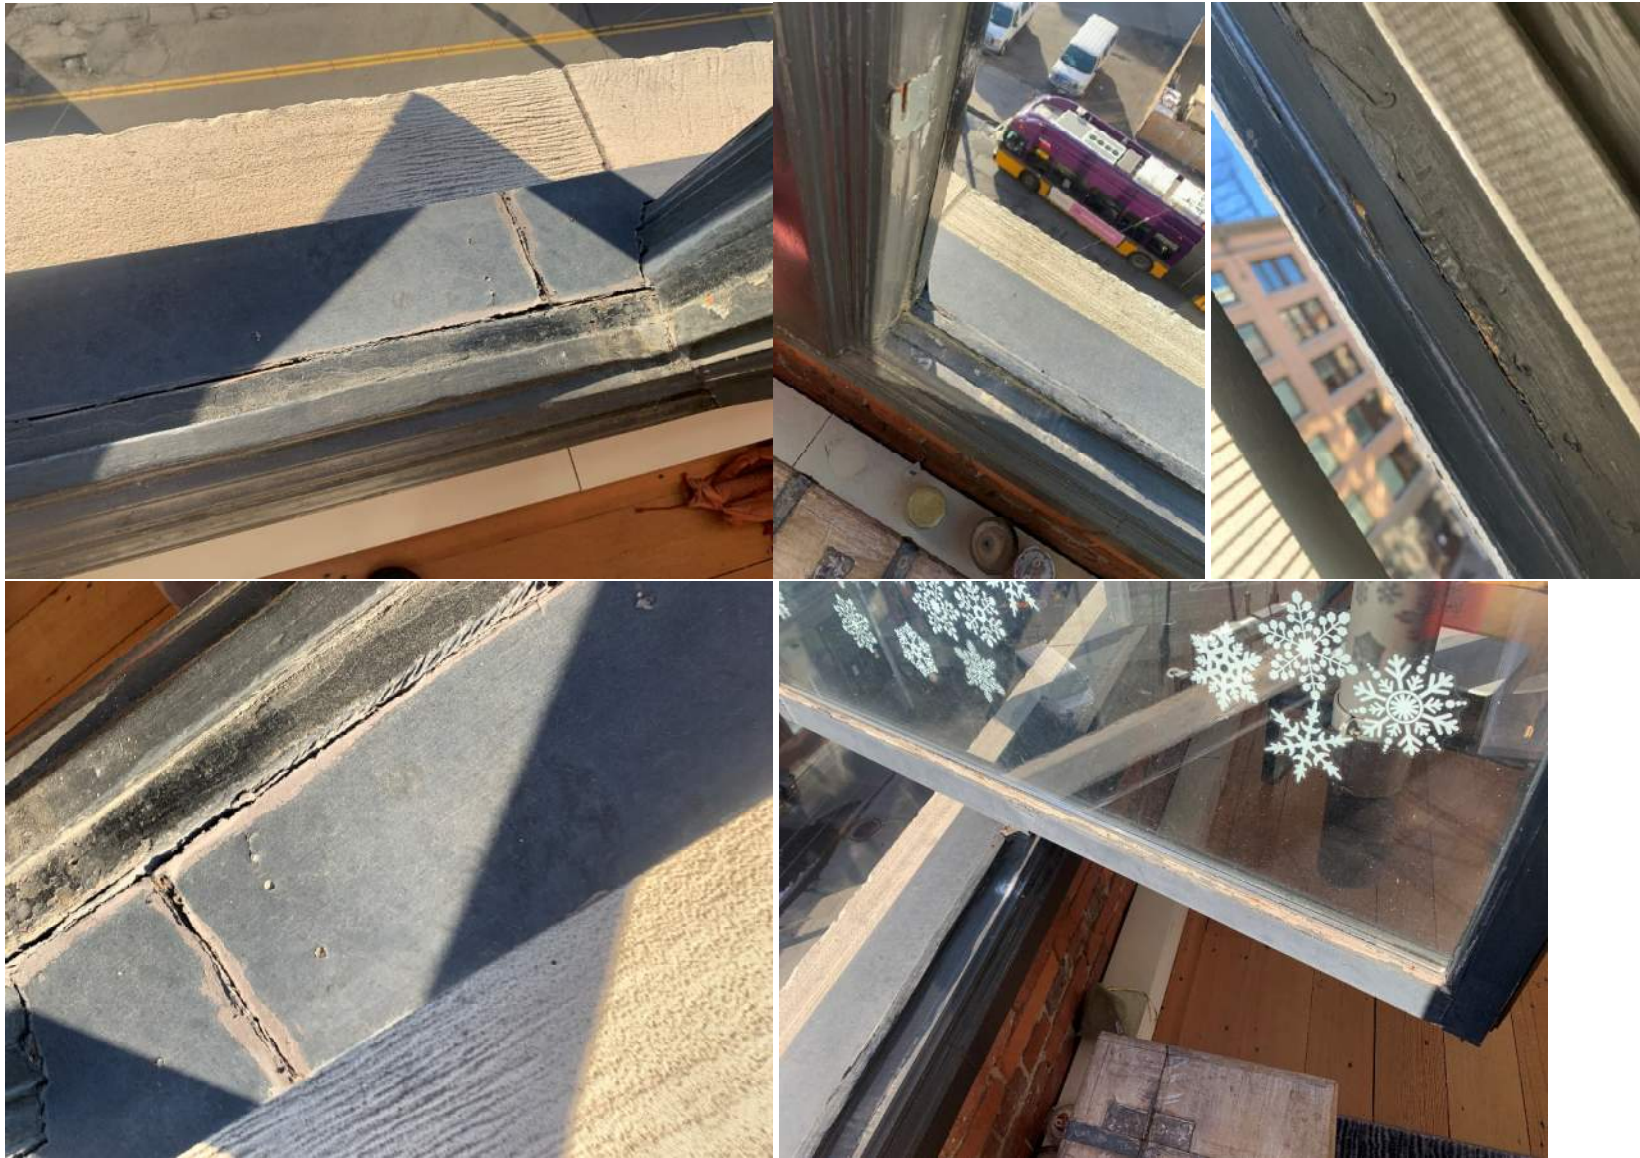
UNIT 4C

Unit 4C: Upper row typical damage to sill, frame and sash including open joints in the sash, weather checking and peeling paint. Lower row damage to sill trim and sash

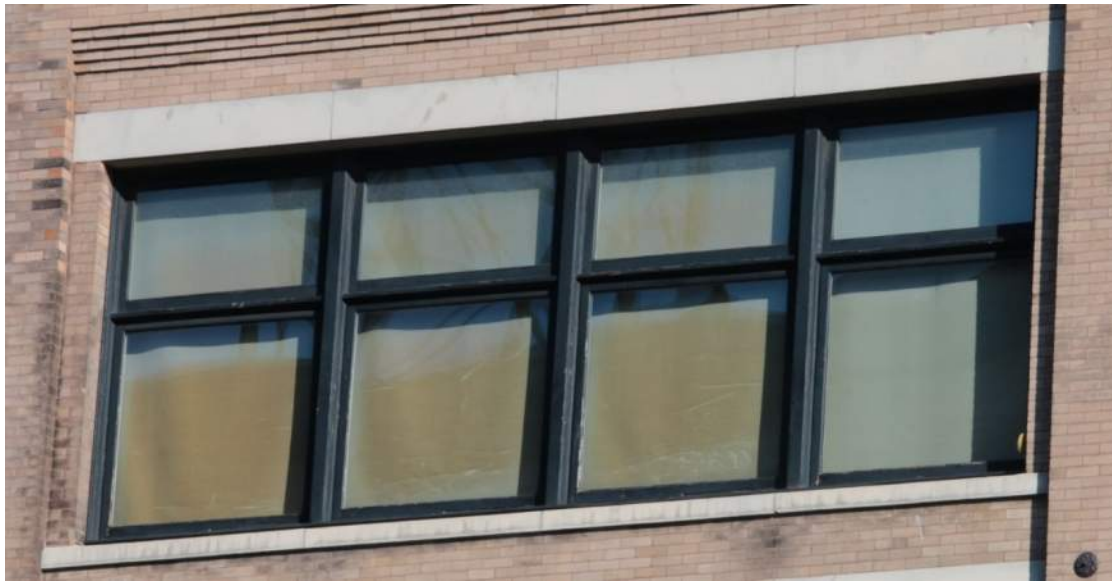
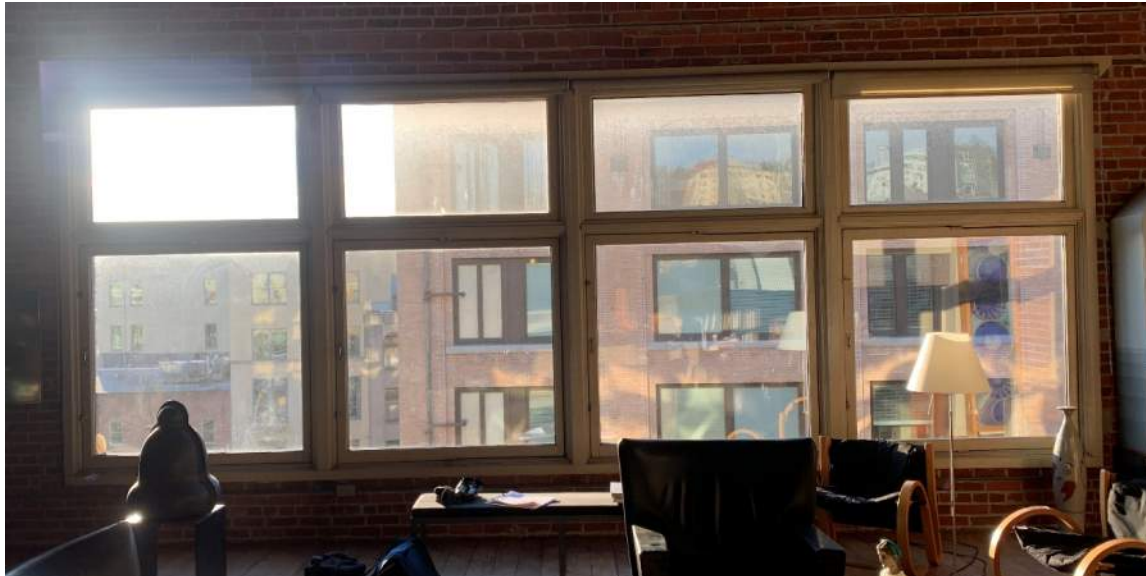
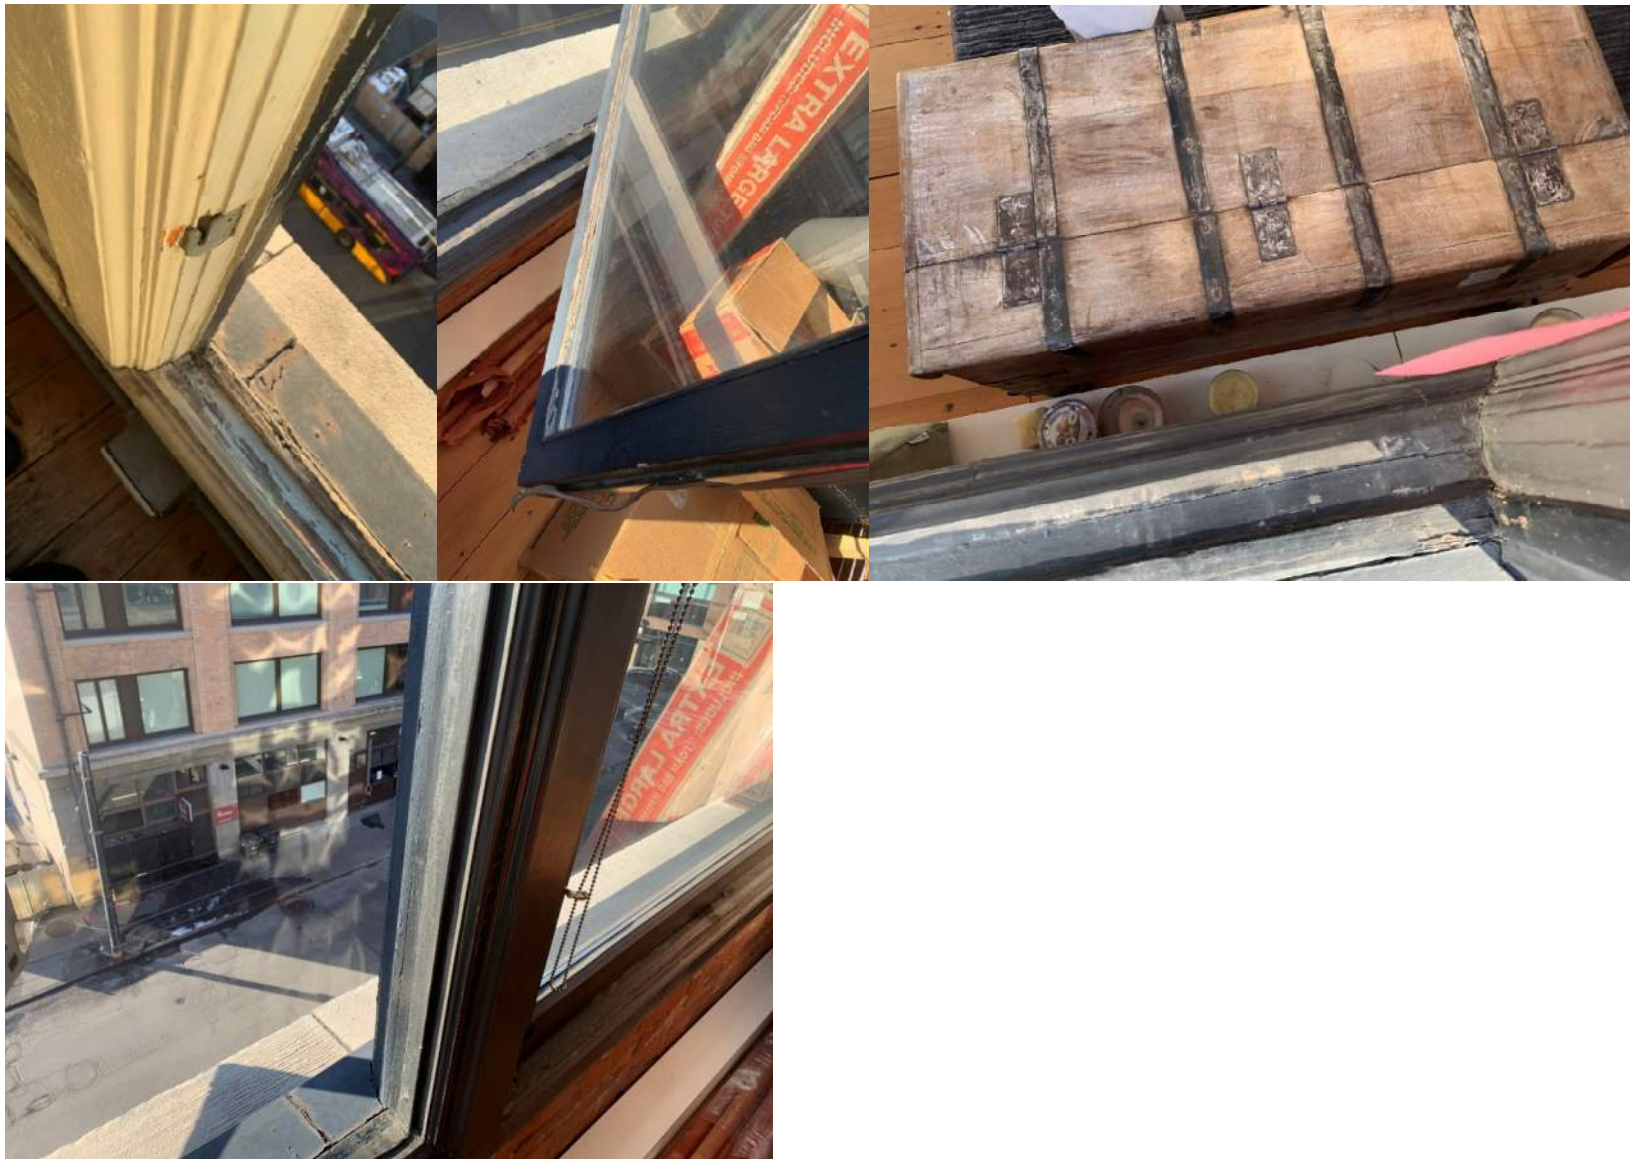
UNIT 5A

Unit 5A: Upper photos – (L) damage and weatherchecking at sill, (C) poor weatherstripping (R) Weather checking and damage sill. Lower photo: weatherchecking and related damage to sill and frame.
