210 THIRD AVENUE SOUTH - WEST UNIT WINDOW SURVEY- FLOORS 2-5 AND WEST STOREFRONT ADDENDUM - FLOOR 1

Cross 2 Design Group for True North Construction Management, Inc.

The Lofts Window Survey

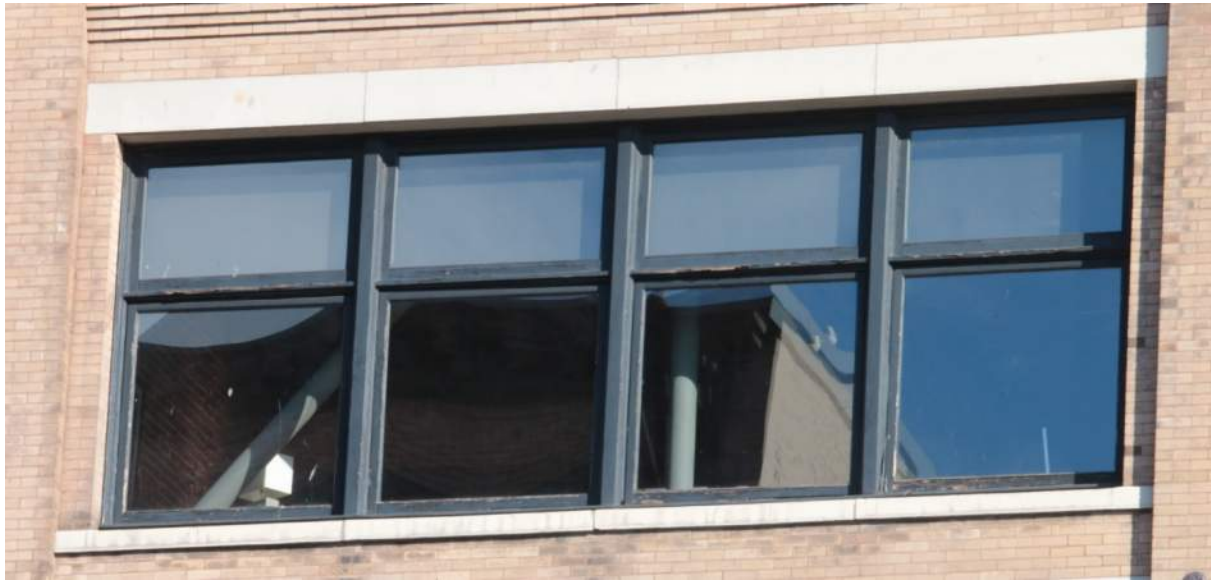
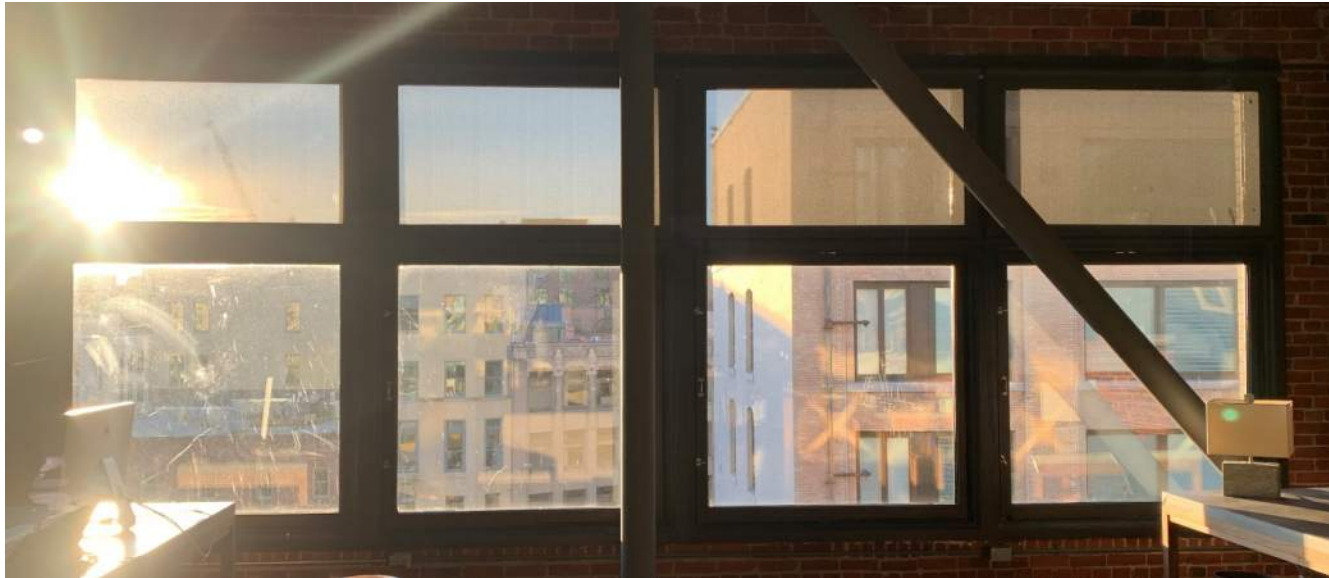
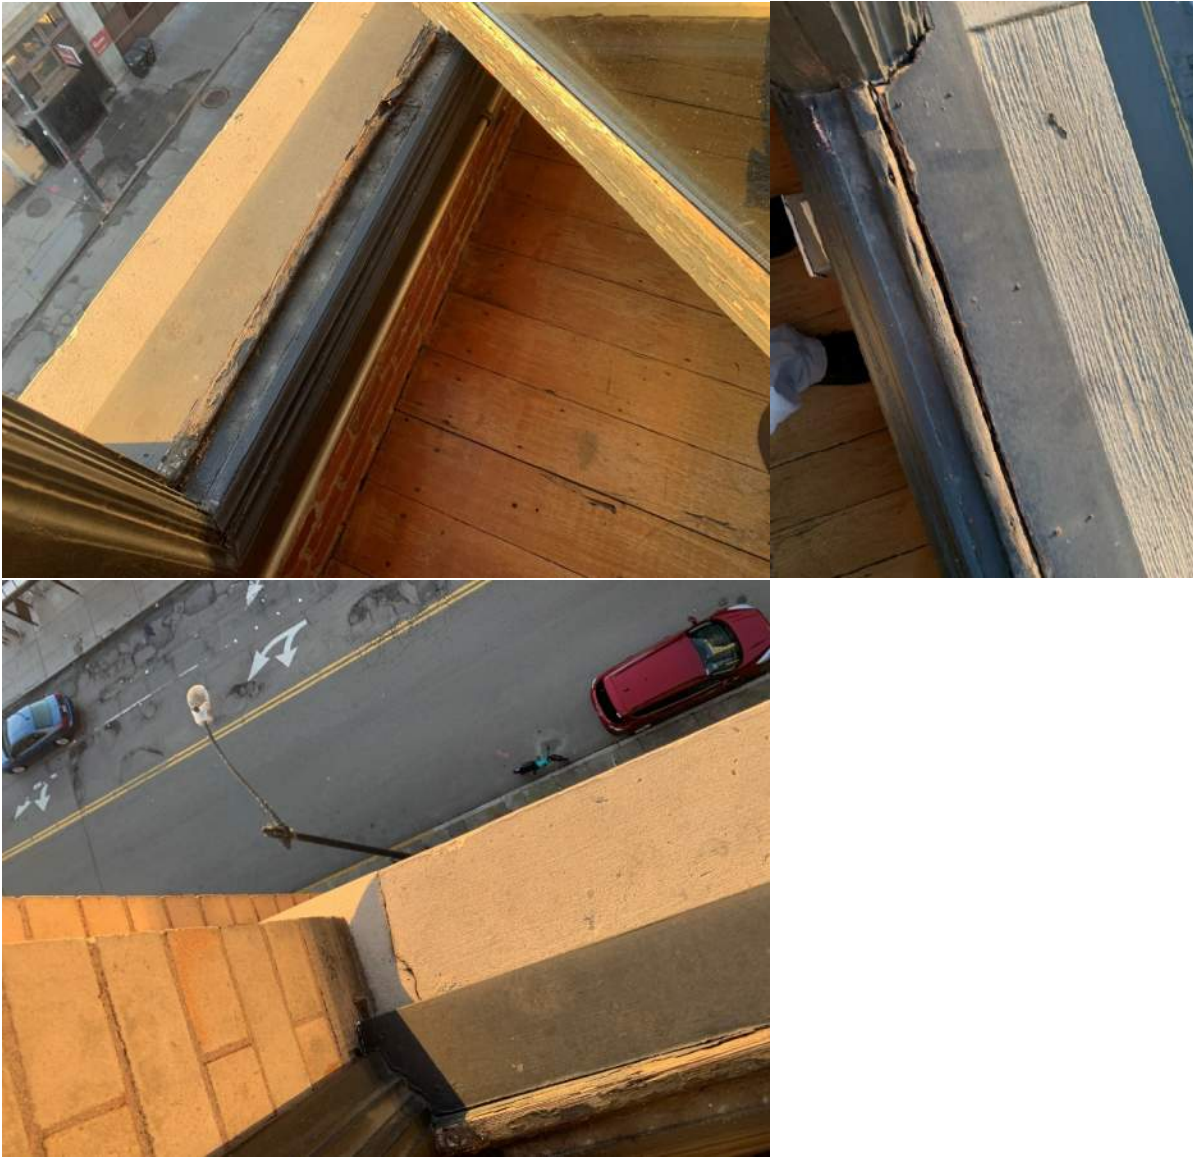
UNIT 5C

Unit	Window ID	Size	Type	Interior Frame	Exterior Frame	Interior Wood Sill	Exterior Wood Sill	Sash	Weatherstrip	Sash stop	Glazing Stop	Glazing	Remarks
5C	W5C	21'-4" x 8'-1"	F/PT	OR, P	OR, PR, C		PR, C, P	PR, C, P			PR, P, C	NO	Rot in mull / frame and S. Jamb stop., glazing stops, checked / rot in multiple sash and glazing stops. Damaged weatherstrips. Damage to horizontal frame between upper and lower sashes Interior repainted relatively recently

Unit 5C: photos showing checking and rot in sash and glazing stops particularly near the sill.

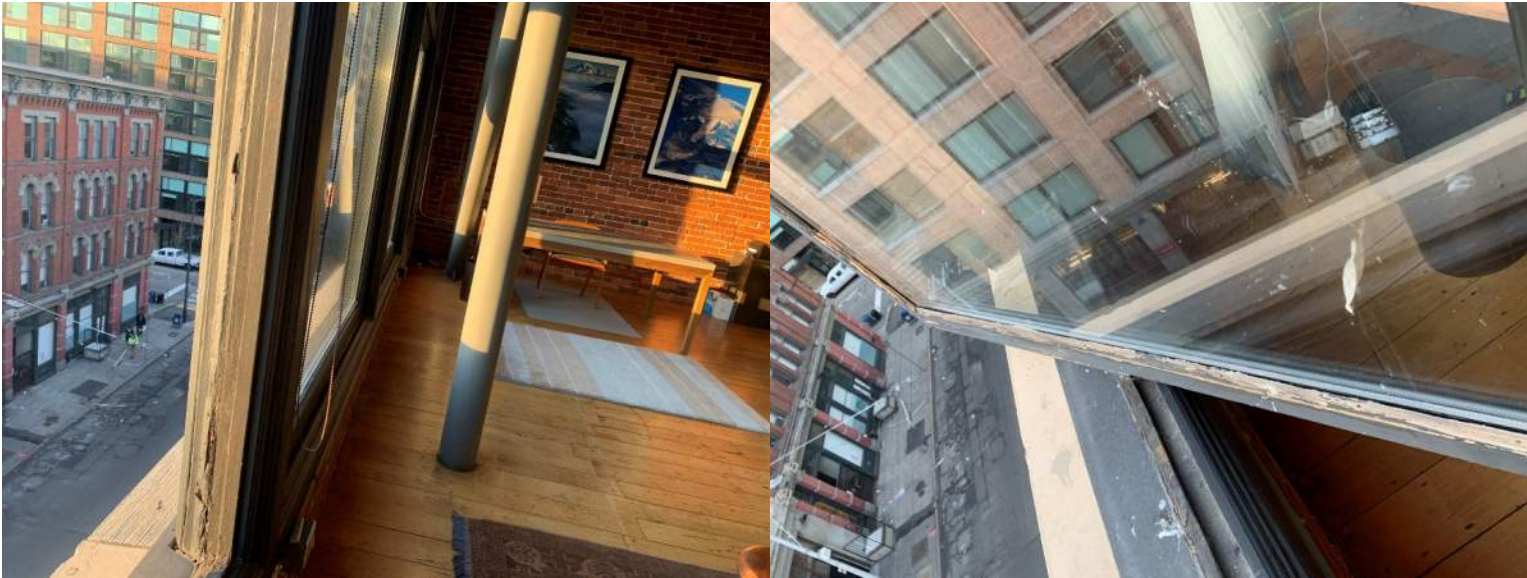
Unit 5C: photos showing rot and damage in frame mullion(L) and in the sash and sill ®

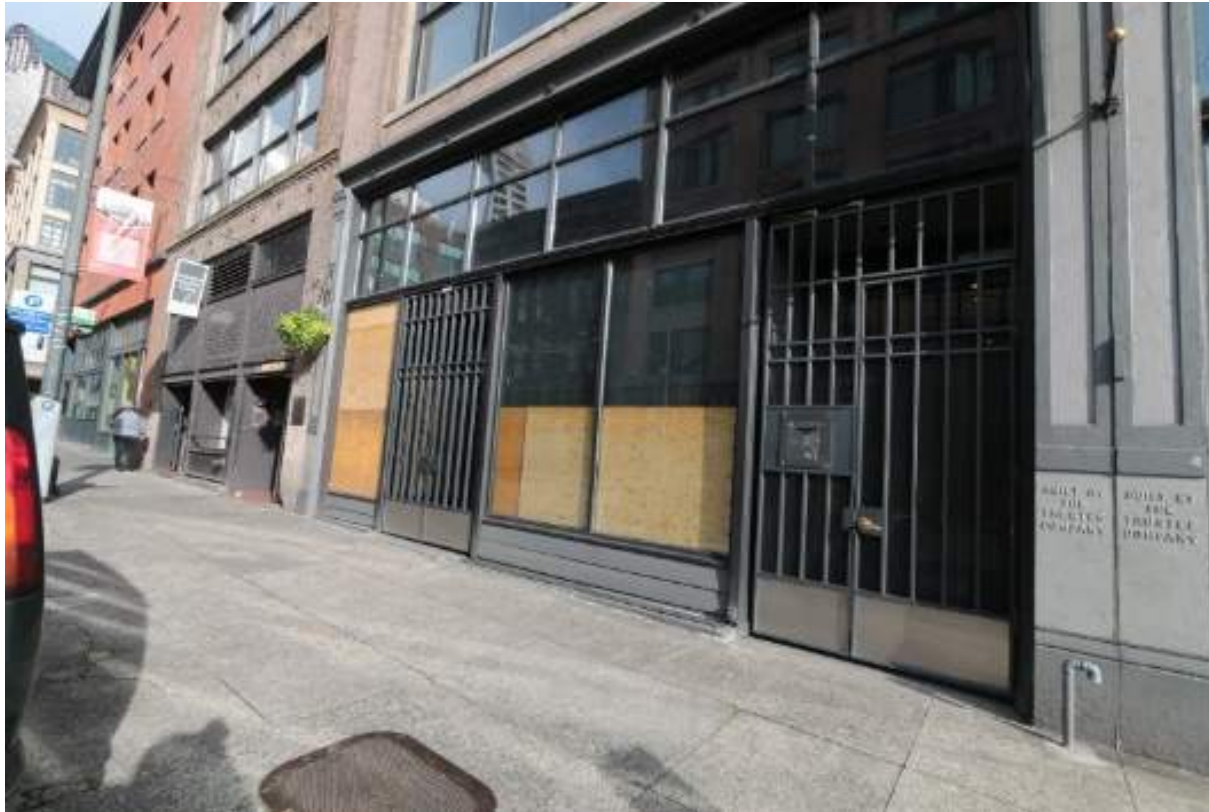
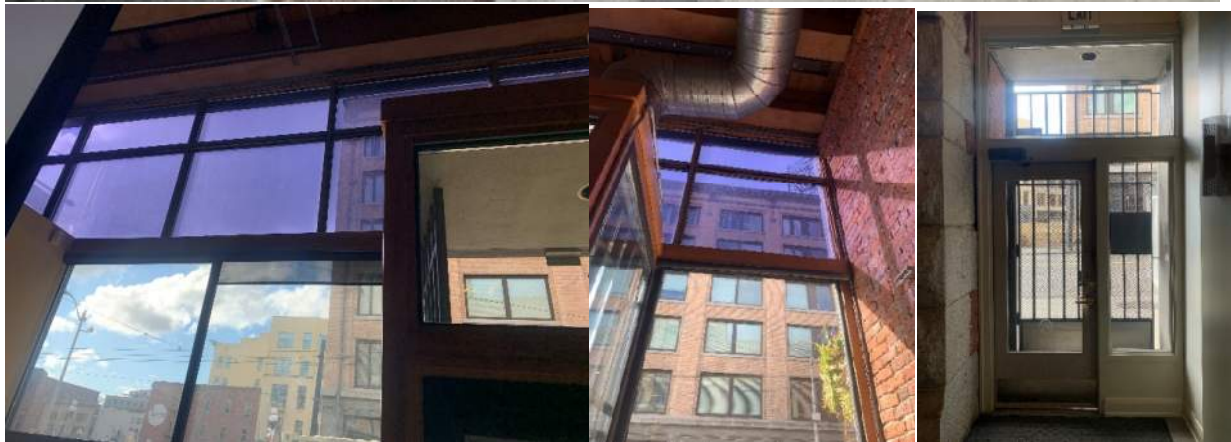
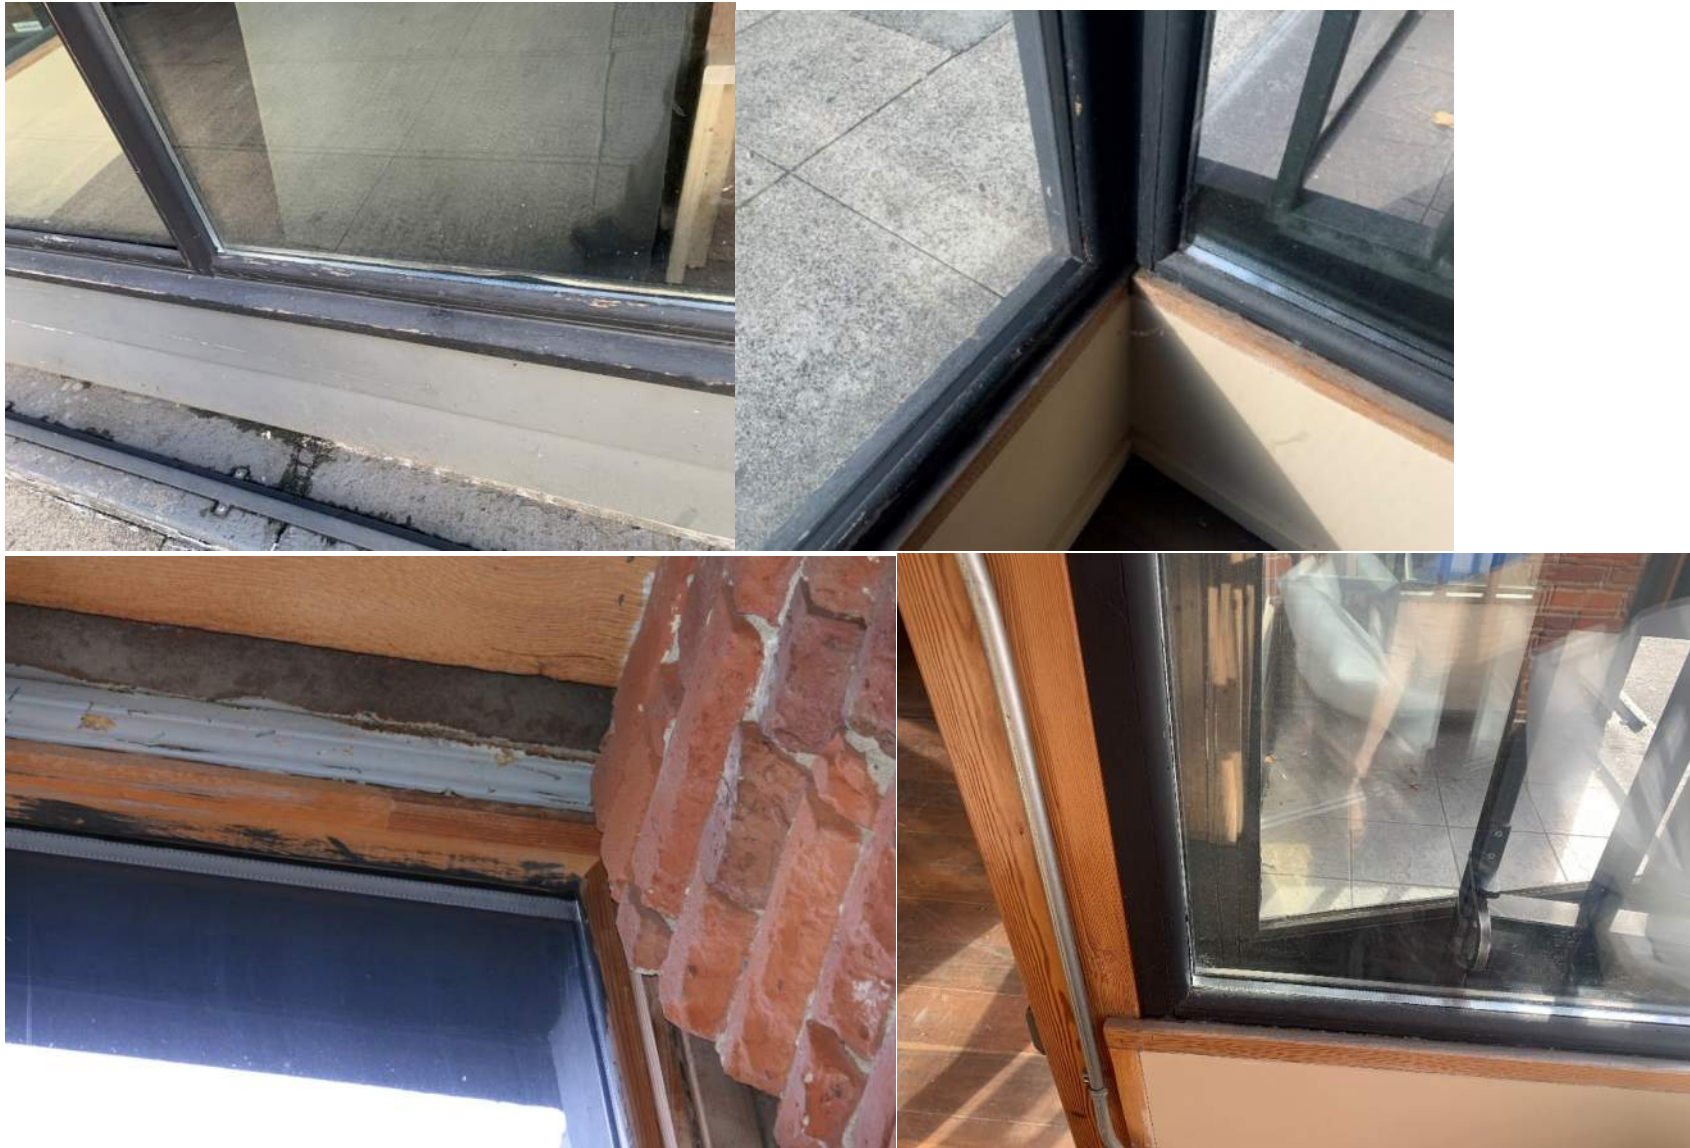
210 THIRD AVENUE SOUTH -STOREFRONT N (208-210)

NORTH (208-210)	N	27'-10"x 16'-6"	F/SF	U	U	P, C, NO	P, C, NO	U	N/A	N/A	U/NO	NO	Condo entryway (210) and vacated ground floor unit (208). There was visible weather checking of the interior storefront sill stop in the 208 space. Multiple paint layers are visible in the texture of the brick mold and horizontal mullion beam. Interior upper molding appears to be relatively new / unaged / weathered, no paint layers are visible. Entries are inset with Stucco soffit.
-----------------	---	--------------------	------	---	---	----------	----------	---	-----	-----	------	----	--

North Storefront (208-210): Upper Left Photo - Weatherchecking and environmental damage at sill. Upper and lower right photos - weather checking at interior of storefront in unit 208.

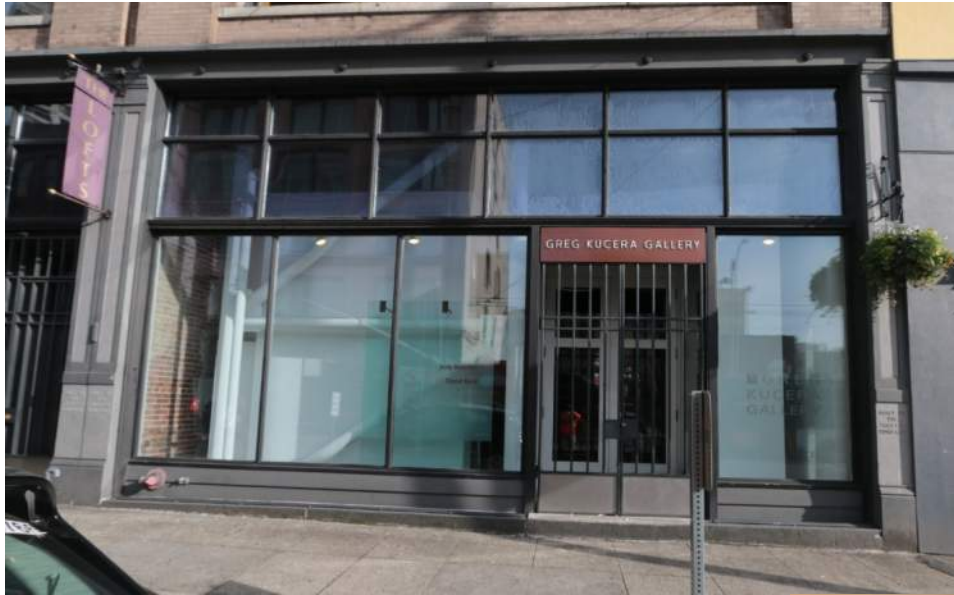
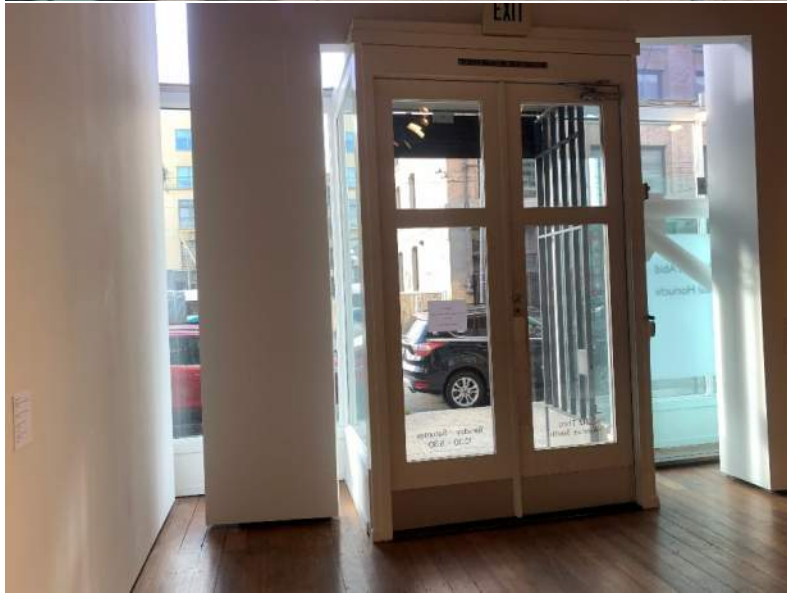
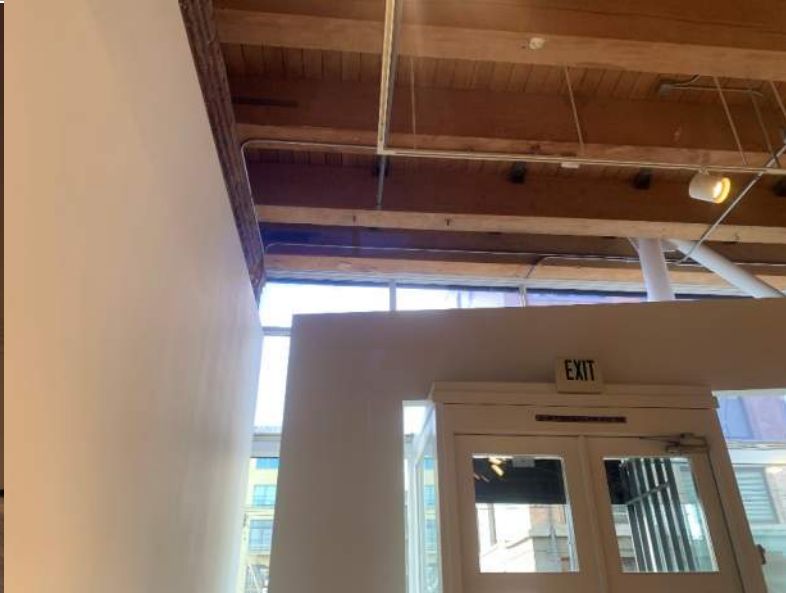
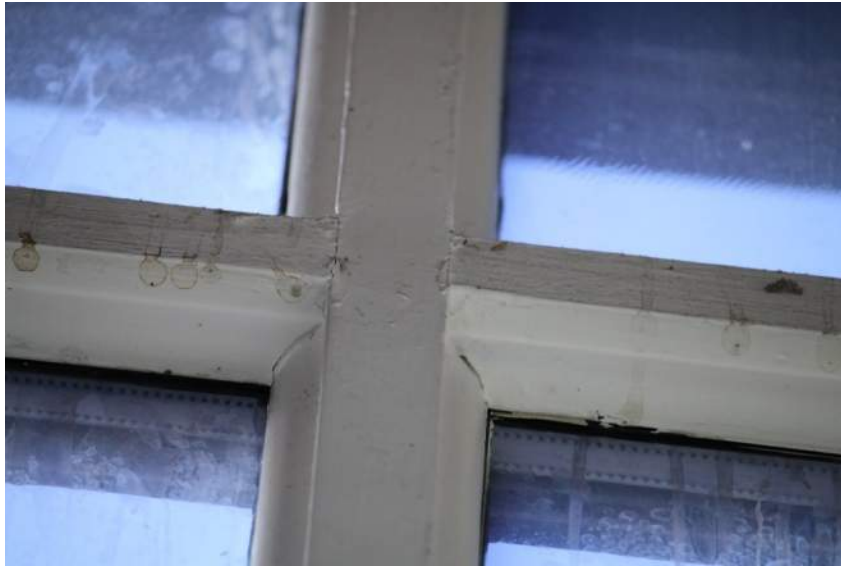
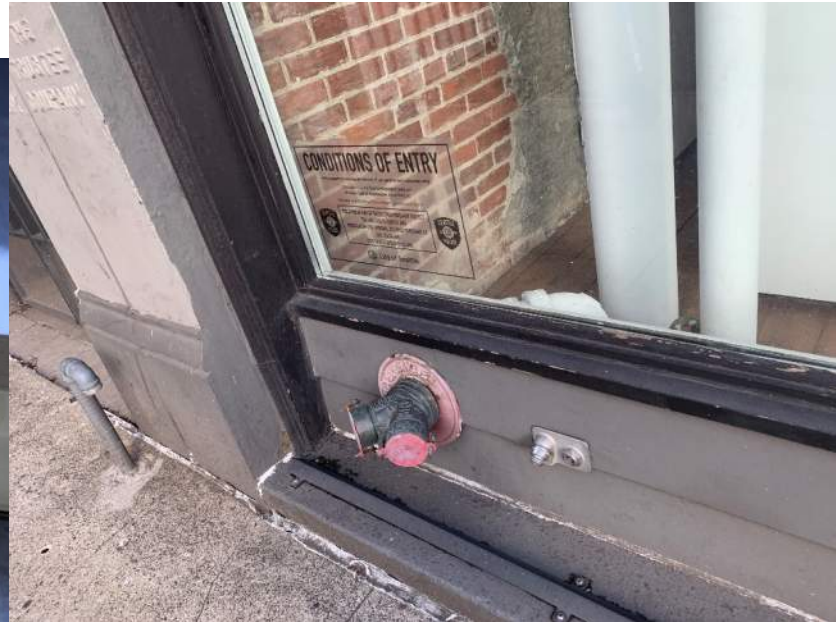
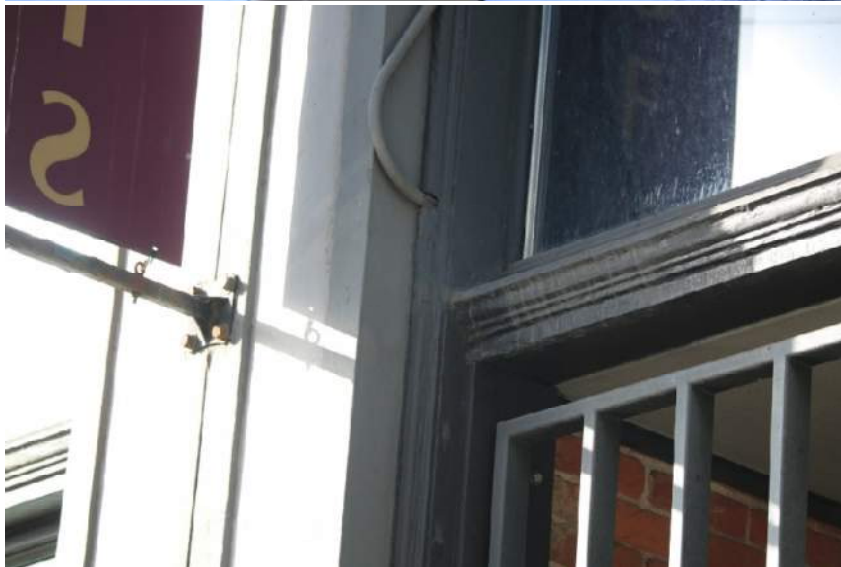
Unit	Window ID	Size	Type	Interior Frame	Exterior Frame	Interior Wood Sill	Exterior Wood Sill	Sash	Weatherstrip	Sash stop	Glazing Stop	Glazing	Remarks
SOUTH (212)	S	27'-10"x 16'-6"	F/SF	U	U	P, C, NO	P, C, NO	U	N/A	N/A	U/NO	NO	Greg Kucera Gallery (212). The brick mold surrounding the opening on the exterior was significantly weathered in appearance. Multiple paint layers are visible in the texture of the brick mold and horizontal mullion beam. Upper exterior and interior show multiple coats of paint / more weathering. Entries are inset with a stucco soffit.

South (212) : Upper Left – staining and related damage at upper sash / muntin’s. Upper Right – weathered brick at jamb and sill trim Lower Left – intersection of brick mold at jamb and horizontal mullion showing weathering .
