# **Gatewood Elementary**

## **Historic Wood Window Replacement**

Seattle Public Schools

Seattle Department of Neighborhoods  
Historic Preservation & Landmarks

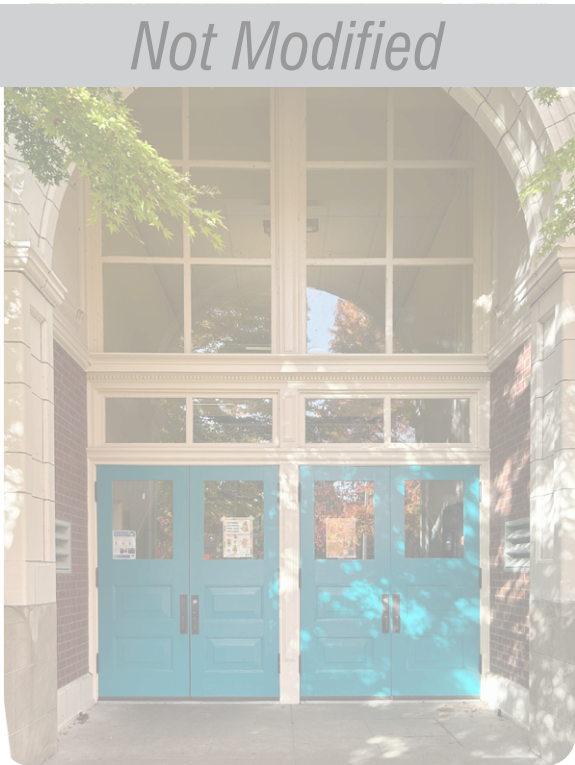
NA Windows above Entrances

Fixed historic windows above the Entrances at both the South (primary) and North (Secondary) doors were recently refurbished in 2022. Our team has determined that replacement and/or refurbishment of these units is not necessary at this time.

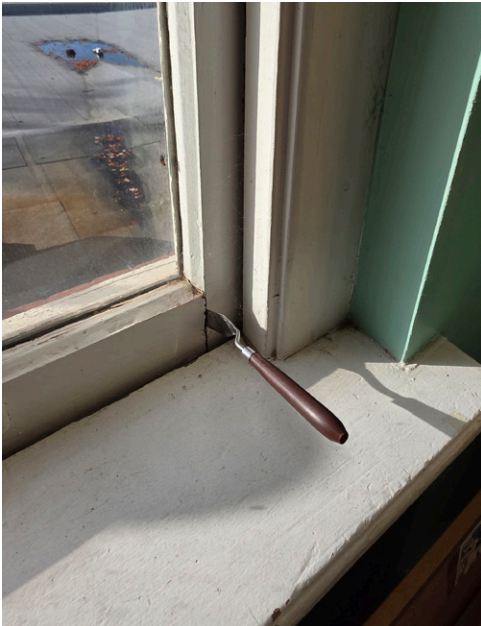
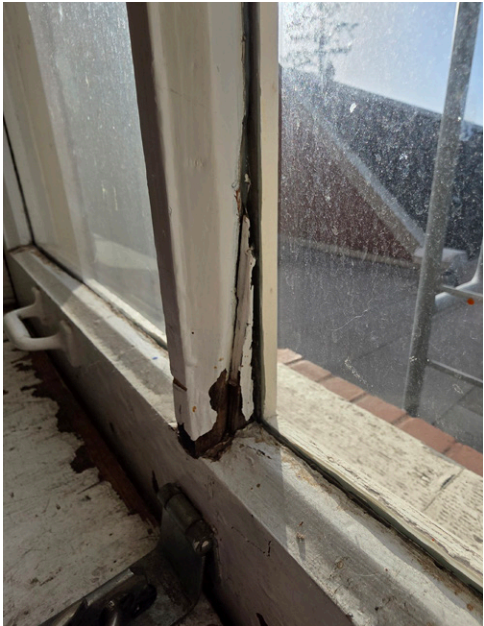
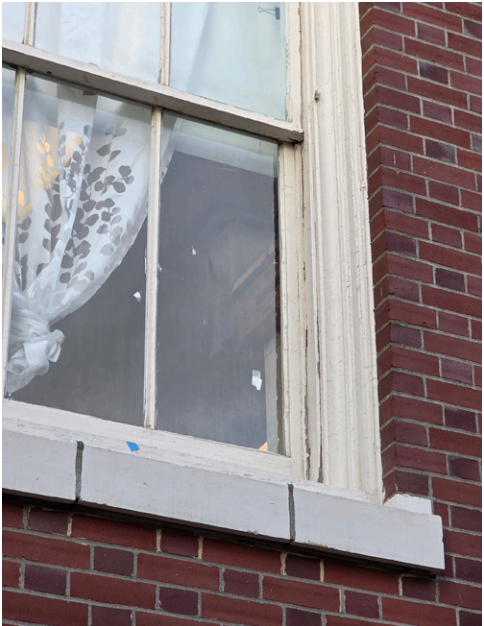
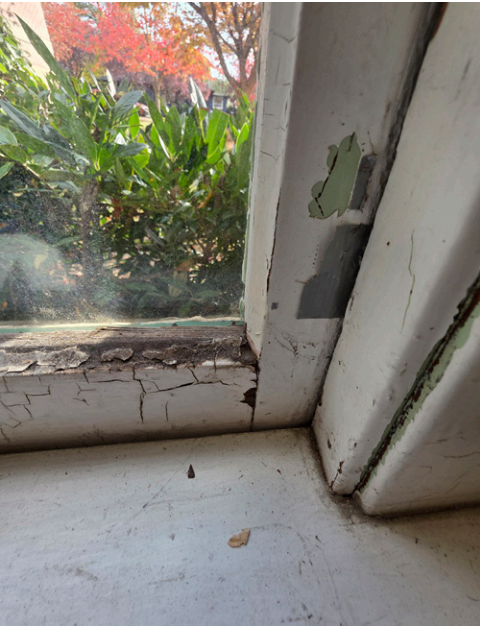
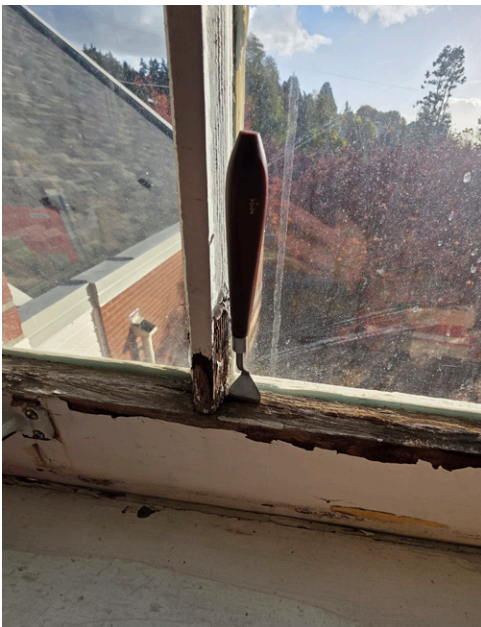
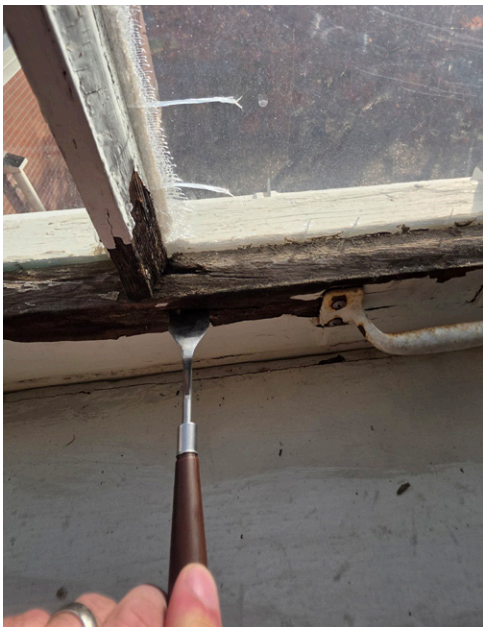
Existing Conditions & Damage

Found across all four elevations, wood windows set within brick façades represent the predominant historic condition. These assemblies include large double-hung units typical of classrooms and corridors, fixed transoms, and smaller operable windows in stairwells. Trim profiles associated with this window type are consistent and uniform throughout the building.

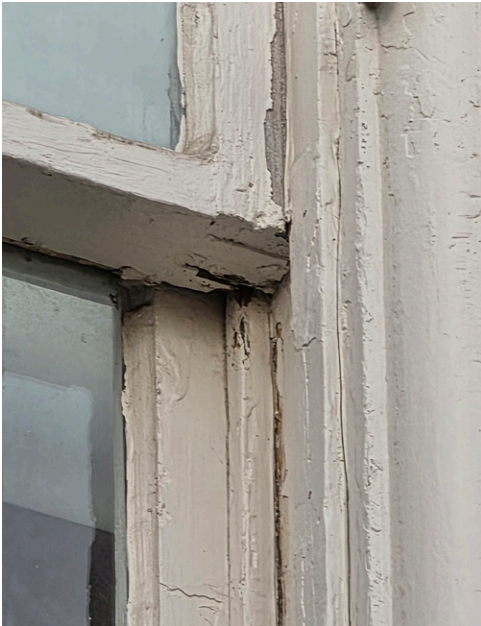
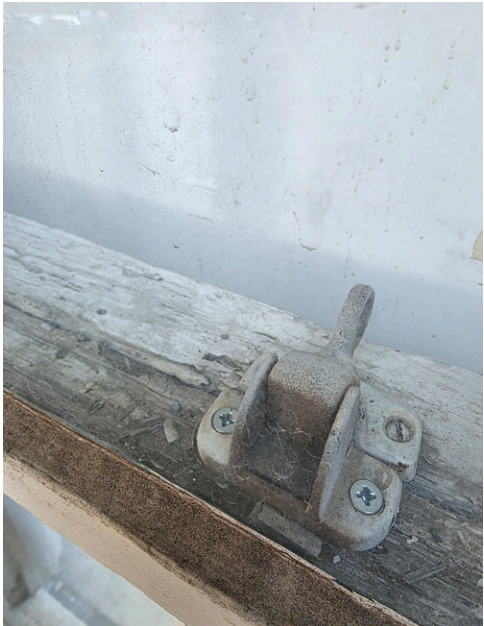
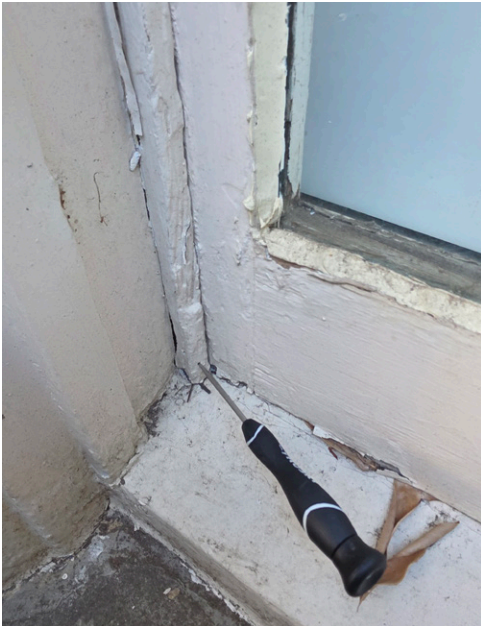
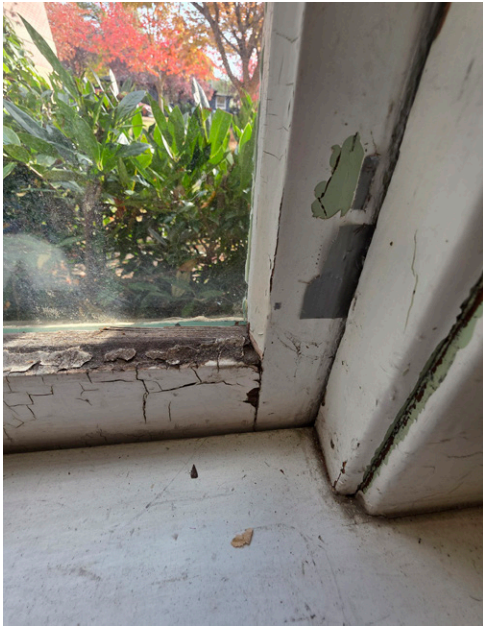
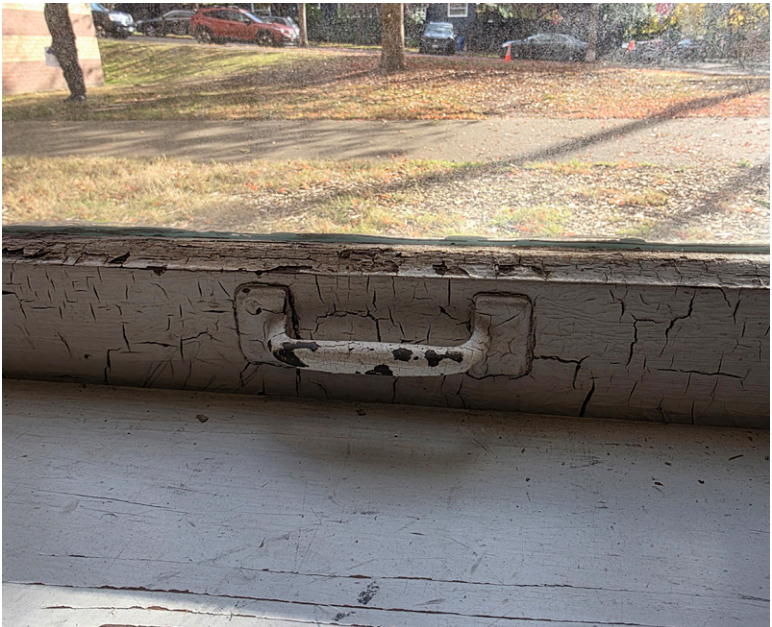
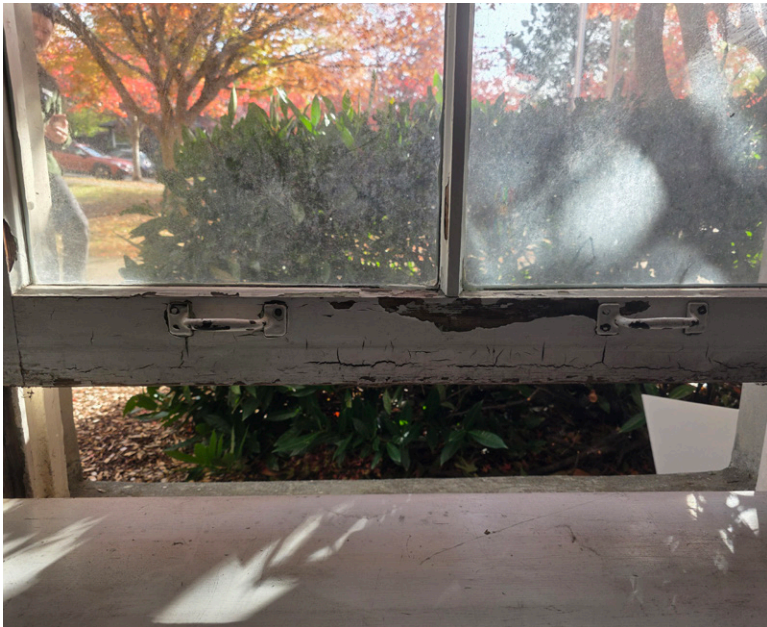
This condition occurs exclusively on the ground floor along the North and South façades. The fenestration consists of large, double-hung operable window assemblies serving early education classrooms. Subtle variations in trim profiles distinguish the North façade windows from those on the South, reflecting minor design and fabrication differences.

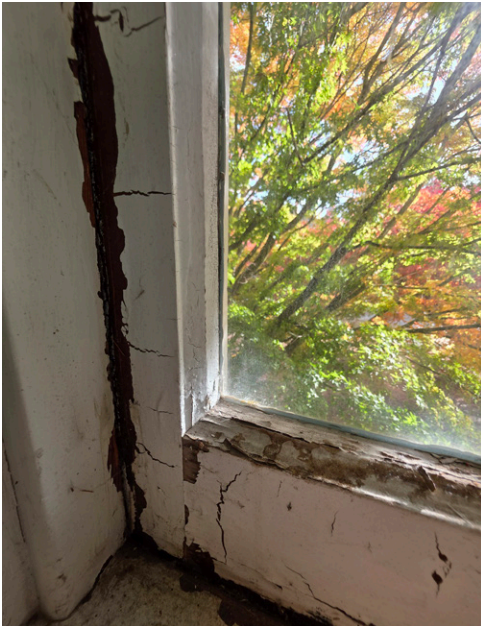
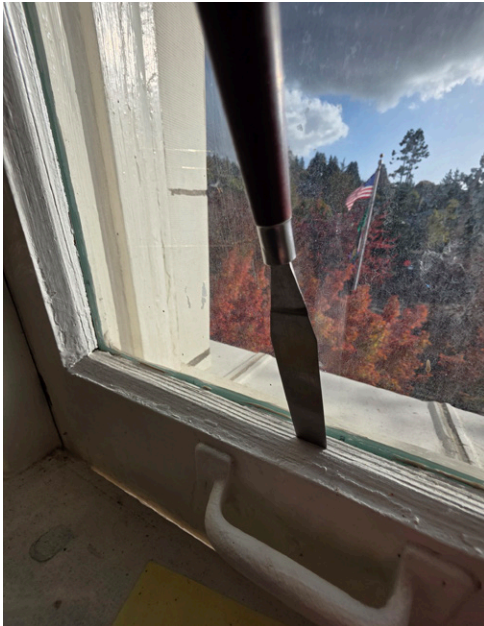
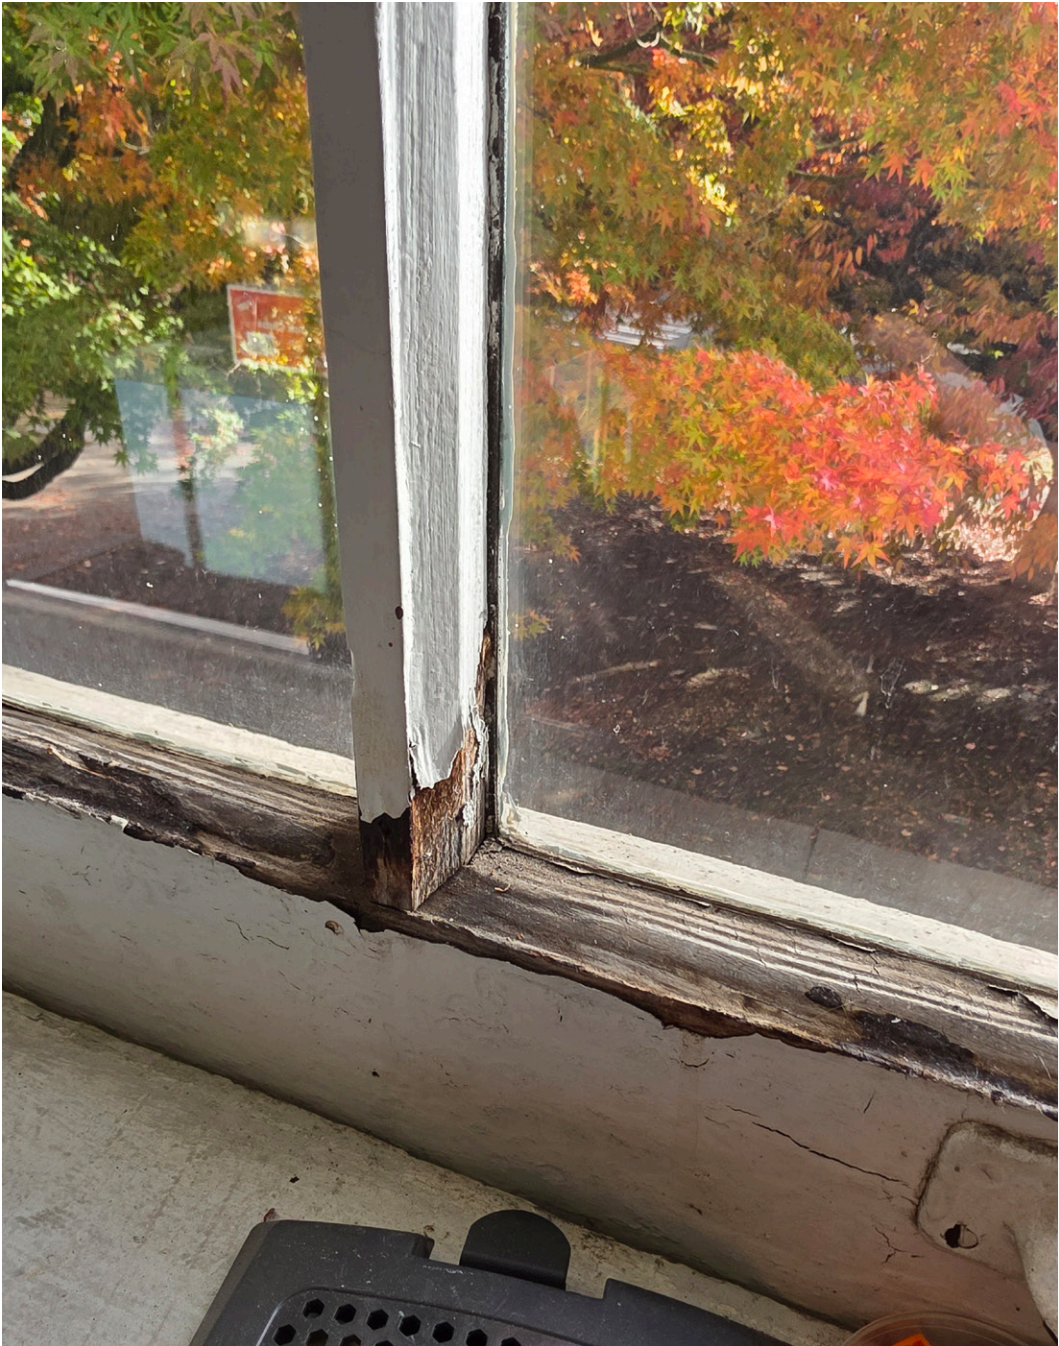
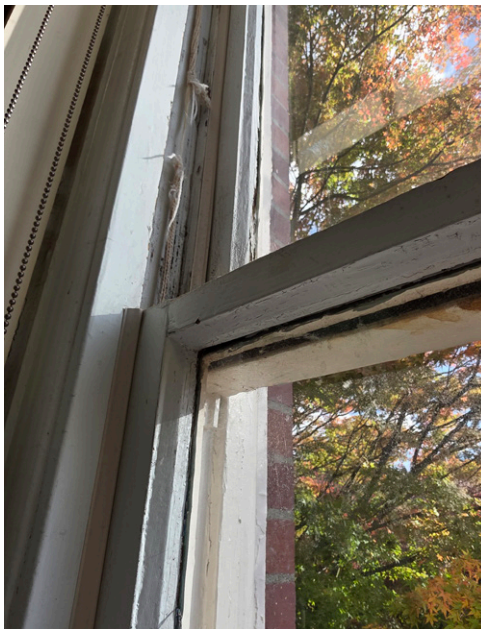
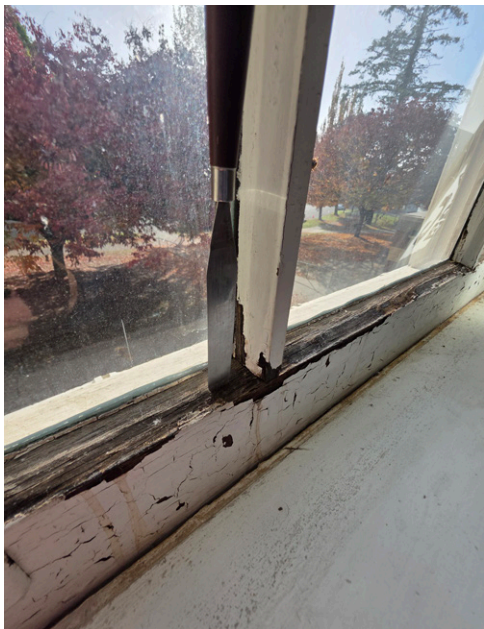
Existing Conditions & Damage

Windows integrated within the ornamental terra cotta façade elements are confined to the central bay of the South façade. Fenestration types in this area vary, including single-hung, fixed, and casement units. The surrounding trim profiles are distinct to this condition, emphasizing its unique architectural composition and detailing.
