Gatewood Elementary

Historic Wood Window Replacement

Seattle Public Schools

Seattle Department of Neighborhoods Historic Preservation & Landmarks

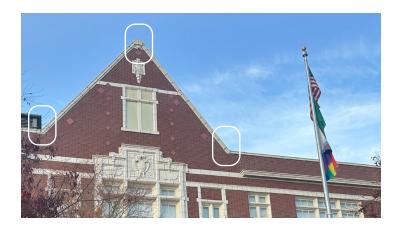
1910 design included Terra cotta Ballards to accentuate the roof line and wall dormers as shown in the original documents. As a part of the 1922 West addition, Ballards were removed

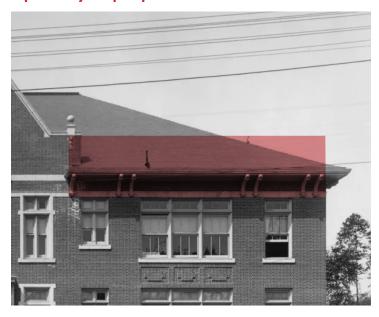
The 1922 addition project created a brick parapet around the entire roof, including 1920 section.

Changes made to the original building can be seen where the eaves and soffits of the 1910 building was replaced by the parapet extension.

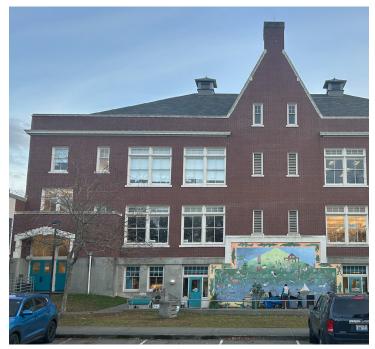
The 1922 addition project created a brick parapet around the entire roof, including 1920 section.

Changes made to the original building can be seen where the eaves and soffits of the 1910 building was replaced by the parapet extension.

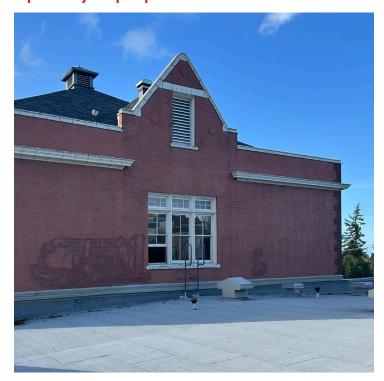
The 1922 addition project created a brick parapet around the entire roof, including 1920 section. Changes made to the original building can be seen where the eaves and soffits of the 1910 building was replaced by the parapet extension.

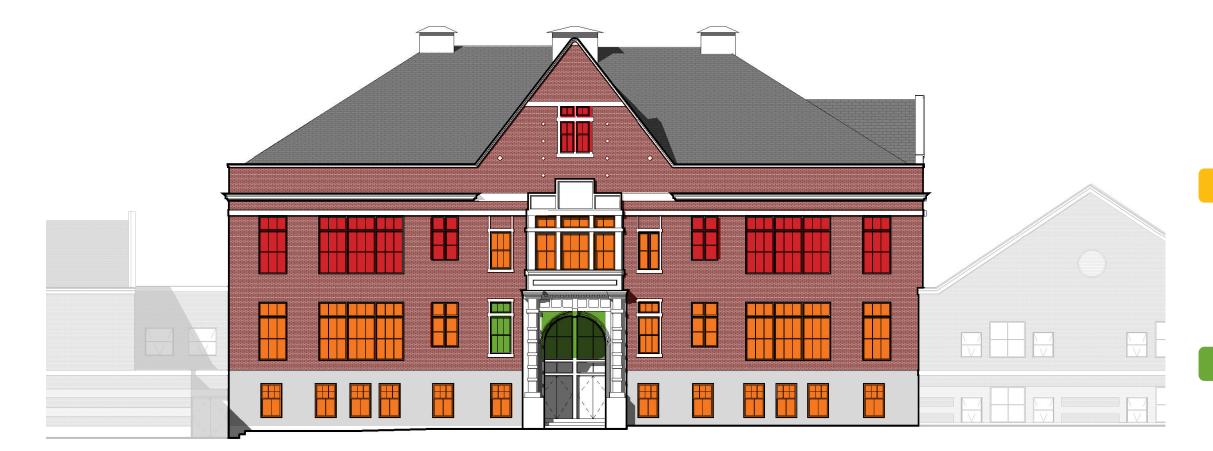
Although some repairs have been performed recently, the windows on this elevation are generally in the worst condition. On the 3rd floor, the majority of the windows are no longer safe to operate due to complete deterioration of lower sash bottom rails. Wood deterioration is concentrated, but limited to, skyward facing horizontal elements and the base of vertical elements that are in contact with glazing. Note: The attic window directly above the schools south main entry is currently boarded up due to wood deterioration.

Exterior wood casings all appear/are believed to be original circa1913, and are generally covered in multiple layers of paint coatings but in serviceable condition with areas of spot deterioration along the base of vertical casing pieces. Exterior sills and sub sills also appear/are believed to be original circa1913 but are covered with extremely heavy layers of paint concealing otherwise age/deteriorated wood.

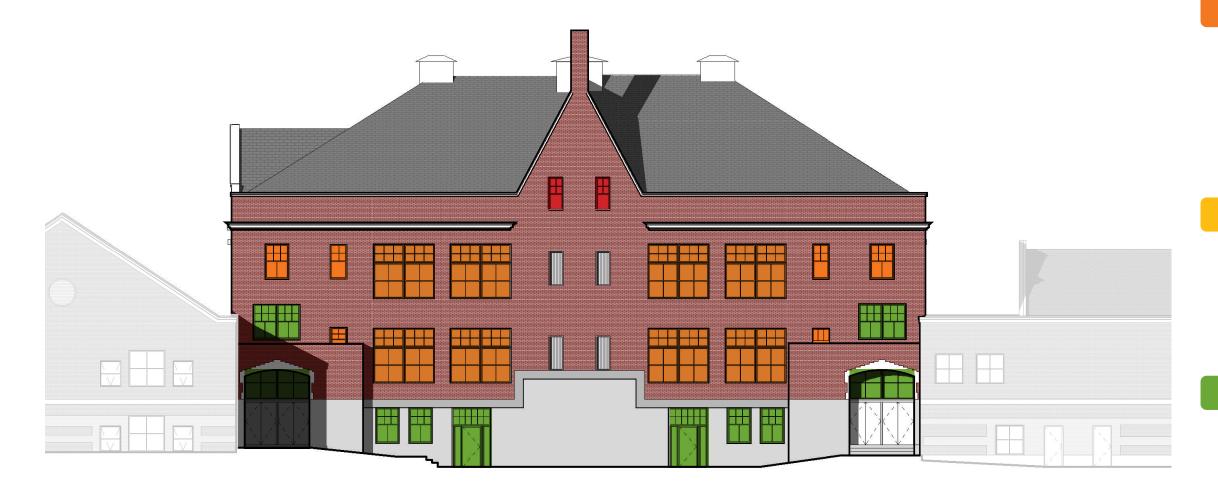
The majority of recent repairs have been performed on this elevation. As a less weathered facing elevation these windows are generally in better condition. Wood deterioration is concentrated along skyward facing horizontal elements and the base of vertical elements that are in contact with glazing. The two (2) attic windows on this elevation are currently boarded up due to wood deterioration

Exterior wood casings all appear/are believed to be original circa1913, and are generally covered in multiple layers of paint coatings but in serviceable condition with areas of spot deterioration along the base of vertical casing pieces. Exterior sills and sub sills also appear/are believed to be original circa1913 but are covered with extremely heavy layers of paint concealing otherwise age/deteriorated wood.

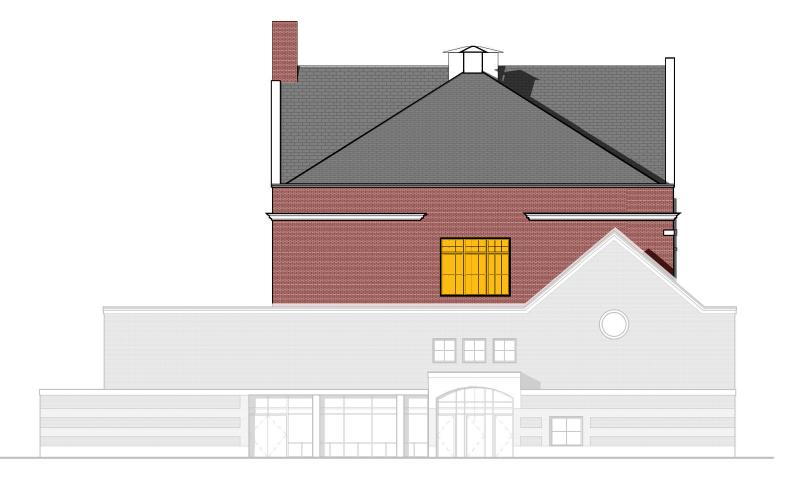
WEST ELEVATION - OVERALL NOTES:

These 3rd floor windows were repaired around 2013 and were repainted along with their exterior casings in 2018. Wood deterioration is isolated to the lower operable sashes and concentrated along skyward facing horizontal elements and the base of vertical elements that are in contact with glazing. Exterior sills and sub sills also appear/are believed to be original circa1913 and although experiencing coating failure, appear generally serviceable.

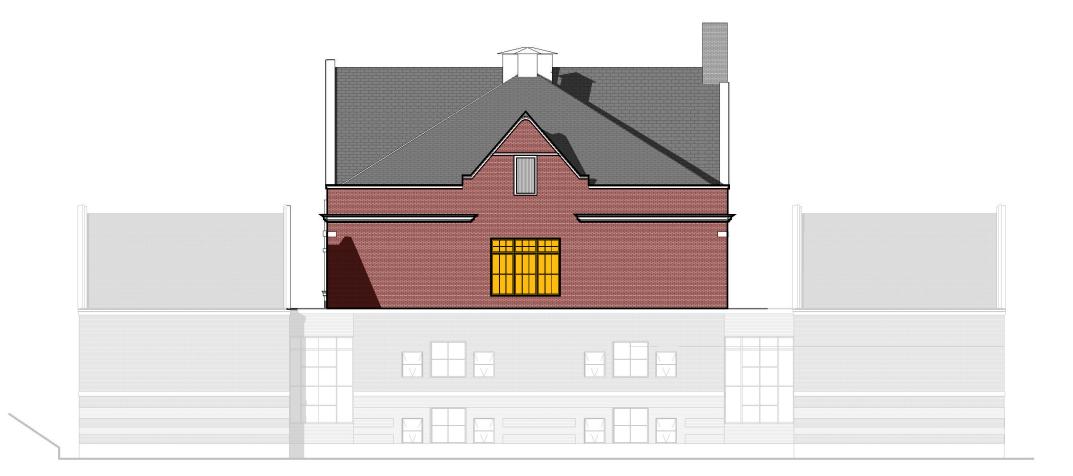
EAST ELEVATION - OVERALL NOTES:

These 3rd floor windows were repaired around 2013 and were repainted along with their exterior casings in 2018. Wood deterioration is isolated to the lower operable sashes and concentrated along skyward facing horizontal elements and the base of vertical elements that are in contact with glazing. Exterior sills and sub sills also appear/are believed to be original circa1913 and although experiencing coating failure, appear generally serviceable.

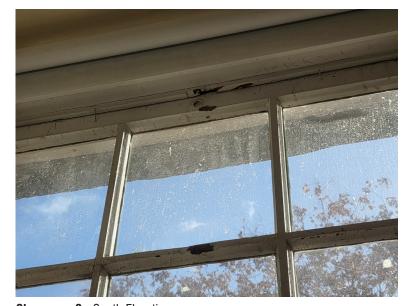
Classroom 2 - South Elevation
Paint Failure and extensive wood deterioration.
New/refurbishment of hardware required.

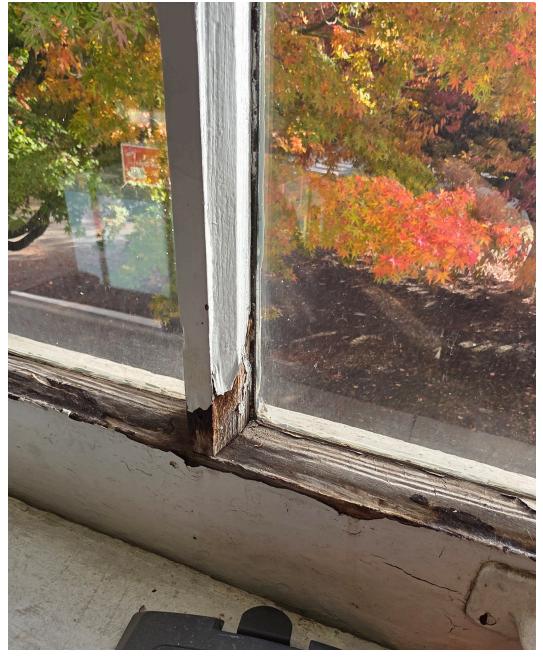
Office 225 - South Elevation Paint Failure and extensive wood Deterioration typical for jambs and bottom rails
