# Gatewood Elementary

Historic Wood Window Refurbishment & Glazing Replacement

Seattle Public Schools

Seattle Department of Neighborhoods  
Historic Preservation & Landmarks

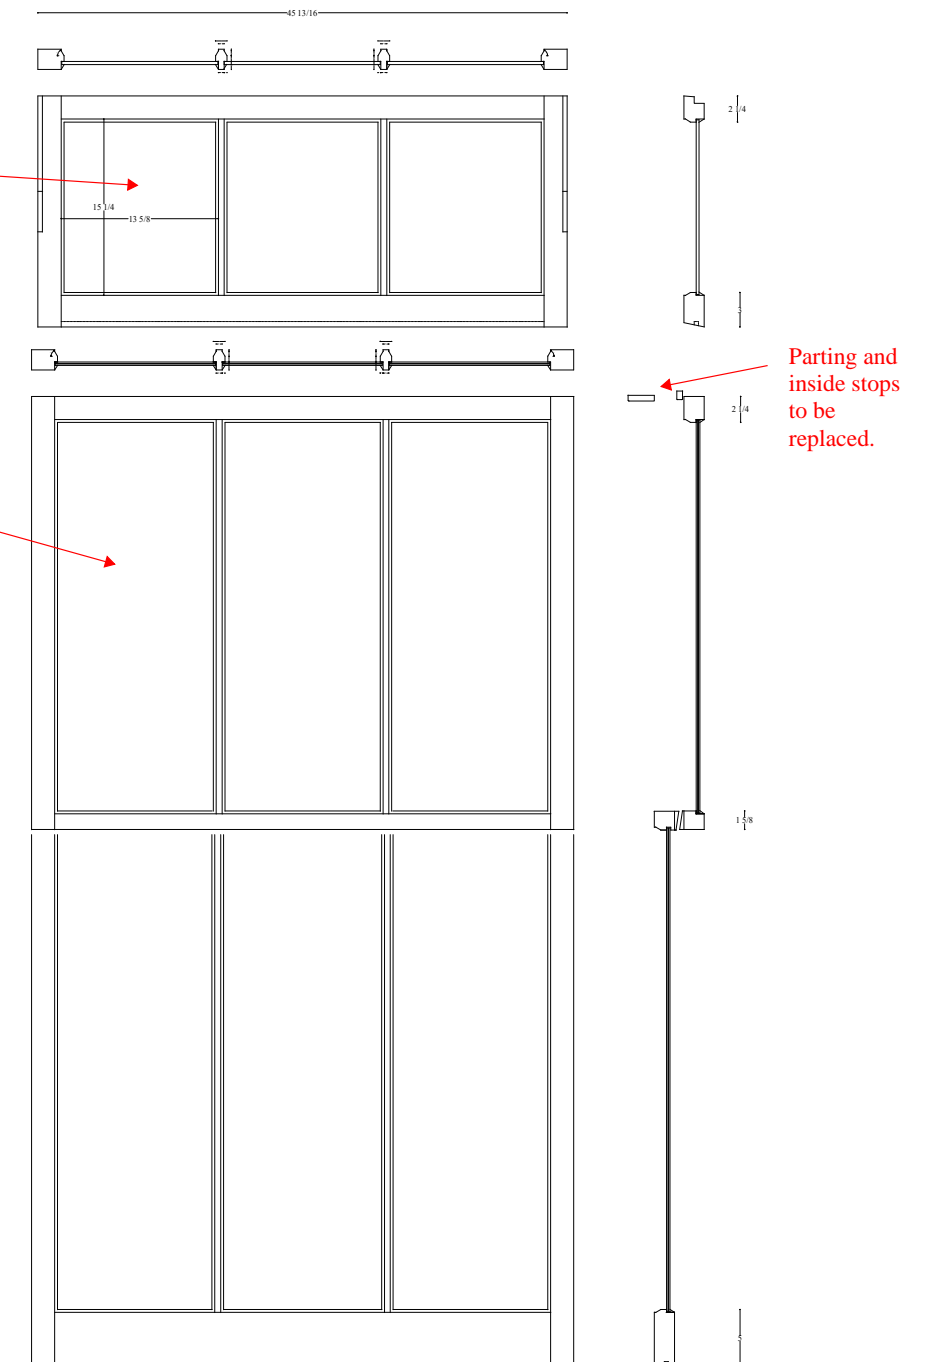
1. The exterior and interior window frames and exterior sub sill were able to be refurbished without replacement of any wood components.
2. All of the parting and inside stops split during removal because of their thin profiles or because of existing wood deterioration. Although an attempt was made to save the stops during this mock-up Legacy Renovations was not successful and believes replacement of the wood stops will be required for any window where the stops are removed for sash refurbishment.

Parting and inside stops to be replaced.

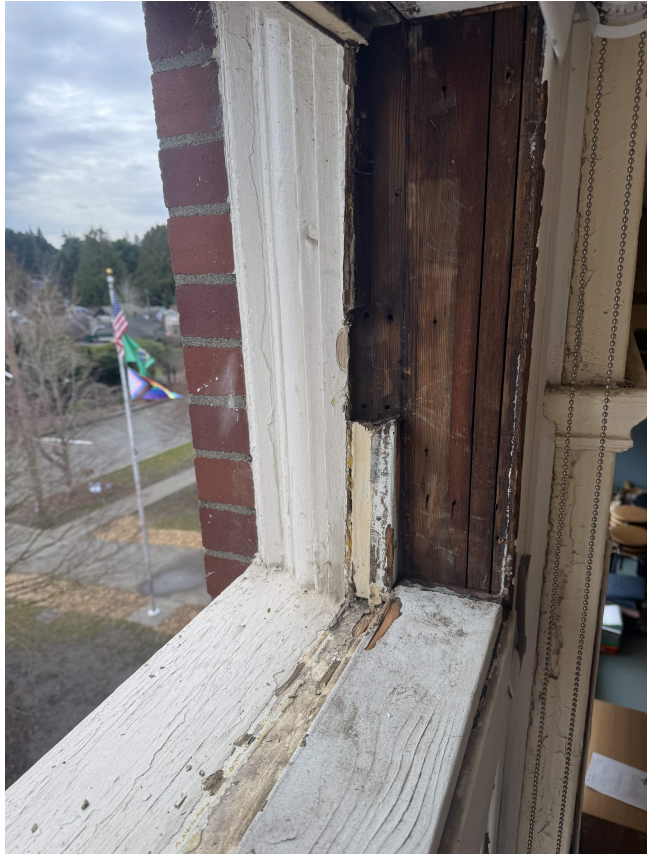
Upper frame with pivoting transom sash removed

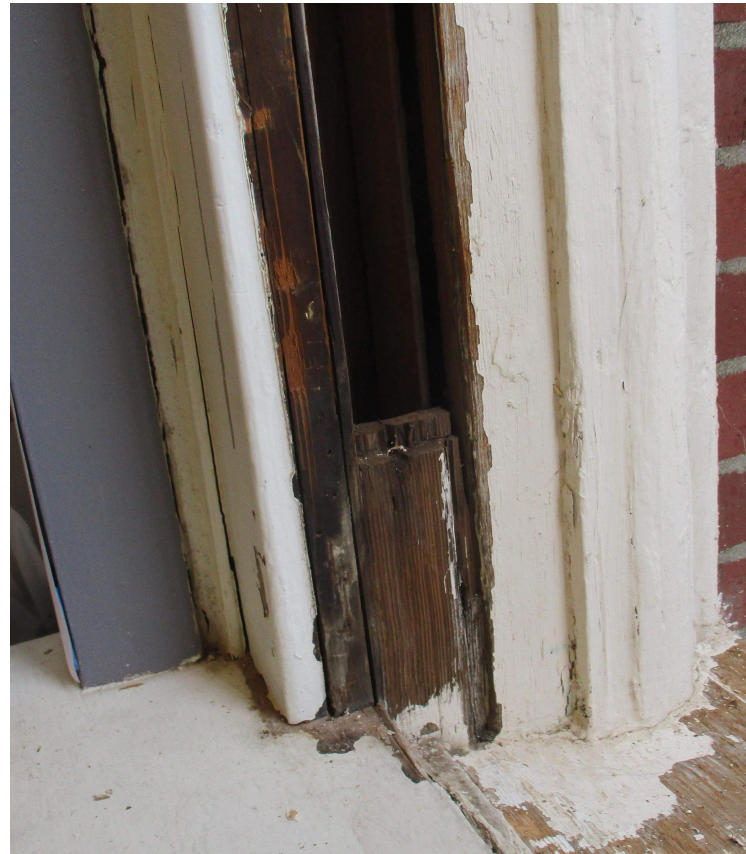
Lower frame with double hung sashes removed

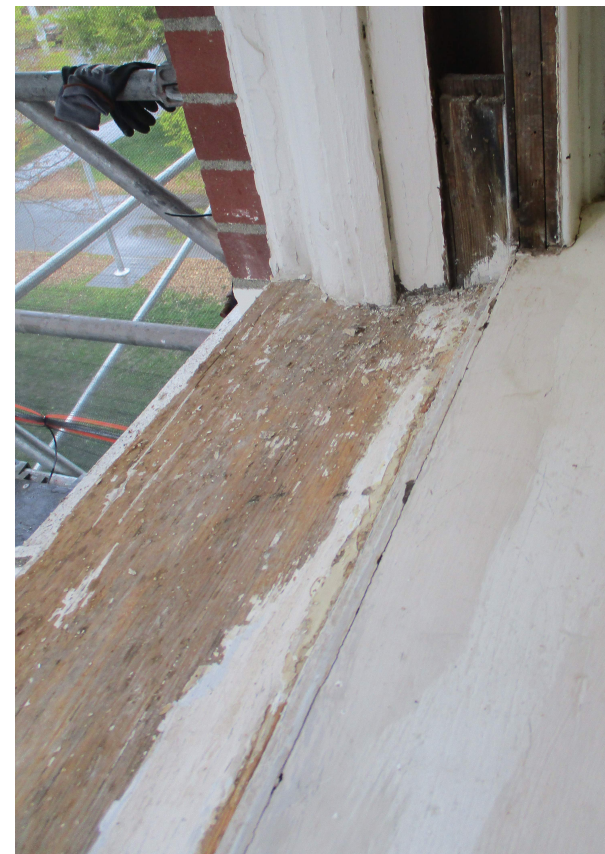
Subsill with loose paint removed and prior to epoxy repairs

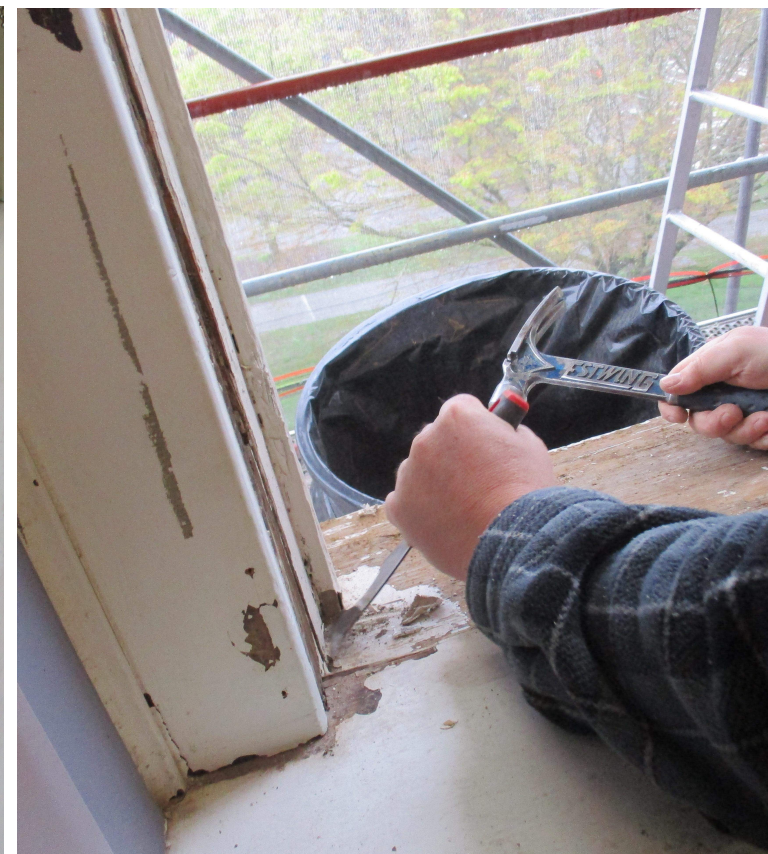
Careful removal of exterior sealants and minor wood rot

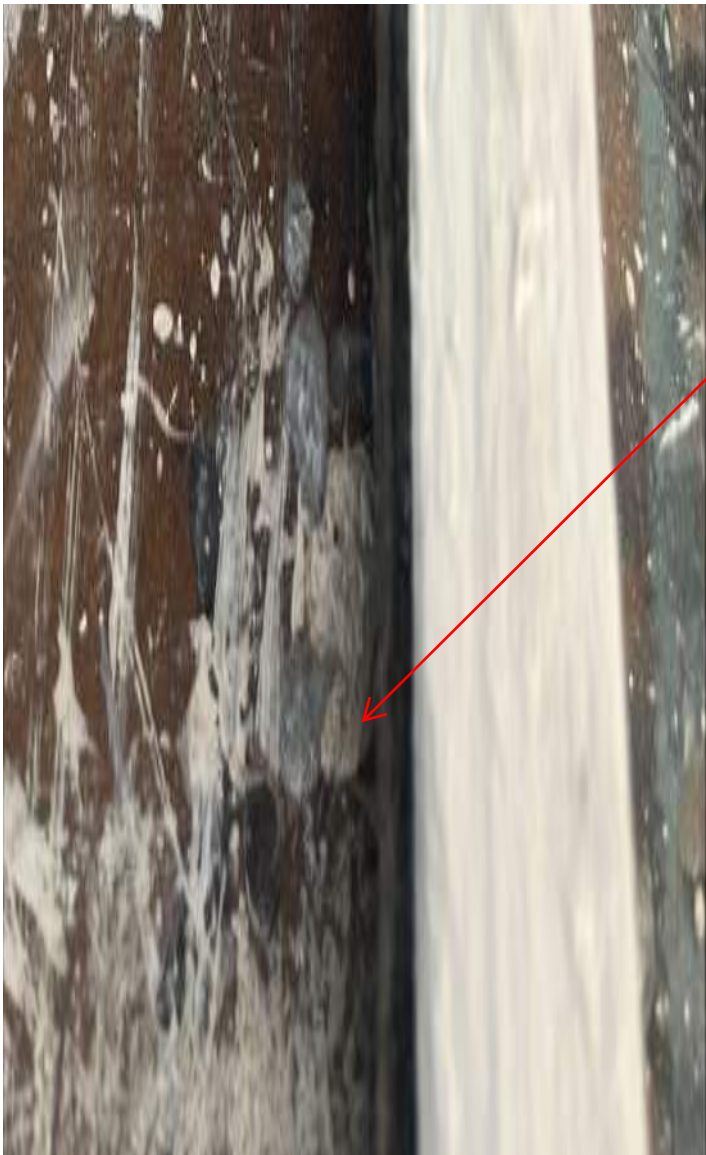
Rot beginning in Muntins and failing paint

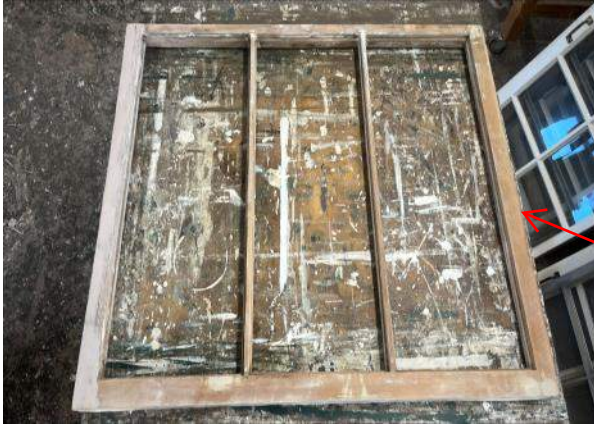
Paint has been removed to expose deterioration

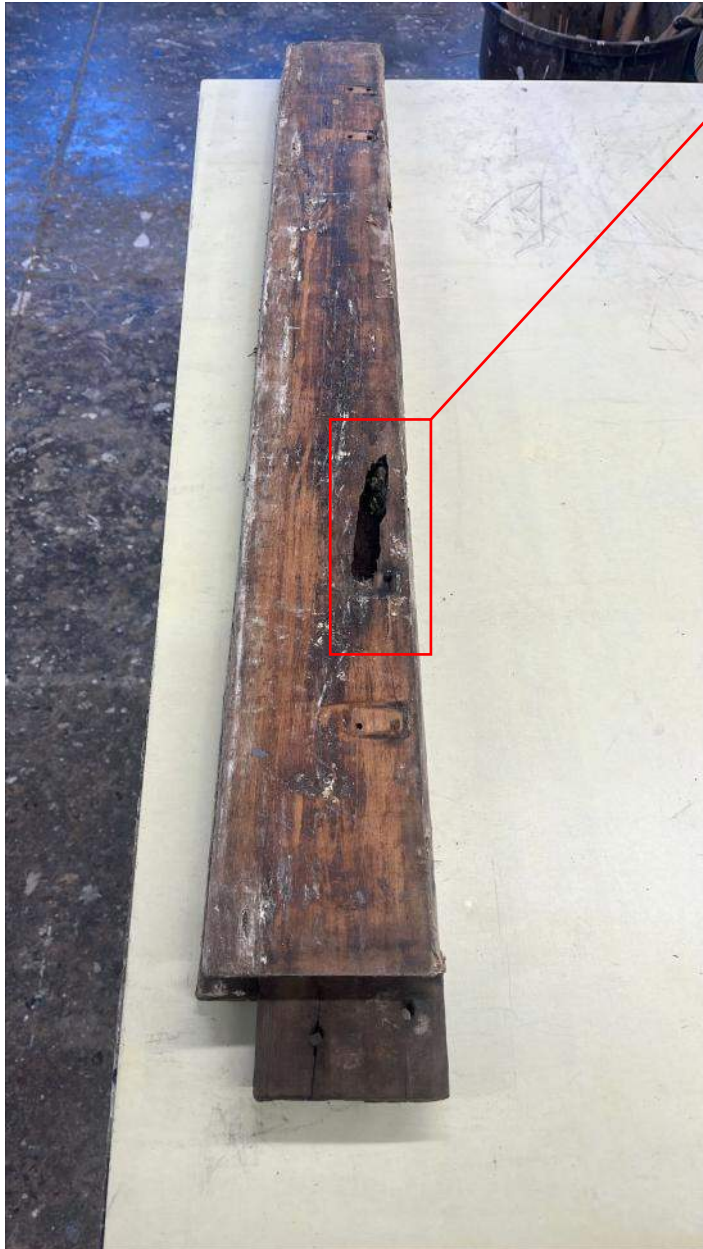
# Bottom rail repair

3. Replacement of wood components on the sashes included.
  - a. The bottom rail of the lower sash which was expected as we could poke through it with a probe before we even started this mock-up. Estimate for the other windows is that somewhere around 25% of all bottom rails will need replacement and potentially a handful of vertical stiles.

The bottom rail of the bottom sash was rotten beyond repair

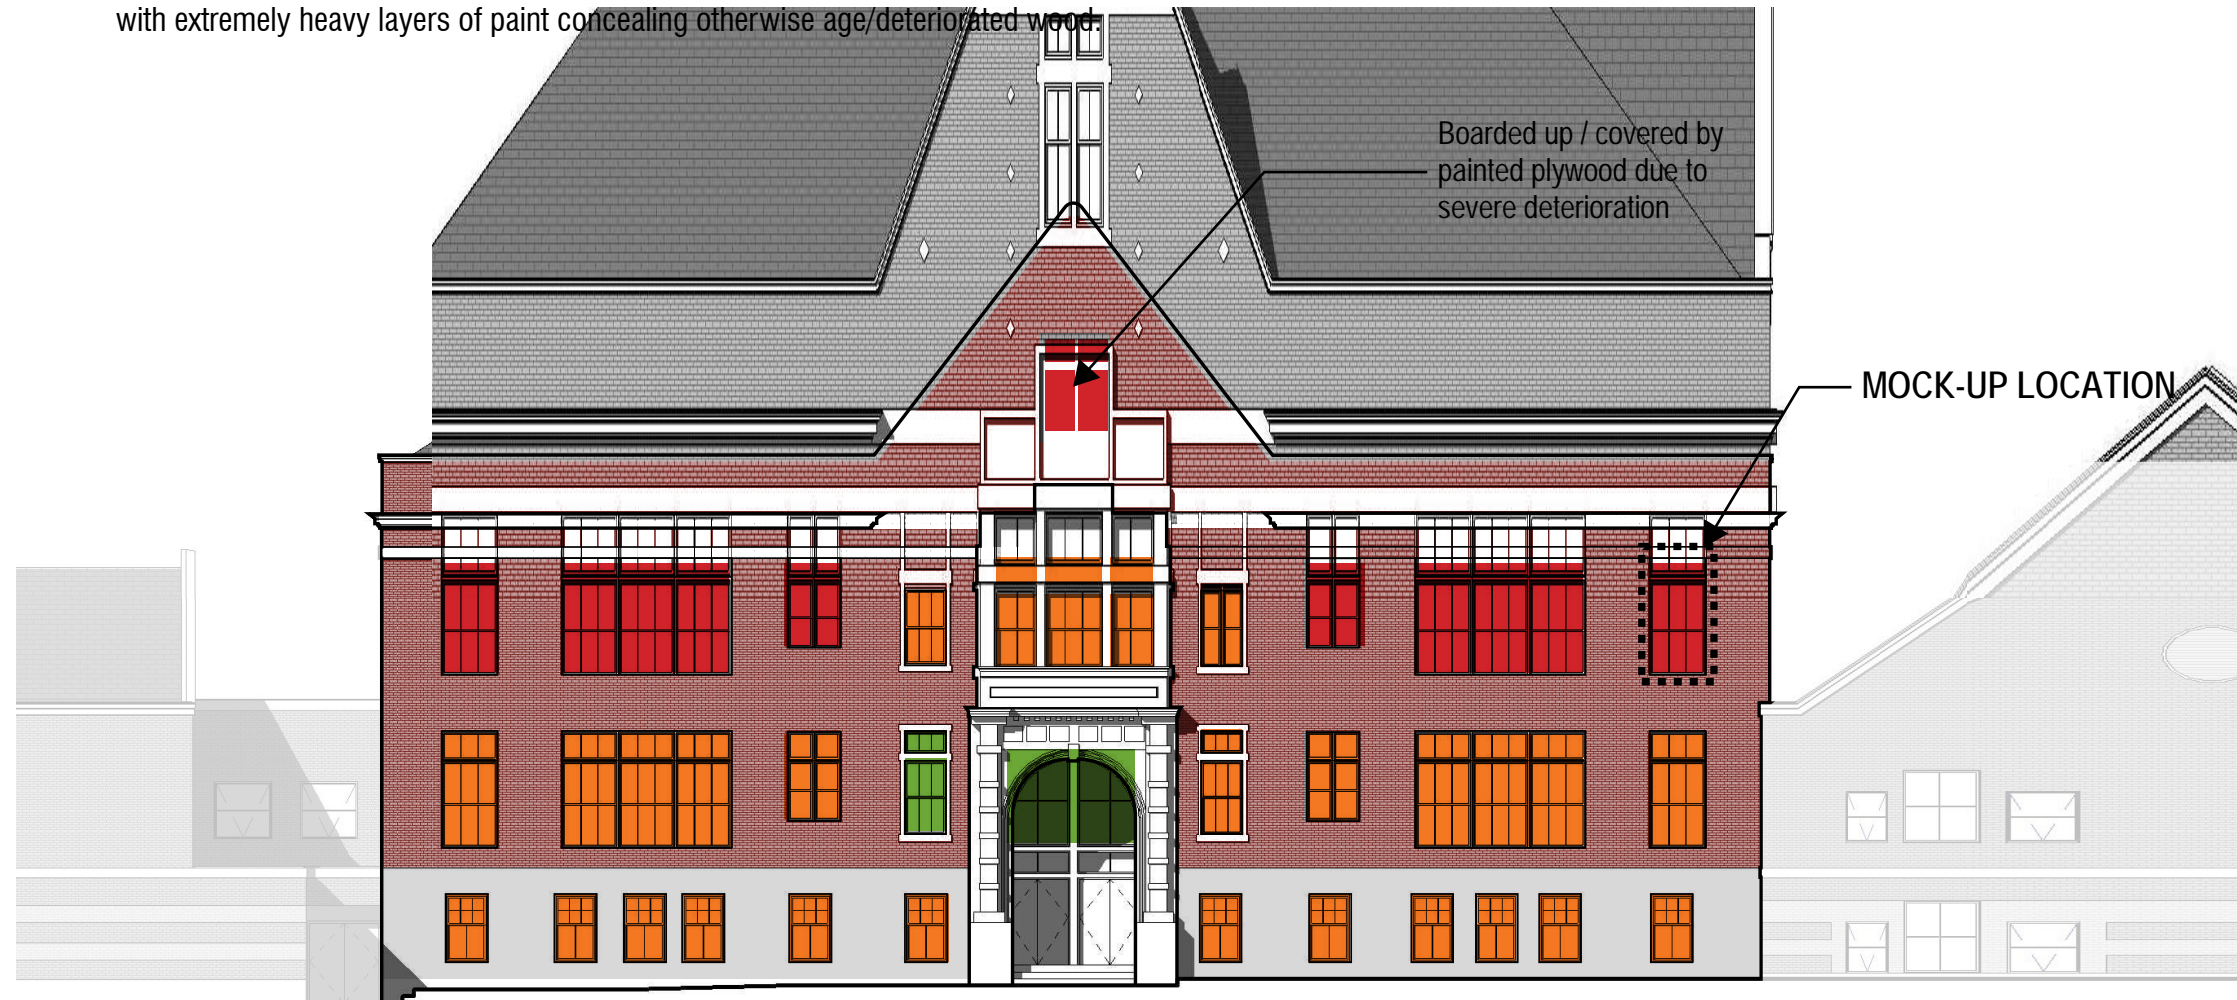
### SOUTH ELEVATION - OVERALL NOTES:

Although some repairs have been performed recently, the windows on this elevation are generally in the worst condition. On the 3rd floor, the majority of the windows are no longer safe to operate due to complete deterioration of lower sash bottom rails. Wood deterioration is concentrated, but limited to, skyward facing horizontal elements and the base of vertical elements that are in contact with glazing. *Note: The attic window directly above the schools south main entry is currently boarded up due to wood deterioration.*

Exterior wood casings all appear/are believed to be original circa 1910, and are generally covered in multiple layers of paint coatings but in serviceable condition with areas of spot deterioration along the base of vertical casing pieces. Exterior sills and sub sills also appear/are believed to be original circa 1910 but are covered with extremely heavy layers of paint concealing otherwise age/deteriorated wood.

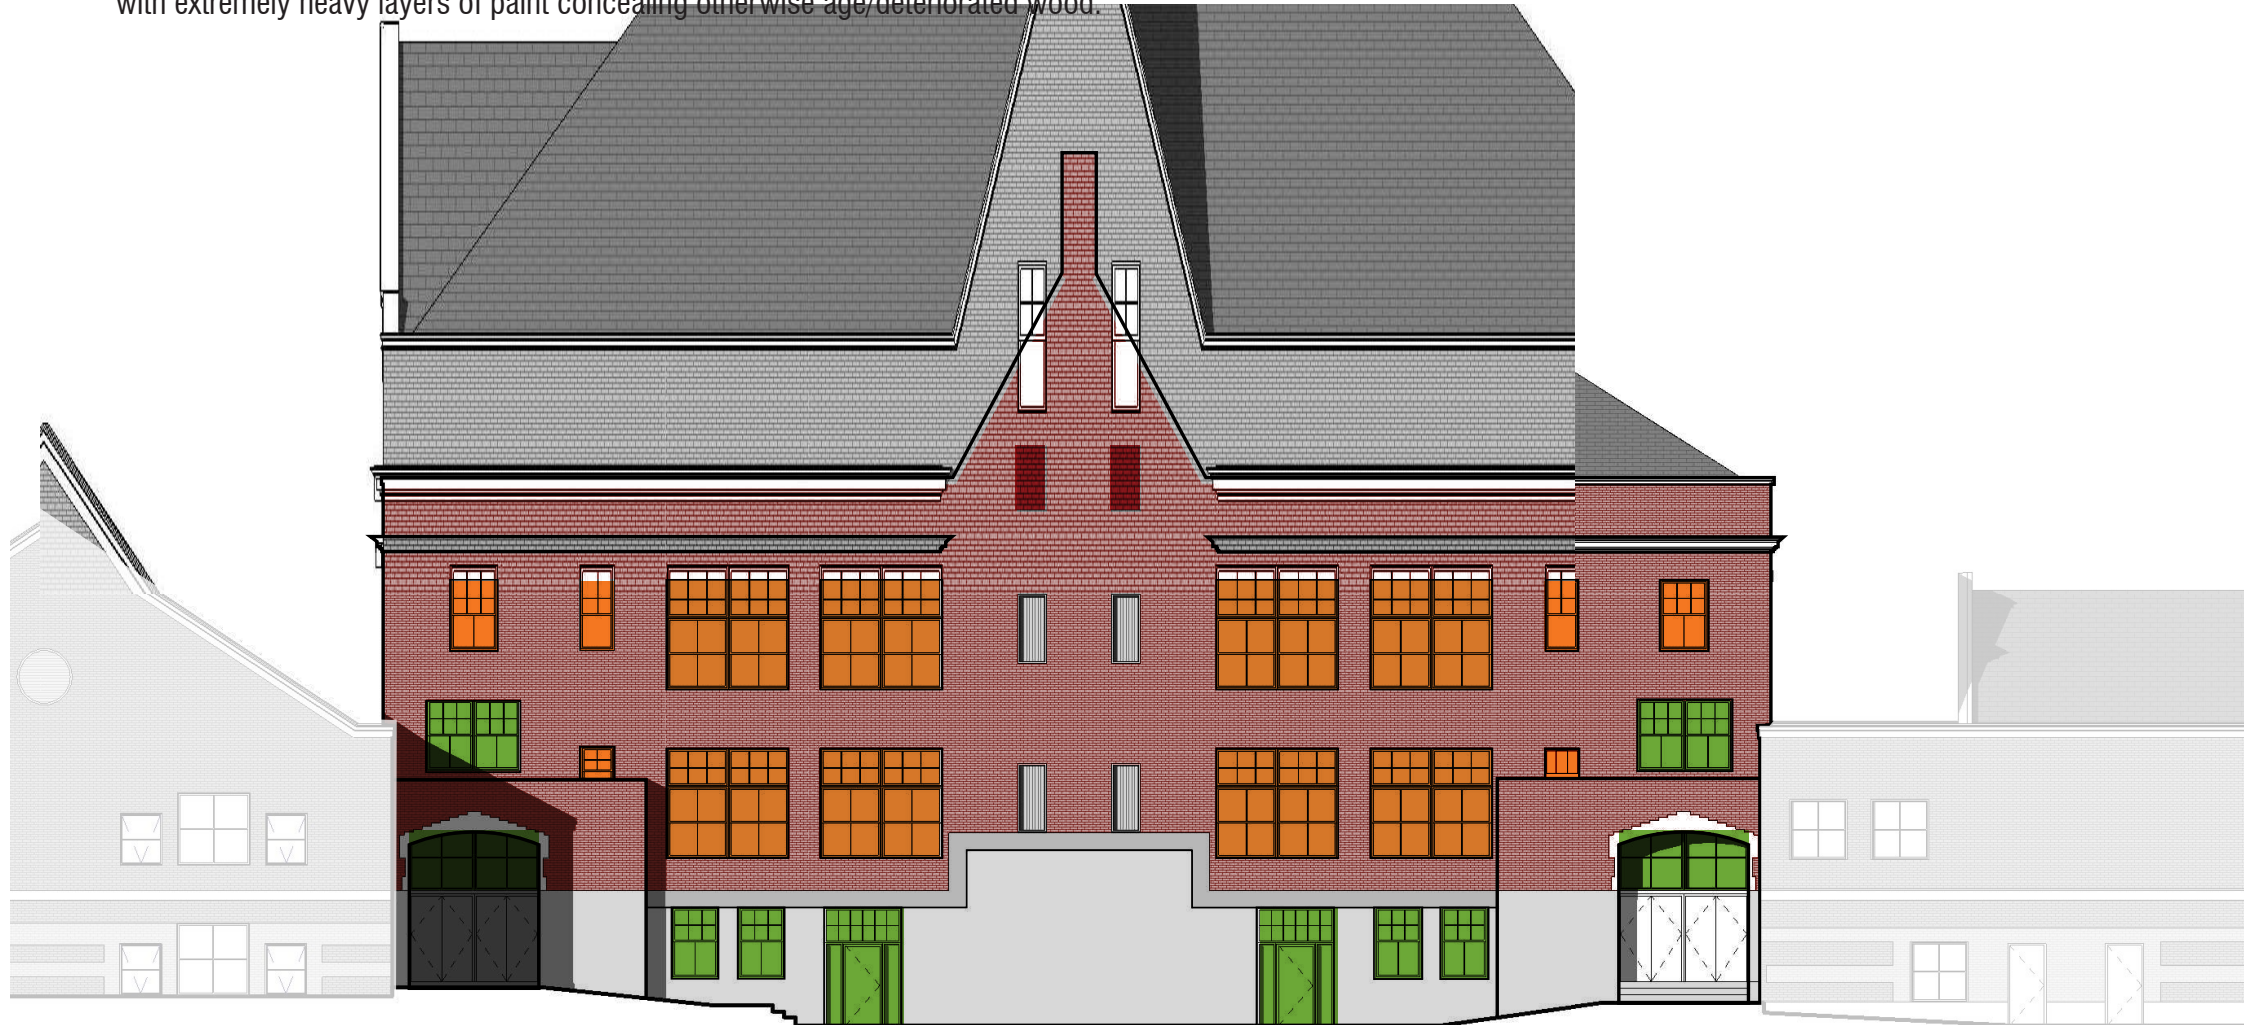
### NORTH ELEVATION - OVERALL NOTES:

The majority of recent repairs have been performed on this elevation. As a less weathered facing elevation these windows are generally in better condition. Wood deterioration is concentrated along skyward facing horizontal elements and the base of vertical elements that are in contact with glazing. The two (2) attic windows on this elevation are currently boarded up due to wood deterioration

Exterior wood casings all appear/are believed to be original circa 1910, and are generally covered in multiple layers of paint coatings but in serviceable condition with areas of spot deterioration along the base of vertical casing pieces. Exterior sills and sub sills also appear/are believed to be original circa 1910 but are covered with extremely heavy layers of paint concealing otherwise age/deteriorated wood.

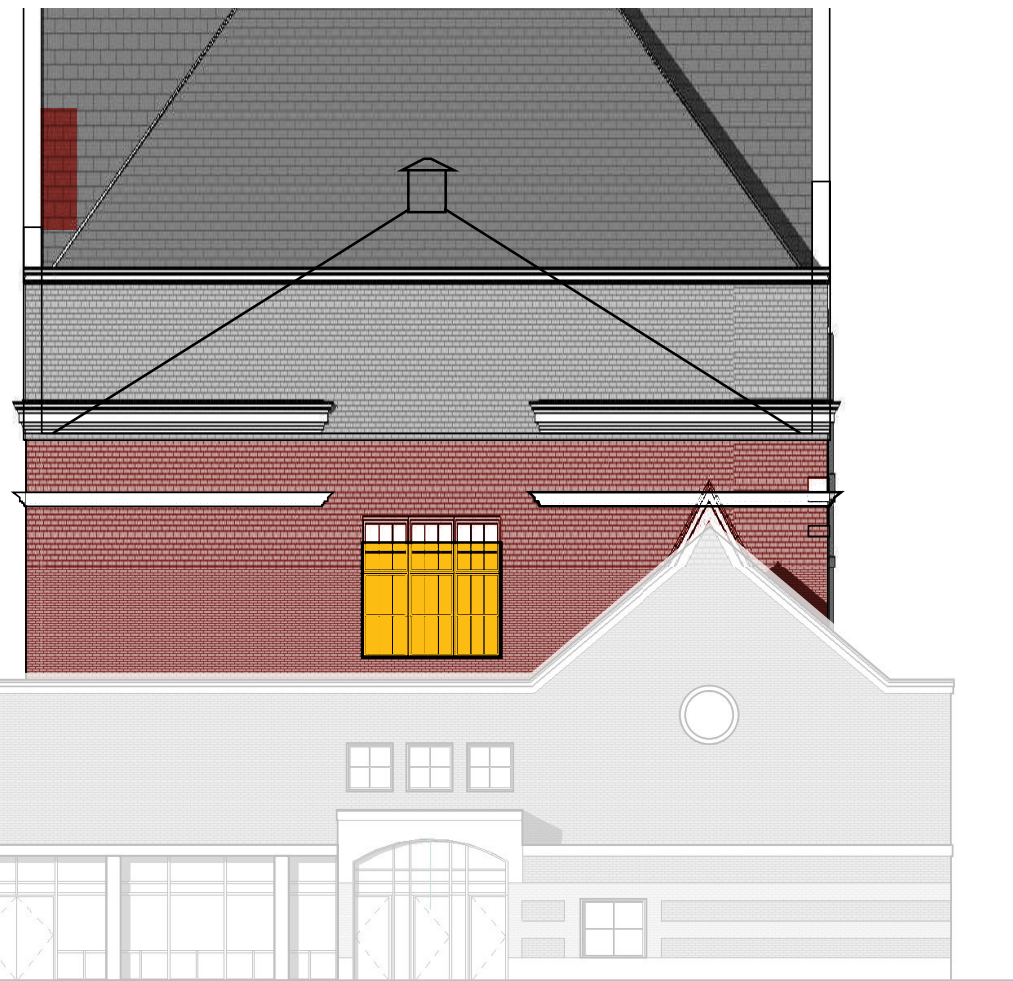
### WEST ELEVATION - OVERALL NOTES:

These 3rd floor windows were repaired around 2013 and were repainted along with their exterior casings in 2018. Wood deterioration is isolated to the lower operable sashes and concentrated along skyward facing horizontal elements and the base of vertical elements that are in contact with glazing. Exterior sills and sub sills also appear/are believed to be original circa 1910 and although experiencing coating failure, appear generally serviceable.

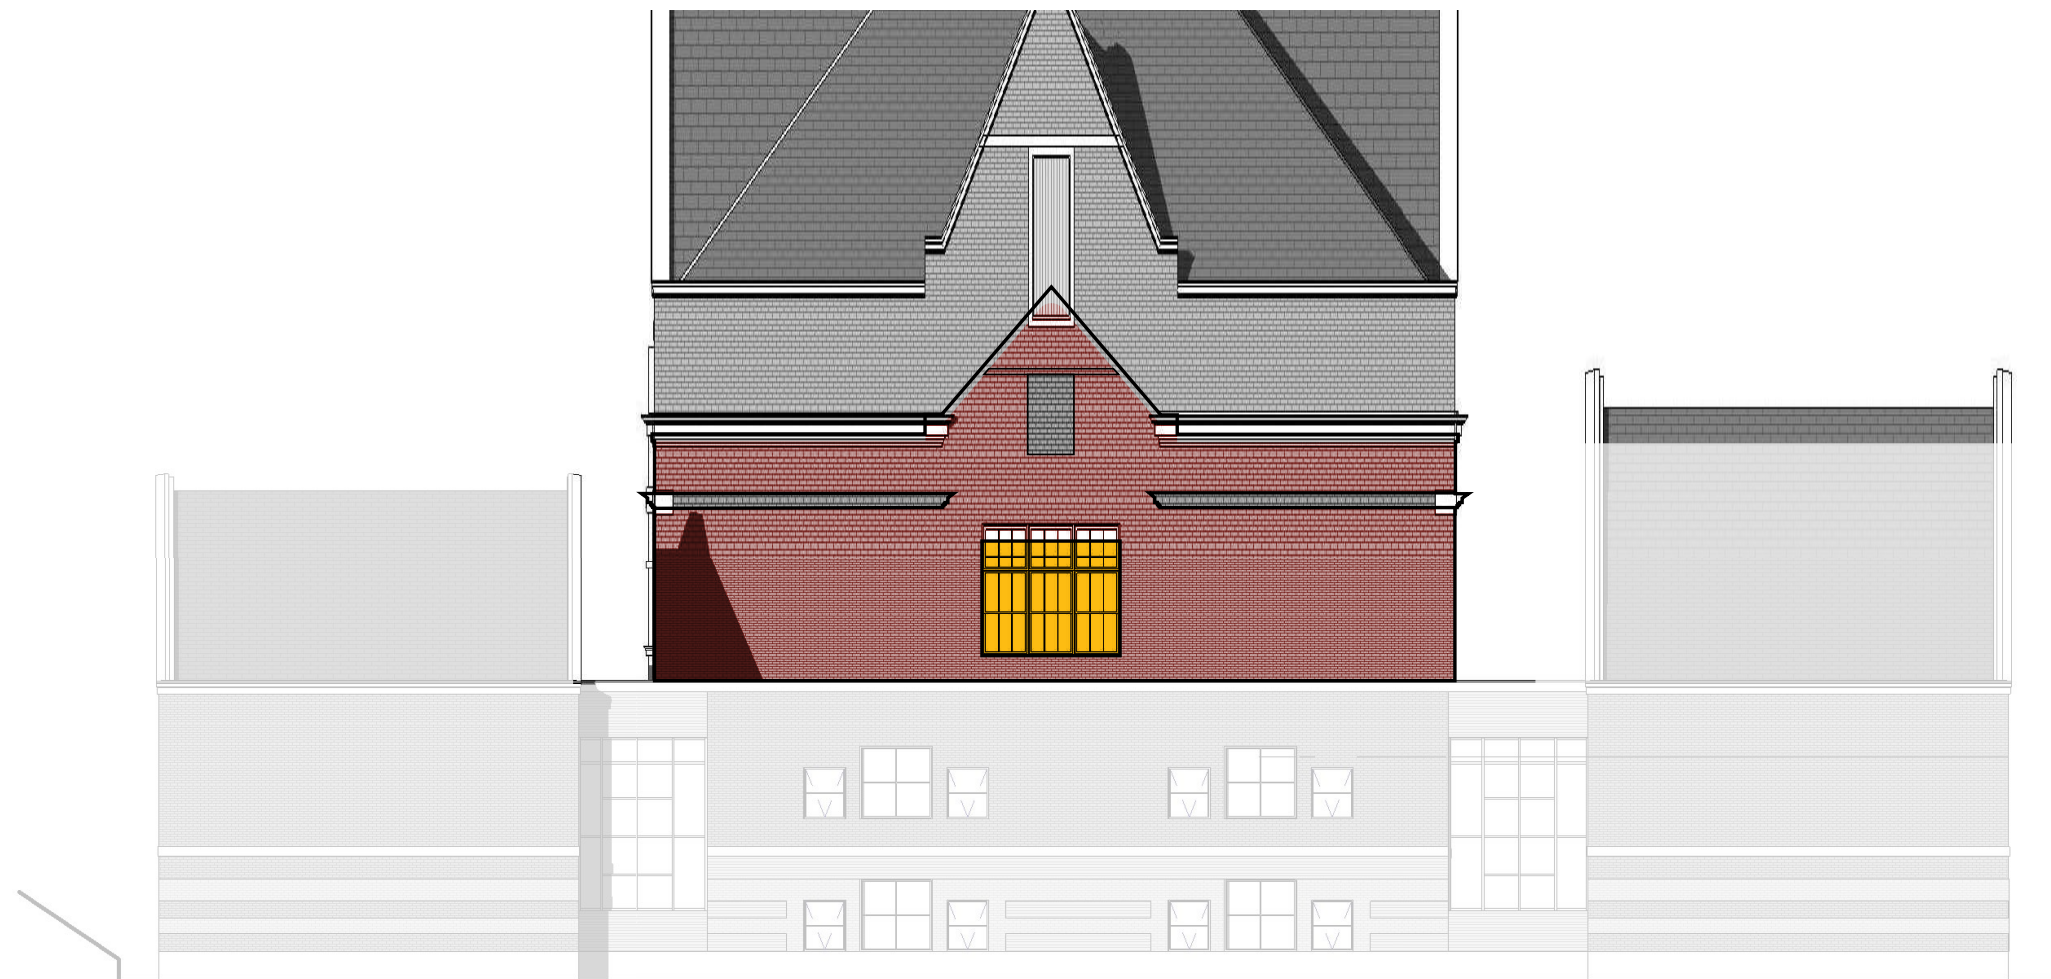
### EAST ELEVATION - OVERALL NOTES:

These 3rd floor windows were repaired around 2013 and were repainted along with their exterior casings in 2018. Wood deterioration is isolated to the lower operable sashes and concentrated along skyward facing horizontal elements and the base of vertical elements that are in contact with glazing. Exterior sills and sub sills also appear/are believed to be original circa 1910 and although experiencing coating failure, appear generally serviceable.
