UNB Rehabilitation Photographs

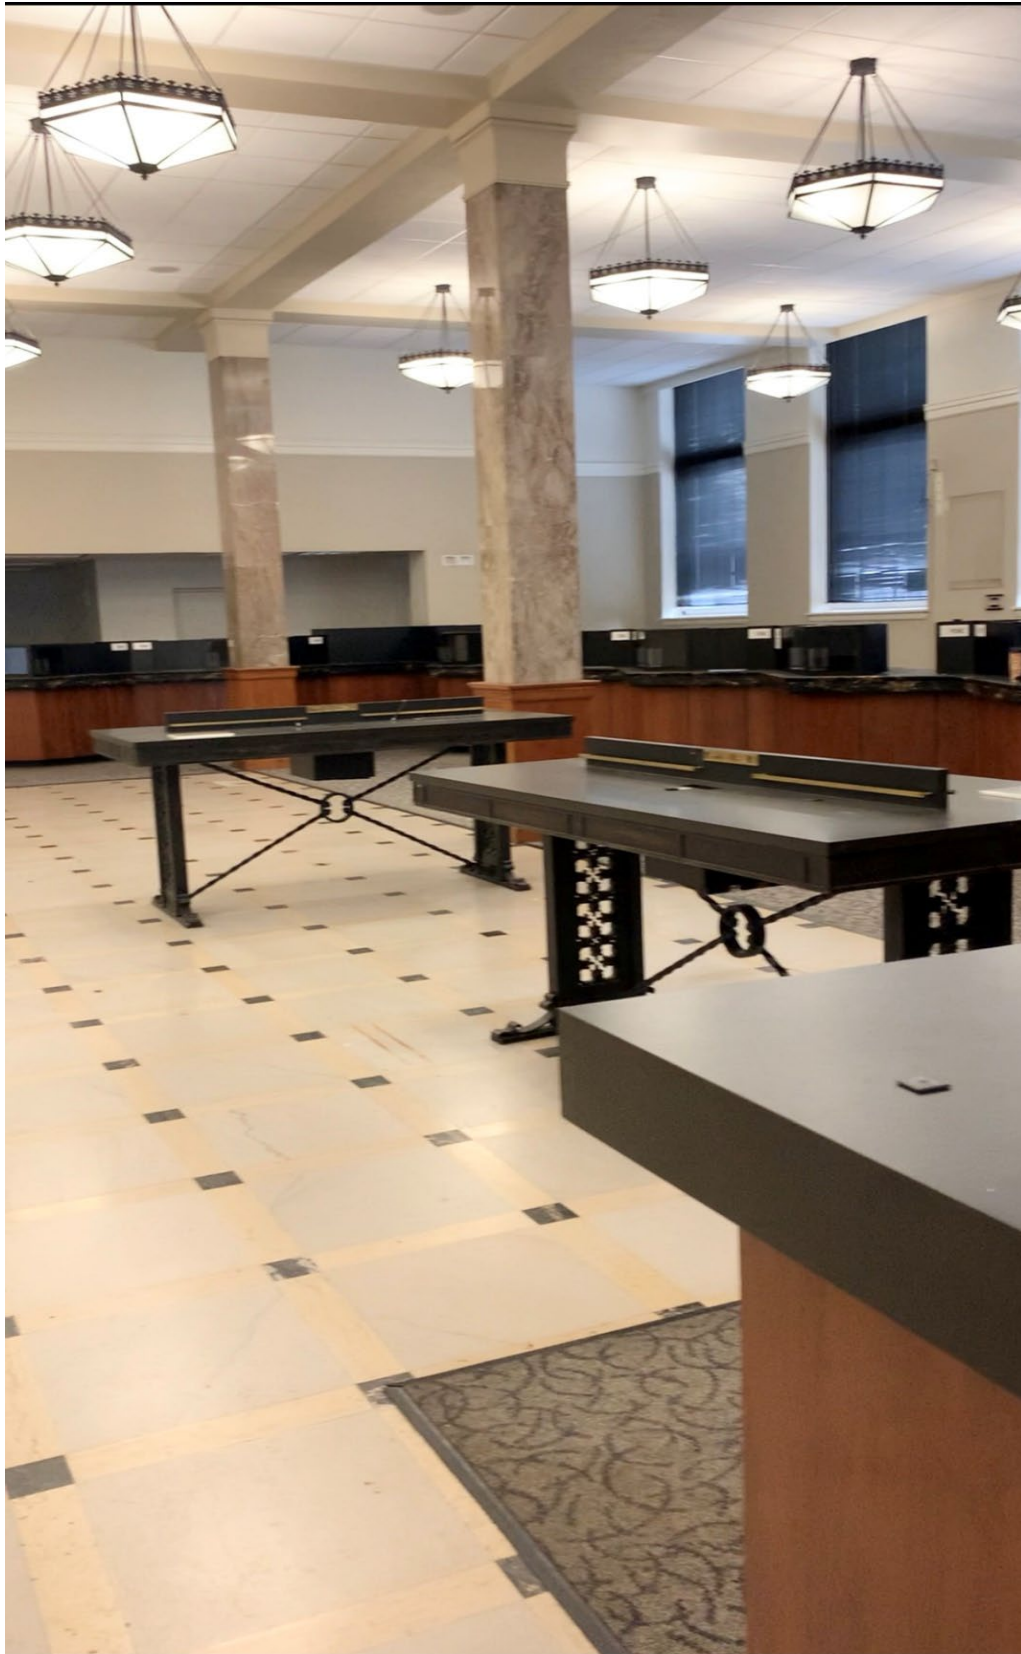
1. Before construction - Bank teller stations at purchase. First floor looking SE.

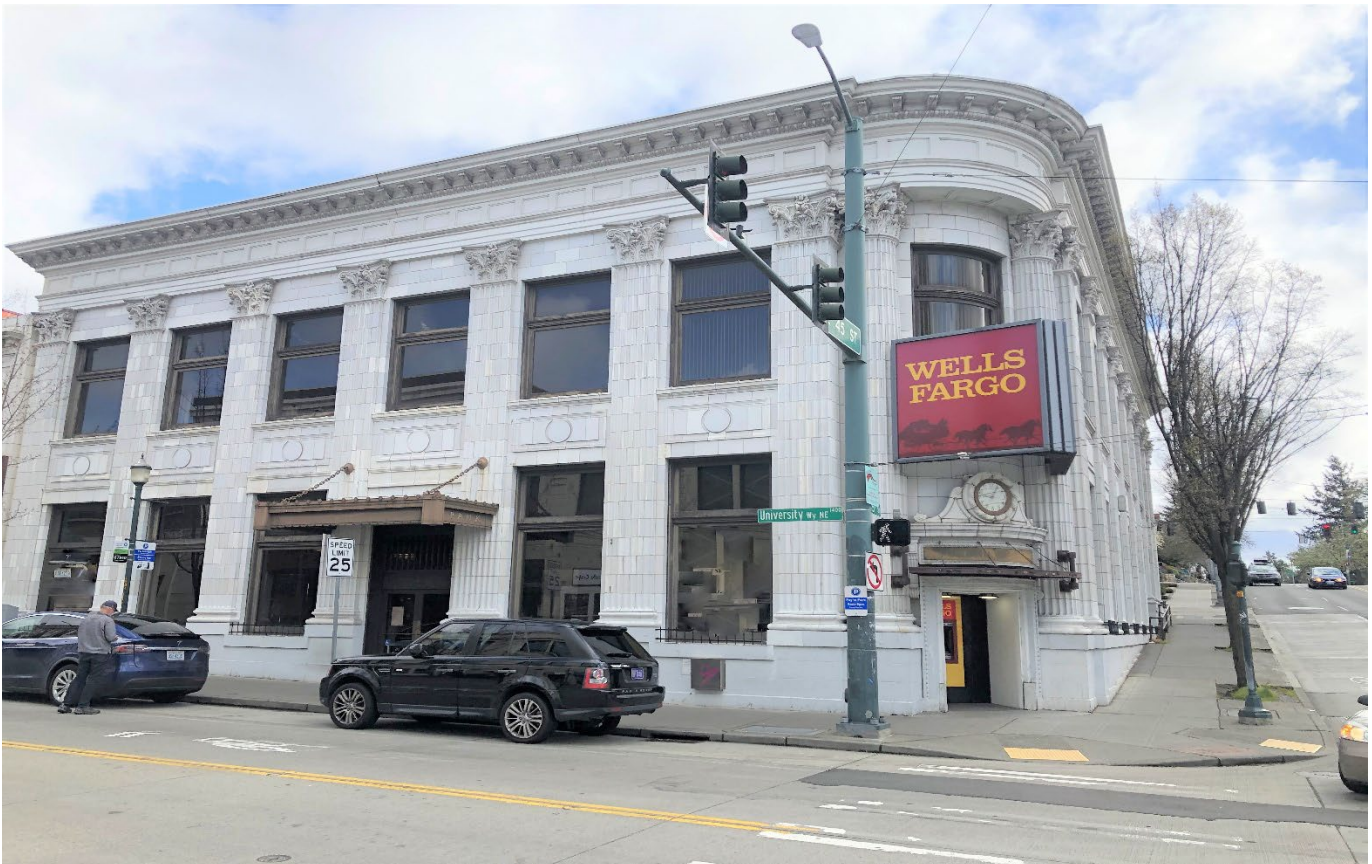
Before construction - Exterior at purchase as a closed down Wells Fargo Bank. Exterior has failing paint, faded canopies, tucking on stone, cracked glazing, lack of lighting, etc.

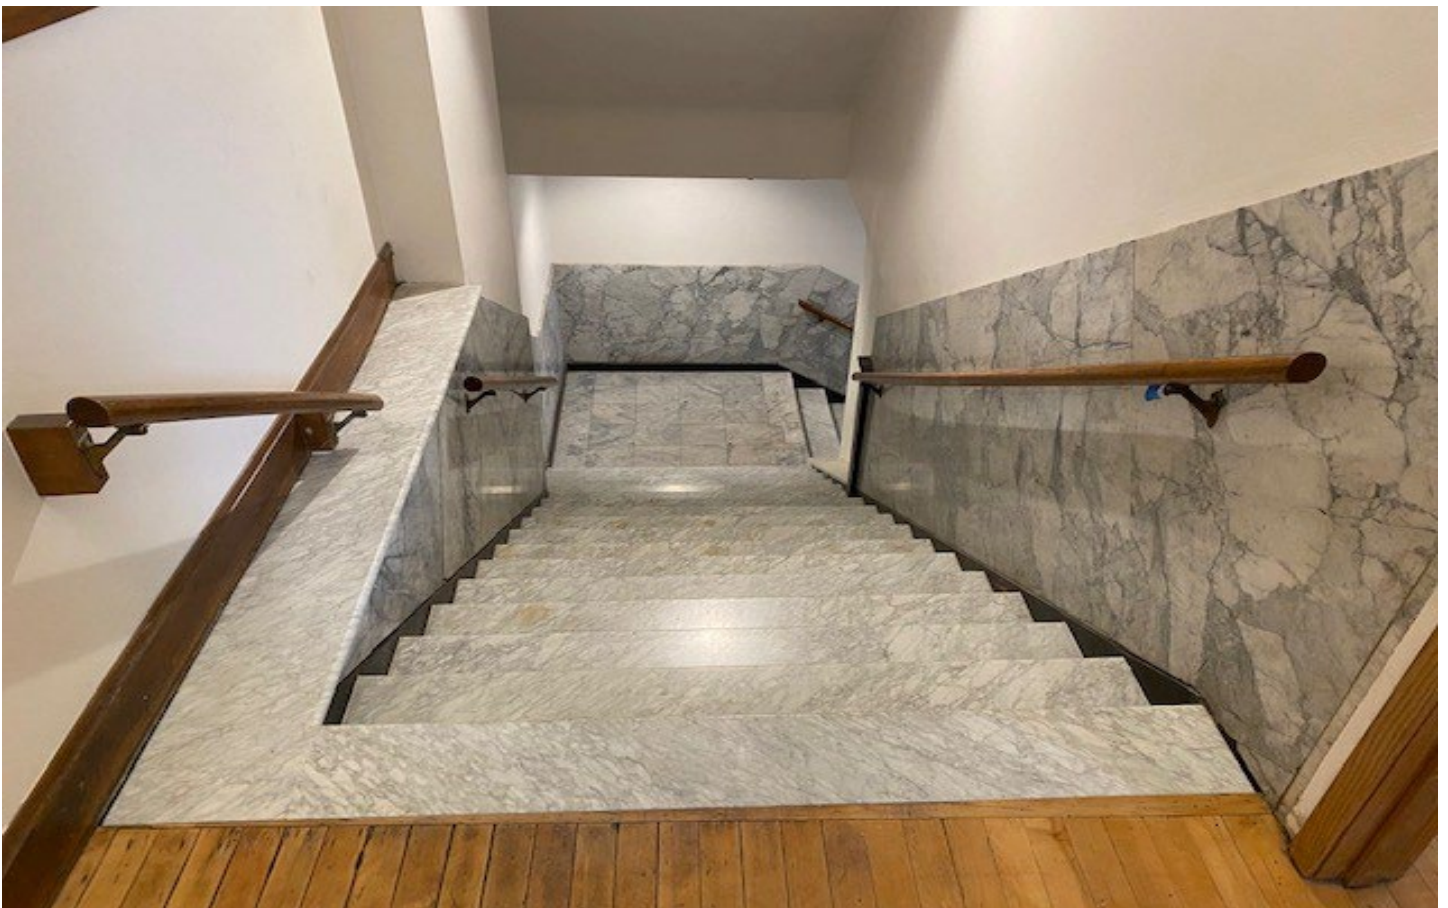
During LL construction- 45th street lobby restored during LL work. Second floor looking E.

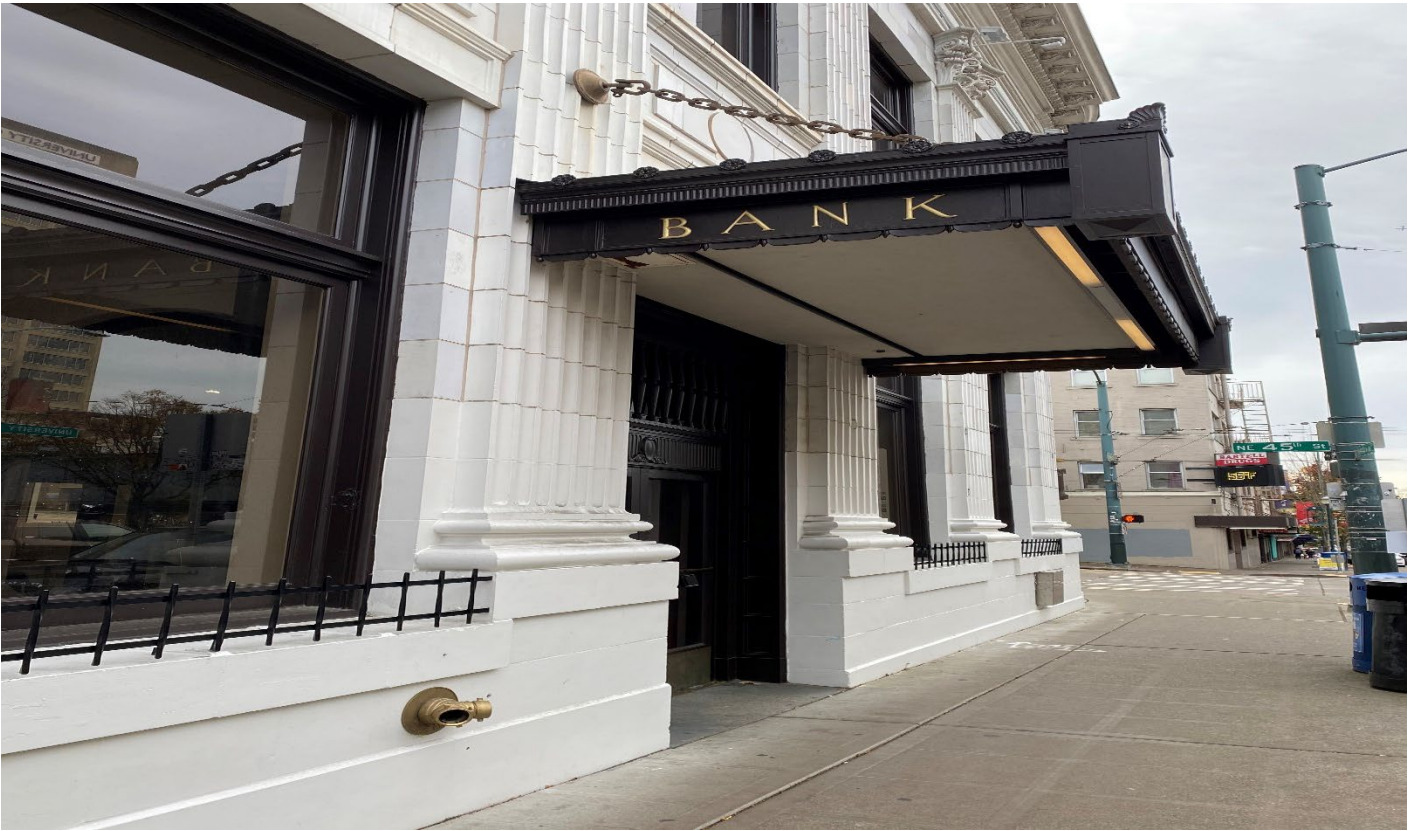
During LL construction- Entry post rehab. Cleaned up stone/canopy/windows/glazing.

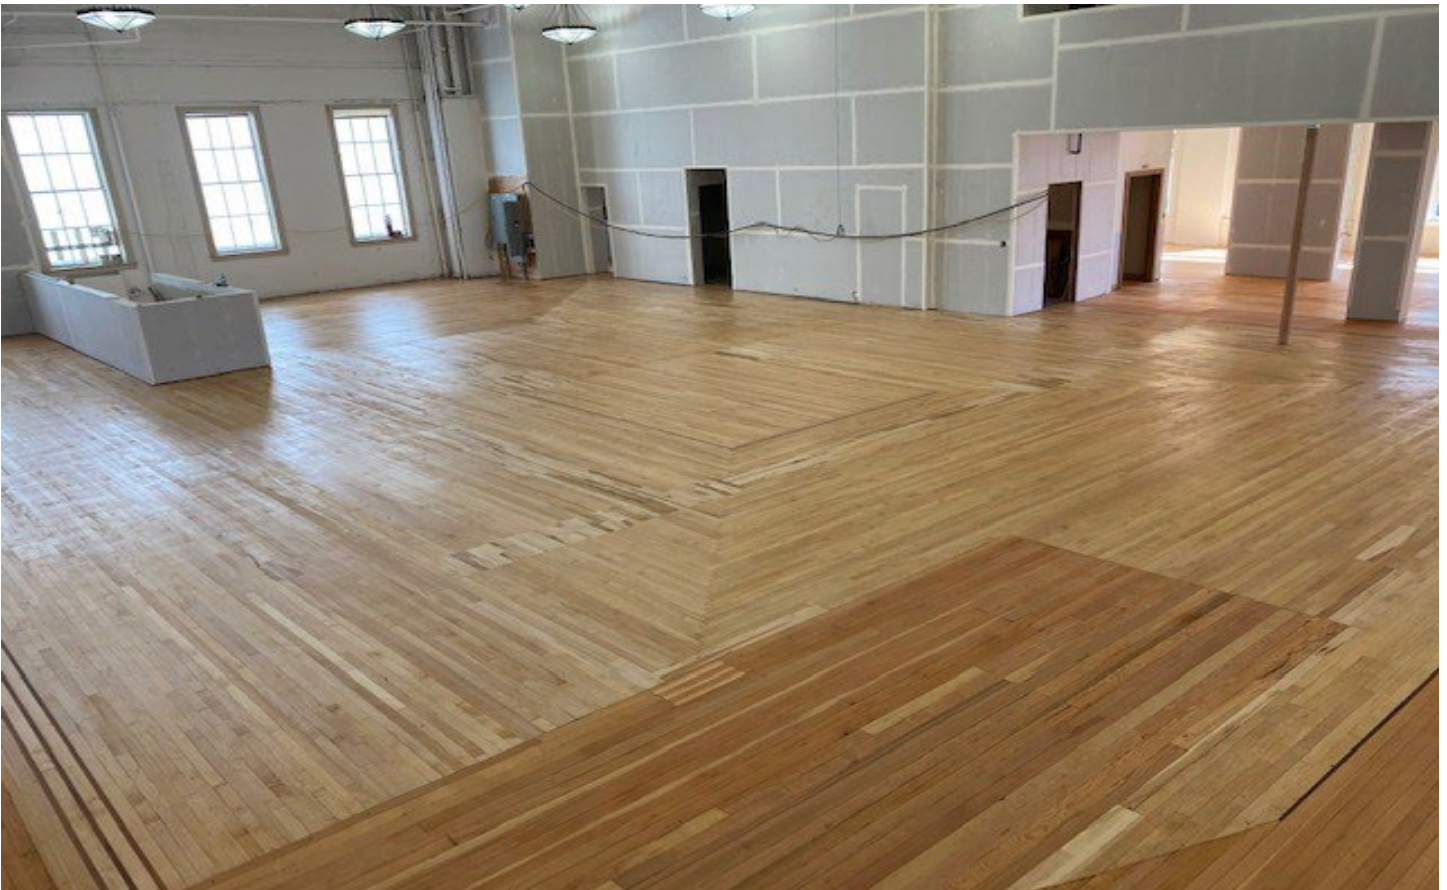
During LL construction- hard wood restoration looking SW, second floor.

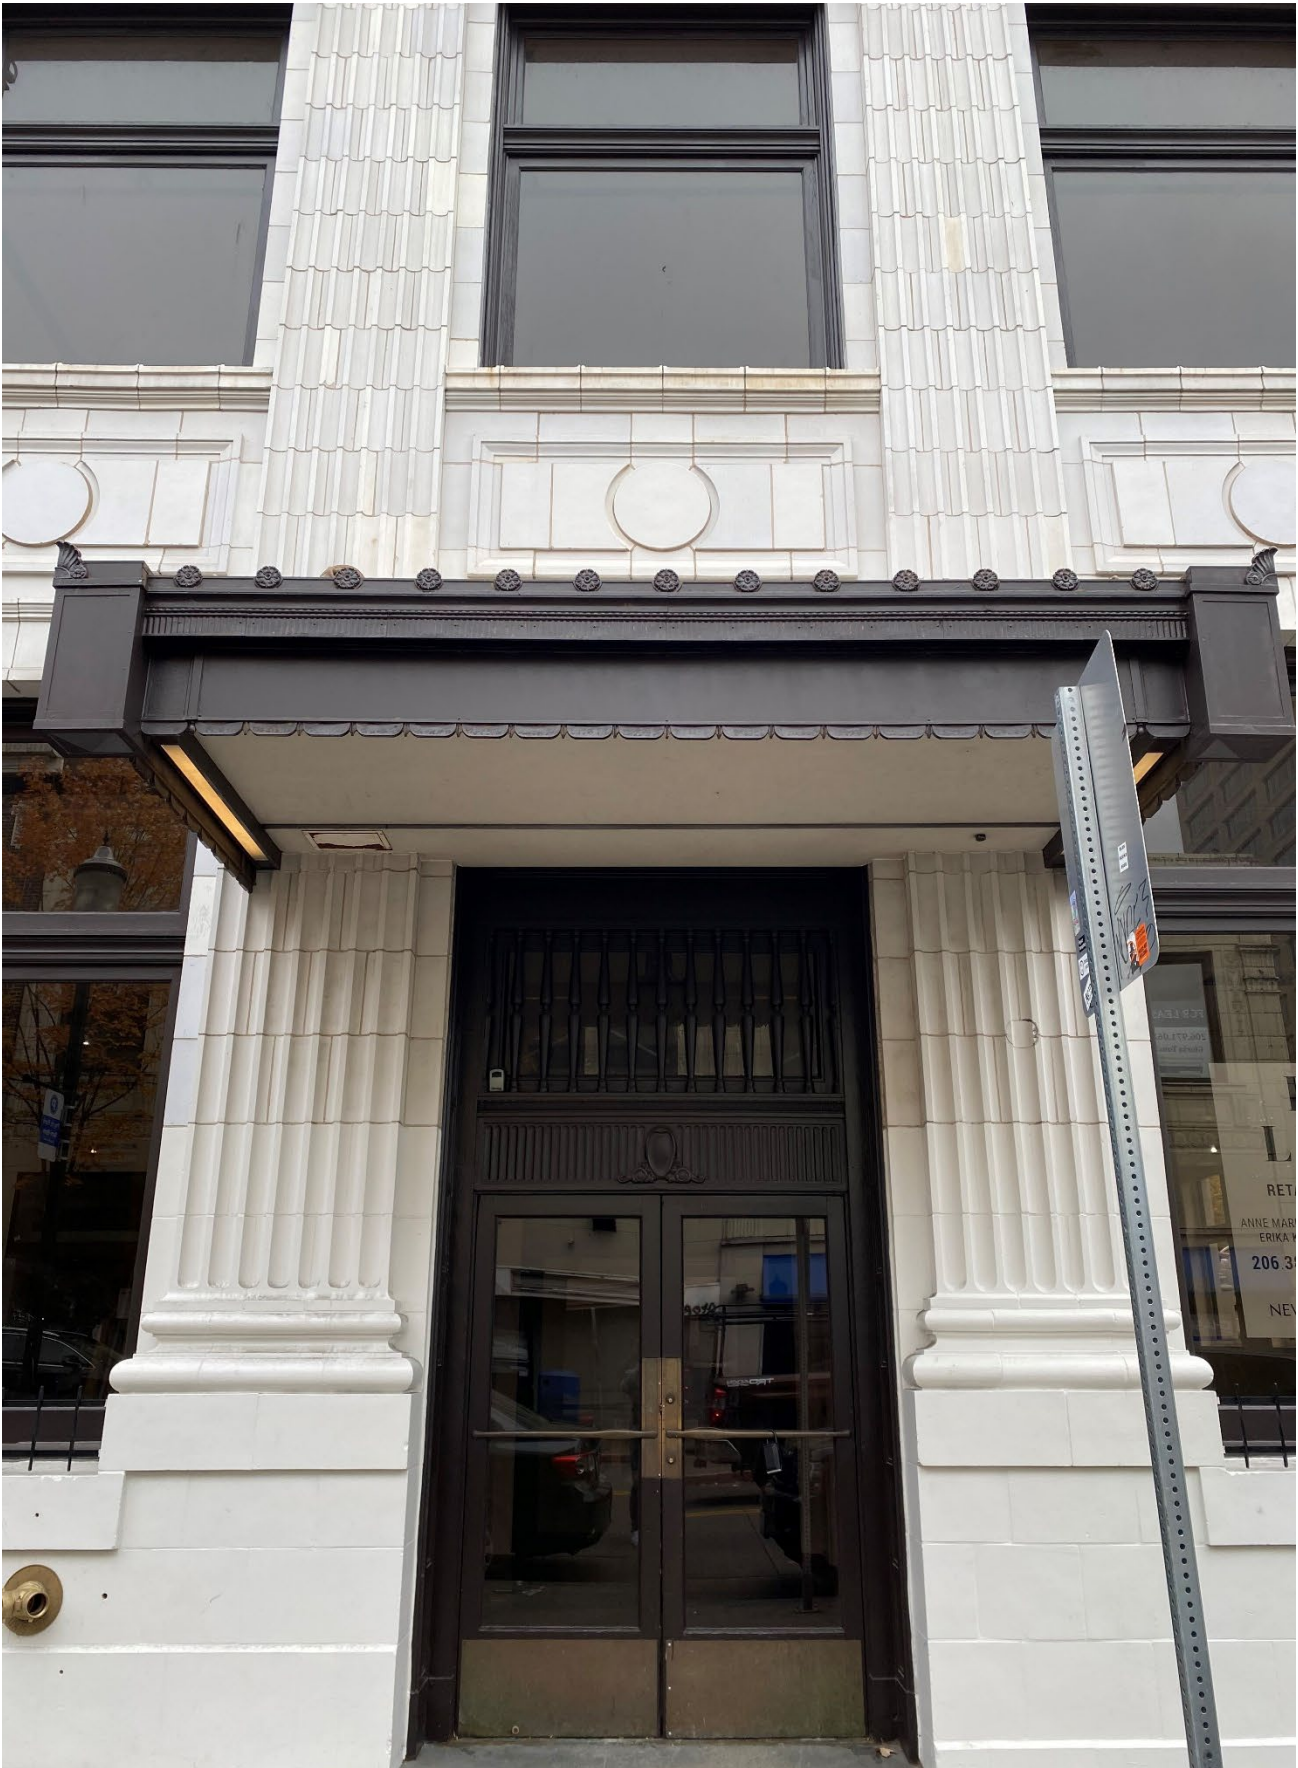
During LL construction- Rehab canopy / front doors, etc. - post LL work. Looking E.

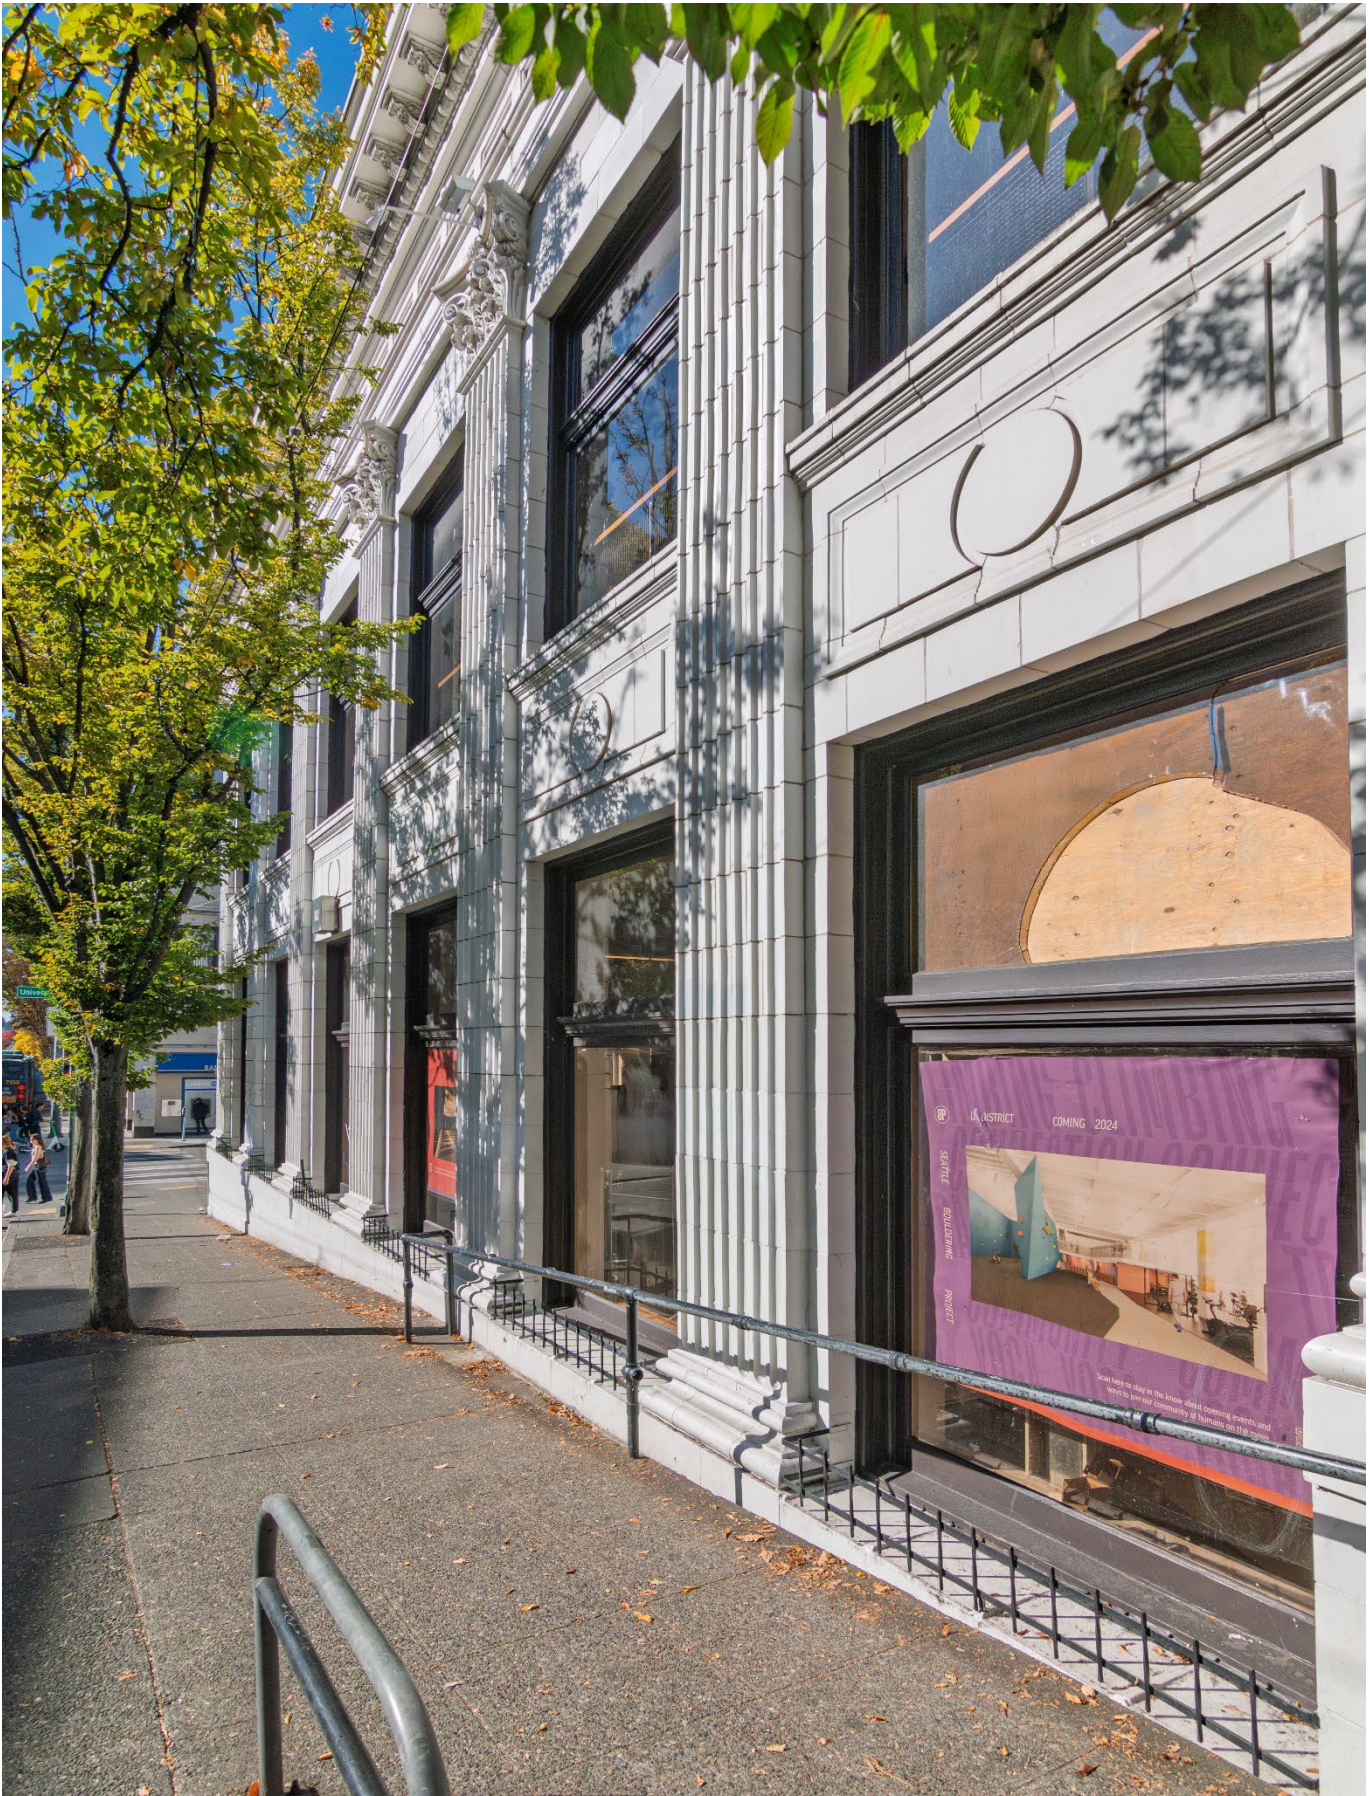
During final LL construction- Fixing broken glass at LL phase. Façade looking NW.
