LEONA CONDOMINIUMS REMEDIATION

916 QUEEN ANNE AVE. N, SEATTLE, WA 98109

WINDOW REPLACEMENT PROPOSAL

THE SURVEY OF WINDOWS AND DOORS AT THE LEONA CONDOS WERE COMPLETED IN APRIL 2021. MOST OF THE WINDOWS APPEAR TO HAVE DETERIORATED AND THE CONDITION OF THE WINDOWS/DOORS HAVE WORSEN FOR THE LAST TWO YEARS.

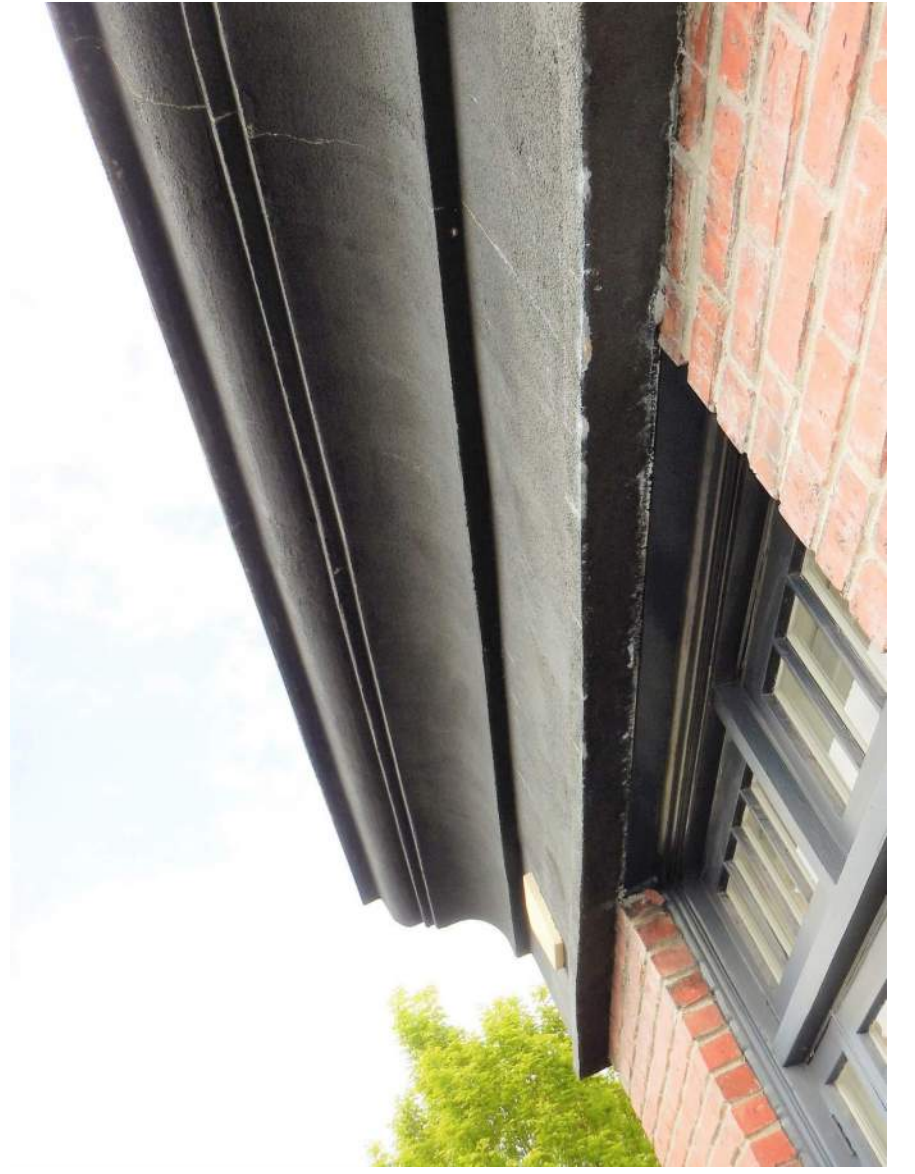
WINDOW - 1

- 1. Deterioration at the Sash
- 2. Deterioration at the Frame
- 3. Deterioration at Exterior Paint
- 4. Corroded Lintel
- 5. Operation Difficulty
- 6. Lock damage/missing/not engaging
- 7. Water intrusion
- 8. Separation at joint
- 9. Separation at rail/stile/muntin
- 10. Swelling at sill
- 11. Cracking of frame

Condition: Moderate

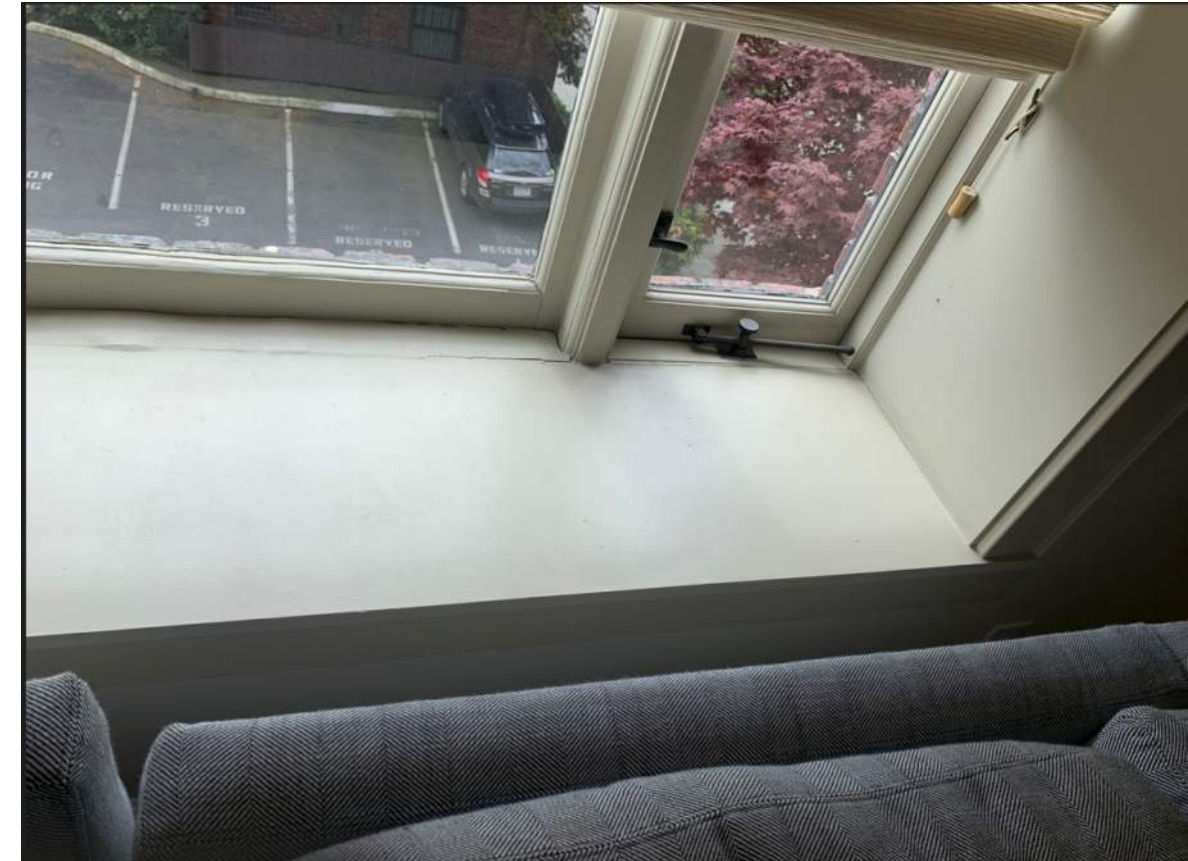
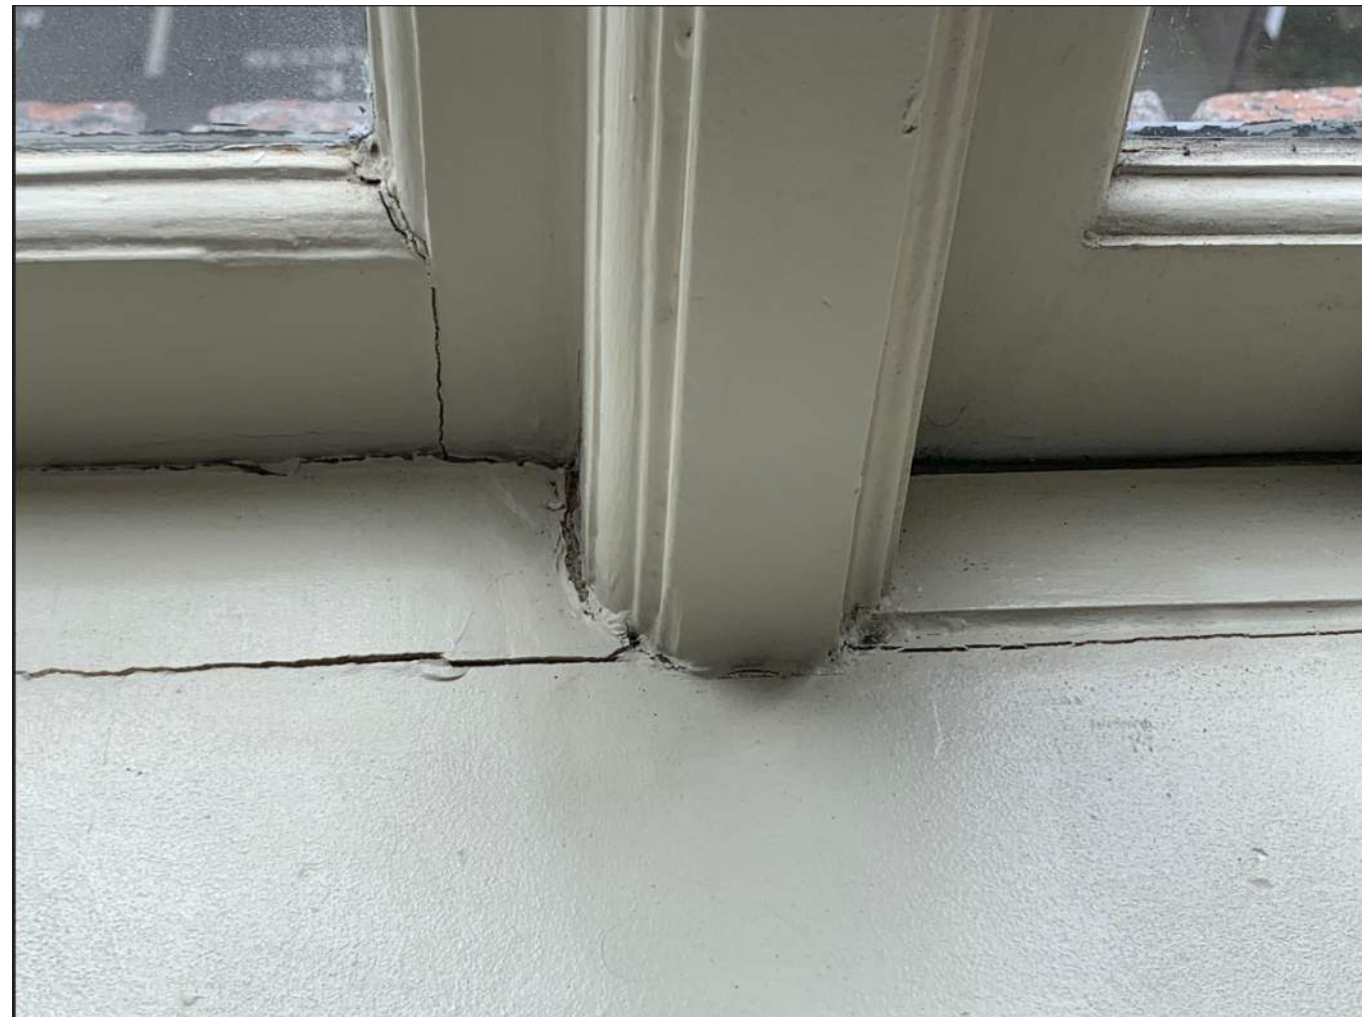
WINDOW - 2

1. Deterioration at the Sash
2. Deterioration at the Frame
3. Deterioration at Exterior Paint
4. Corroded Lintel
5. Operation Difficulty
6. Lock damage/missing/not engaging
7. Water intrusion
8. Separation at joint
9. Separation at rail/stile/muntin
10. Swelling at sill
11. Cracking of frame

Condition: Moderate

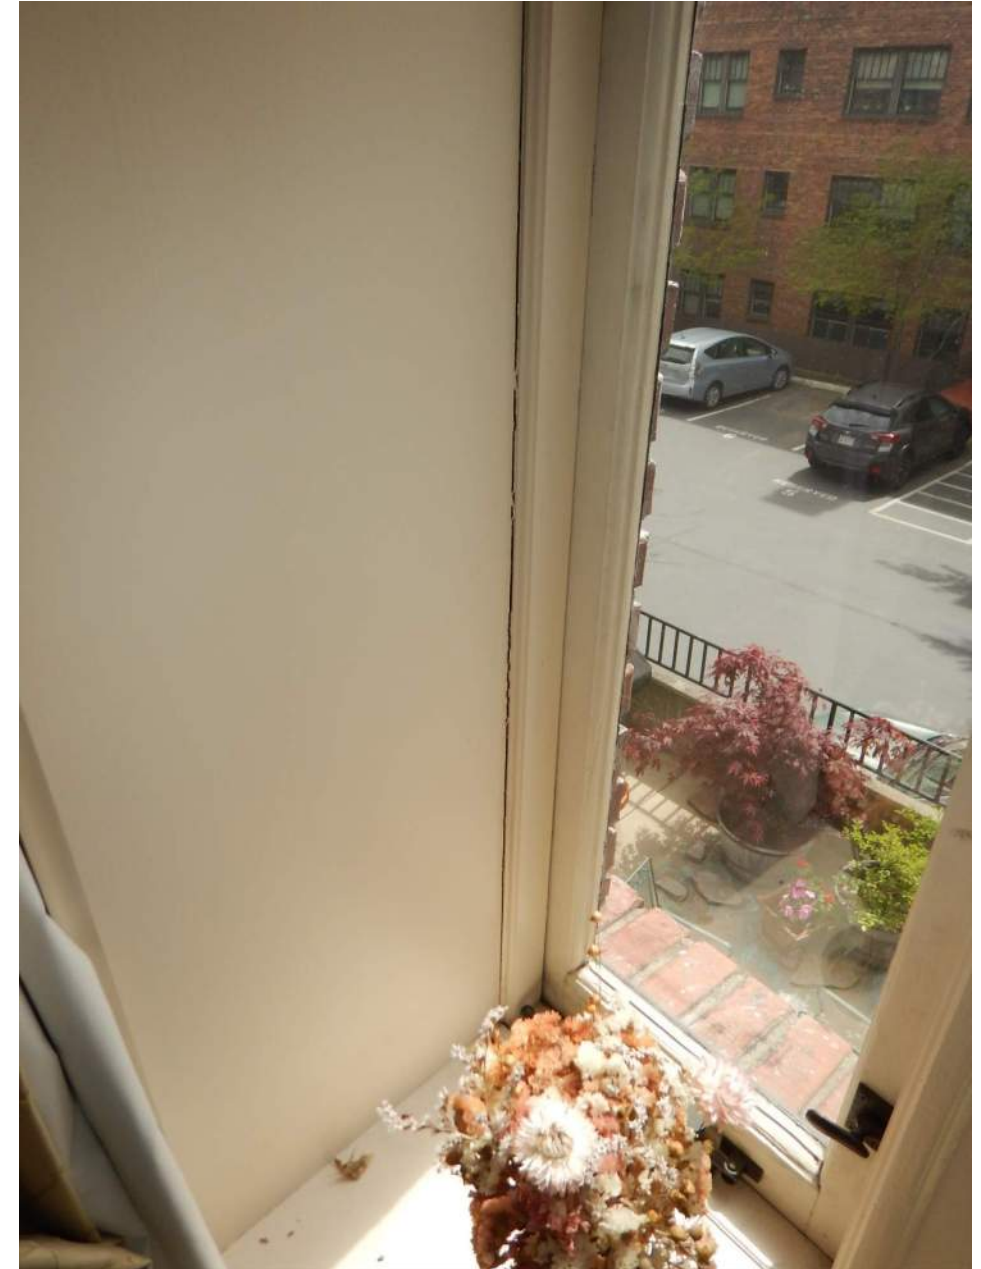
WINDOW - 3

- 1. Deterioration at the Sash
- 2. Deterioration at the Frame
- 3. Deterioration at Exterior Paint
- 4. Corroded Lintel
- 5. Operation Difficulty
- 6. Lock damage/missing/not engaging
- 7. Water intrusion
- 8. Separation at joint
- 9. Separation at rail/stile/muntin
- 10. Swelling at sill
- 11. Cracking of frame

Condition: Poor

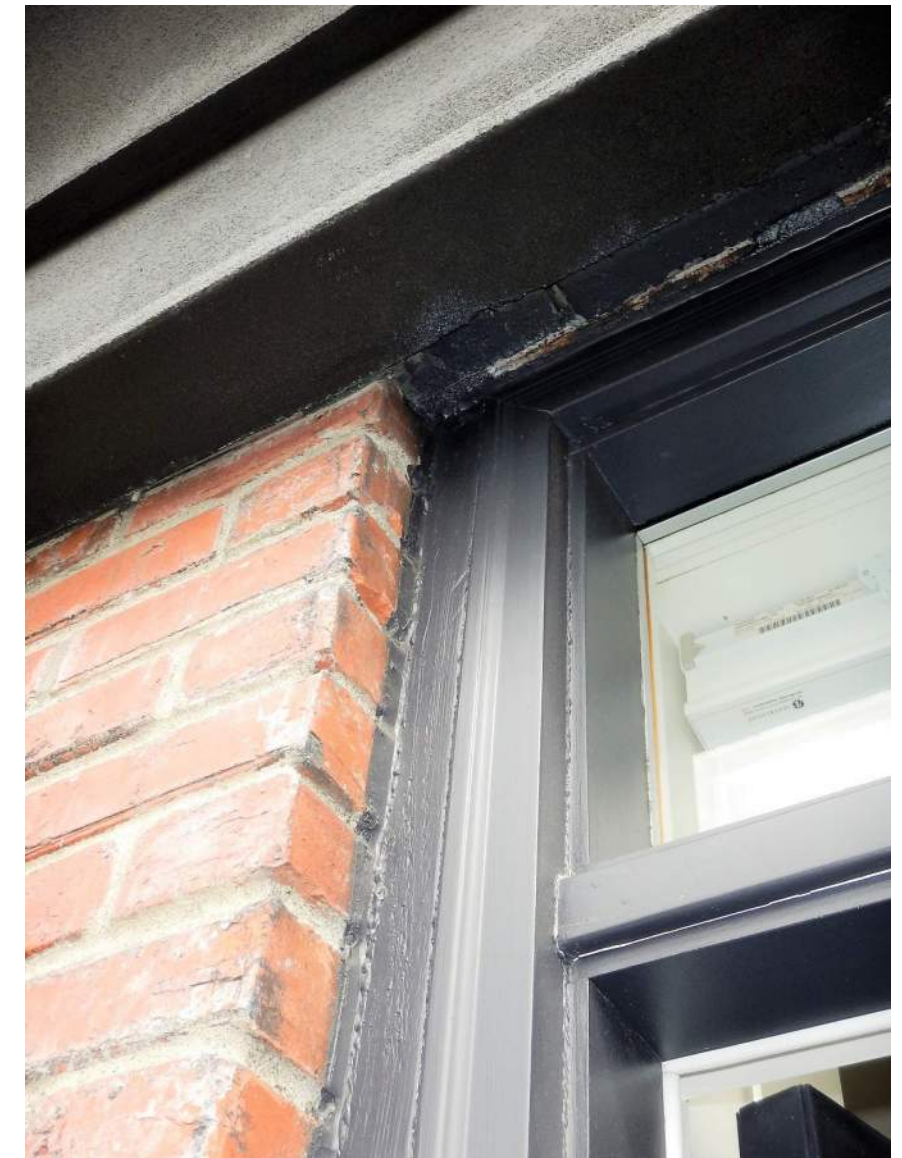
DOOR - 4

1. Deterioration at the Sash
2. Deterioration at the Frame
3. Deterioration at Exterior Paint
4. Corroded Lintel
5. Operation Difficulty
6. Lock damage/missing/not engaging
7. Water intrusion
8. Separation at joint
9. Separation at rail/stile/muntin
10. Swelling at sill
11. Cracking of frame

Condition: Moderate

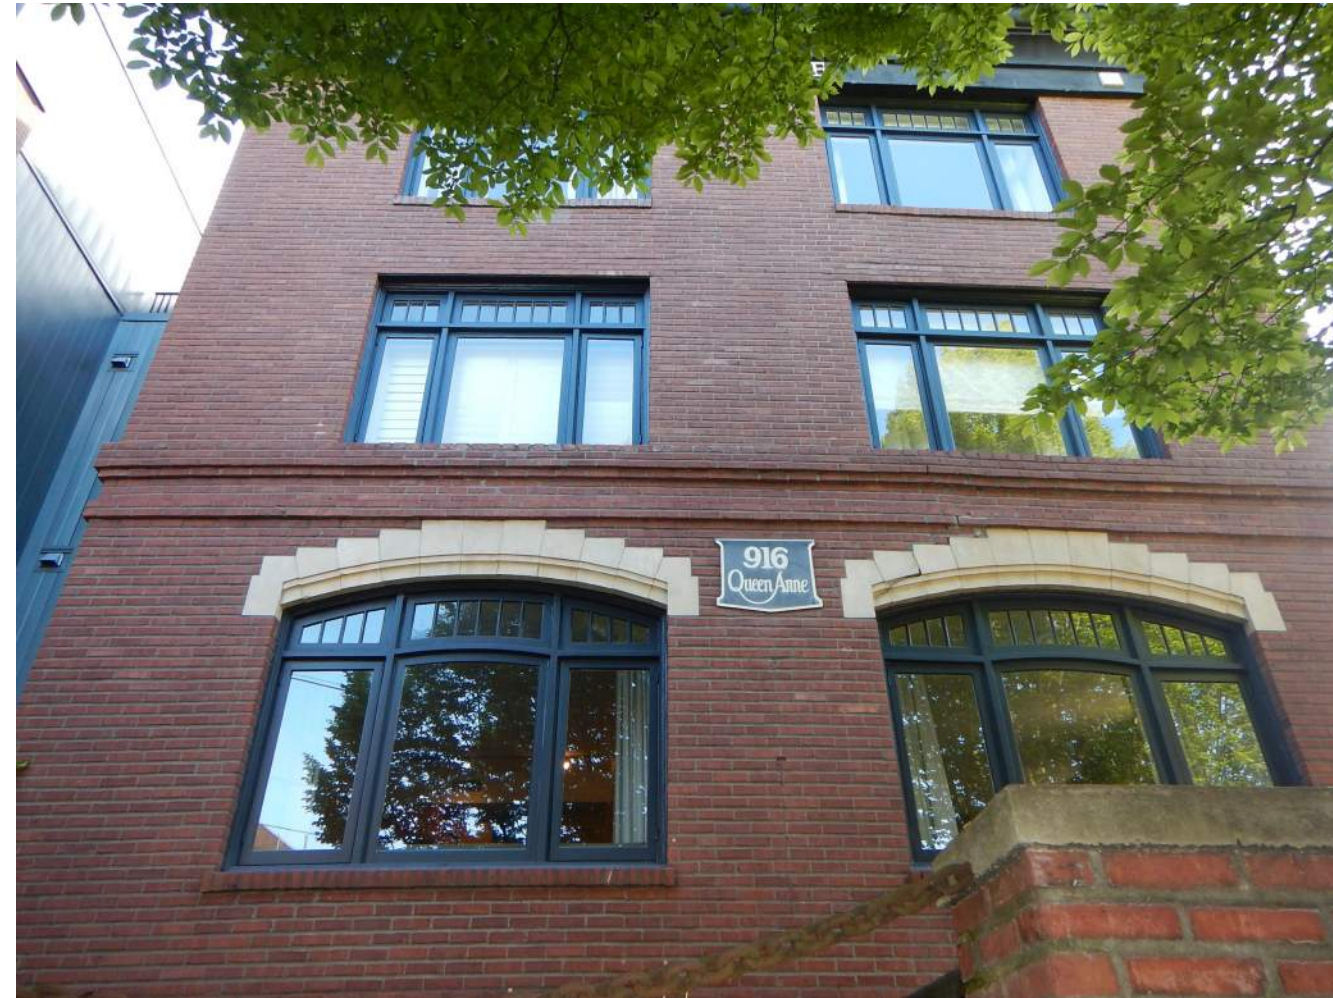
WINDOW - 5

1. Deterioration at the Sash
2. Deterioration at the Frame
3. Deterioration at Exterior Paint
4. Corroded Lintel
5. Operation Difficulty
6. Lock damage/missing/not engaging
7. Water intrusion
8. Separation at joint
9. Separation at rail/stile/muntin
10. Swelling at sill
11. Cracking of frame

Condition: Moderate

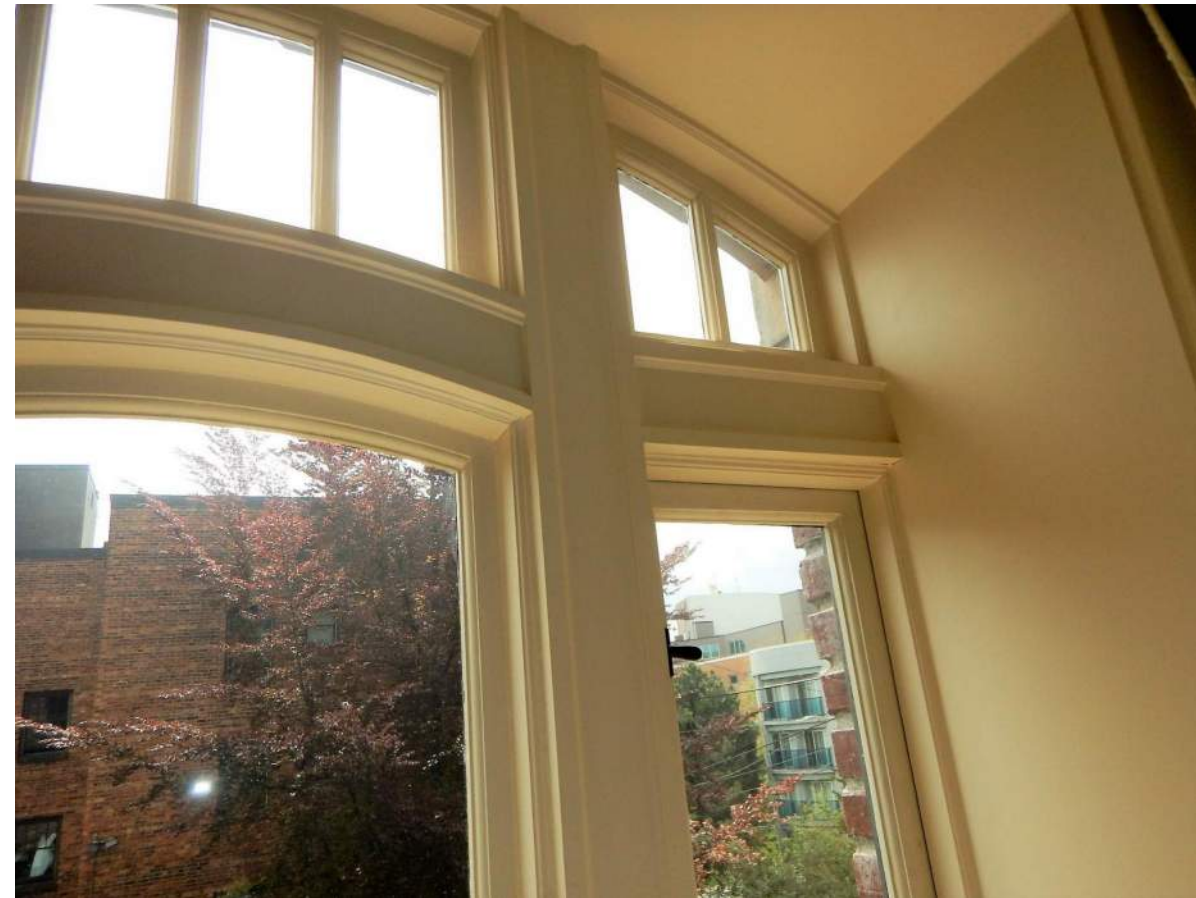
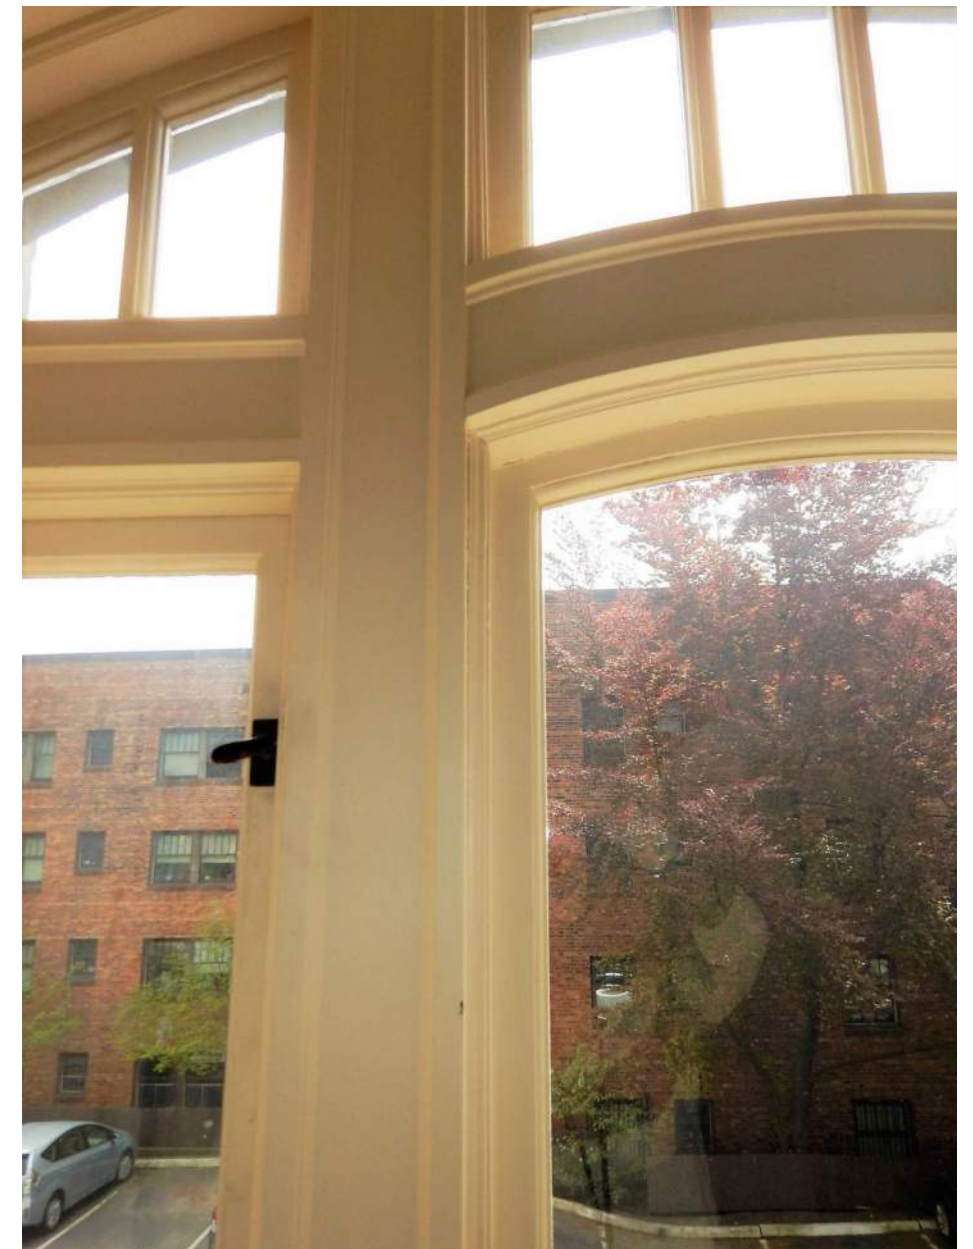
WINDOW - 6

1. Deterioration at the Sash
2. Deterioration at the Frame
3. Deterioration at Exterior Paint
4. Corroded Lintel
5. Operation Difficulty
6. Lock damage/missing/not engaging
7. Water intrusion
8. Separation at joint
9. Separation at rail/stile/muntin
10. Swelling at sill
11. Cracking of frame

Condition: Moderate

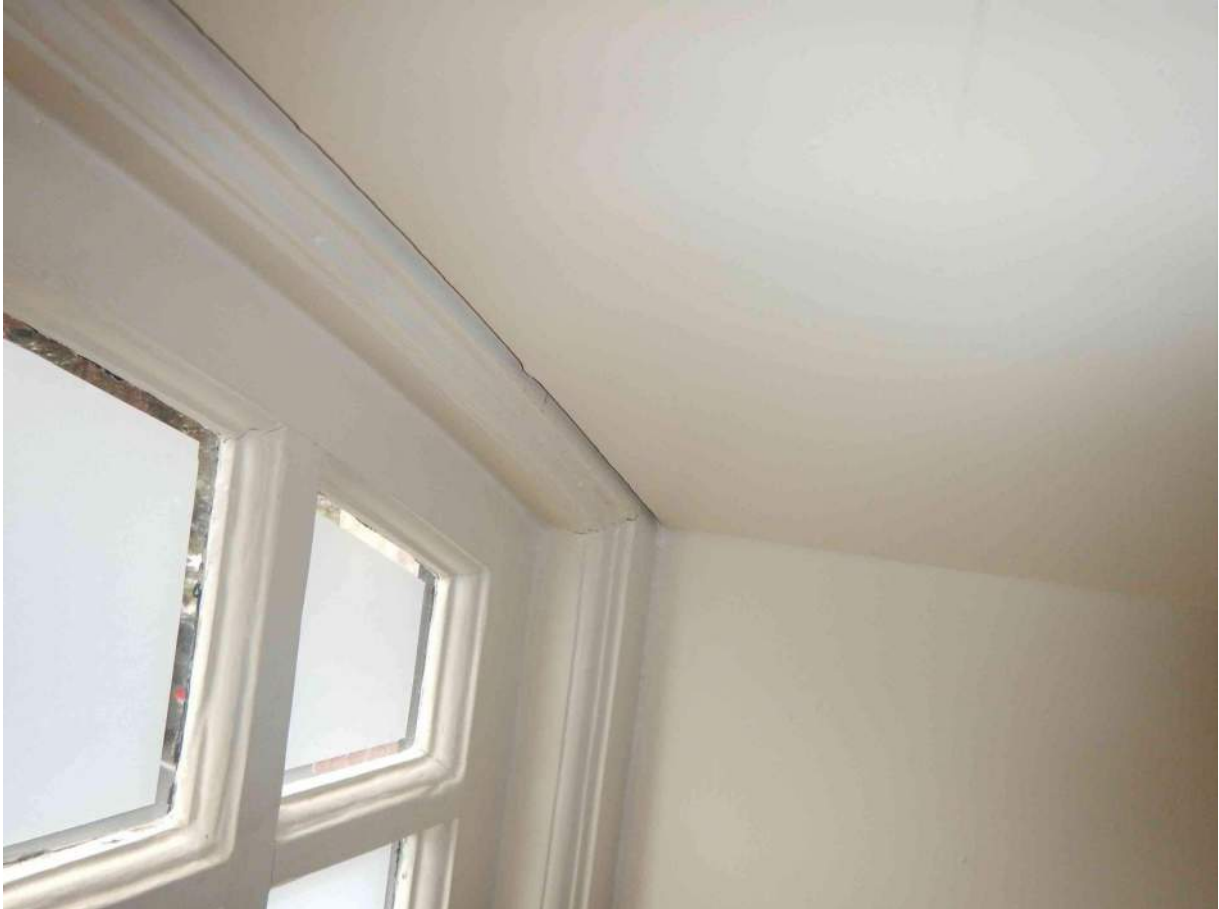
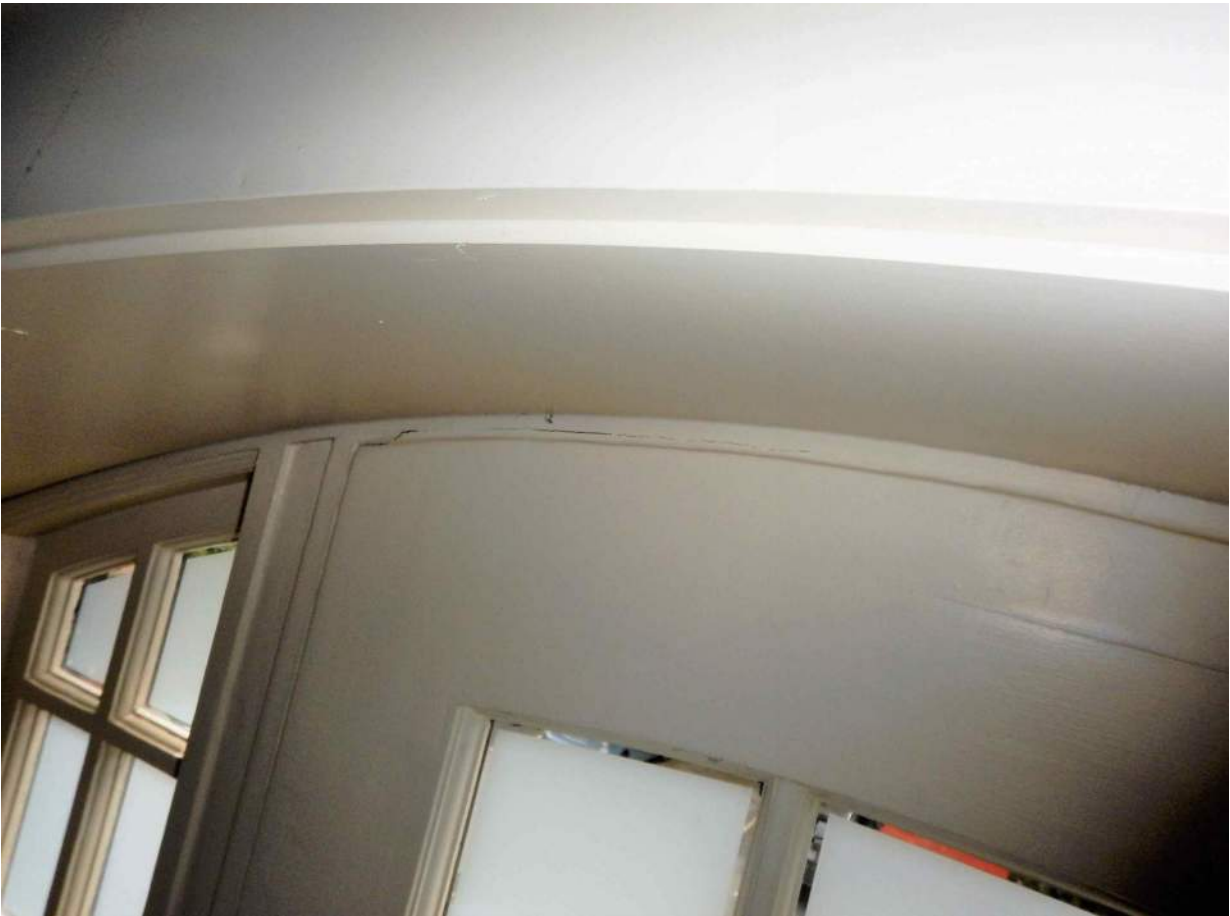
Door - 7

- 1. Deterioration at the Sash
- 2. Deterioration at the Frame
- 3. Deterioration at Exterior Paint
- 4. Corroded Lintel
- 5. Operation Difficulty
- 6. Lock damage/missing/not engaging
- 7. Water intrusion
- 8. Separation at joint
- 9. Separation at rail/stile/muntin
- 10. Swelling at sill
- 11. Cracking of frame

Condition: Moderate

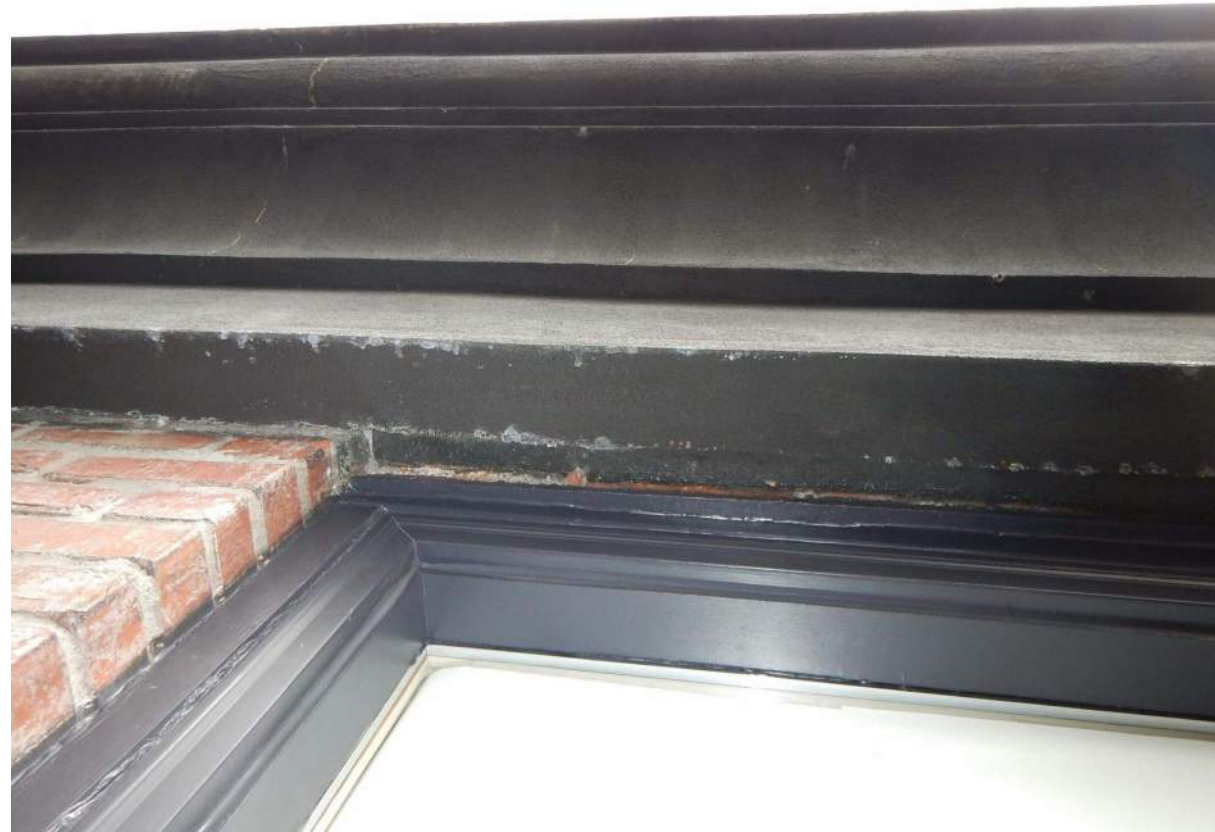
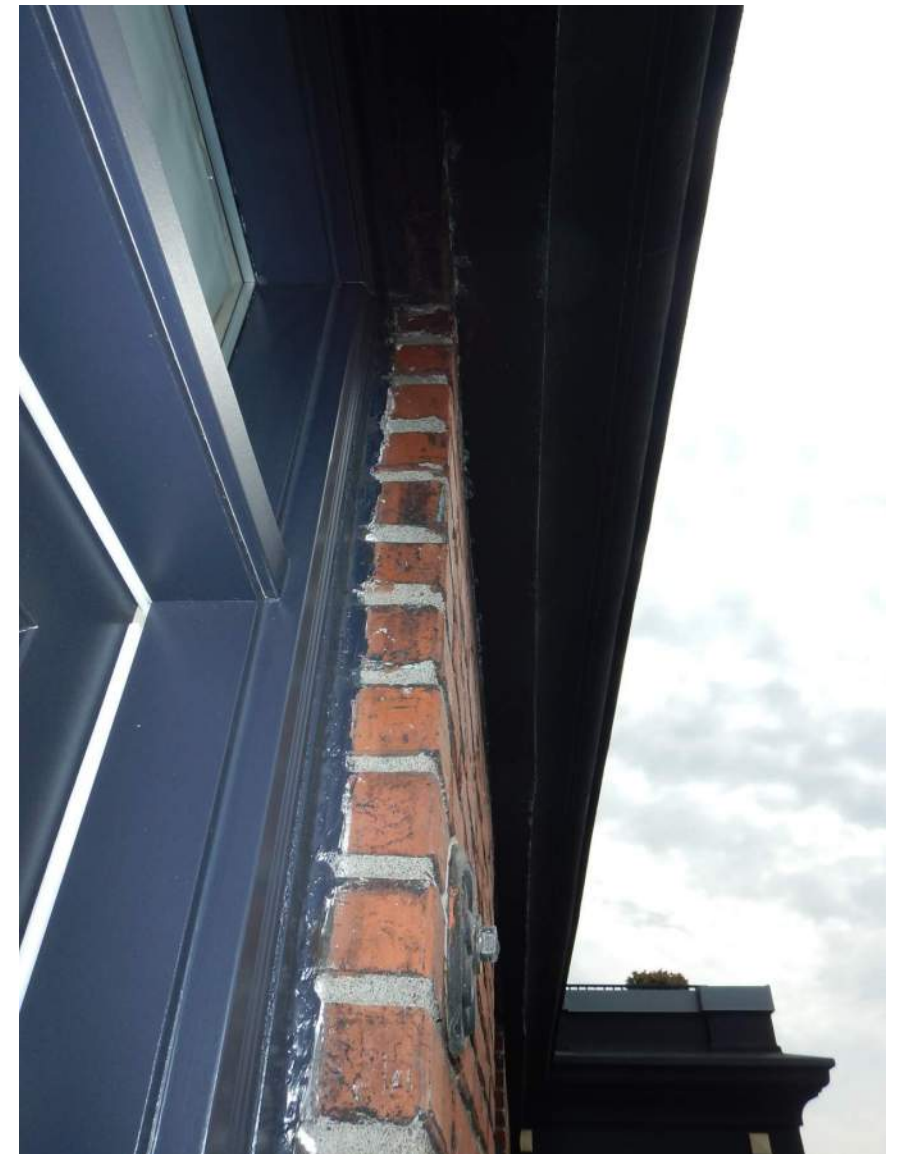
DOOR - 8

1. Deterioration at the Sash
2. Deterioration at the Frame
3. Deterioration at Exterior Paint
4. Corroded Lintel
5. Operation Difficulty
6. Lock damage/missing/not engaging
7. Water intrusion
8. Separation at joint
9. Separation at rail/stile/muntin
10. Swelling at sill
11. Cracking of frame

Condition: Moderate

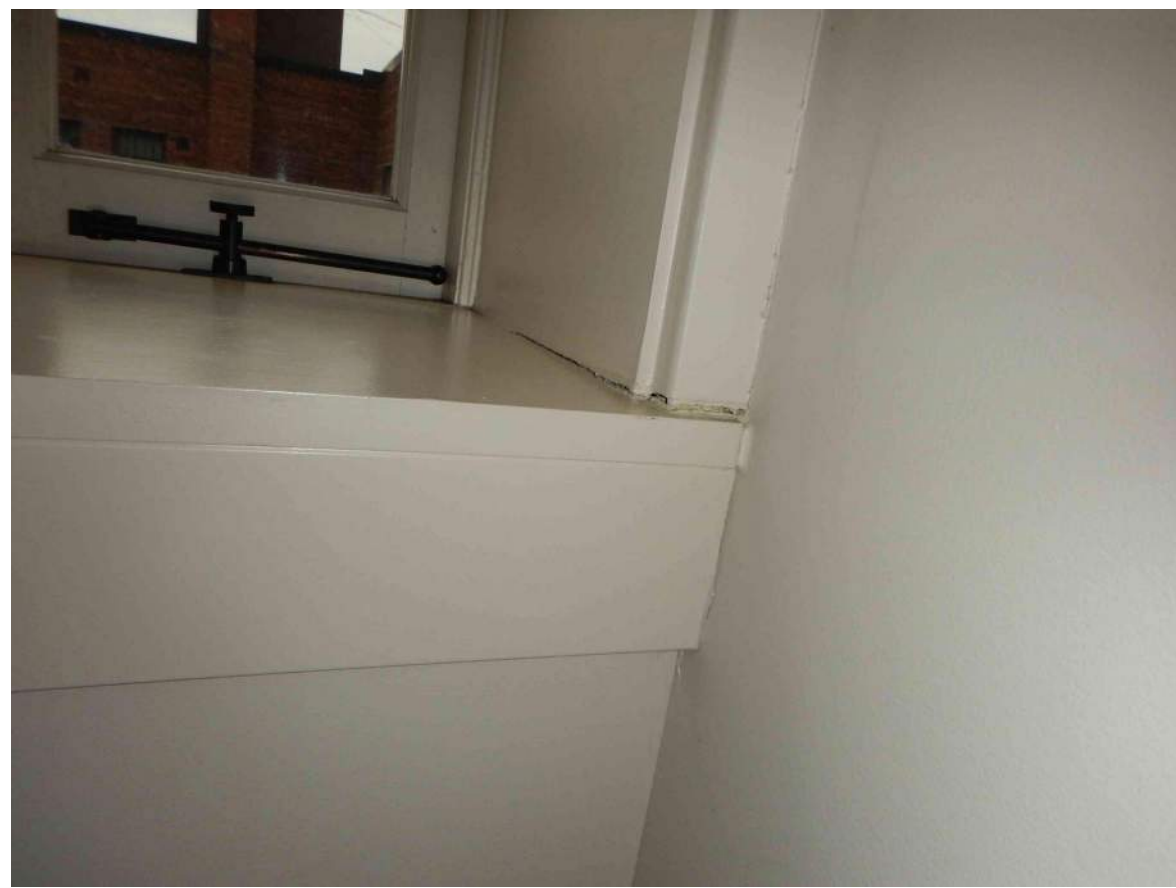
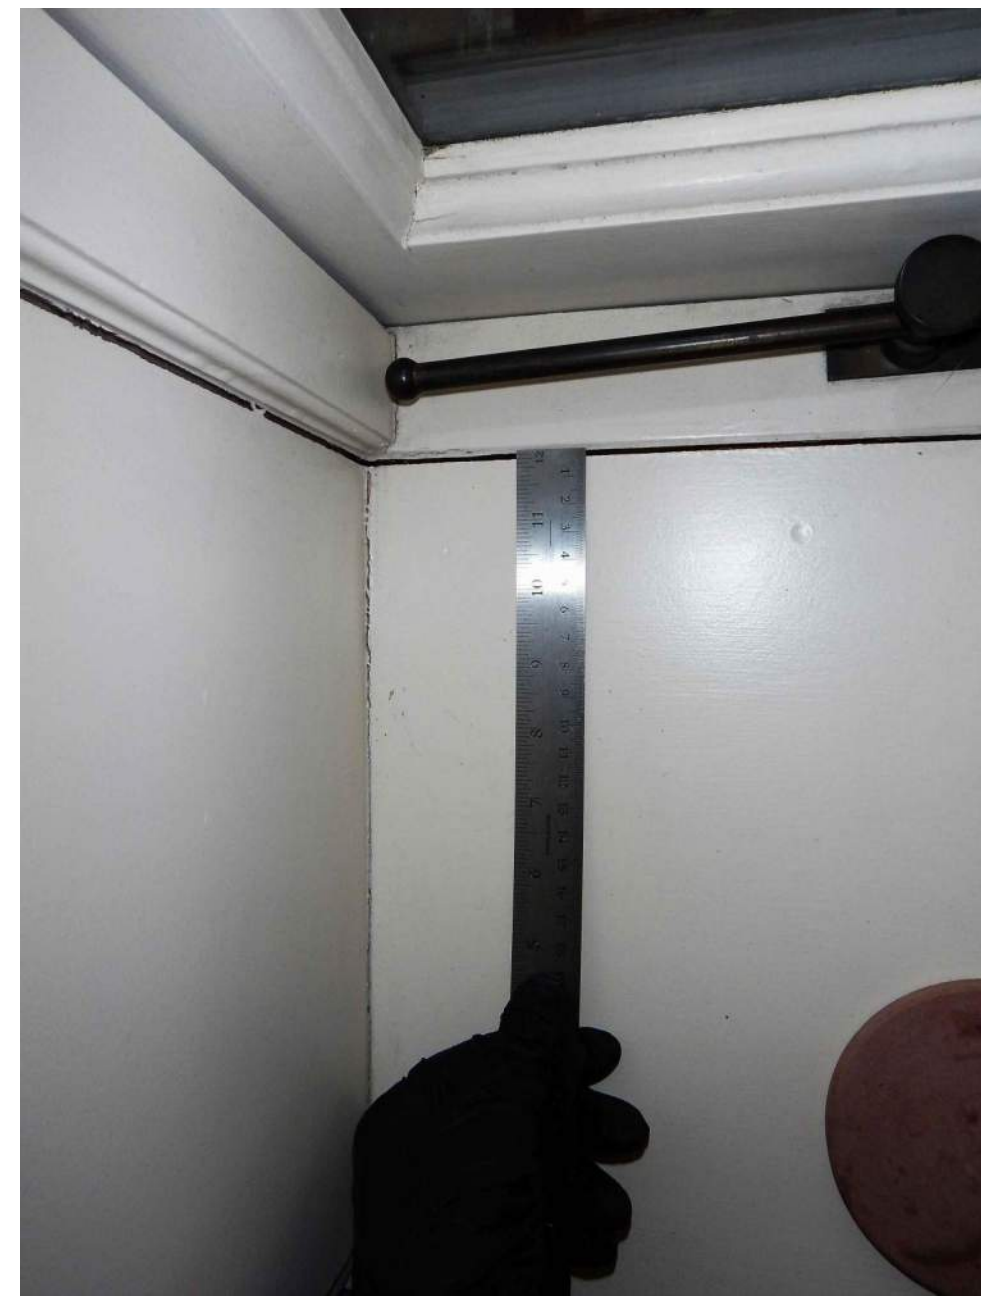
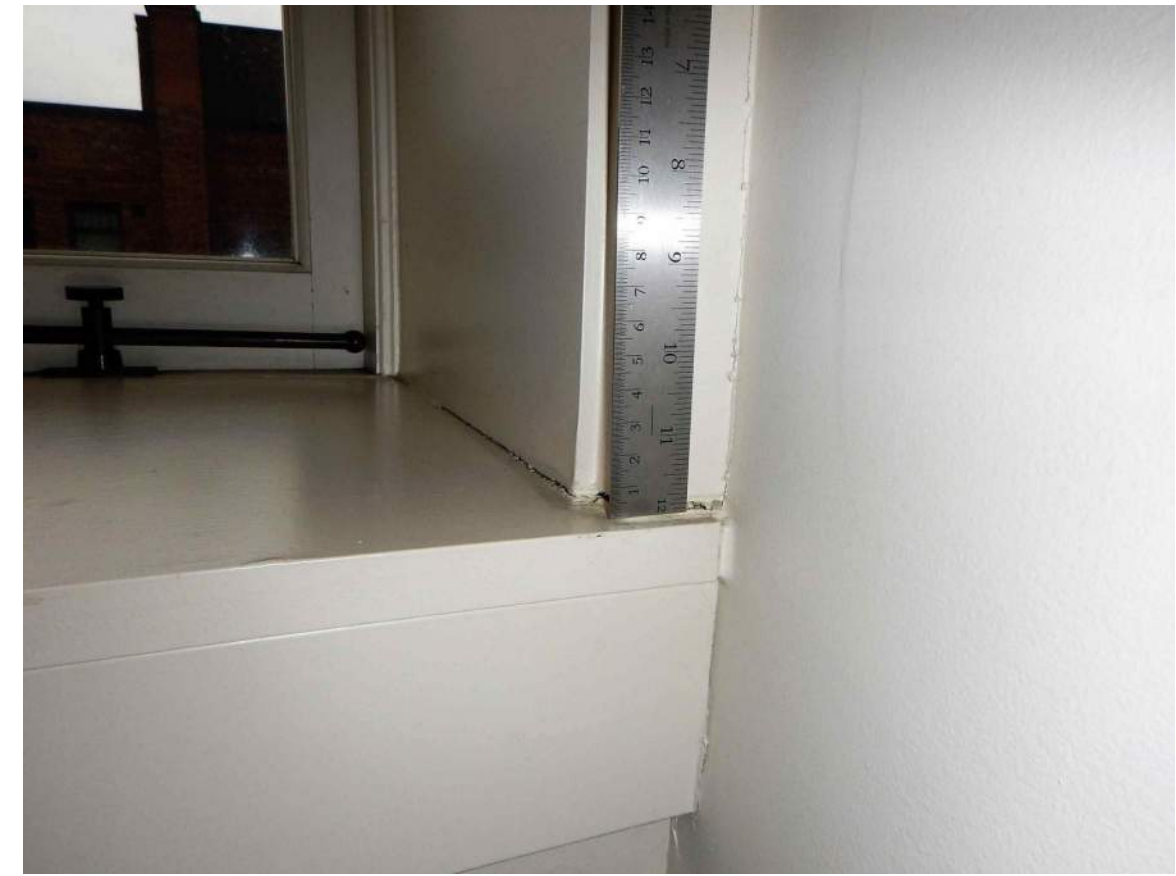
WINDOW - 9

- 1. Deterioration at the Sash
- 2. Deterioration at the Frame
- 3. Deterioration at Exterior Paint
- 4. Corroded Lintel
- 5. Operation Difficulty
- 6. Lock damage/missing/not engaging
- 7. Water intrusion
- 8. Separation at joint
- 9. Separation at rail/stile/muntin
- 10. Swelling at sill
- 11. Cracking of frame

Condition: Moderate

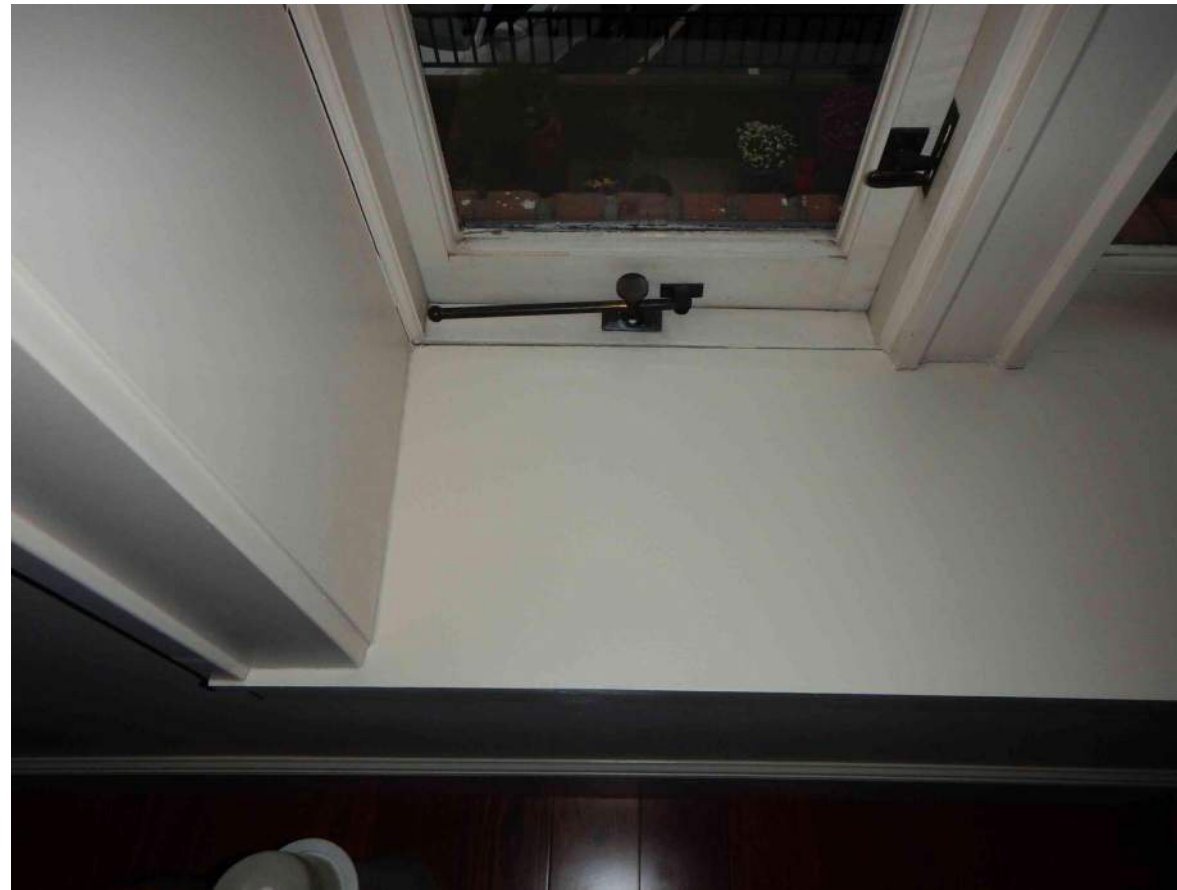
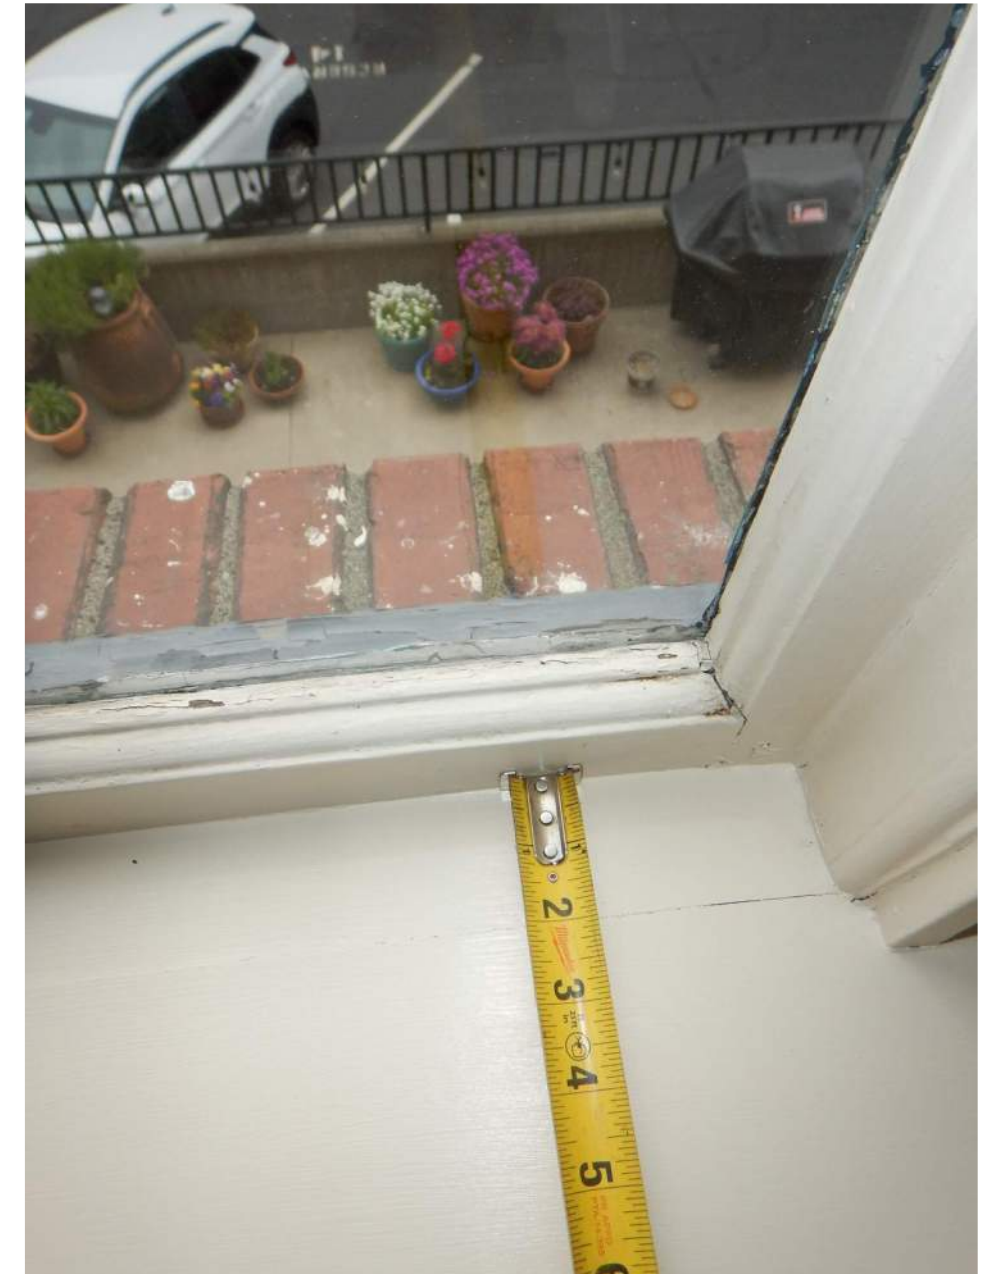
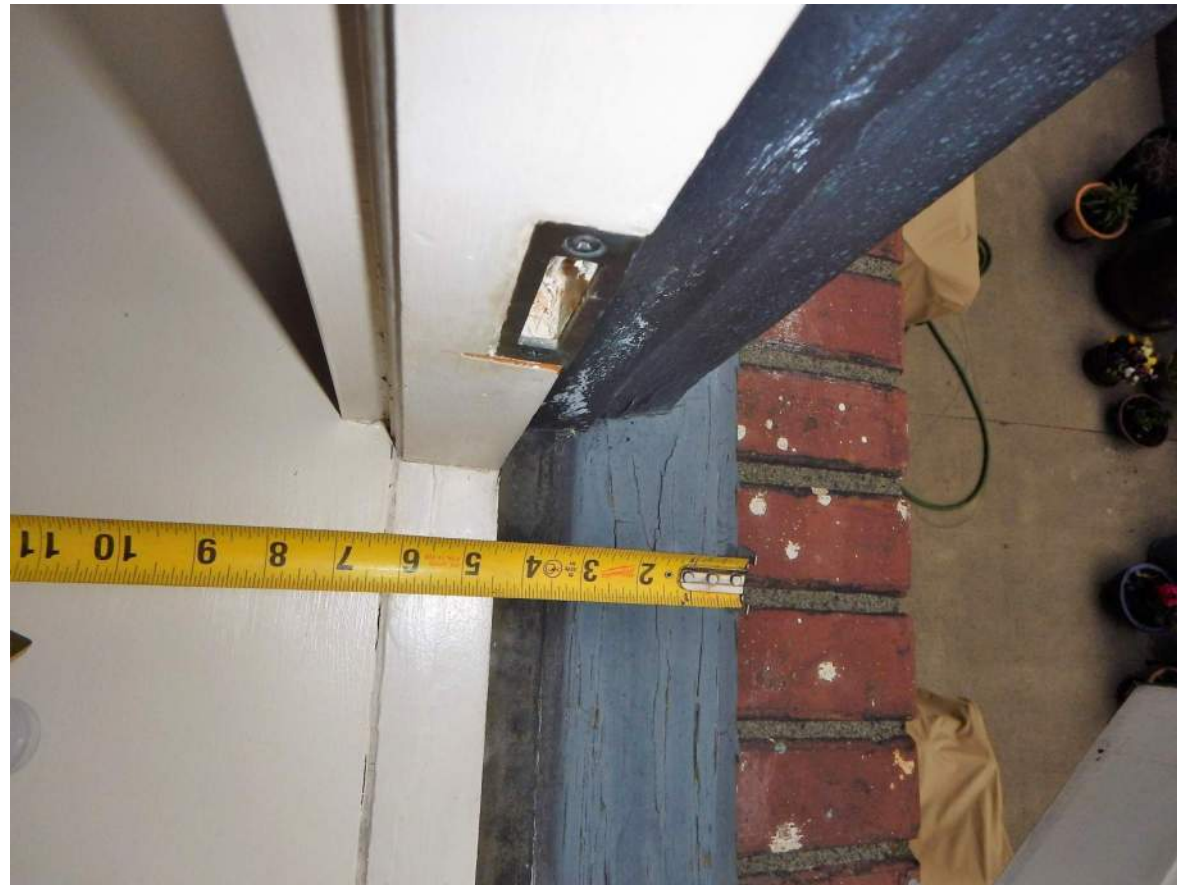
Type: W9

1. Deterioration at the Sash
2. Deterioration at the Frame
3. Deterioration at Exterior Paint
4. Corroded Lintel
5. Operation Difficulty
6. Lock damage/missing/not engaging
7. Water intrusion
8. Separation at joint
9. Separation at rail/stile/muntin
10. Swelling at sill
11. Cracking of frame

Condition: Moderate
