LEONA CONDOMINIUMS REMEDIATION

916 QUEEN ANNE AVE. N, SEATTLE, WA 98109

WINDOW REPLACEMENT PROPOSAL

THE SURVEY OF WINDOWS AND DOORS AT THE LEONA CONDOS WERE COMPLETED IN APRIL 2021. MOST OF THE WINDOWS APPEAR TO HAVE DETERIORATED AND THE CONDITION OF THE WINDOWS/DOORS HAVE WORSEN FOR THE LAST TWO YEARS.

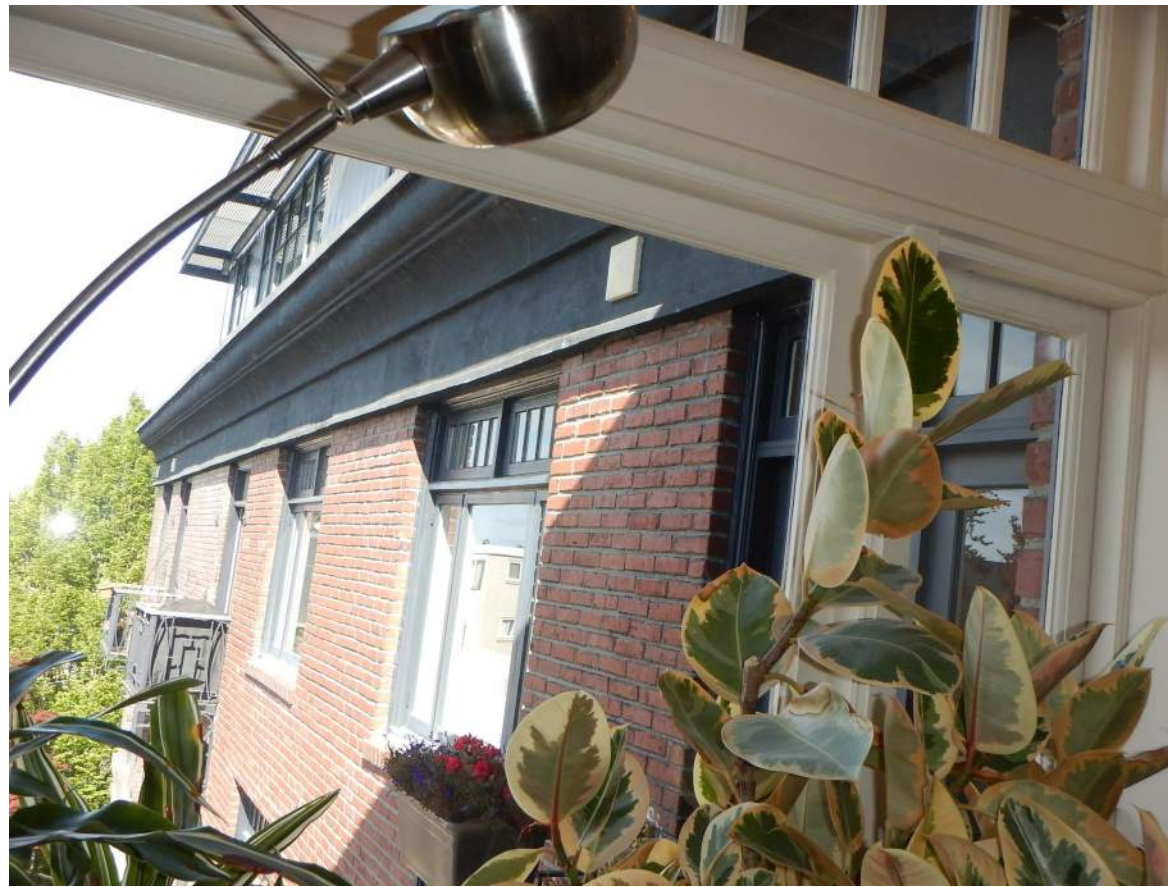
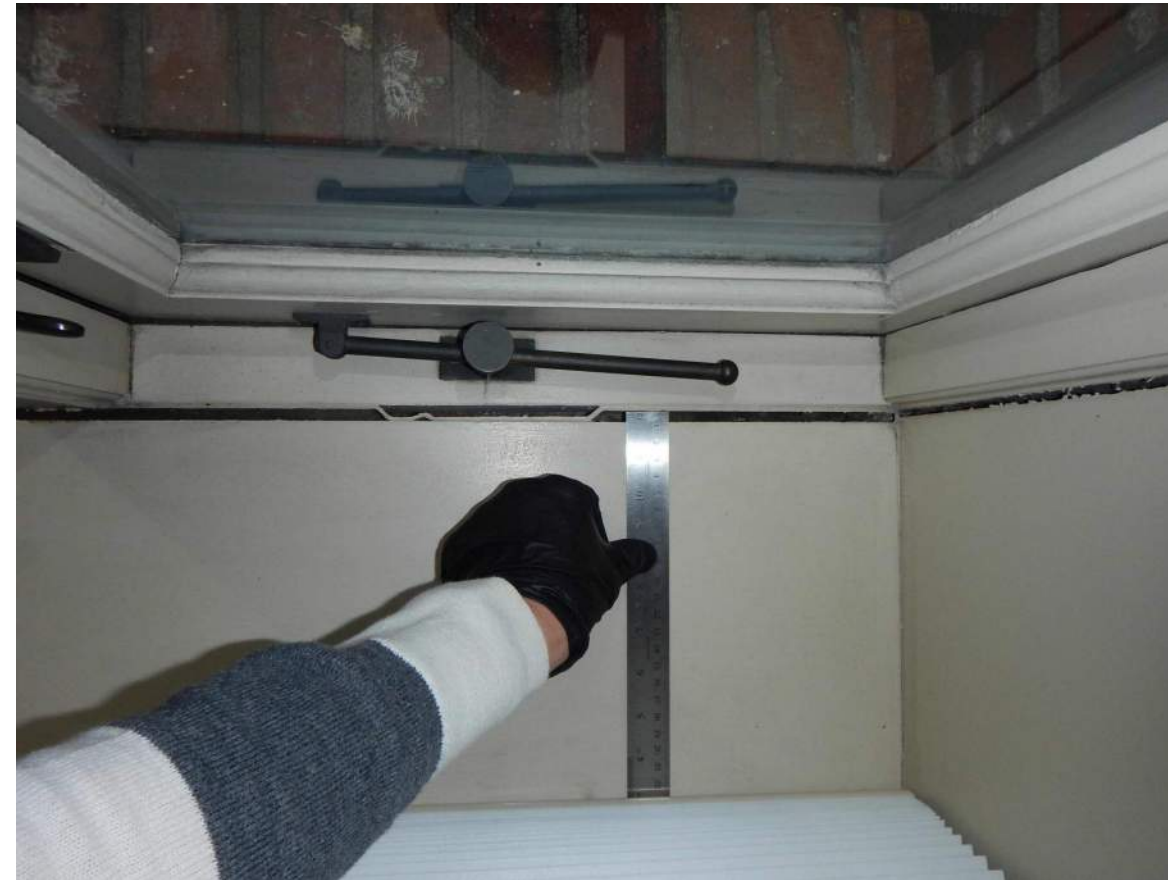
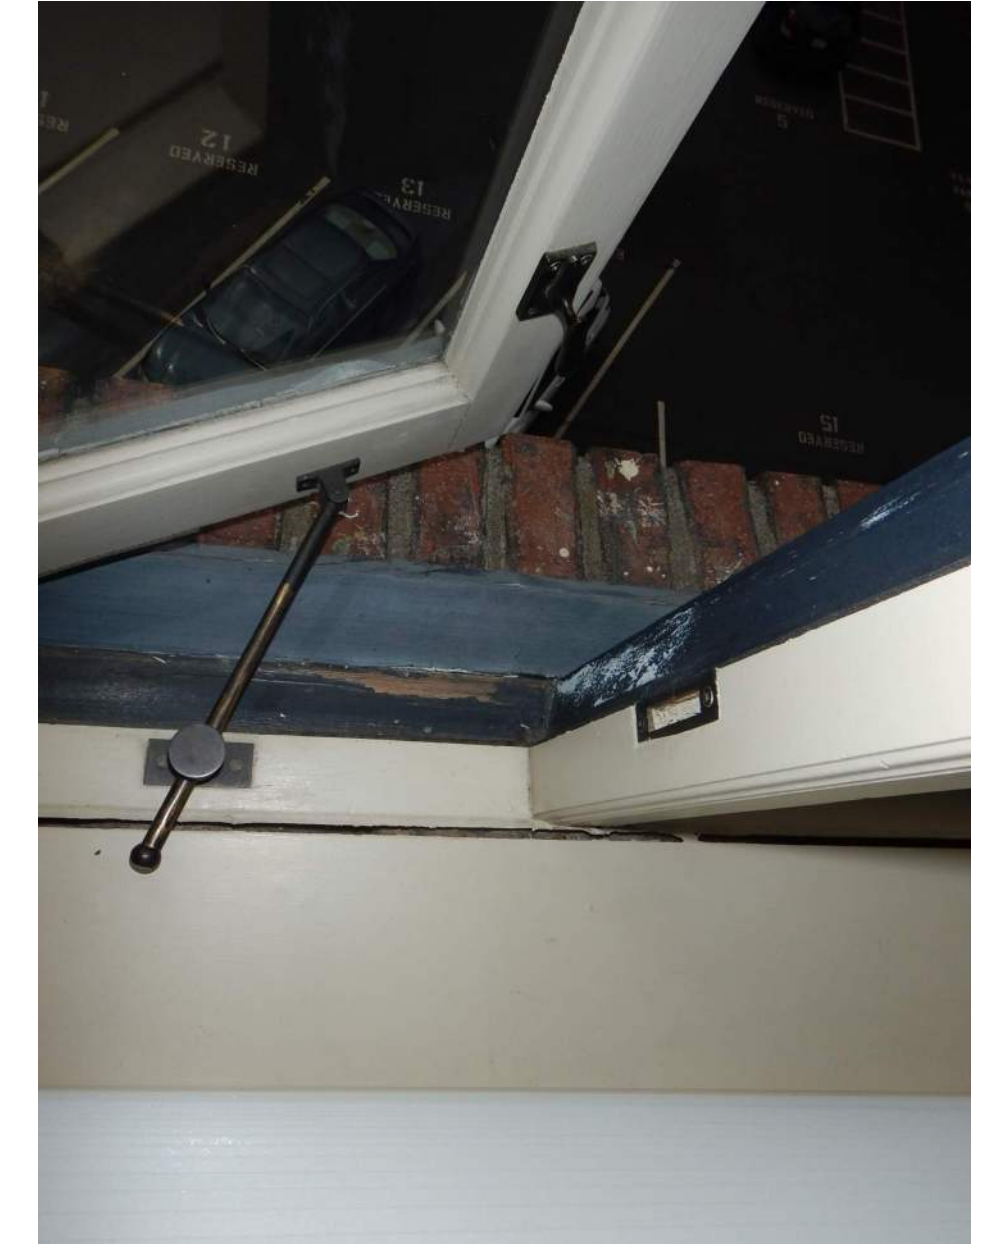
WINDOW - 14

1. Deterioration at the Sash
2. Deterioration at the Frame
3. Deterioration at Exterior Paint
4. Corroded Lintel
5. Operation Difficulty
6. Lock damage/missing/not engaging
7. Water intrusion
8. Separation at joint
9. Separation at rail/stile/muntin
10. Swelling at sill
11. Cracking of frame

Condition: Moderate

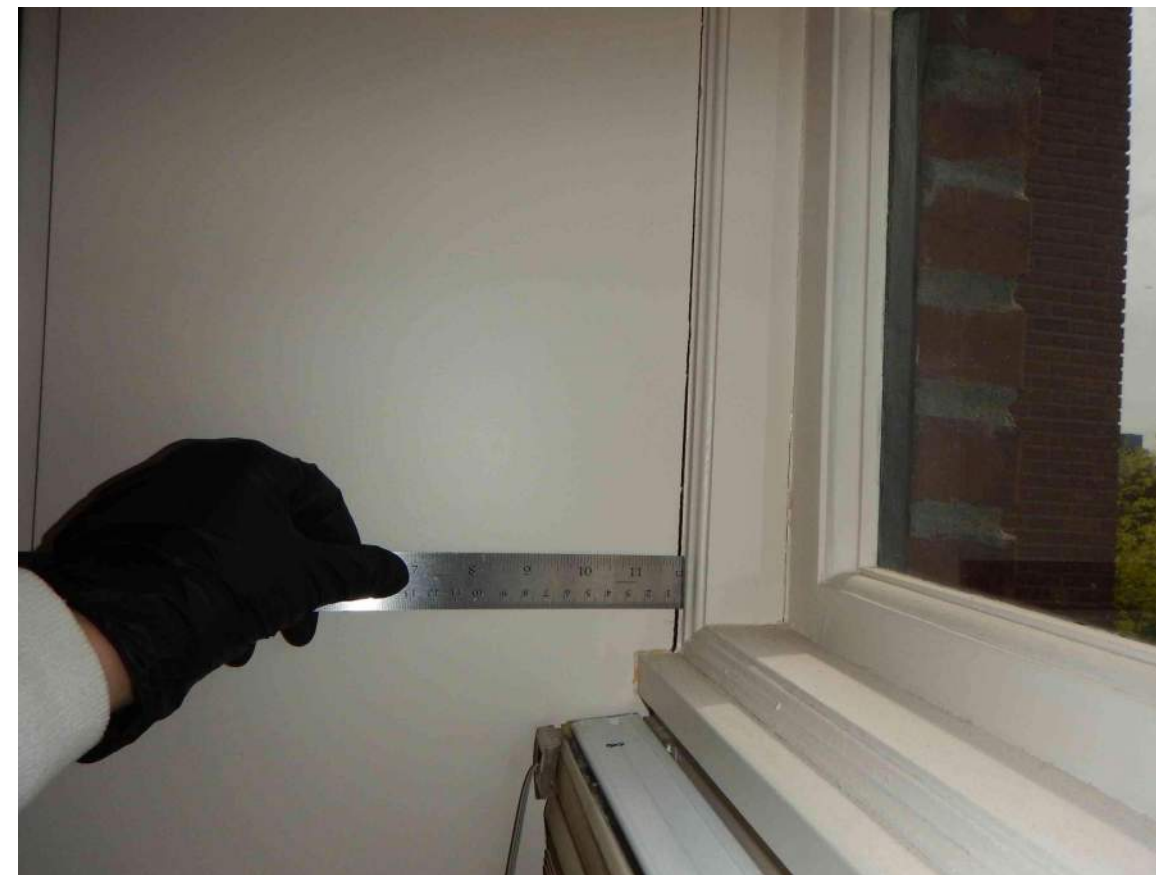
WINDOW - 15

1. Deterioration at the Sash
2. Deterioration at the Frame
3. Deterioration at Exterior Paint
4. Corroded Lintel
5. Operation Difficulty
6. Lock damage/missing/not engaging
7. Water intrusion
8. Separation at joint
9. Separation at rail/stile/muntin
10. Swelling at sill
11. Cracking of frame

Condition: Moderate

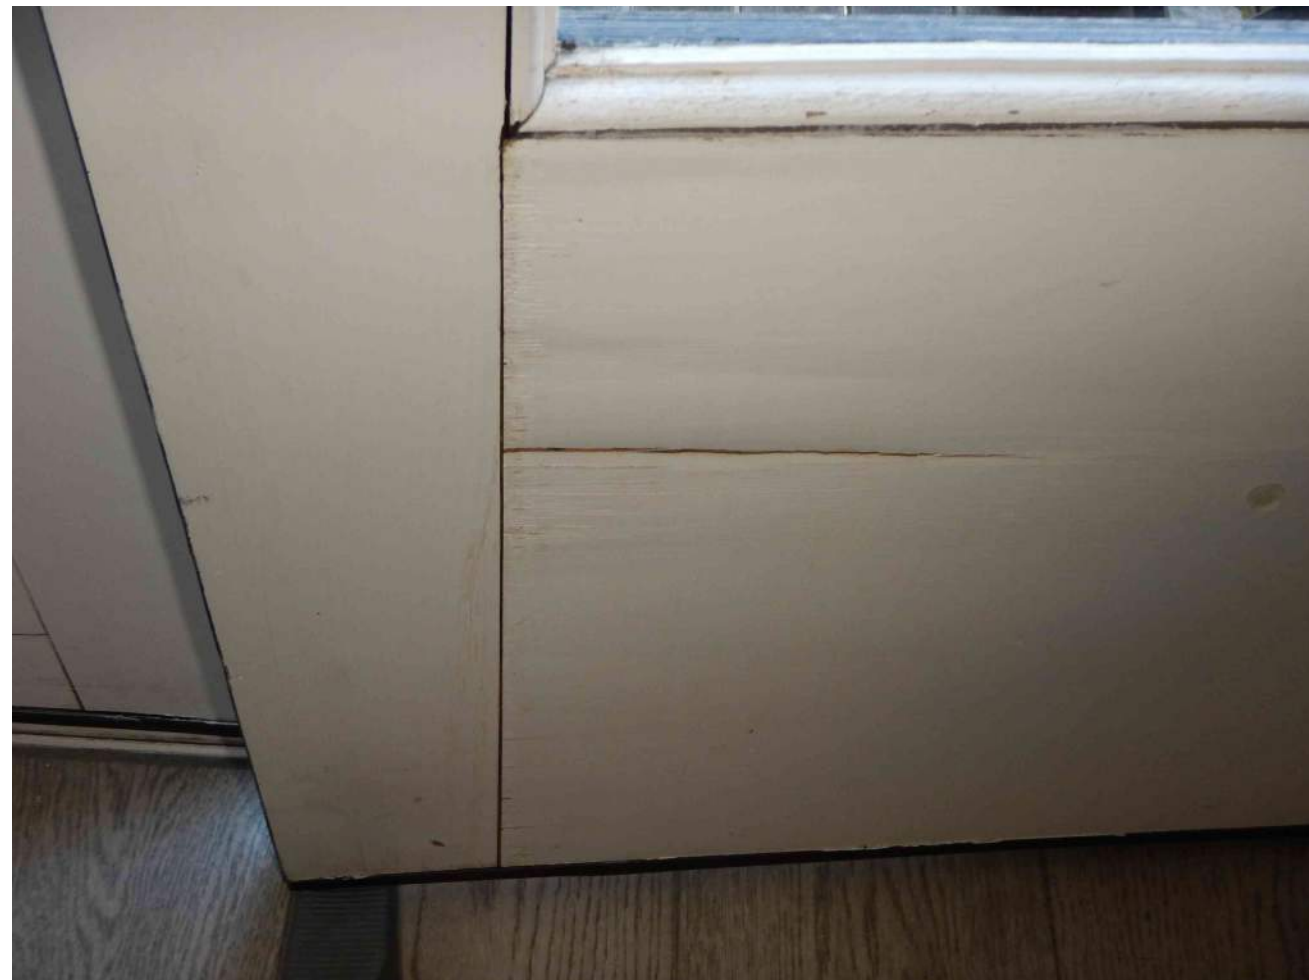
1. Deterioration at the Sash
2. Deterioration at the Frame
3. Deterioration at Exterior Paint
4. Corroded Lintel
5. Operation Difficulty
6. Lock damage/missing/not engaging
7. Water intrusion
8. Separation at joint
9. Separation at rail/stile/muntin
10. Swelling at sill
11. Cracking of frame

Condition: Poor

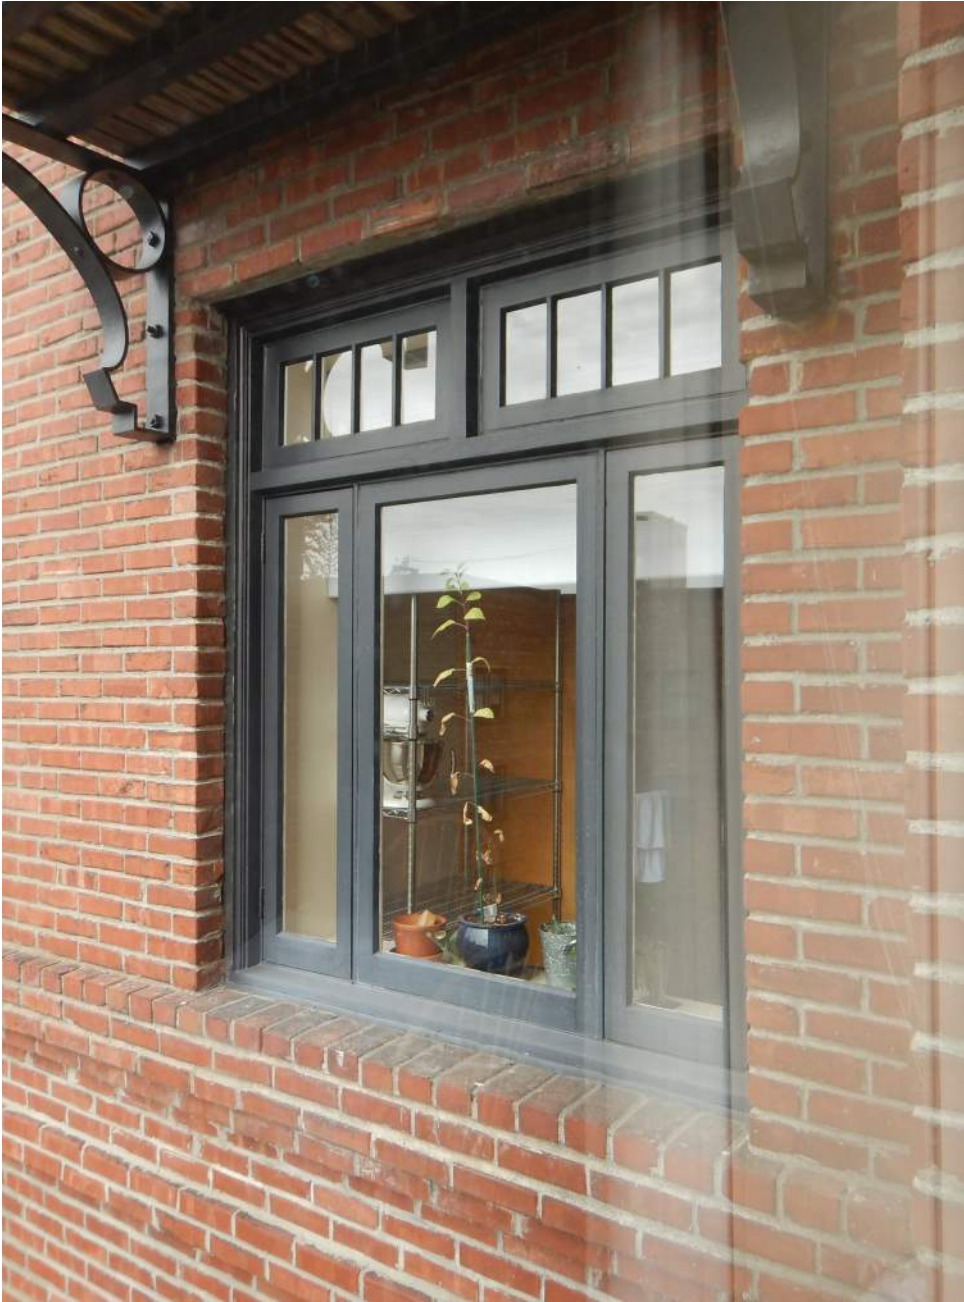
WINDOW - 18

- 1. Deterioration at the Sash
- 2. Deterioration at the Frame
- 3. Deterioration at Exterior Paint
- 4. Corroded Lintel
- 5. Operation Difficulty
- 6. Lock damage/missing/not engaging
- 7. Water intrusion
- 8. Separation at joint
- 9. Separation at rail/stile/muntin
- 10. Swelling at sill
- 11. Cracking of frame

Condition: Moderate

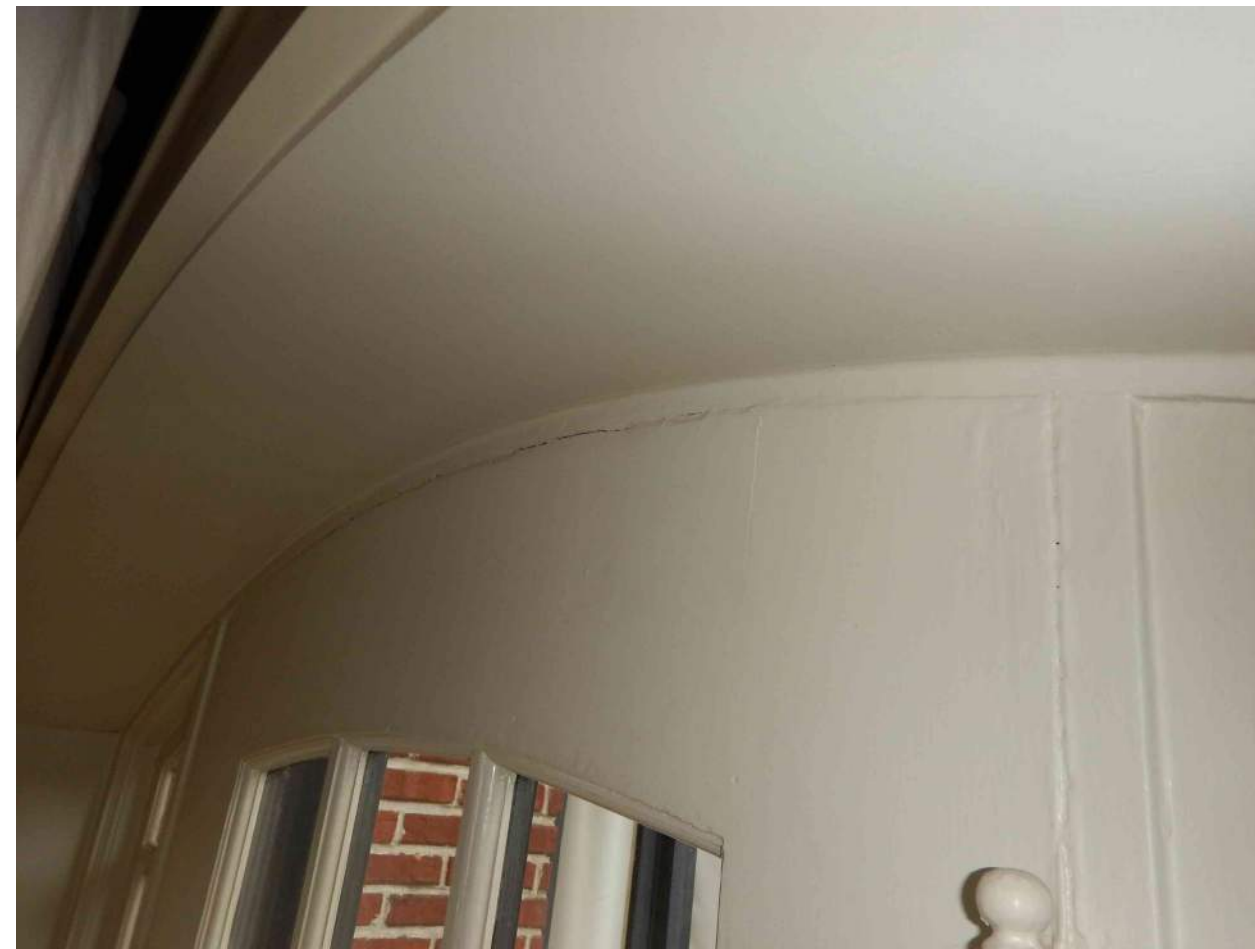
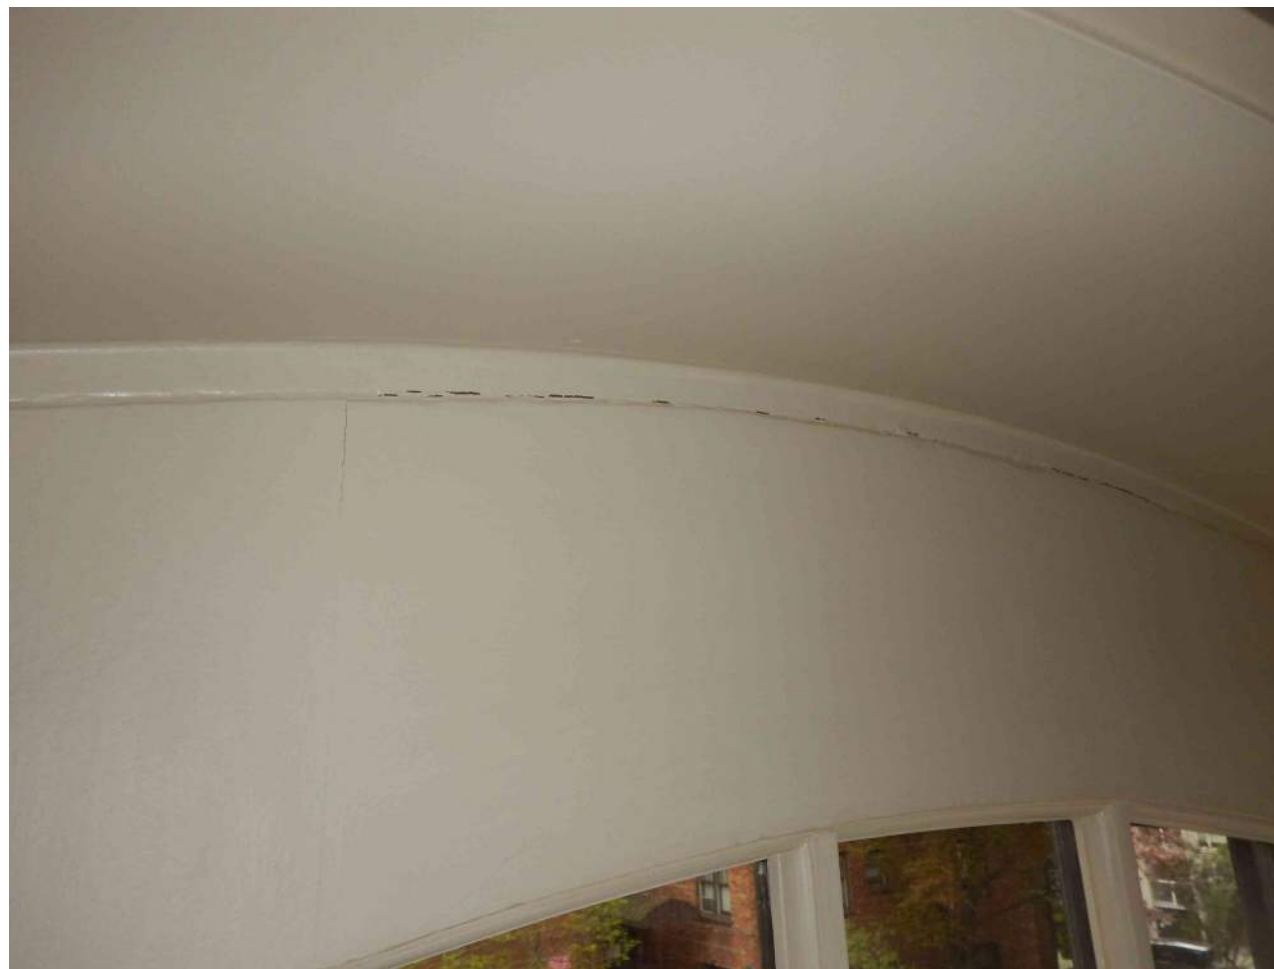
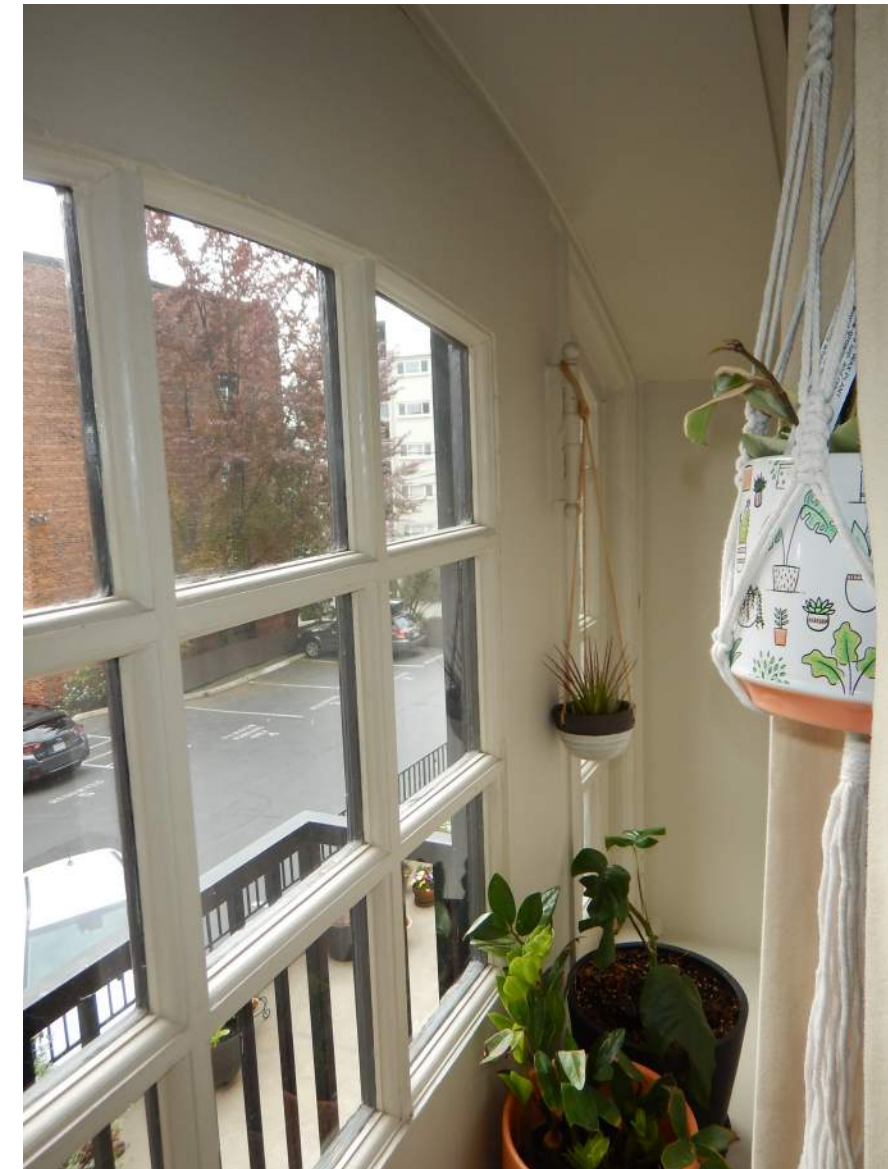
DOOR - 19

1. Deterioration at the Sash
2. Deterioration at the Frame
3. Deterioration at Exterior Paint
4. Corroded Lintel
5. Operation Difficulty
6. Lock damage/missing/not engaging
7. Water intrusion
8. Separation at joint
9. Separation at rail/stile/muntin
10. Swelling at sill
11. Cracking of frame

Condition: Moderate

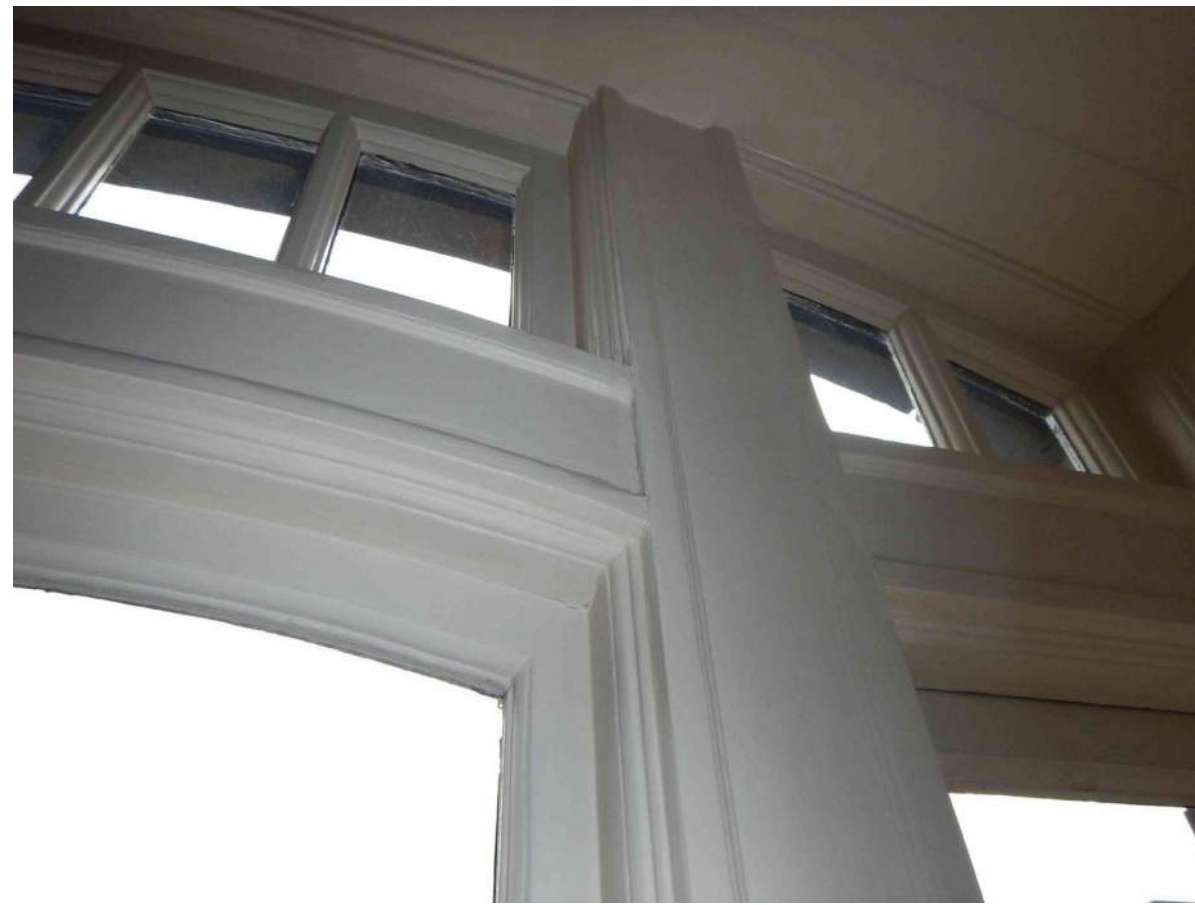
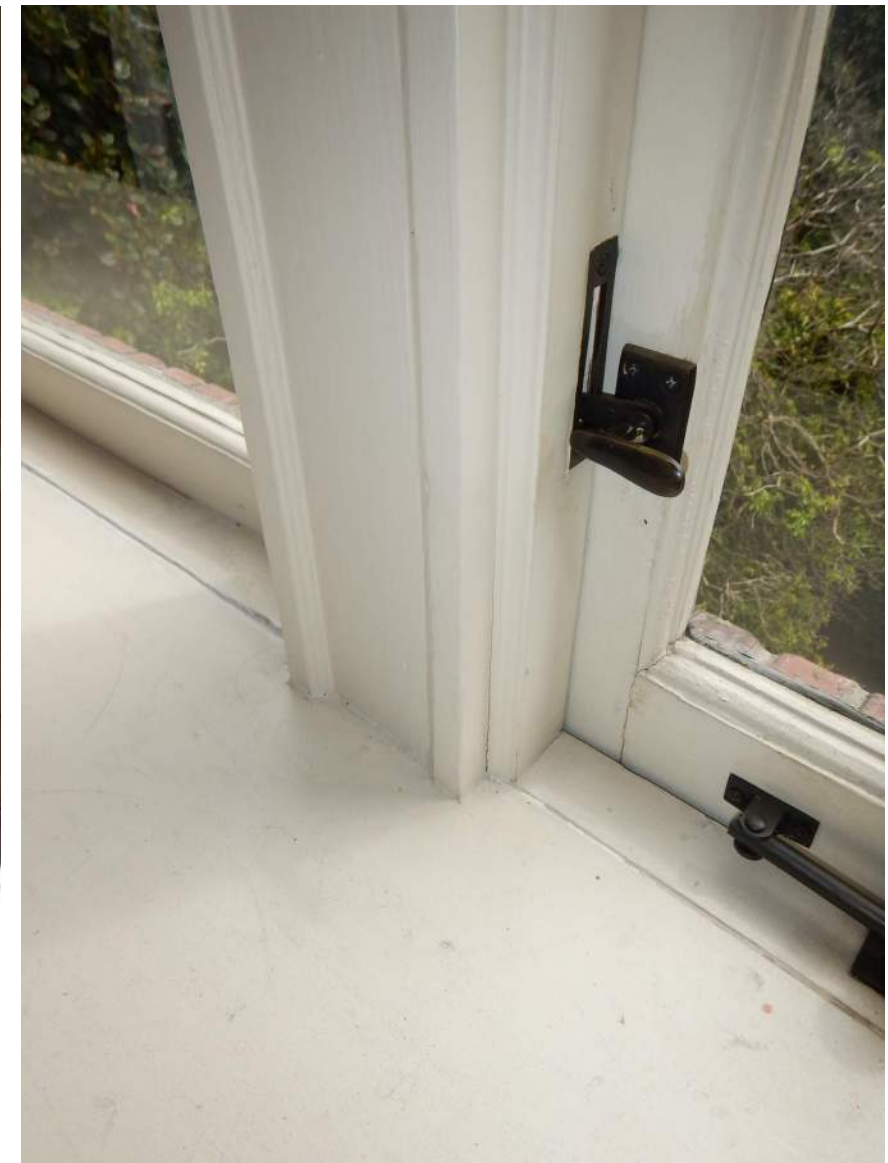
1. Deterioration at the Sash
2. Deterioration at the Frame
3. Deterioration at Exterior Paint
4. Corroded Lintel
5. Operation Difficulty
6. Lock damage/missing/not engaging
7. Water intrusion
8. Separation at joint
9. Separation at rail/stile/muntin
10. Swelling at sill
11. Cracking of frame

Condition: Moderate

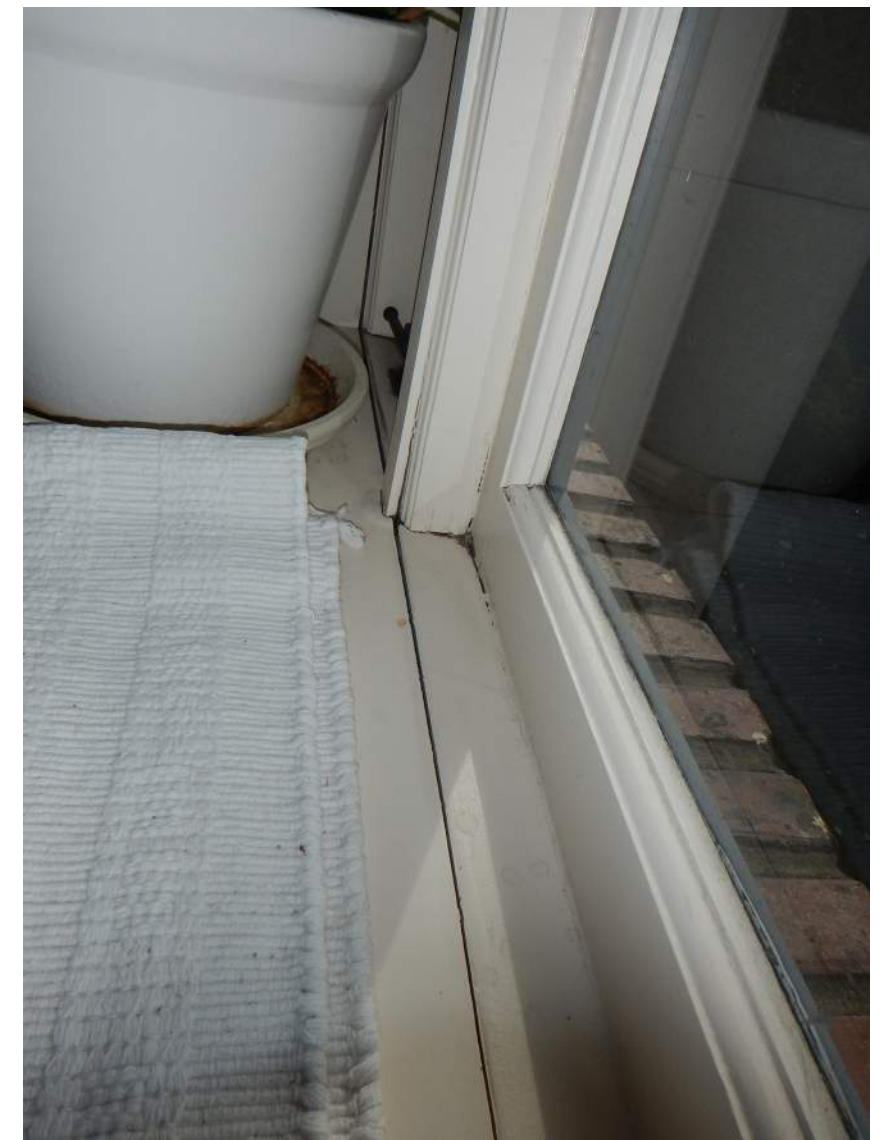
WINDOW - 23

1. Deterioration at the Sash
2. Deterioration at the Frame
3. Deterioration at Exterior Paint
4. Corroded Lintel
5. Operation Difficulty
6. Lock damage/missing/not engaging
7. Water intrusion
8. Separation at joint
9. Separation at rail/stile/muntin
10. Swelling at sill
11. Cracking of frame

Condition: Poor

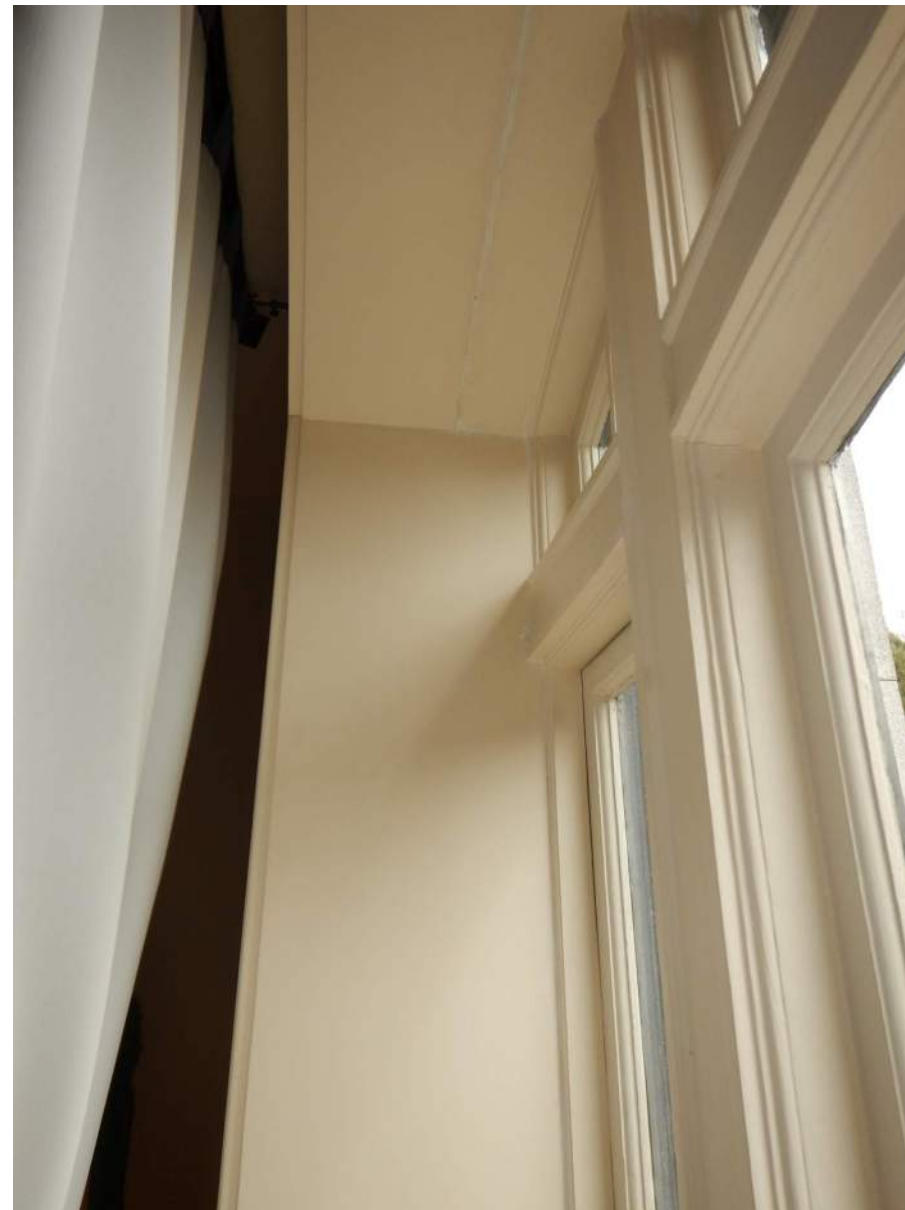
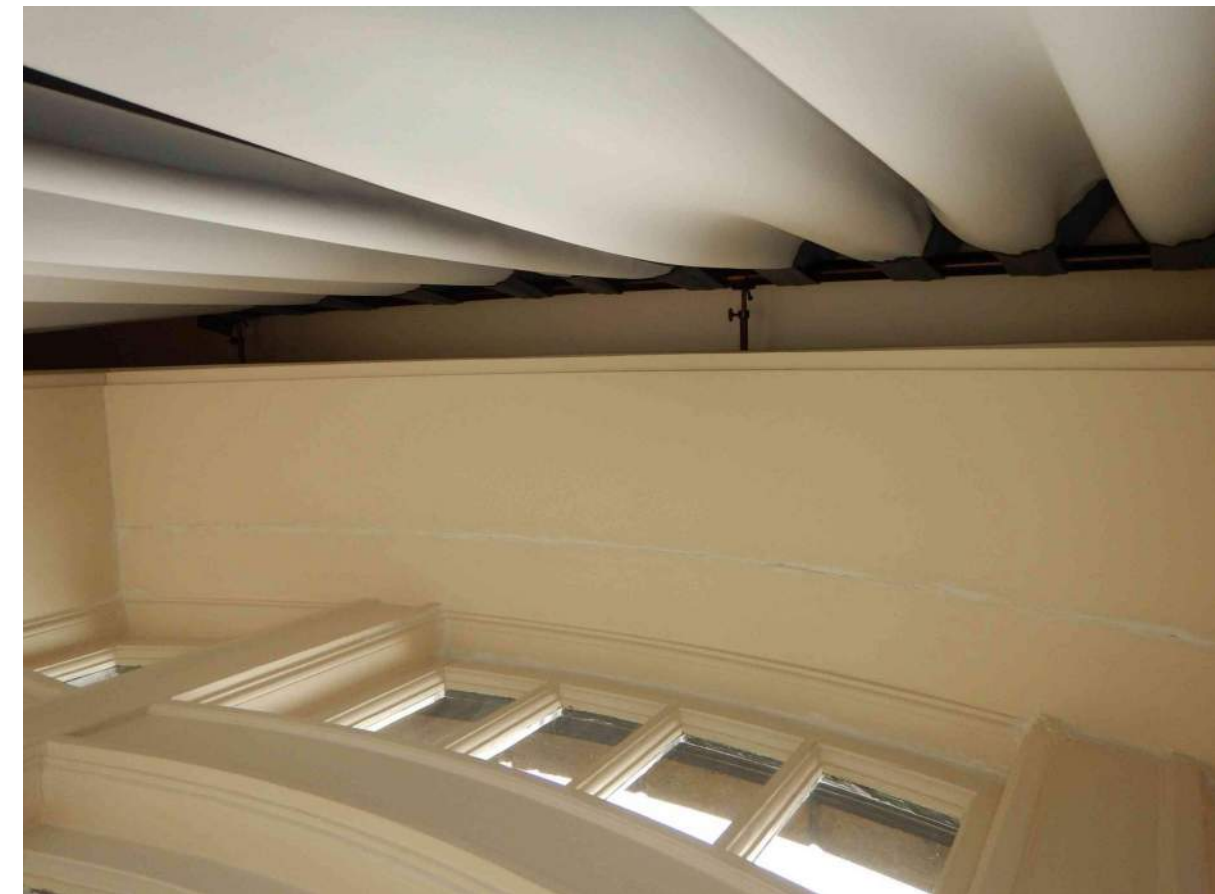
1. Deterioration at the Sash
2. Deterioration at the Frame
3. Deterioration at Exterior Paint
4. Corroded Lintel
5. Operation Difficulty
6. Lock damage/missing/not engaging
7. Water intrusion
8. Separation at joint
9. Separation at rail/stile/muntin
10. Swelling at sill
11. Cracking of frame

Condition: Moderate

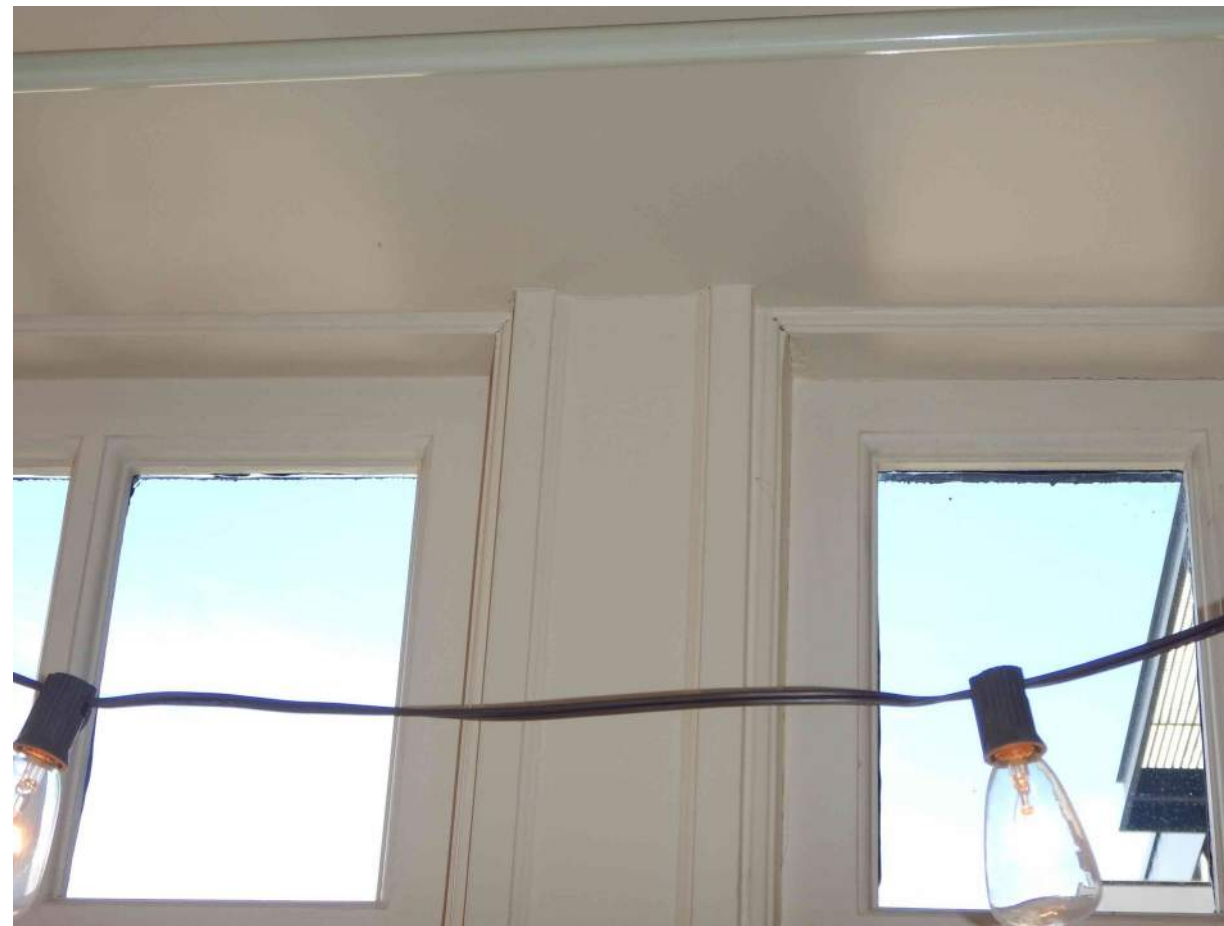
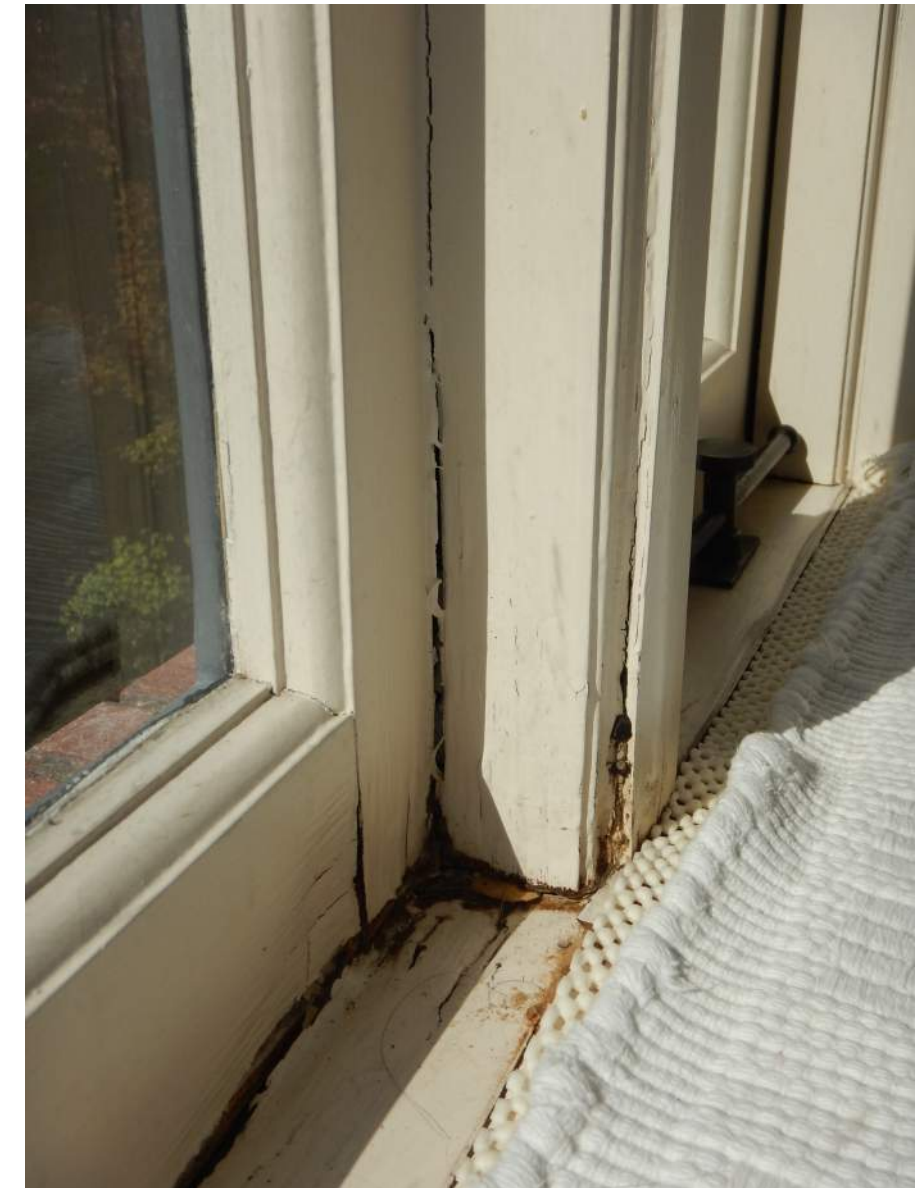
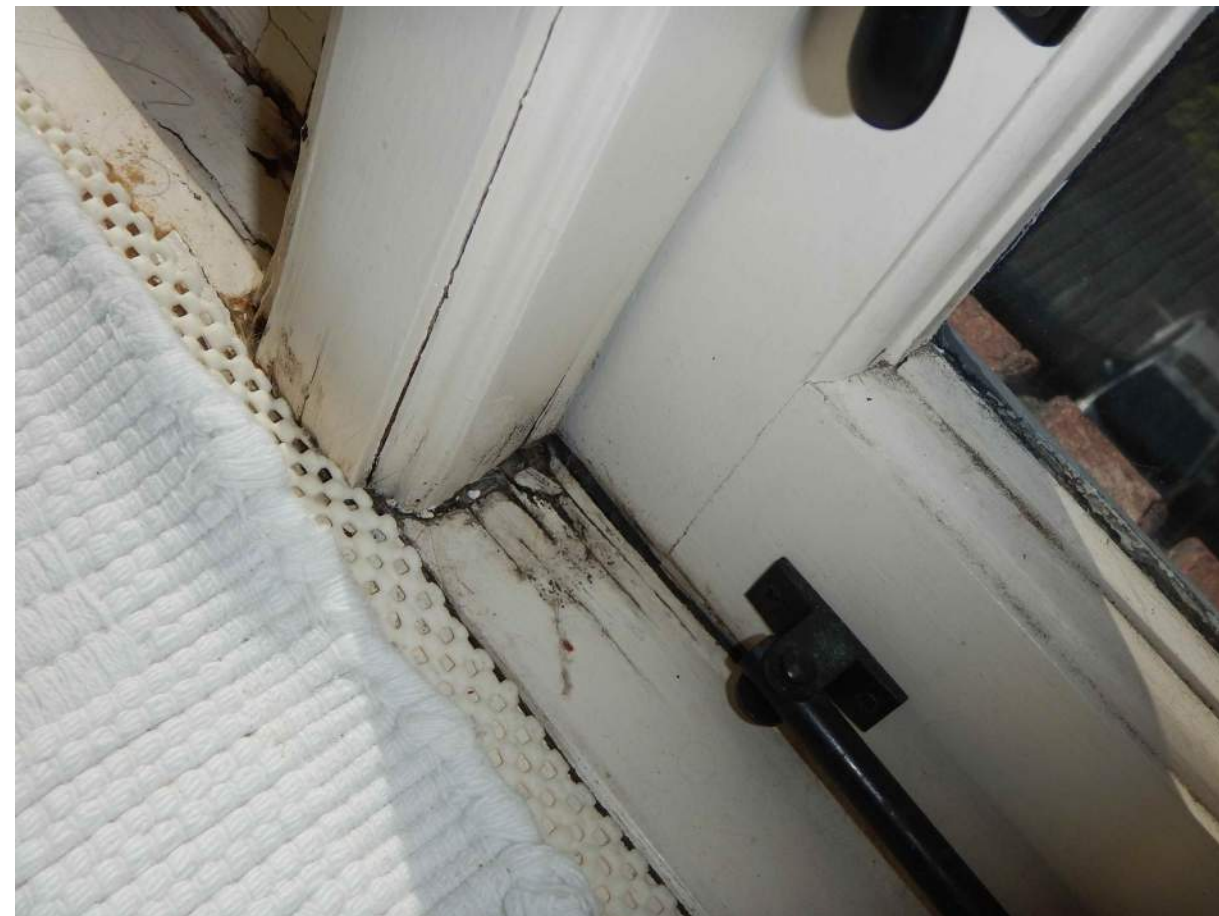
WINDOW - 26

1. Deterioration at the Sash
2. Deterioration at the Frame
3. Deterioration at Exterior Paint
4. Corroded Lintel
5. Operation Difficulty
6. Lock damage/missing/not engaging
7. Water intrusion
8. Separation at joint
9. Separation at rail/stile/muntin
10. Swelling at sill
11. Cracking of frame

Condition: Poor

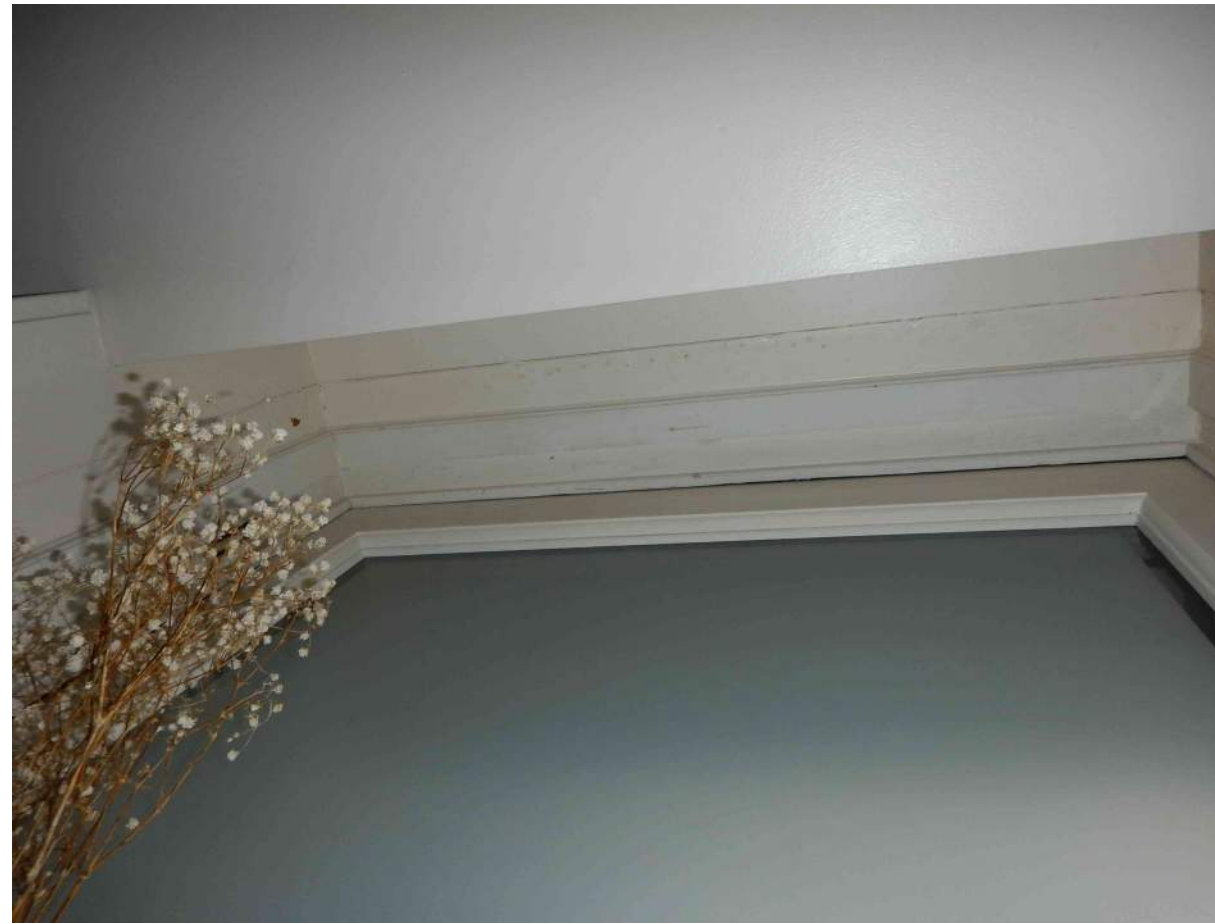
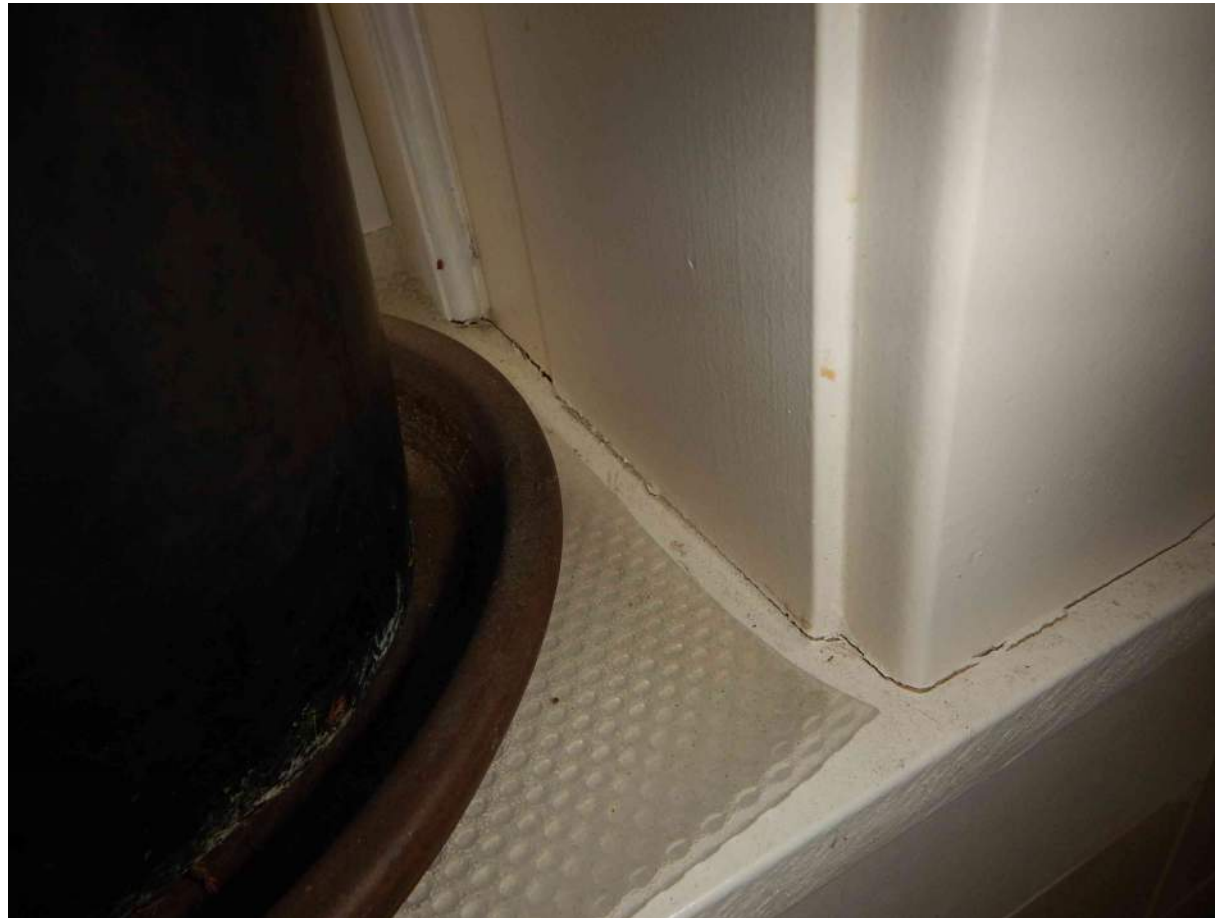
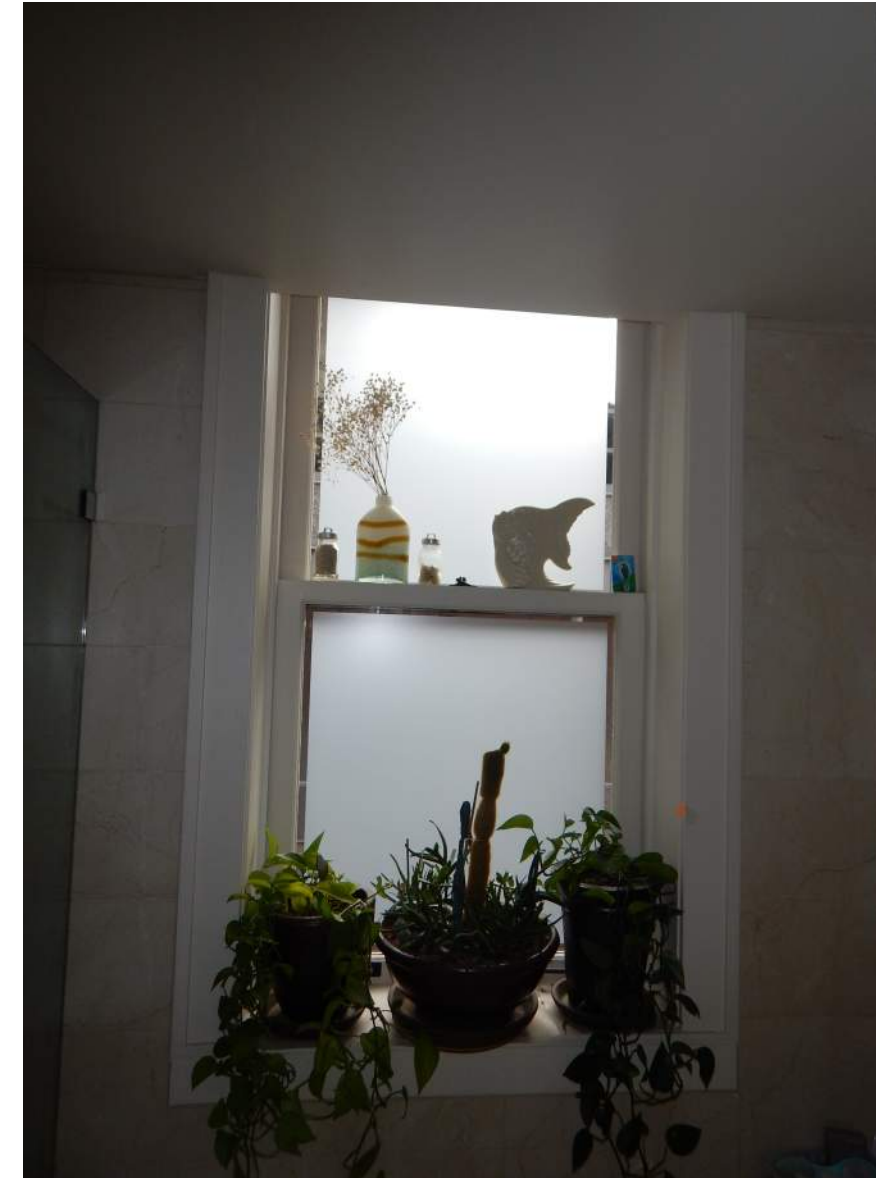
1. Deterioration at the Sash
2. Deterioration at the Frame
3. Deterioration at Exterior Paint
4. Corroded Lintel
5. Operation Difficulty
6. Lock damage/missing/not engaging
7. Water intrusion
8. Separation at joint
9. Separation at rail/stile/muntin
10. Swelling at sill
11. Cracking of frame

Condition: Moderate
