LEONA CONDOMINIUMS REMEDIATION

916 QUEEN ANNE AVE. N, SEATTLE, WA 98109

WINDOW REPLACEMENT PROPOSAL

THE SURVEY OF WINDOWS AND DOORS AT THE LEONA CONDOS WERE COMPLETED IN APRIL 2021. MOST OF THE WINDOWS APPEAR TO HAVE DETERIORATED AND THE CONDITION OF THE WINDOWS/DOORS HAVE WORSEN FOR THE LAST TWO YEARS.

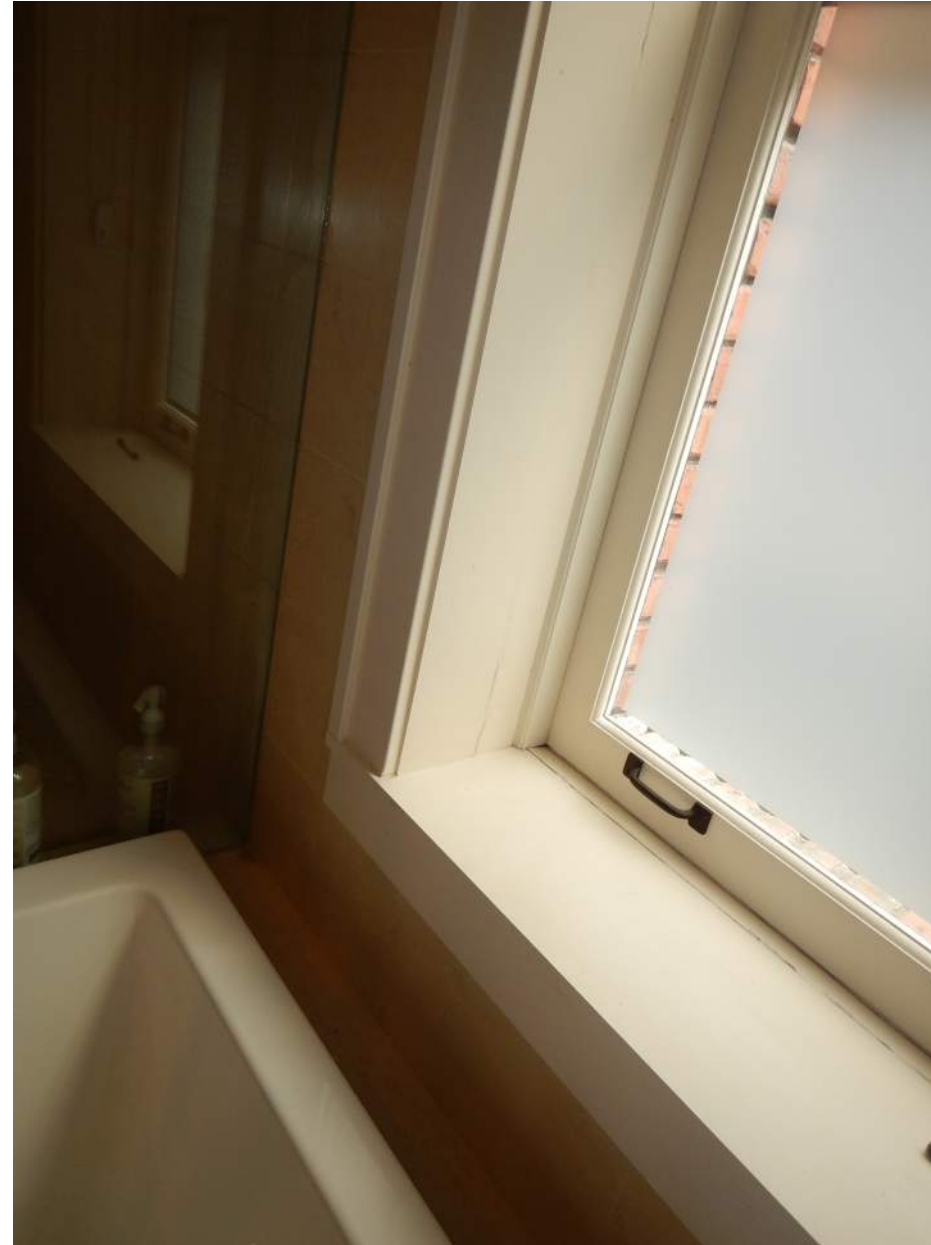
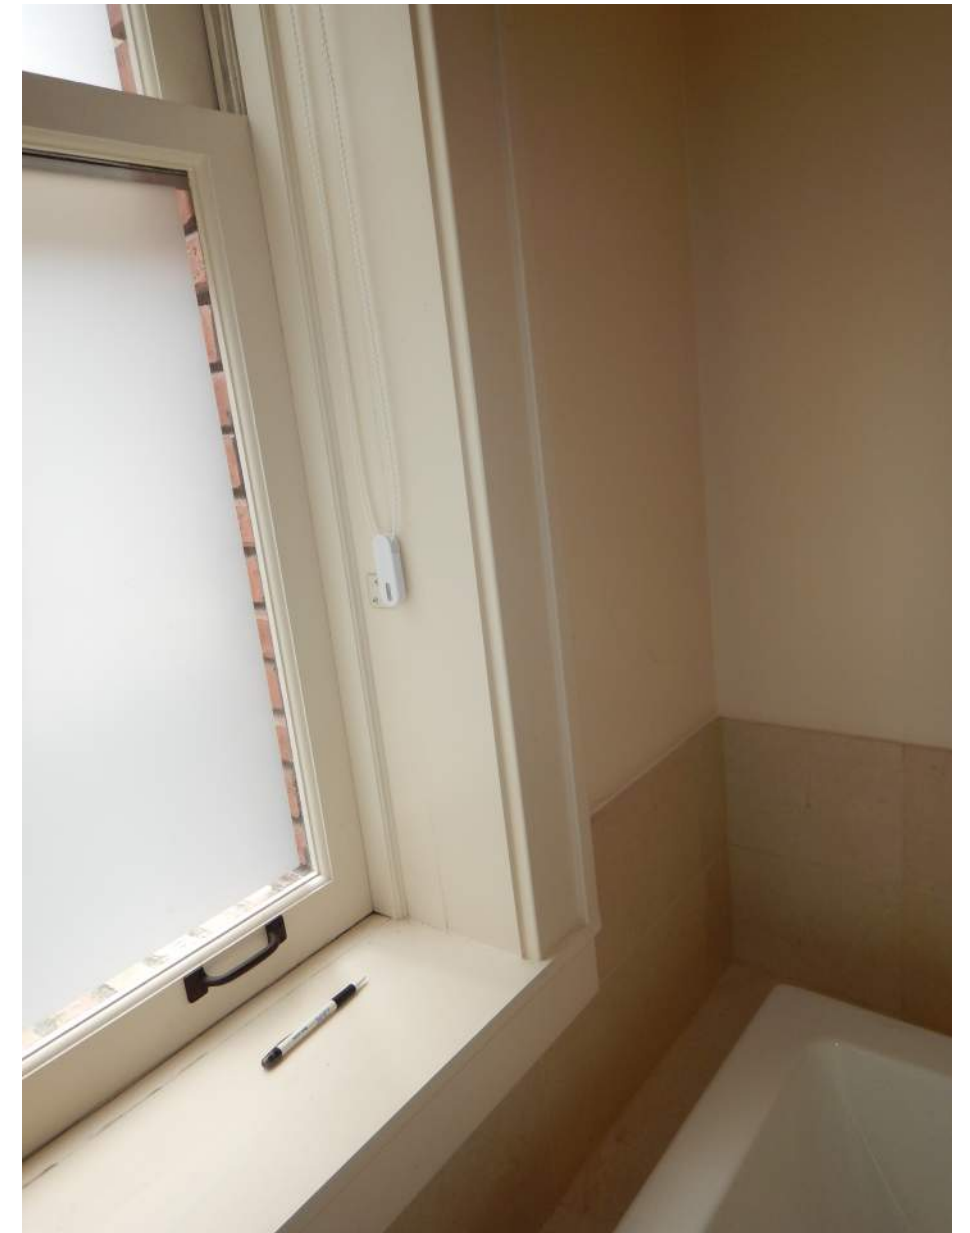
WINDOW - 30

1. Deterioration at the Sash
2. Deterioration at the Frame
3. Deterioration at Exterior Paint
4. Corroded Lintel
5. Operation Difficulty
6. Lock damage/missing/not engaging
7. Water intrusion
8. Separation at joint
9. Separation at rail/stile/muntin
10. Swelling at sill
11. Cracking of frame

Condition: Moderate

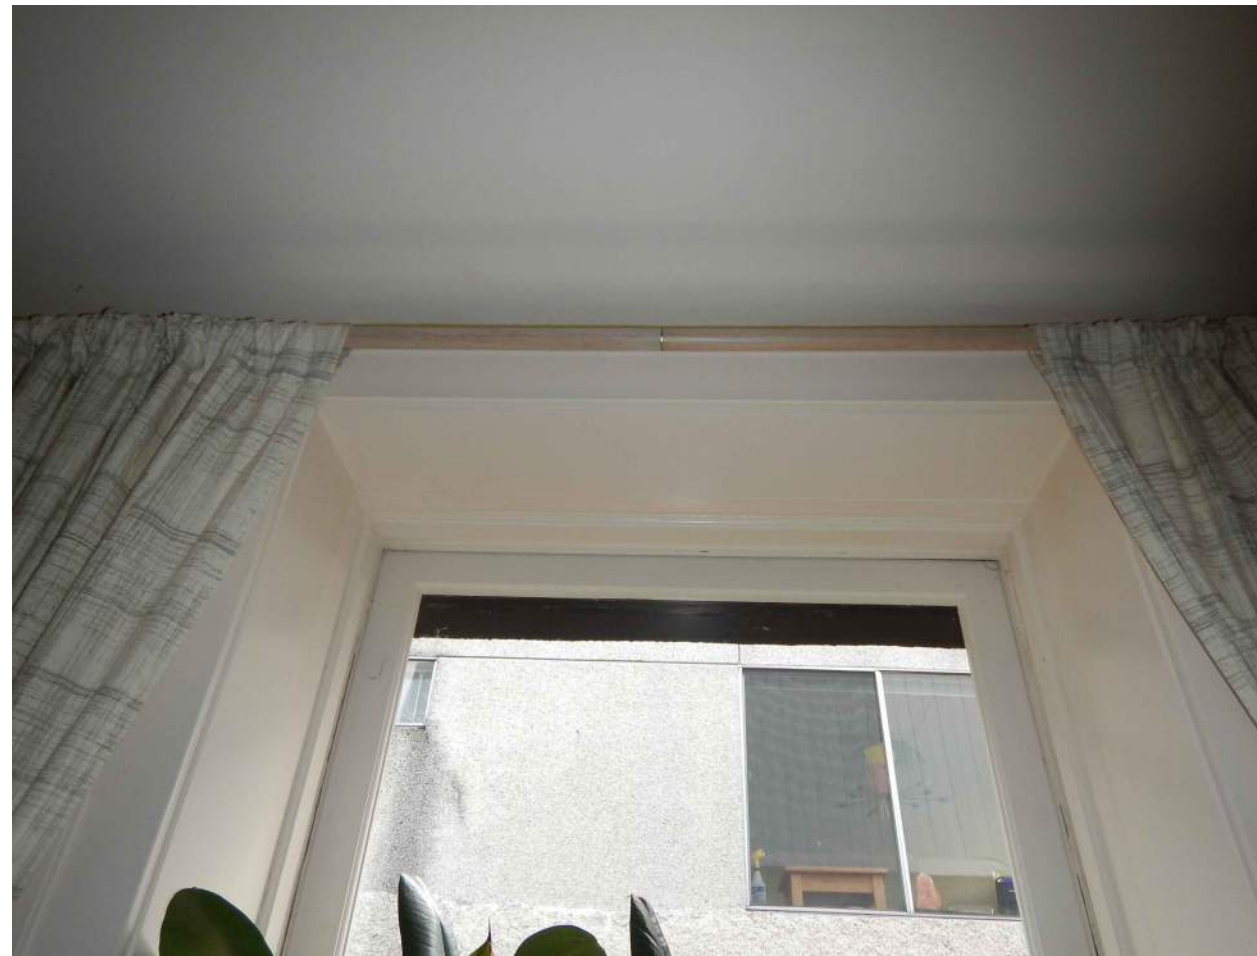
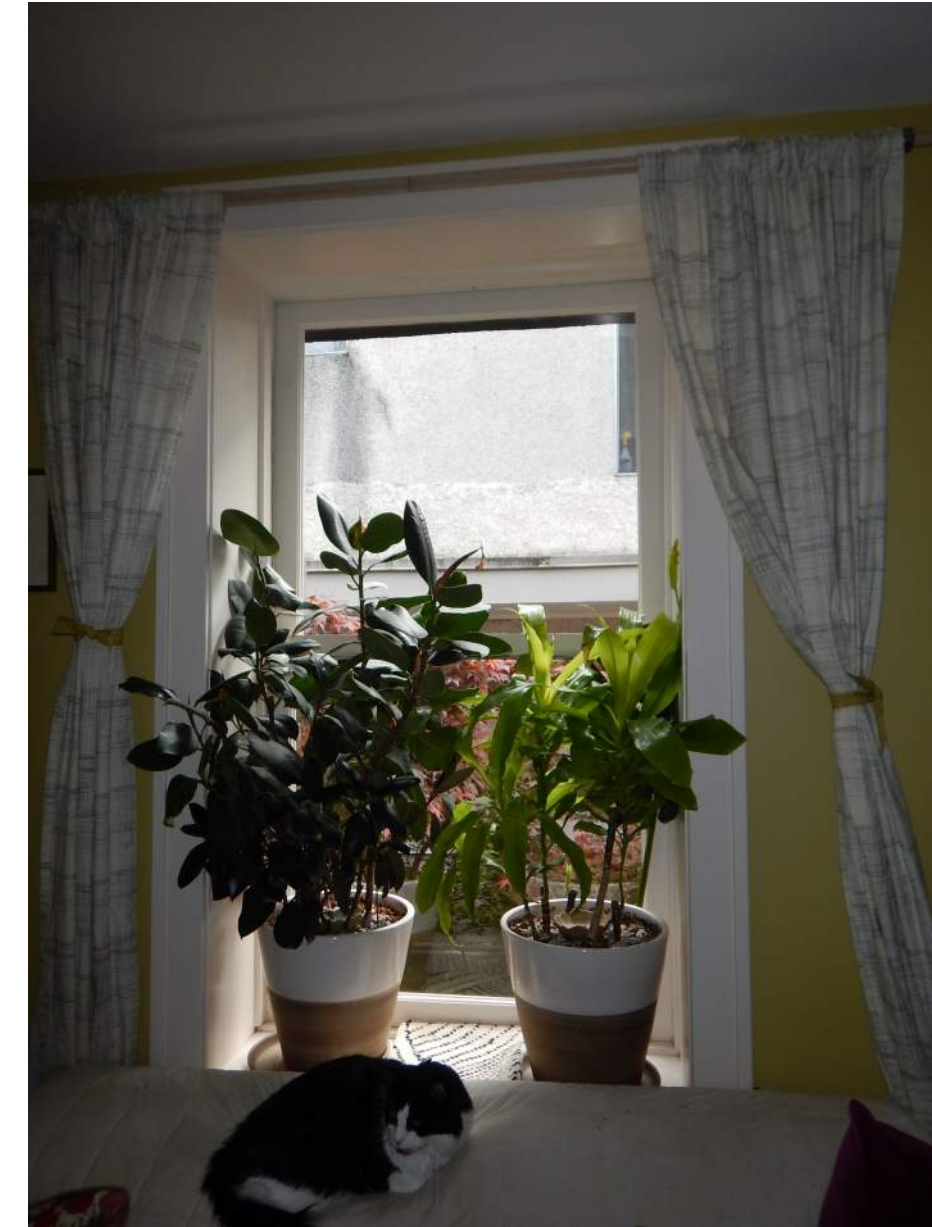
WINDOW - 31

1. Deterioration at the Sash
2. Deterioration at the Frame
3. Deterioration at Exterior Paint
4. Corroded Lintel
5. Operation Difficulty
6. Lock damage/missing/not engaging
7. Water intrusion
8. Separation at joint
9. Separation at rail/stile/muntin
10. Swelling at sill
11. Cracking of frame

Condition: Moderate

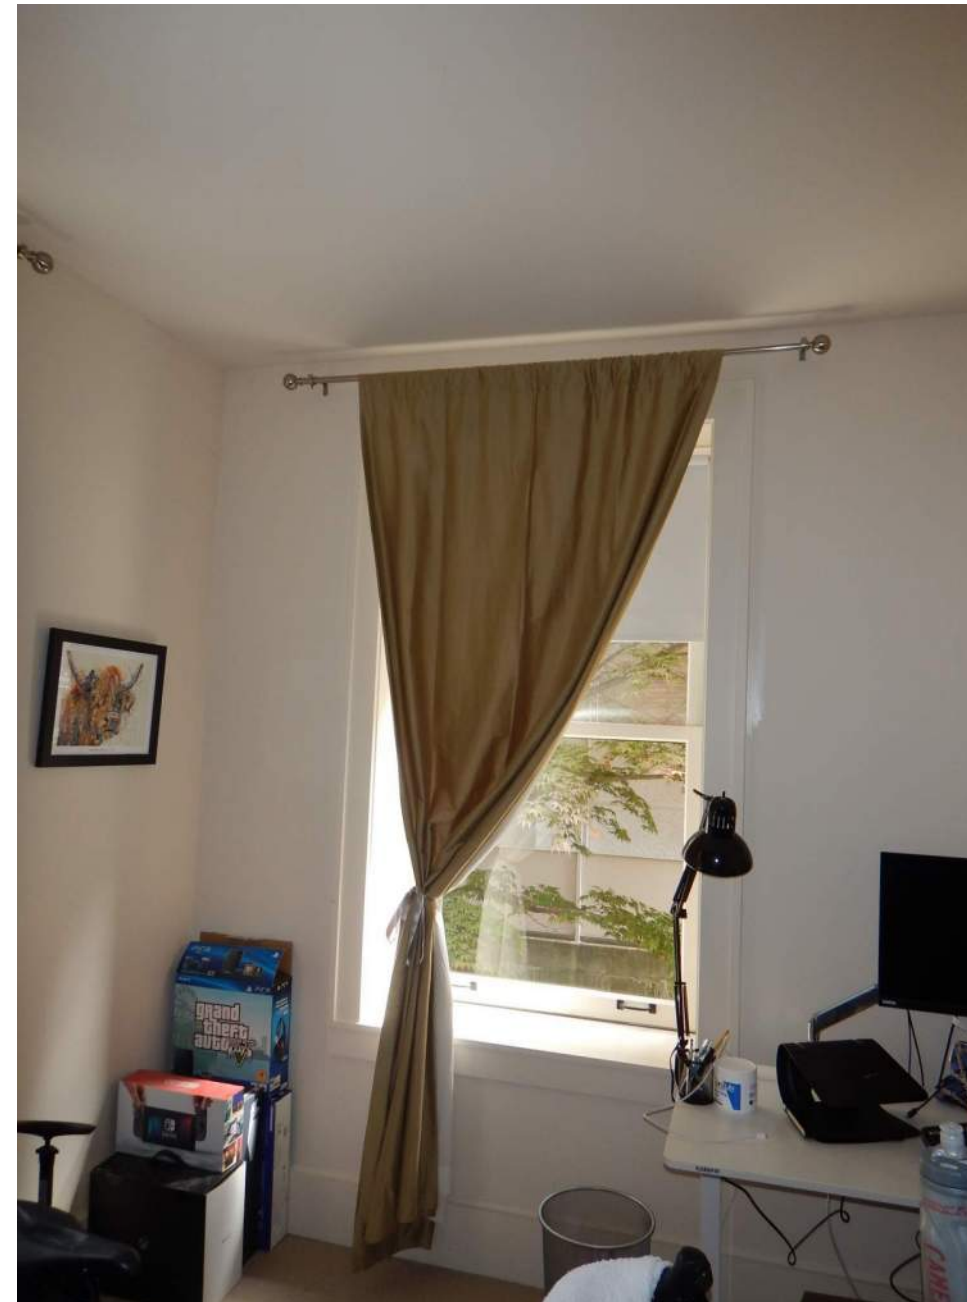
WINDOW - 32

1. Deterioration at the Sash
2. Deterioration at the Frame
3. Deterioration at Exterior Paint
4. Corroded Lintel
5. Operation Difficulty
6. Lock damage/missing/not engaging
7. Water intrusion
8. Separation at joint
9. Separation at rail/stile/muntin
10. Swelling at sill
11. Cracking of frame

Condition: Moderate

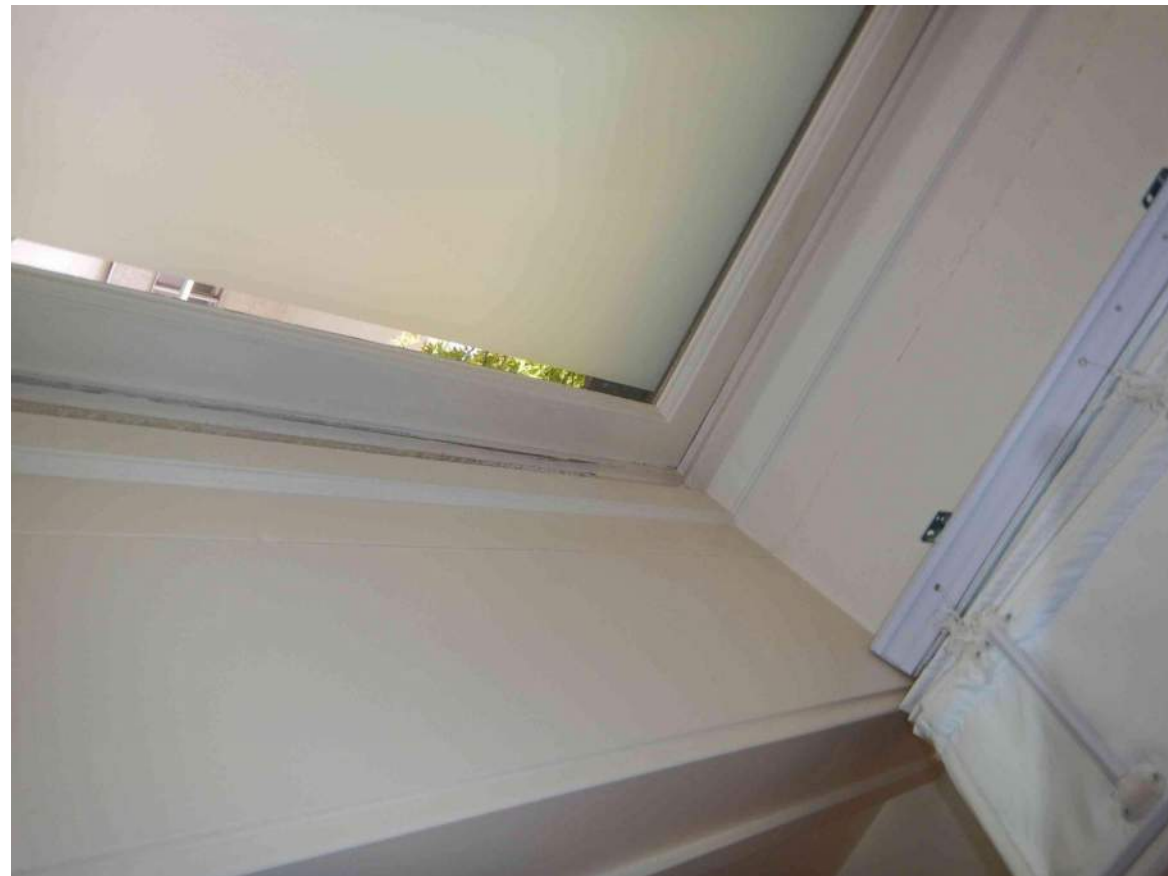
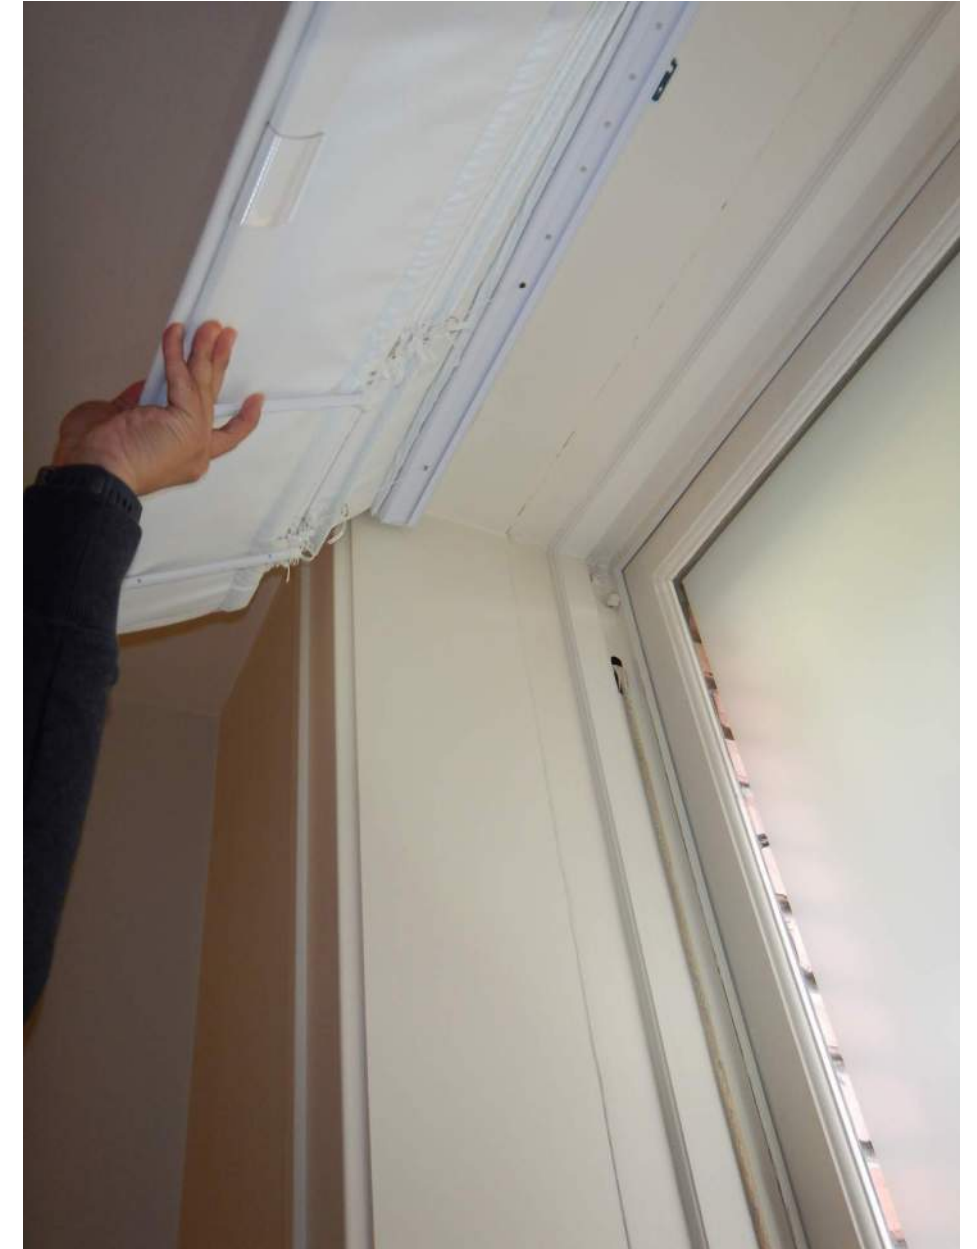
WINDOW - 33

1. Deterioration at the Sash
2. Deterioration at the Frame
3. Deterioration at Exterior Paint
4. Corroded Lintel
5. Operation Difficulty
6. Lock damage/missing/not engaging
7. Water intrusion
8. Separation at joint
9. Separation at rail/stile/muntin
10. Swelling at sill
11. Cracking of frame

Condition: Moderate

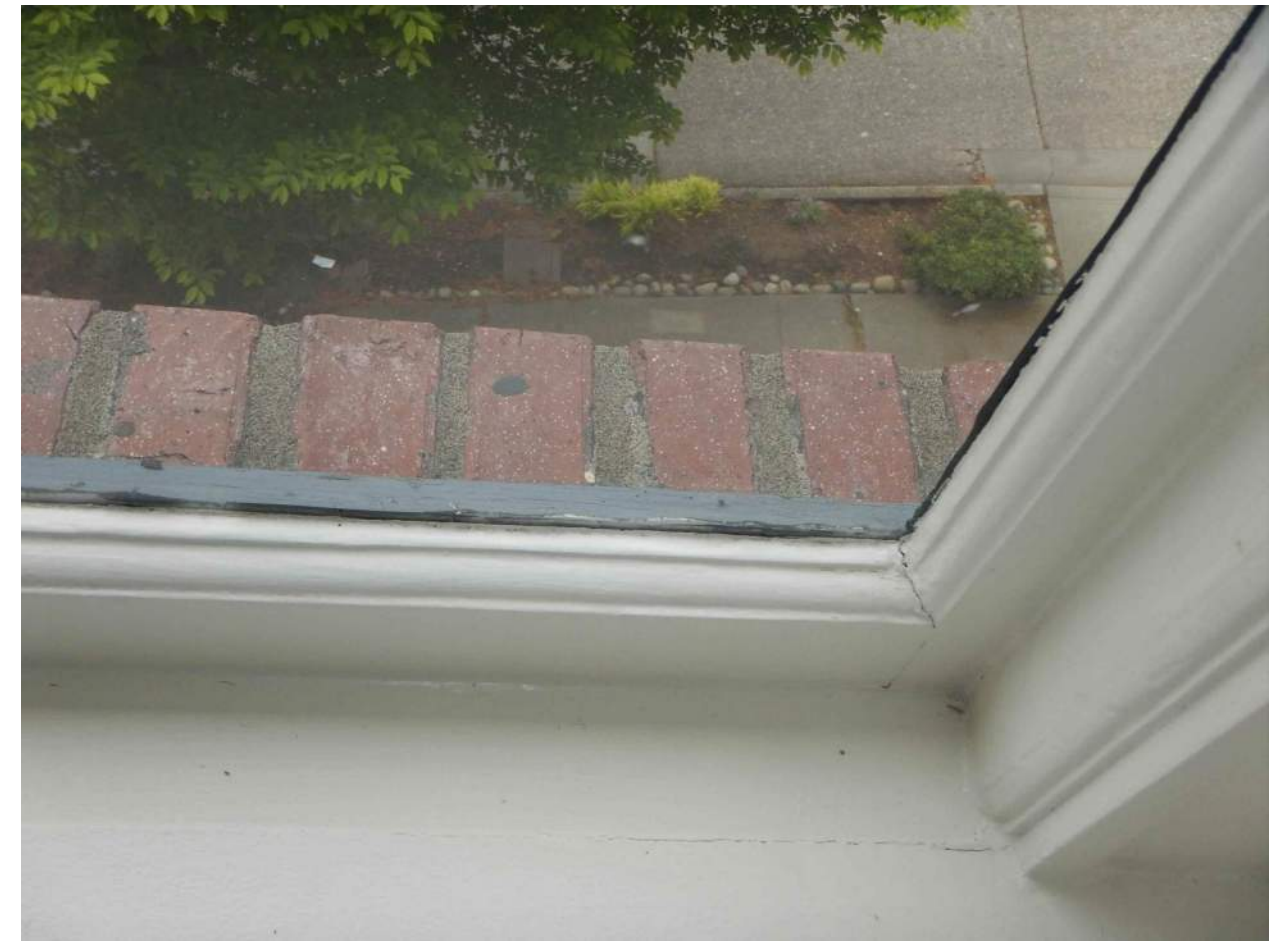
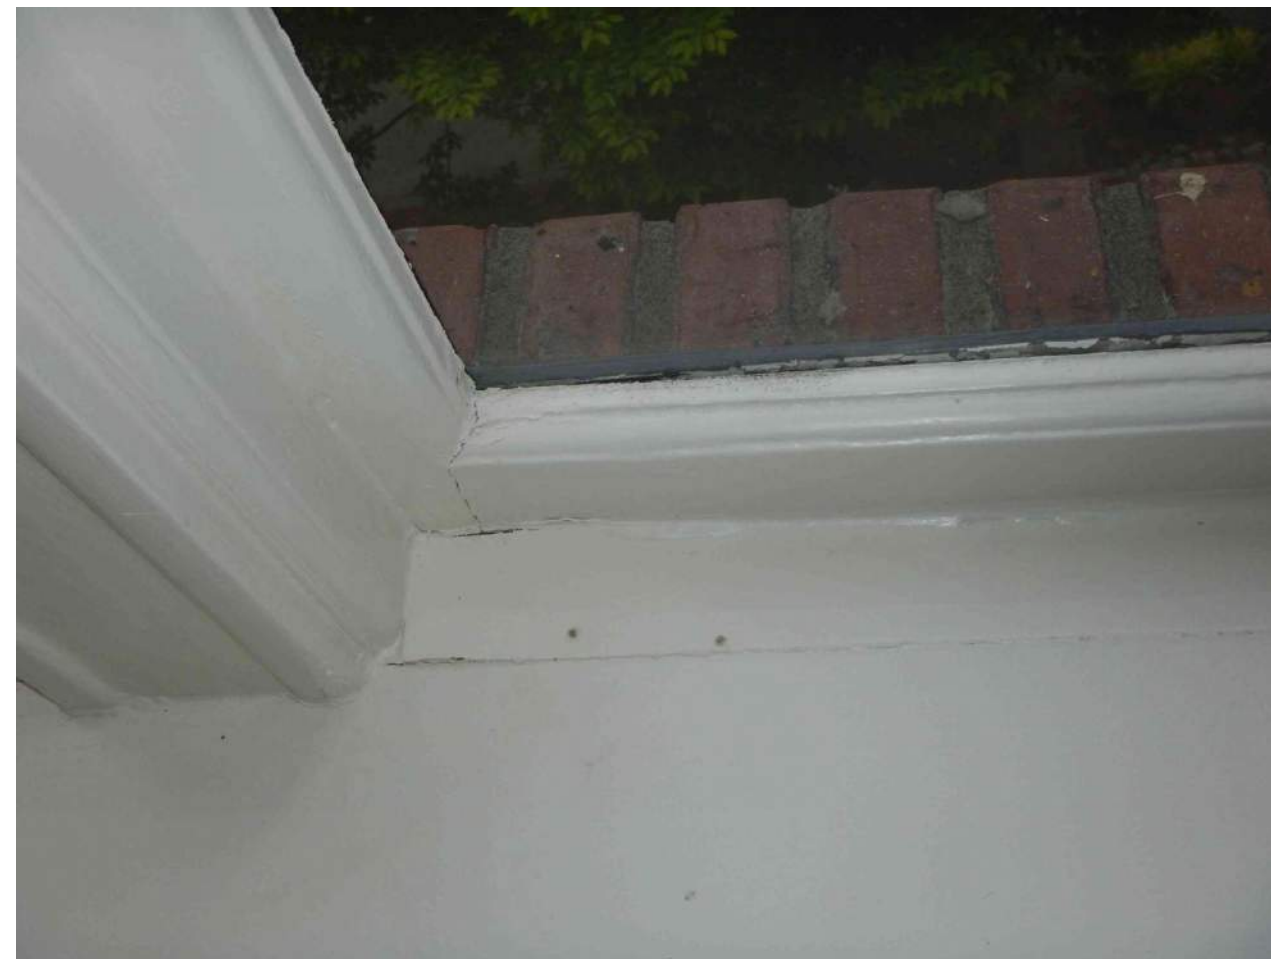
WINDOW - 34

1. Deterioration at the Sash
2. Deterioration at the Frame
3. Deterioration at Exterior Paint
4. Corroded Lintel
5. Operation Difficulty
6. Lock damage/missing/not engaging
7. Water intrusion
8. Separation at joint
9. Separation at rail/stile/muntin
10. Swelling at sill
11. Cracking of frame

Condition: Moderate

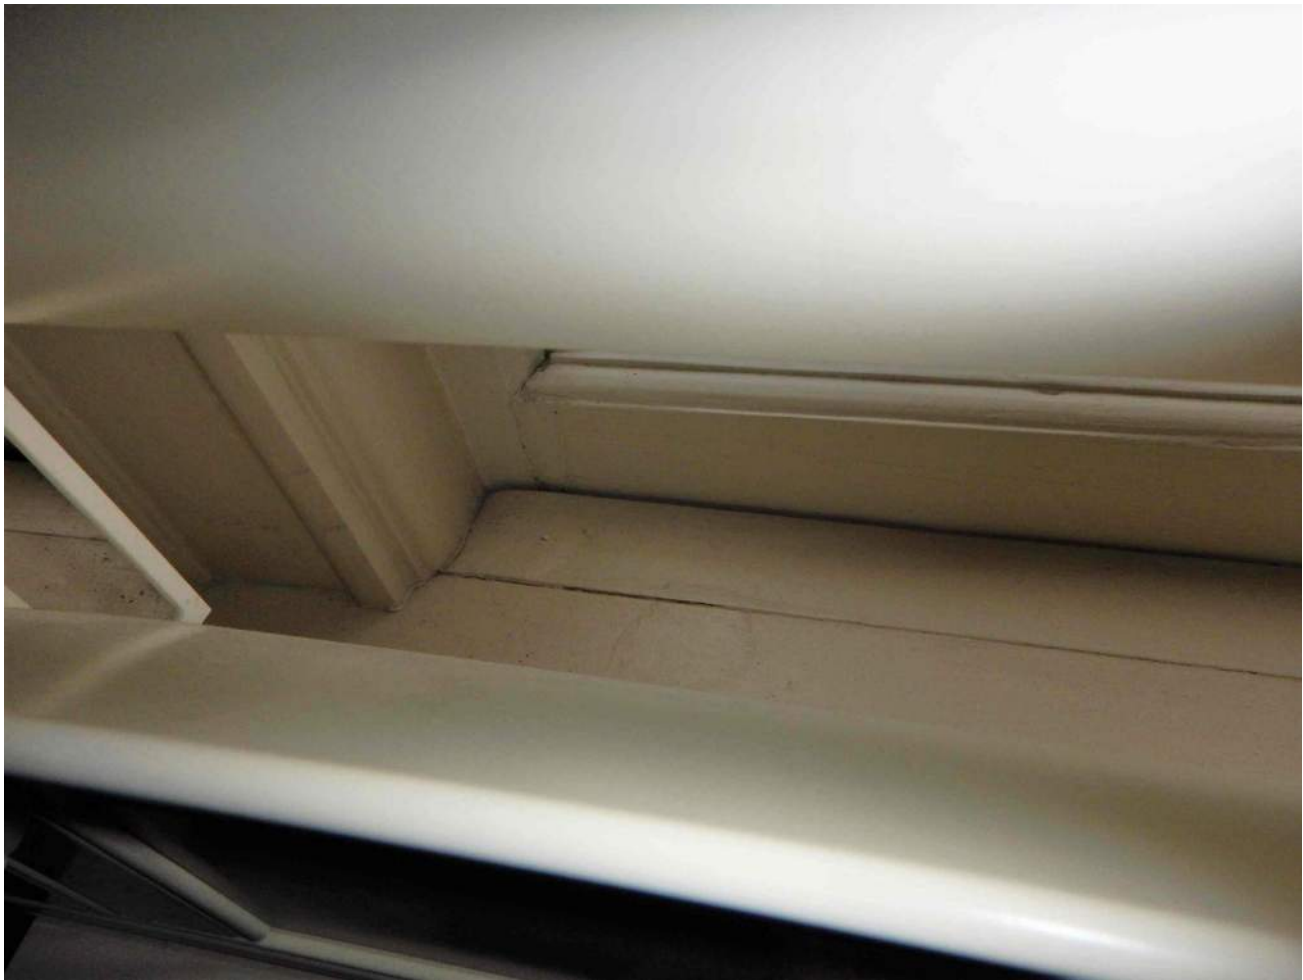
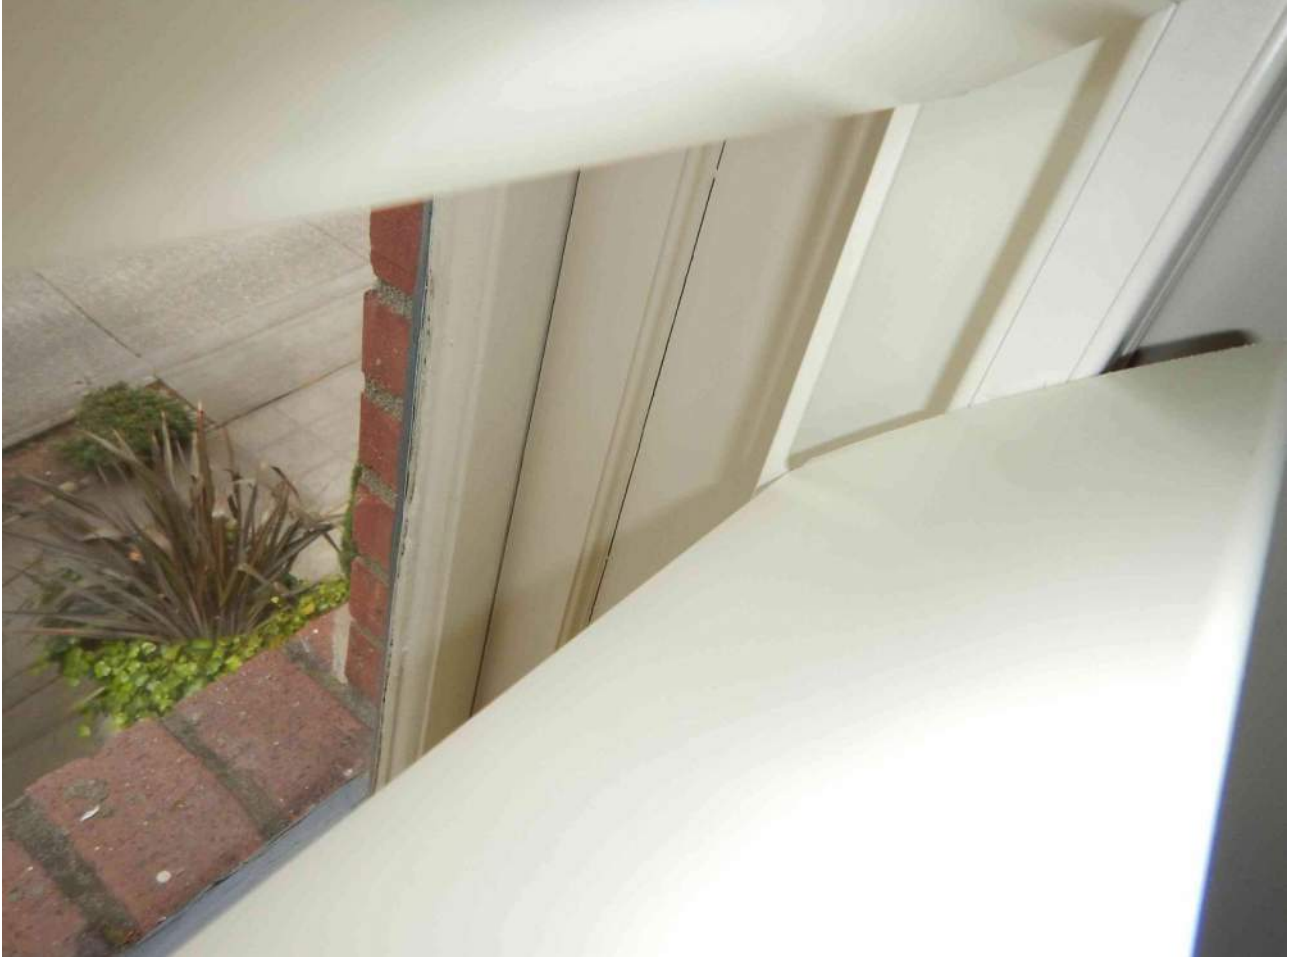
WINDOW - 35

- 1. Deterioration at the Sash
- 2. Deterioration at the Frame
- 3. Deterioration at Exterior Paint
- 4. Corroded Lintel
- 5. Operation Difficulty
- 6. Lock damage/missing/not engaging
- 7. Water intrusion
- 8. Separation at joint
- 9. Separation at rail/stile/muntin
- 10. Swelling at sill
- 11. Cracking of frame

Condition: Moderate

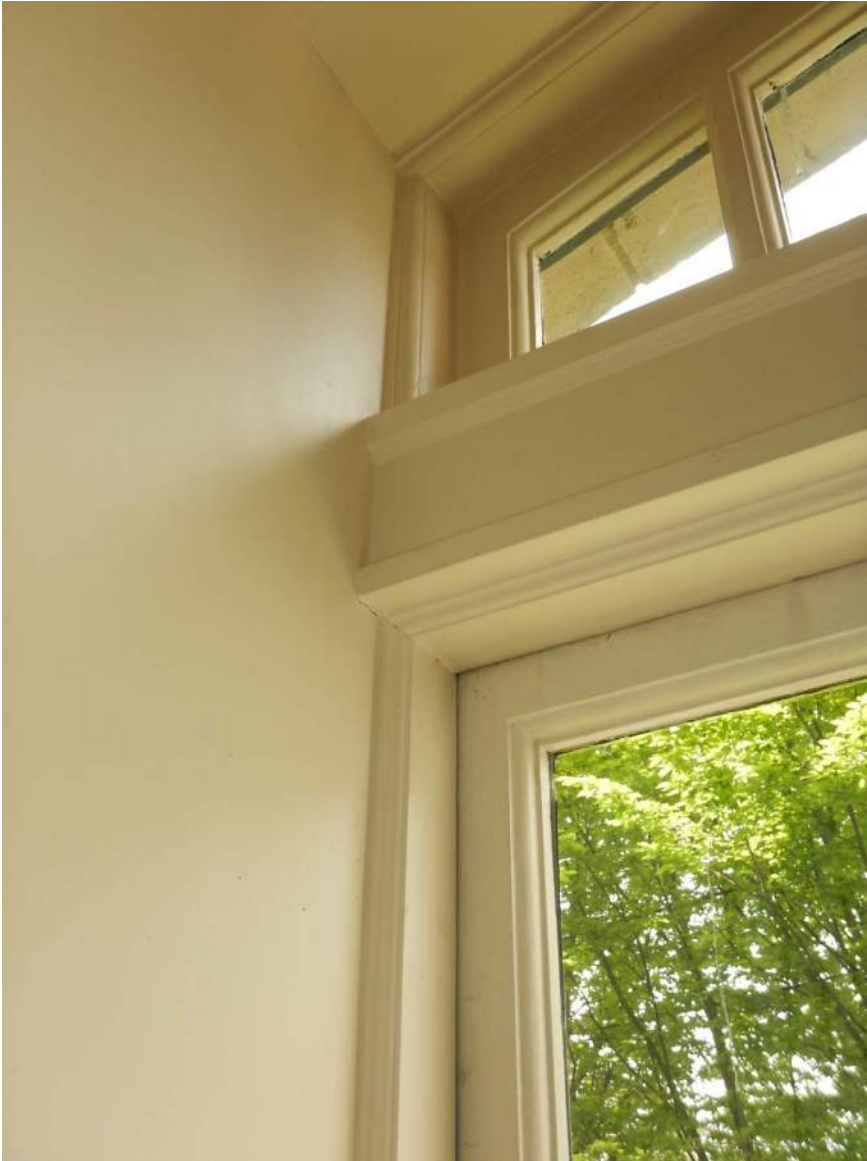
WINDOW - 36

- 1. Deterioration at the Sash
- 2. Deterioration at the Frame
- 3. Deterioration at Exterior Paint
- 4. Corroded Lintel
- 5. Operation Difficulty
- 6. Lock damage/missing/not engaging
- 7. Water intrusion
- 8. Separation at joint
- 9. Separation at rail/stile/muntin
- 10. Swelling at sill
- 11. Cracking of frame

Condition: Moderate

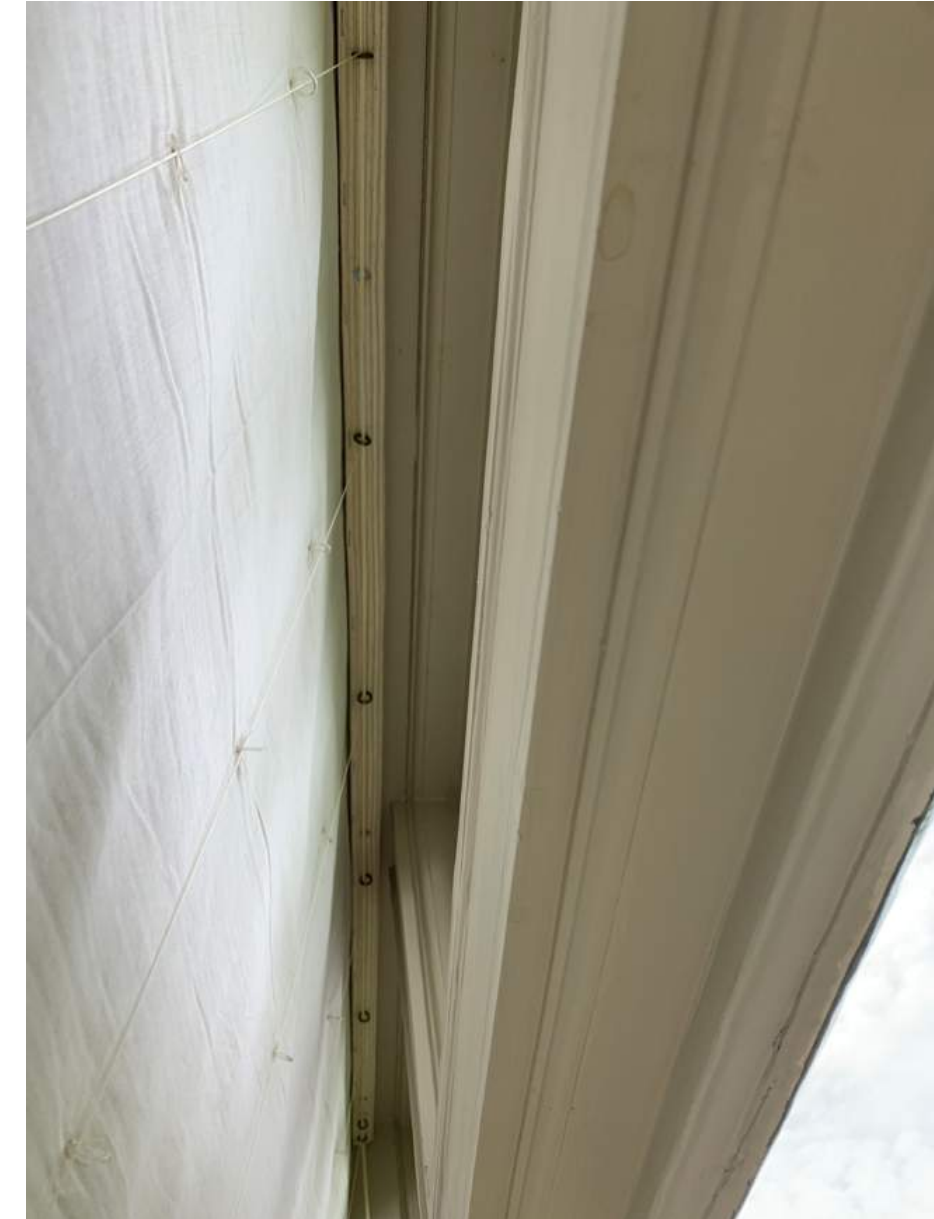
1. Deterioration at the Sash
2. Deterioration at the Frame
3. Deterioration at Exterior Paint
4. Corroded Lintel
5. Operation Difficulty
6. Lock damage/missing/not engaging
7. Water intrusion
8. Separation at joint
9. Separation at rail/stile/muntin
10. Swelling at sill
11. Cracking of frame

Condition: Moderate

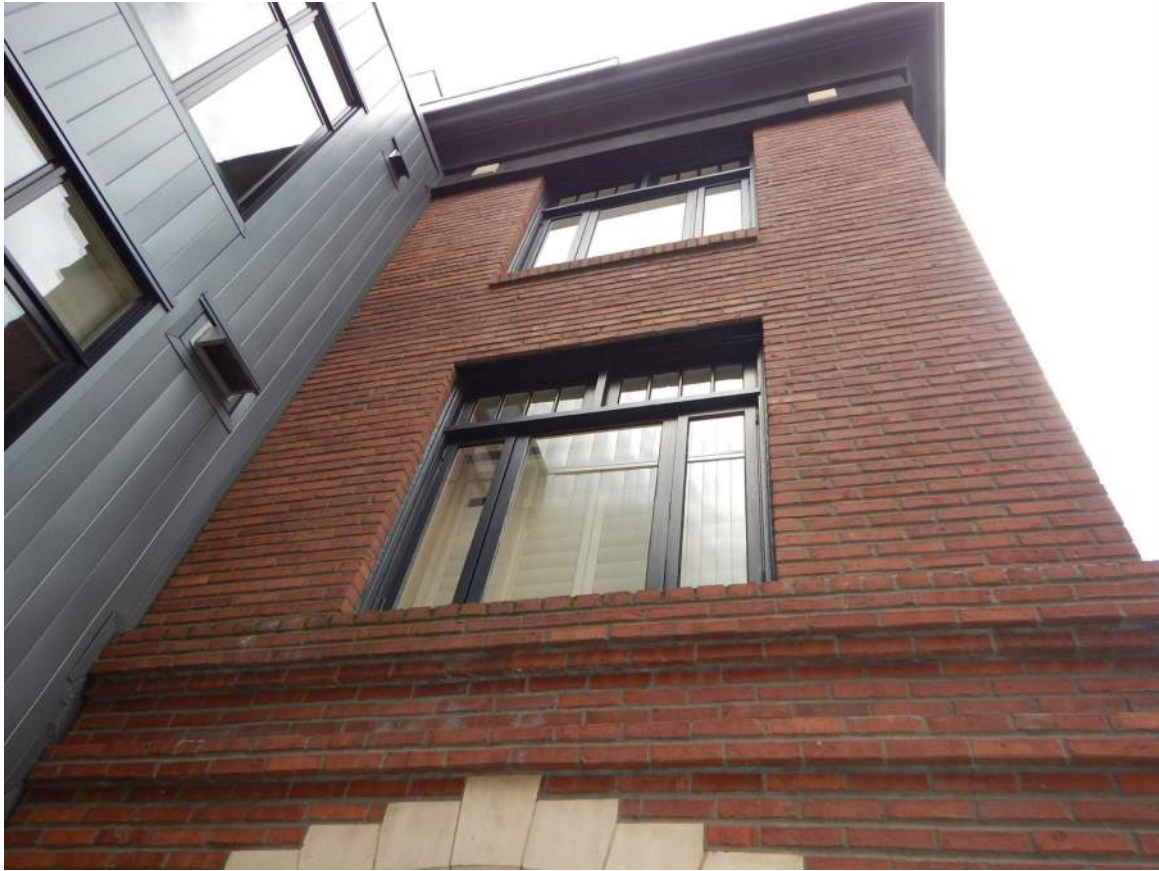
- 1. Deterioration at the Sash
- 2. Deterioration at the Frame
- 3. Deterioration at Exterior Paint
- 4. Corroded Lintel
- 5. Operation Difficulty
- 6. Lock damage/missing/not engaging
- 7. Water intrusion
- 8. Separation at joint
- 9. Separation at rail/stile/muntin
- 10. Swelling at sill
- 11. Cracking of frame

Condition: Moderate

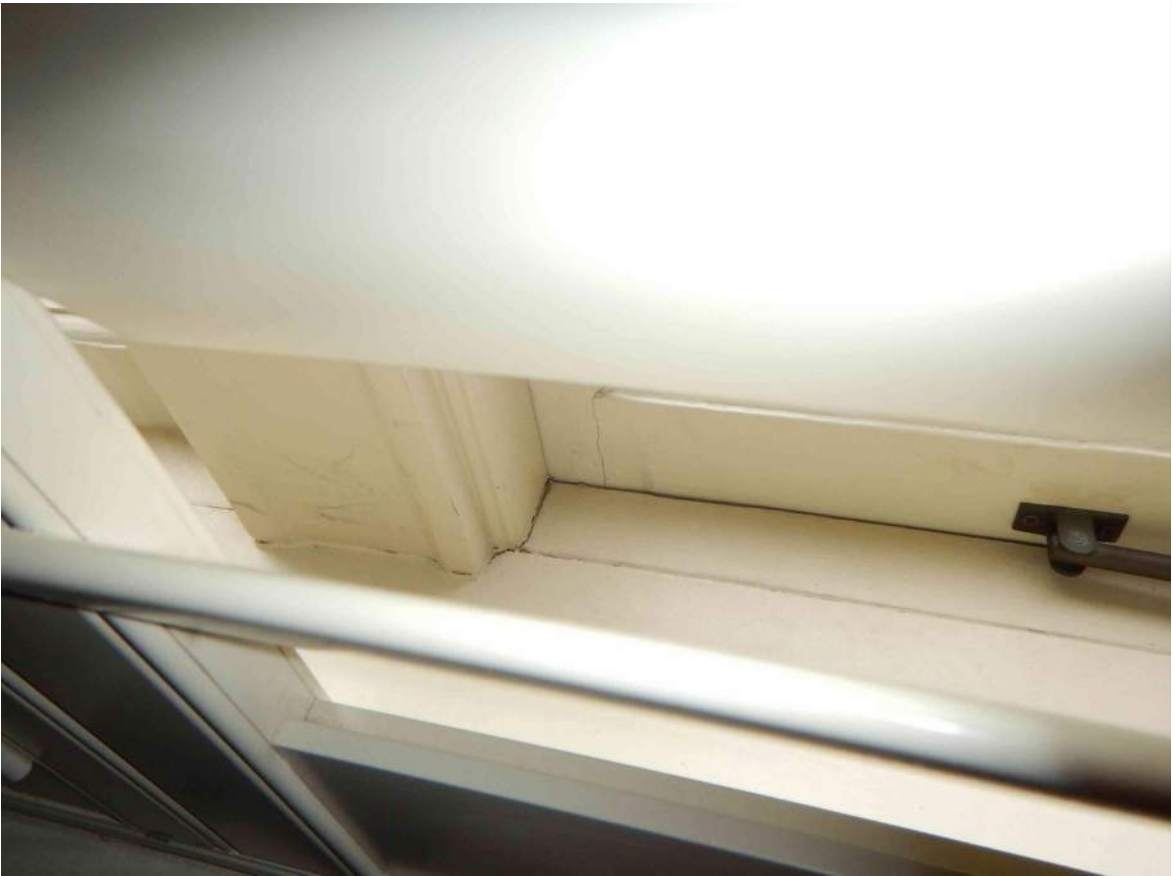
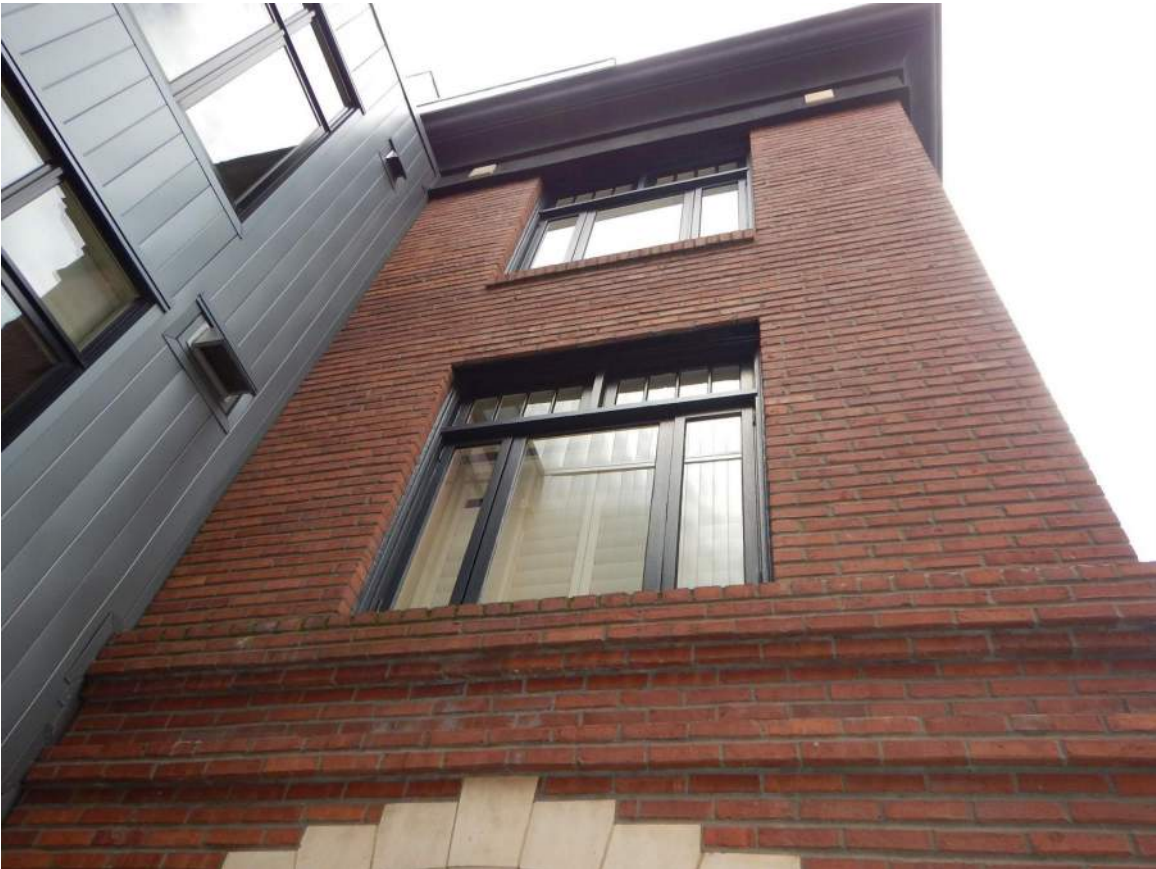
WINDOW - 41

- 1. Deterioration at the Sash
- 2. Deterioration at the Frame
- 3. Deterioration at Exterior Paint
- 4. Corroded Lintel
- 5. Operation Difficulty
- 6. Lock damage/missing/not engaging
- 7. Water intrusion
- 8. Separation at joint
- 9. Separation at rail/stile/muntin
- 10. Swelling at sill
- 11. Cracking of frame

Condition: Moderate

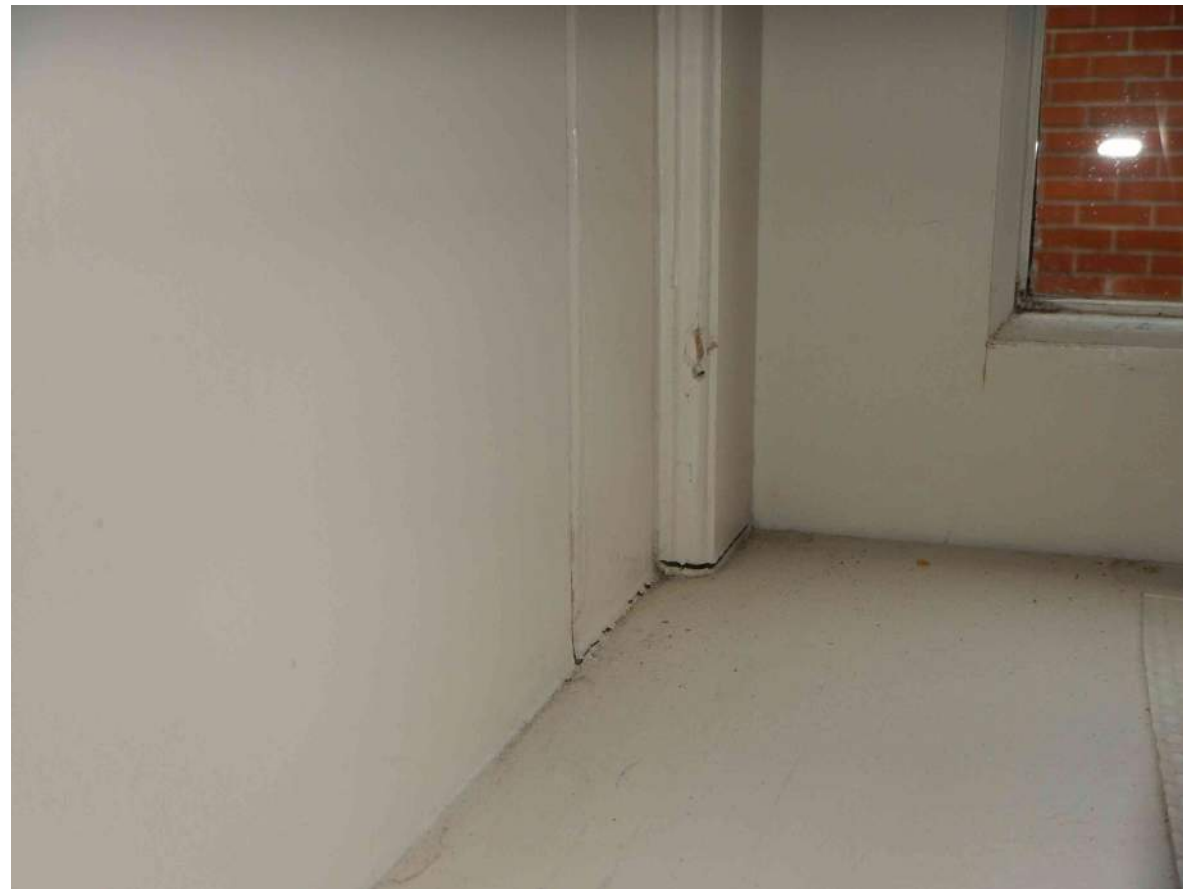
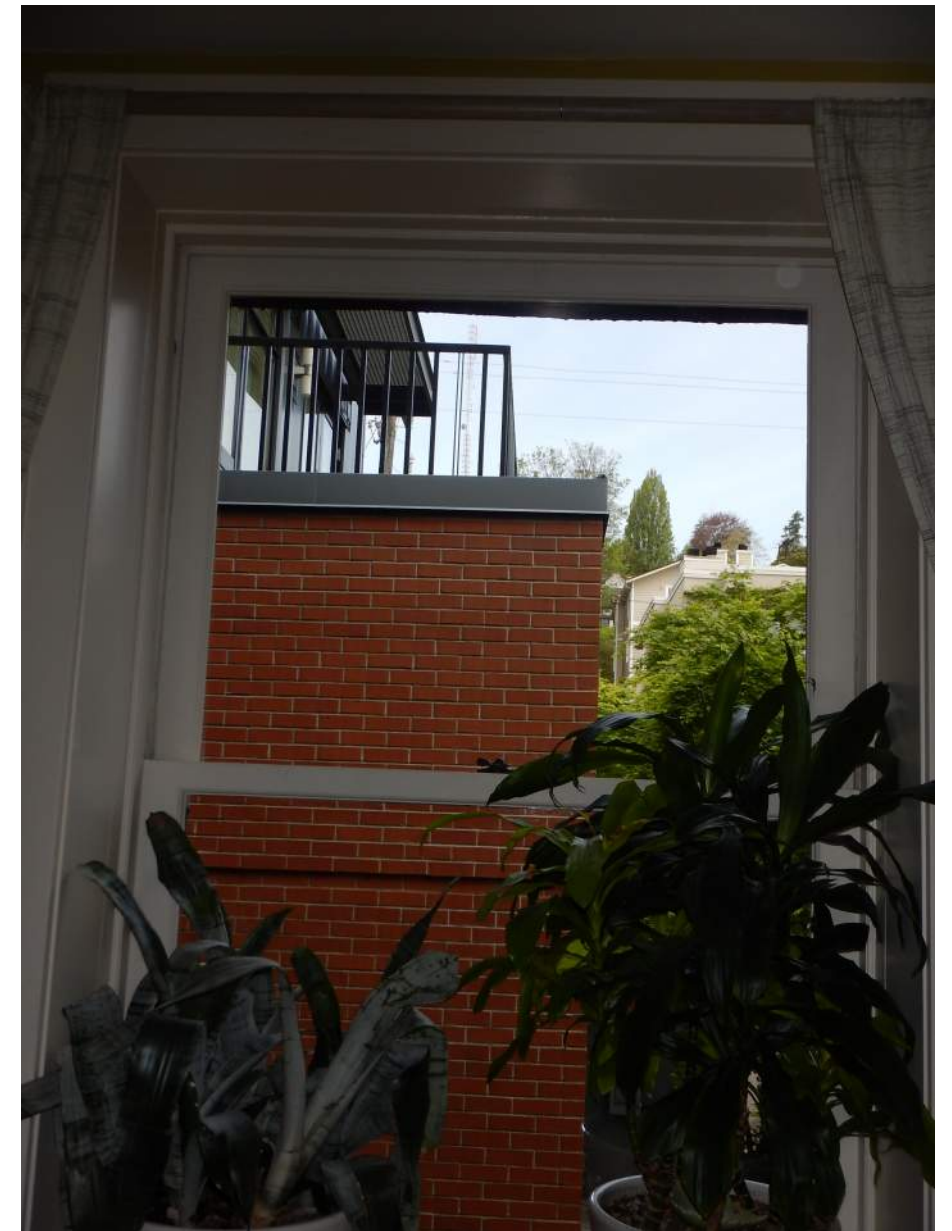
1. Deterioration at the Sash
2. Deterioration at the Frame
3. Deterioration at Exterior Paint
4. Corroded Lintel
5. Operation Difficulty
6. Lock damage/missing/not engaging
7. Water intrusion
8. Separation at joint
9. Separation at rail/stile/muntin
10. Swelling at sill
11. Cracking of frame

Condition: Moderate
