LEONA CONDOMINIUMS REMEDIATION

916 QUEEN ANNE AVE. N, SEATTLE, WA 98109

WINDOW REPLACEMENT PROPOSAL

THE SURVEY OF WINDOWS AND DOORS AT THE LEONA CONDOS WERE COMPLETED IN APRIL 2021. MOST OF THE WINDOWS APPEAR TO HAVE DETERIORATED AND THE CONDITION OF THE WINDOWS/DOORS HAVE WORSEN FOR THE LAST TWO YEARS.

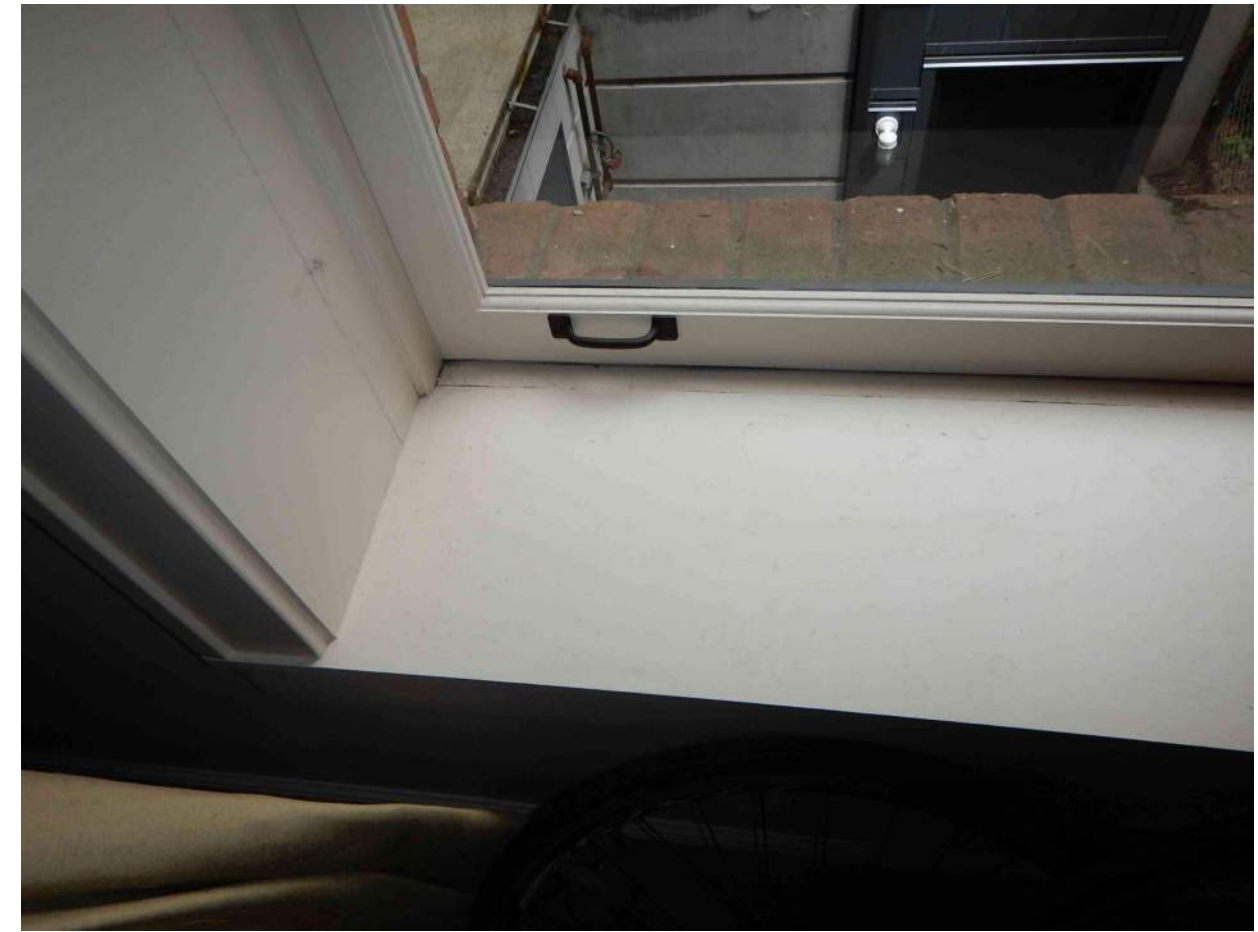
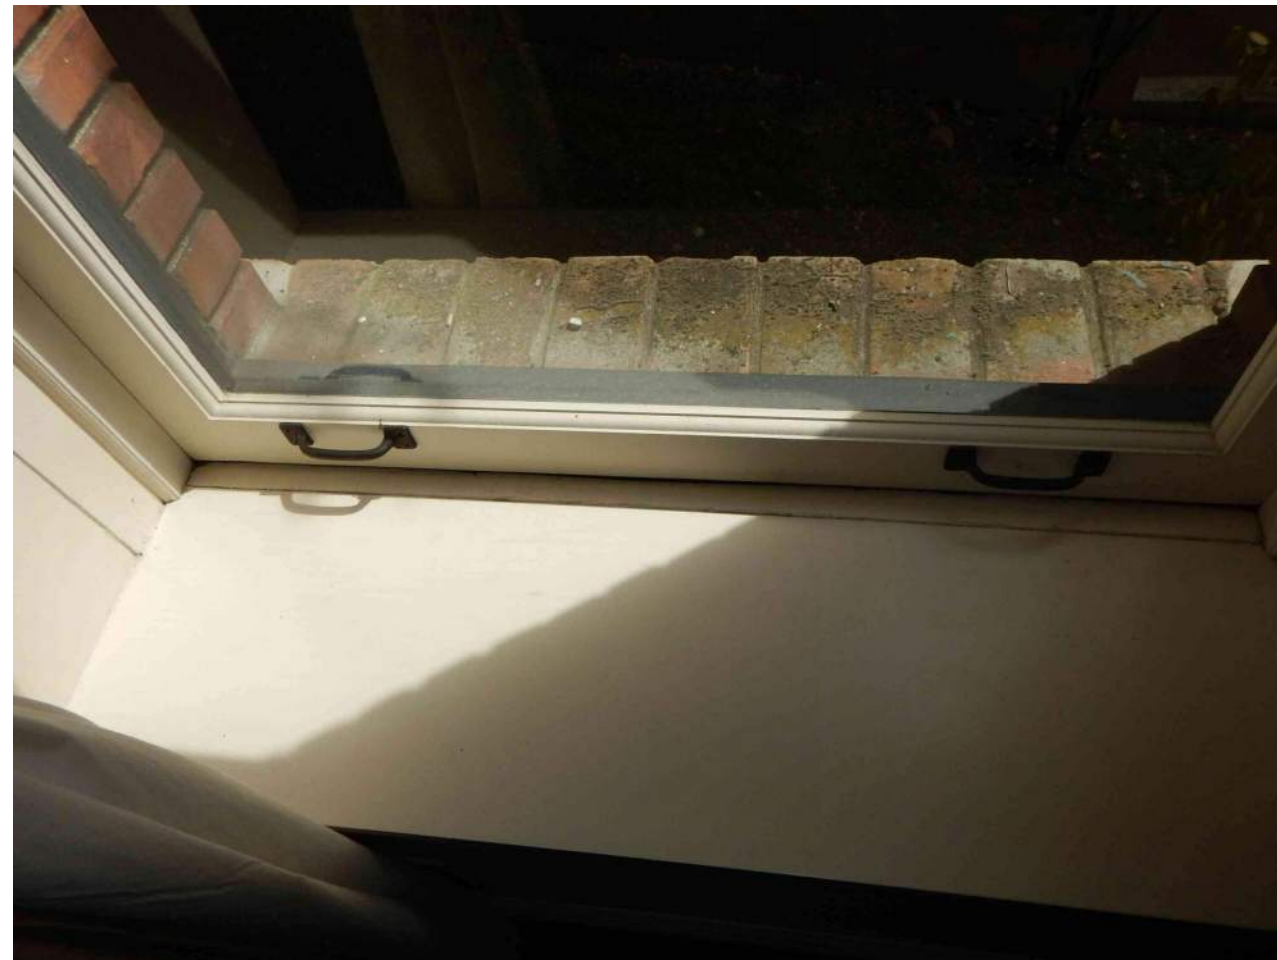
WINDOW - 44

1. Deterioration at the Sash
2. Deterioration at the Frame
3. Deterioration at Exterior Paint
4. Corroded Lintel
5. Operation Difficulty
6. Lock damage/missing/not engaging
7. Water intrusion
8. Separation at joint
9. Separation at rail/stile/muntin
10. Swelling at sill
11. Cracking of frame

Condition: Moderate

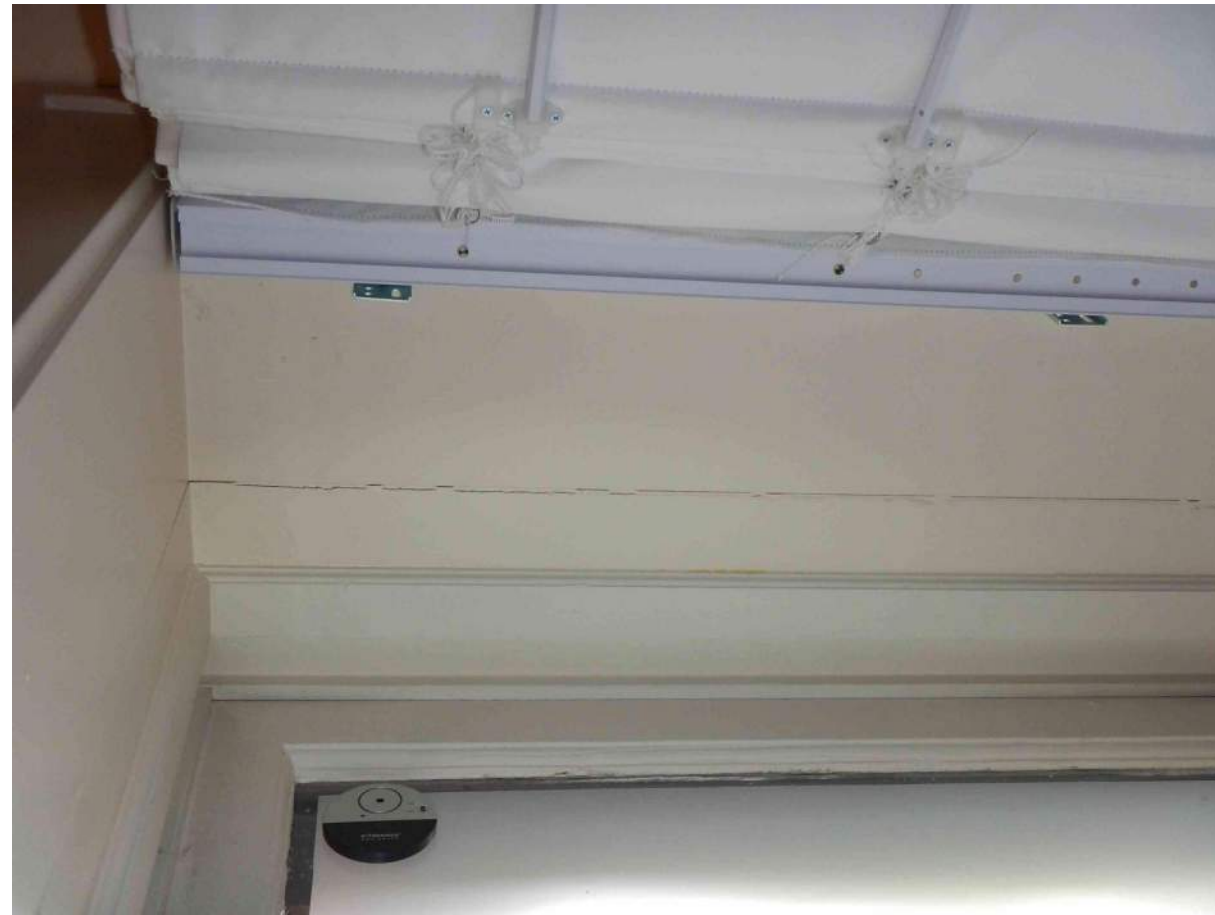
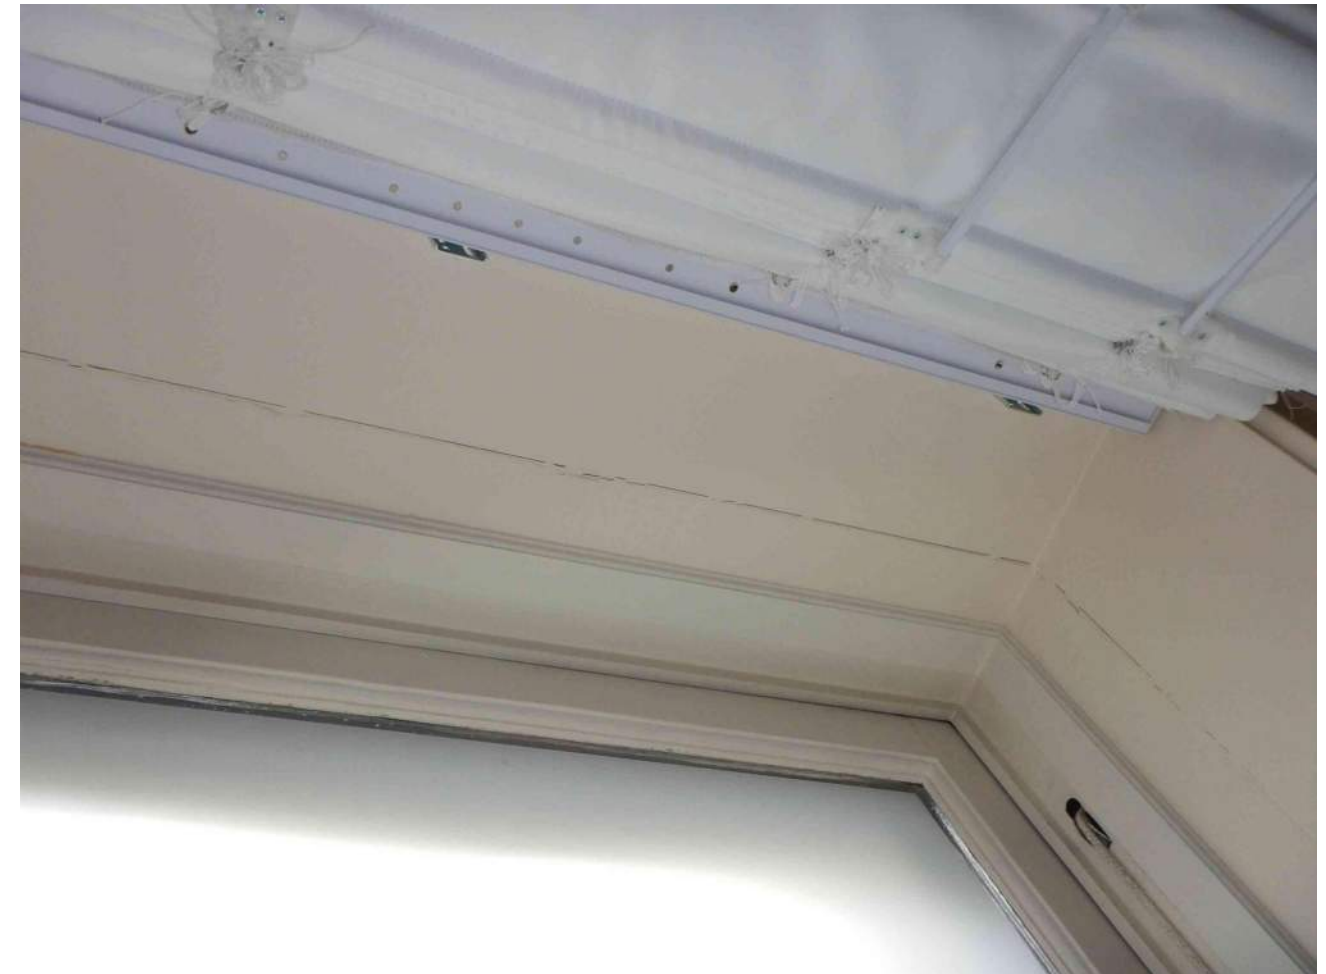
WINDOW - 45

1. Deterioration at the Sash
2. Deterioration at the Frame
3. Deterioration at Exterior Paint
4. Corroded Lintel
5. Operation Difficulty
6. Lock damage/missing/not engaging
7. Water intrusion
8. Separation at joint
9. Separation at rail/stile/muntin
10. Swelling at sill
11. Cracking of frame

Condition: Moderate

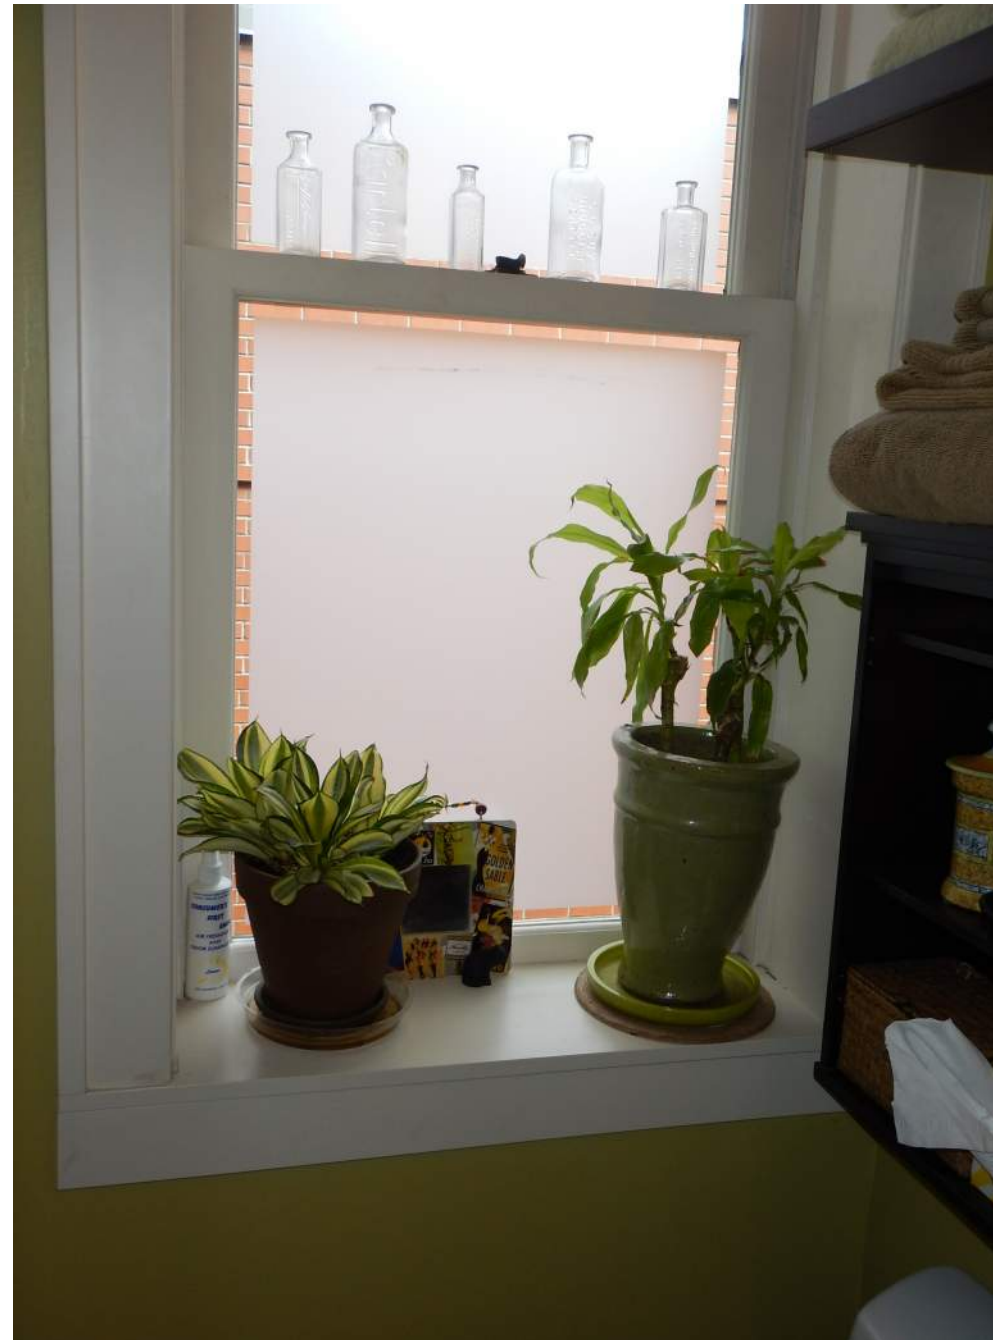
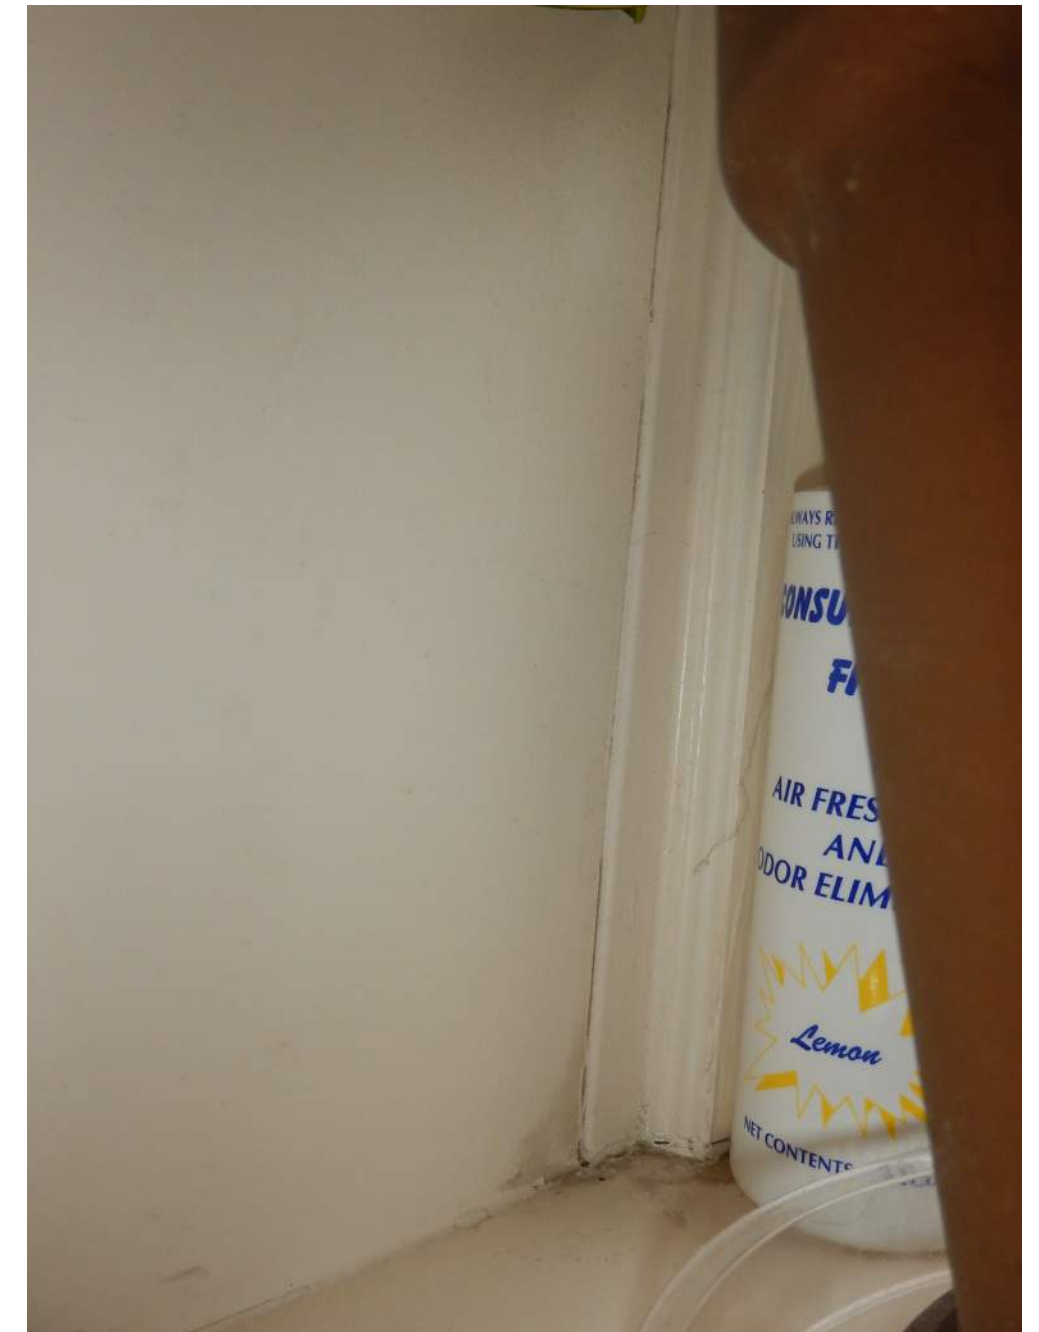
WINDOW - 46

1. Deterioration at the Sash
2. Deterioration at the Frame
3. Deterioration at Exterior Paint
4. Corroded Lintel
5. Operation Difficulty
6. Lock damage/missing/not engaging
7. Water intrusion
8. Separation at joint
9. Separation at rail/stile/muntin
10. Swelling at sill
11. Cracking of frame

Condition: Moderate
