DESCRIPTION OF PROPOSED WORK – Medallion Lintels:

BUILDING AND PROJECT BACKGROUND:

Seattle Tower is a mixed-use retail and office building located at 1218 Third Avenue in downtown Seattle. Constructed in 1929, the Seattle Tower integrated its design elements within a single system that created a building of enduring strength and stature. The use of setbacks and vertical piers, a lightening of the brick color as it climbs towards the sky, the limited use of horizontal lines, and a finished form on all four sides come together to create a distinct and notable icon in downtown Seattle. The interior features of the building are equally impressive with elaborate bronze work, extensive use of marble, custom hardware, and design motifs.

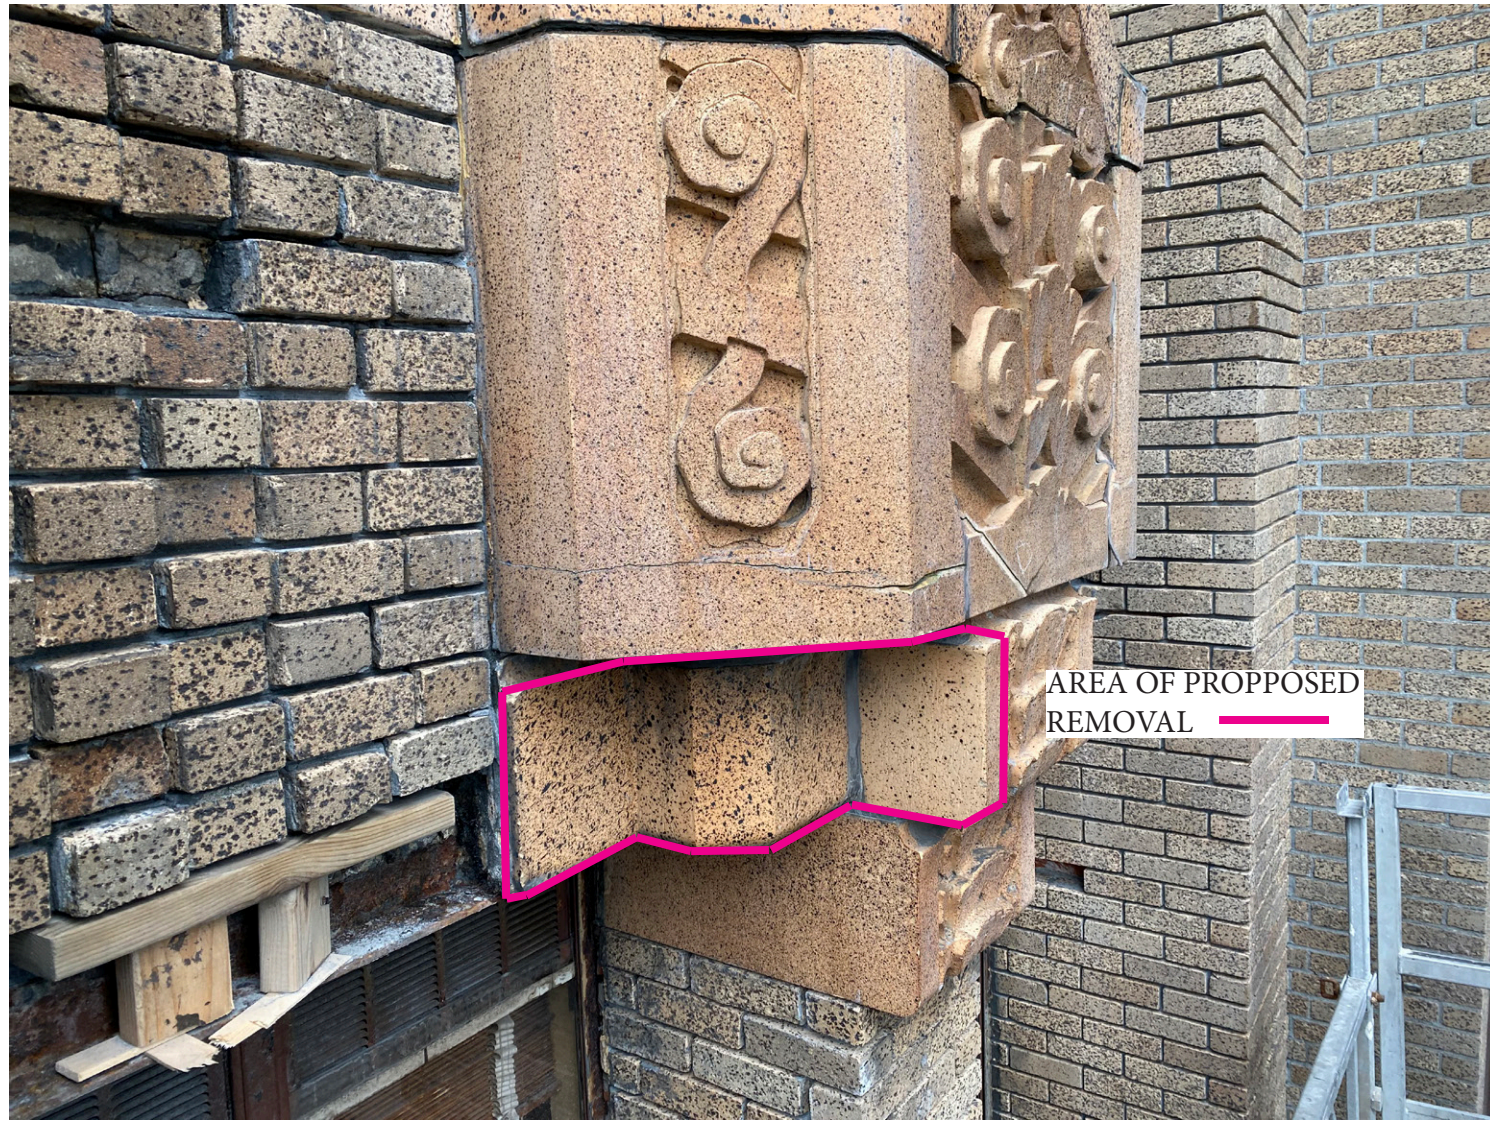
In preparation for the work, the contractor examined one interface and found extensive damage to the point the terracotta accent piece came off in chunks during the investigation. We understand that while an investigation is not necessarily representative of a naturally occurring process, over time this breakage would have happened due to weather, which would lead to pieces falling off and onto the structure or street below. Visual inspections at other locations show relatively similar levels of damage at the other fourteen medallion locations.

DETAIL OF DAMAGE AT LINTEL, BRICK, AND TERRACOTTA MEDALLION INTERFACE, TYPICAL OF ALL LOCATIONS TO VARYING DEGREES.

THESE IMAGES SHOW THE EXISTING DETERIORATION AND DAMAGE AT THE LINTEL, BRICK, AND TERRACOTTA INTERFACE AND THE REASON THE REPAIRS IS SO NECESSARY.

At each lintel and medallion location, the contractor will provide abatement to remove the terracotta block, surrounding brick units, and damaged lintels. The contractor will carefully remove and record each brick so they may be reinstalled after the repair work. However, even with the most careful precautions, the contractor may damage bricks and if that occurs, they will replace them with new bricks to match as closely as possible those that were removed.

To access the lintels, the contractor will remove the side terracotta accent pieces taking care not to damage the existing secondary support and primary medallion pieces. The contractor will provide shoring at each location to support the surrounding bricks and terra cotta during the lintel repair. Following the repair, the contractor

will rebuild the surrounding masonry wall. Where the contractor removed the terracotta block, they will install new bricks to emulate the form and detail of the prior terracotta side support. The contractor will color match these new bricks as closely as possible to the adjacent existing terracotta.

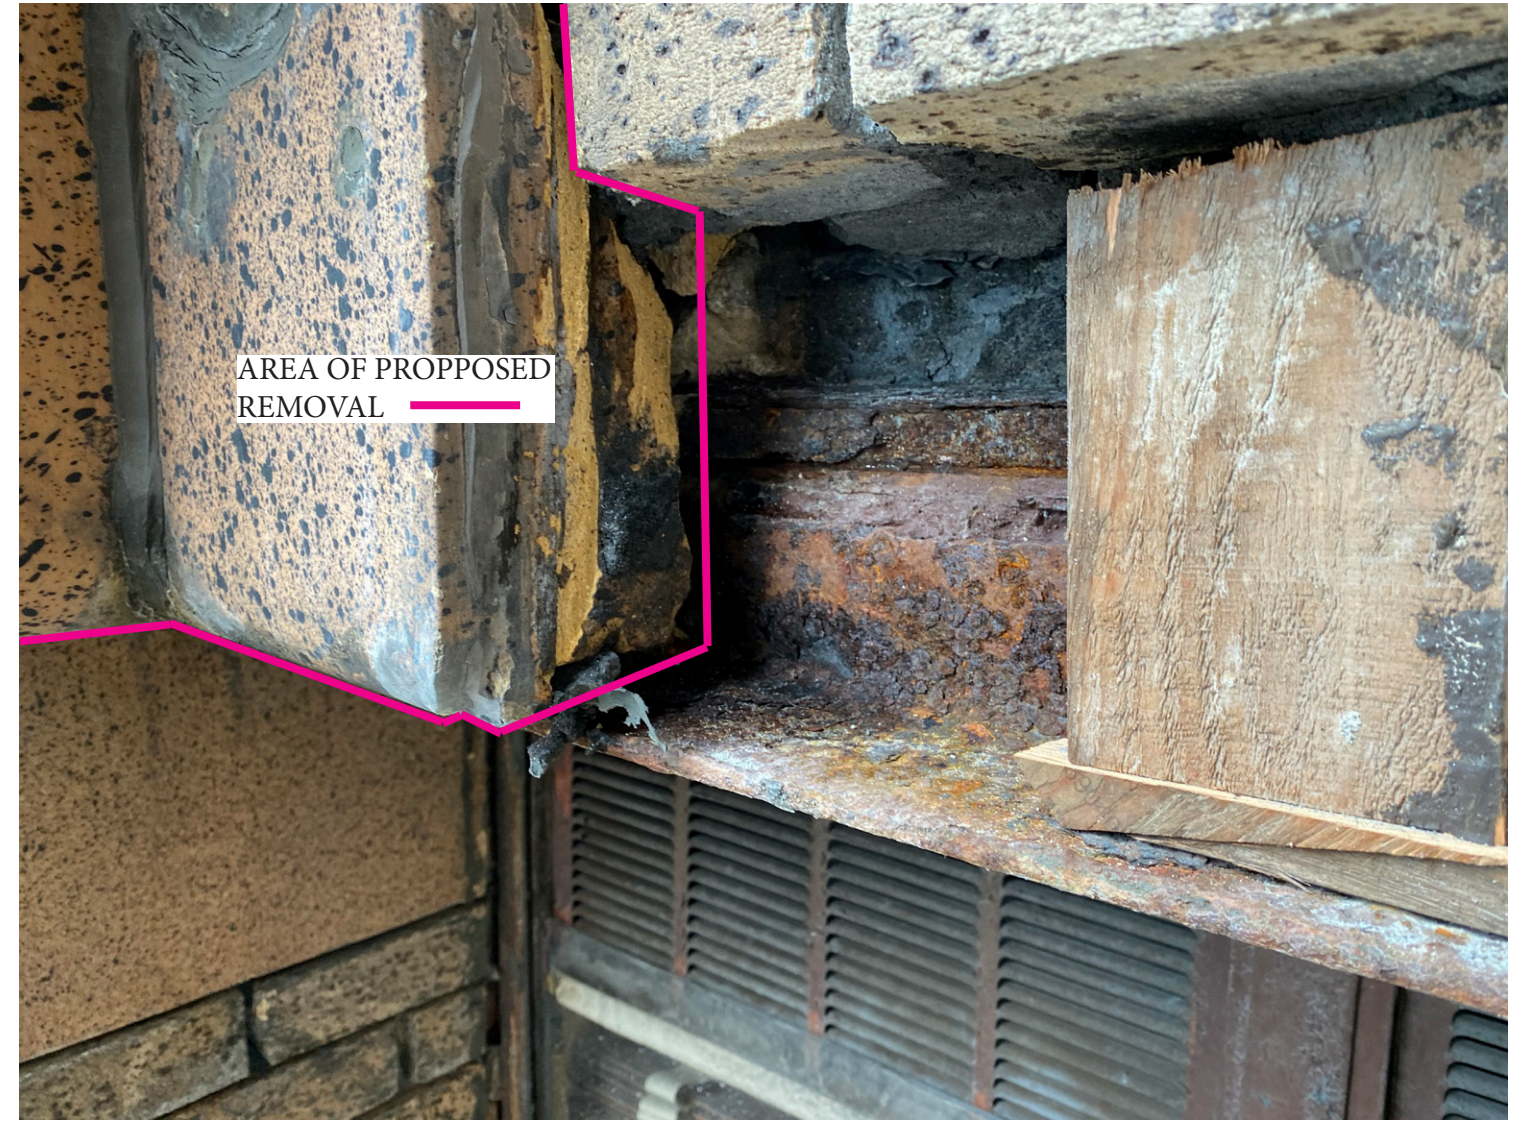
DETAIL OF DAMAGE AT LINTEL, BRICK, AND TERRACOTTA MEDALLION INTERFACE, TYPICAL OF ALL LOCATIONS TO VARYING DEGREES.
