DESCRIPTION OF PROPOSED WORK – Medallion Lintels:

Certificate of Approval Application

Seattle Tower

DESCRIPTION OF PROPOSED WORK – Exterior Column Vents:

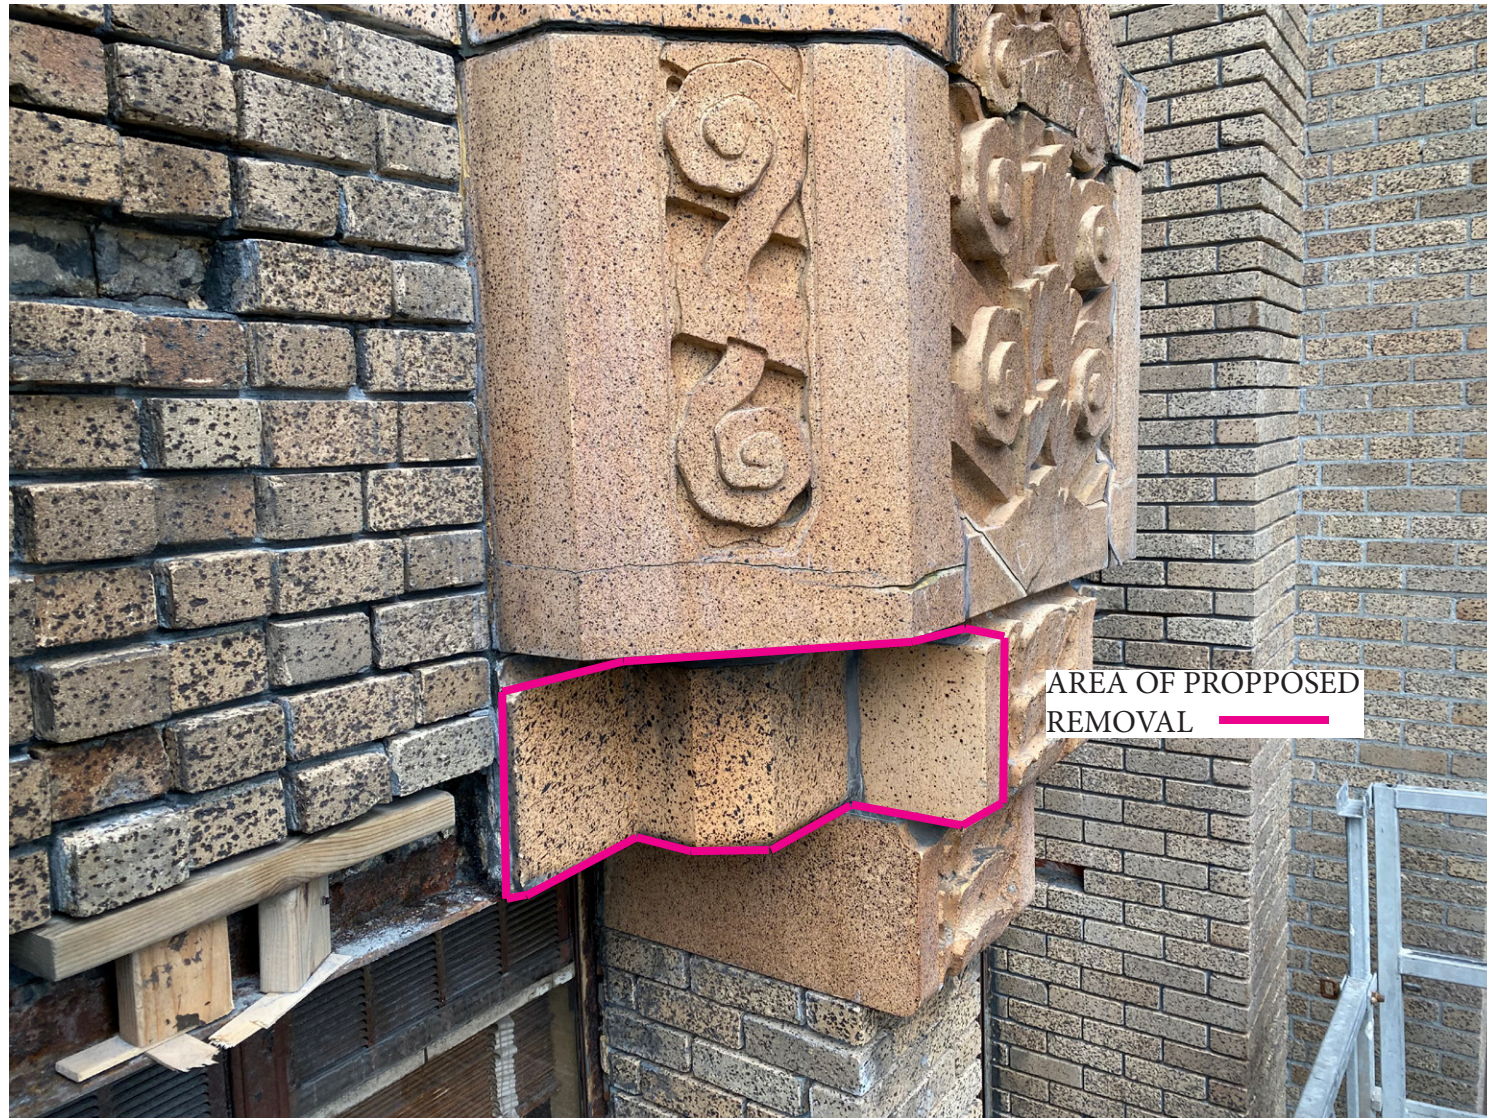
In preparation for the work, the contractor examined one interface and found extensive damage to the point the terracotta accent piece came off in chunks during the investigation. We understand that while an investigation is not necessarily representative of a naturally occurring process, over time this breakage would have happened due to weather, which would lead to pieces falling off and onto the structure or street below. Visual inspections at other locations show relatively similar levels of damage at the other fourteen medallion locations.

DETAIL OF DAMAGE AT LINTEL, BRICK, AND TERRACOTTA MEDALLION INTERFACE, TYPICAL OF ALL LOCATIONS TO VARYING DEGREES.

THESE IMAGES SHOW THE EXISTING DETERIORATION AND DAMAGE AT THE LINTEL, BRICK, AND TERRACOTTA INTERFACE AND THE REASON THE REPAIRS IS SO NECESSARY.

To access the lintels, the contractor will remove the side terracotta accent pieces taking care not to damage the existing secondary support and primary medallion pieces. The contractor will provide shoring at each location to support the surrounding bricks and terra cotta during the lintel repair. Following the repair, the contractor

will rebuild the surrounding masonry wall. Where the contractor removed the terracotta block, they will install new bricks to emulate the form and detail of the prior terracotta side support. The contractor will color match these new bricks as closely as possible to the adjacent existing terracotta.

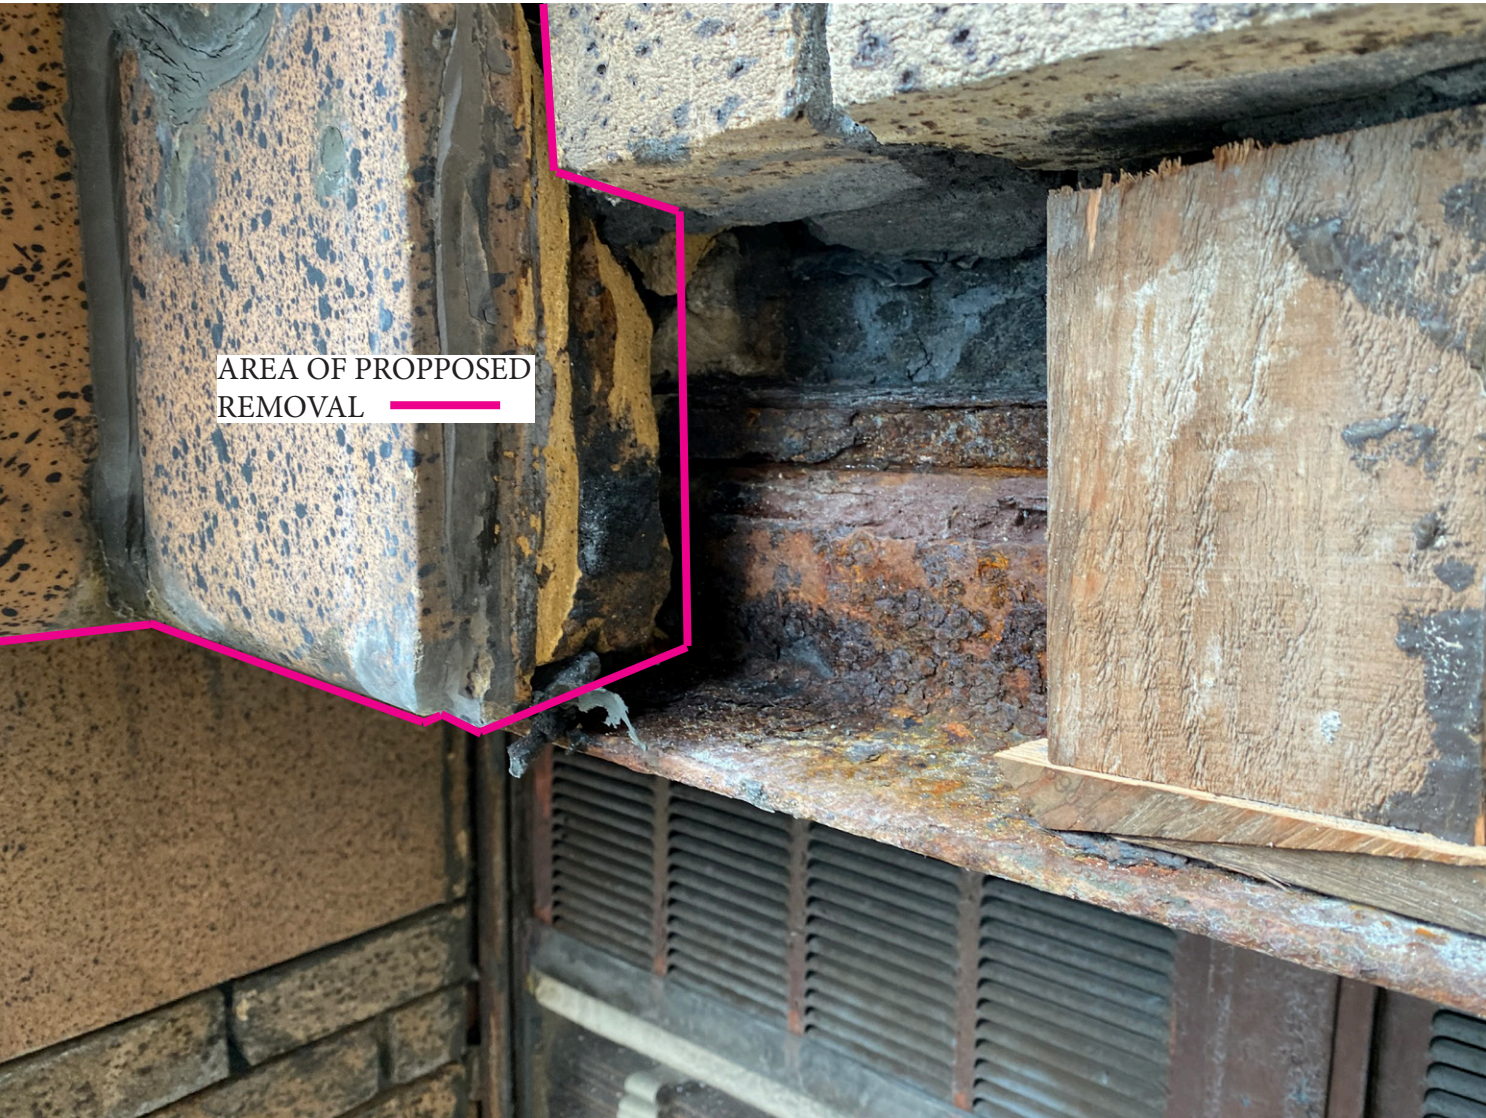
DETAIL OF DAMAGE AT LINTEL, BRICK, AND TERRACOTTA MEDALLION INTERFACE, TYPICAL OF ALL LOCATIONS TO VARYING DEGREES.

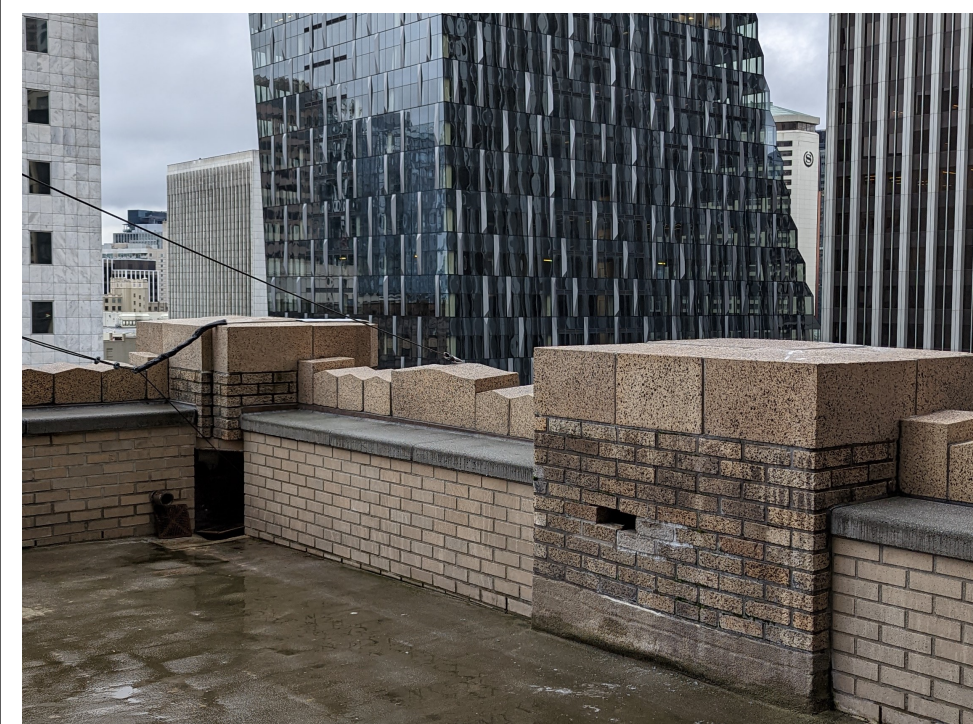
Column Caps

Seattle Tower is a mixed-use retail and office building located at 1218 3rd Ave in downtown Seattle. The building was constructed in 1929 with a reinforced concrete structure and masonry exterior façade. The façade incorporates exterior columns that run the length of the building. The columns are known to house steampipes that provide steam to heat the building. From Evolution's on-going investigation, we have observed that steampipes increase the temperature and humidity within the columns and have resulted in vapor drive to occur which has caused damage to interior finishes at various locations of the building.

The proposed scope of work will include installing brick sized relief vents at exterior columns to release the humid air caused by uninsulated steam pipes housed in the columns. Approximately 12-vents per column will be installed. The location of the vents will be concentrated at column caps, column step backs, and at slab interfaces every 3-to-4 floors to encourage ventilation throughout the length of the columns. See attached elevations for column and vent locations.
