From: Aban, Eduardo <Eduardo.Aban@seattle.gov>
Sent: Thursday, June 6, 2024 2:16 PM
To: Graves, David <David.Graves@seattle.gov>
Cc: Jones, Carson <Carson.Jones@seattle.gov>; Stevens, Scott <Scott.Stevens@seattle.gov>
Subject: RE: Gas Works: Cracking Towers structure leaning
Importance: High

I conducted the inspection of the cracking tower structure at Gas Works. The following are my findings:

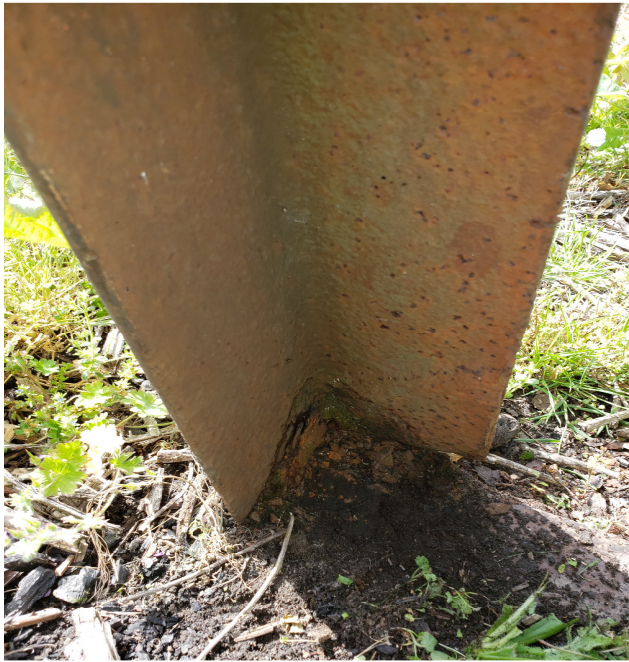
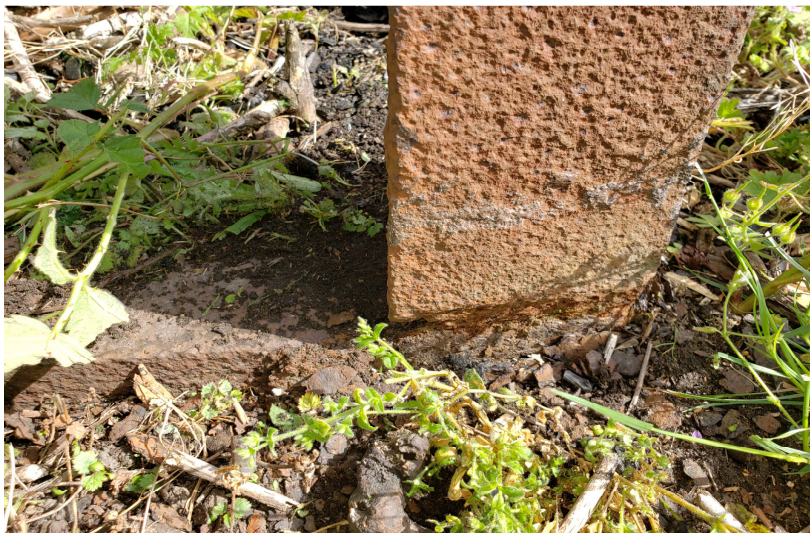
1. The southeast vertical support element of the structure is fractured at the base.

It is my recommendation that the tower structure be taken down. It is a failed structure that is unsafe to be left at its current condition/position. It is not recommended to be rebuilt or refurbished because its elements are deteriorated and badly corroded. The demolition of this tower must be done as soon as possible.

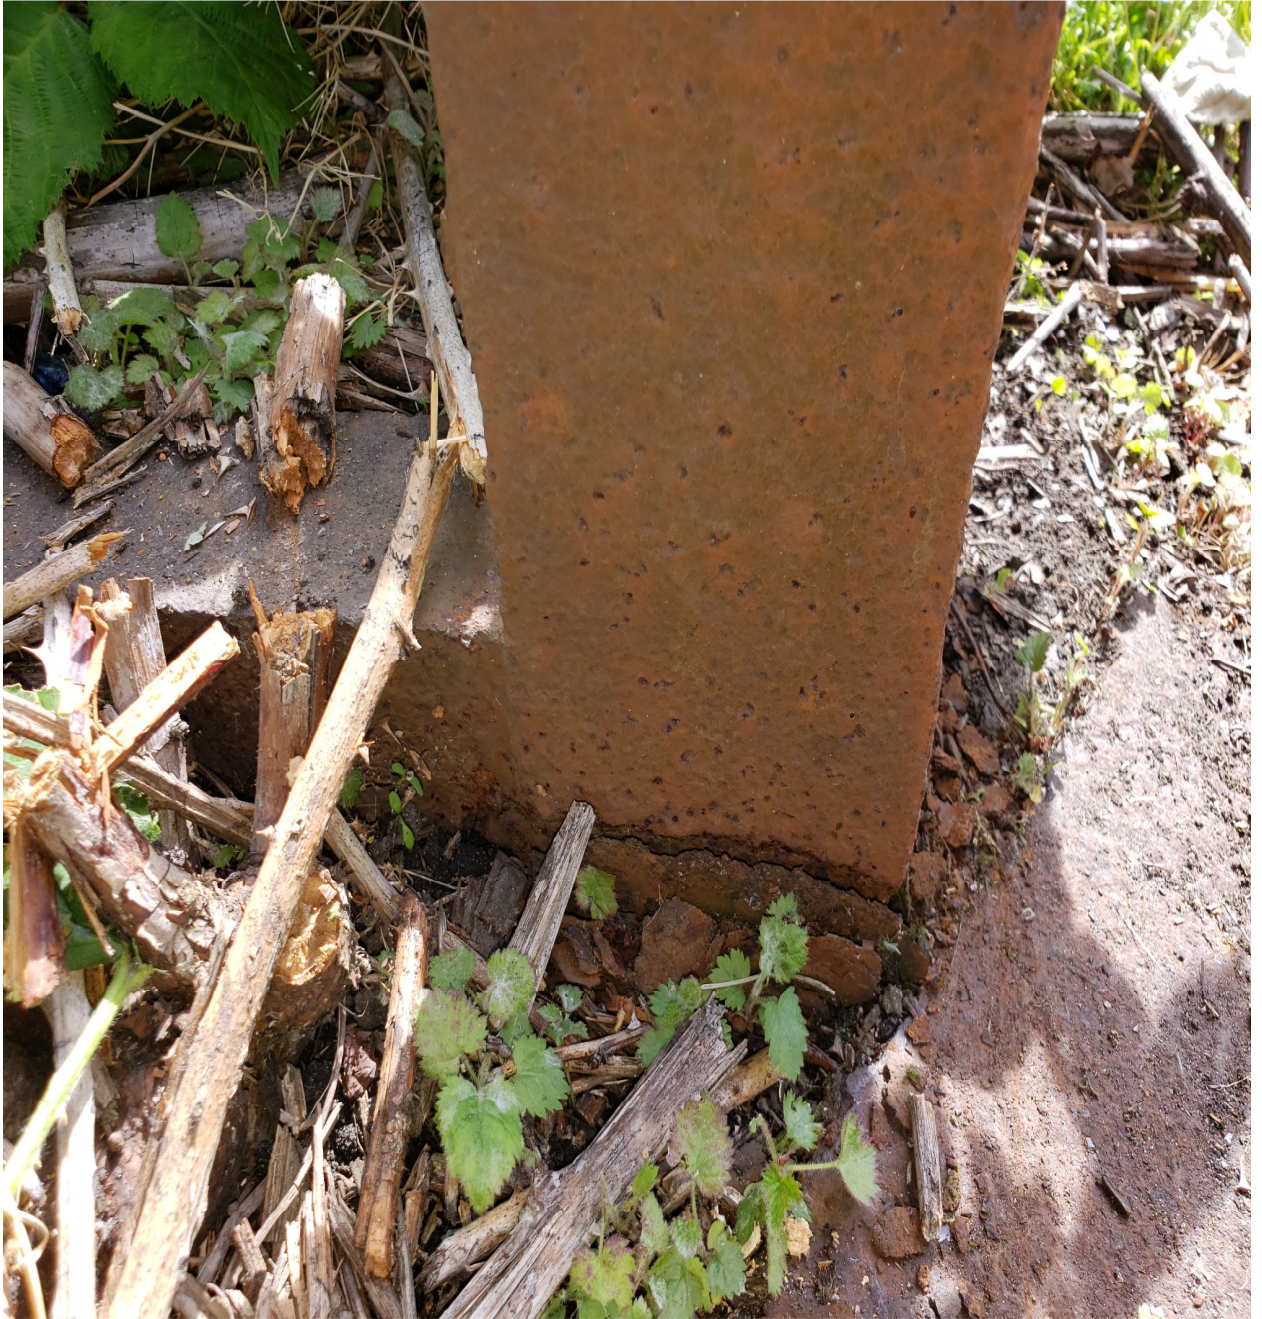
2. The southwest vertical support element is badly corroded that the steel material is peeling off, therefore reducing the effective strength of this element.

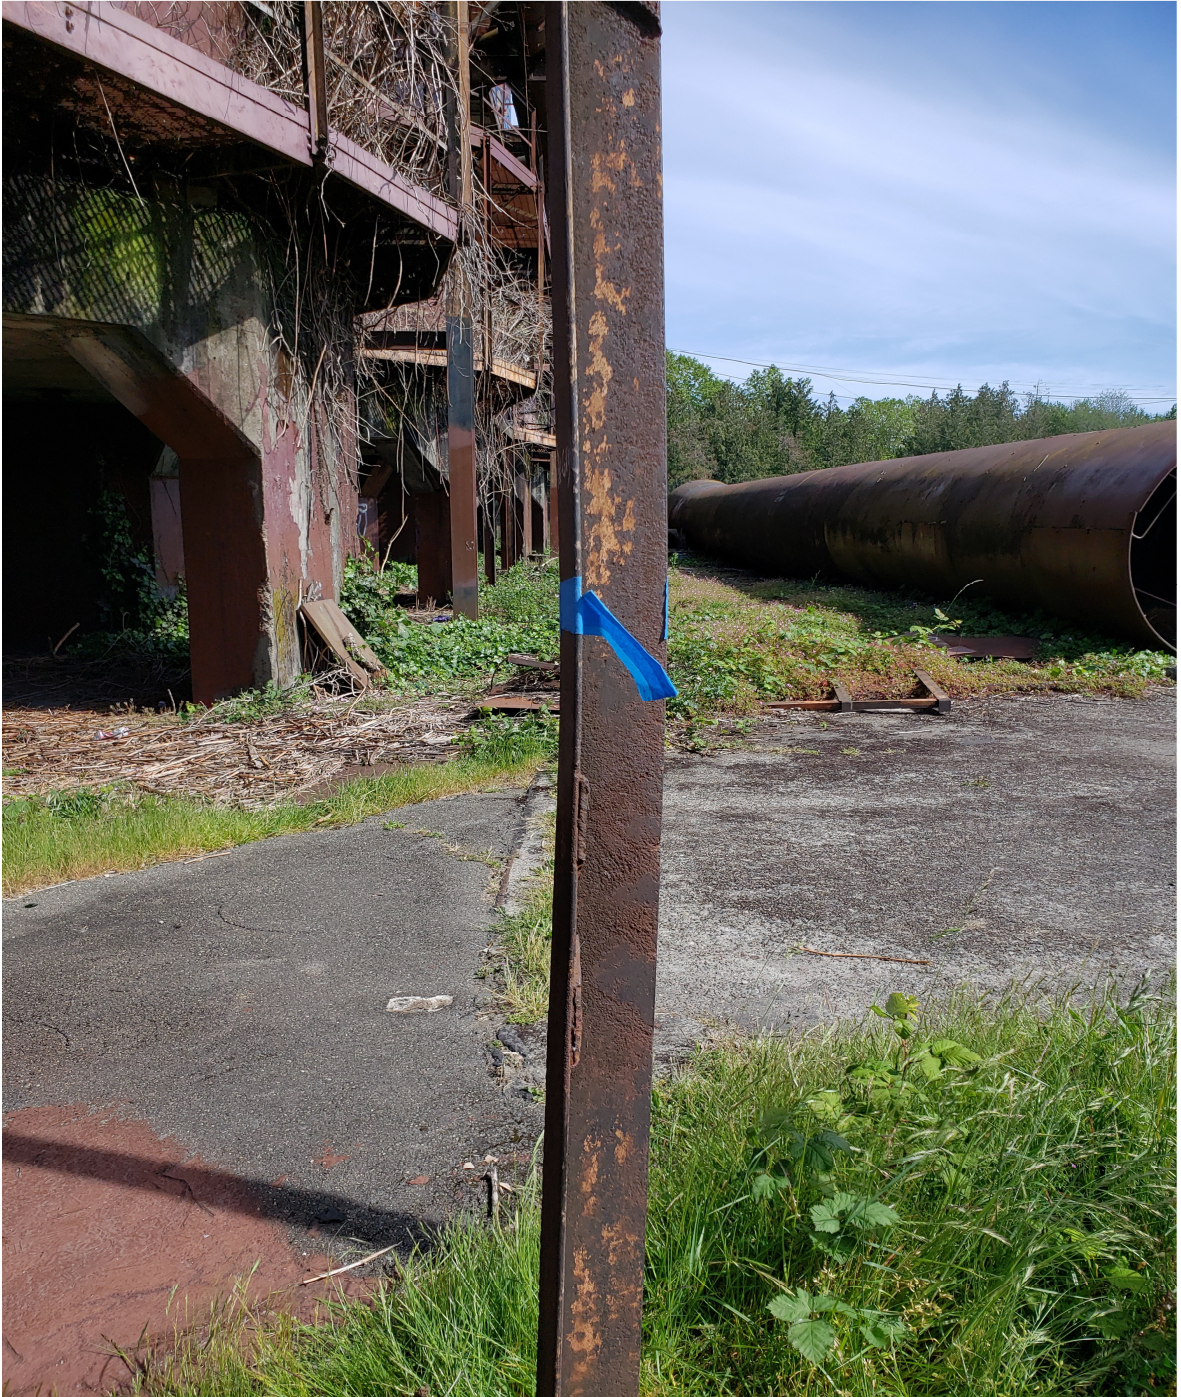
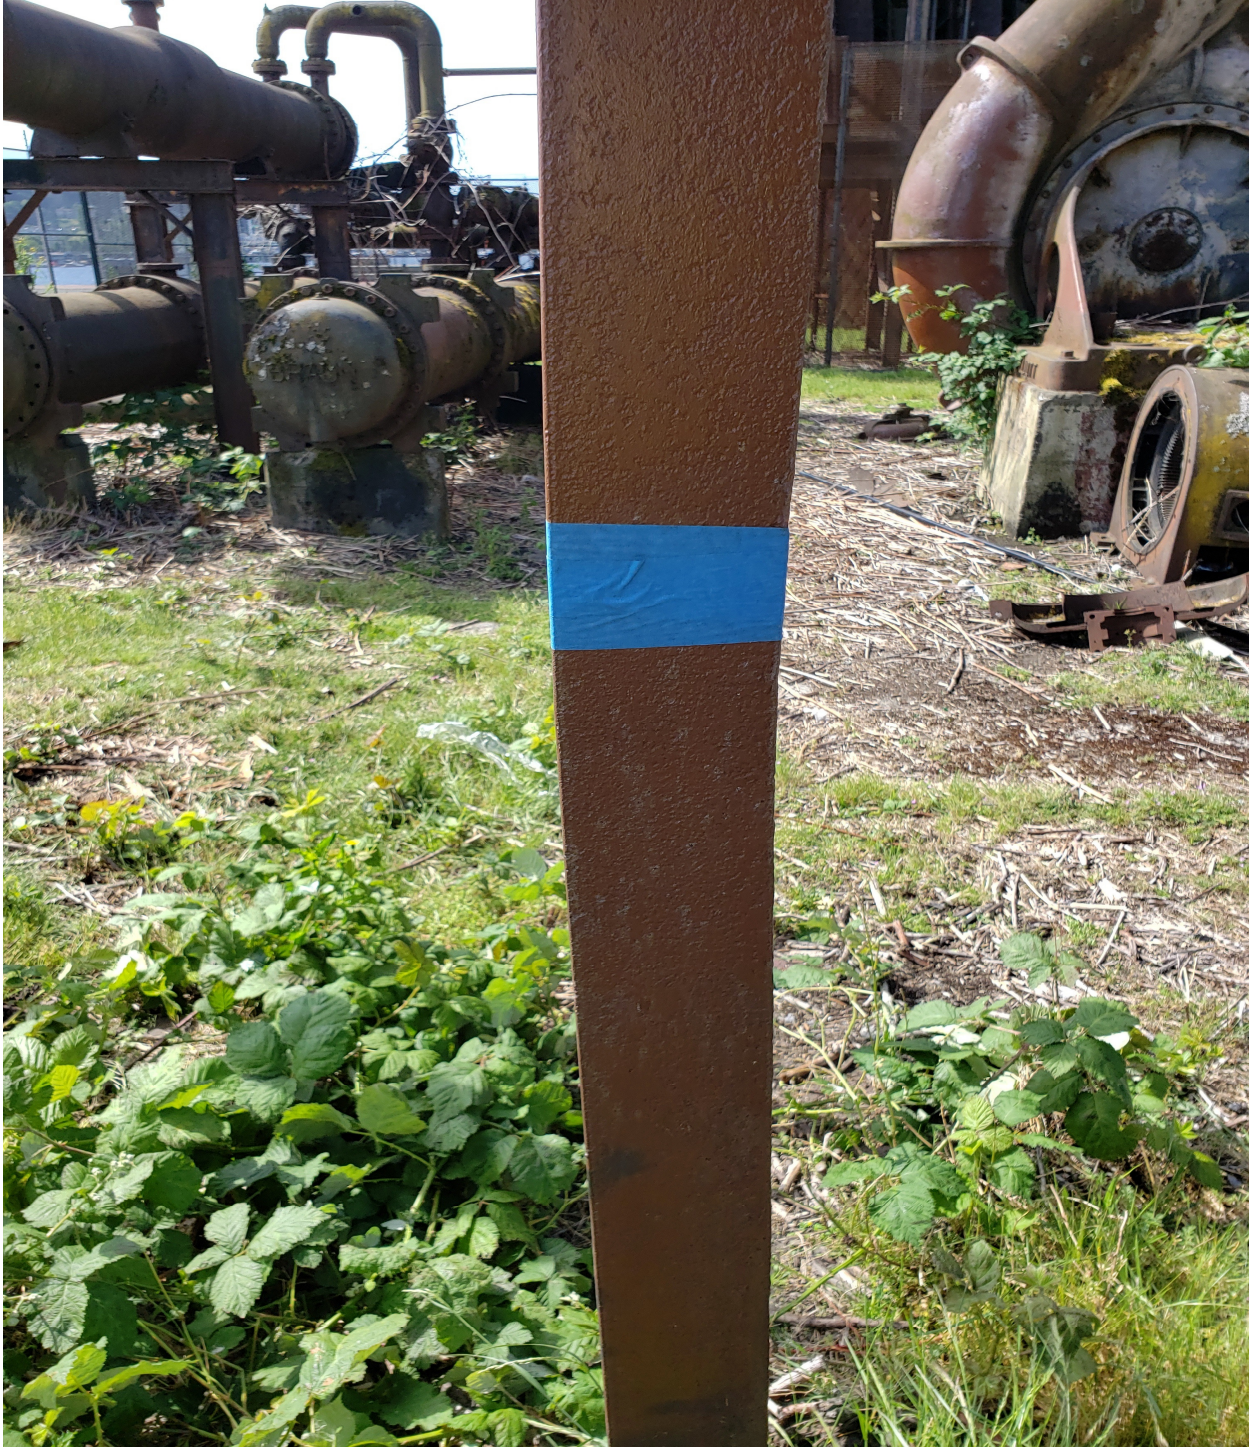
3. The northwest vertical support element is bent due to being hit by maintenance vehicle.

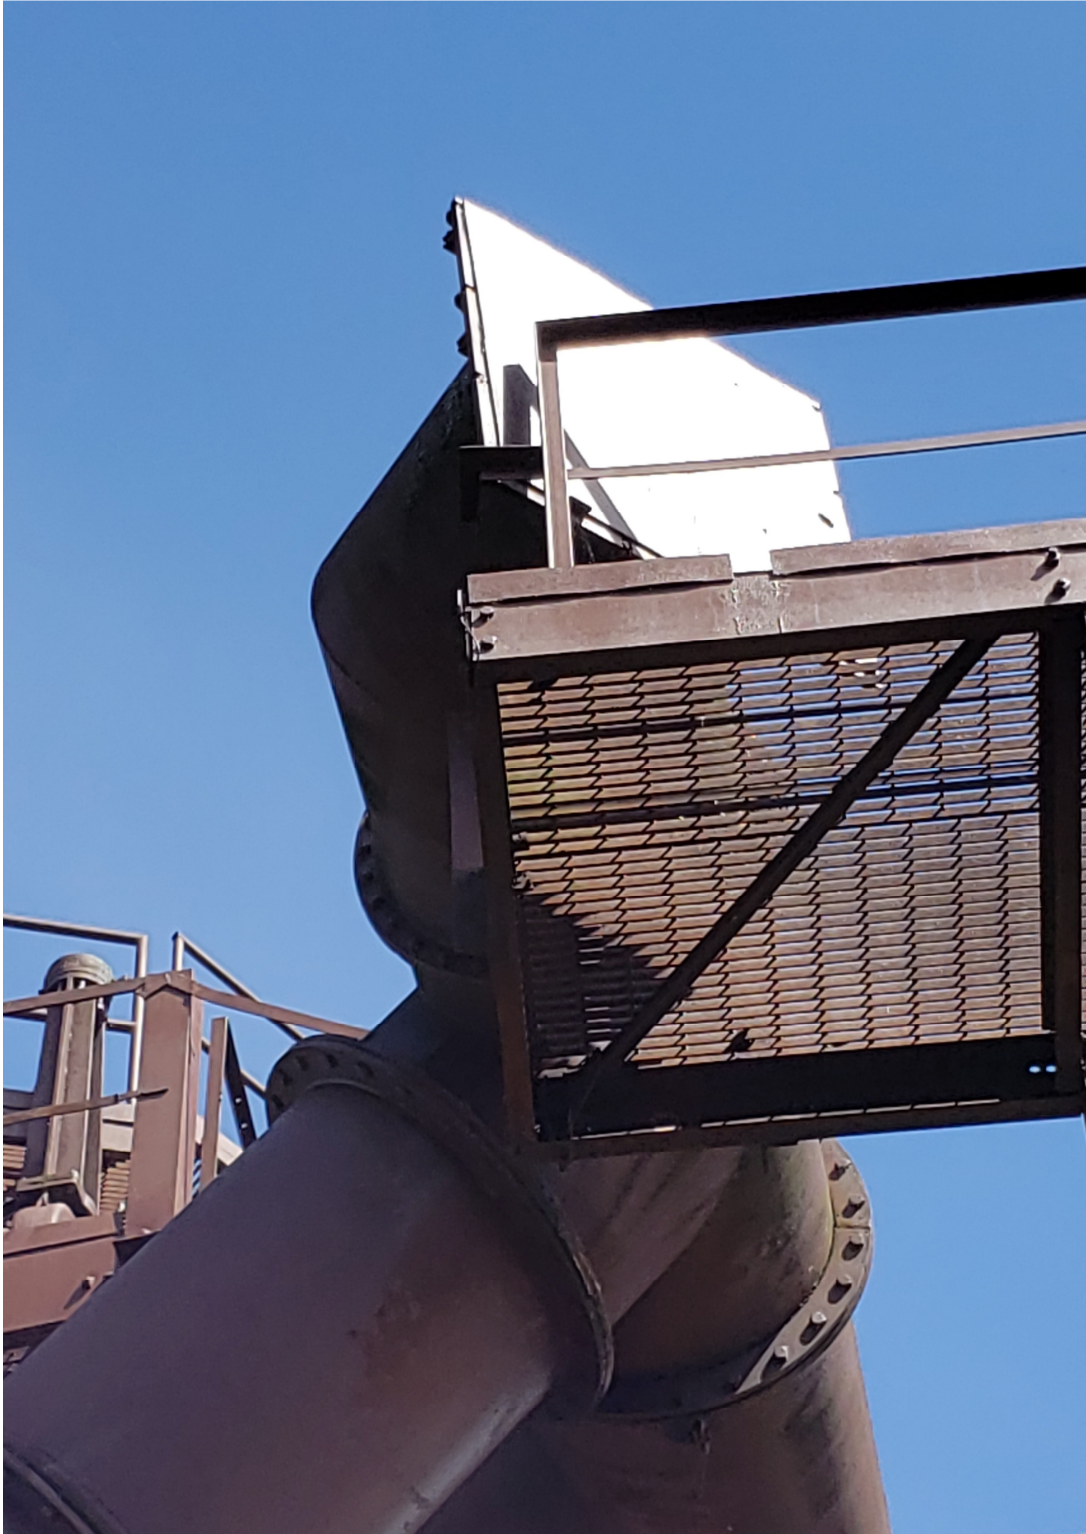
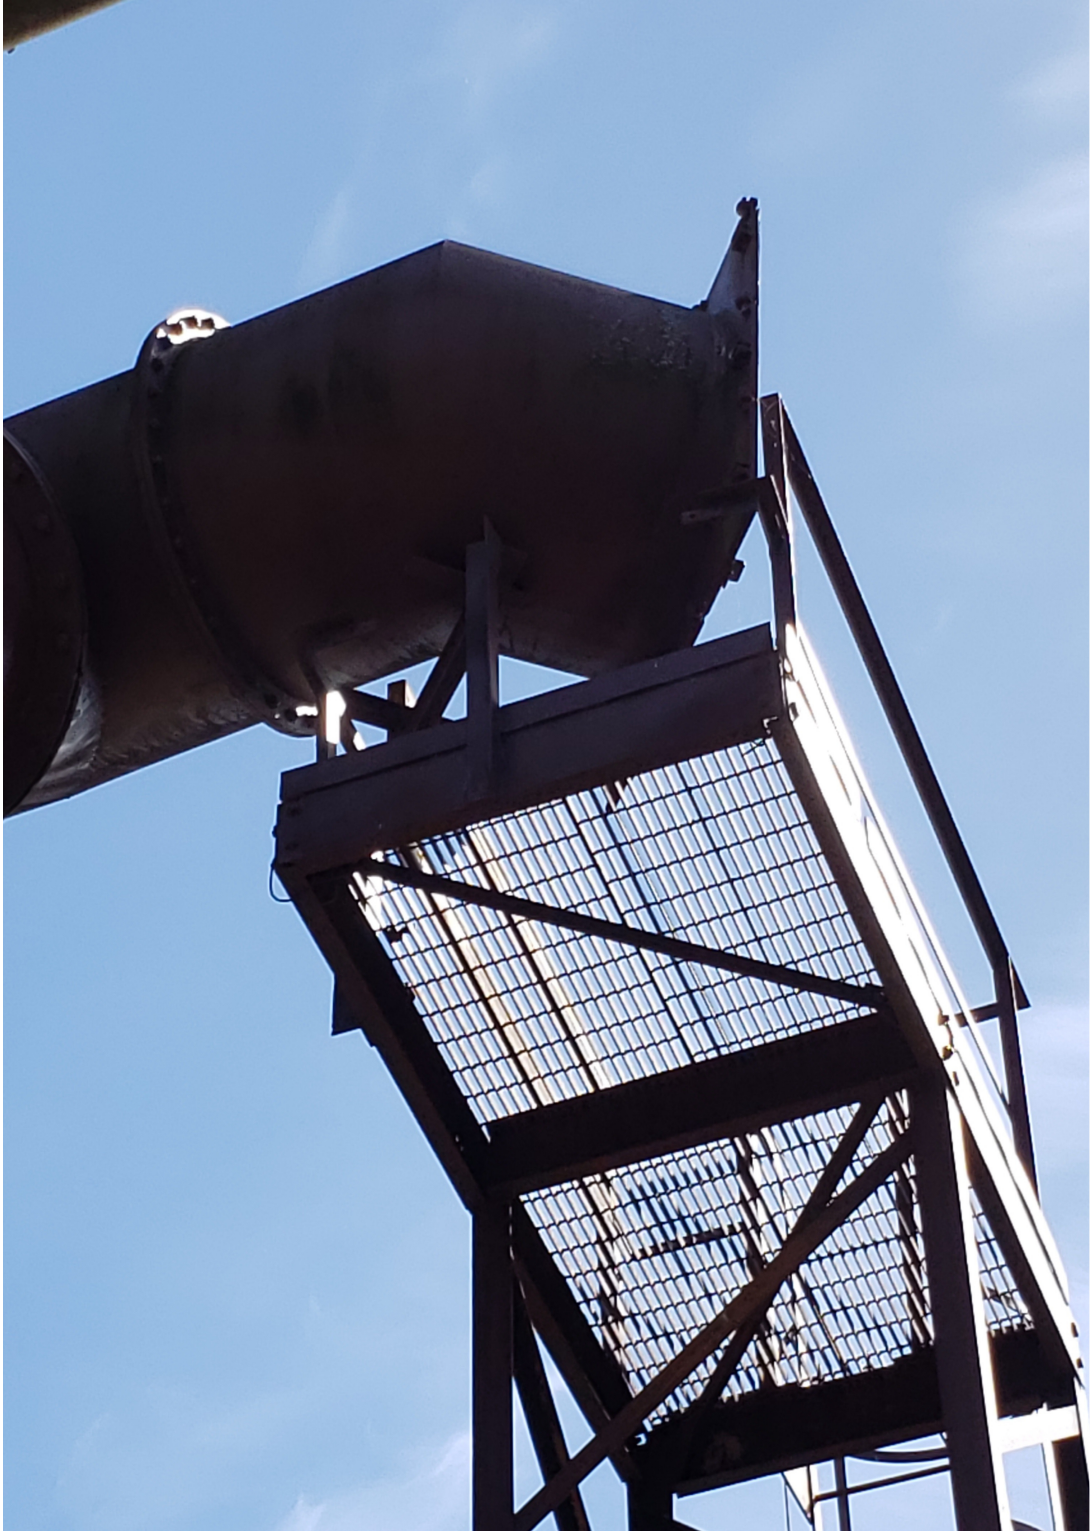
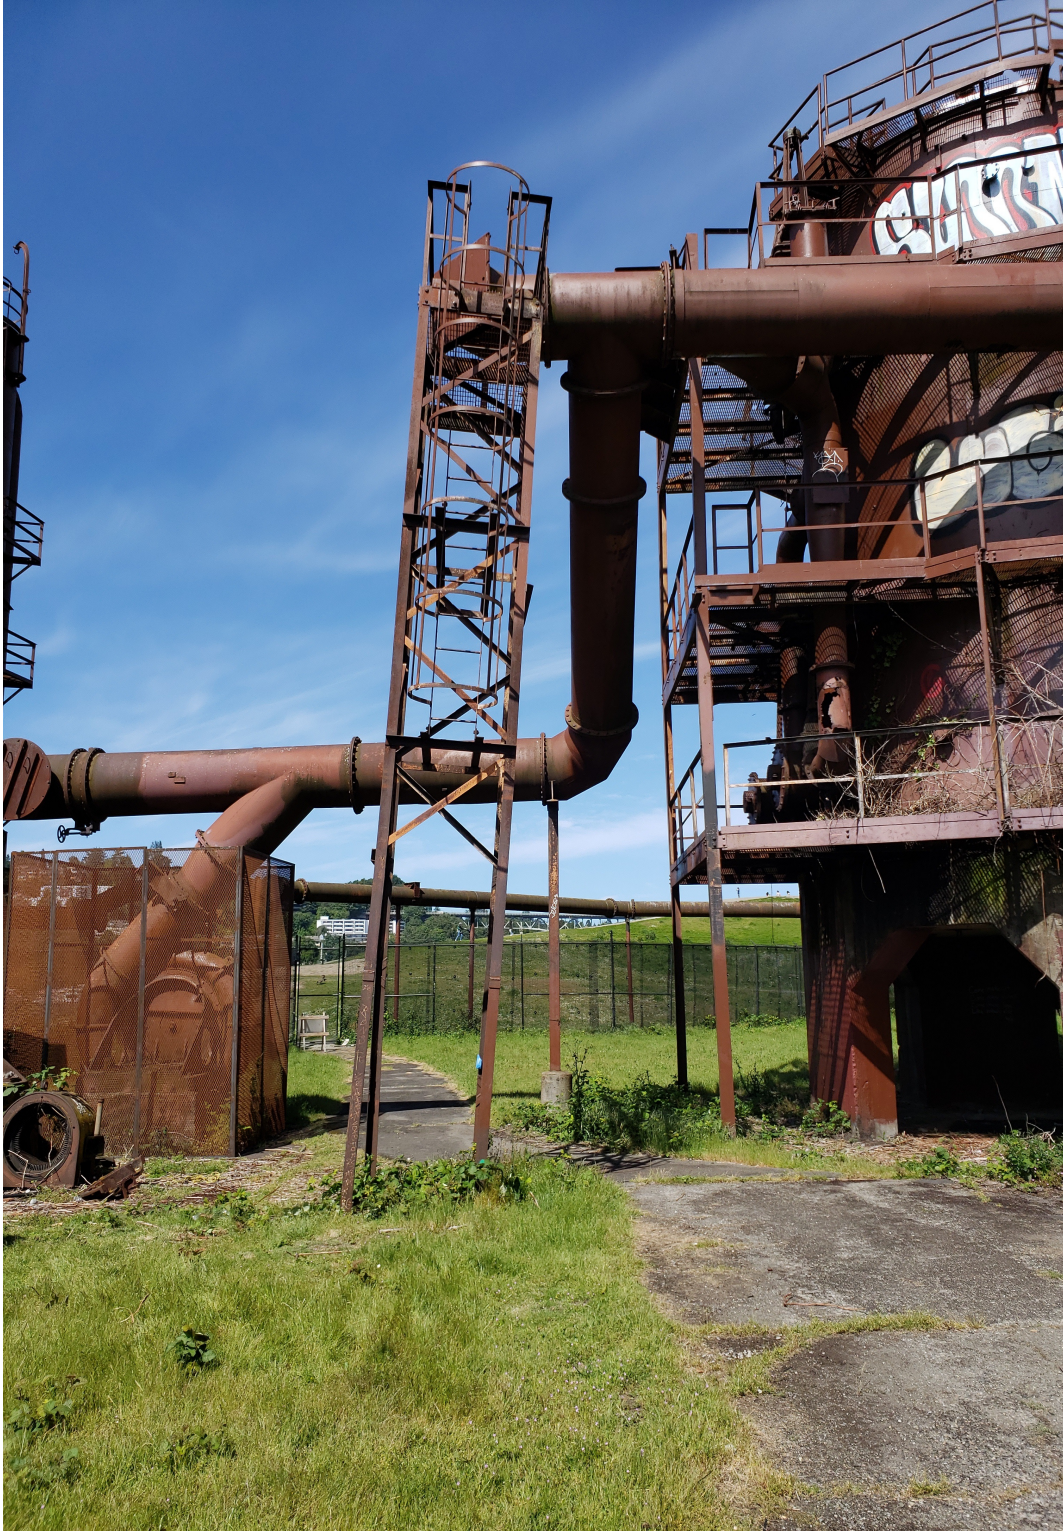
4. The tower structure is leaning and being prevented from falling to the ground by horizontal pipe flange that is in line with the top of the tower.
