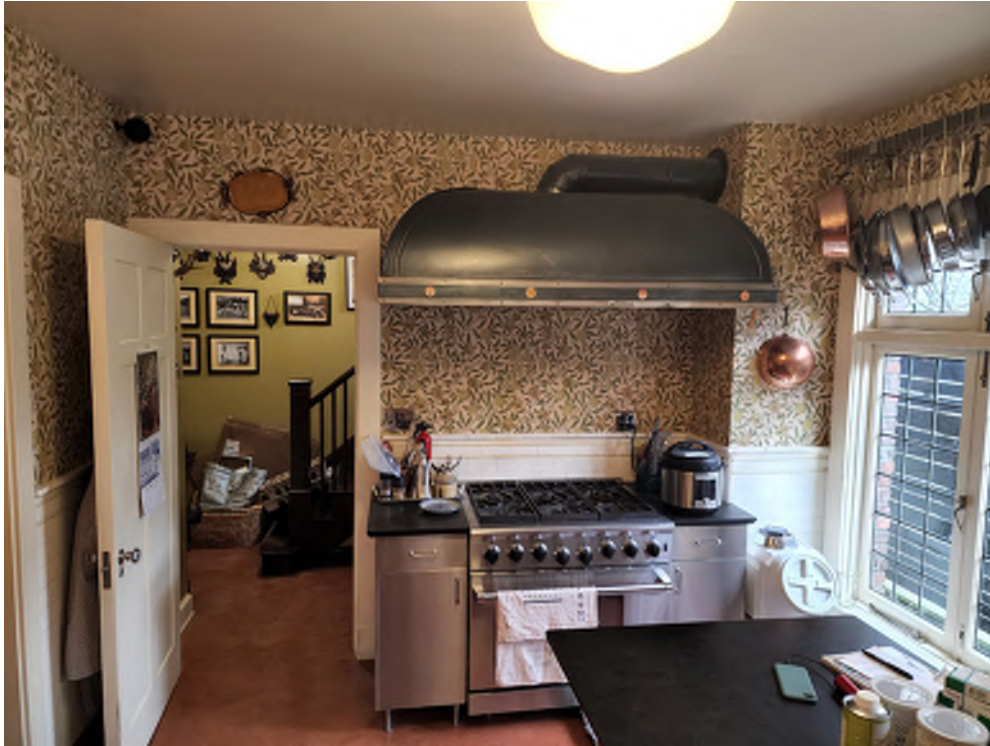
Non-original pre-manufactured kitchen cabinets that were installed by a previous owner. (Photo taken: March 21, 2022)

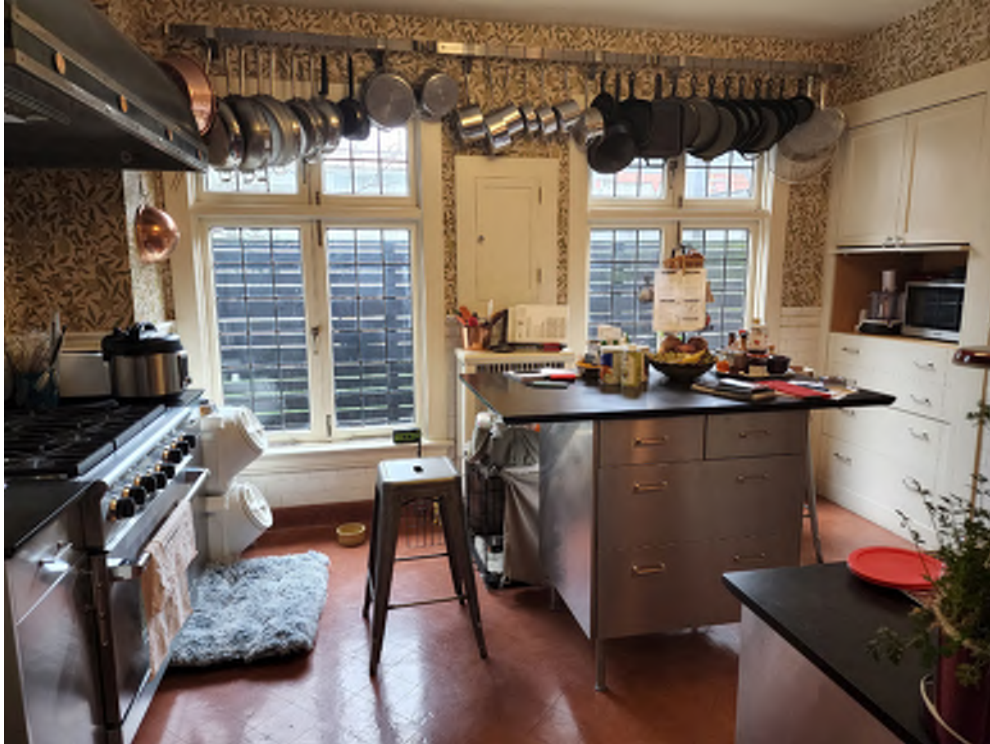
Non-original pre-manufactured kitchen cabinets that were installed by a previous owner. (Photo taken: March 21, 2022)

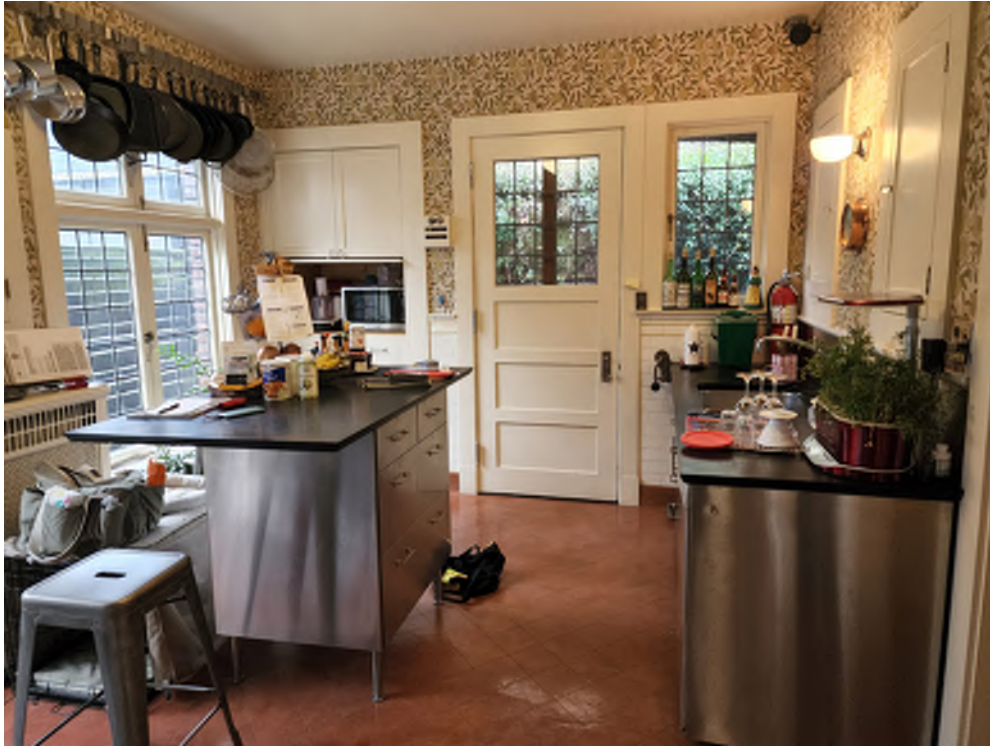
Non-original pre-manufactured kitchen cabinets that were installed by a previous owner. A non-original cabinet that was installed in place of the original icebox is also visible in the southwest corner of next to the kitchen door. (Photo taken: March 21, 2022)

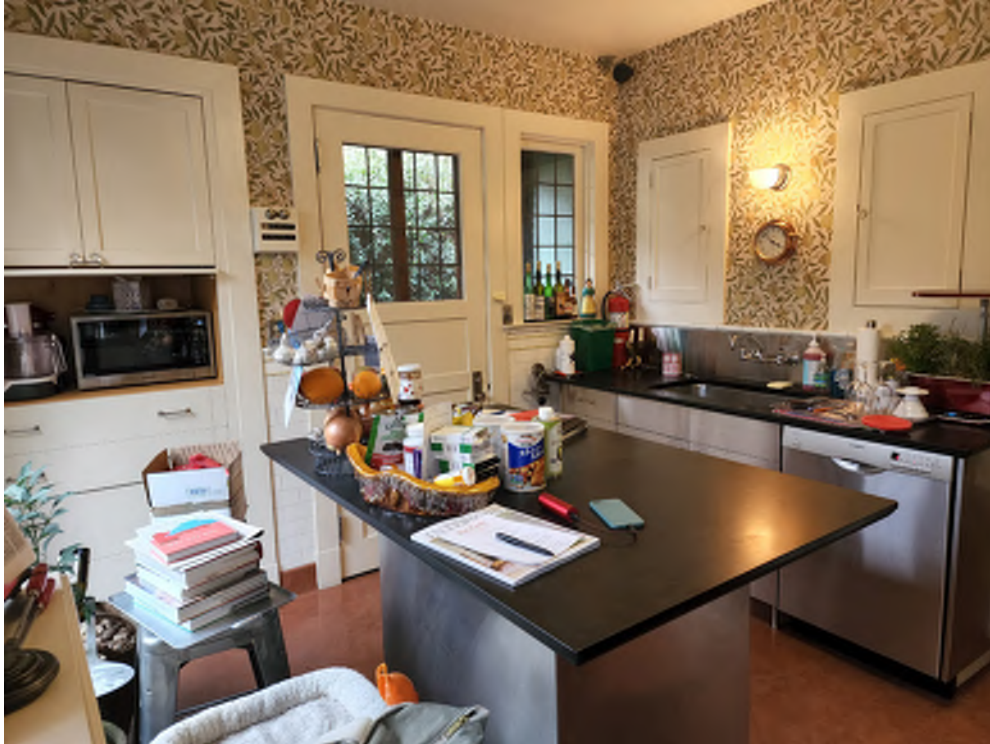
Non-original pre-manufactured kitchen cabinets that were installed by a previous owner. Note the metal backsplash behind the sink. (Photo taken: March 21, 2022)

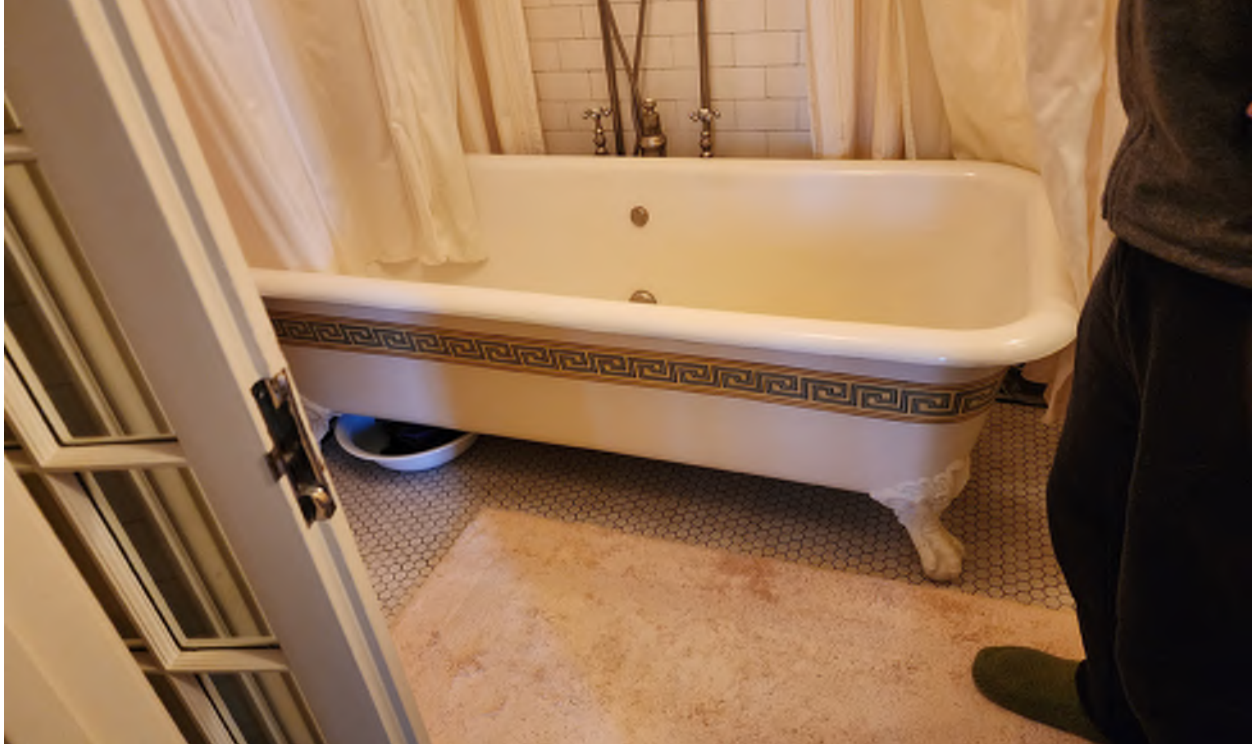
The original primary bathtub before refinishing. The Greek key decoration was added by the current owners and is not historic. (Photo taken: December 21, 2022)

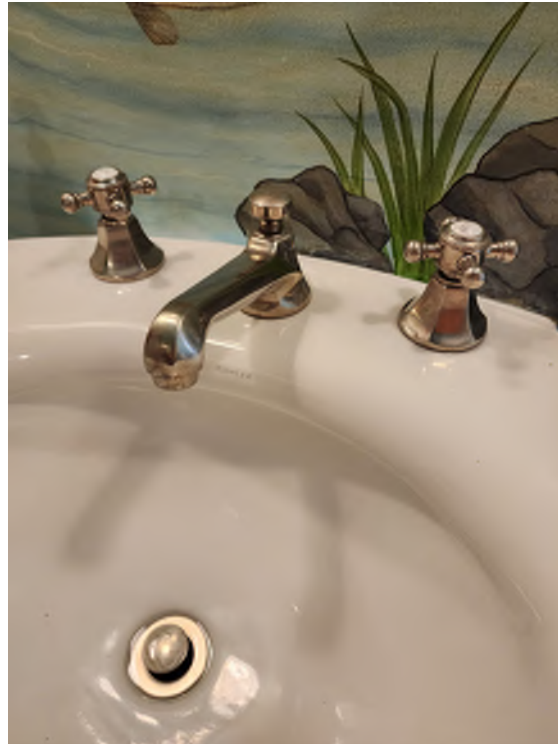
Existing sink faucet in the guest bathroom that had been replaced by a previous owner. (Photo taken: July 25, 2023)

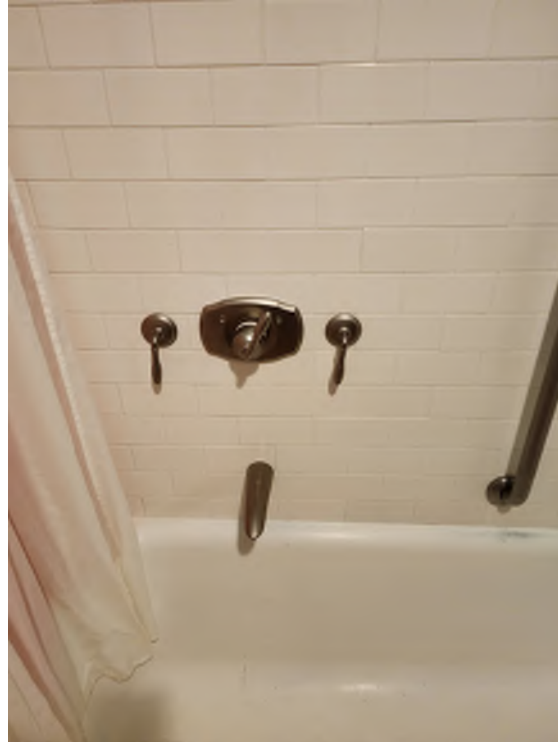
Existing shower valves and tub filler in the guest bathroom that had been replaced by a previous owner. (Photo taken: July 25, 2023)

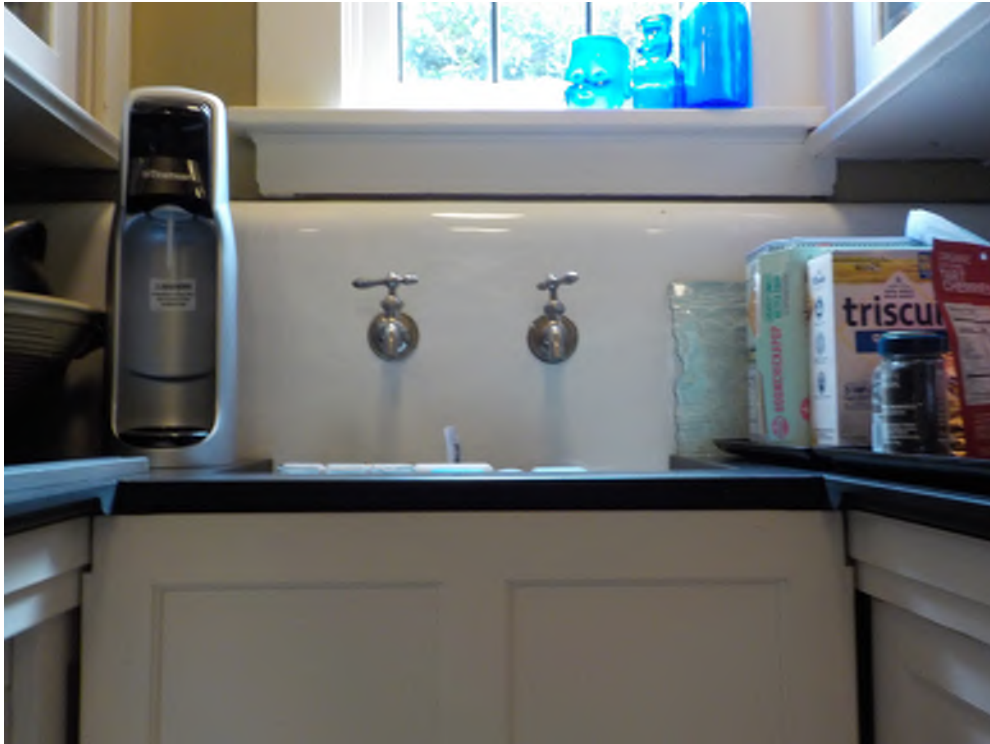
Original Butler's Pantry sink faucets which could no longer be repaired. (Photo taken: March 2, 2022)

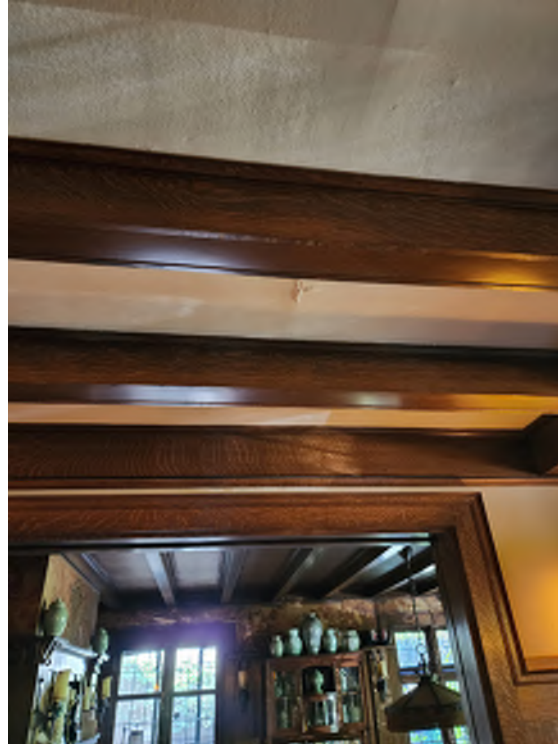
Water damage at foyer ceiling from the bathroom above. (Photo taken: September 8, 2023)

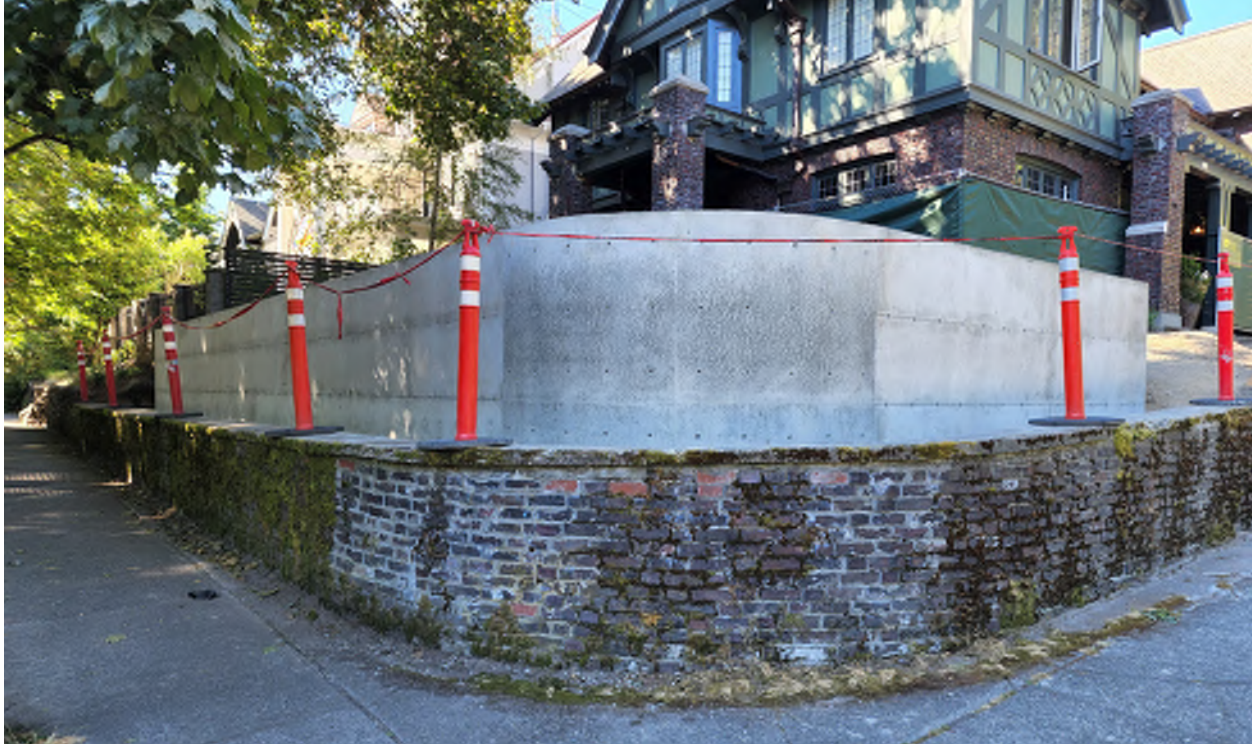
Historic site wall at the northeast corner of the property before repointing. (Photo taken: August 29, 2022)

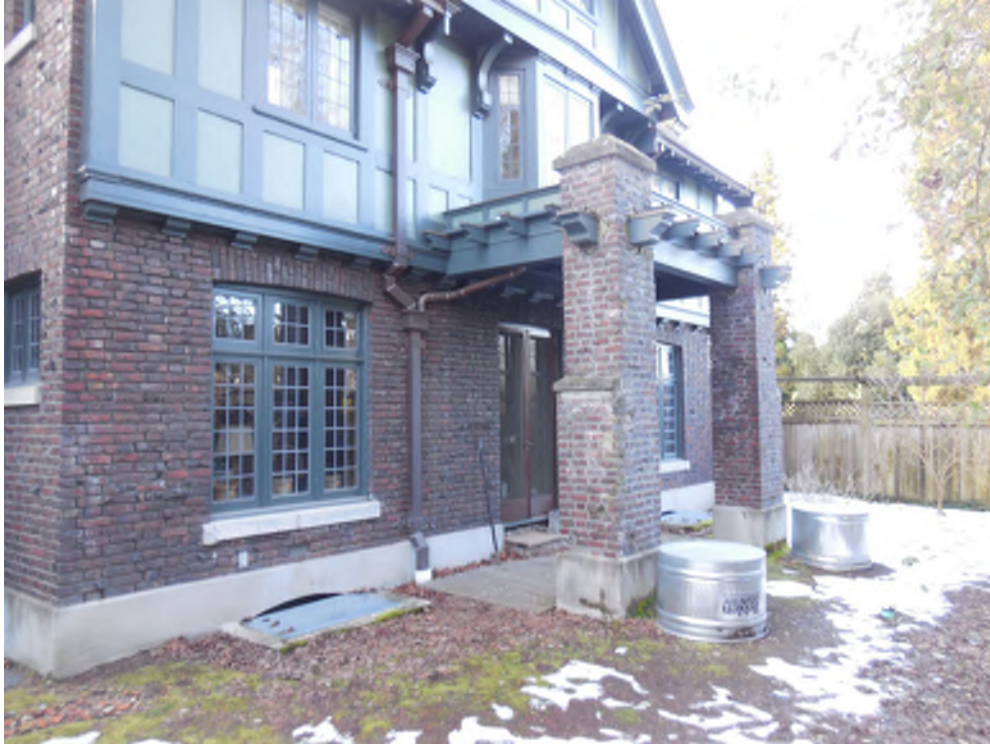
Existing east elevation prior to construction. The original east patio was badly damaged and had been carefully documented and removed in 2007. (Photo taken: August 20, 2021)

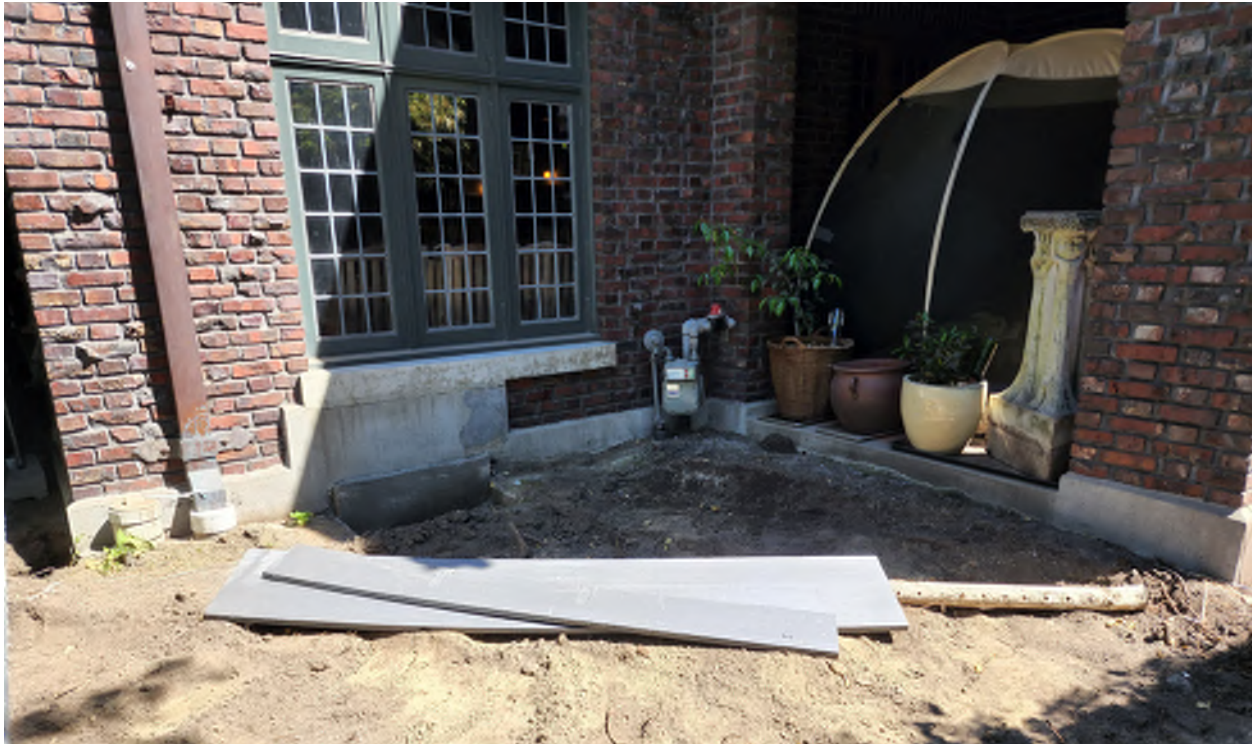
The coal chute was originally located below the dining room window at the northwest side of the house. It was removed by a previous owner and patched with an obtrusive concrete panel. (Photo taken: July 26,2022)

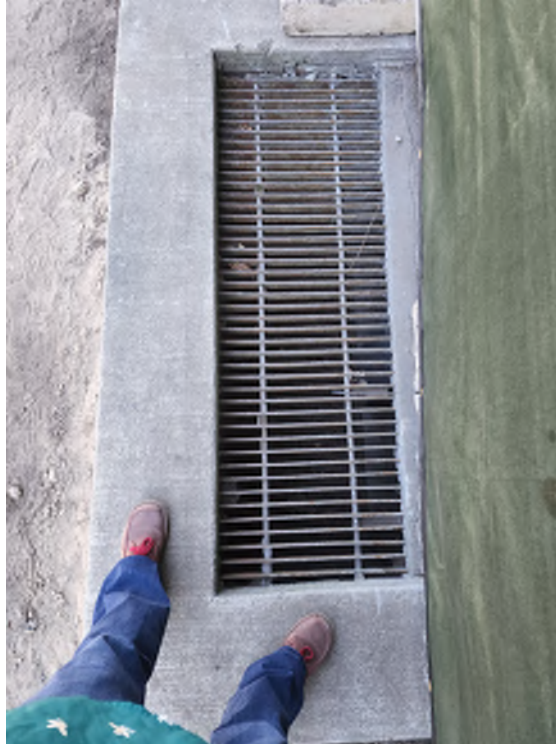
Original window well grate with spalling metal visible. These were originally cast into the concrete window wells, and a later concrete cap was added on top of the northeast well that was causing it to crack and pull away from the house. (Photo taken: July 26, 2022)

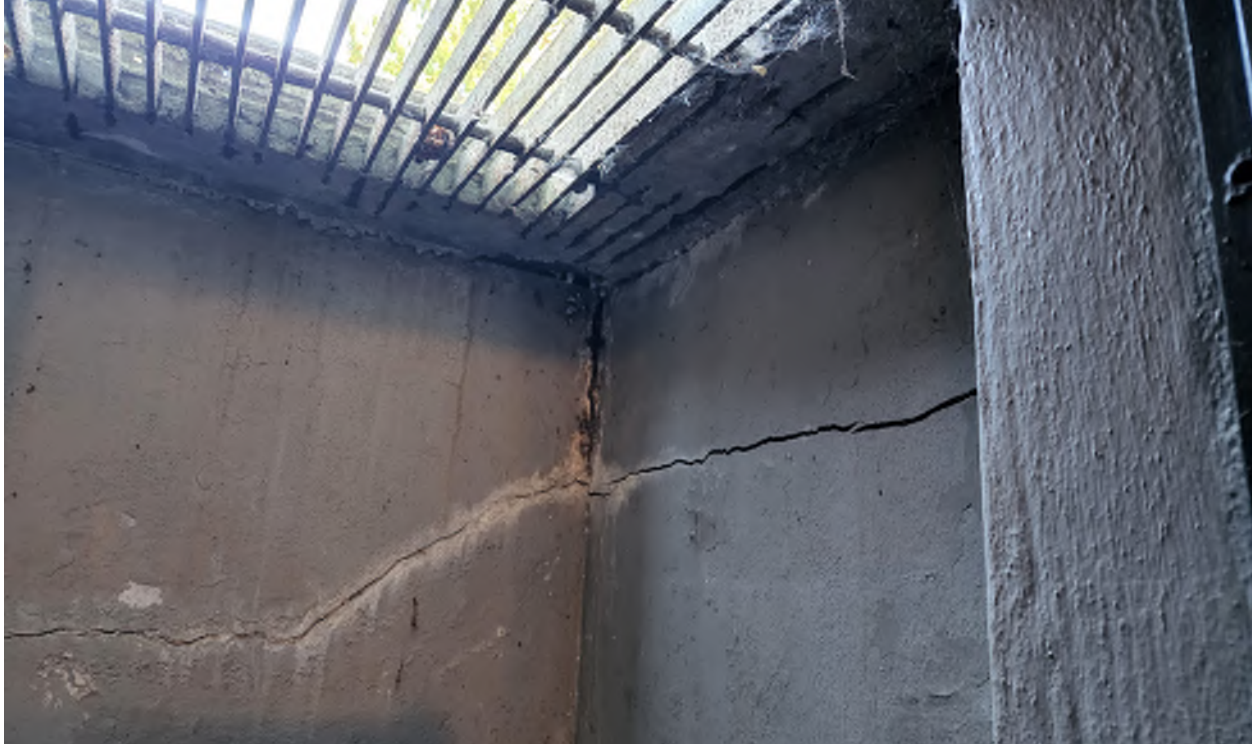
Cracking in the northeast window well. (Photo taken: August 2, 2022)
