PART 1 – PROJECT NARRATIVE

1.1. Nathan Eckstein Middle School description

PHOTOS OF EXISTING CONDITIONS

ECKSTEIN MIDDLE SCHOOL

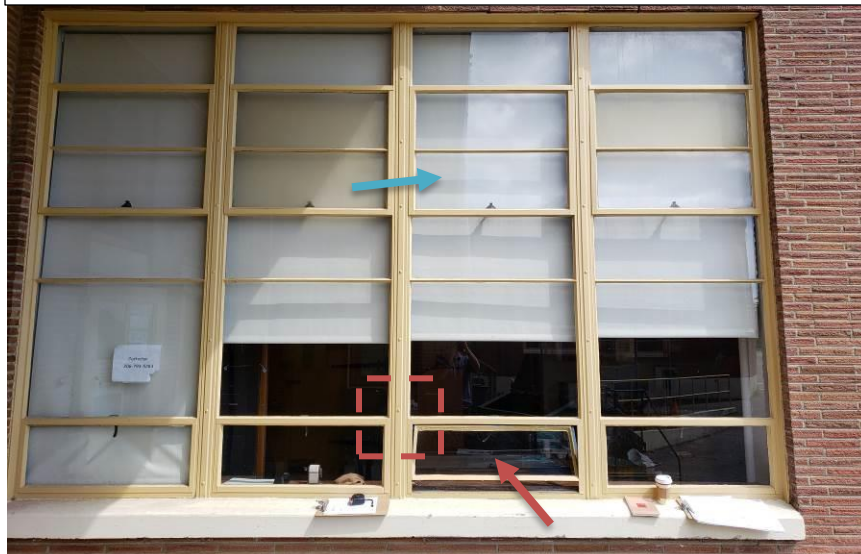
Photo-1 below depicts a series of original windows consisting of fixed, operableoppers (red arrow), and awnings (blue arrow). Red dashed area below depicts the location of photo-4. Various shades of replacement glazing (appearing darker) are also evident in the photo below.

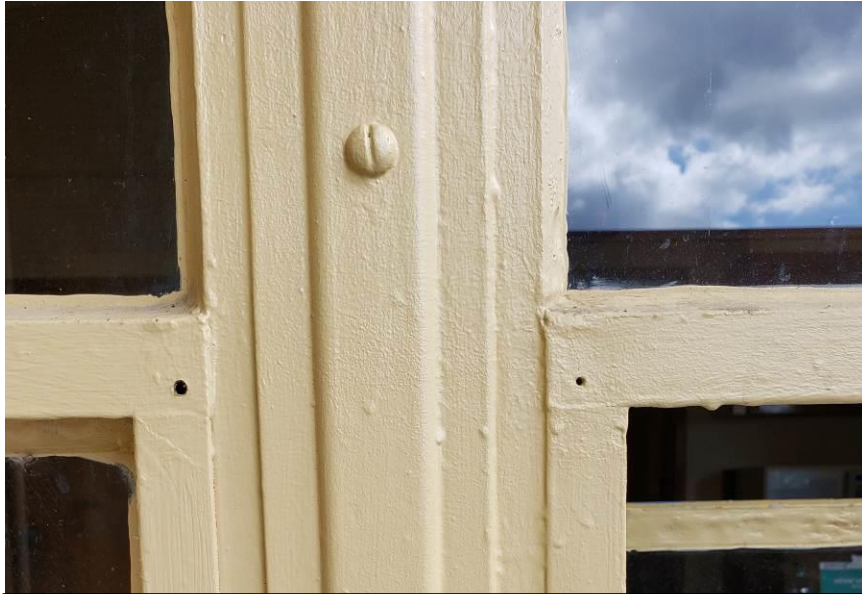
Photo-2 above is an up close view at the intersection between lower operable awnings and the fixed portion of the window.

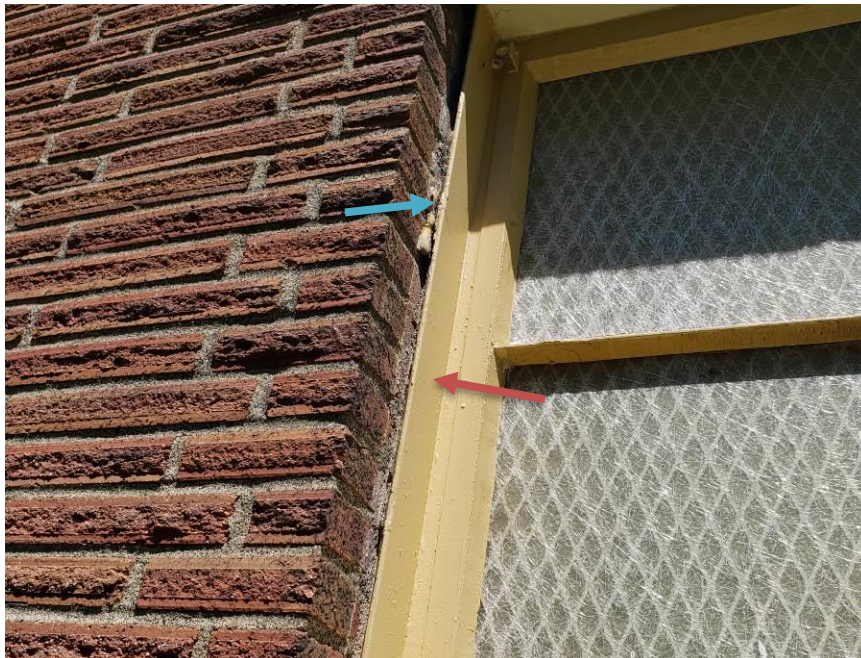
Photo-4, Red arrow above points to a painted steel plate used to secure the flange at the jamb of an original window. Blue arrow points to deteriorated asbestos containing sealant. This photo also shows an example of how the original glazing has been replaced in many locations with reinforced fiberglass panels

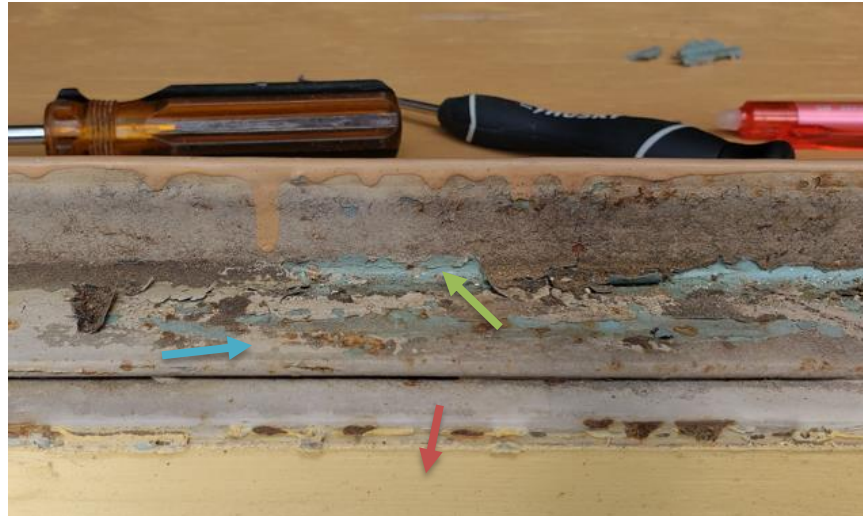
Note: Both layers of paint on the original/historic windows beneath the current outermost exterior paint coating were found to contain lead. The original paint sheen (observed on the inside face of steel mullions) has some light reflective qualities indicating that it was a Satin or (now faded) Semi-gloss. *Note: There are several other existing interior paint colors/sheens but all appear to be hand painted and not original.*

Photo-5 above was taken within the sill of an operable window sash where the current top paint coating (non-historic, see red arrow), can be seen dripping over an underlying tan colored coating (presumed historic top coat, see blue arrow) that is currently peeling off an underlying green colored coating (presumed primer, see green arrow).

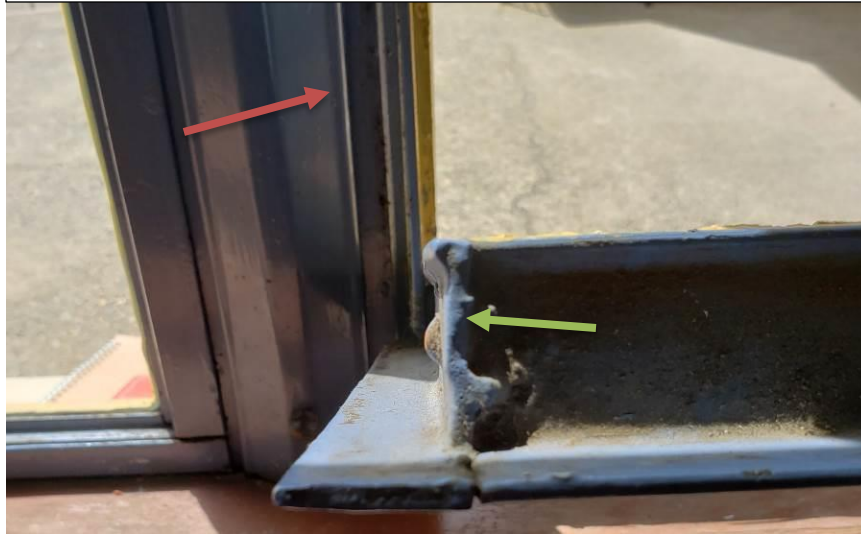
Photo-7 below depicts the typical “blue” color found on the interior portions of many original steel framed windows/operable sashes. This blue color appears to have been applied over the original lighter tan and green paints. Red arrow points to the 1/16-inch thick formed steel mullion plates that are also used to secure the window jambs on the interior side of the windows. Green arrow below points to the thick coating of blue paint applied on the window depicted below

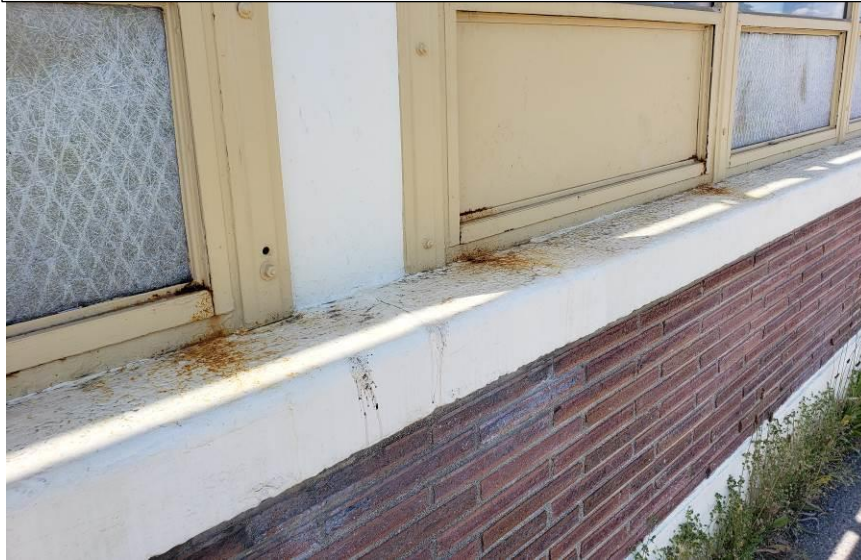
Photo-8 below depicts the common form of corrosion found at the lower corners of in-swing hopper windows.

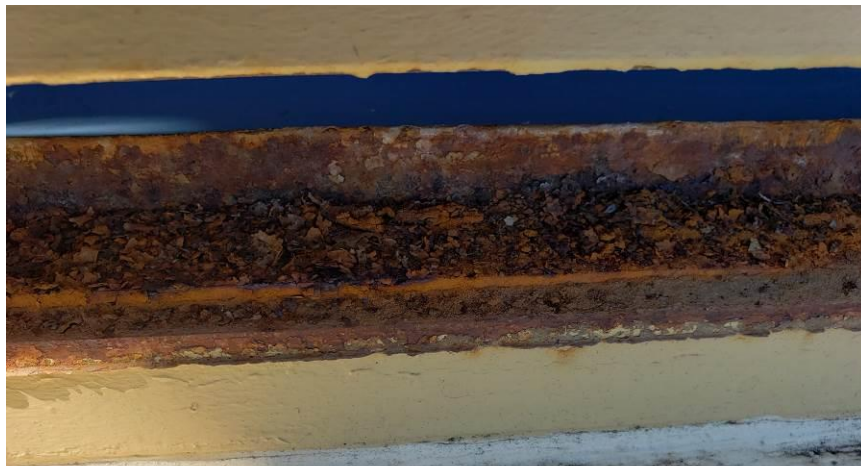
Photo-9 above depicts the sill of a window frame that is corroding due to moisture leaks at the lower corner of an in-swing hopper window. *Note: Although the existing steel frames were observed to have various amounts of pitting, the corrosion observed would not prevent some form of refurbishment even in locations where the steel welds have failed.*

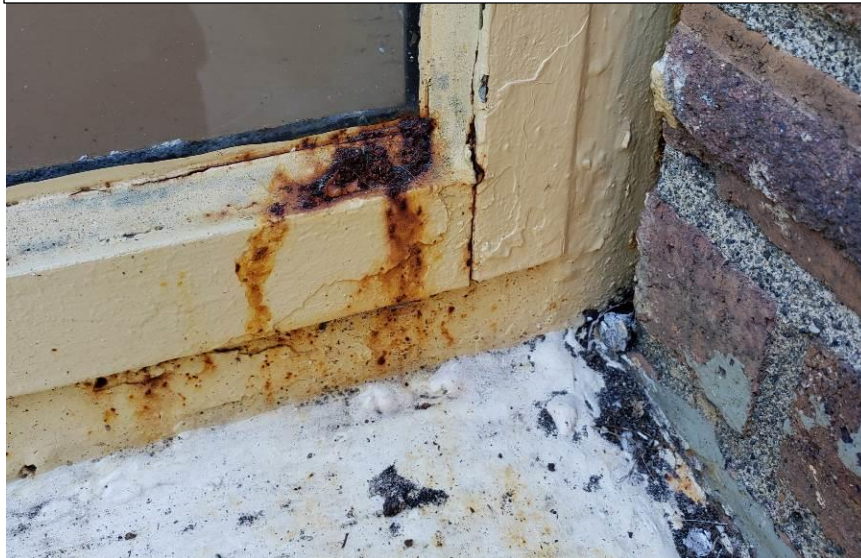
Photo-11 below depicts a close up view of the corrosion found at the lower corners of in-swing hopper windows. Red arrow below points to a failed weld at an operable sash.

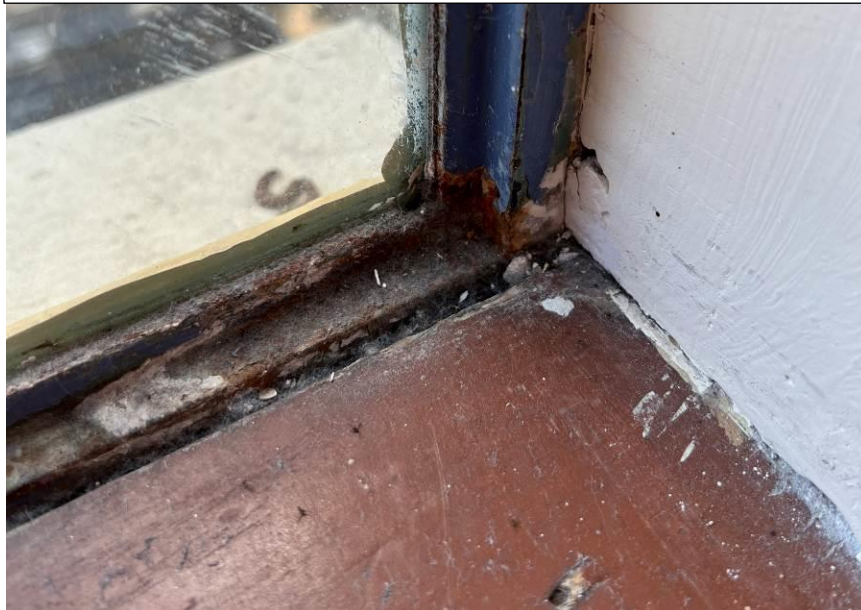
Photo-12 below depicts corrosion on the interior side of a fixed window.

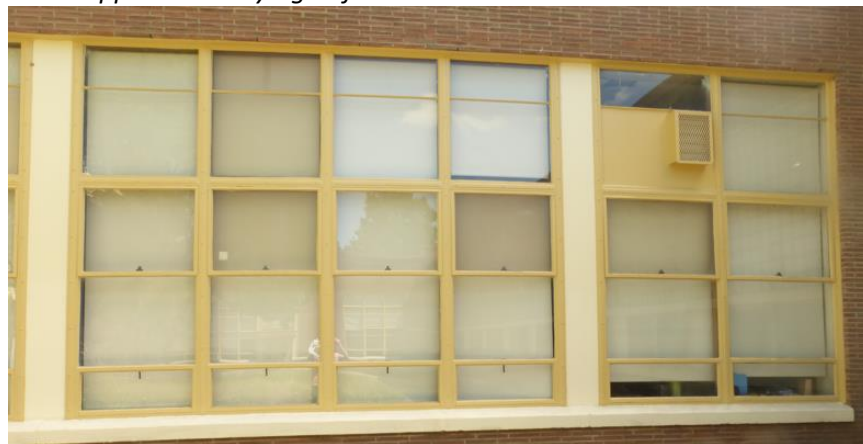
Photo-13 above depicts three distinct glazing colors over a series of adjacent windows as well as an example of a glazing panel that was infilled for an exhaust vent.

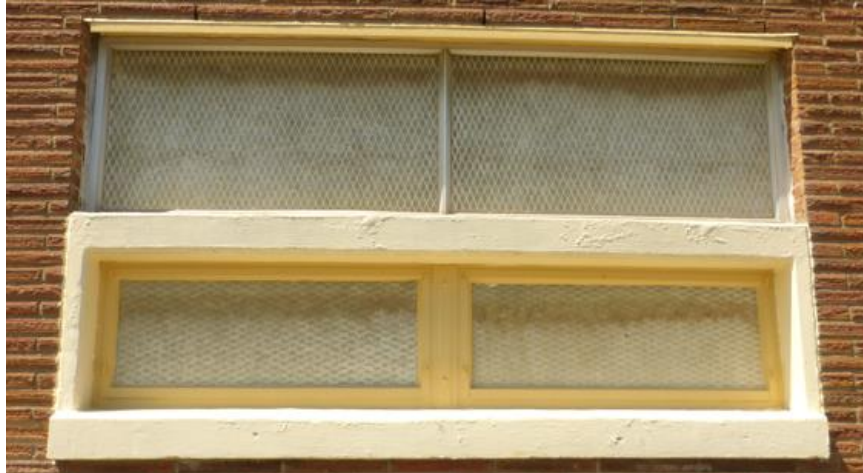
Photo-14 above depicts window glazing that has been replaced with fiberglass/expanded steel mesh panels. *Note: Record drawings indicate the top portion of the window above was originally glass block.*

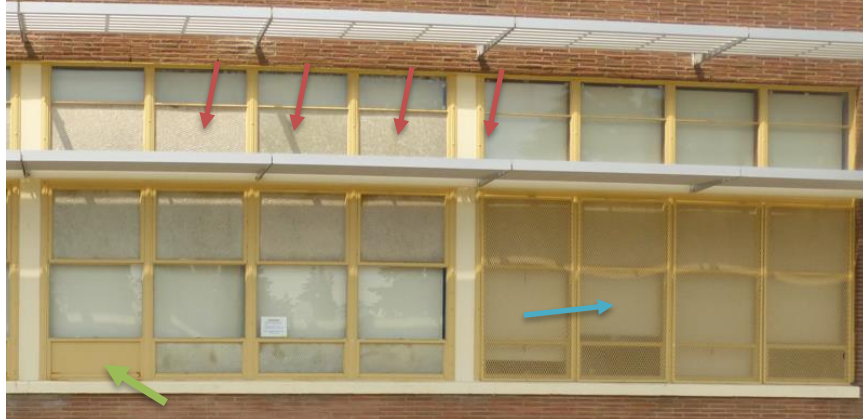
Photo-15 above depicts window glazing that has been replaced with fiberglass/expanded steel mesh panels (red arrow), where the glazing of a lower in-swing hopper has been replaced with a painted sheet metal panel (green arrow), and where a painted steel screen is installed over a section of windows (blue arrow).
