Nathan Eckstein Middle School Window Replacement

Landmark Preservation Board
Marc A. Tegen, Project Manager

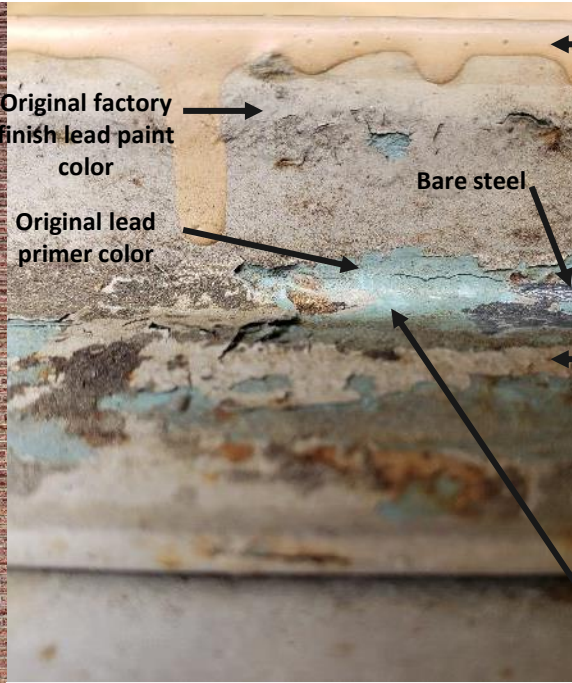
Close-up photo above depicts the various current and historic paint finishes.

Current acrylic latex paint color
-Exact Color SW 6388

Original Factory Finish Lead Paint
-Very similar to SW 6143

Original Factory Lead Primer
-Close to SW 6143

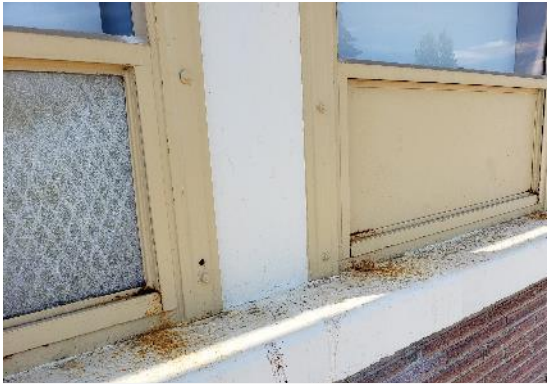
Corrosion at corners of sashes

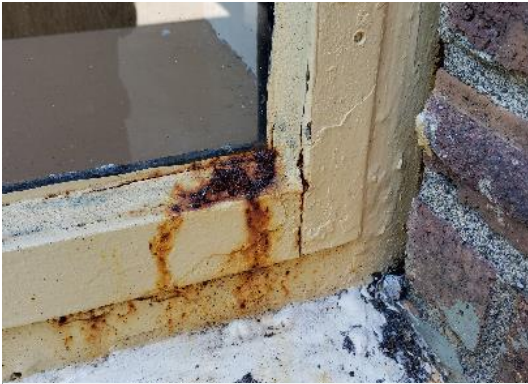
Corrosion at corner of sash and broken weld

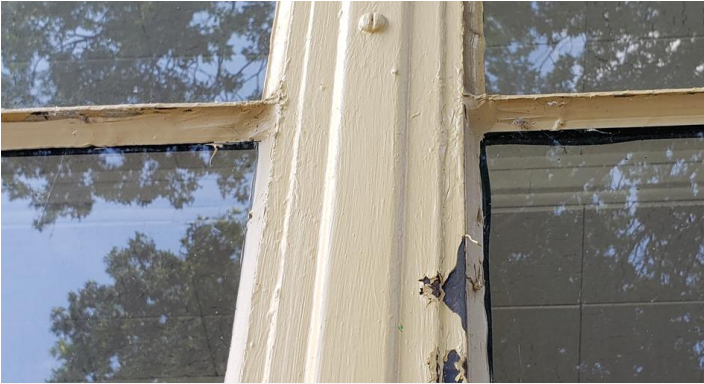
Corrosion at frame

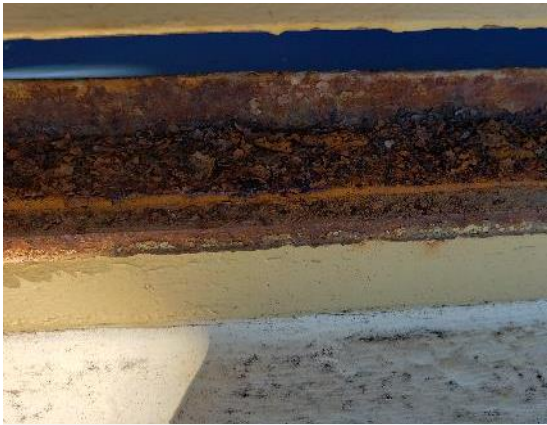
Rust scaling at frame beneath sash

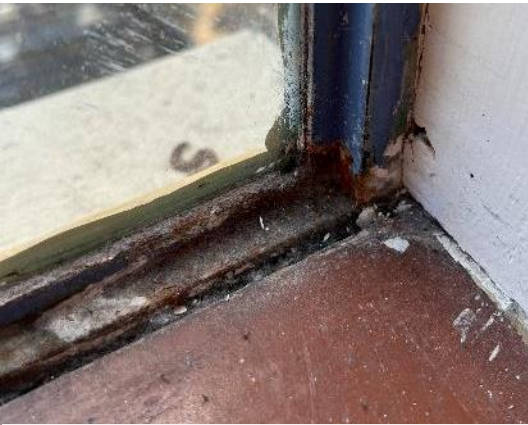
Rust scaling at interior of fixed frame

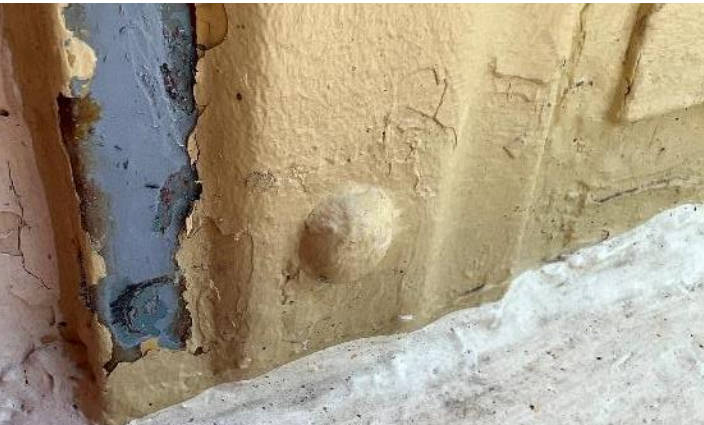
Epoxy repair at corroded corner

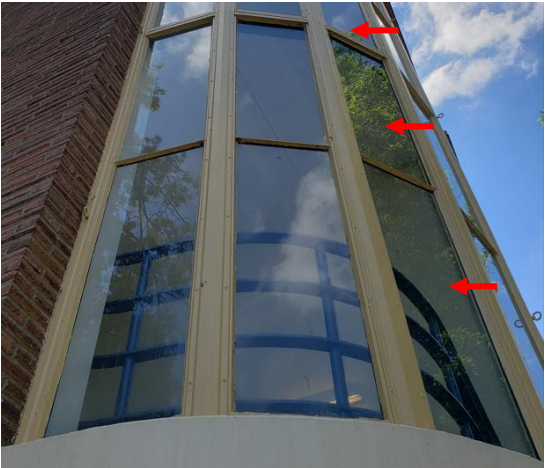
Red = darker glass with green color

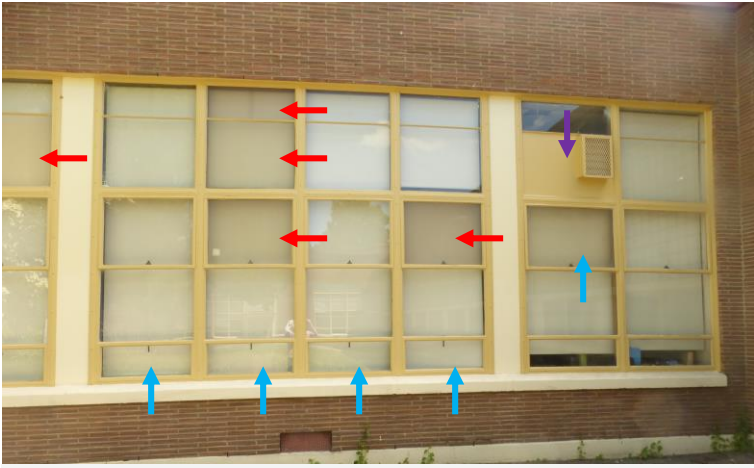
Red & blue = darker glass, purple = metal panel

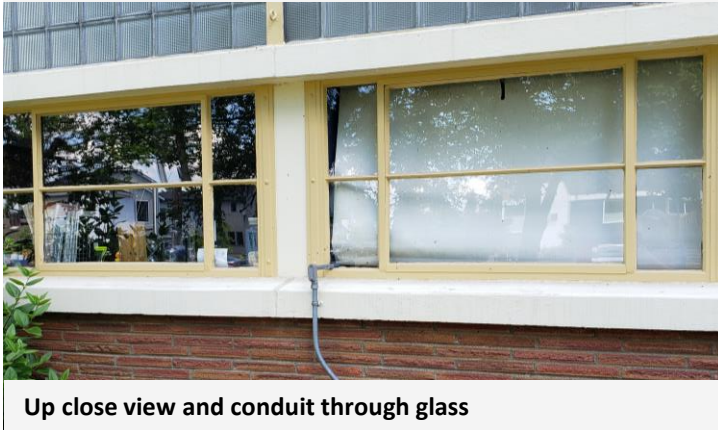
Up close view and conduit through glass

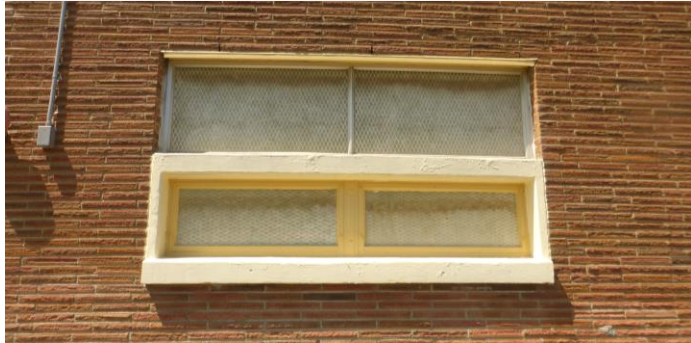
Narrow fixed windows below missing glass block walls

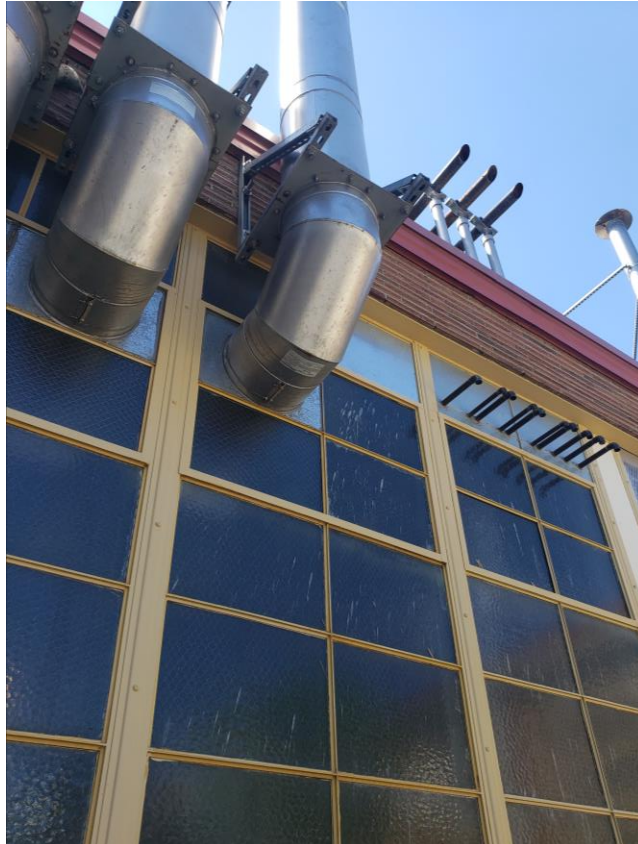
Infill of glazing for ductwork and pipe penetrations

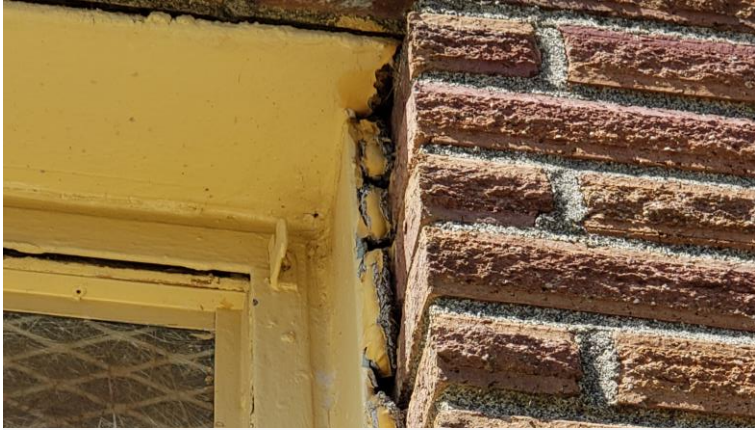
Failing asbestos sealant and steel angle corrosion

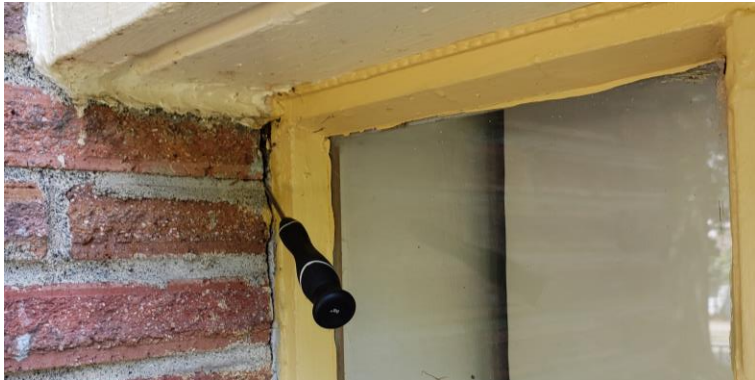
Window flange set against brick masonry without steel angle

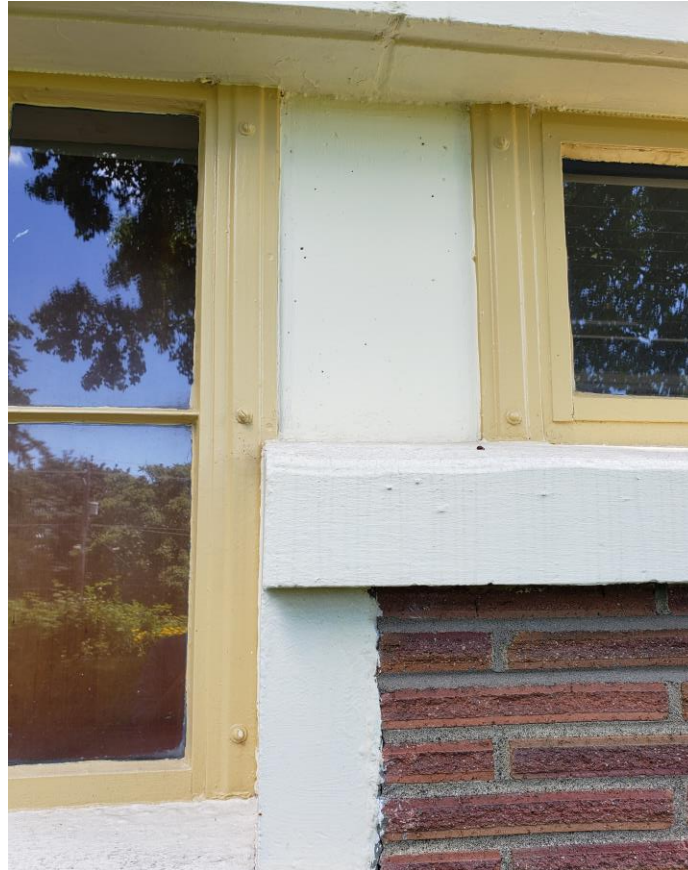
Notched steel mullion around transition in concrete ledge
