## OVERVIEW

The stone paving in the Plaza in front of SAAM has deteriorated significantly within the primary vehicle drive areas. Seattle Department of Parks and Recreation is investigating repair alternatives and is seeking input from the Architectural Review Committee on the method of repairs.

## VOLUNTEER PARK DRIVE PLAZA PAVING

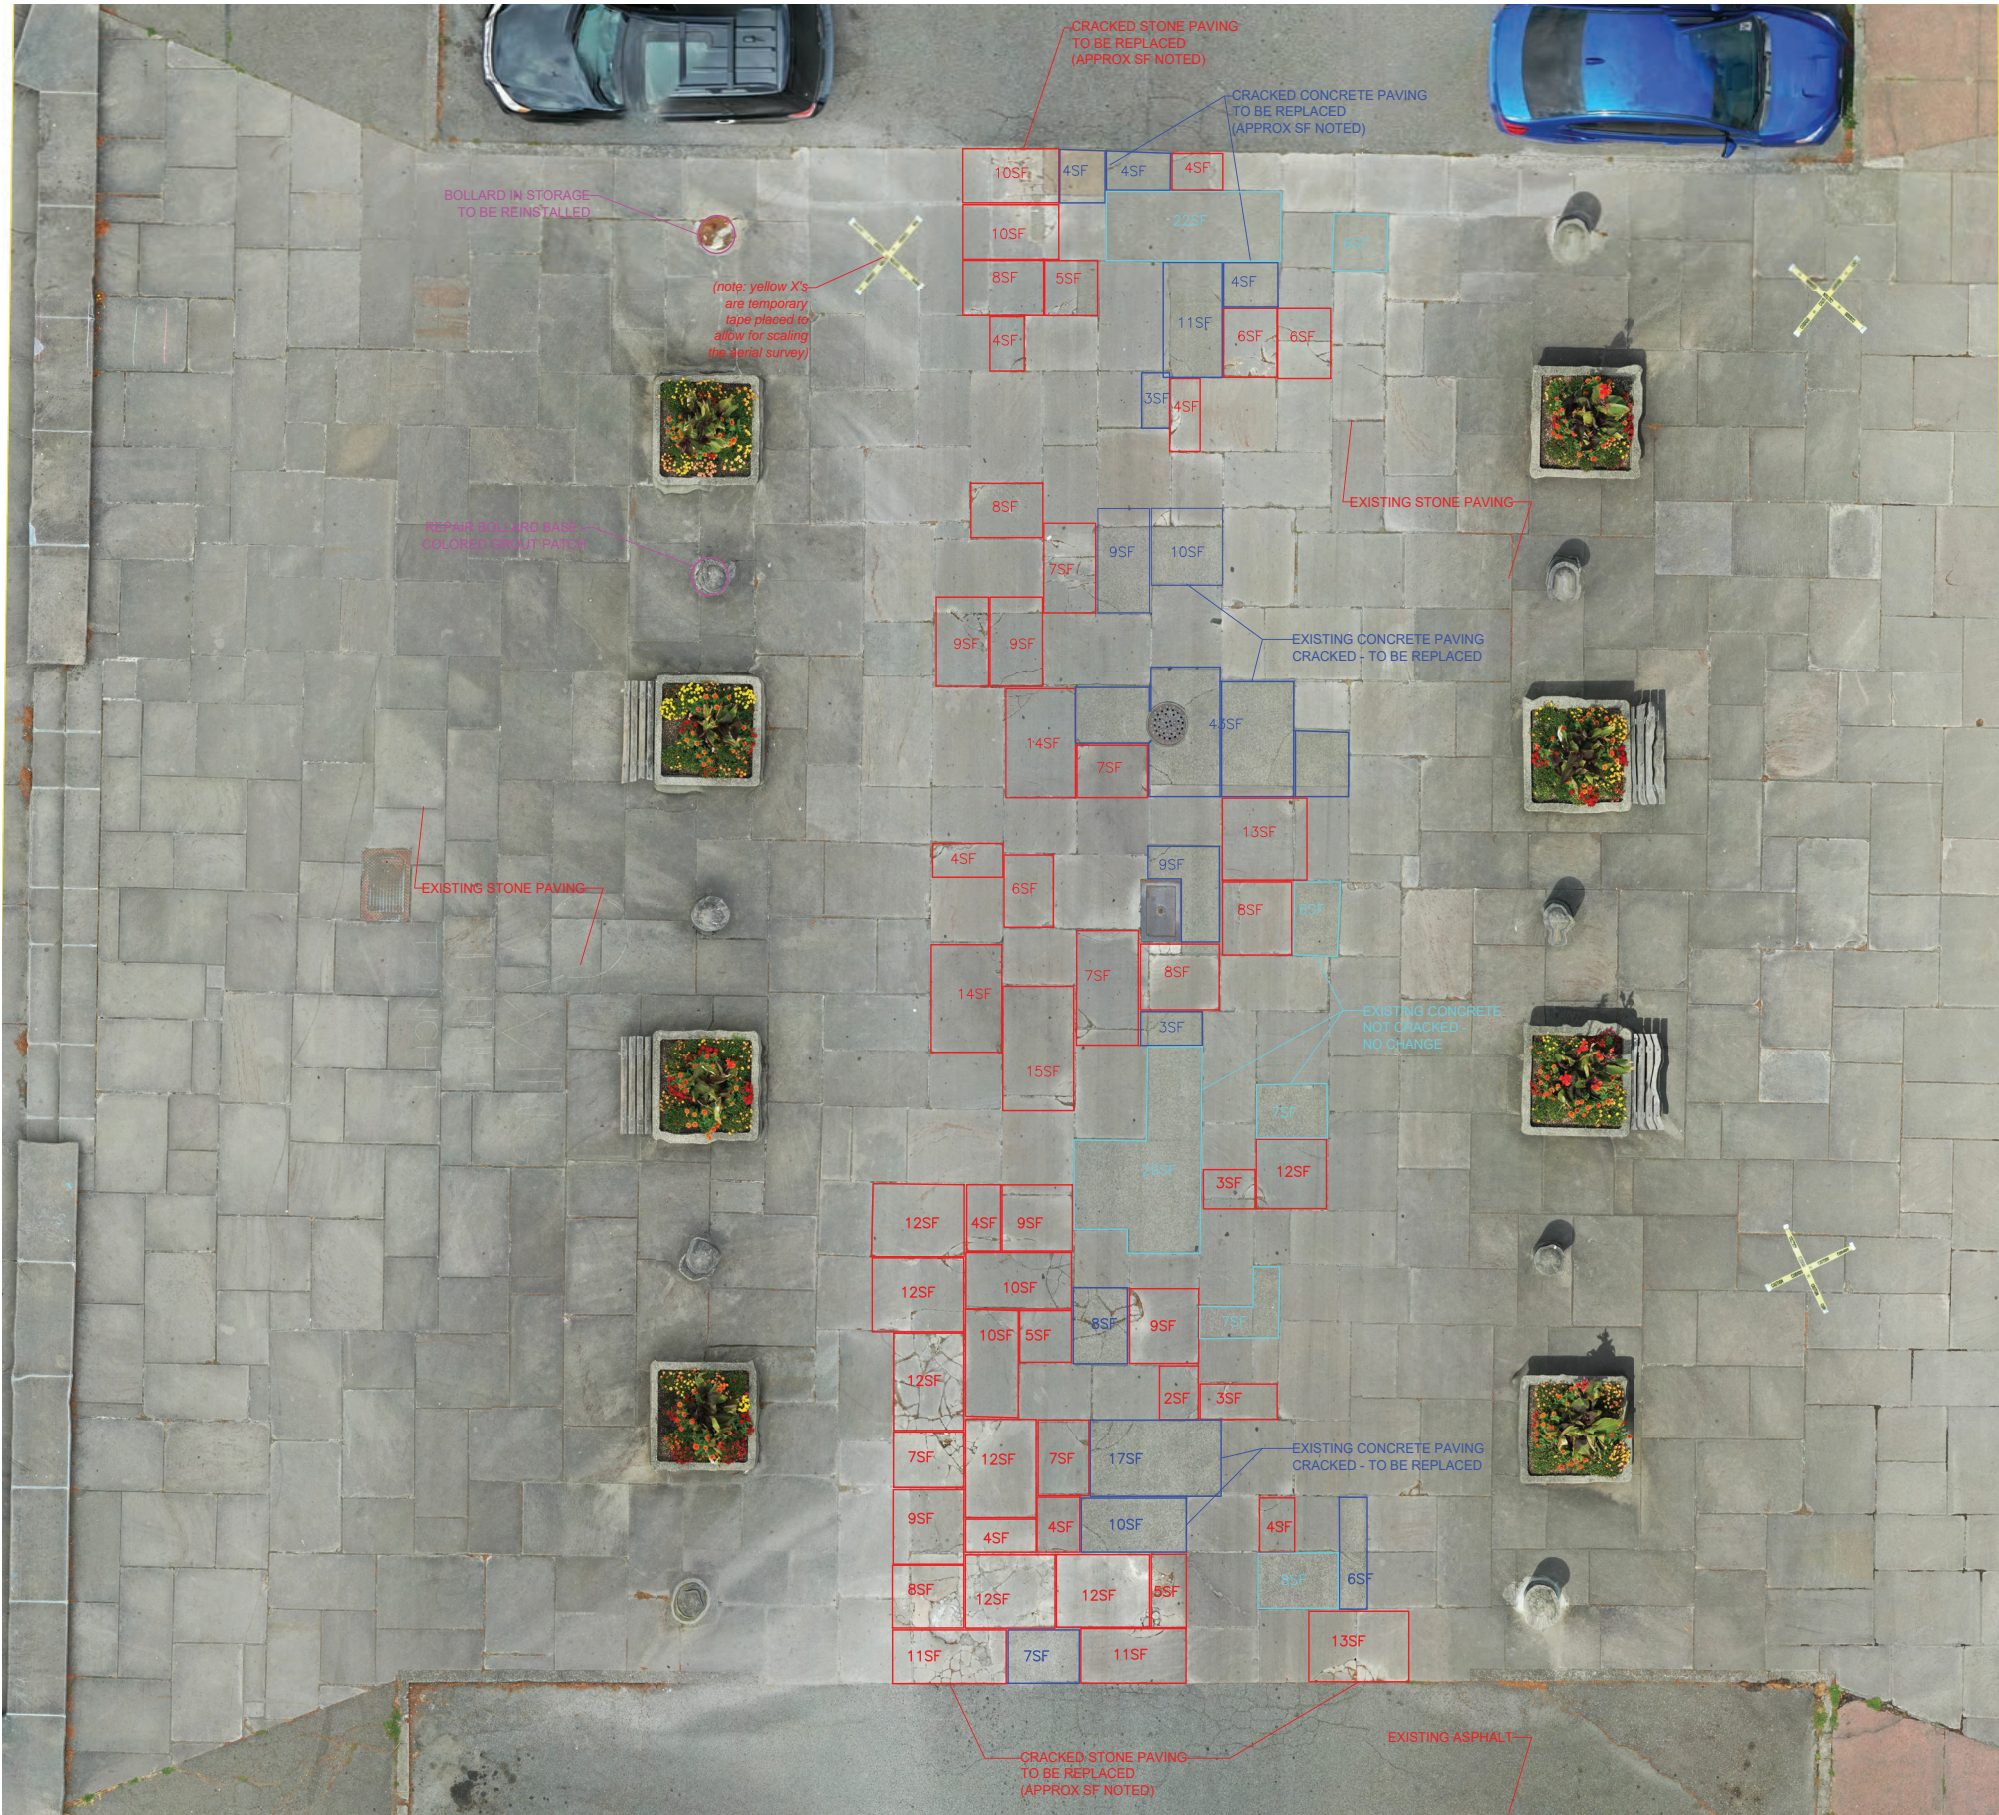
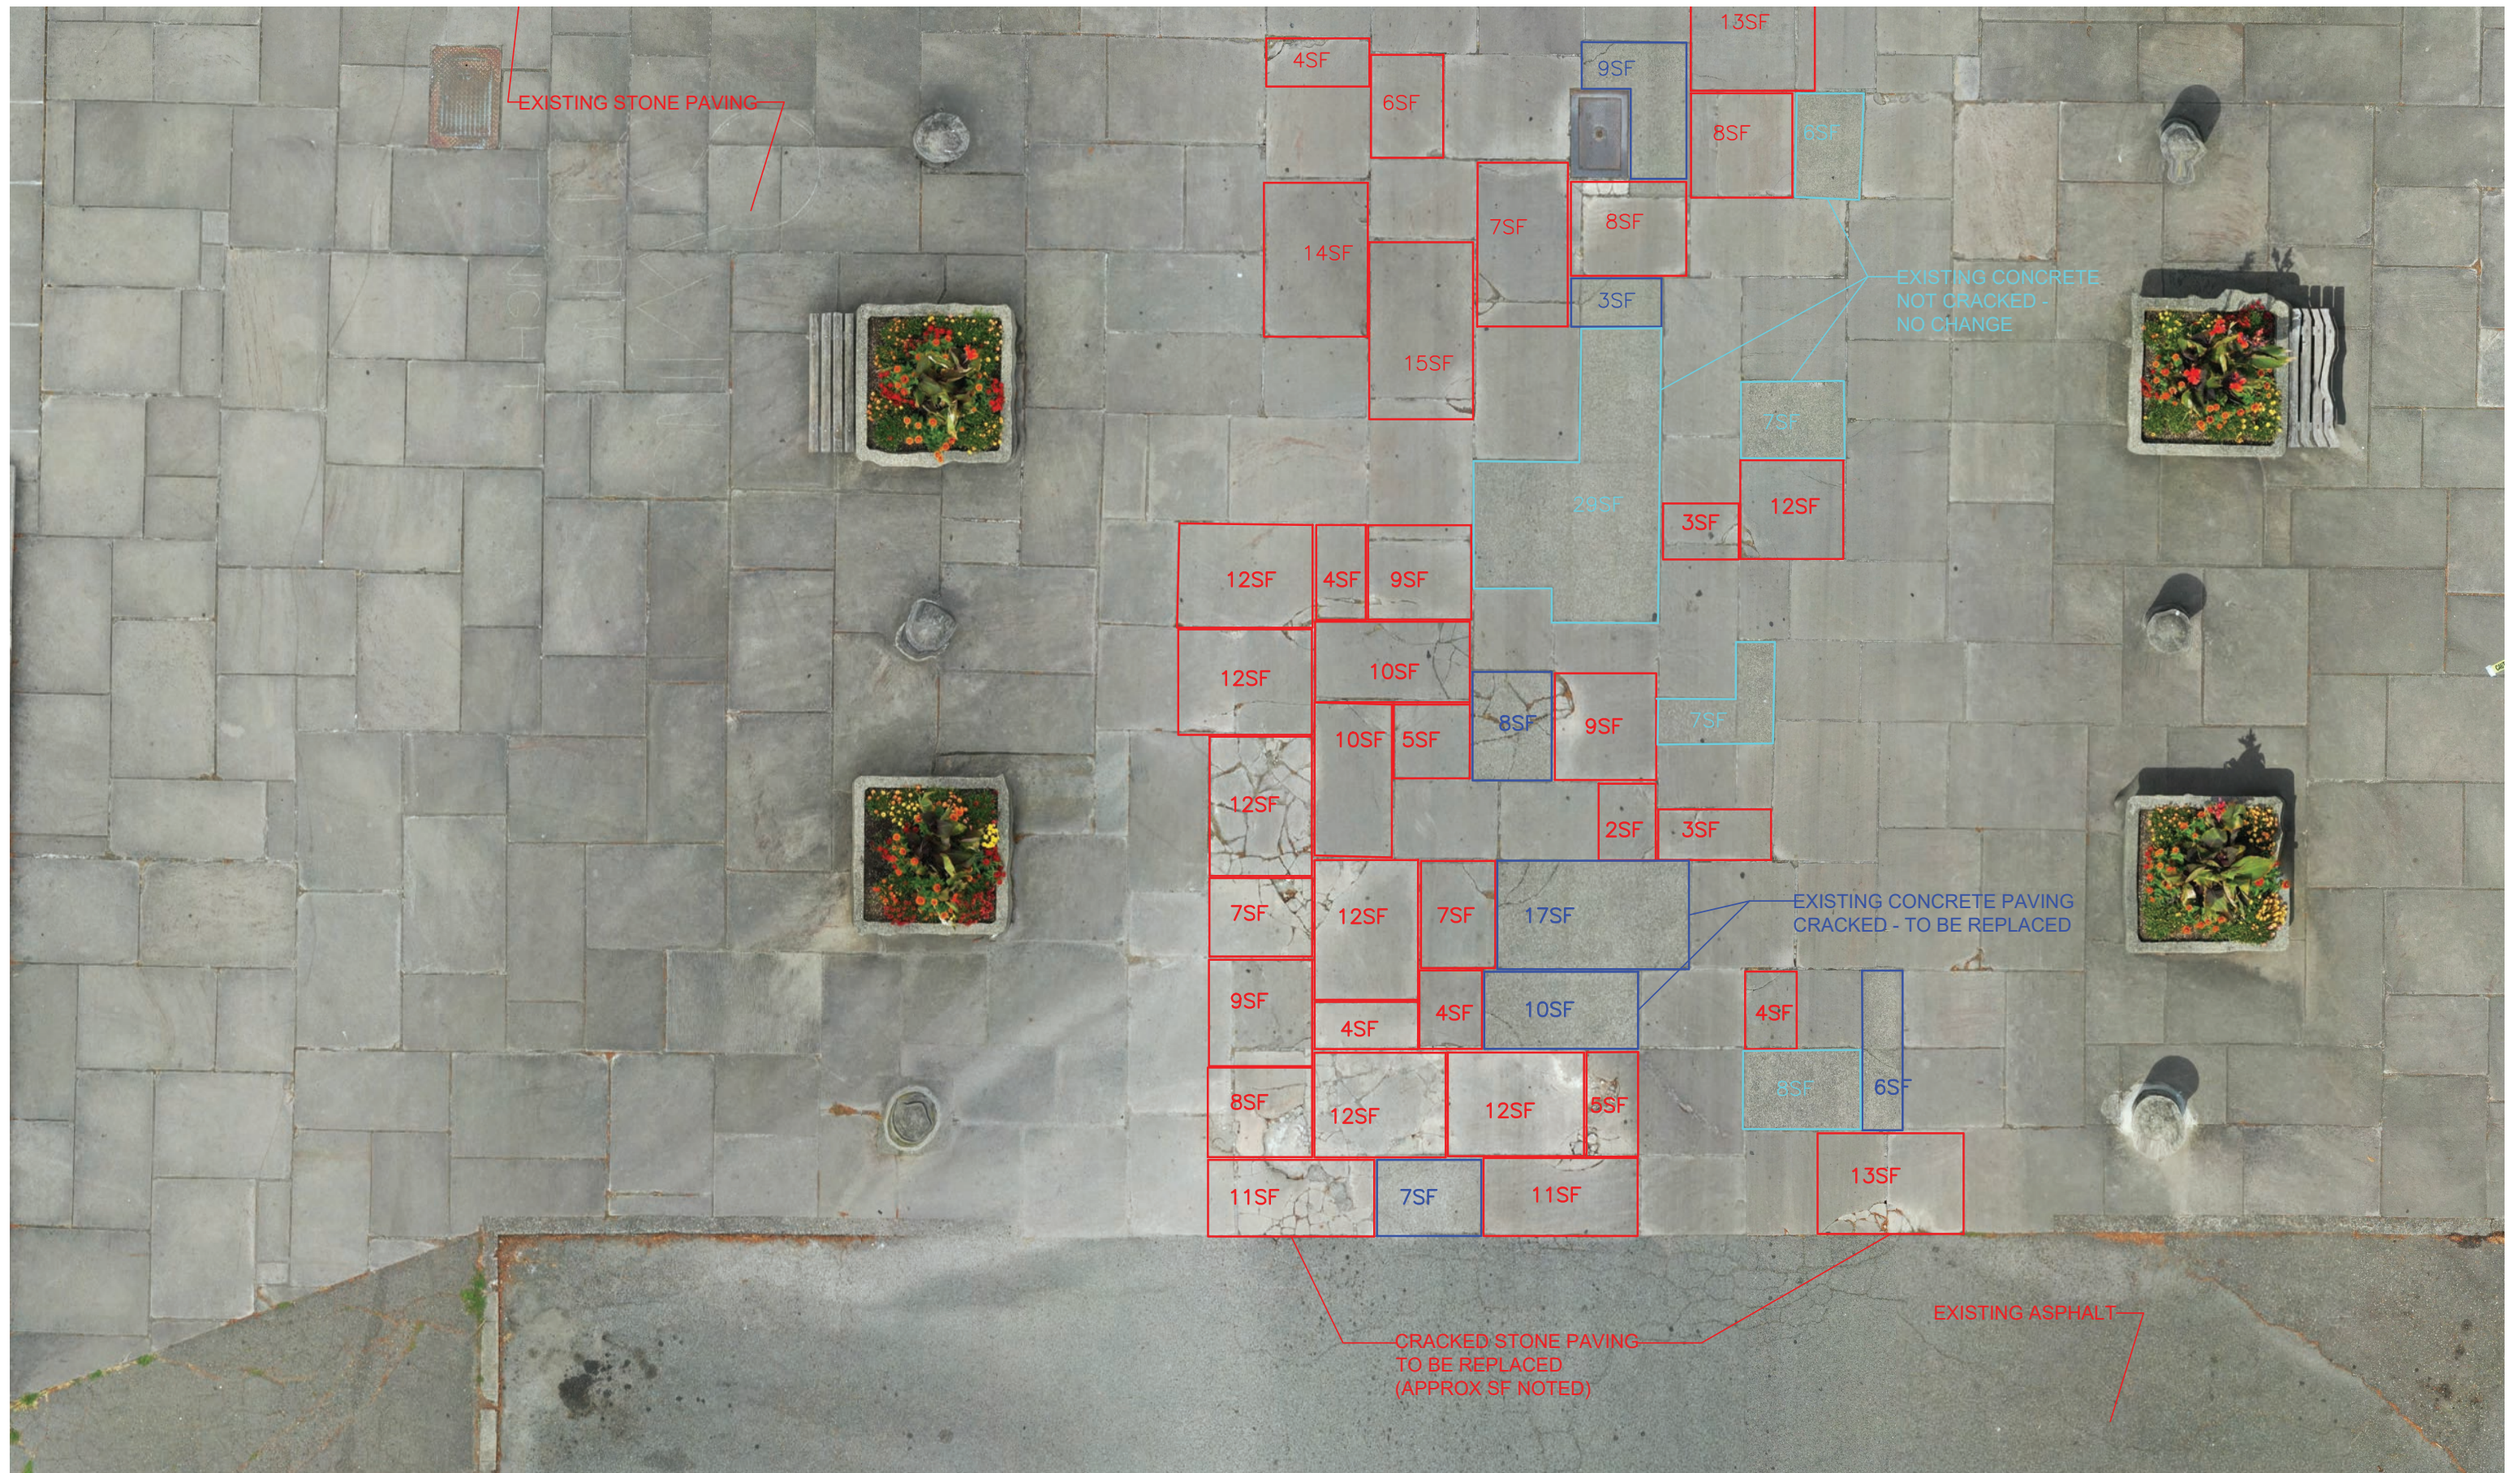
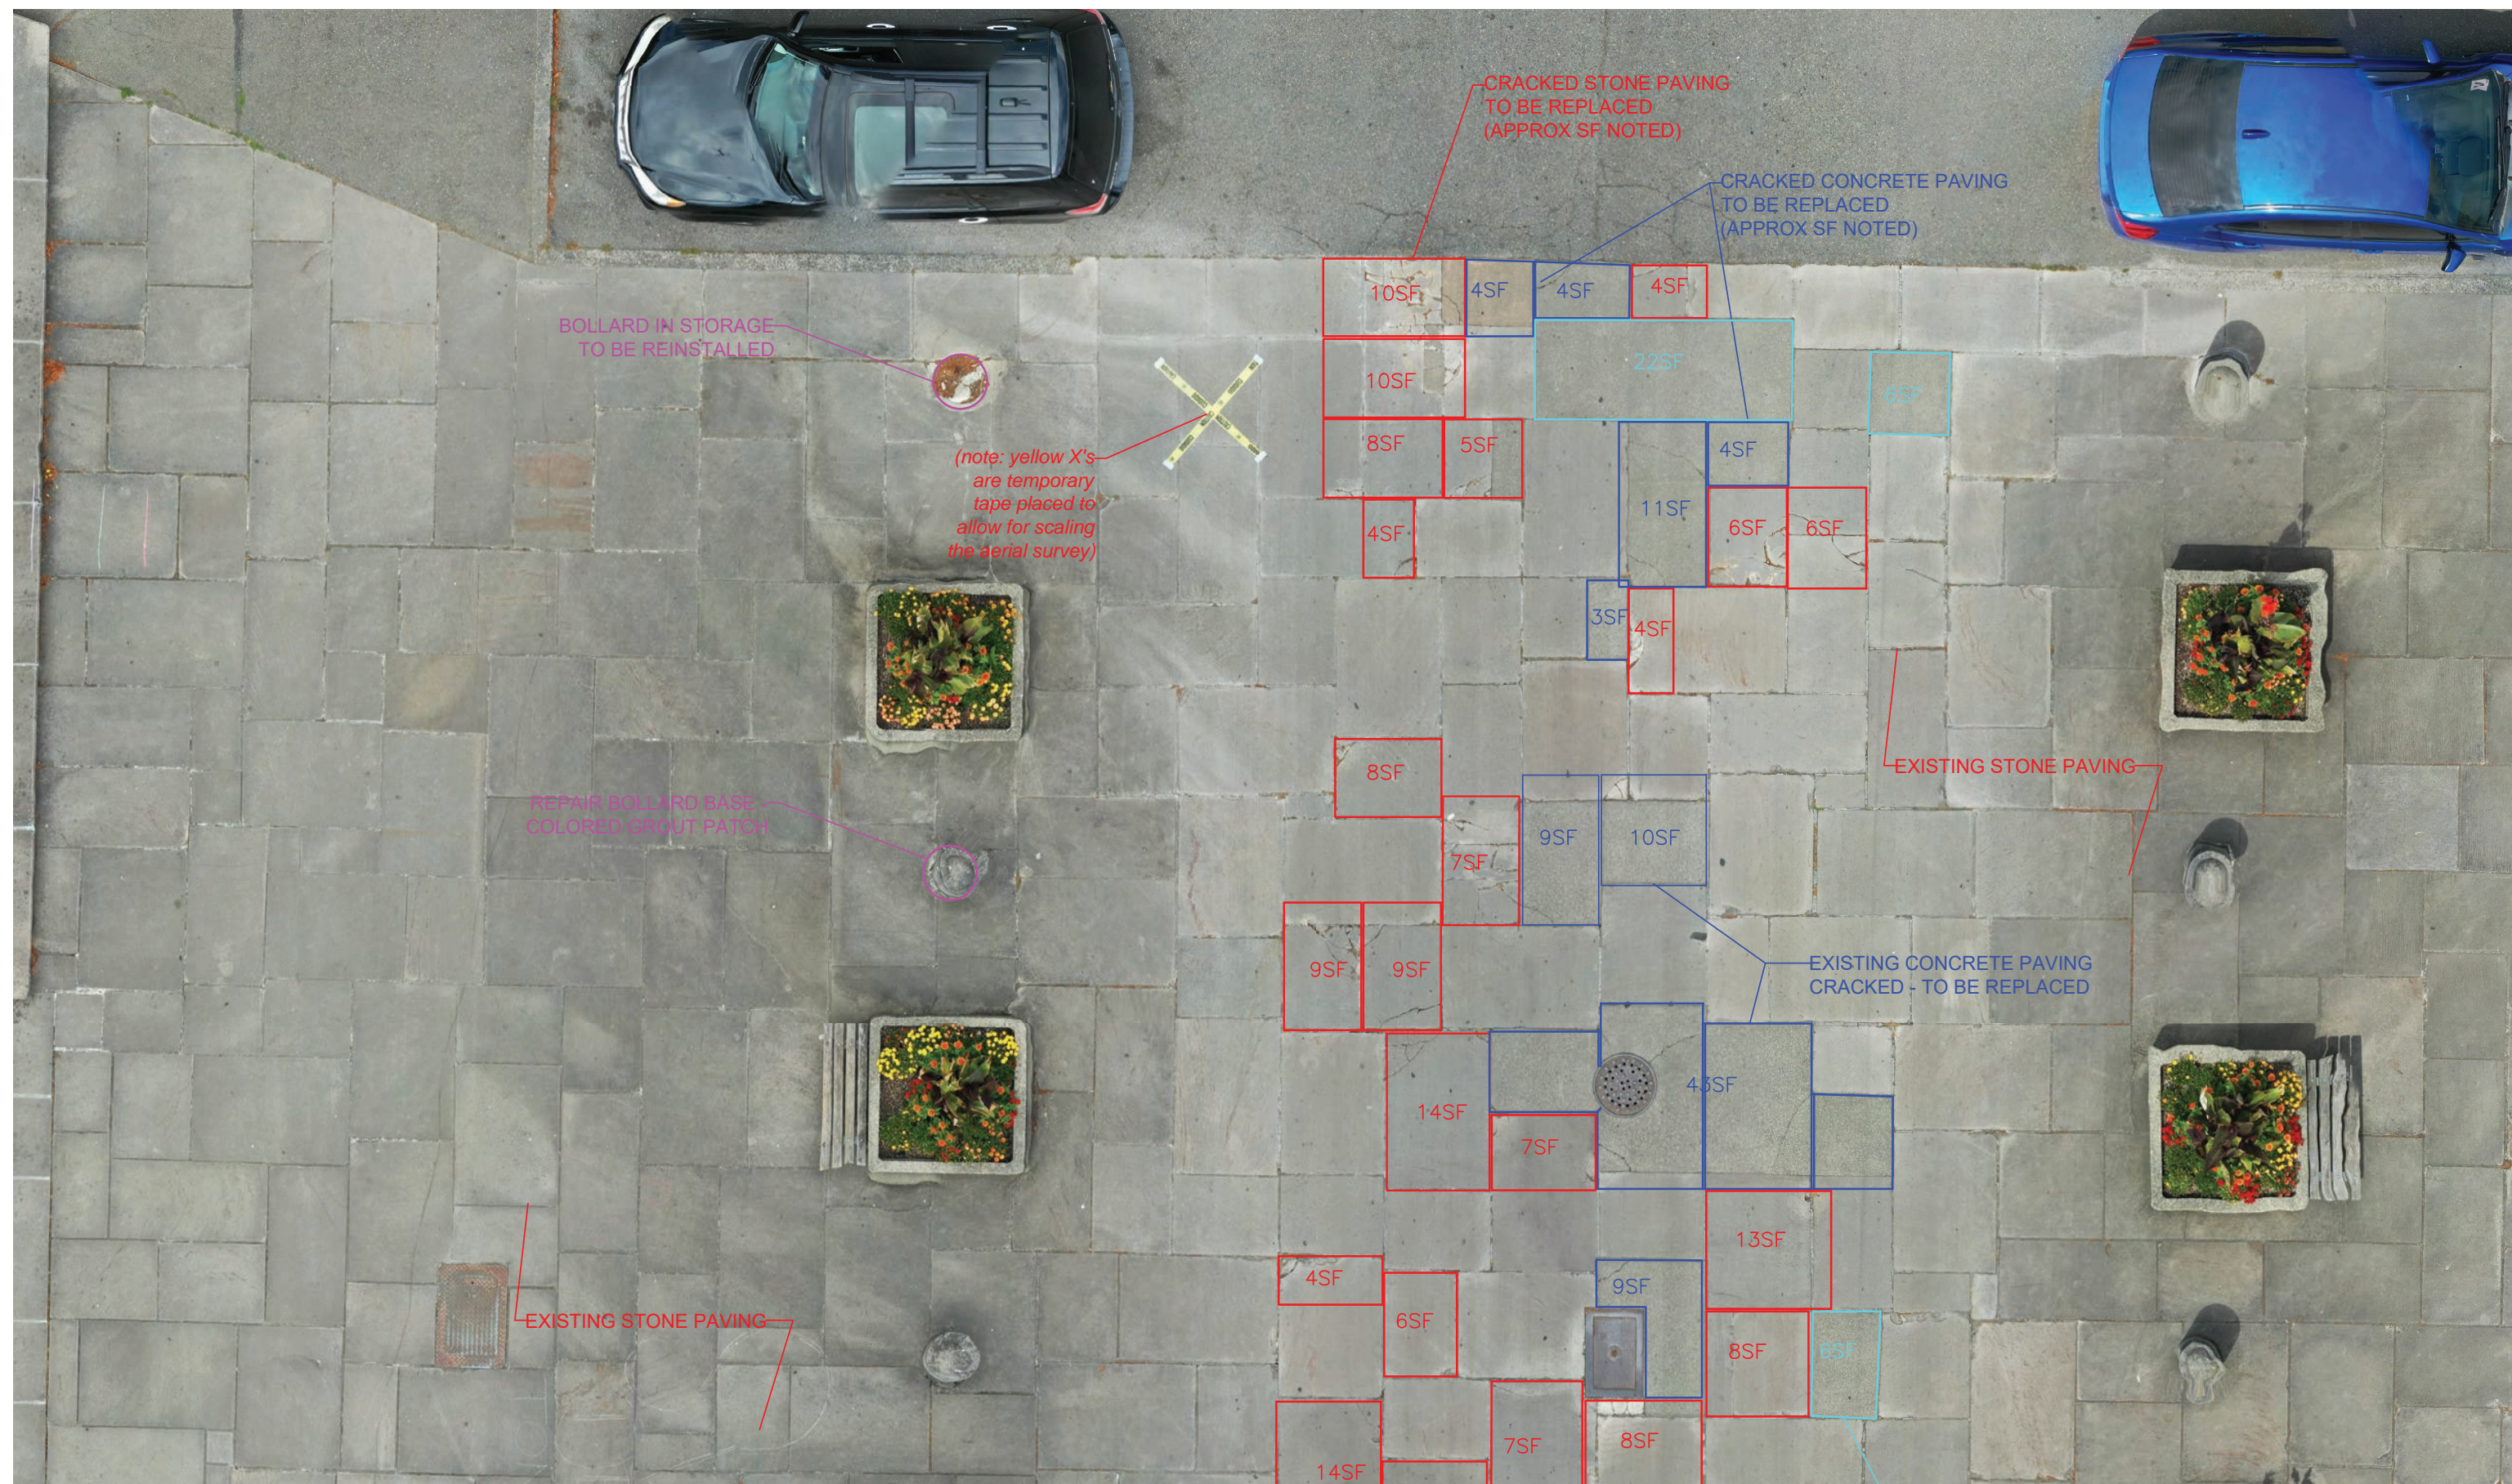
AERIAL SURVEY: PLAZA PLAN - NORTH

Based on detailed site reviews, the plan highlights three areas as follows:

Red: stone pavers with significant deterioration and recommended to be replaced: (410 sf)

Blue: concrete paving with some cracking which is not as problematic as the disintegrating stones, but would ideally be replaced if feasible within the budget: (150 sf)

Light blue: other existing conc. paving infills without any cracking: (80 sf)

The Southwest portion of the plaza represents the most extreme area of deterioration, with numerous stones completely disintegrated.

The blue dotted lines show the primary vehicle pathway which is where nearly all deterioration has occurred.

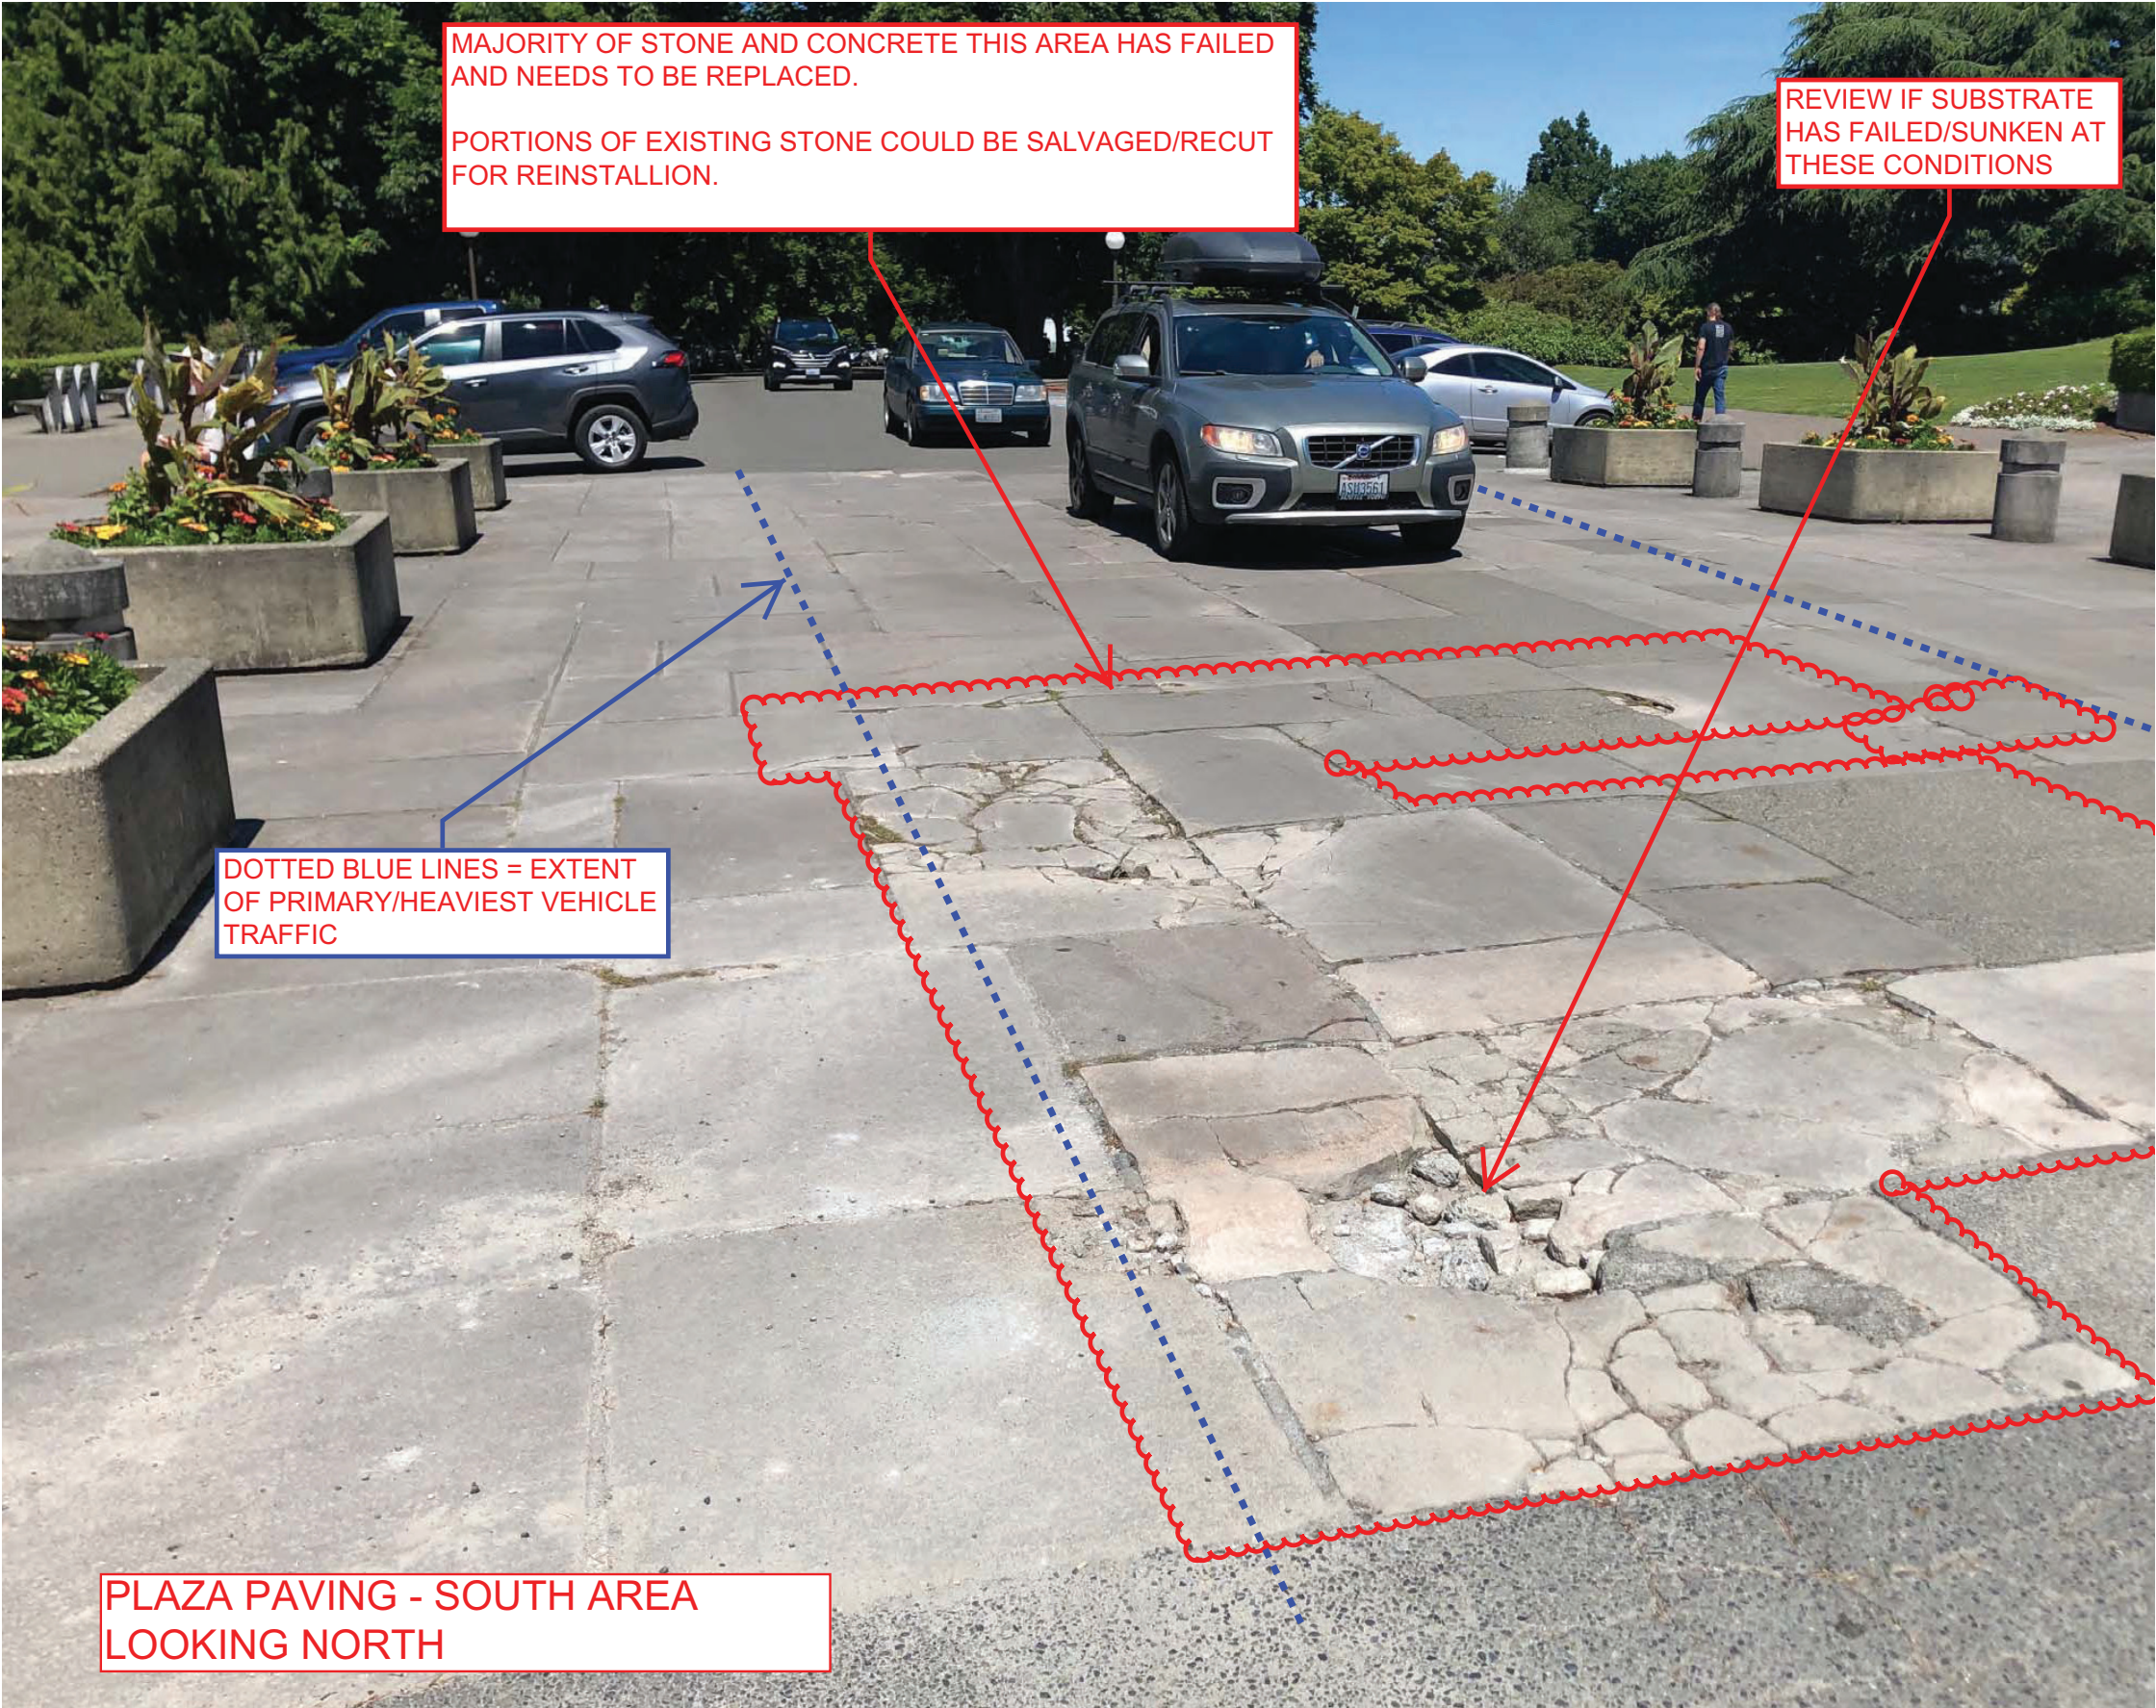
The Southwest portion of the plaza represents the most extreme are of deterioration, with numerous stones completely disintegrated.

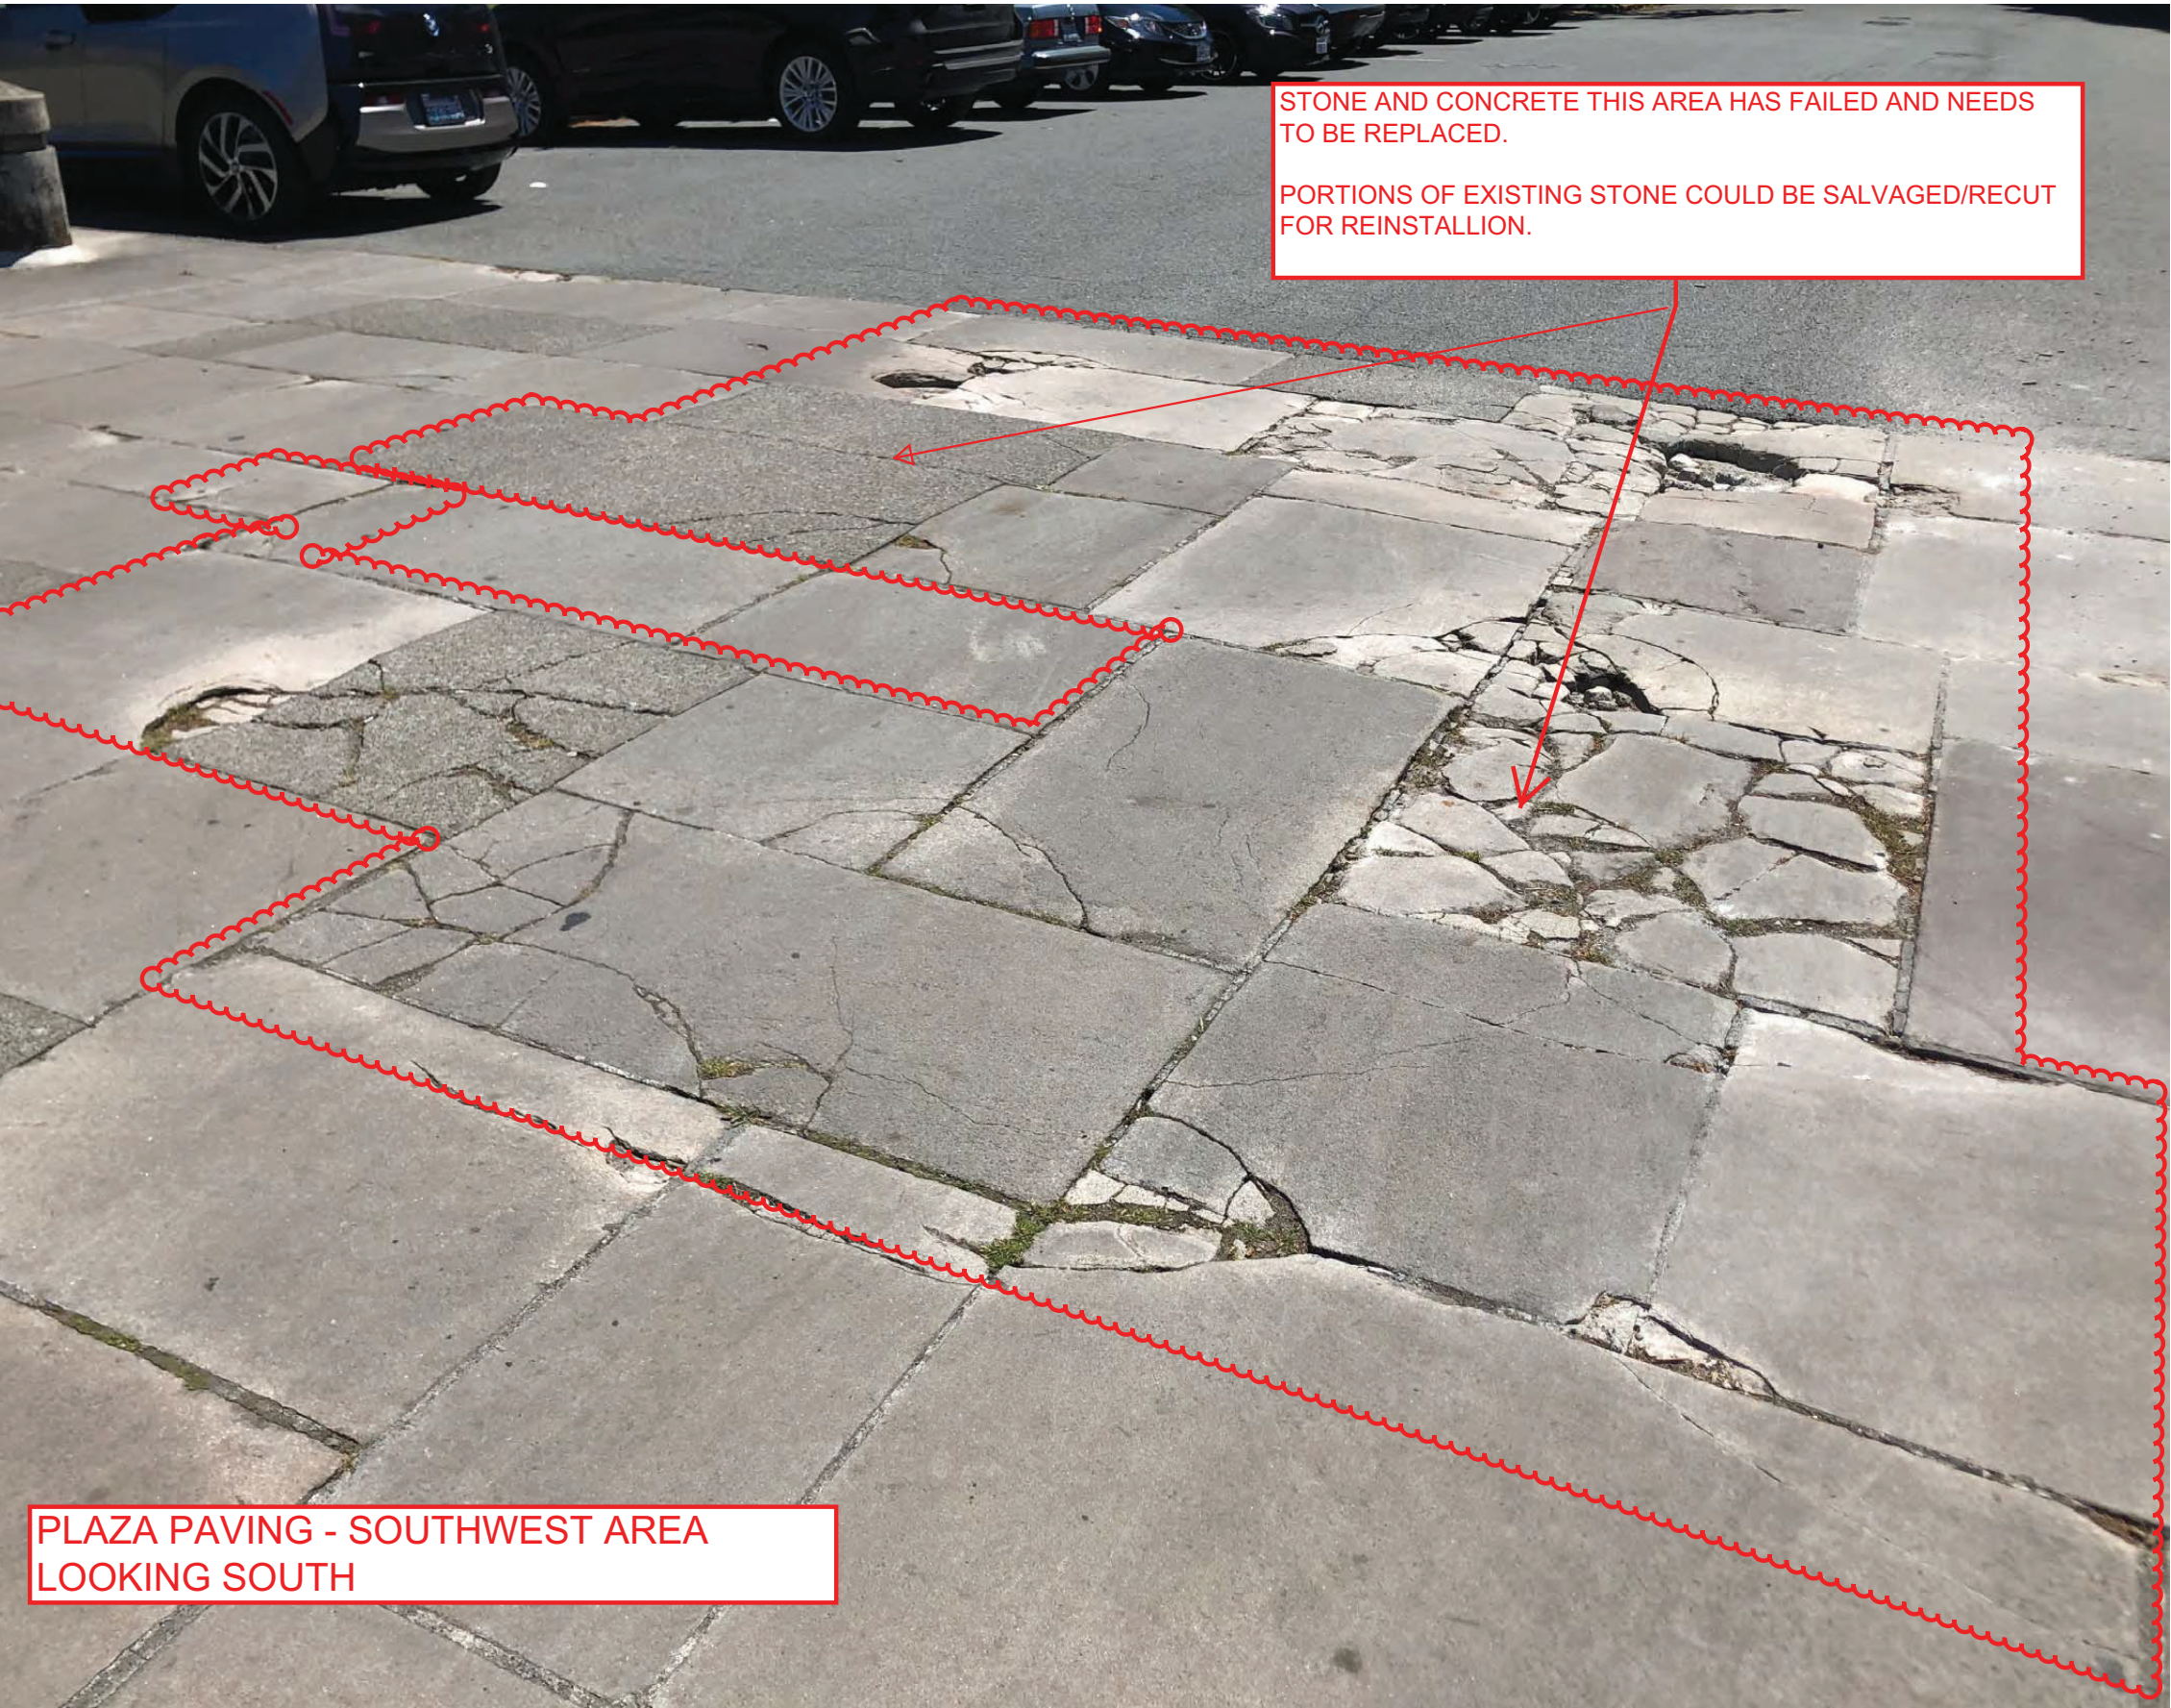
The Southwest portion of the plaza represents the most extreme are of deterioration, with numerous stones completely disintegrated.

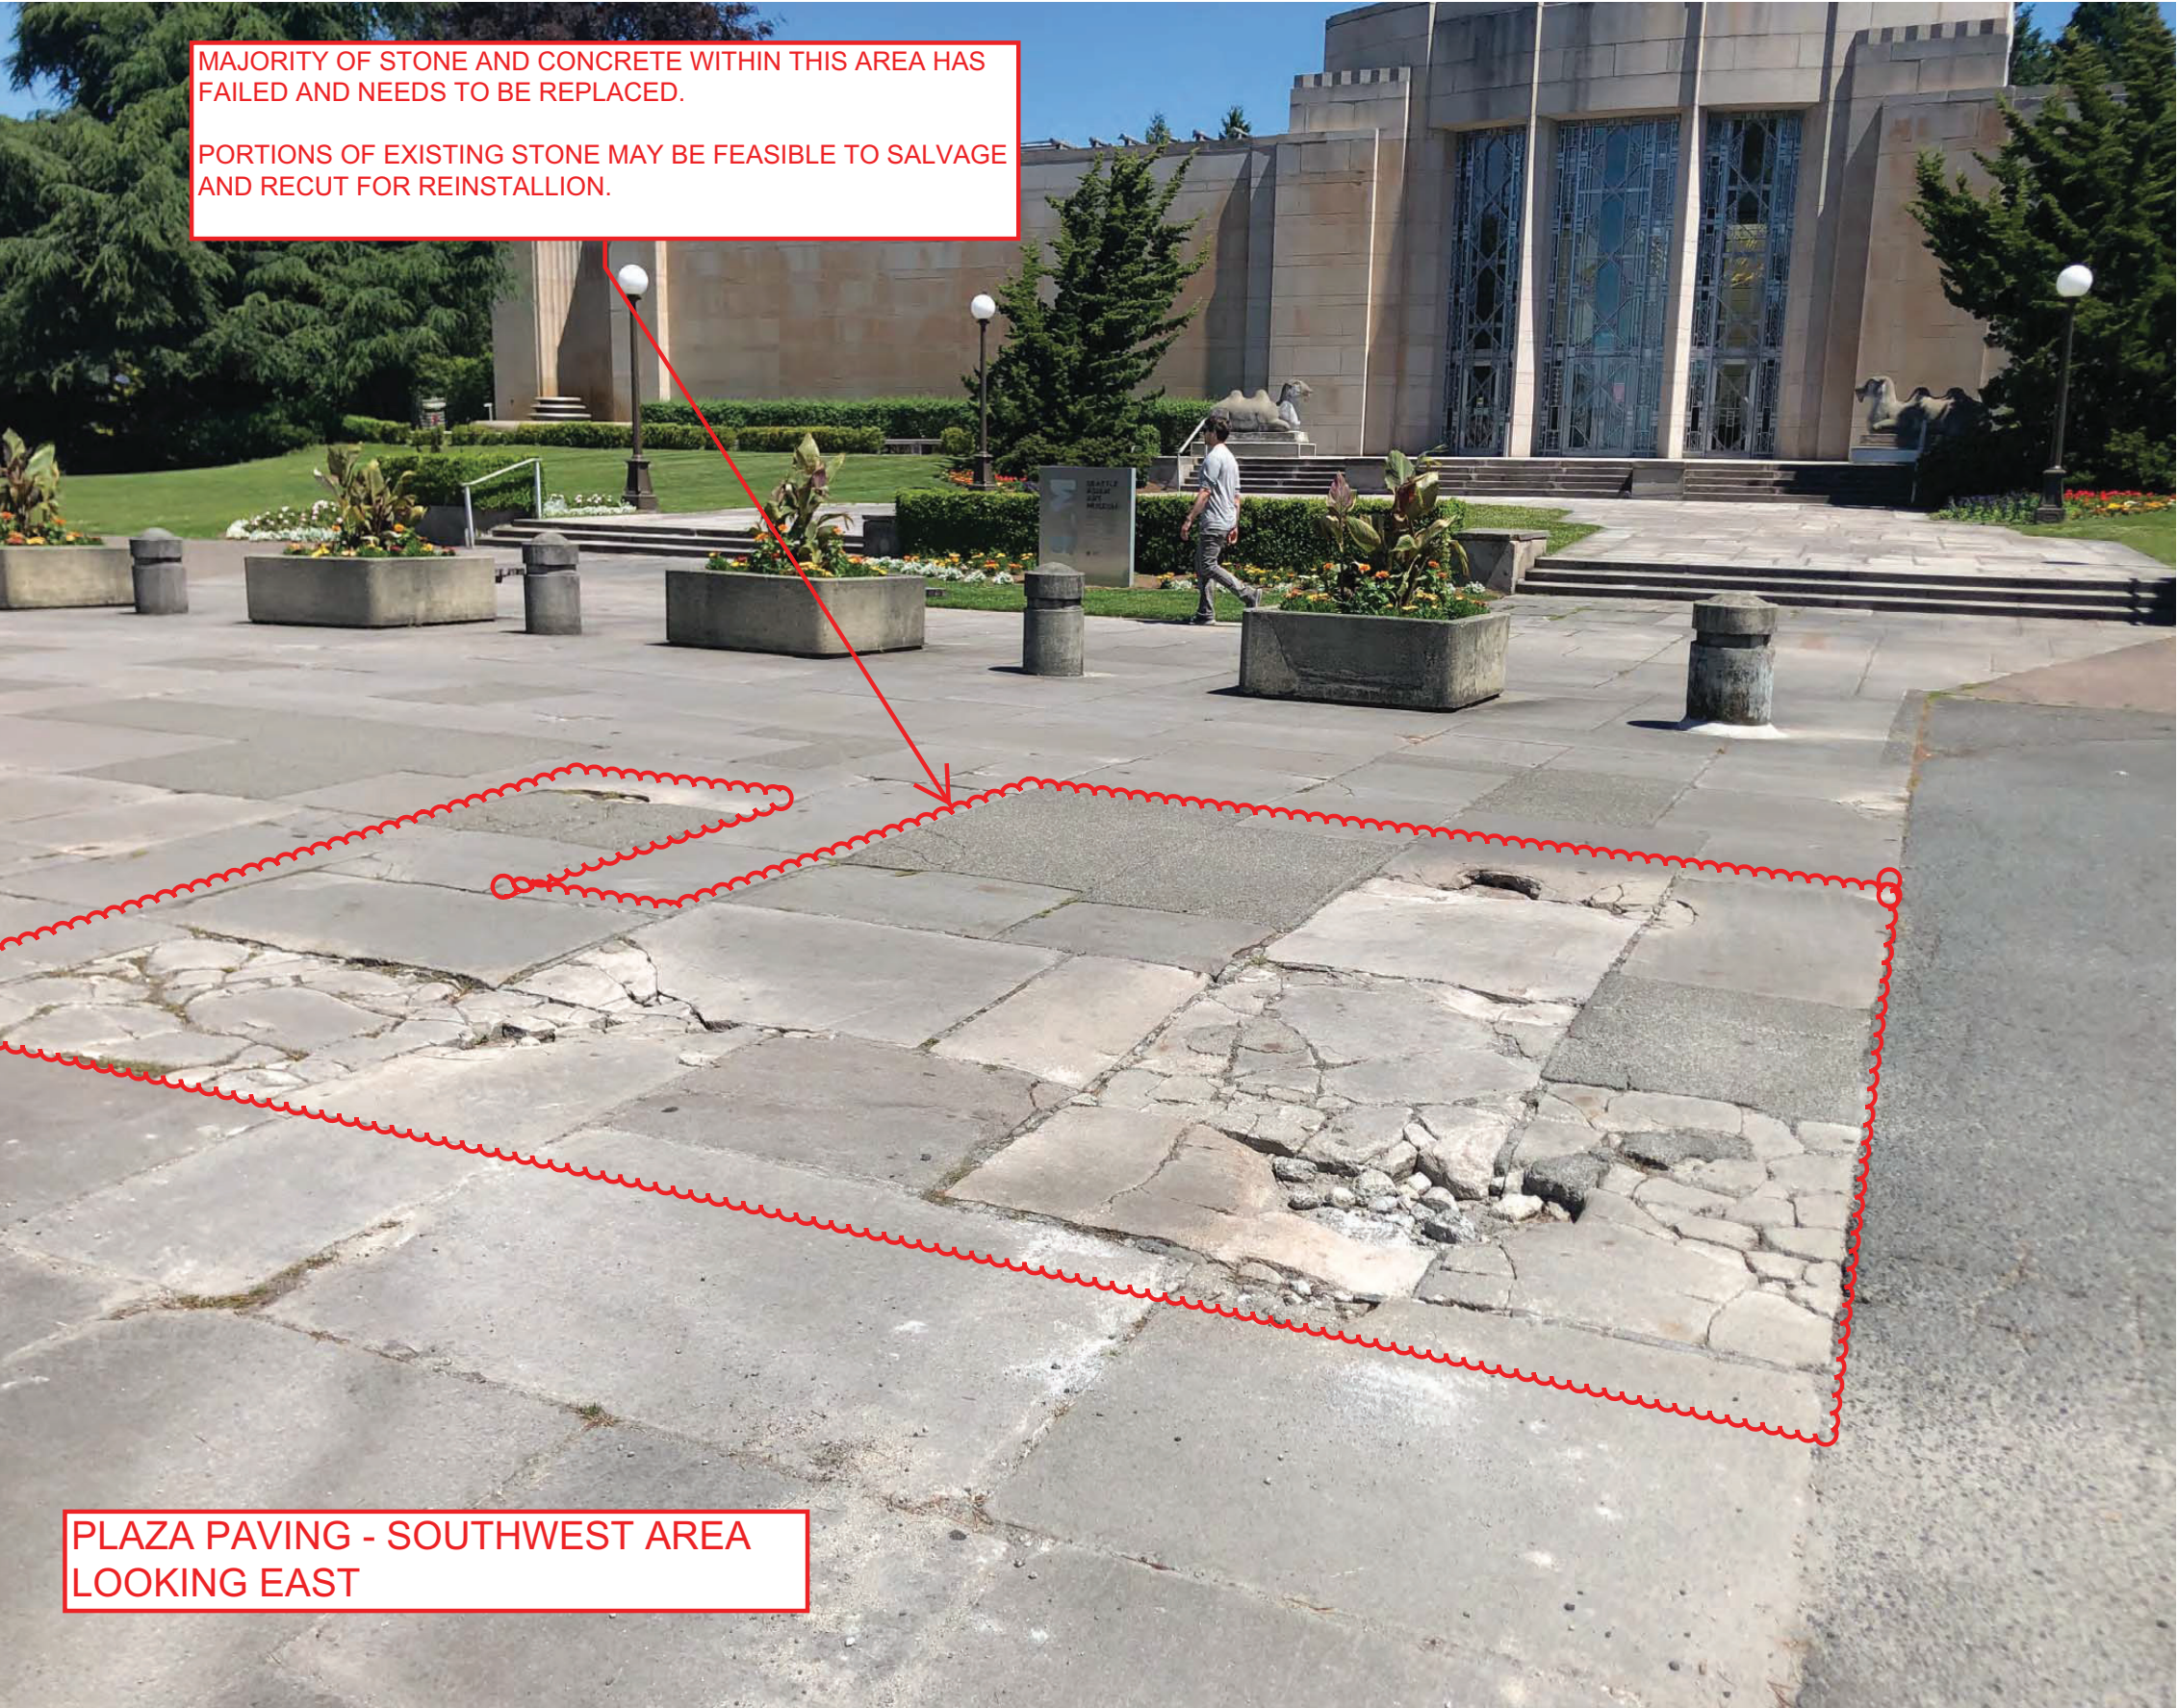
The Southeast portion of the plaza has less extensive deterioration than at Southwest, but the stones closest to asphalt have failed, notably along the edge of asphalt paving. An adjoining concrete infill has minor cracks so is noted to ideally be replaced if feasible within the budget.
