## OVERVIEW

The stone paving in the Plaza in front of SAAM has deteriorated significantly within the primary vehicle drive areas. Seattle Department of Parks and Recreation is investigating repair alternatives and is seeking input from the Architectural Review Committee on the method of repairs.

## VOLUNTEER PARK DRIVE PLAZA PAVING

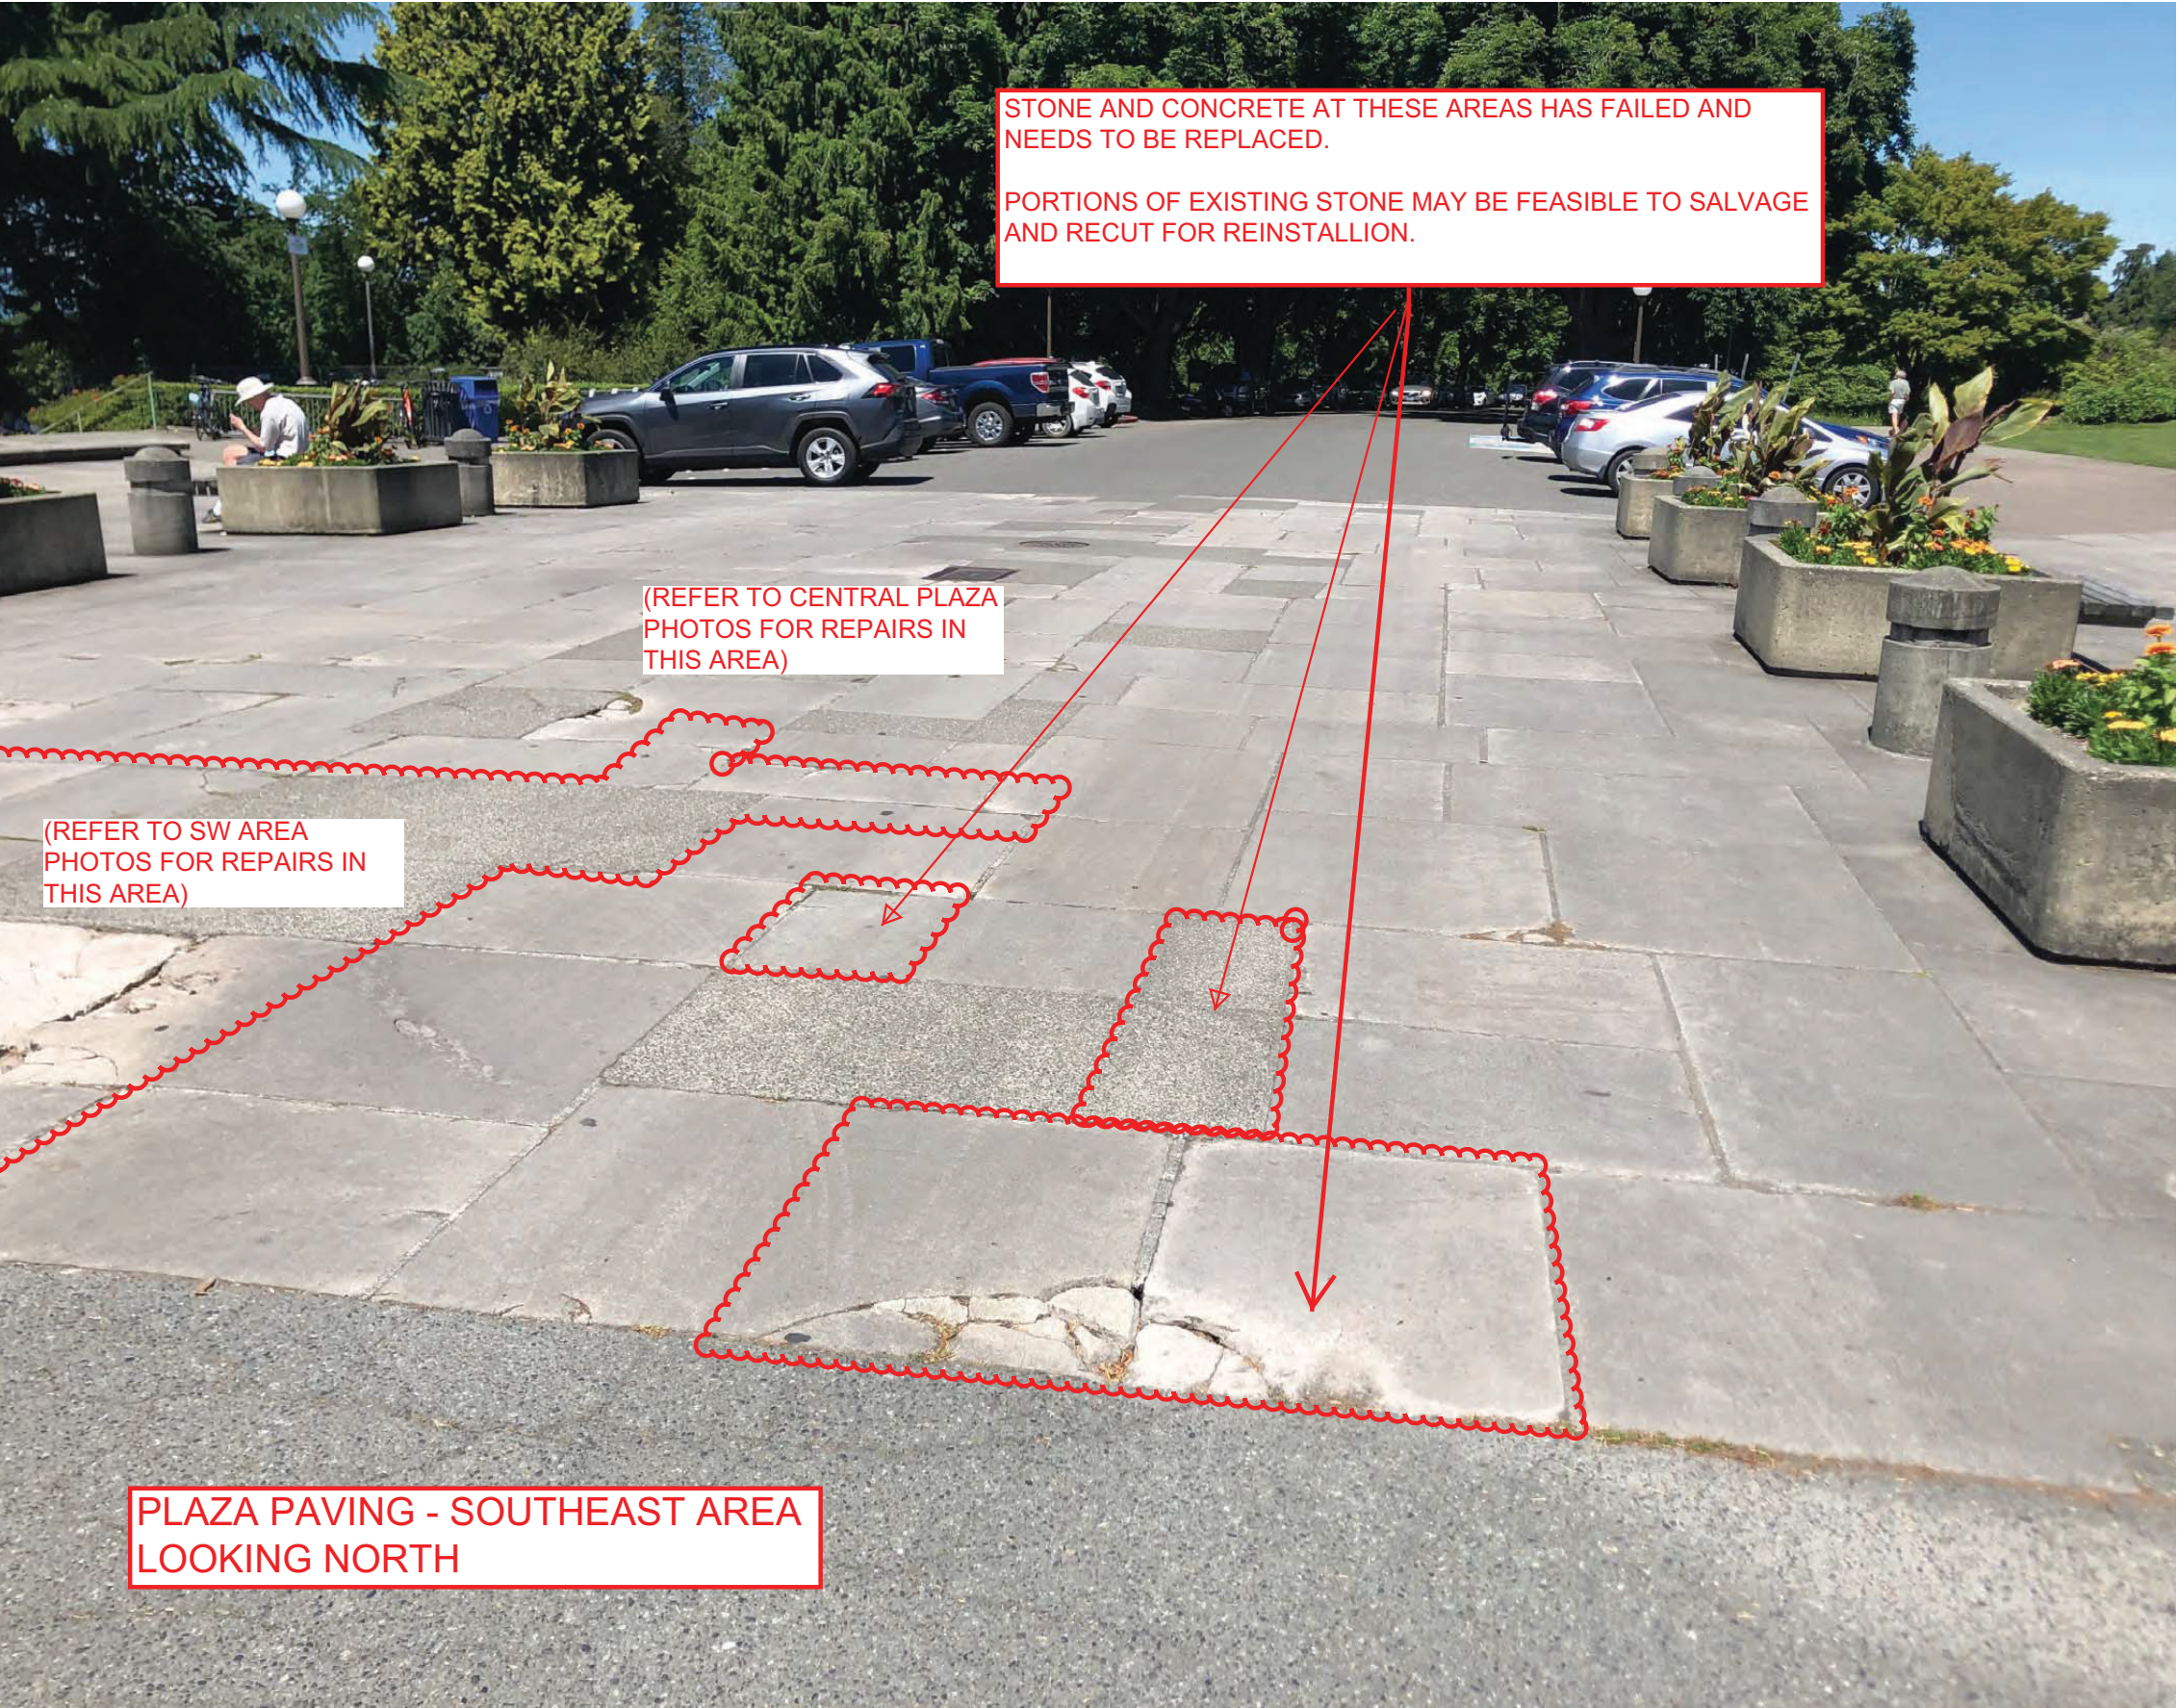
The central plaza area has numerous stones with edges and corners that have eroded or cracked to the extent that water accumulates in the pockets, resulting in further erosion and water infiltration below the stones, contributing to accelerated deterioration. The deterioration is exacerbated in winter by freeze thaw of ice and when snow removal has resulted in further damage to irregular stone edges.

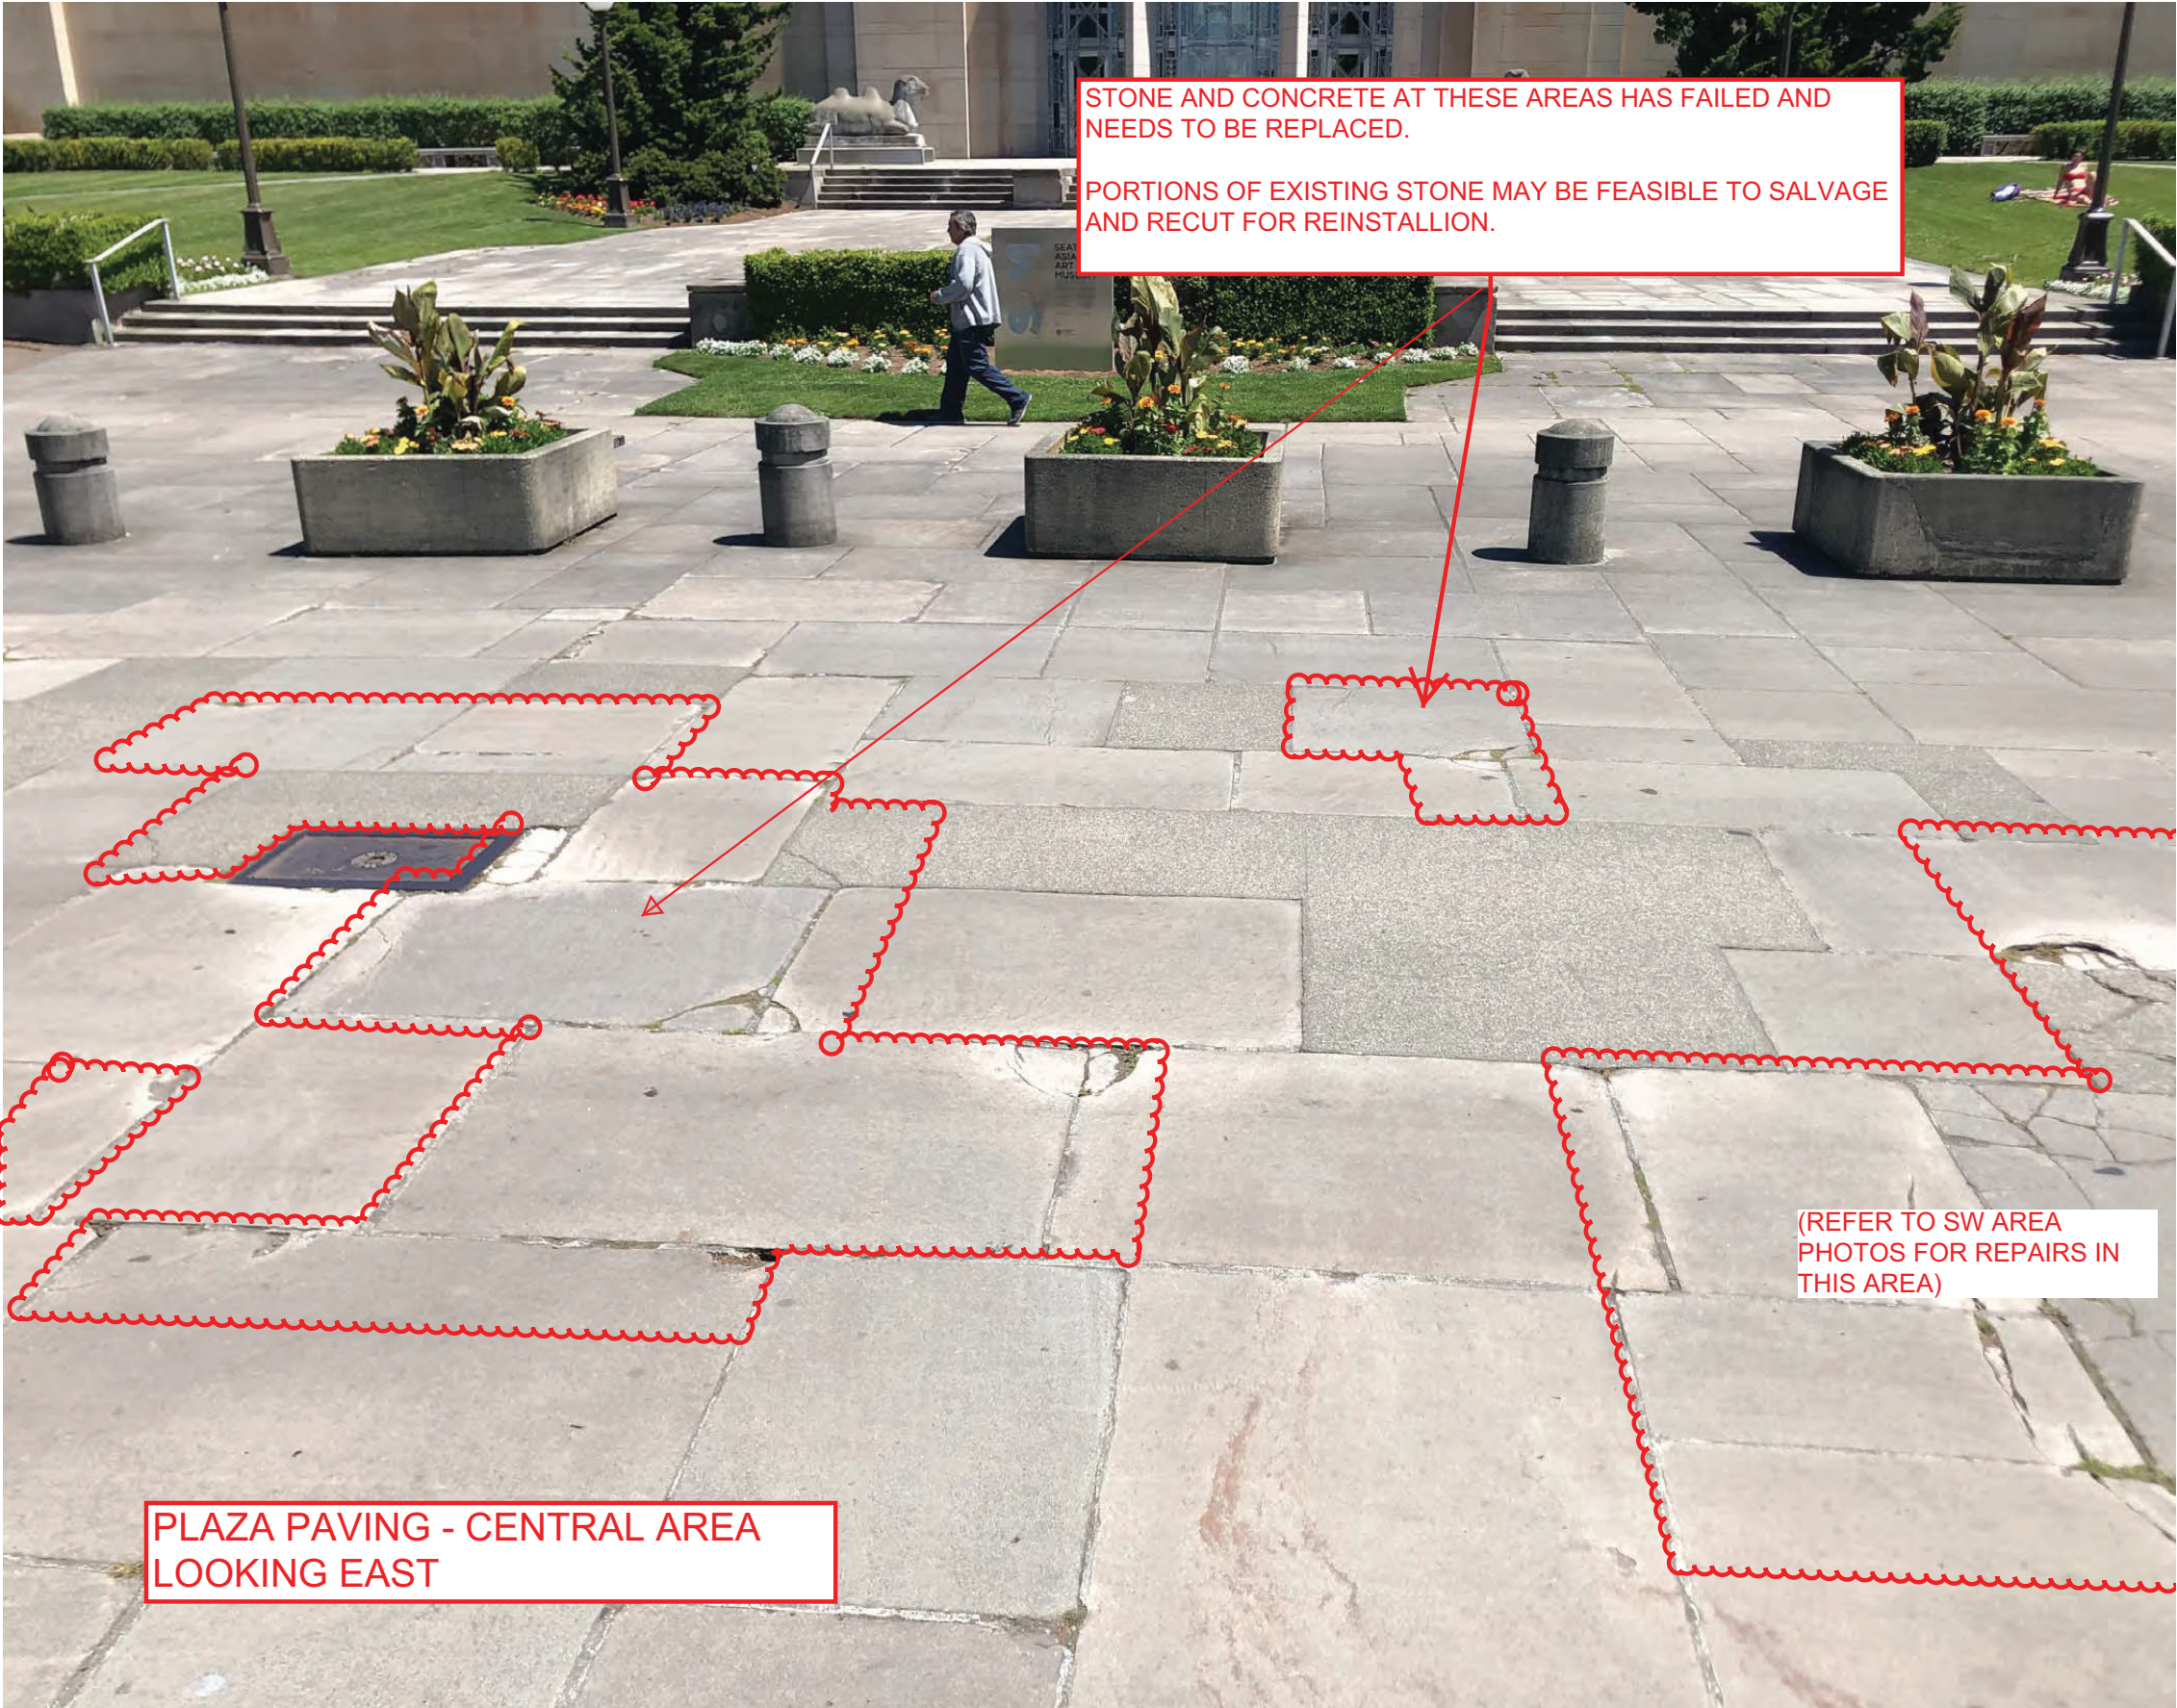
The North central plaza area also has extensive stone areas with edges and corners that have eroded or cracked to the extent that water is accumulating in the pockets and infiltrating below the stone, resulting in accelerated cracking and deterioration.

The concrete on the right-hand side of photo has some minor cracks which are not as problematic as the cracks in stone, but the concrete is proposed to be replaced here as well, if feasible within the budget.

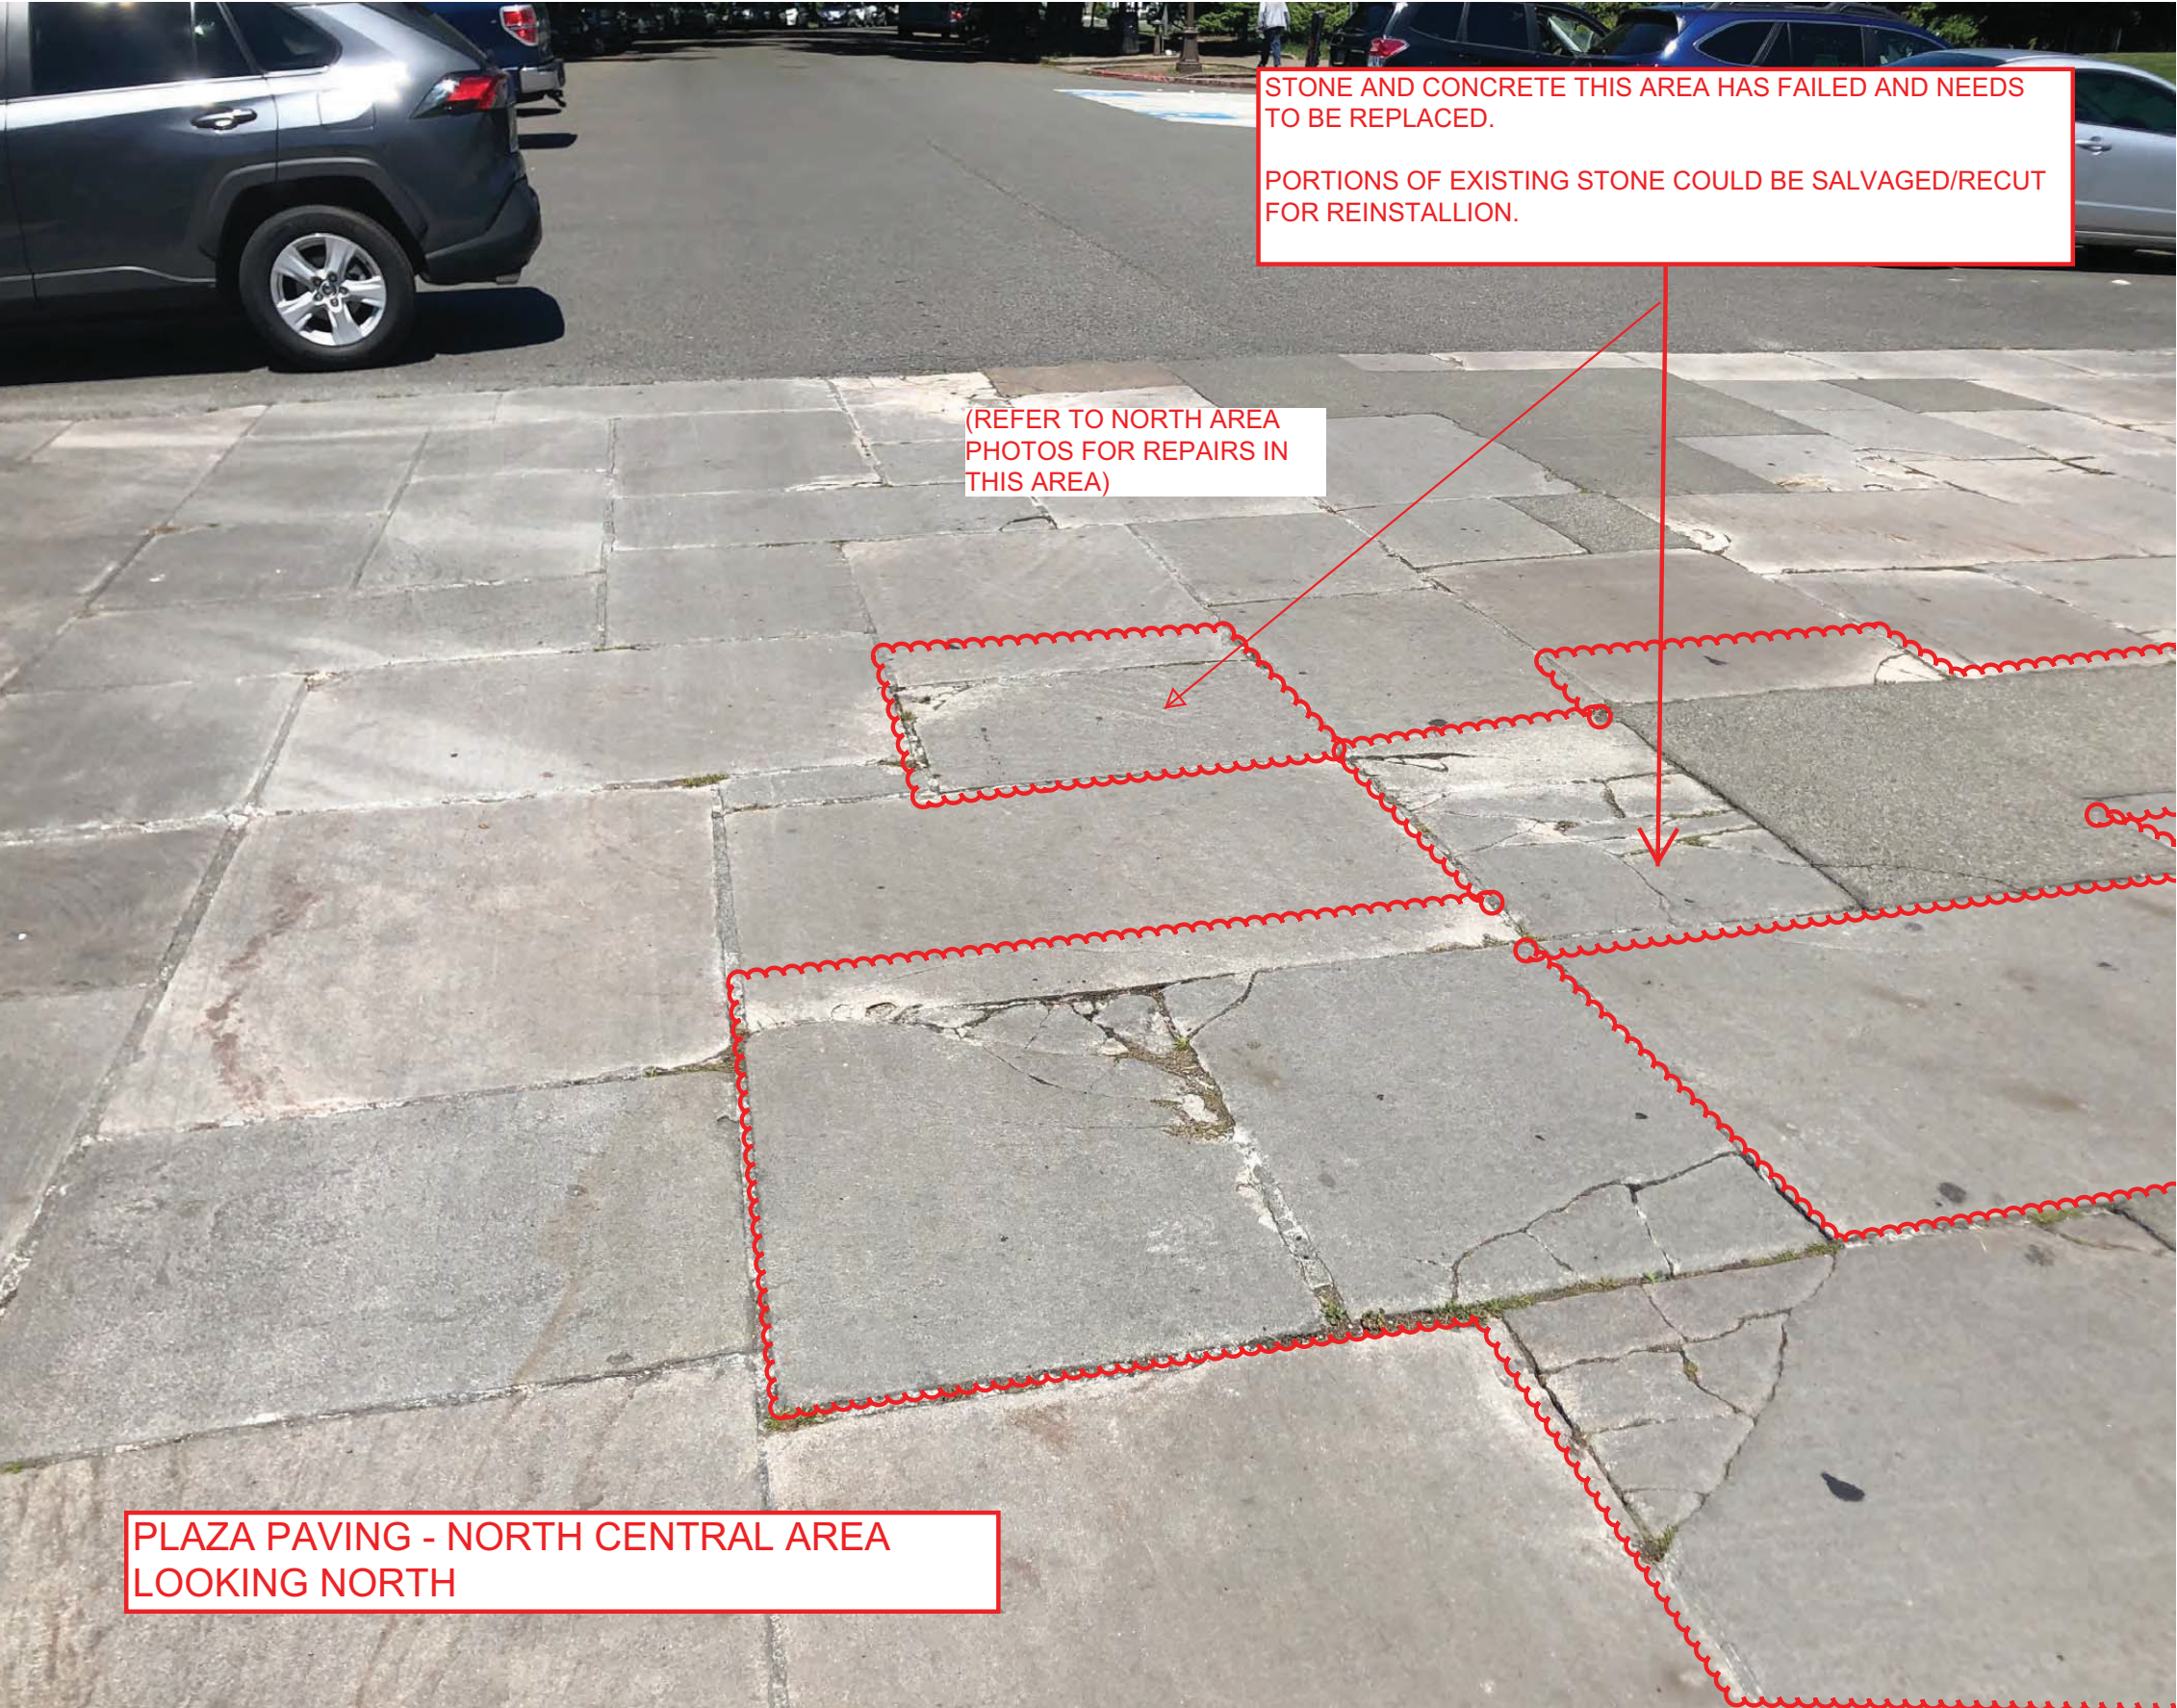
The condition of the North plaza area is similar to the south area, with more extreme deterioration at the transition from asphalt. Note the previously replaced concrete sections evidently done at different times (one portion is colored brown while the remainder is gray.)

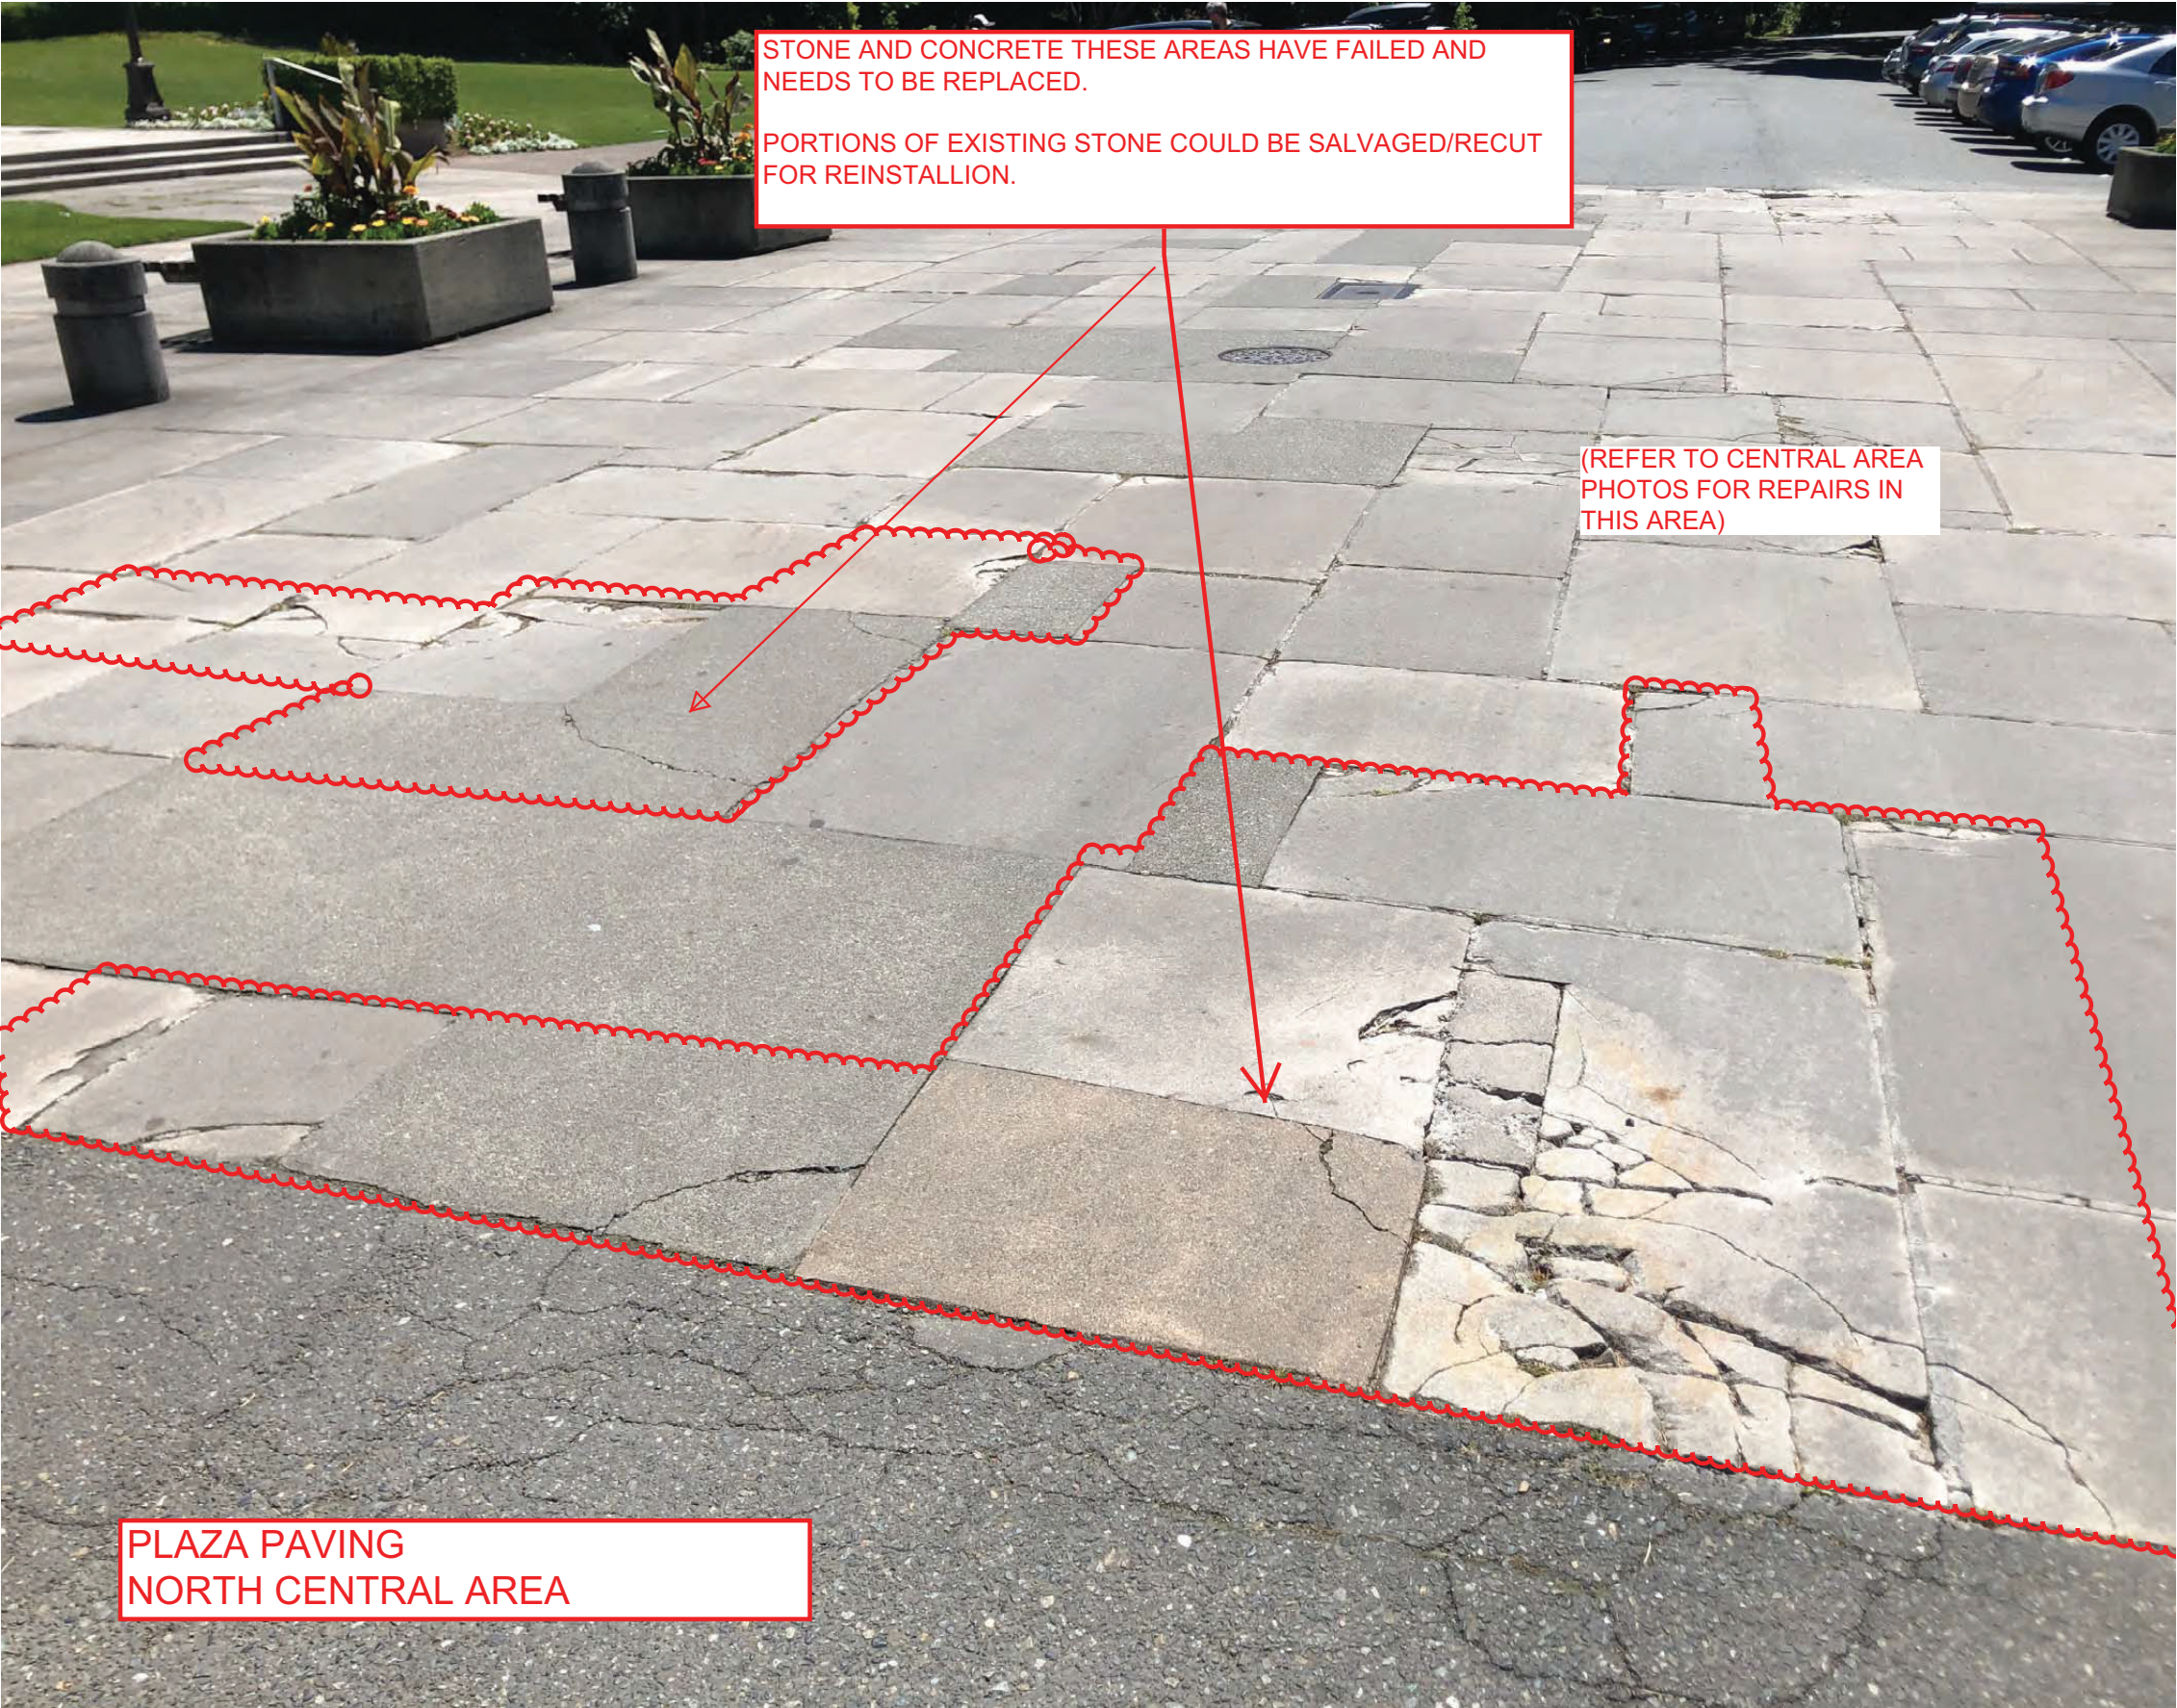
One existing bollard was knocked over by a vehicle and another was damaged by a vehicle. These will be reinstalled and restored to original condition.

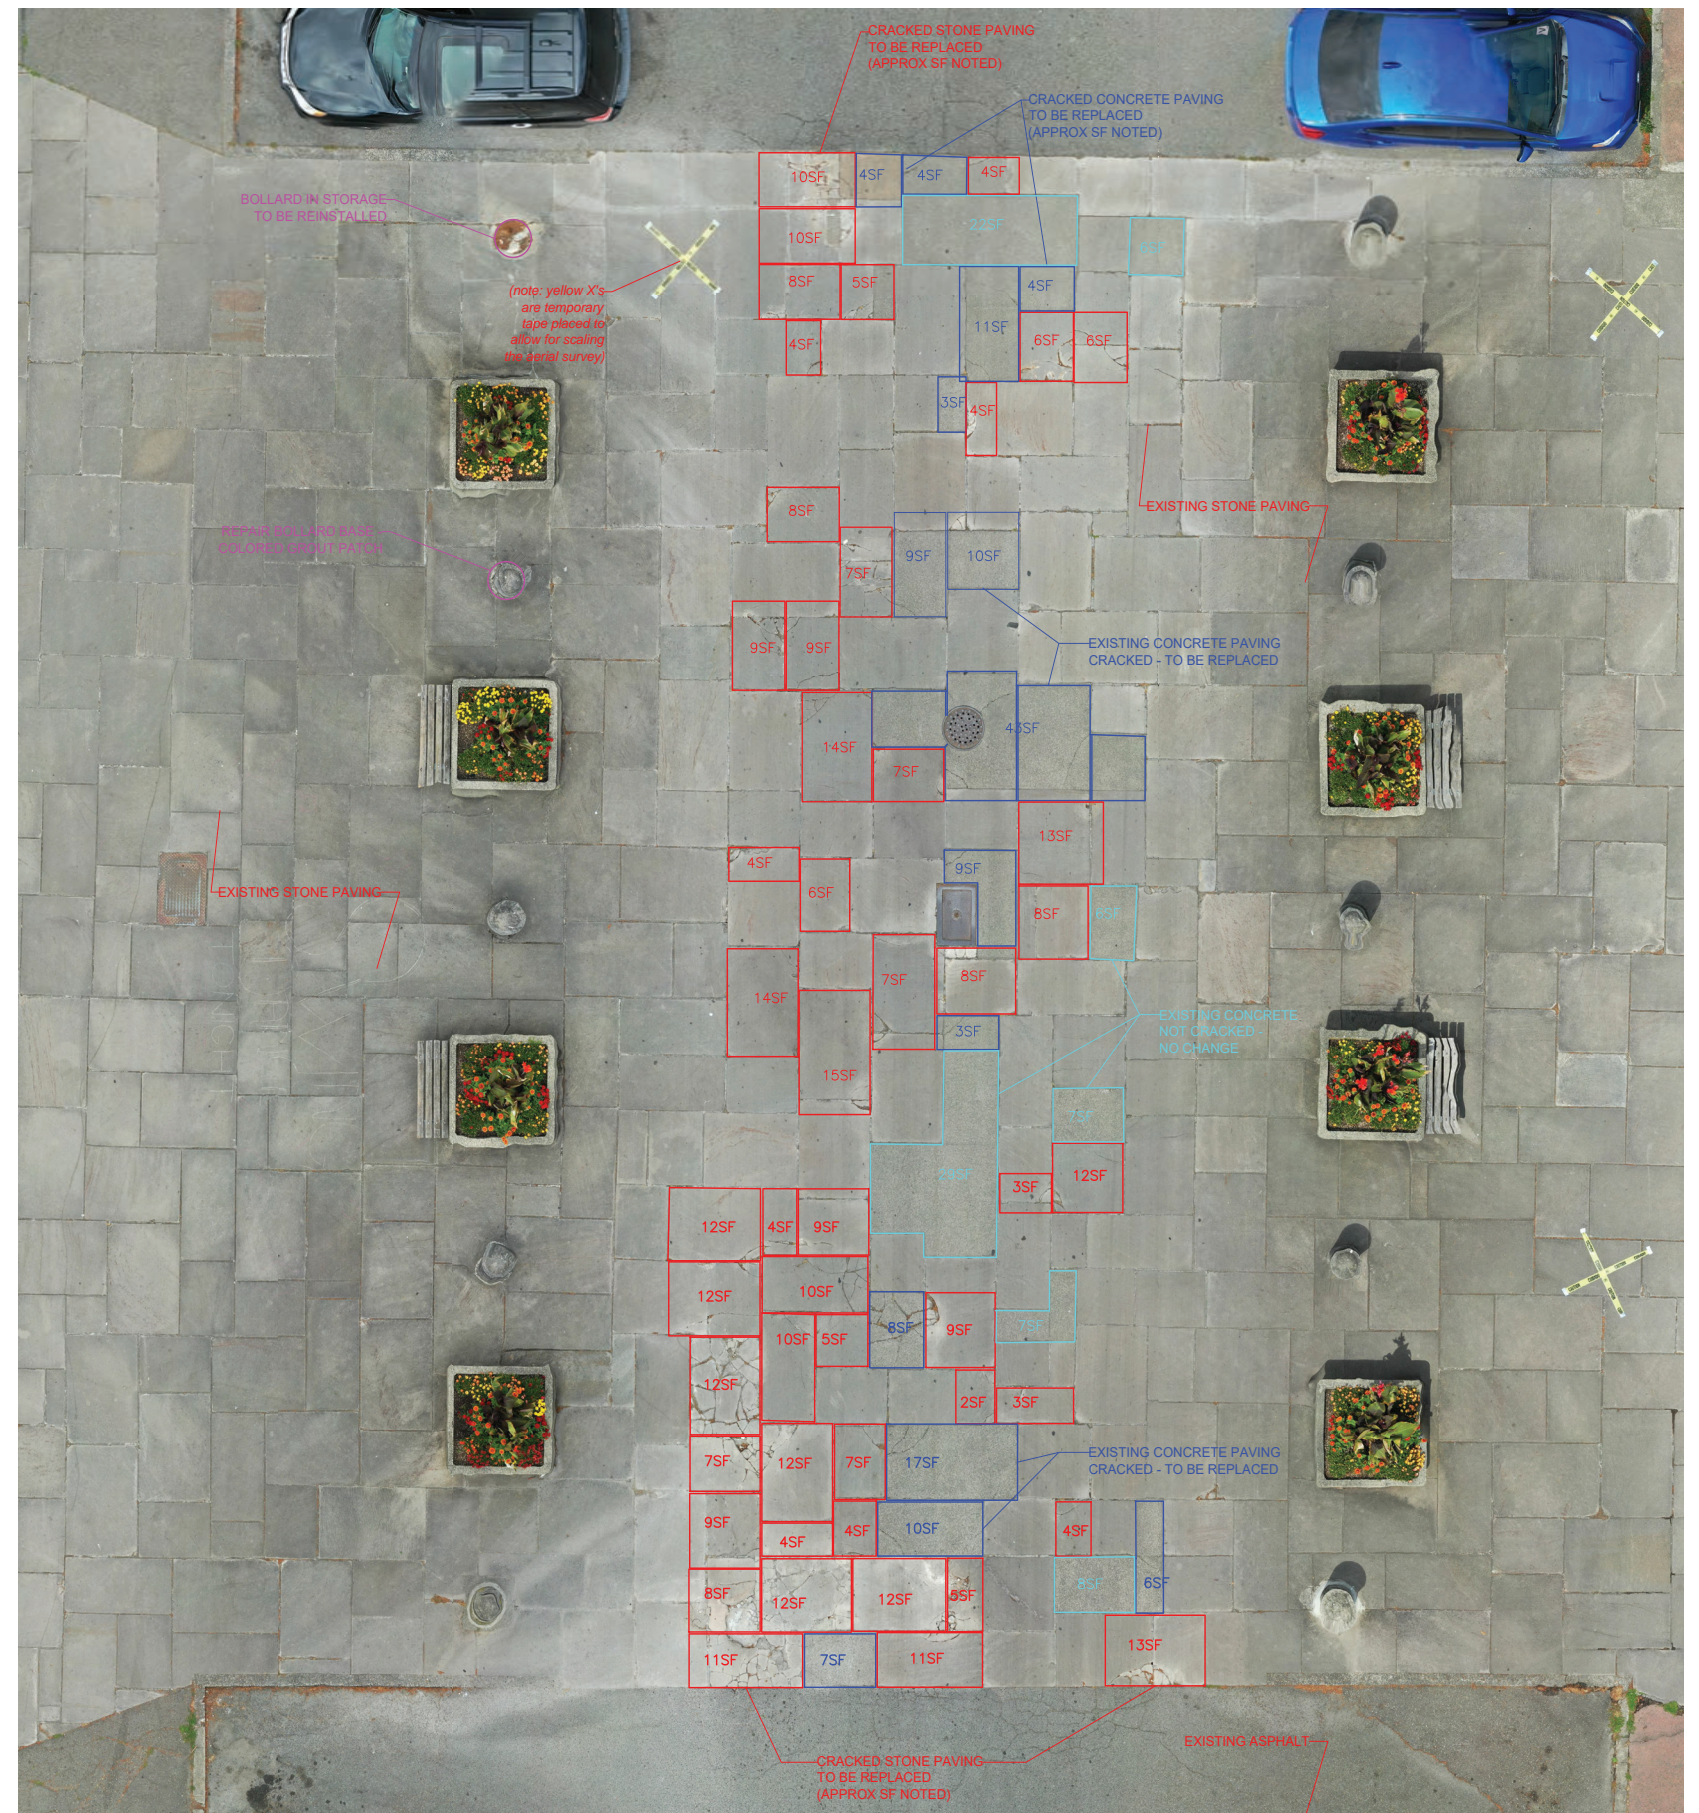
AERIAL SURVEY: PLAZA PLAN

Red: stone needing replacement: 410 sf

Dark Blue: concrete needing replacement: 150sf

Light Blue: other concrete infills with no cracks: 80sf

1) Pioneer Masonry, the contractor who recently completed repairs to the SAAM pedestrian paving indicated that the repairs to cracked stones, as implemented in the pedestrian paving areas, are not feasible within the vehicle drive areas. They advised that full replacement of damaged stones is the only repair they see as feasible given the high traffic use. They noted that the relatively soft Wilkeson stone, as well as potential matching replacement stone, are not typically recommended for vehicular roadways.

2) SPR is currently seeking pricing and samples from Select Stone in Montana to determine the cost of replacement of the failed stone with new stone. Replacement with concrete may also be explored if stone is infeasible due to costs, and given the poor performance of stone in the vehicle traffic areas.
