# SANDPOINT 18 & 41

## Building Condition Assessment

March 30, 2026

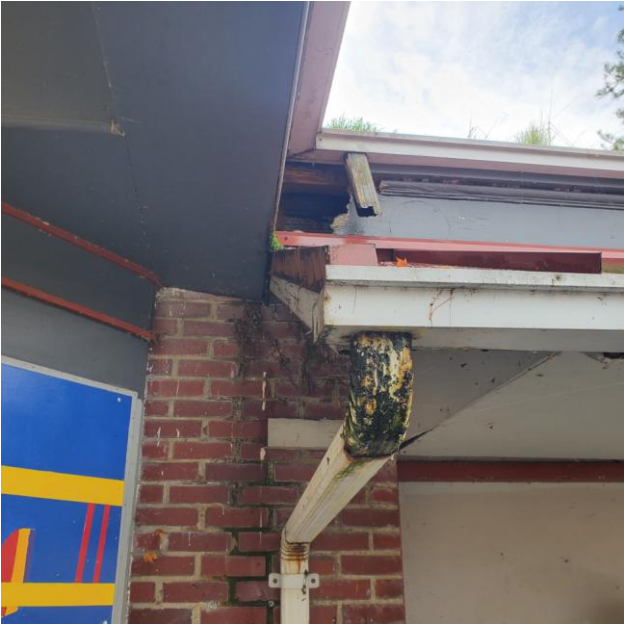
<p><b>41.4</b></p>

A photograph showing a close-up of a gutter system on a brick building. The gutter is severely damaged, with a large section missing or broken, exposing the roof structure. The brickwork is visible on the left side of the frame.	<p>Drainage repairs required</p>
<p><b>41.5</b></p>

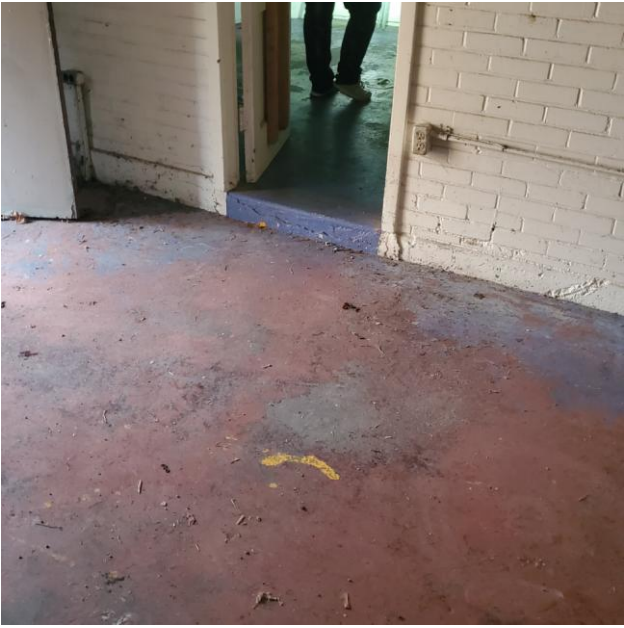
A photograph of a doorway in a building. The floor inside the room is significantly higher than the floor outside, creating a large step. The walls are white brick, and the floor outside is a reddish-brown color.	<p>The floor elevations in the building is not consistent resulting in accessibility issues.</p>

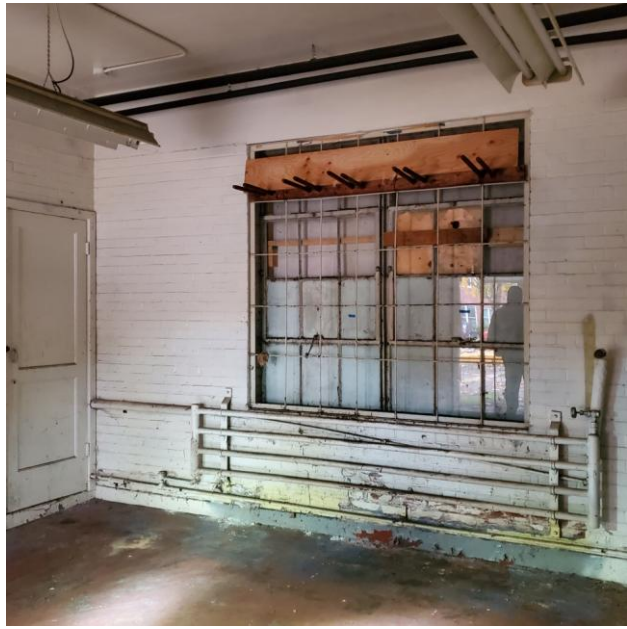
<p><b>41.6</b></p>

<p>Existing steel framed, single pane glazing. No insulation present on exterior walls (typical)</p>
--------------------	---	--

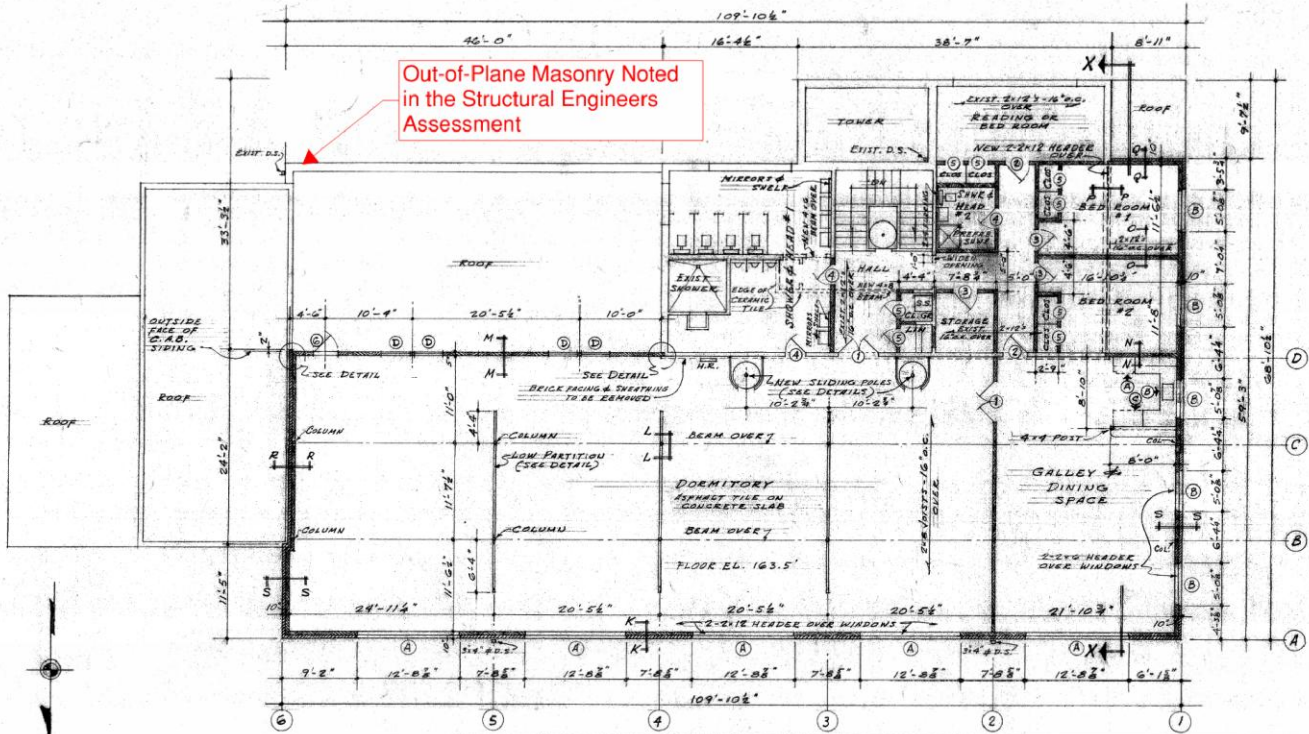
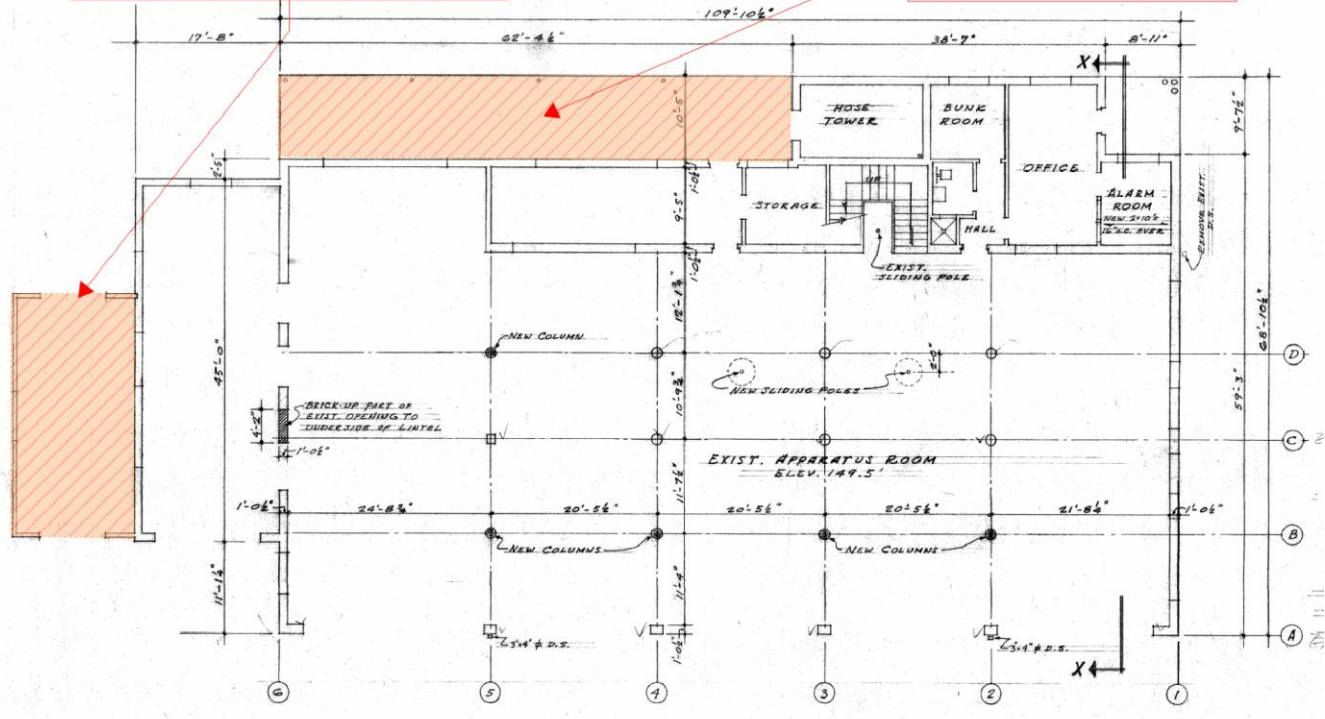
Building Section that Recently Collapsed and Was Demolished

Building Addition Removed in the 2013 Emergency Stabilization Due to Roof Collapse

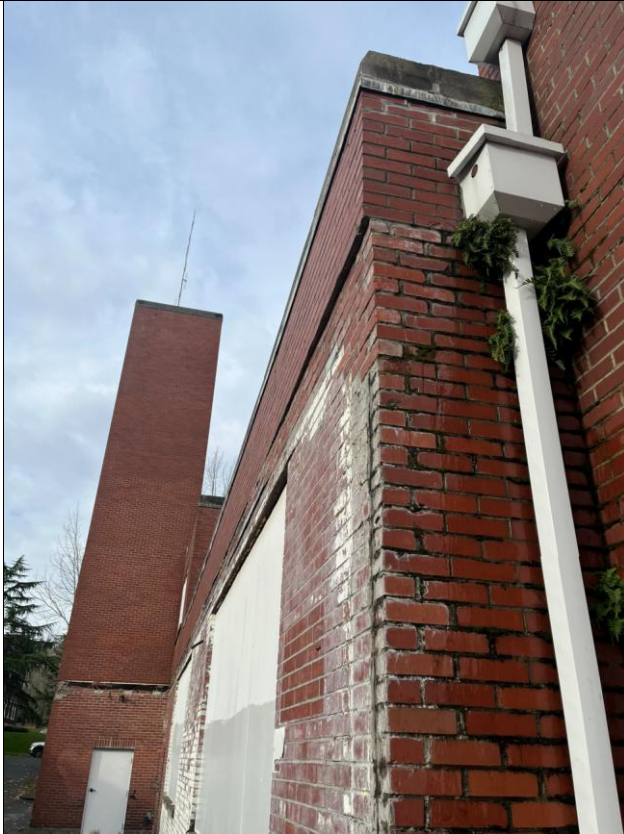
<p><b>18-1</b></p>	 	<p>Hose-drying tower viewed looking northeast (with boarded up openings).</p> <p>The tower is constructed with unreinforced masonry. Options are a steel space frame or demolishing the tower (estimate includes the steel brace frame).</p> <p>The canopy at the lower left did not receive a new roof in the 2013 Emergency Stabilization project (RE photo 18-4)</p>
<p><b>18-2</b></p>	 	<p>Out of plane masonry just left of the lower scupper collection box.</p> <p>Water may be backing up to the lower collection box (rainwater leader is no draining).</p> <p>Then copious amount of efflorescence indicates the masonry is water saturated.</p> <p>The exposed wall on the left dates back to the original 1936 construction; it was an addition that was removed as part of the 2013 Emergency Stabilization.</p>

- The 58 ft tall brick tower on the south side presents a high seismic hazard. The preferred upgrade is to remove the tower. This may not be allowed due to the building's Landmark status, in which case reinforce the tower internally with a structural steel space frame.

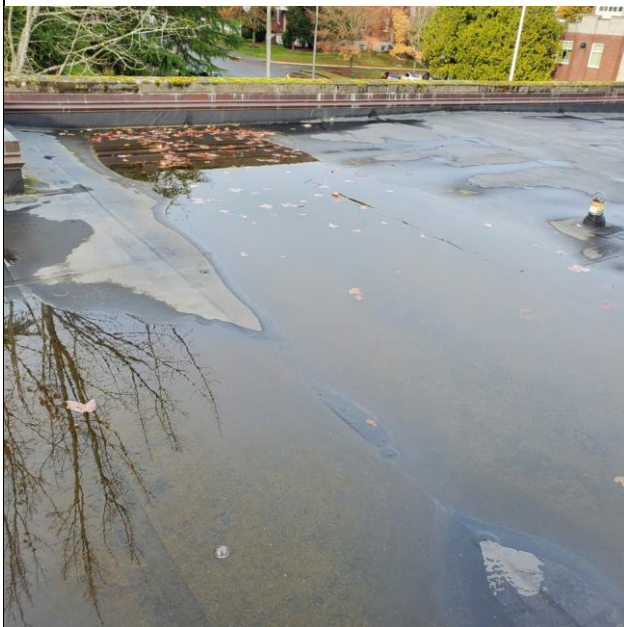
18.3

There are some areas of roof ponding. The EPDM single ply membrane roof was installed in 2013, and is performing well. There is no insulation in the roof assembly, and the low height of the precast parapet would prevent future insulation from being added on top of the roof deck. Roof insulation would need to be applied to the underneath side of the roof deck

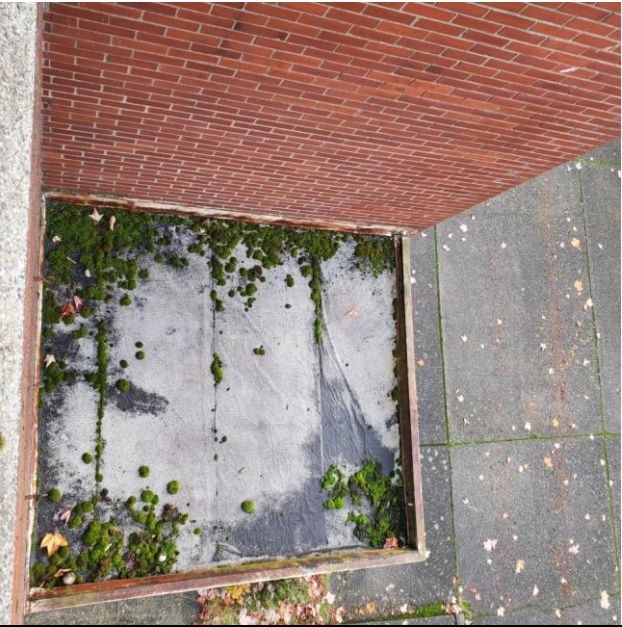
<p><b>18.4</b></p>

<p>Entry canopy at entrance, view from above</p>
<p><b>18-5</b></p>

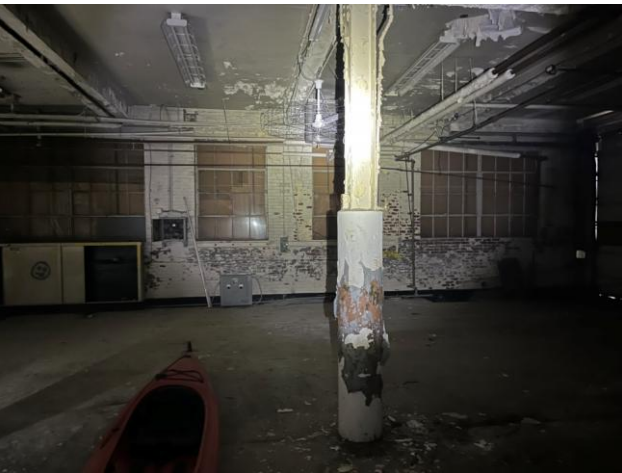
<p>Steel column at first floor, with concrete plinth (typical first floor structural framing). Copious amounts of peeling paint on the first floor ceiling. The paint is lead-containing. Existing steel sash, single-pane glazing assemblies (boarded up from the outside) are seen in the background</p>

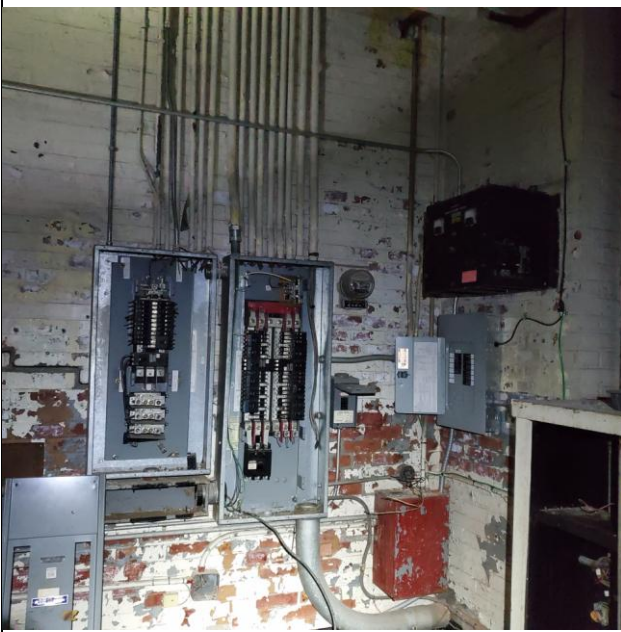
18.6

The main electrical service was disconnected. An 100-amp panel was added in the 2013 Emergency Stabilization project for dehumidification fans (controlled with barometric controls) and pathway lighting. A new electrical service from Seattle City Light will be required.

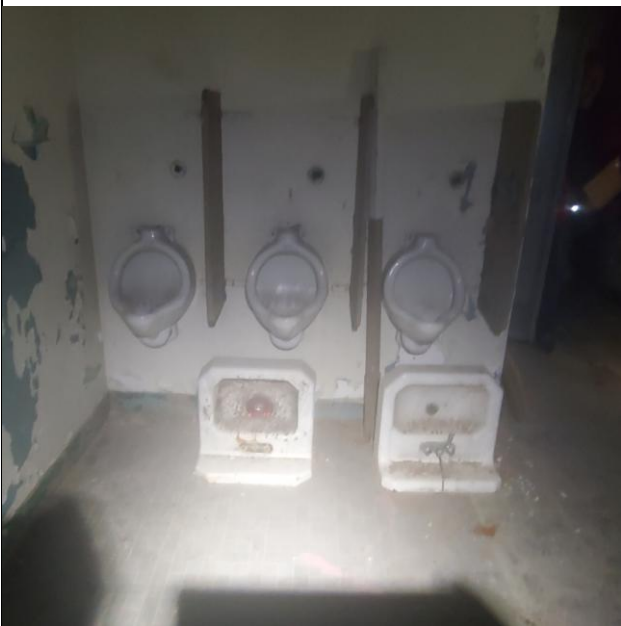
18-7

Typical condition of the existing toilet rooms. The fixtures and toilet room layout date back to Navy use.

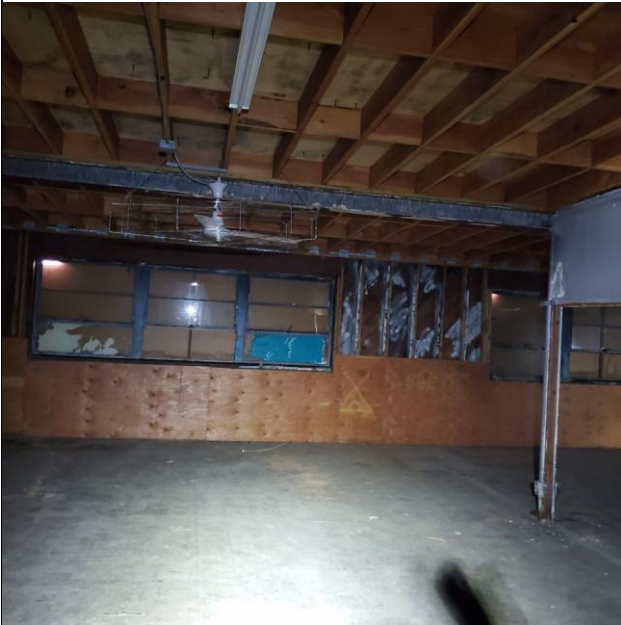
18-8

Second floor wood framing that was installed in the 2013 Emergency Stabilization project.

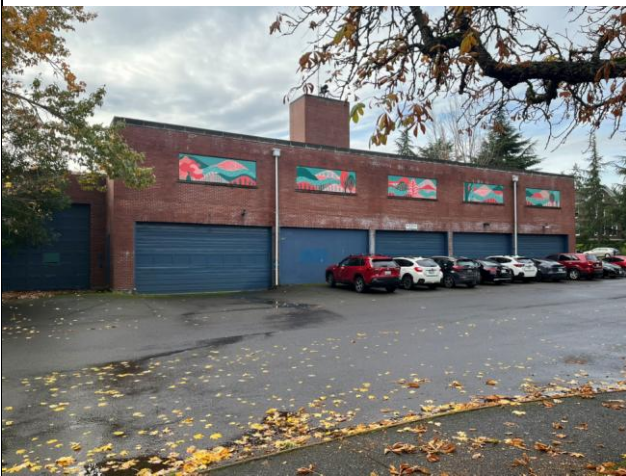
18-9

View of FS 18 looking to the SW. The two garage bays on the left (east) are at a lower elevation than the bays directly to the west. The differing slab heights are carried through to the interior. Condition creates accessibility challenges both inside and outside the building
