**MAGNOLIA BRIDGE REPLACEMENT  
REHABILITATION ALTERNATIVE  
STUDY REPORT - DRAFT**

**October 2005**

Seattle Department of Transportation  
Agreement No. T01-34

**HNTB**

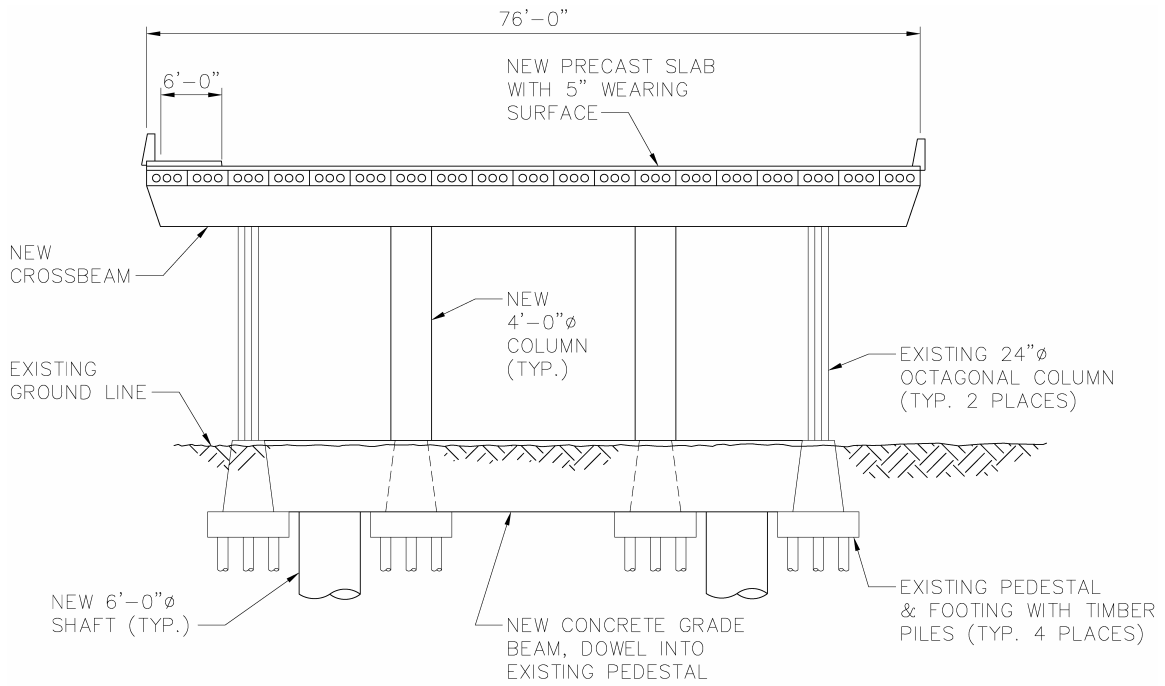
**Figure 2 Center Ramp Removed, Bents 20 through 34**

A different system was used for Bent 20 to Bent 34 since the interior columns at these bents will be demolished as part of the Access Ramp Replacement. At these locations the interior columns will be replaced with 4'-0" diameter columns that are designed to resist all the seismic forces in bents. (See Figure 2)

The center ramp from Bents 20 to 34 does not meet current live load requirements and does not have sufficient seismic capacity. It also results in a substandard edge of lane taper rate where the eastbound through lane transitions from the center ramp area to the two-lane ramp to 15<sup>th</sup> Avenue West. The columns supporting the center ramp also show the most significant signs of corrosion. The proposed solution is to remove and replace interior deck and columns. The replacement structure is a prestressed slab superstructure with 4' diameter circular columns. The new interior columns will take all lateral seismic forces. Drilled shaft foundations would be required to support the applied seismic forces. (See Figure 2 on page 18.)

| <b>Deficiency</b> | <b>Proposed Approach</b> |
|---|--|
| Center ramp from Bents 20 to 34 does not meet current live load requirements and does not have sufficient seismic capacity. | Remove and replace interior deck and columns. Replace with prestressed slabs and 4' diameter circular columns that will take all the lateral seismic forces. |

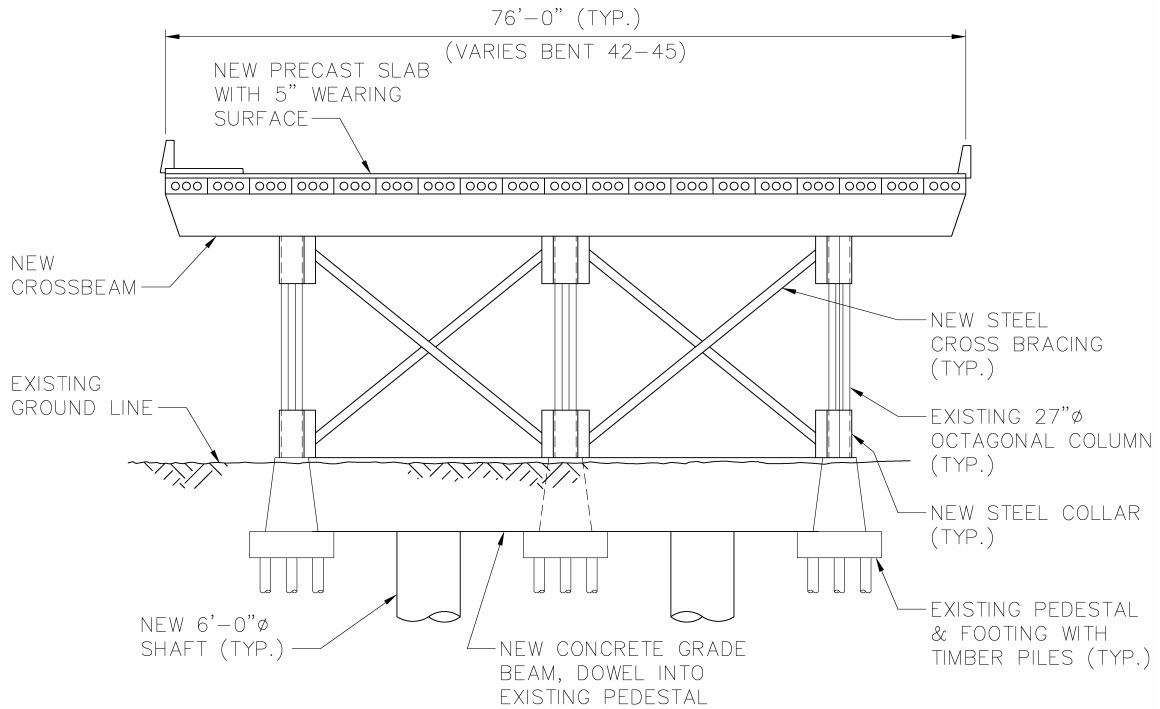
**Figure 3 Column Lateral Bracing, Bents 18, 19, and 35 through 46**

The timber pile foundations are not sufficient to resist lateral seismic forces and for the increased dead and live loads to meet current design requirements. Timber piles have a low lateral resistance and are not connected to footings so they have no uplift capacity. For Bents 18, 19, 35 to 45 and 59 to 81, a grade beam would be provided between columns. The grade beam would be supported by two, 6-foot diameter drilled shafts. (See Figure 3 on page 18.)

| <b>Deficiency</b> | <b>Proposed Approach</b> |
|---|--|
| Timber pile foundations are not sufficient for seismic lateral forces and uplift forces for Bents 18, 19, 35 to 46 and 59 to 81. | Provide grade beam between columns with two 6' diameter drilled shafts. |

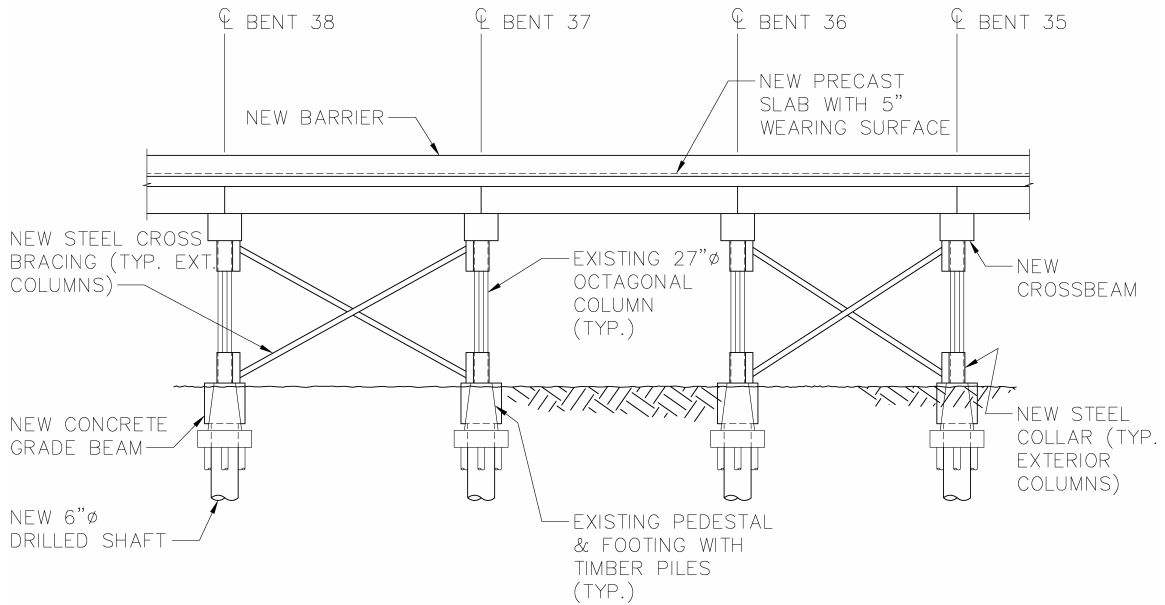
**Figure 5 Column Longitudinal Bracing (see text for other locations)**

The existing longitudinal bracing is insufficient for calculated longitudinal seismic forces for Bents 18, 19, and 35 to 82. Longitudinal cross bracing is proposed for each bent. Bracing would be along exterior column lines. Cross bracing would be added to exterior column lines between Bents 18 and 19, 35 and 36, 37 and 38, 39 and 40, 41 and 42, 43 and 44, and 45 and 46. Existing concrete bracing would be replaced with steel cross bracing between Bents 43 and 44. Cross bracing would be added to both column lines for Bents 47 and 48, 48 and 49, 52 and 53, 53 and 54, and 57 and 58. Existing concrete bracing would be replaced with steel cross bracing on Bents 50 and 51, 55 and 56, 59 and 60, 61 and 62, 63 and 64, 67 and 68, 71 and 72, and 75 and 76. (See Figure 5 on page 20.)

| Deficiency | Proposed Approach |
|--|--|
| Most of the existing longitudinal bracing system does not have sufficient strength to resist longitudinal seismic forces. | Replace the existing bracing with new longitudinal bracing. |

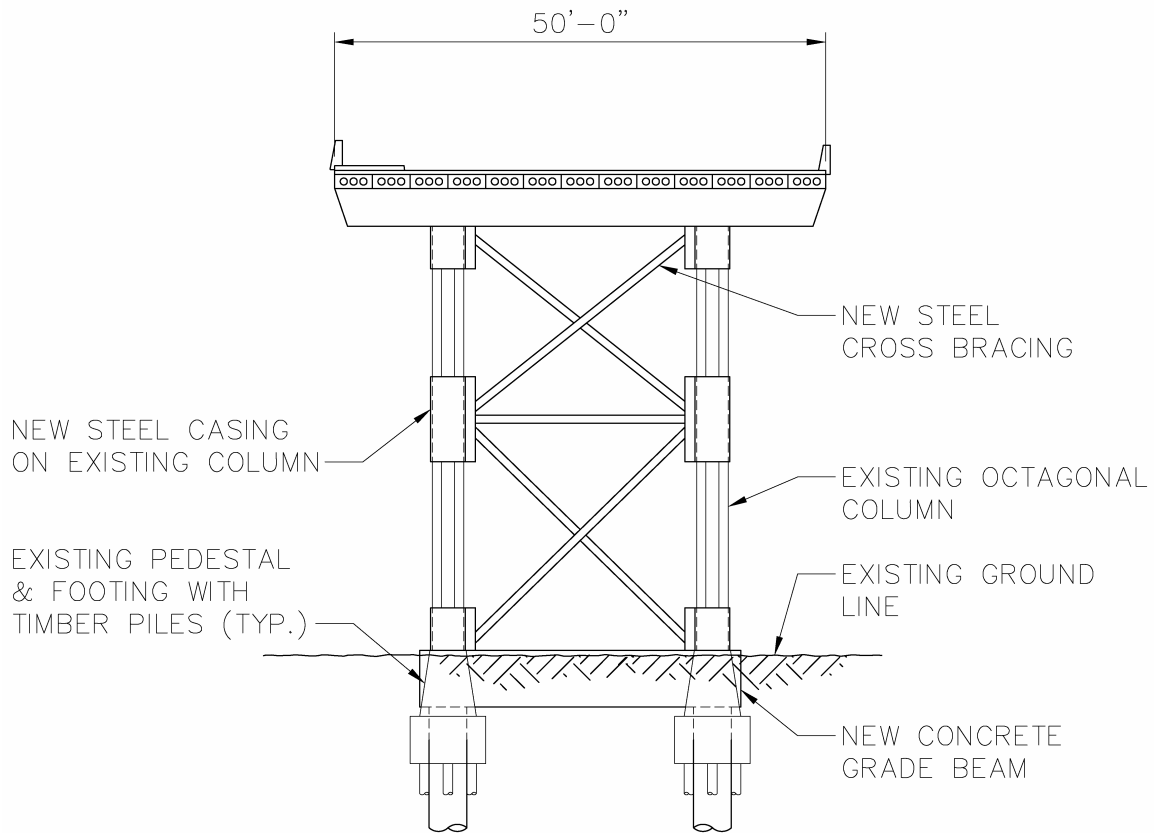
**Figure 6 Transverse Cross Bracing, "X" Orientation, Bents 62 through 76**

As the braced frames get taller in the bents leading up to Magnolia, the capacity of the columns is exceeded by the seismic forces. The lateral force is resisted by a moment couple of upward and downward forces in the columns. The uplift capacity of column is insufficient to resist lateral seismic overturning forces for Bents 47 to 81. In order to increase the tension capacity of the columns, steel jackets around the columns are proposed that would carry the uplift force to the foundation. The steel jacket would need to be detailed with studs so that it acts compositely with concrete column. (See Figure 6 on page 20.)

The existing steel transverse cross brace system for Bents 62 to Bent 76 needs to be strengthened to accommodate the large seismic loads specified under current design standards. The proposal would replace the existing bracing with new bracing that has adequate capacity for seismic loads and meets current code requirements. (See Figure 6 on page 20.)

Bracing systems in which all braces are oriented in the same direction are not allowed by current design guidelines MCEER/ATC 49. This requirement is so there is redundancy in the bracing system. The proposed solution would replace existing "Z" bracing with "X" bracing. (See Figure 6 on page 20.)

The width to thickness ratio,  $b/t$ , for the braces does not meet current design guidelines MCEER/ATC 49 requirements. This requirement is to prevent local buckling of the bracing members. Existing "Z" bracing would be replaced with "X" bracing that meets thickness requirements. (See Figure 6 on page 20.)

| <b>Deficiency</b> | <b>Proposed Approach</b> |
|---|--|
| The lateral cross brace system for Bent 62 to Bent 76 does not have sufficient strength to resist lateral seismic forces. | The proposal is to replace the existing bracing with new bracing that meets current code requirements. |
| Bracing systems in which all braces are oriented in the same direction are not allowed by current design guidelines MCEER/ATC 49. This requirement is so there is redundancy in the bracing system. | Replace existing Z bracing with X bracing. |

| Deficiency | Proposed Approach |
|--|--|
| The width to thickness ratio, b/t, for the braces does not meet current design guidelines MCEER/ATC 49 requirements. This requirement is to prevent local buckling of the bracing members. | Replace existing Z bracing with X bracing that meets thickness requirements. |
