1265 S King Street Application for Certificate of Approval

ISRD Board Meeting - 3/14/2023

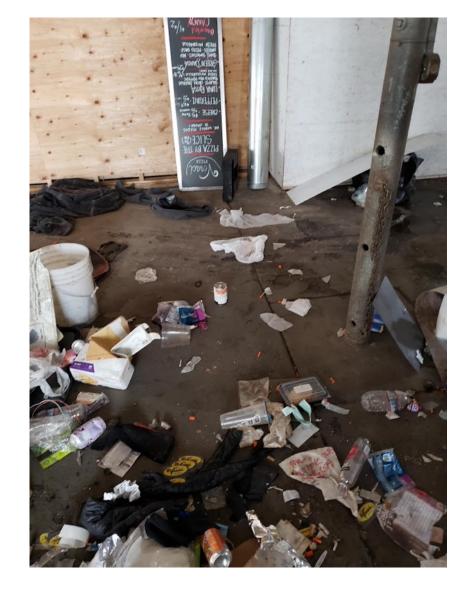
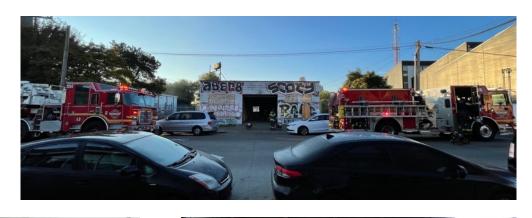
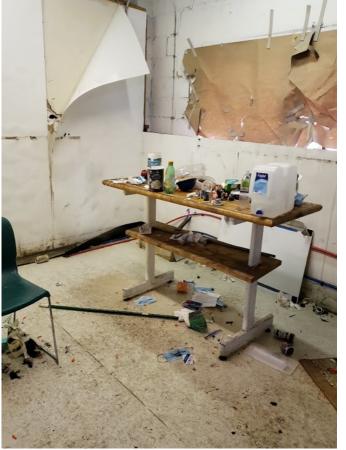
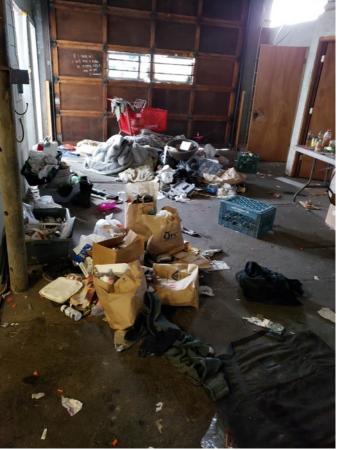
Recent Vandalism Incidents

- Property has been vacant and secured since acquisition in 2019
- Repeated instances of forced entry and vandalism since then
- Immediate and significant remediation effort undertaken in 2021 in response to squatters and drug use
- Seattle Fire Department responded in November 2022 in response to indoor burning
- In consideration of ongoing vandalism, we seek permission to proceed with demolition in advance of redevelopment application, in the interest of public health and safety in the community

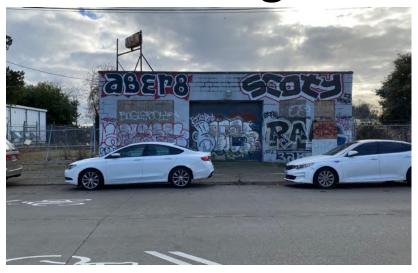
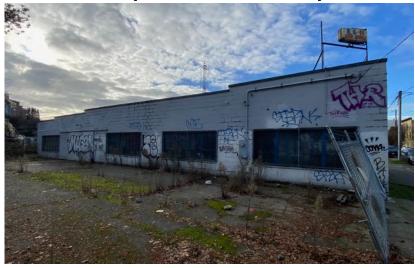
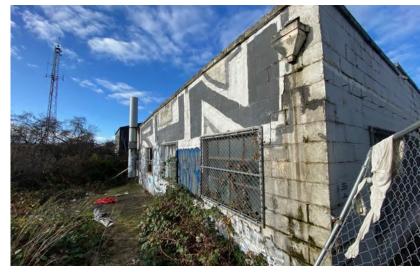
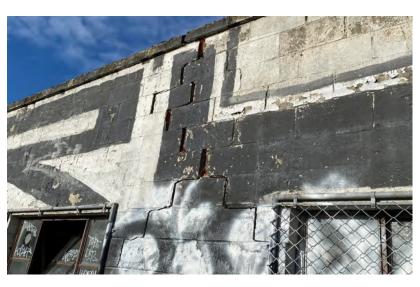
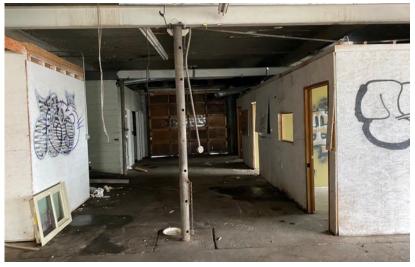
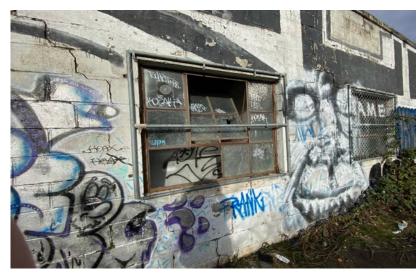
Building Condition (current)

- Building exists substantially unaltered since construction in 1948 and is in poor condition
 - Membrane roof: Several leaks are evident
 - Concrete slab-on grade foundation: Cracking and settling in places
 - <u>Painted CMU walls:</u> Significant cracking. CMU is un-grouted and unreinforced. Mortar is deteriorated in many areas.
 - Industrial steel sash windows: Cracked, broken, and missing glazing.
 - Two garage doors and one pedestrian door: Intact with limited functionality
 - <u>Structural System:</u> Consists of unreinforced CMU walls and interior wooden beams. Foundation settlement has contributed to poor condition of CMU walls.
