SURVEY OF EXISTING CONDITIONS

EXTERIOR IMPROVEMENTS AT PHARMACY WINDOWS

Project: Neighborcare Pike Market

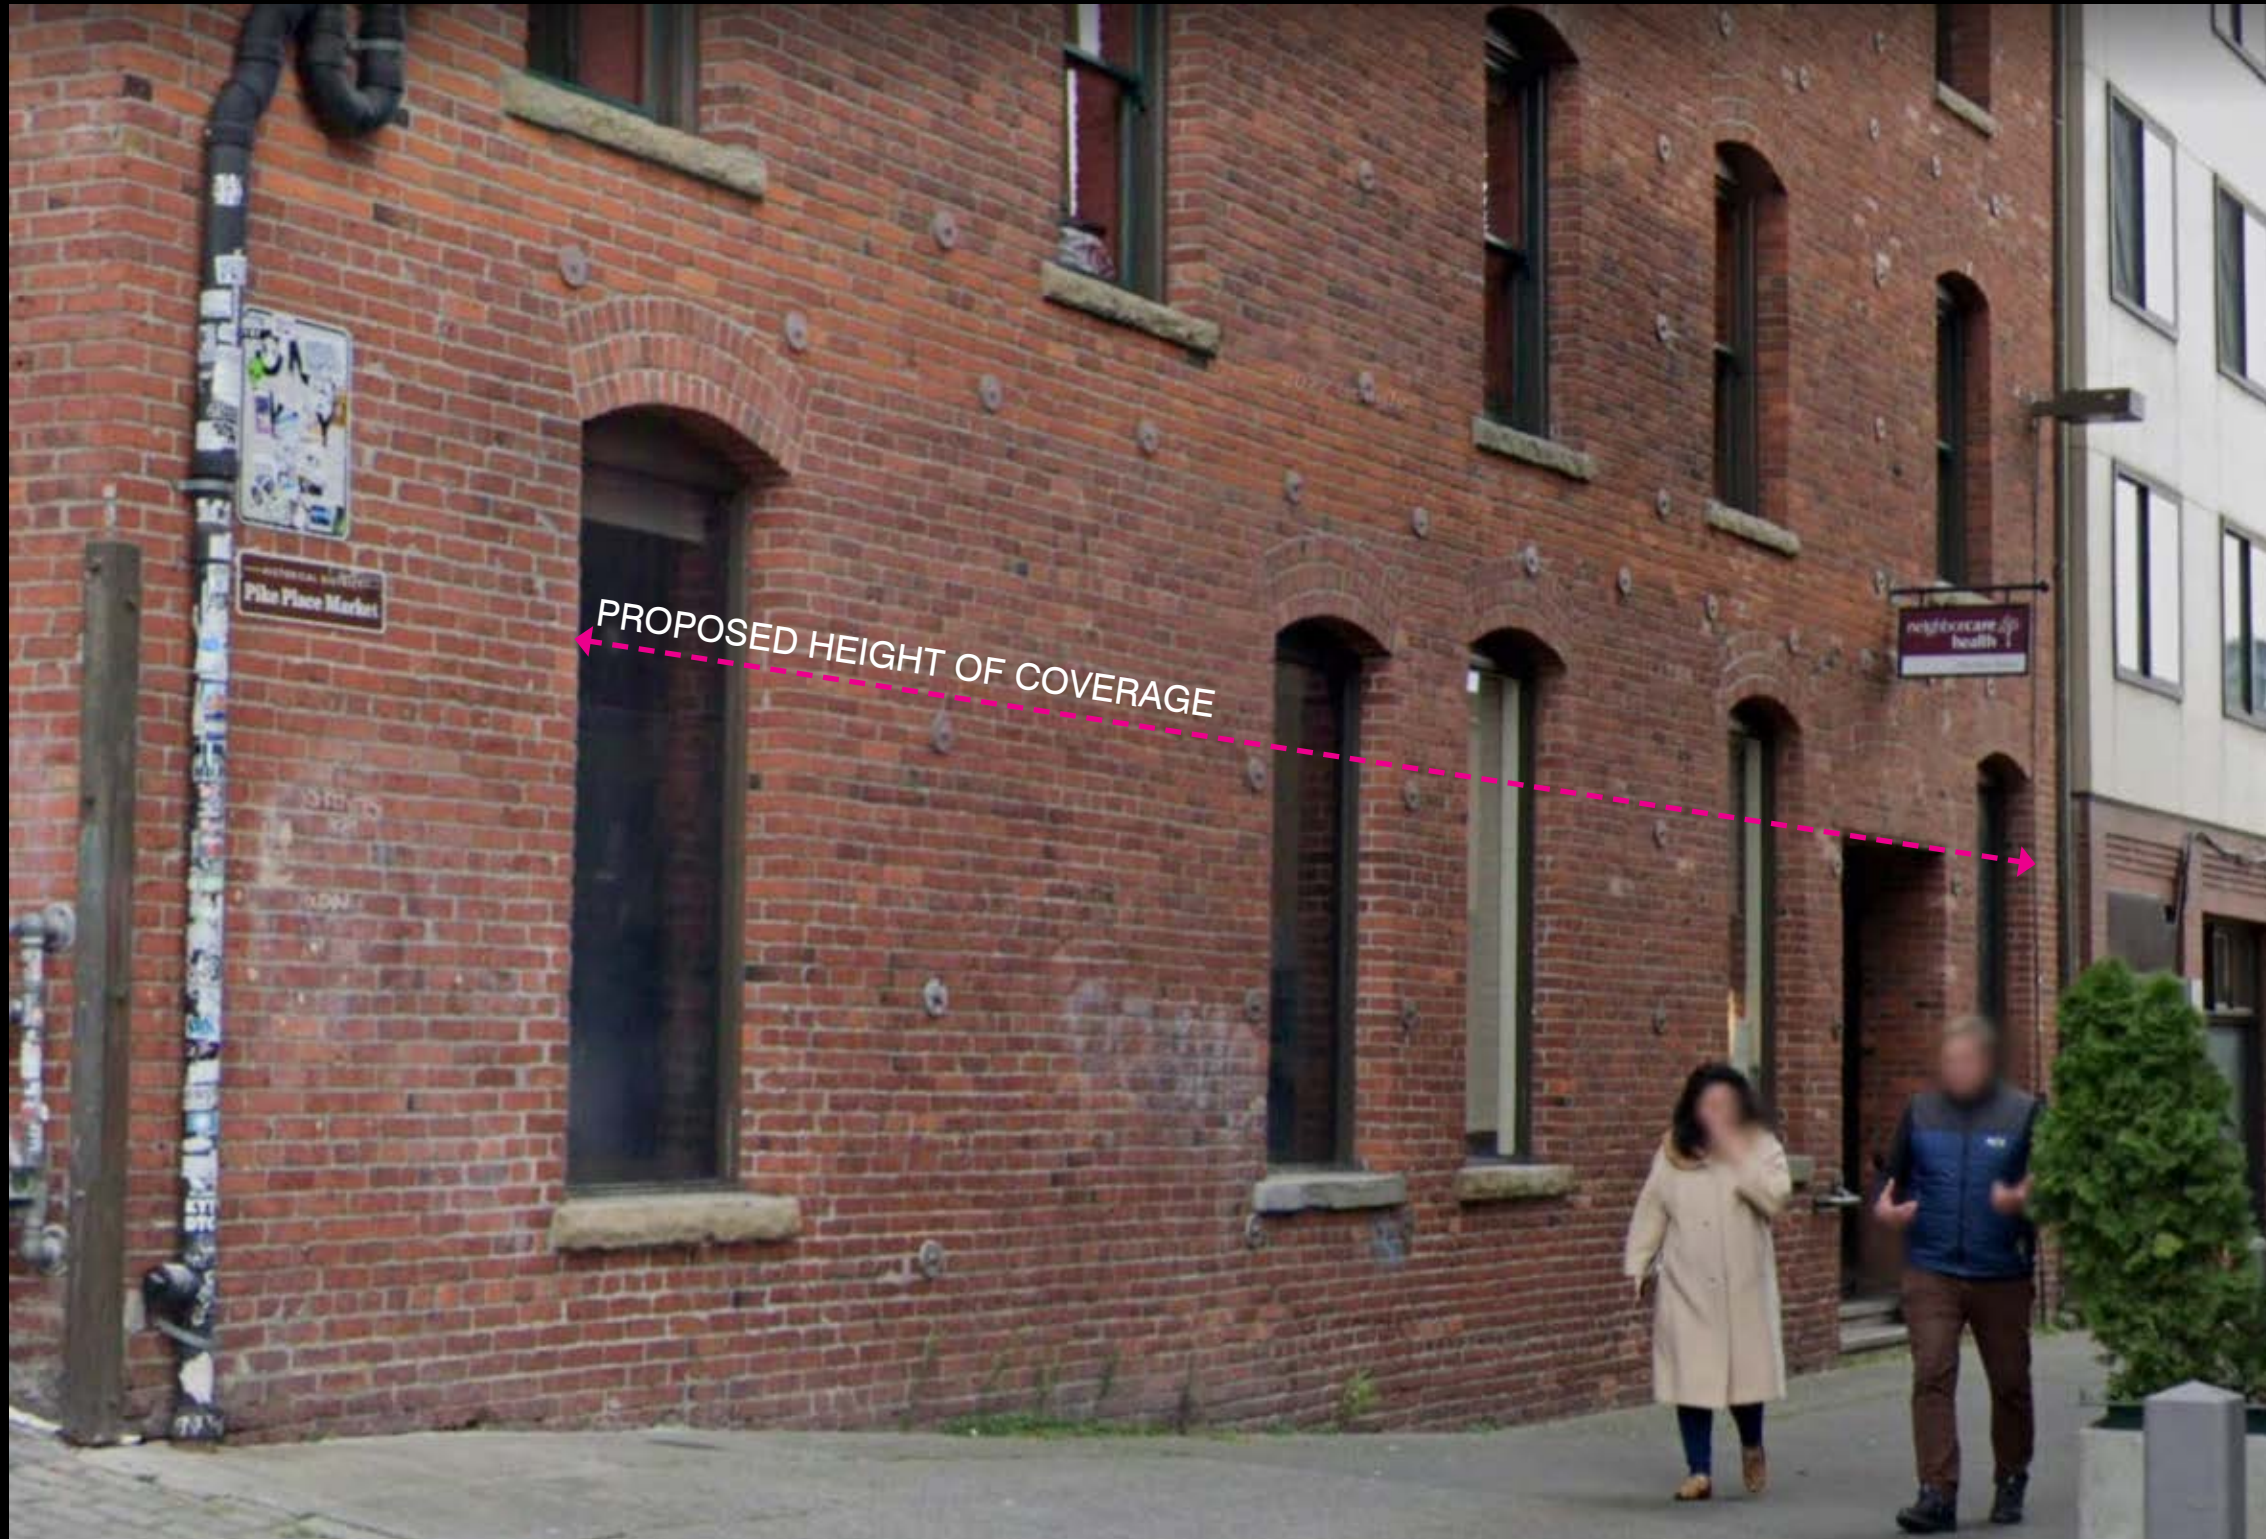
POST ALLEY - PHARMACY WINDOWS

SITE OBSERVATION :
THERE ARE 5 FULL HEIGHT
WINDOWS ALONG POST ALLEY.
FOUR BELONG TO PHARMACY/
LOBBY. ALL WINDOWS APPEAR TO
BE DECENT CONDITION

PROPOSED SOLUTION:
ADD ORNAMENTAL IRON BARS
FOR SECURITY. PROPOSED
COVERAGE IS TO COVER
TWO THIRDS OF THE HEIGHT
- APPROXIMATELY 8' FROM
GROUND PLANE TO SECURE
ELEVATION. DESIGN TO REGISTER
HORIZONTALLY WITH TOP OF
ENTRANCE OPENNING.

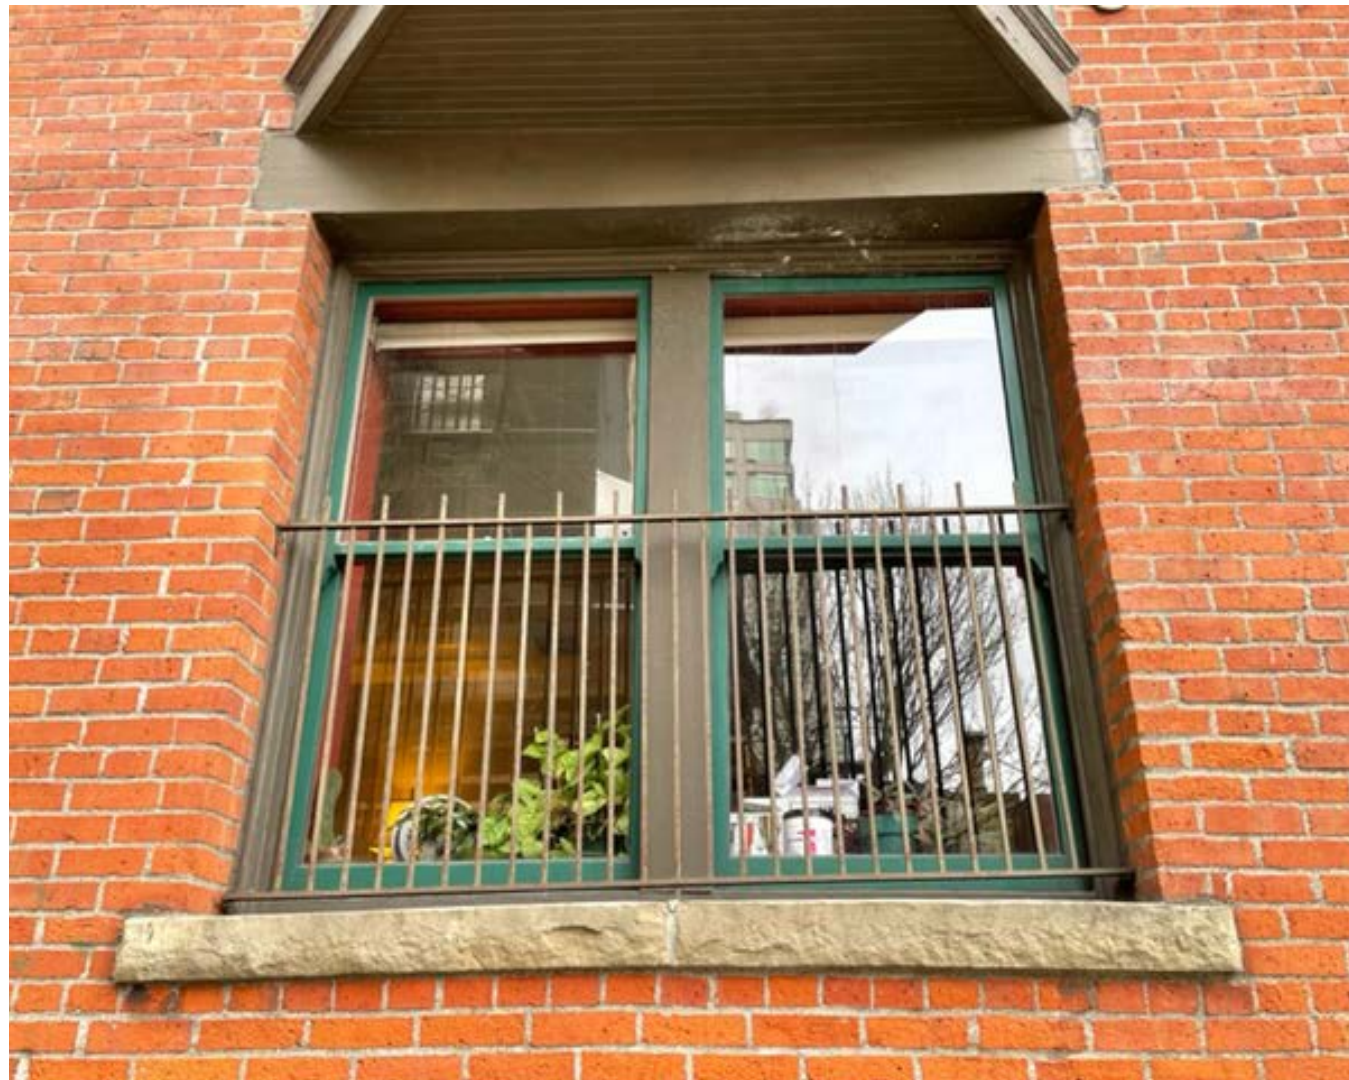
EXTERIOR WINDOW
PHOTO TAKEN FROM VIRGINIA ST
FACING EAST

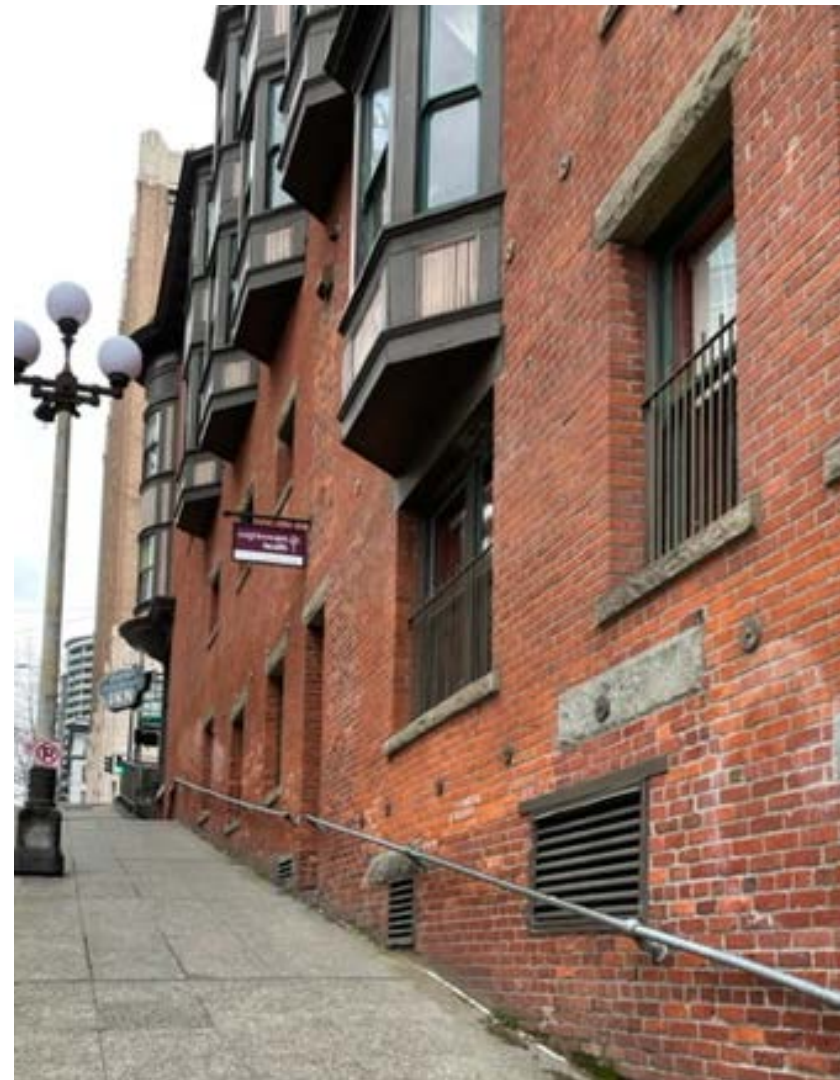
EXTERIOR AT VIRGINIA ST
PHOTO TAKEN FROM VIRGINIA ST
FACING NE

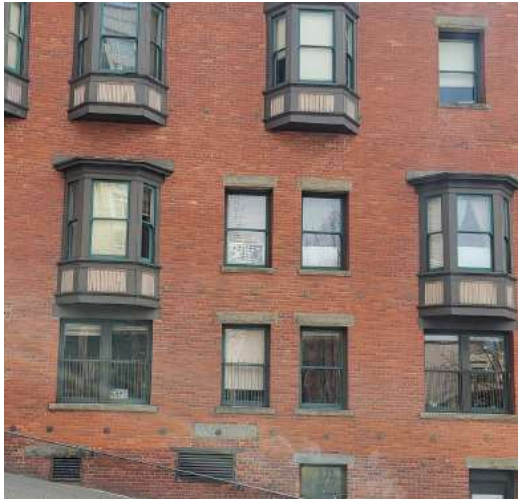
EXISTING WINDOW GUARDS ON NW FACADE

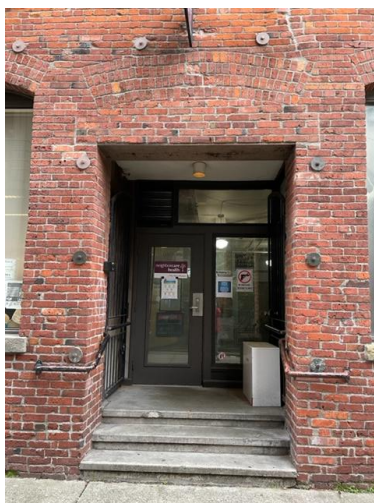
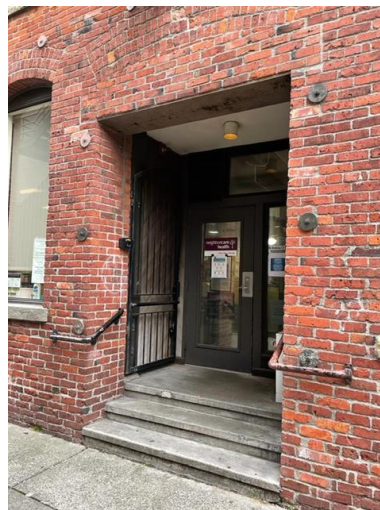
EXISTING SECURITY GATE
(No proposed alterations to this gate).
