**Date:** March 24, 2026  
**To:** City of Seattle Landmarks Preservation Board  
**CC:** Erin Doherty, Landmarks Preservation Program Staff  
**From:** David Graves, AICP, Strategic Advisor  
**Subject:** Gas Works Park Cracking Towers – Pedestrian Appurtenance Removal Certificate of Approval Application

# GAS WORKS PARK "CRACKING TOWERS": EMERGENCY SELECTIVE DECONSTRUCTION

1901 N NORTHLAKE WAY 98103

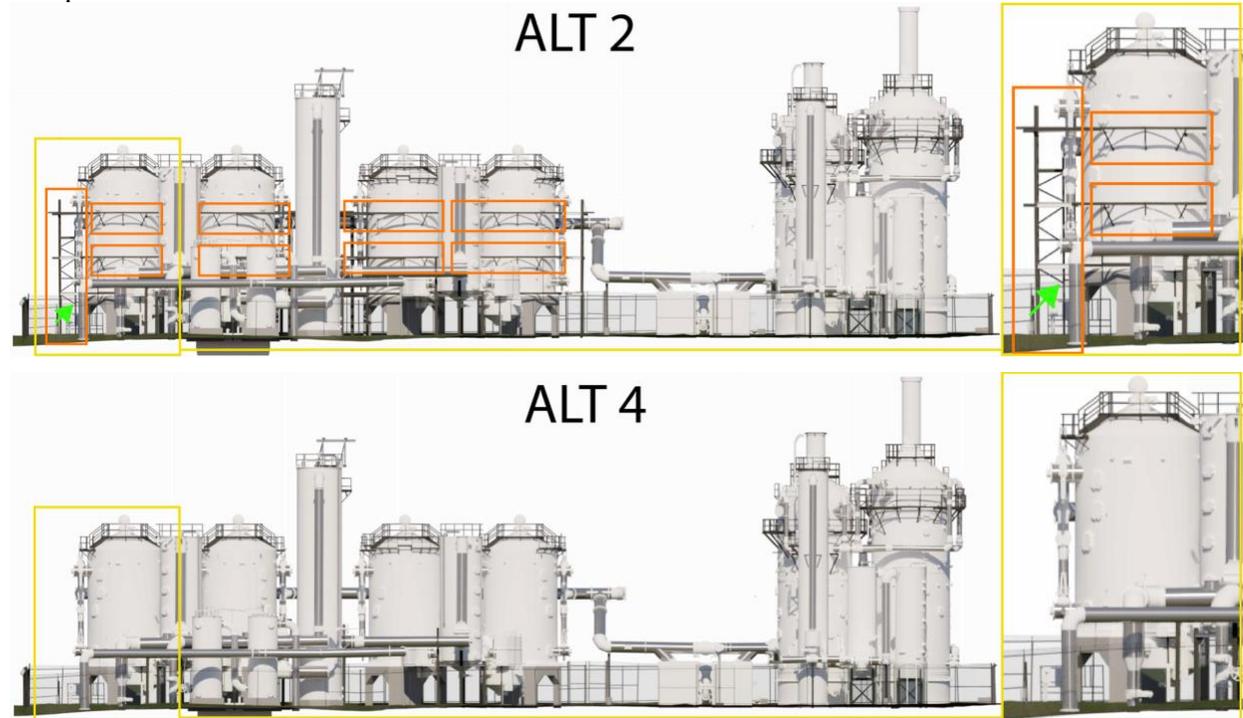
depictions of the Gas Works Park Towers components from ALT 2, there are supporting components for several catwalks that are not selected for removal.

**Figure 1.** Post-deconstruction west elevation images for ALT 2 (top) and ALT 4 (bottom) with selected enlargement. The orange rectangles indicate some of the components in ALT 2 that are selected for removal in ALT 4. There is a component (green arrow) not selected for removal in ALT 2 that is less than 11 feet in height.

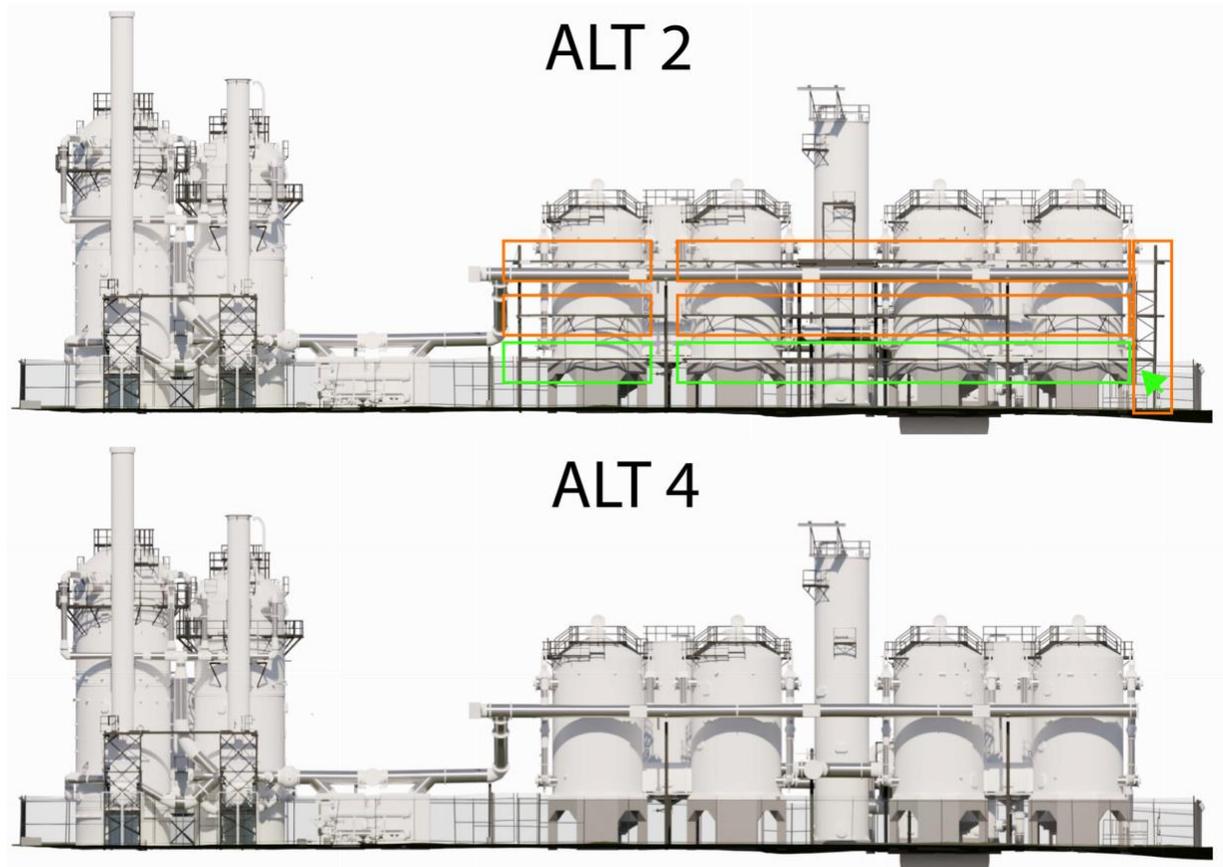
The supporting components for several of the catwalks that are not selected for removal in ALT 2 are approximately 11 to 12 feet above the ground; see Figure 2 and Figure 3. Additionally, there was a lower component not selected for removal in ALT 2 that was less than 11 feet in height; see Figure 1 and Figure 2.

**Figure 2.** Post-deconstruction east elevation images for ALT 2 (top) and ALT 4 (bottom). The orange/green rectangles indicate some of the components in ALT 2 that are selected for removal in ALT 4. The green rectangles indicate structures that are approximately 11 to 12 feet in height. There is a component (green arrow) not selected for removal in ALT 2 that is less than 11 feet in height.

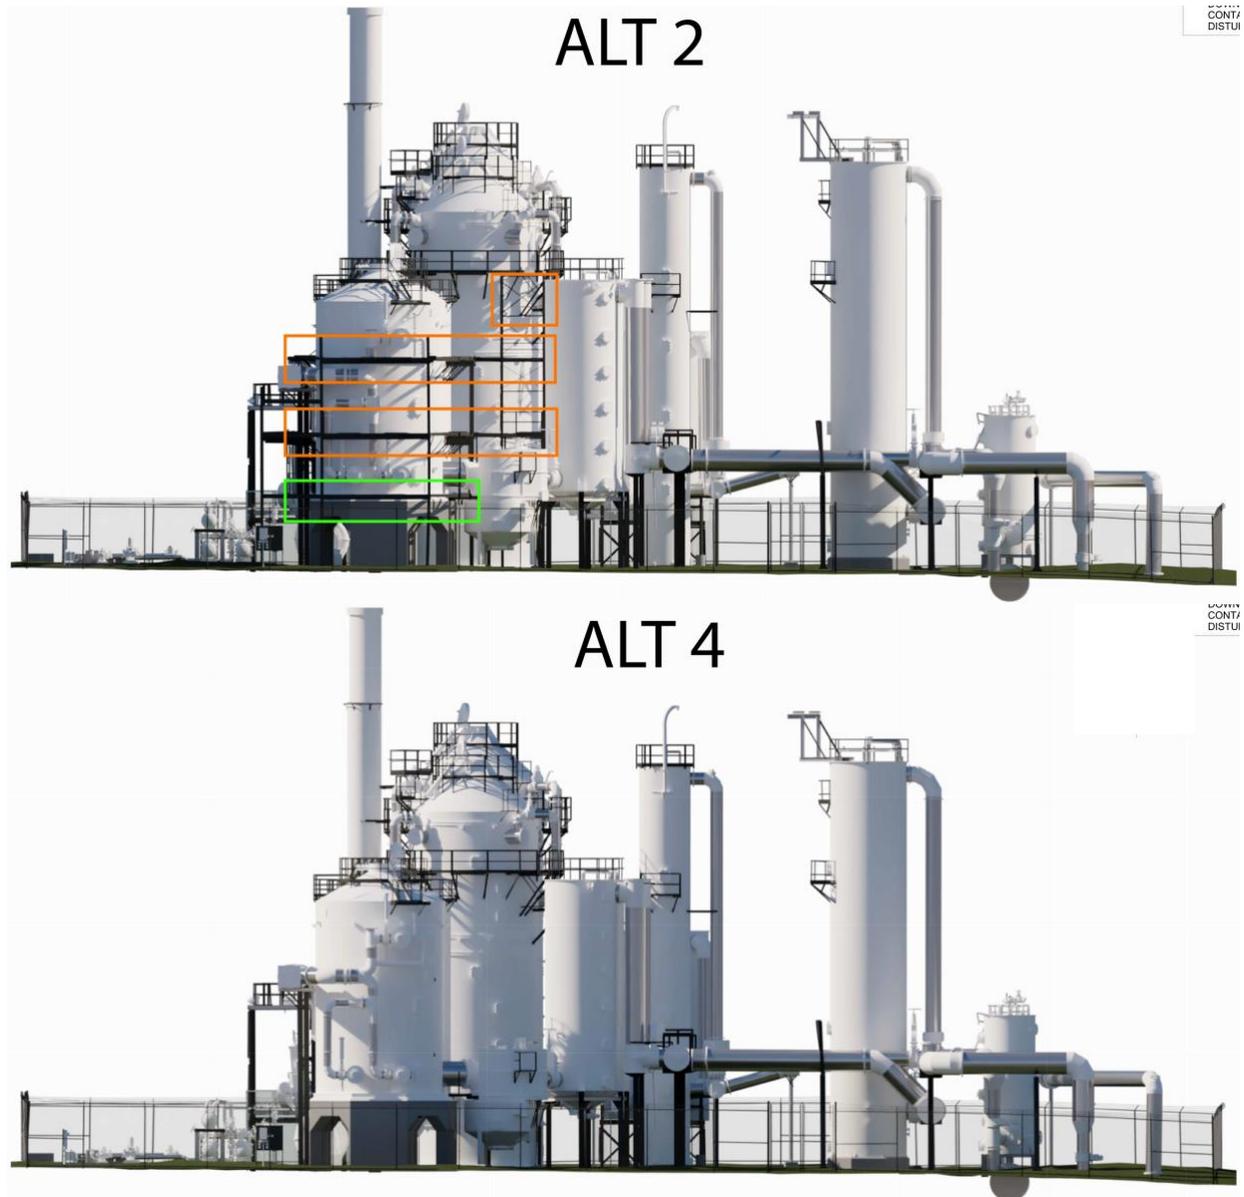
There are additional components selected for removal in ALT 4 compared to ALT 2 as depicted in the north elevation images; see Figure 3.

**Figure 3.** Post-deconstruction north elevation images for ALT 2 (top) and ALT 4 (bottom). The orange/green rectangles indicate structures in ALT 2 that are selected for removal in ALT 4. The green rectangle indicates structures that are approximately 11 to 12 feet in height.

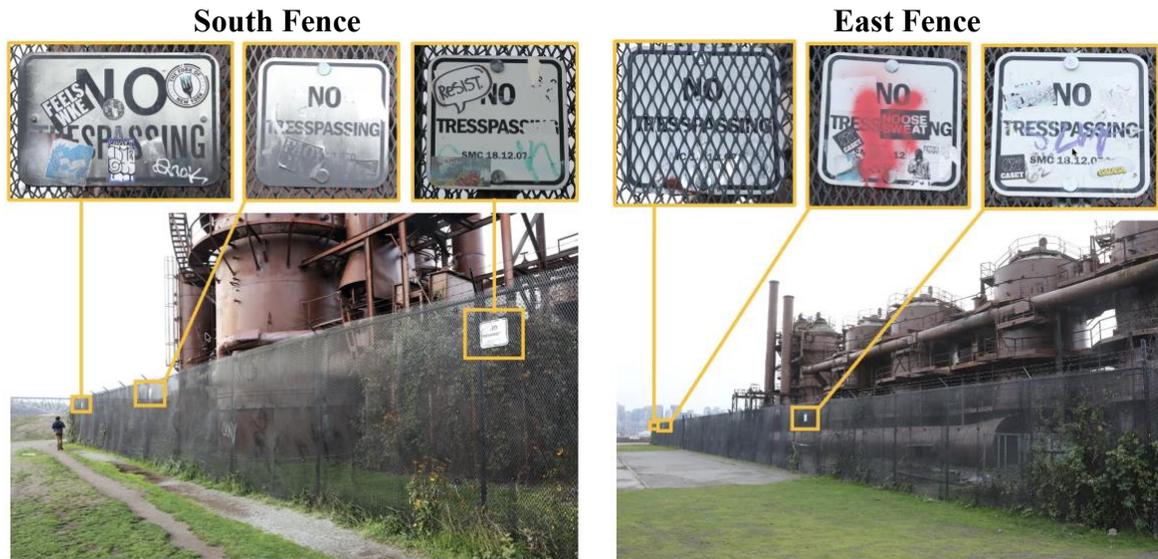
above the ground. Three “NO TRESPASSING” signs were posted on the east fence, and three signs were posted on the south fence; see Figure 2. As depicted in Figure 2, several of these signs contained graffiti, decals, and/or stickers on the front surface of the sign that partially obscured legibility of the sign.

**Figure 2.** Photographs taken during GEAR’s November 12, 2025, site inspection, depicting numerous “NO TRESPASSING” signs posted on the south (*left*) and east (*right*) sides of the perimeter fence.

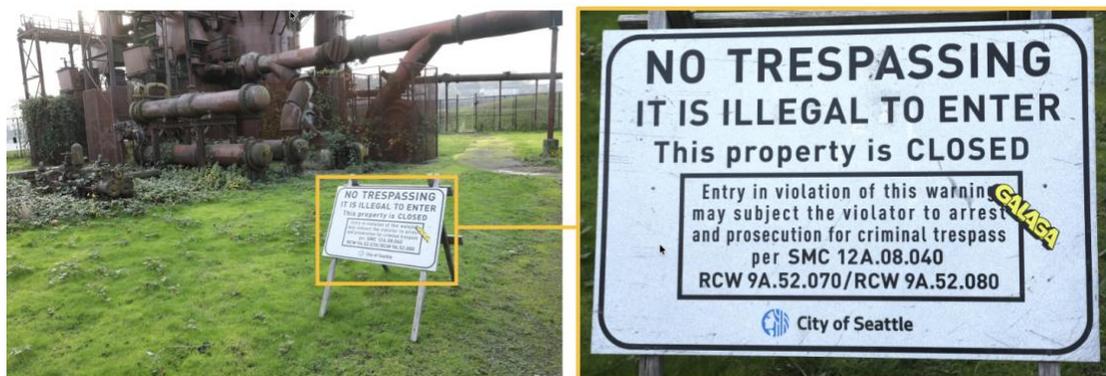
In addition, at the time of GEAR’s inspection, a portable A-frame sign was located in the interior of the fenced perimeter near the (locked) gate on the east side of the perimeter fence; see Figure 3. The sign, approximately 2 feet wide by 3 feet long, contains black-colored text on a white background that reads: “NO TRESPASSING,” “IT IS ILLEGAL TO ENTER,” “This property is CLOSED;” see Figure 3. Below this text, the sign reads, “Entry in violation of this warning may subject the violator to arrest and prosecution for criminal trespass,” with indication of the applicable SMC and RCWs; see Figure 3. In addition, during GEAR’s inspection, a second A-board sign with this same text was observed in a stored position beneath the structure; the sign contained a significant amount of graffiti which occluded and obscured the legibility of the text.

**Figure 3.** A photograph taken during GEAR’s November 12, 2025, site inspection, depicting a portable A-frame “NO TRESPASSING,” “IT IS ILLEGAL TO ENTER” sign.

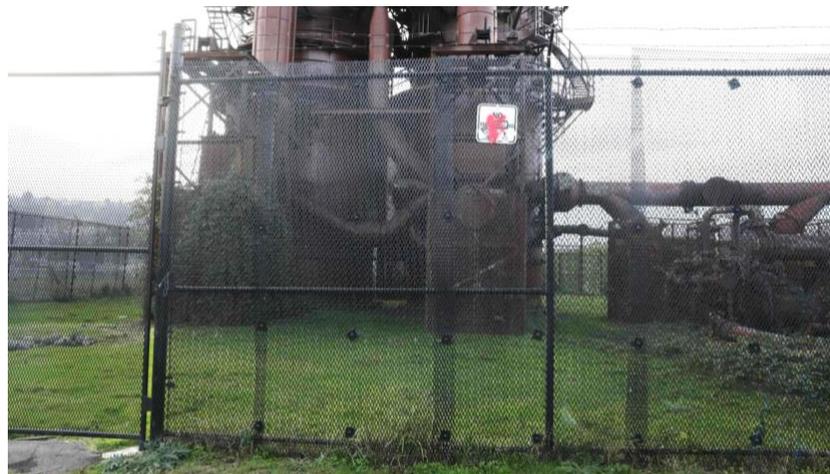
The Gas Works Park structure is enclosed around its perimeter by a metal grating fence, with three rows of barbed wire installed at the top of the fence; see Figure 5. Relative to the ground on the exterior sides of the fence, the metal-grated fence measures approximately 9 feet, 4 inches to 10 feet, 2 inches tall in height, with the barbed wire extending the height of the fence to approximately 10 feet, 4 inches to 11 feet, 2 inches. The interior of the fenced area is accessed (by authorized personnel) via a gate on the east side of the perimeter fence; the gate is locked and secured via a chain and padlock. Additional, non-functional gates (i.e., welded shut) are present in other areas around the perimeter fence.

**Figure 5.** A photograph taken during GEAR’s November 12, 2025, site inspection, depicting a section of the metal-grated fencing and barbed wire that extends around the perimeter of the subject enclosure.

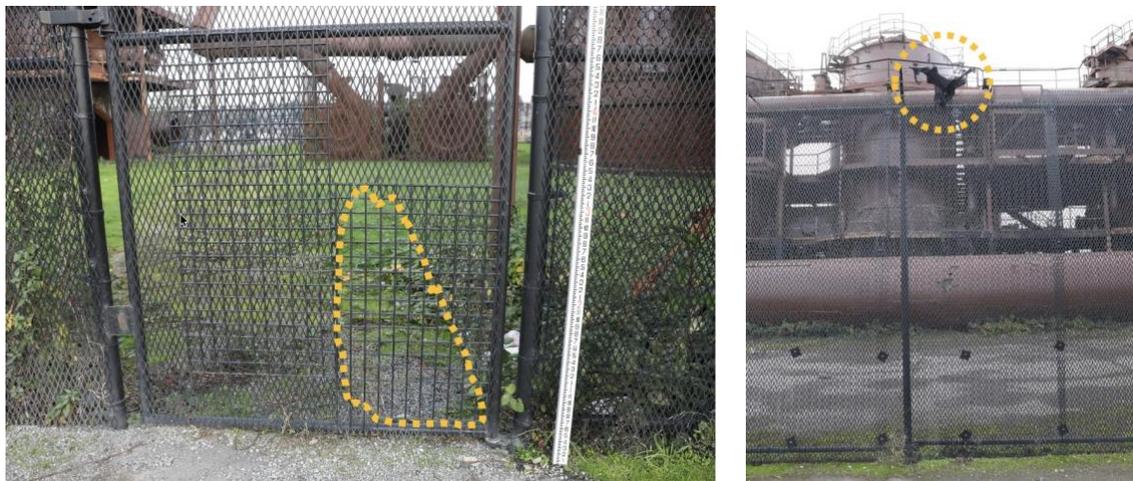
**Figure 6.** Photographs taken during GEAR’s November 12, 2025, site inspection. *Left*) A photograph depicting a missing section of metal fencing on the west perimeter (with additional metal-grating welded over the missing section). *Right*) A partially torn/ripped garment on the barbed wire at the top of the fencing on the east perimeter.

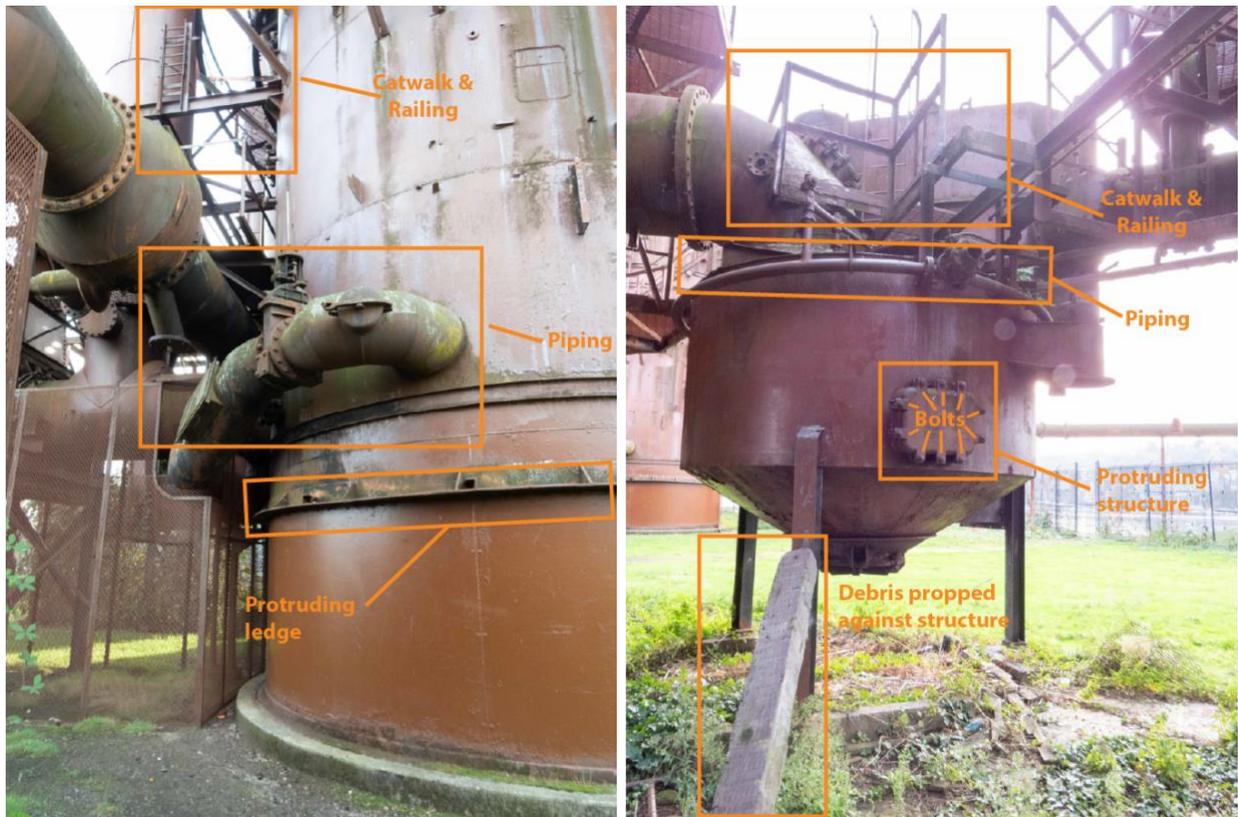
**Figure 11.** *Left)* A protruding ledge on a tower that was approximately 6 feet above a concrete slab that protruded approximately 8 inches from the vertical tower wall. Above the protruding ledge was piping that was less than 11 feet in height from the protruding ledge below and further in height was a catwalk and railing. *Right)* A protruding structure that was approximately 7 to 8 feet above the ground and protruded approximately 7 inches from the wall. This structure had bolts that provided additional areas for finger holds. Above the lower protruding structures there was additional piping and a catwalk and railing within 11 feet. At the time of the inspection, there was debris that was propped against the structure.

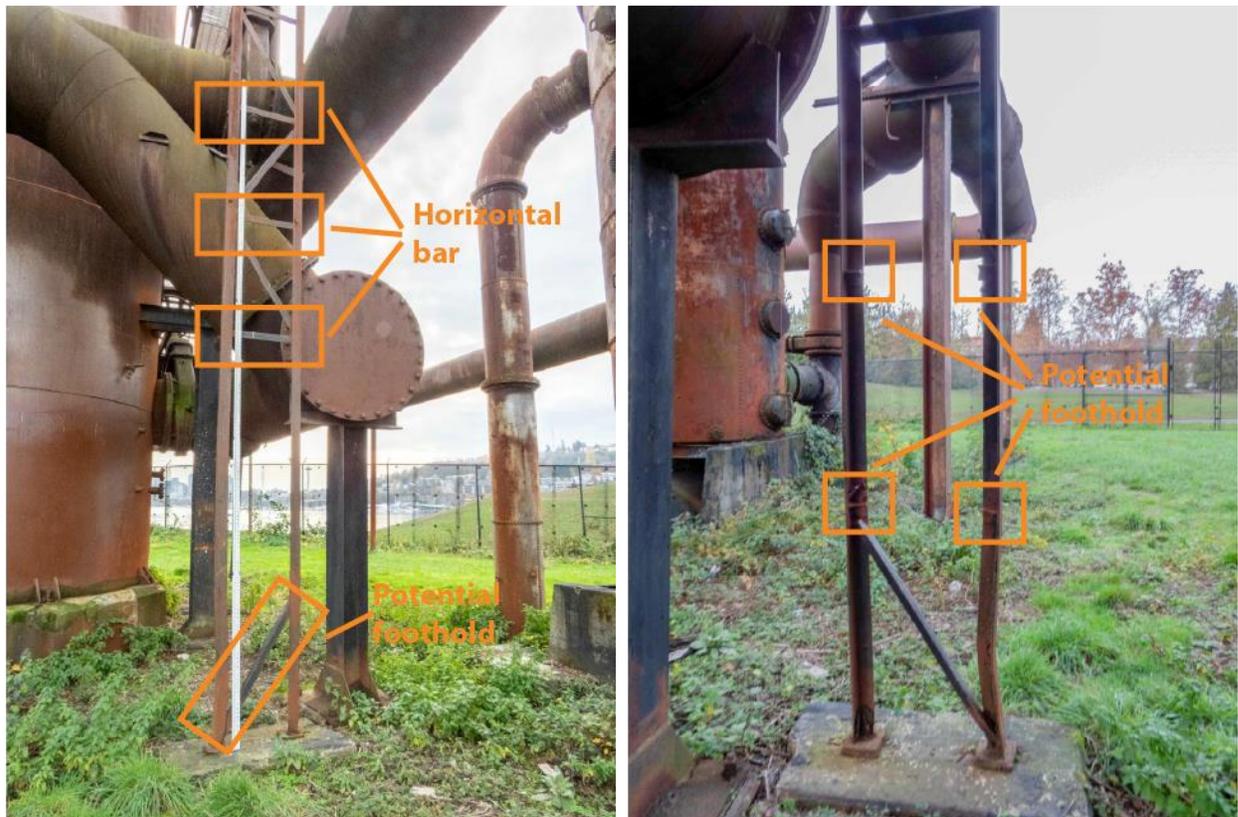
**Figure 12.** *Left*) Horizontal metal bars. The lowest horizontal bar was approximately 9 feet in height and narrow in diameter that provided a graspable surface that fingers could wrap around. Below this horizontal bar there was a diagonal bar that could provide a foothold to assist in reaching the horizontal bar. *Right*) The other side of the same structure. There were horizontal ledges that could provide potential footholds.

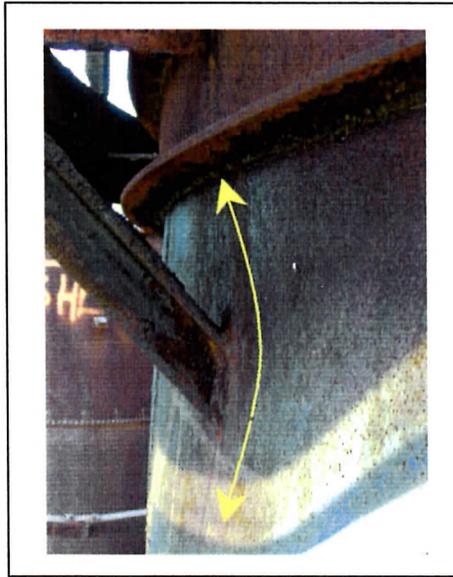
1. Supporting Level 2 catwalk, shell depressions at the catwalk knee braces along the south side.

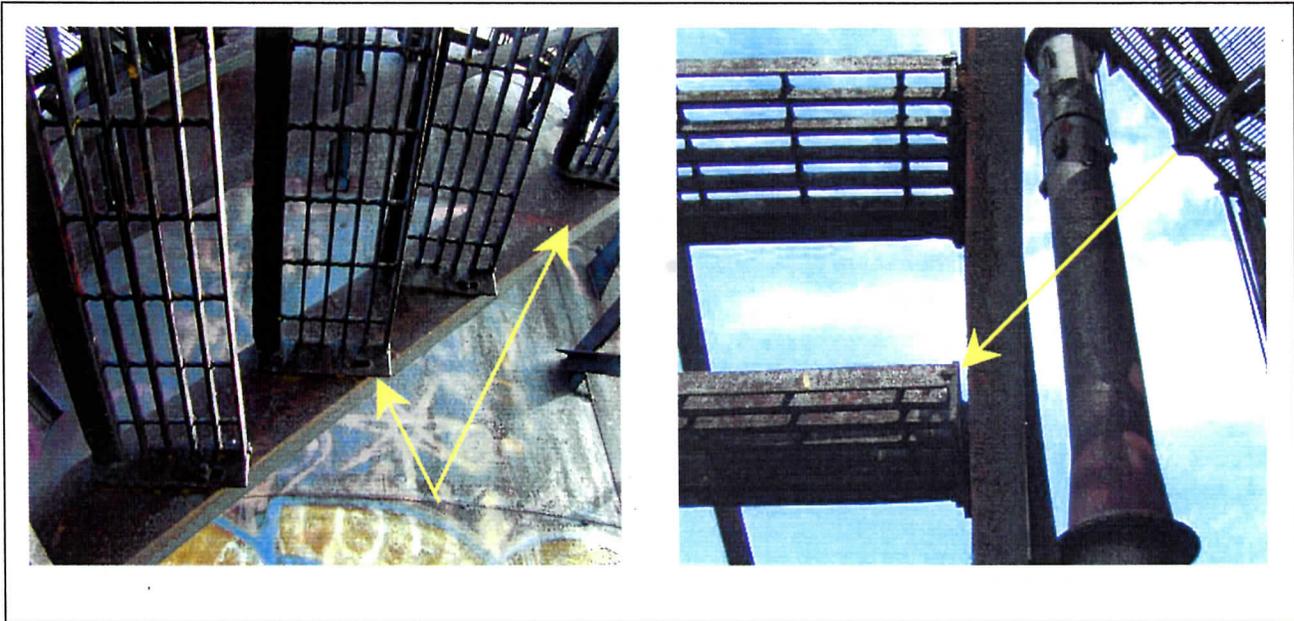
3. South stairway from catwalk levels 2 to 3 has missing stair steps. Bolts have failed at various treads due to corrosion-separating some stringer channels from grating steps. Catwalk grating has numerous panels missing and is heavily corroded. None of the stair or catwalk grates appear to be in a safe or usable condition.

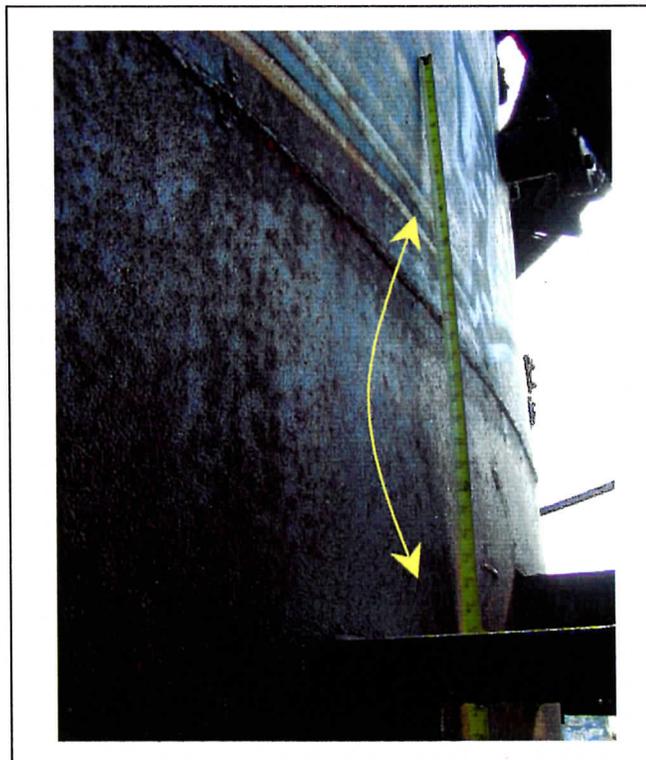
4. Deformations and buckles in shell walls at the south elevation of catwalk Level 1. Depressions and buckles are 1" nominally out of plane.

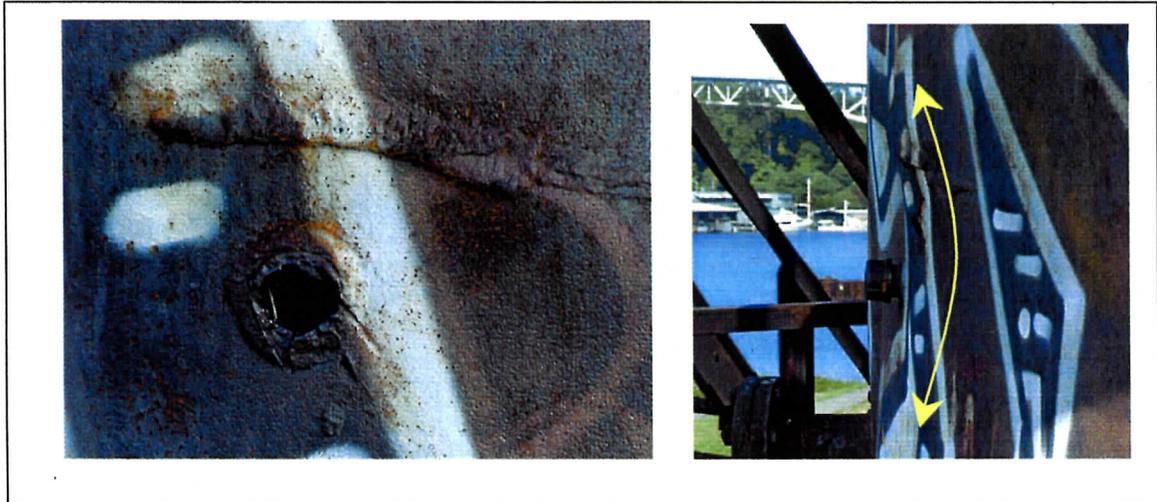
5. A repair weld was made to a tear/crack in the shell at catwalk Level 2. The shell also has a depression at this nozzle location.

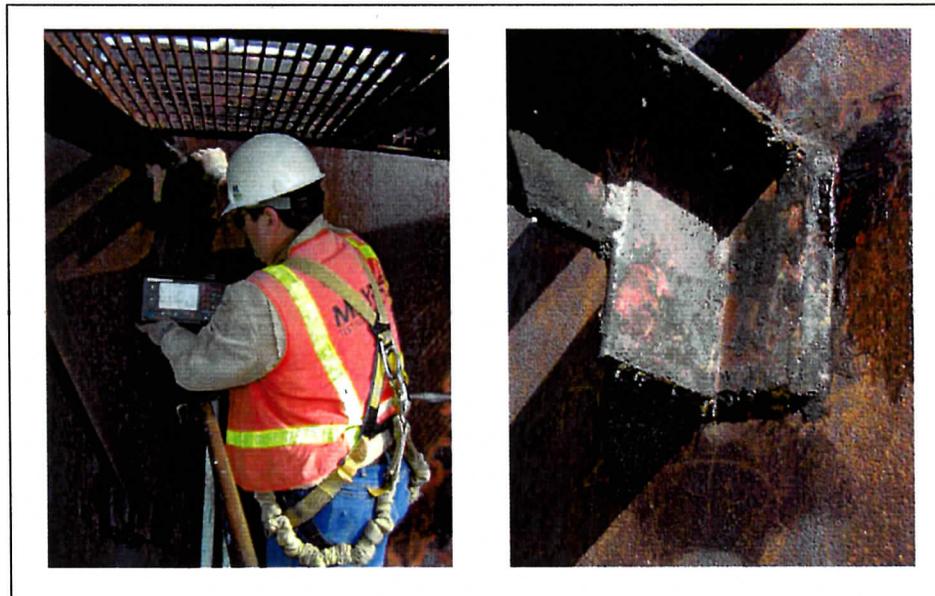
6. Welds of catwalk support systems appear to be in fair condition with no apparent in service failures.

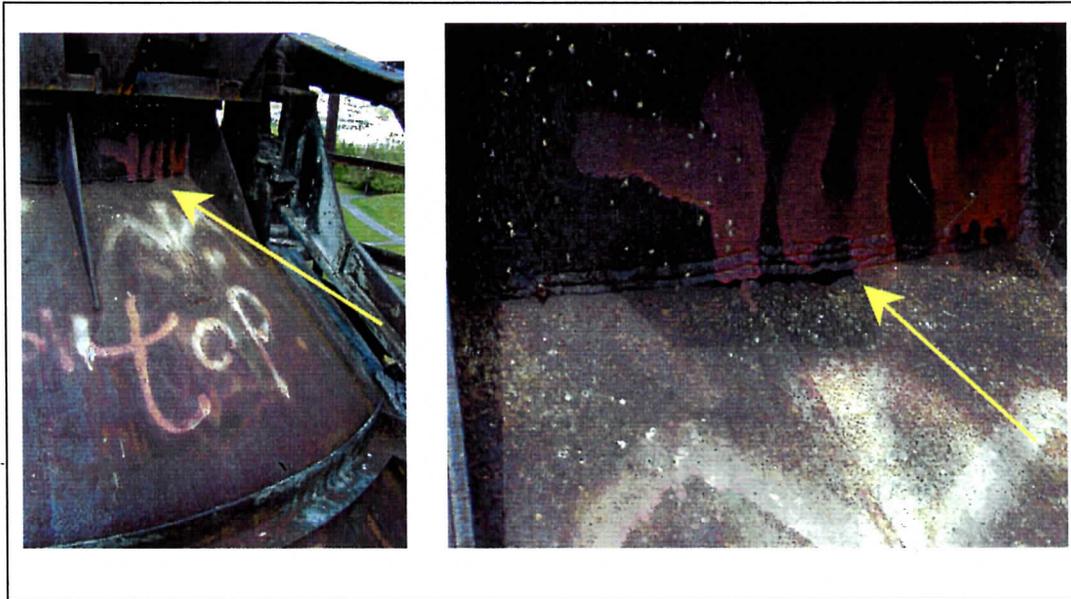
7. The conical roof section at top of vessel has holes corroded completely through its wall at manway fit-up connection joint. Thickness readings taken here ranged from 0.370", 0.360", and 0.160".

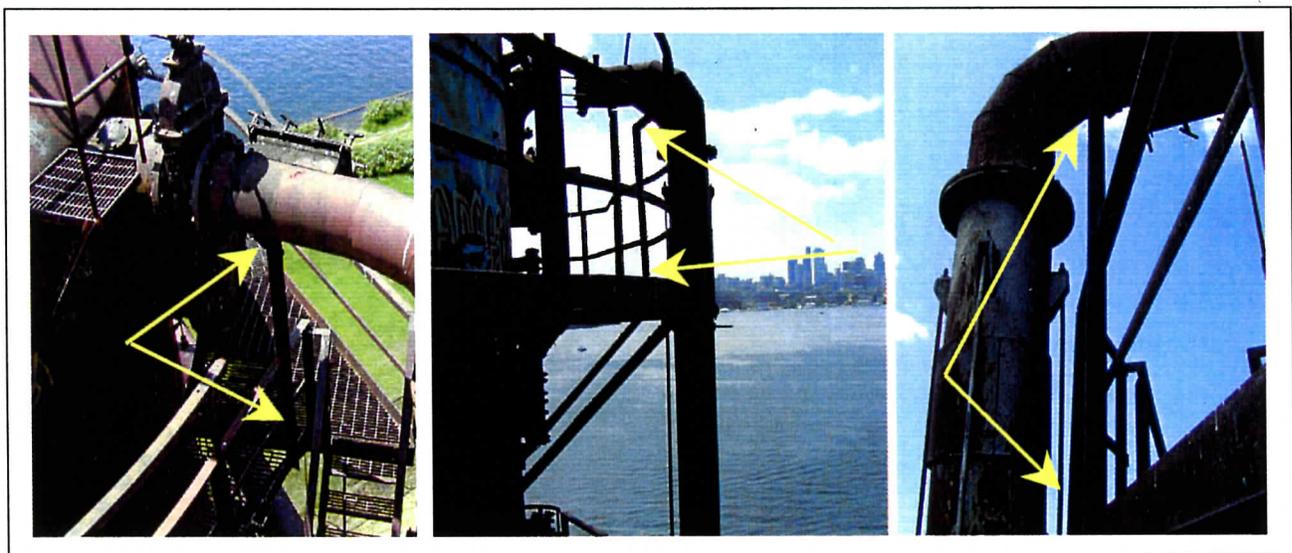
8. Vessel's upper piping is largely supported by upper catwalk framing. In one case, corrosion has left a 10' section of piping almost entirely resting on stanchion angle being carried by catwalk.
