TALARIS PROJECT RECAP

BUILDINGS A, B, C / EXISTING CONDITIONS AND BUILDING CHARACTERISTICS

BUILDING D / EXISTING CONDITIONS AND BUILDING CHARACTERISTICS

BUILDING F / EXISTING CONDITIONS AND BUILDING CHARACTERISTICS

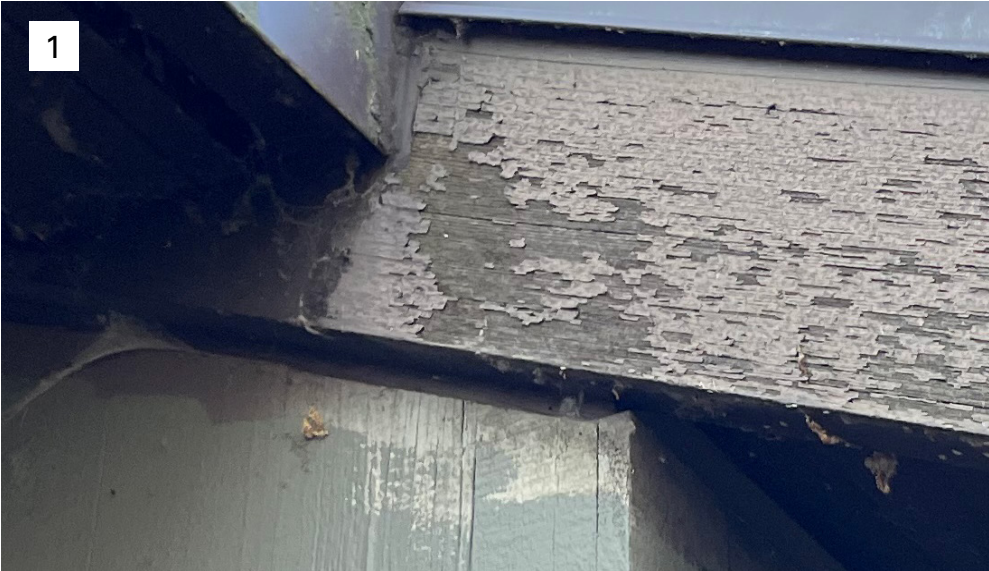
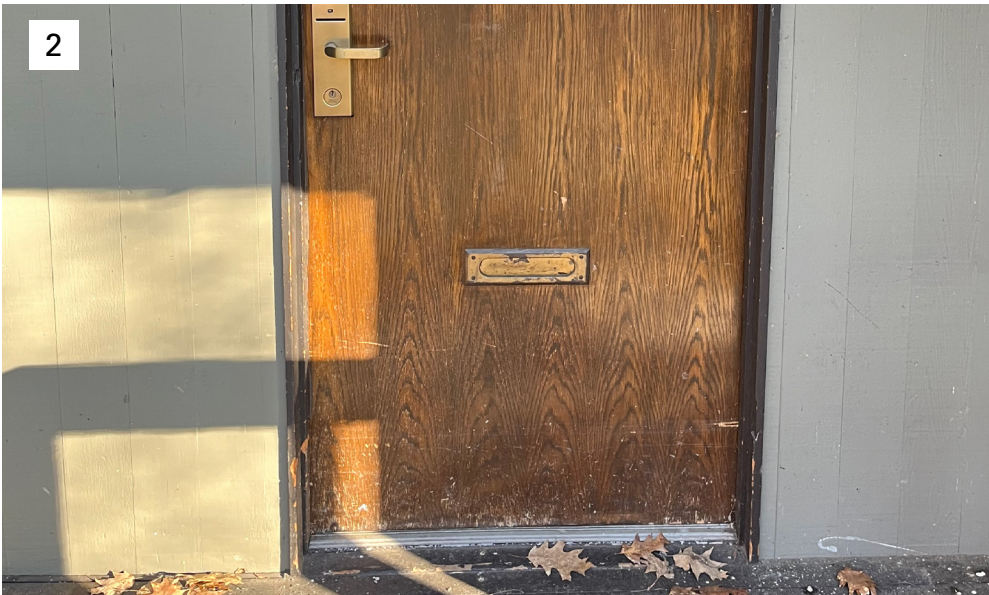
- 1. THE SIDING IS 3/4" X 5 1/2" TONGUE AND GROOVE CEDAR. BUILDINGS HAVE BEEN PAINTED MULTIPLE TIMES
- SOME AREAS HAVE BEEN PAINTED ONCE, OTHER AREAS UP TO THREE TIMES. THE FIRST PAINT COLOR WAS MEDIUM GRAY/BEIGE. THE CURRENT COLOR FOR MOST OF THE BUILDINGS IS A DARK GREEN/GRAY COLOR
- 2. DOORS ARE STAINED OAK WITH DARK BROWN PAINTED WOOD FRAMES

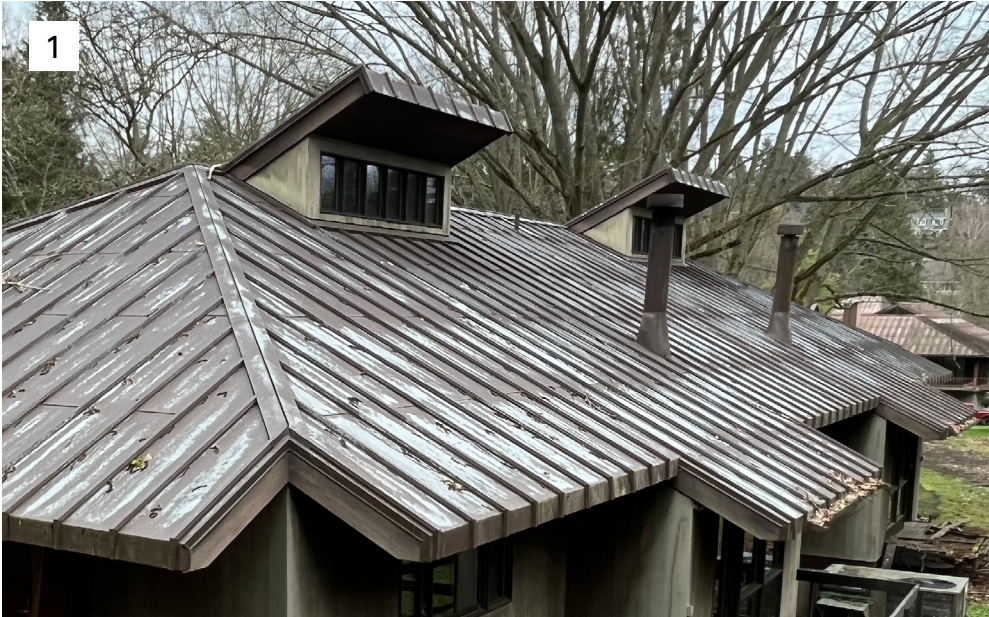
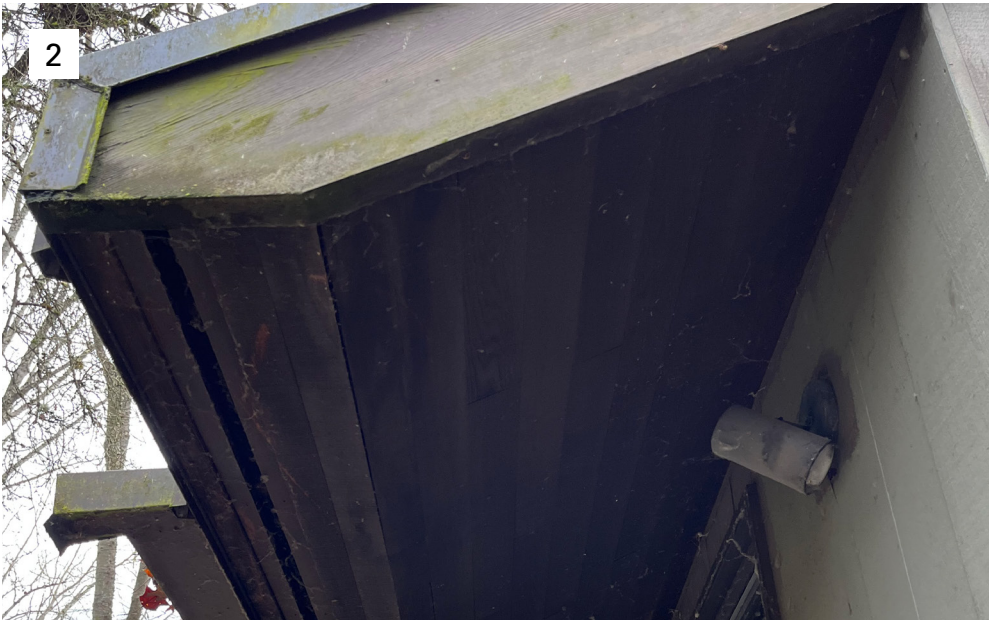
1. BATTEN SEAM METAL ROOFS ARE FINISHED WITH A DARK BROWN PAINT. THE PAINT IS PEELING IN MANY LOCATIONS.

CLERESTORY ROOF EAVES ARE SIMILAR TO DEPTH AT FIRST LEVEL, RAKE OF ROOF DOES NOT HAVE A DEEP EAVE.

2. GUTTERS ARE ONLY LOCATED AT WALKWAYS AND DECKS THAT PASS UNDER THE EAVES.

ROOF DRAINAGE TYPICALLY RUNS OFF ROOF EDGES AND FALLS TO PERIMETER GRAVEL SURFACED STORM SYSTEM.

- ROOFING PANEL FINISH IS IN FAIR TO POOR CONDITION WITH THE MULTIPLE LAYER SURFACE COATING BEGINNING TO FADE AND/OR CRACK AND PEEL DOWN TO PRIMER COAT LAYER IN VARIOUS LOCATIONS.

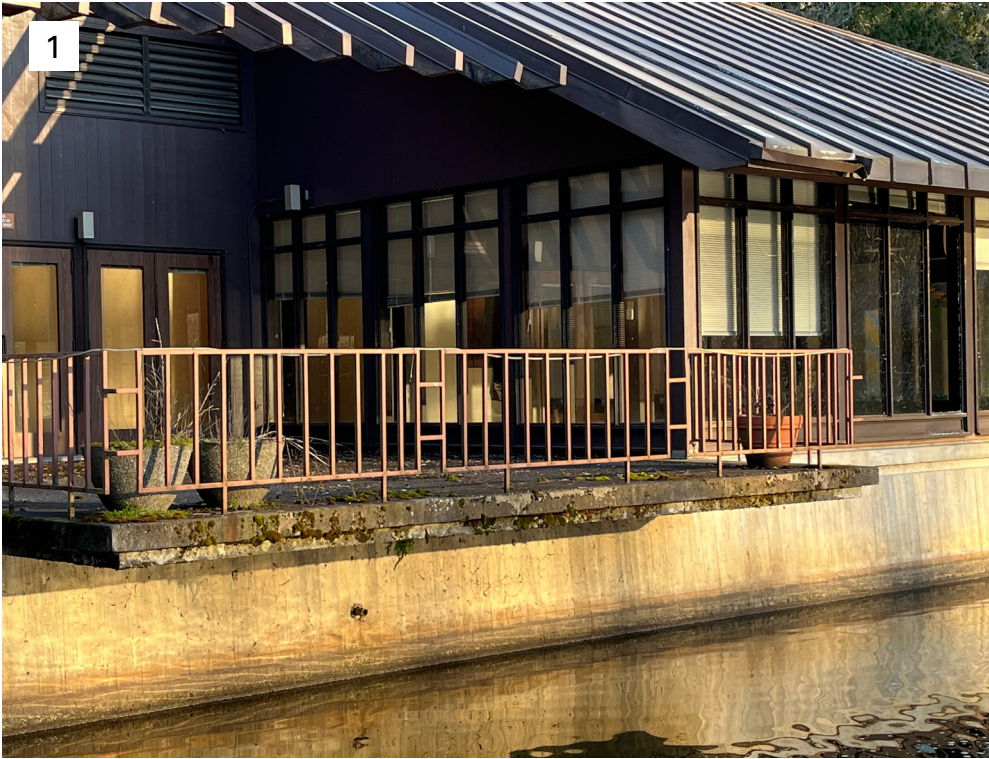
1. TYPICAL EXTERIOR METAL RAILINGS ARE PAINTED 1" SQUARE TUBES WITH A REPEATING PATTERN EVERY 10 FEET. PAINT FINISH IS FADED BUT APPEARS TO MATCH ROOFING IN COLOR.

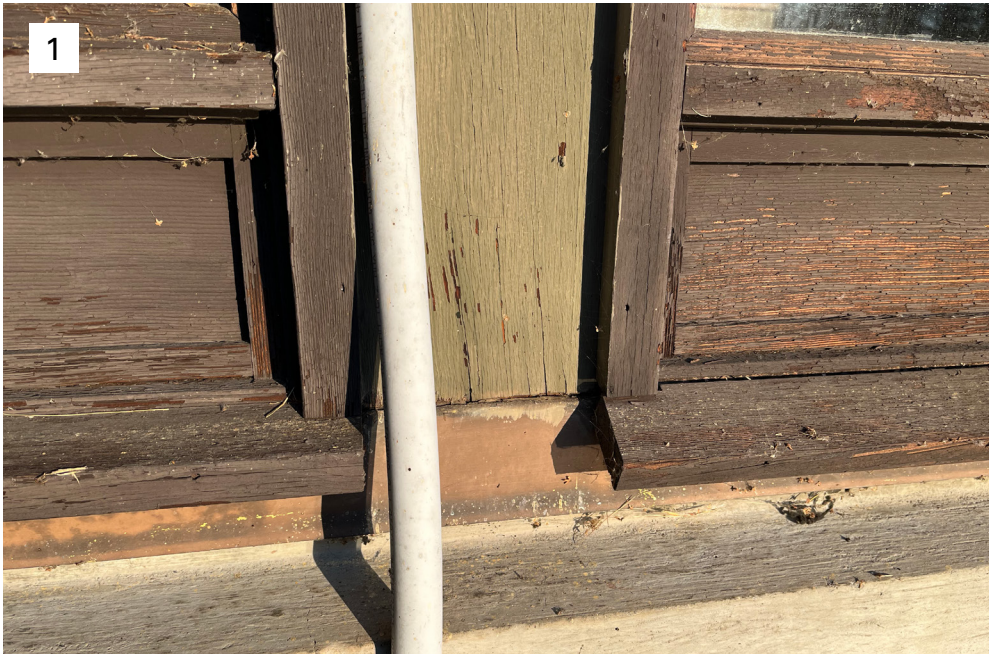
- 1. THE SIDING IS 3/4" X 5 1/2" TONGUE AND GROOVE CEDAR. BUILDINGS HAVE BEEN PAINTED MULTIPLE TIMES

SOME AREAS HAVE BEEN PAINTED ONCE, OTHER AREAS UP TO THREE TIMES. THE FIRST PAINT COLOR WAS MEDIUM GRAY/BEIGE. THE CURRENT COLOR FOR MOST OF THE BUILDINGS IS A DARK GREEN/GRAY COLOR
- 2. THE SOUTH FACADE SHOWS ORIGINAL PAINT COLOR FADED BY SUN AND WEATHERED ABOVE THE BOARD FORMED CONCRETE BASE.

- 1. CEDAR SIDING TO BE PAINTED TO MATCH FIRST LAYER OF GRAY/BEIGE PAINT ON CEDAR
- 2. RAILINGS, WINDOW AND DOOR TRIM, EXPOSED RAFTERS AND DECKING TO BE PAINTED TO MATCH DARK BROWN ON CEDAR.
- 3. DOORS TO BE WOOD VENEER AND STAIN AND LACQUER FINISH.
- 4. ROOFING/FLASHING TO MATCH EXISTING ROOF PAINT COLOR

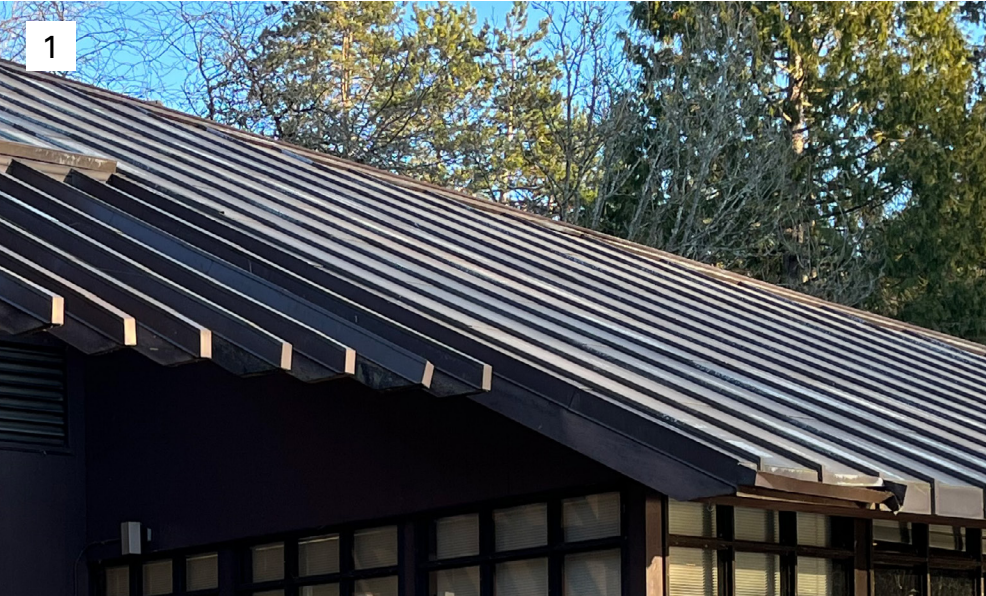
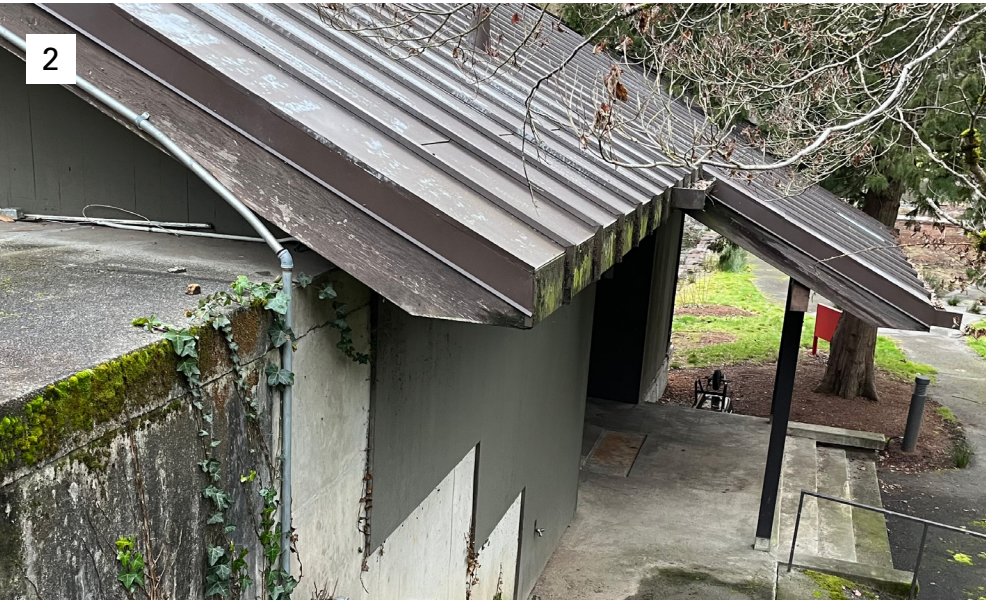
1. BATTEN SEAM METAL ROOFS ARE FINISHED WITH A DARK BROWN PAINT.THE PAINT IS PEELING IN MANY LOCATIONS.

- ROOFING PANEL FINISH IS IN FAIR TO POOR CONDITION WITH THE MULTIPLE LAYER SURFACE COATING BEGINNING TO FADE AND/OR CRACK AND PEEL DOWN TO PRIMER COAT LAYER IN VARIOUS LOCATIONS.
