Magnuson Park Phase 2 Development

Year 7 (2016) Monitoring Report
USACE Reference NWS-2006-52-NOW

Otak, Inc.
11241 Willows Road NE, Suite 200
Redmond, WA 98052
Otak Project No. 31391

January 6, 2017

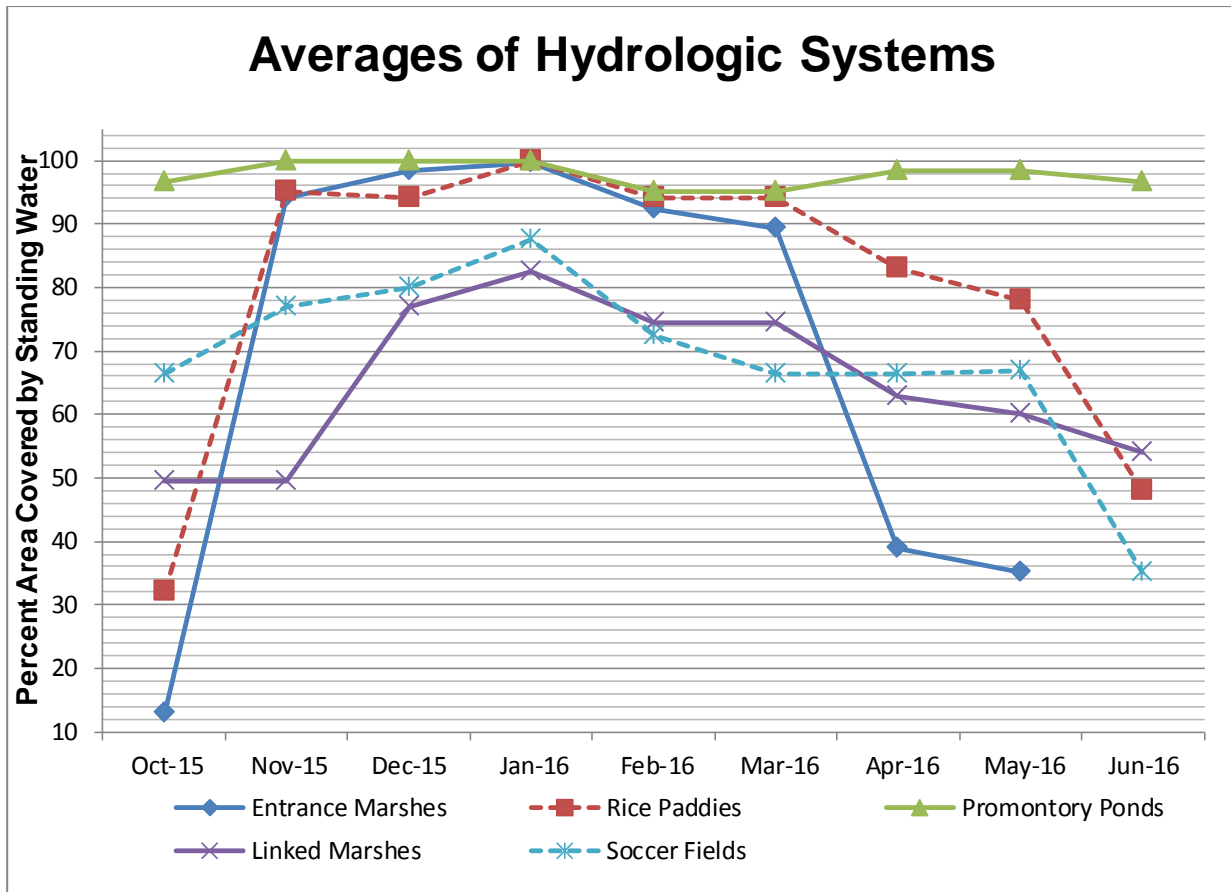
Figure 3.2 Year 7 Average Percent of Hydrologic System Covered by Standing Water

Observed Standing Water: Due to the presence of a cemented layer within ten inches of the soil surface (on average) throughout the Phase 2 Mitigation Area, it was determined that piezometers could not be used to measure soil saturation. Instead, monthly observations and estimates of the extent of ponded water in each of the five hydrology systems were made by Otak staff from October 2015 through June 2016. Sub-areas within the hydrologic systems (individual ponds, swales, rice paddies, etc.) were assumed to be at 100 percent capacity when water was flowing over the limiting structures (e.g., weirs and outlet structures). See Hydrology Monitoring Methods in Appendix C for additional monitoring criteria. Figure 3.2 below represents the averages of the individual sub-areas in the five hydrologic systems. See Figures E-3 through E-7 in Appendix E for the results of individual sub-areas.

As expected, due to consistent inflow and regulated outflow, the Promontory Pond System was at 100 percent capacity nearly the entire duration of the monitoring period. On average, the Entrance Marsh System reached 100 percent capacity during November 2015 and was at or near 100 percent capacity through March of 2016. The Rice Paddy System showed an increase in capacity from November 2015 to March 2016, where it approached 100 percent. The Soccer Field System and Linked Marsh System never achieved 100 percent capacity during the monitoring events, and was highest at 80-85 percent in January 2016 and then decreased to approximately 65 percent in May 2016. Except for the constant source Promontory Ponds, the general pattern was for water levels in the Systems to increase in fall/winter and decrease in the late spring/early summer. As noted above, hydrology performance standards for the monitored wetlands were met for the 2015-2016 water year.

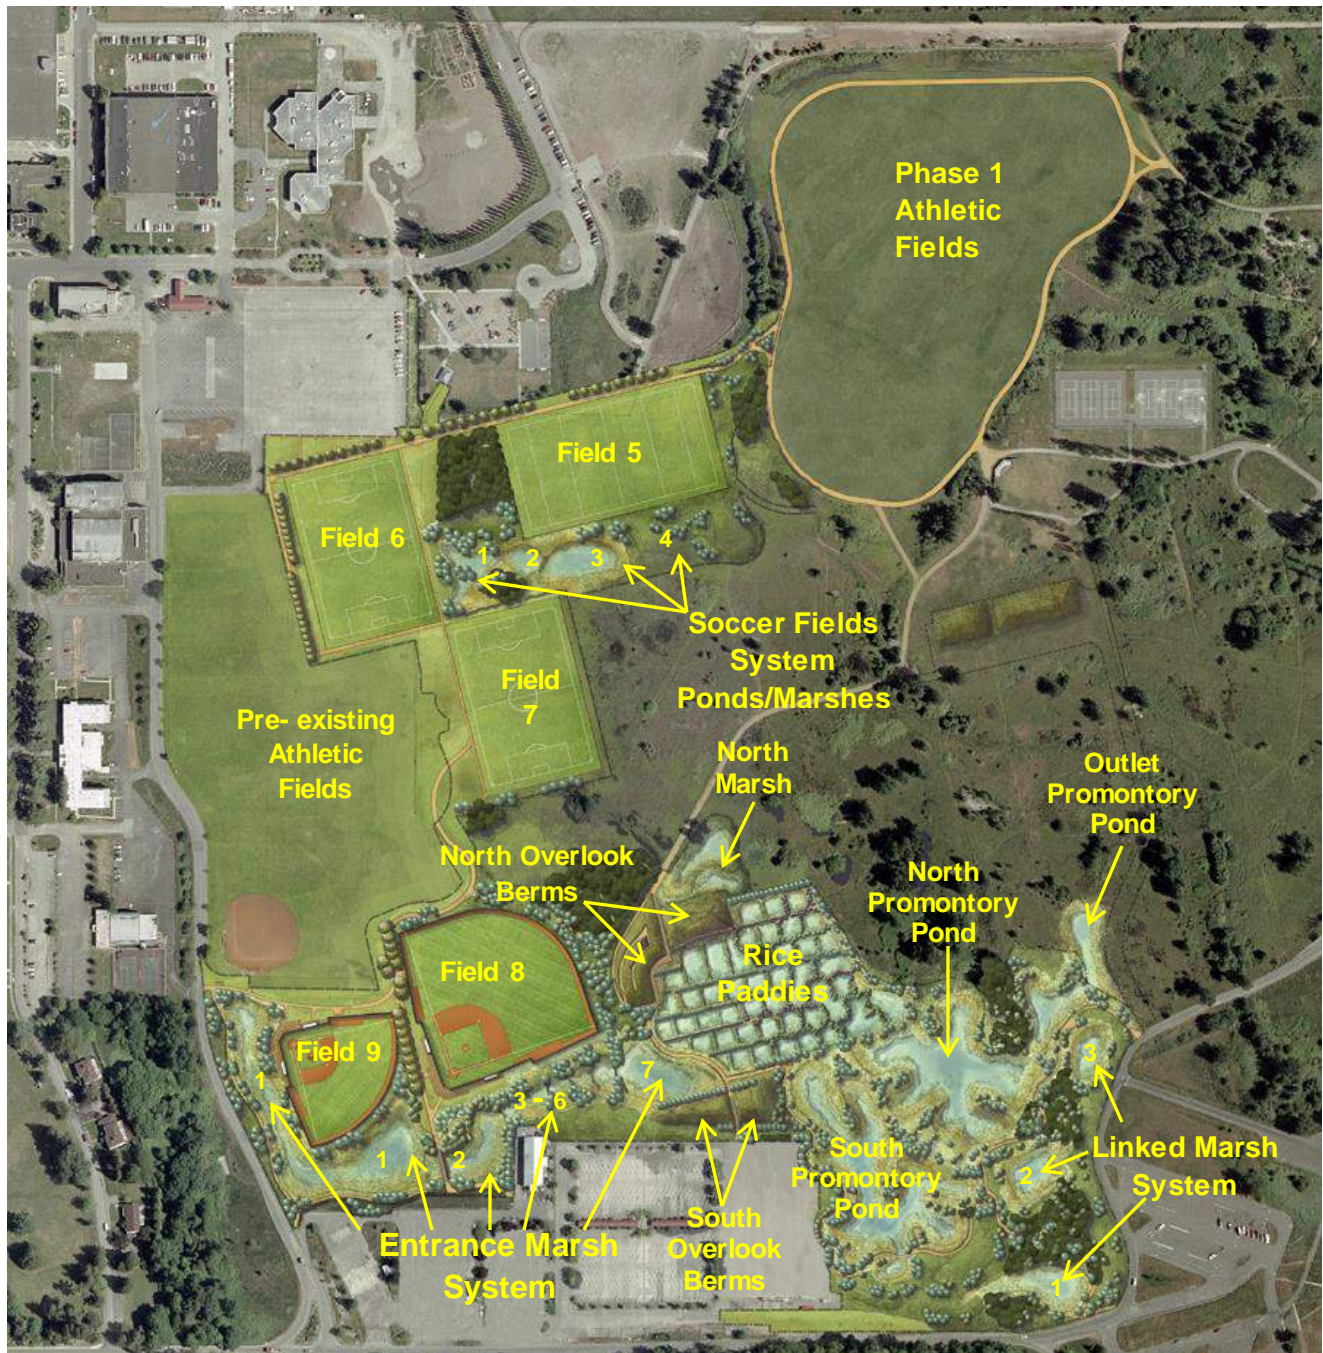
Figure 2. Magnuson Park Phase 2 Development Site Map, January 2009
Note the five hydrologic systems: Entrance Marsh System, Rice Paddies System, Promontory Pond System, Linked Marsh System (NE 65th St.), and the Soccer Field System

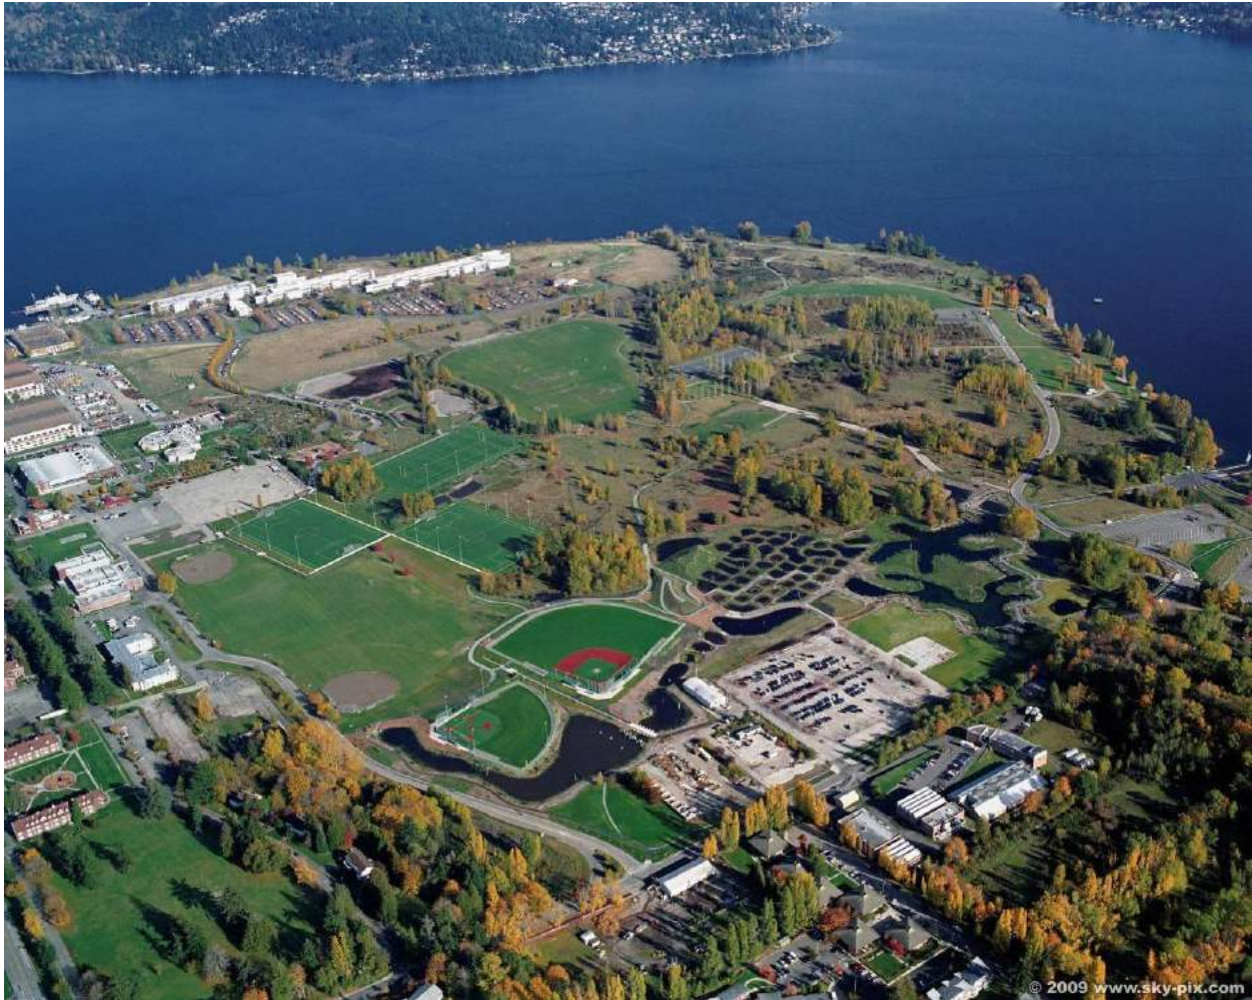
Photo 2. Fall 2009 Aerial Photo of Magnuson Park After Construction.

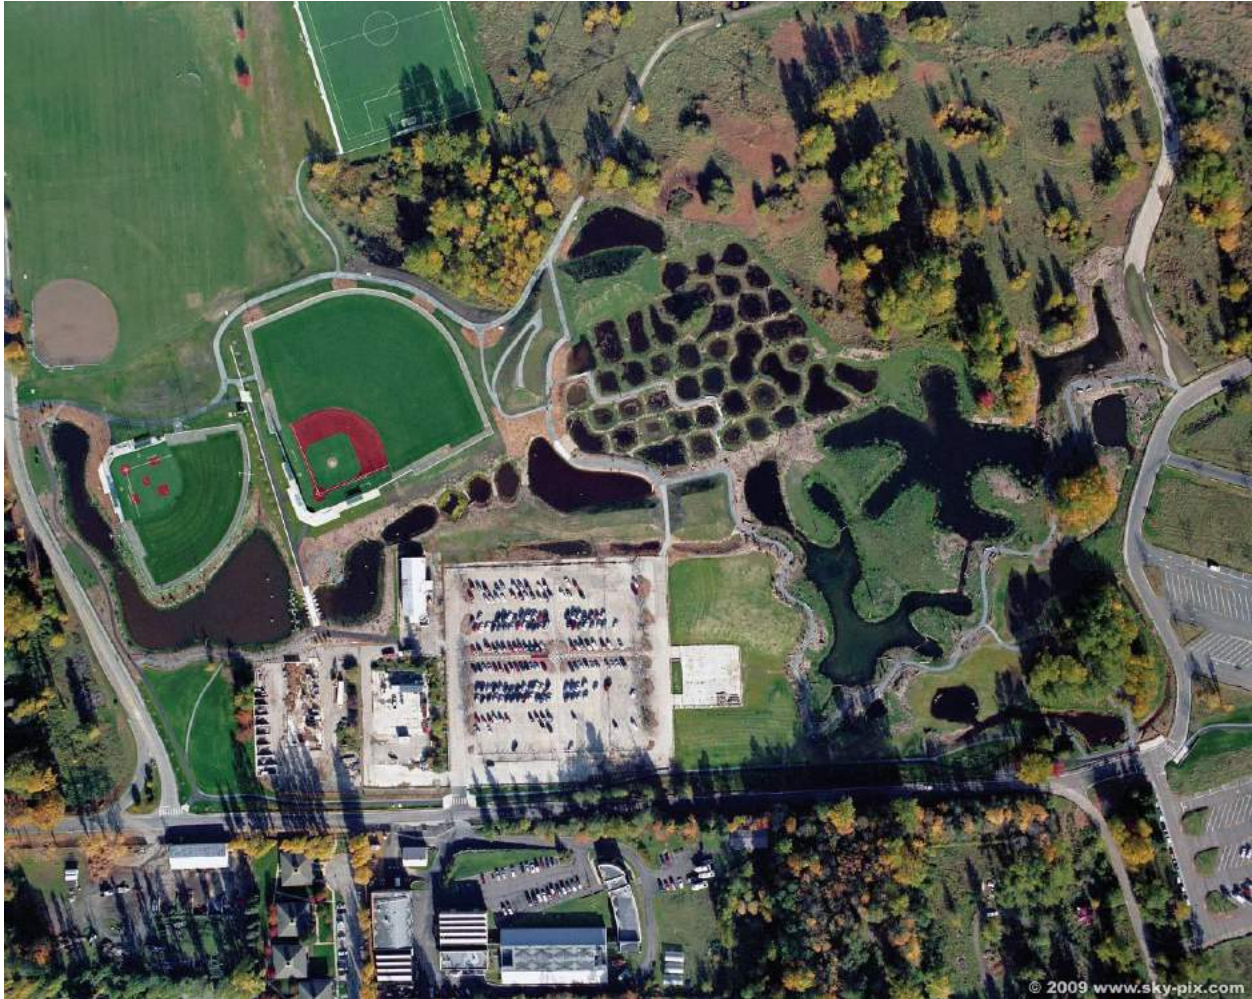
Photo 3. Fall 2009 Aerial Photo of the Southern Portion of the Phase 2 Development Area After Construction, including: Athletic Fields 7, 8, and 9; new trail system; Entrance Marsh System; North Marsh and the Rice Paddies System; Promontory Pond System; and the Linked Marsh System with the new Navy Pond (see Figure 1 that follows for Hydrologic System names).

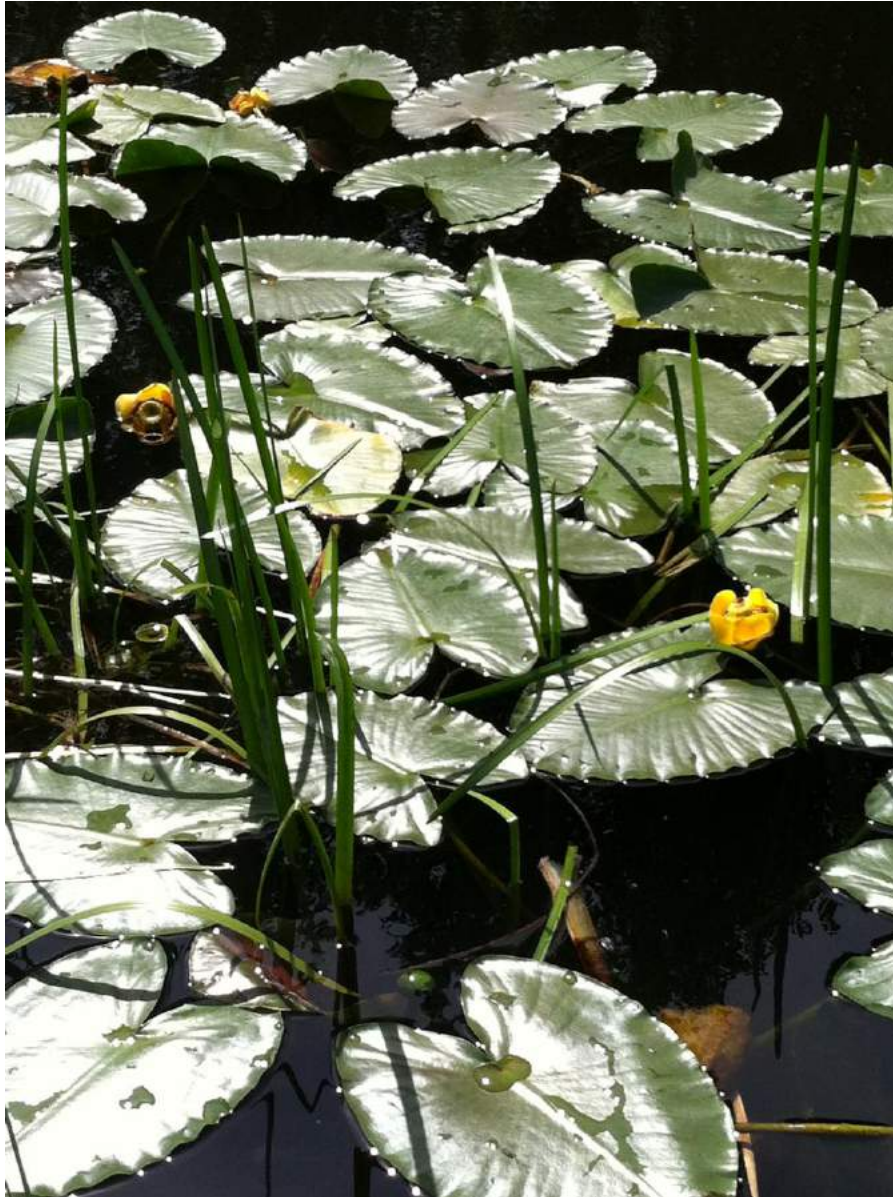
Photo 4. Yellow pond lily in Linked Marsh System.

One of the goals of the Phase 2 Mitigation Project is to engage the public in educational activities (see Photo 4 in Appendix D). Under the direction of Parks staff members, a wide diversity of volunteers from a variety of businesses, schools, government groups, and religious organizations, as well as private individuals, participated in planting and weeding activities.

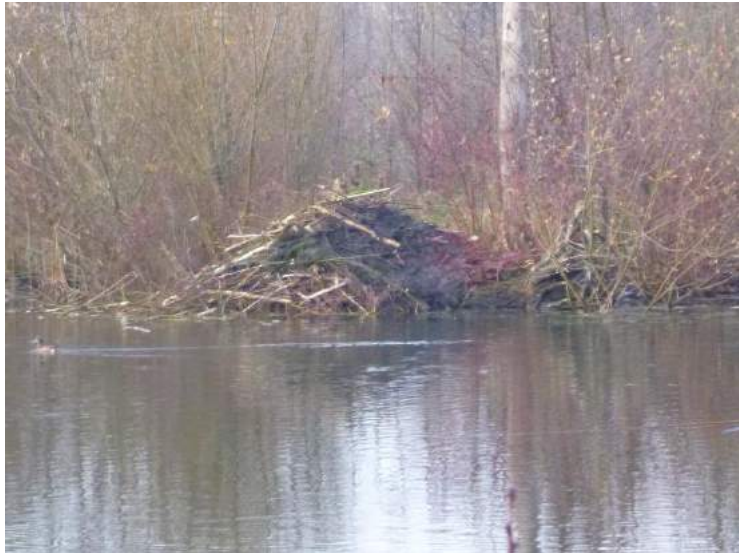
Over the past four years beaver have inhabited the park and constructed dams in the Promontory Pond System, which substantially changed the hydrology on site, raising water levels and causing flooding in areas not previously subjected to inundation. Subsequently, alterations to herbaceous and scrub-shrub plant communities were noted in Year 5 and continued into Year 7. Due to concerns about flooding, trail use and maintenance, and plant mortality for wetland and buffer mitigation sites, a beaver deceiver (water control device) was installed in January 2015 as an adaptive management activity. However, water levels have continued to rise in the Promontory Pond System. Regular maintenance activities now include clearing mud and debris from the outlet (i.e., bird cage) in the Outlet Promontory Pond to prevent flooding adjacent trails and maintain wetland flow patterns. The beaver deceiver has provided some control of water levels in the system, but beaver activity has obviated much of its efficacy.

Photo 5. Beaver lodge in North Promontory Pond.

- Maintain or fix water level control devices (modified Clemson devices) through the existing beaver dams.
- Conduct maintenance activity on the trail and leaky berm facilities in the beaver dam vicinity in order to maintain designed wetland hydrology and flow patterns for the mitigation site.

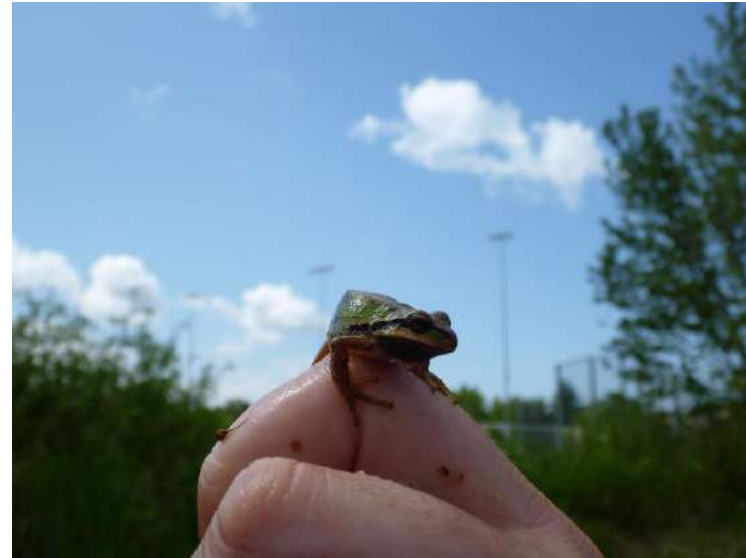
Photo 6. Pacific Chorus Frog in the Soccer Field System.

- Amphibians: Pacific chorus frogs have colonized and established breeding populations in the Phase 2 Mitigation Area (see Section 3 for details; and data in Appendix E). Larval population densities are greatest in the shallow ponds of the rice paddy wetlands, soccer ponds, and linked marsh system. Created wetland breeding and rearing habitat is providing numbers of egg masses and larvae during sampling events compared to pre-Phase 2 project conditions. Although population numbers are down in 2016 compared to previous years, this is likely associated with environmental and temporal variability (e.g. warm, dry spring) and population dynamics variability associated with Pacific chorus frog life history.

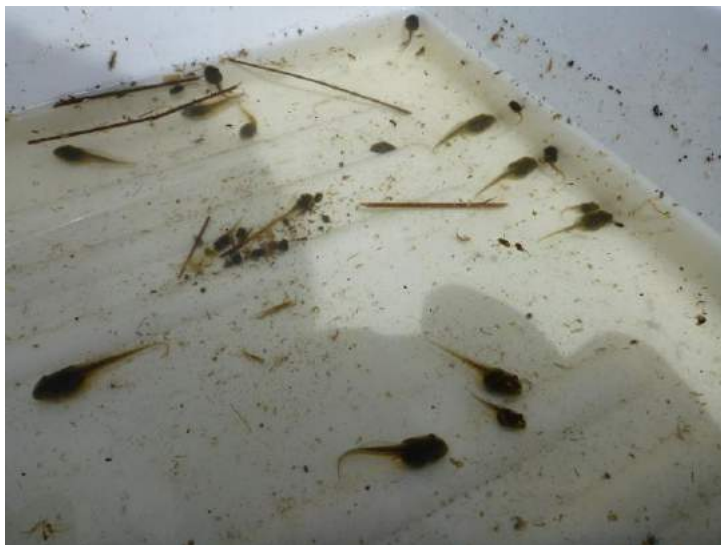
Photo 7. Amphibian larvae sampling (Pacific Chorus Frogs).

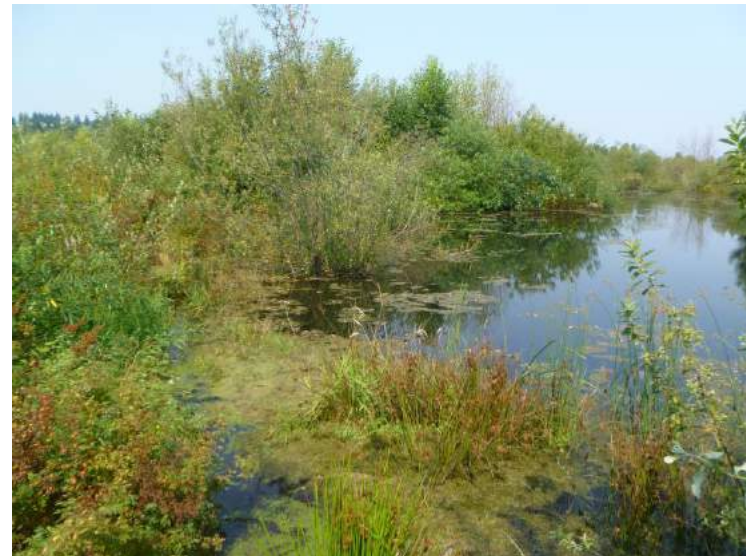
Photo 8. Inundated vegetation on site, beaver-mediated.

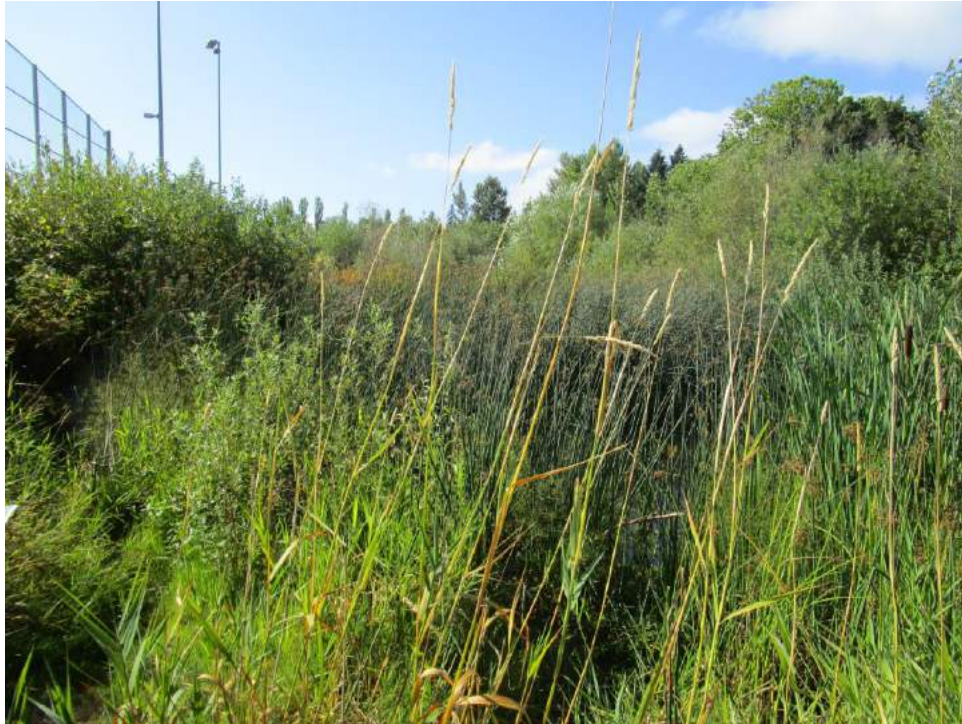
Photopoint 1. Looking south at the north end of Entrance Marsh 1 with the softball field (Field #9) to the southeast (left background); photo taken from the inlet structure on August 12, 2016.

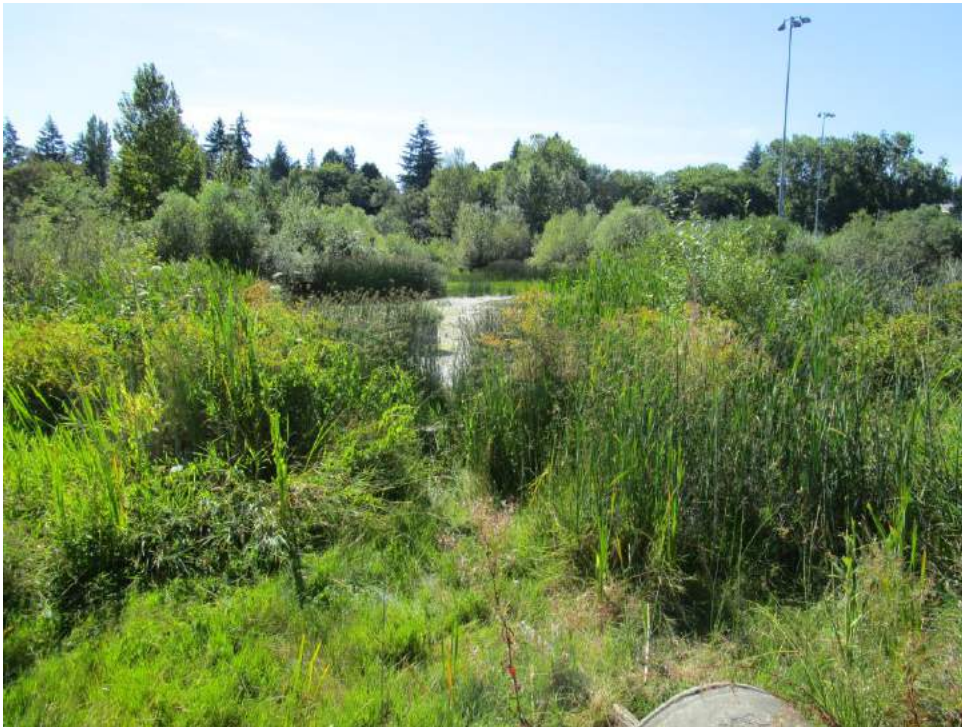
Photopoint 2. Looking west at the east end of Entrance Marsh 1, with the softball field (Field #9) to the north (right background); photo taken from the bridge between Entrance Marshes 1 and 2 on August 12, 2016.

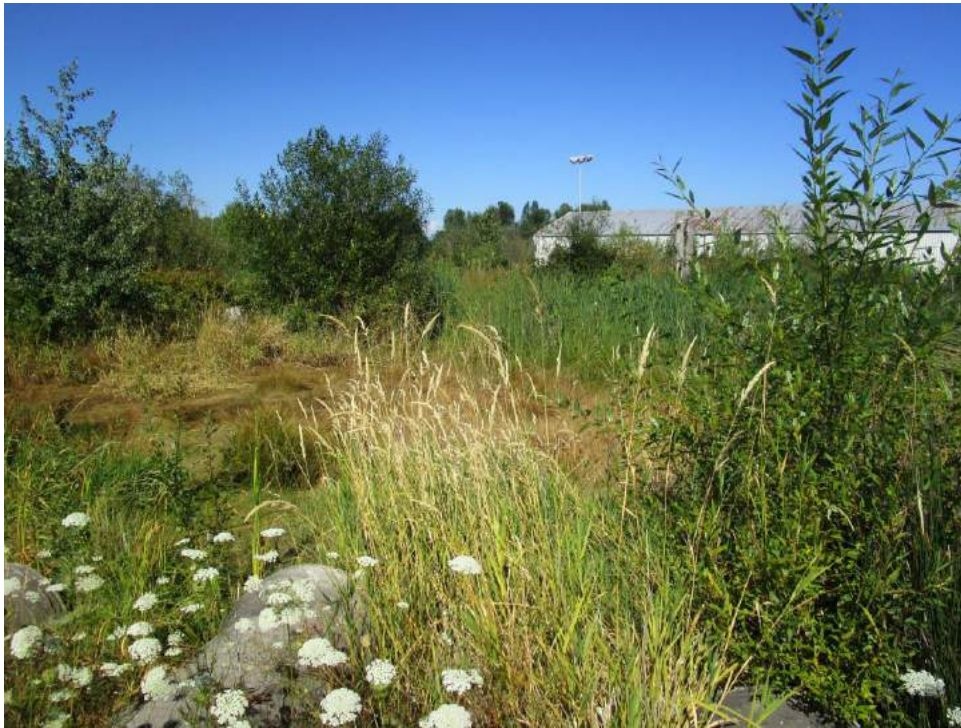
Photopoint 3. Looking east at the west end of Entrance Marsh 2 (foreground) and Building 308 (in the distance), with the baseball field (Field #8) to the north (left background); photo taken from the bridge between Entrance Marshes 1 and 2 on July 28, 2016.

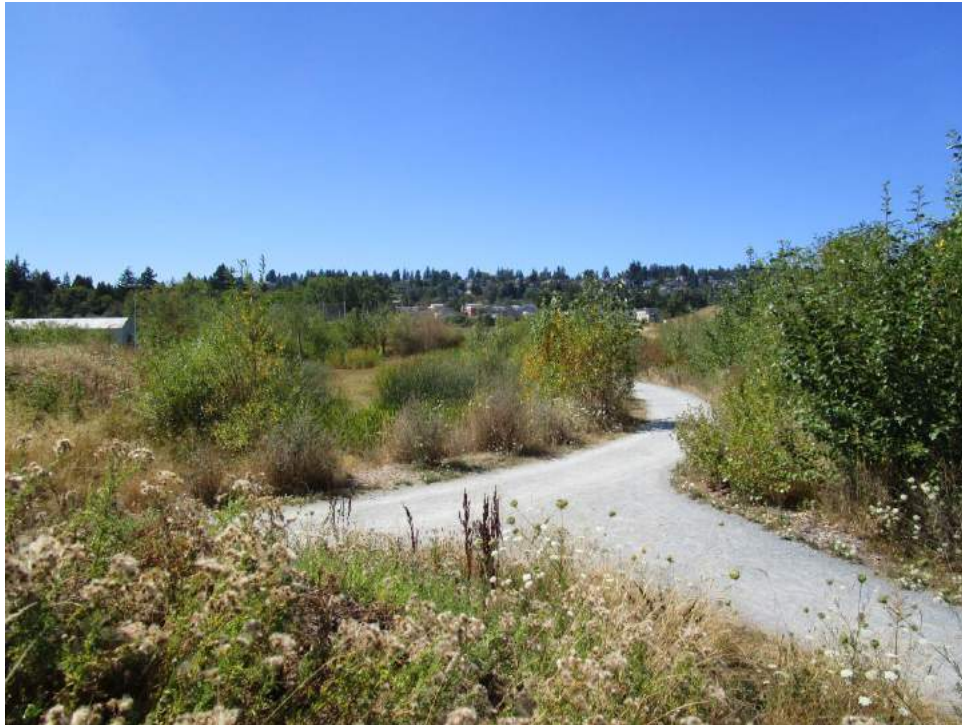
Photopoint 4. Looking northwest at the east end of Entrance Marsh 7 (center left); photo taken from the southwest overlook berm on August 12, 2016.

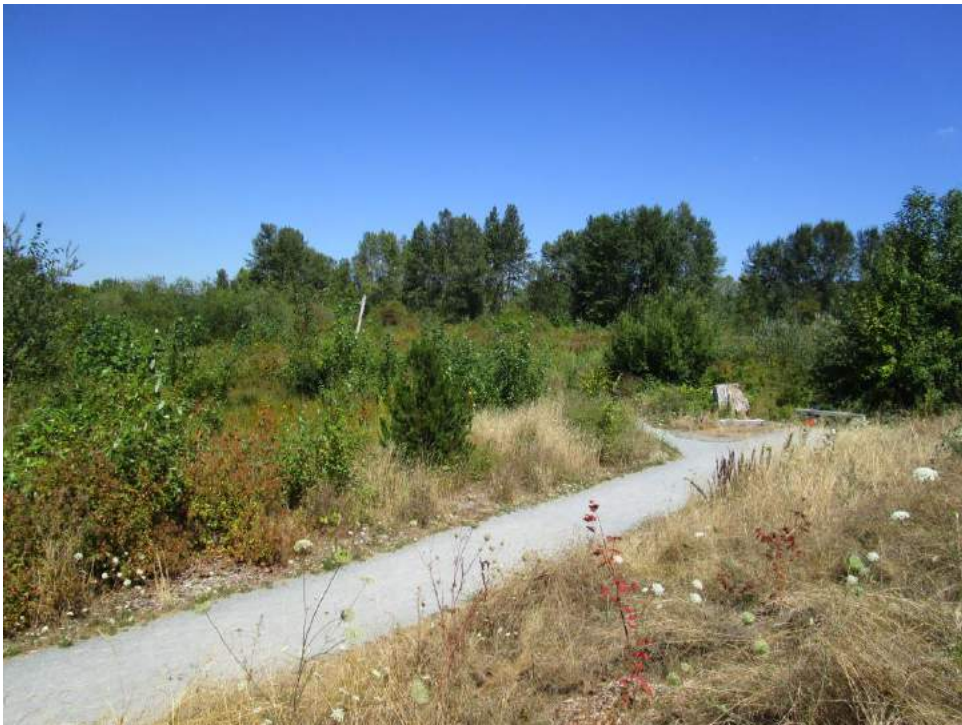
Photopoint 5. Looking northeast at the southern portion of the rice paddies (left) and the northwest lobe of the South Promontory Pond (right); photo taken from the northeast corner of the southeast overlook berm on August 12, 2016.

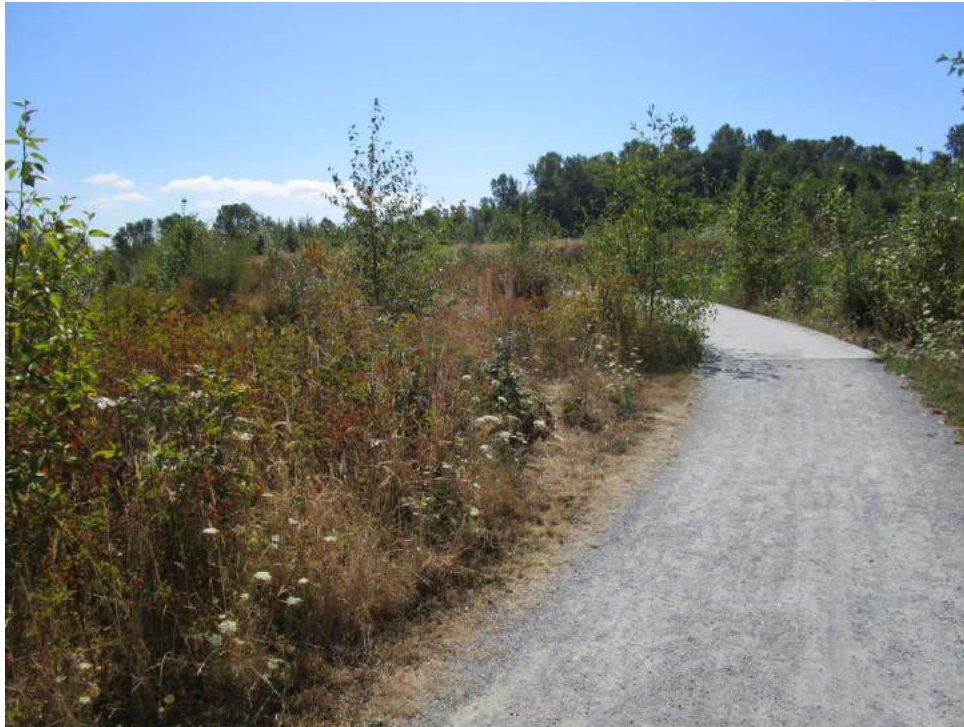
Photopoint 6. Looking east at the western portion of the Rice Paddies (left) and the Entrance Marsh system (right); photo taken from the end of the path at the south end of the northwest Habitat Overlook berm on August 12, 2016.

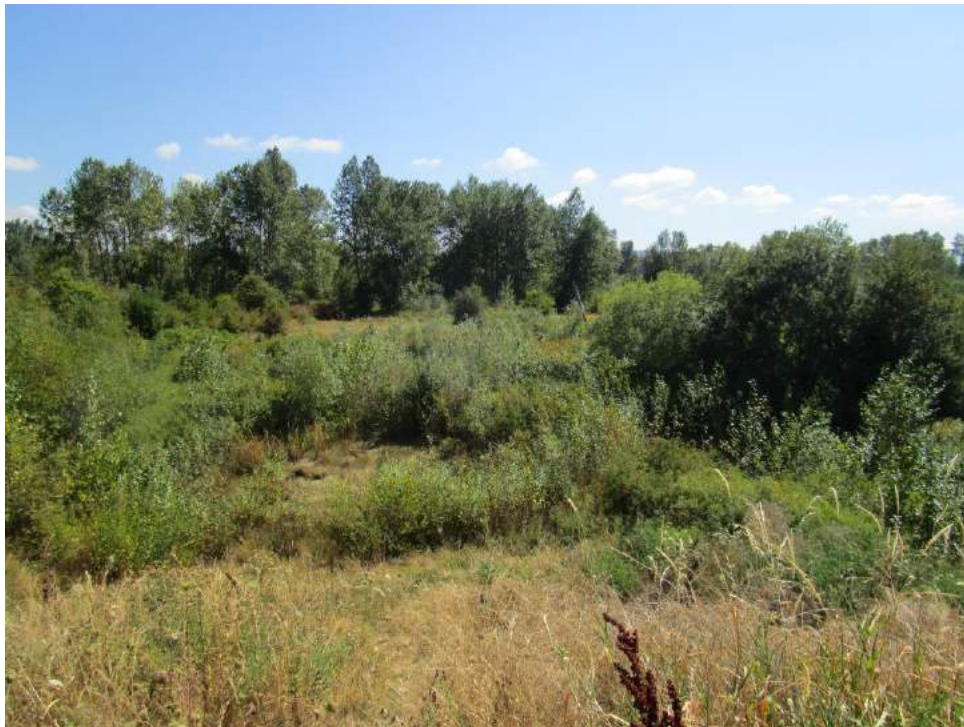
Photopoint 7. Looking northeast at the North Marsh Pond (left) with the Existing Willow Island (right); photo taken from the east end of the northeast Habitat Overlook berm on August 12, 2016.

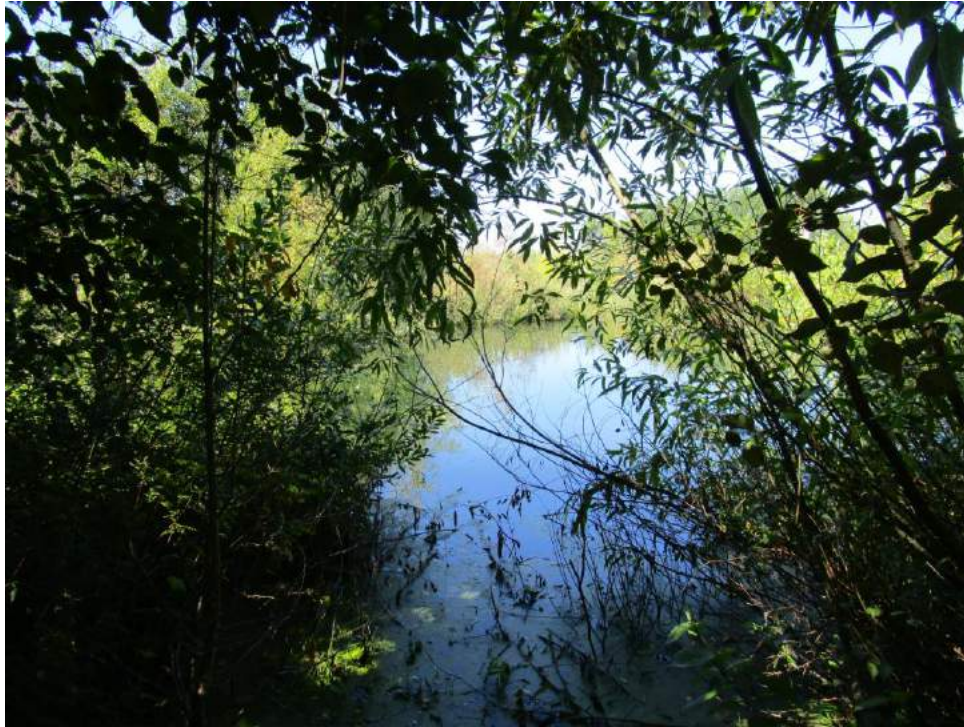
Photopoint 8. Looking north east at the southwest lobe of the South Promontory Pond (left) from the bench; photo taken on August 12, 2016.

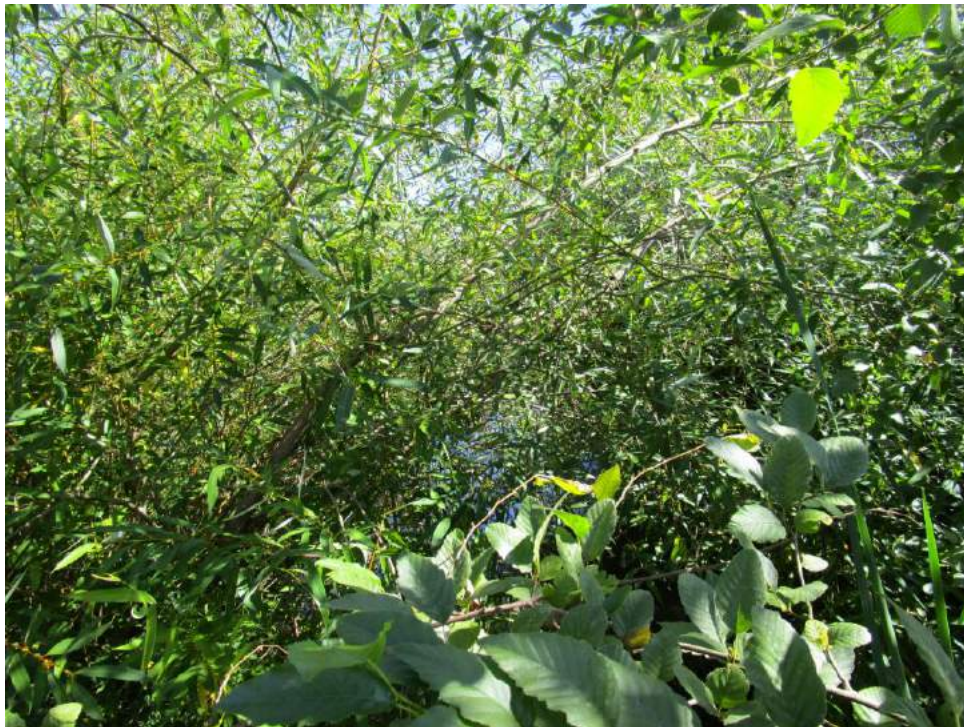
Photopoint 9. Looking south at the east lobe of North Promontory Pond; photo taken from the weir (now beaver dam) between North Promontory Pond and Promontory Outlet Pond on August 22, 2016.

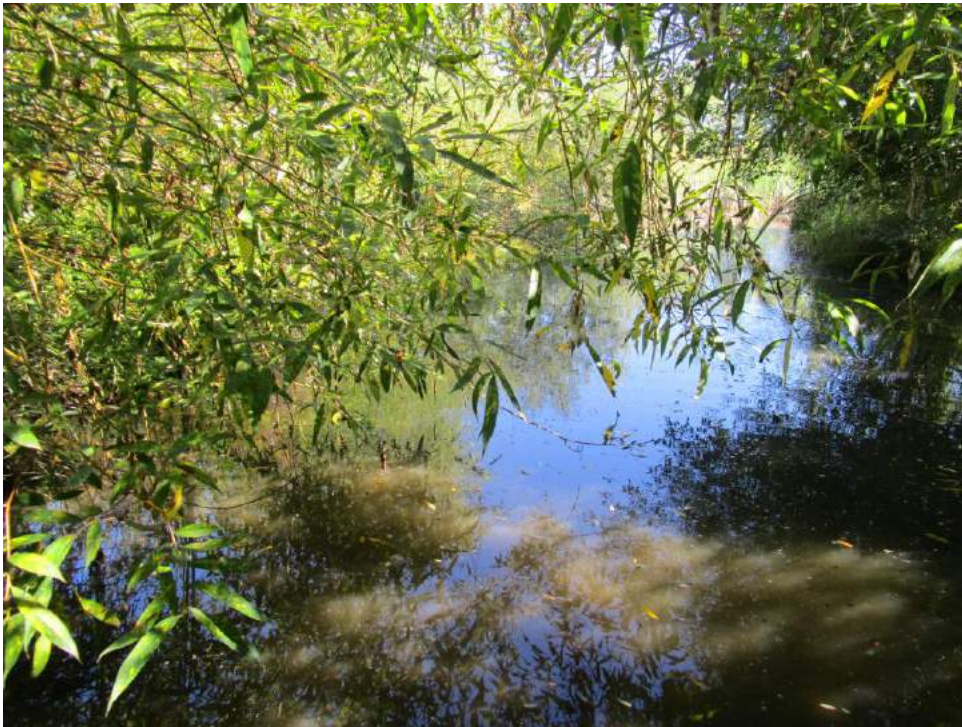
Photopoint 9A. Looking northeast at the southwest end of Promontory Outlet Pond; photo taken from the southeast end of the weir (now beaver dam) between Promontory Outlet Pond and North Promontory Pond on August 22, 2016.

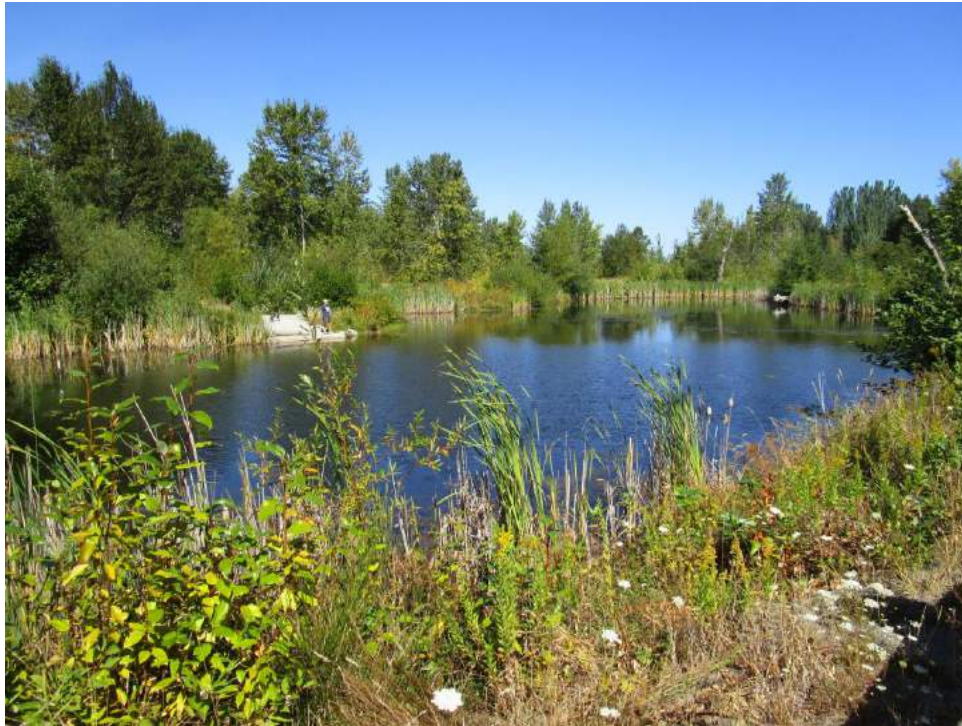
Photopoint 9B. Looking northwest at the southwest end of Promontory Outlet Pond; photo taken from the southeast corner of the Promontory Outlet Pond, north of the northeast entrance path on August 22, 2016.

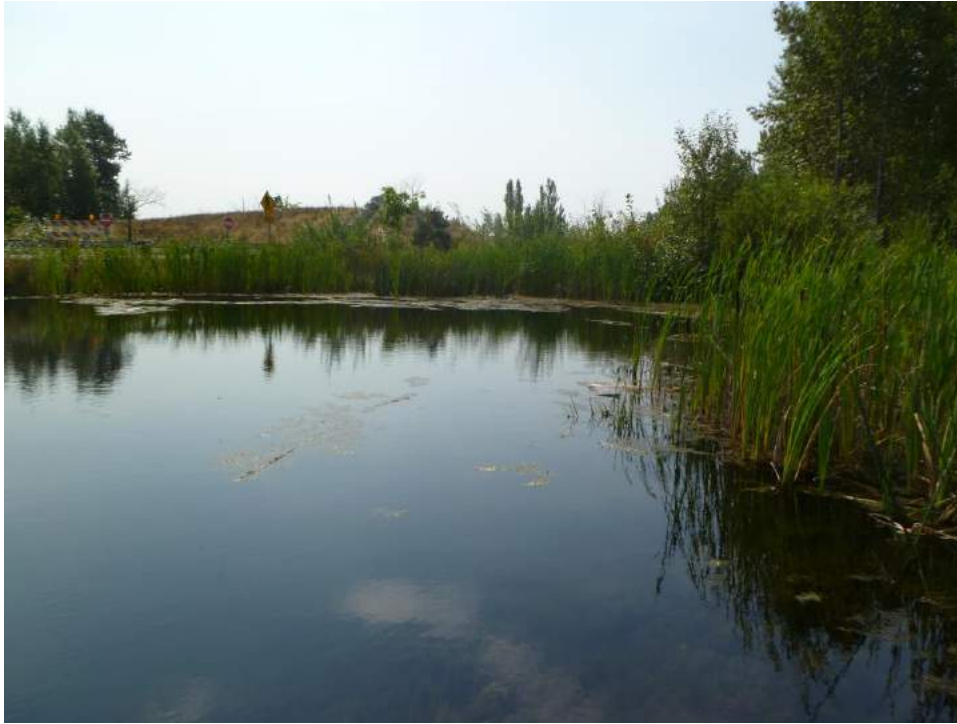
Photopoint 10. Looking east at the north end of Linked Marsh Pond 3 (now joined with Promontory Outlet Pond); photo taken from near the roadway at the east end of the trail on August 22, 2016.

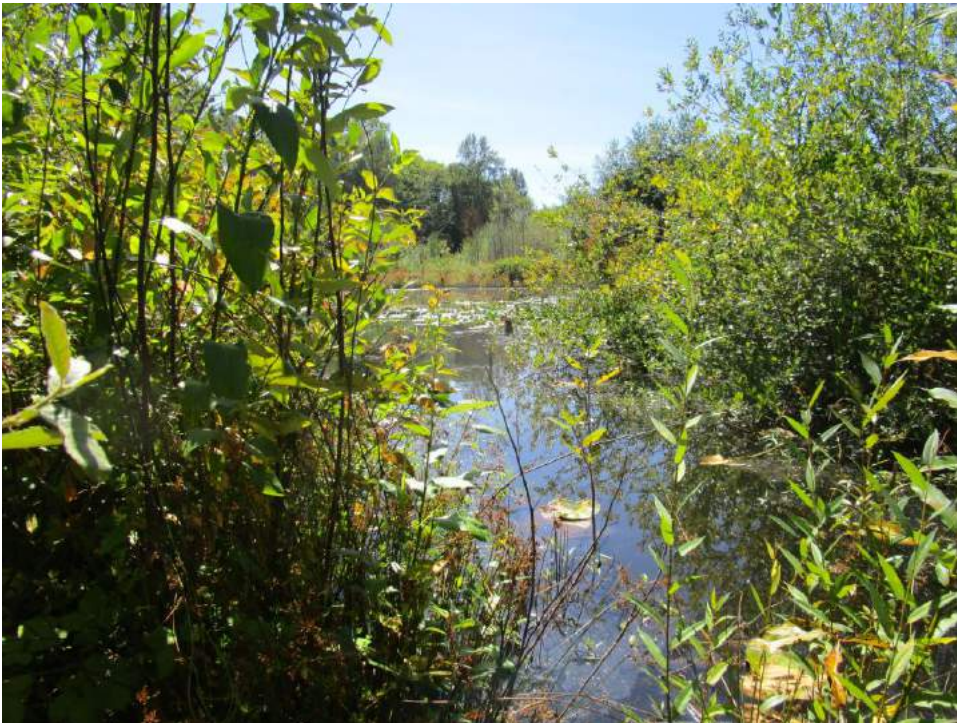
Photopoint 11. Looking southwest at the east end of Linked Marsh Pond 2; photo taken from the west end of the east peninsula on August 22, 2016.

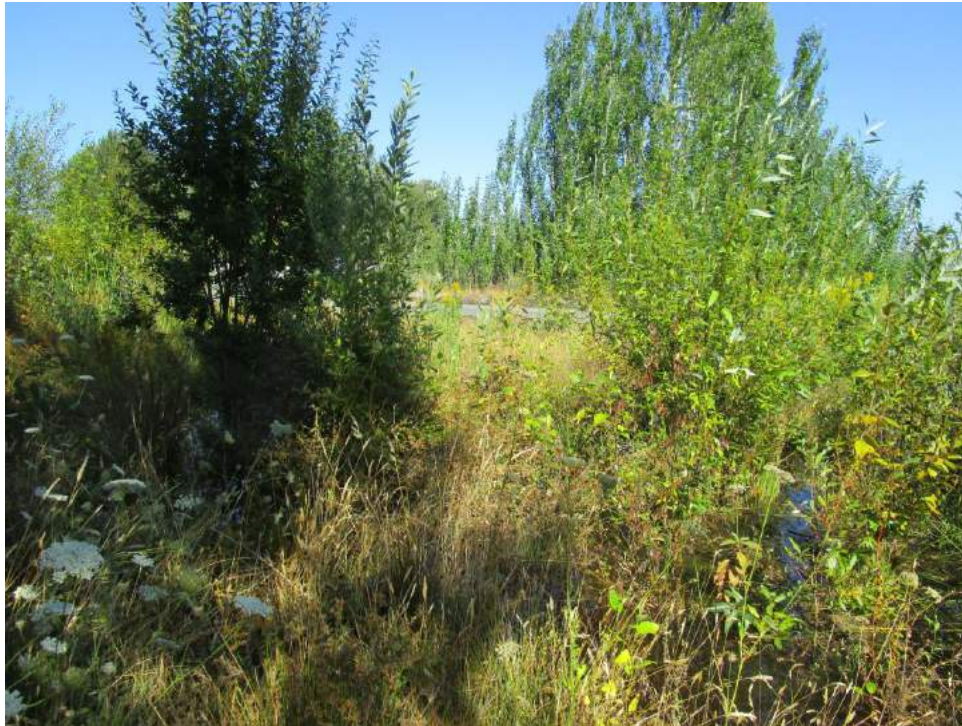
Photopoint 12. Looking east at the south end of Linked Marsh South Swale with the boat launch parking area in the background (left); photo taken from on top of the culvert under the southeast entrance path on August 12, 2016.

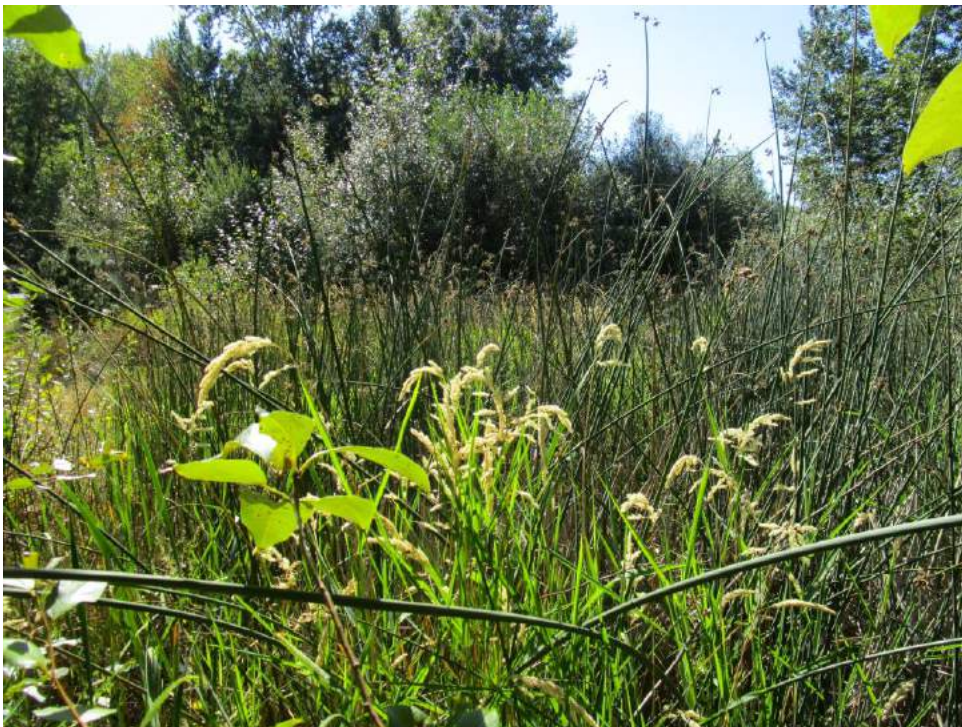
Photopoint 13. Looking west at the east end of Linked Marsh Pond 1 (center); photo taken from on top of the culvert under the southeast entrance path on August 12, 2016.

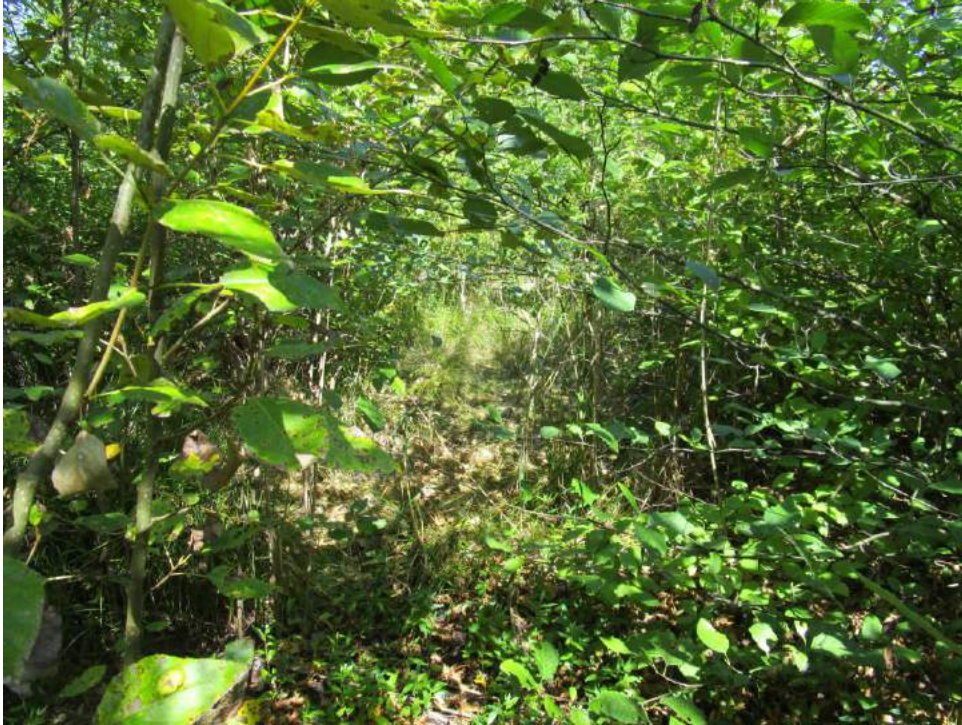
Photopoint 14. Looking northeast at west end of Linked Marsh West Swale; photo taken from the west end of the swale on August 22, 2016.

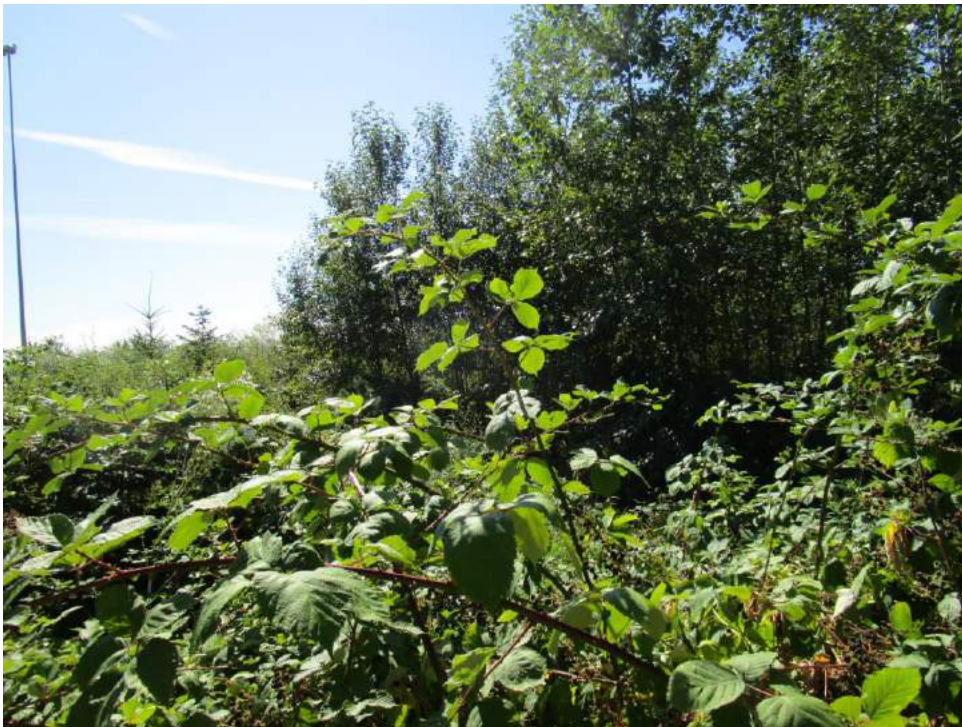
Photopoint 15. Looking south at the buffer on the north side of Soccer Field System Pond 1; photo taken from the small berm south of the madrone grove on July 23, 2016.

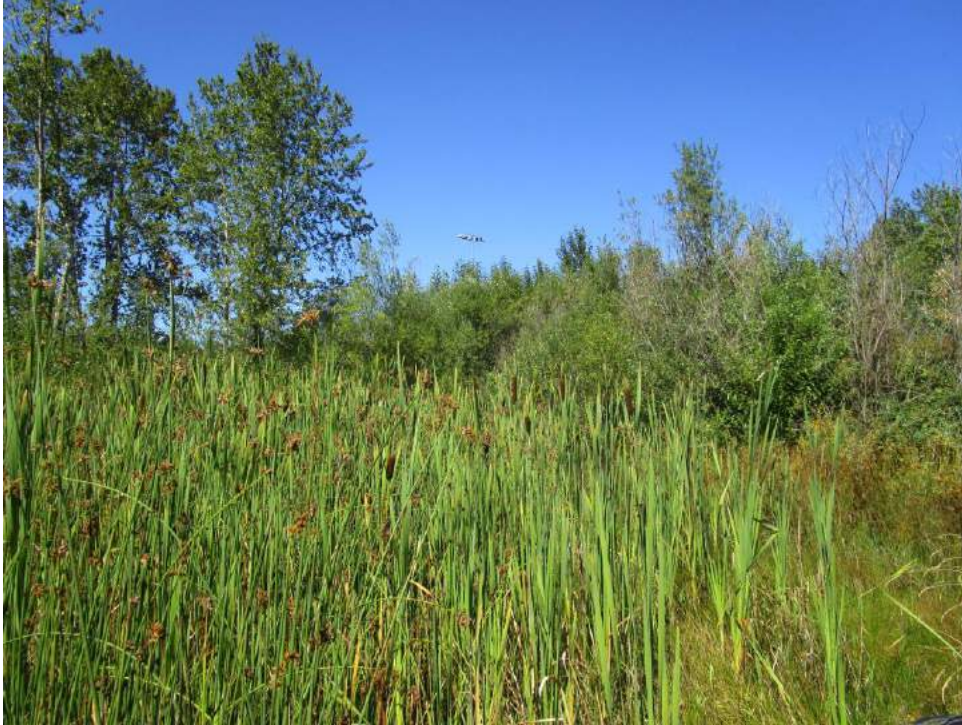
Photopoint 16. Looking west at Soccer Field System Pond 2; photo taken from the weir between Soccer Field System Ponds 2 and 3 on July 28, 2016.
