Magnuson Park Phase 2 Development

Year 7 (2016) Monitoring Report
USACE Reference NWS-2006-52-NOW

Otak, Inc.
11241 Willows Road NE, Suite 200
Redmond, WA 98052
Otak Project No. 31391

January 6, 2017

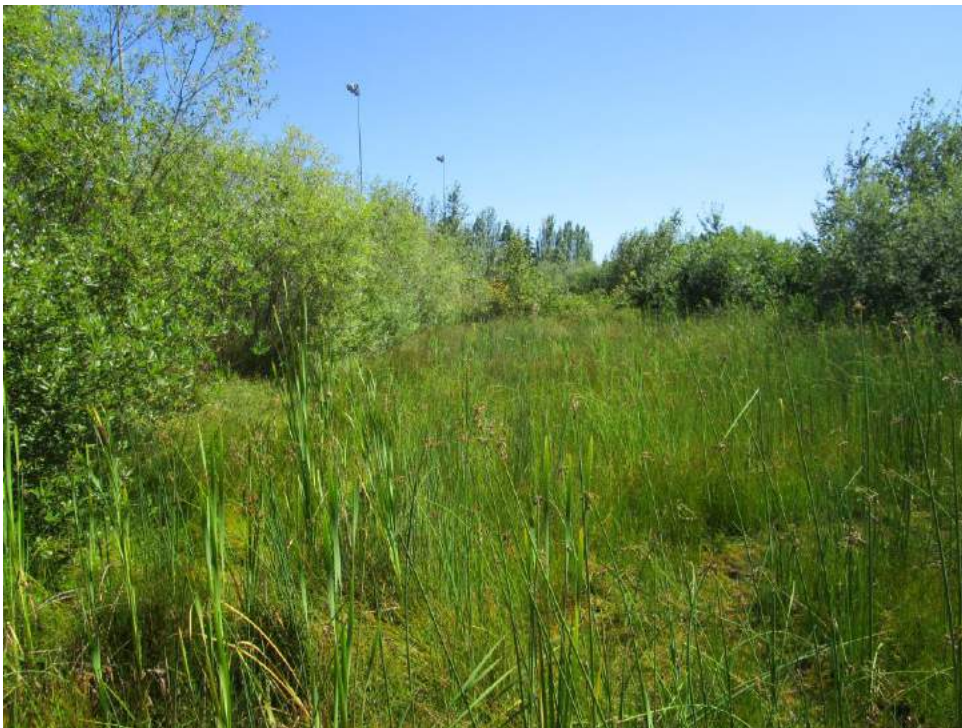
Photopoint 16A. Looking northeast at the west end of Soccer Field System Pond 3 (in the foreground); photo taken from the weir between Soccer Field System Ponds 2 and 3 on July 28, 2016.

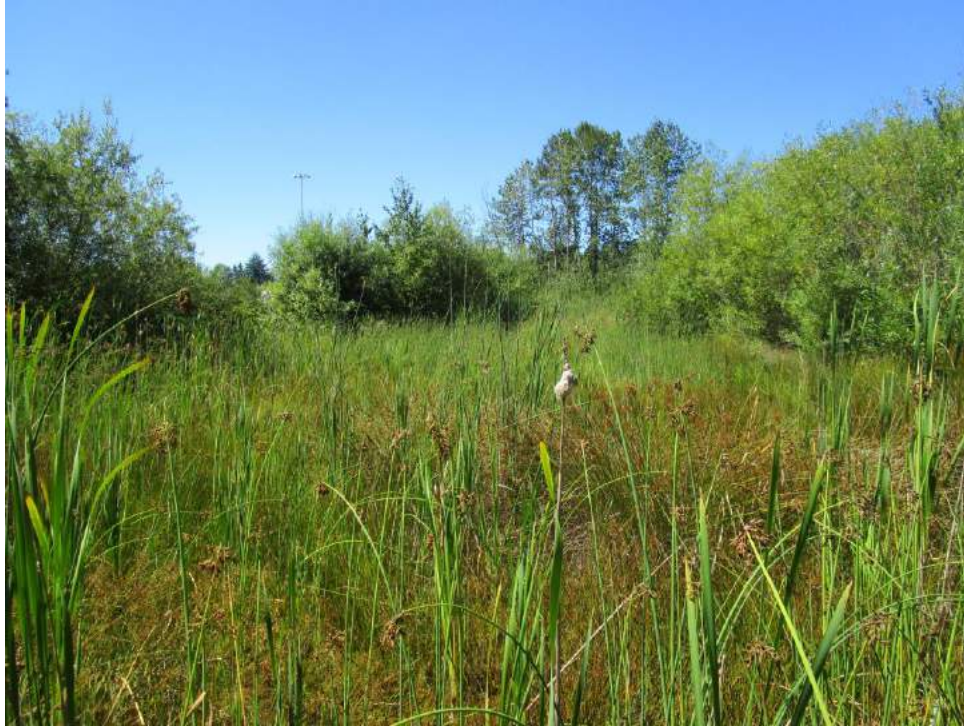
Photopoint 17. Looking west at the east end of Soccer Field Pond 3 (in the foreground); photo taken from the berm between Soccer Field Pond 3 and Soccer Field Pond 4 on July 28, 2016.

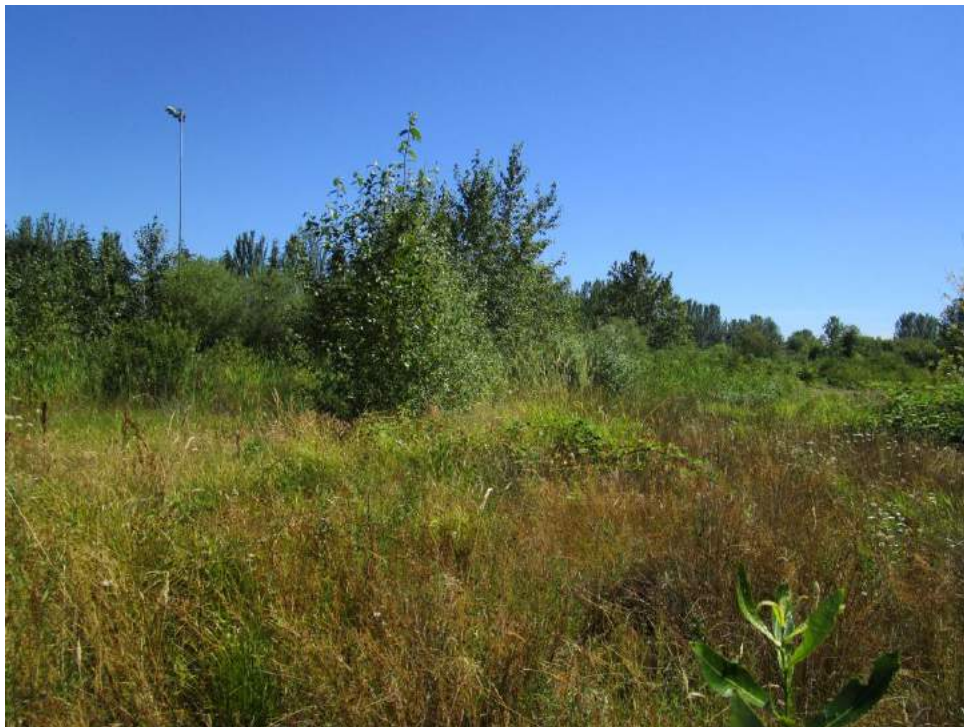
Photopoint 18. Looking northeast at the western portion of Soccer Field Marsh 4; photo taken from the berm between Soccer Field Pond 3 and Marsh 4 on July 28, 2016.

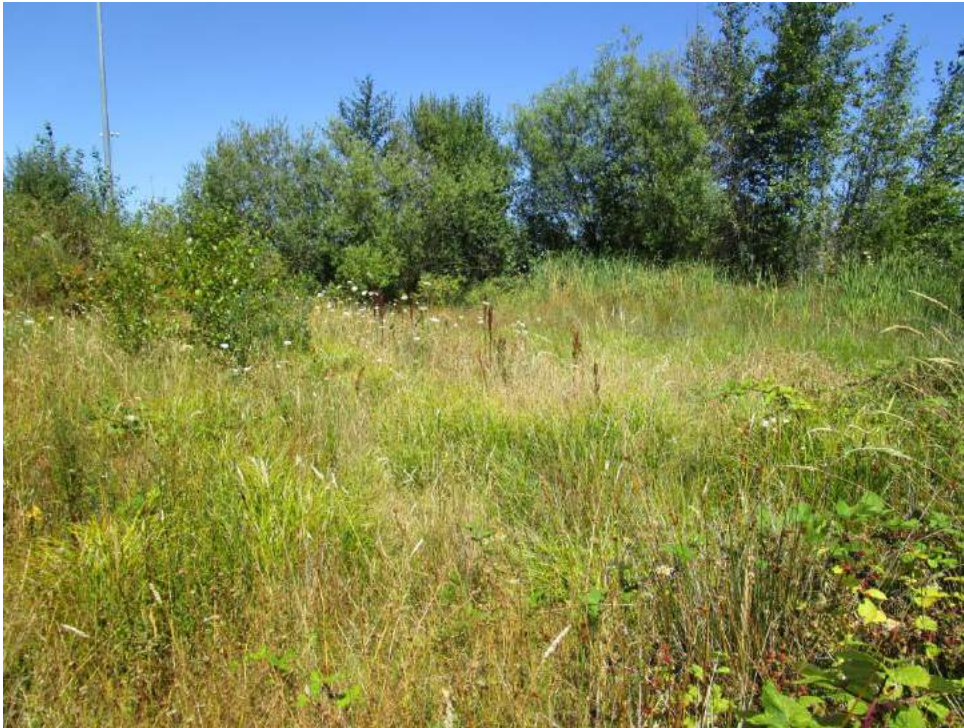
Photopoint 18A. Looking north and east at the eastern portion of Soccer Field Pond 4; photo taken from the south edge of Pond 4 on July 28, 2016.

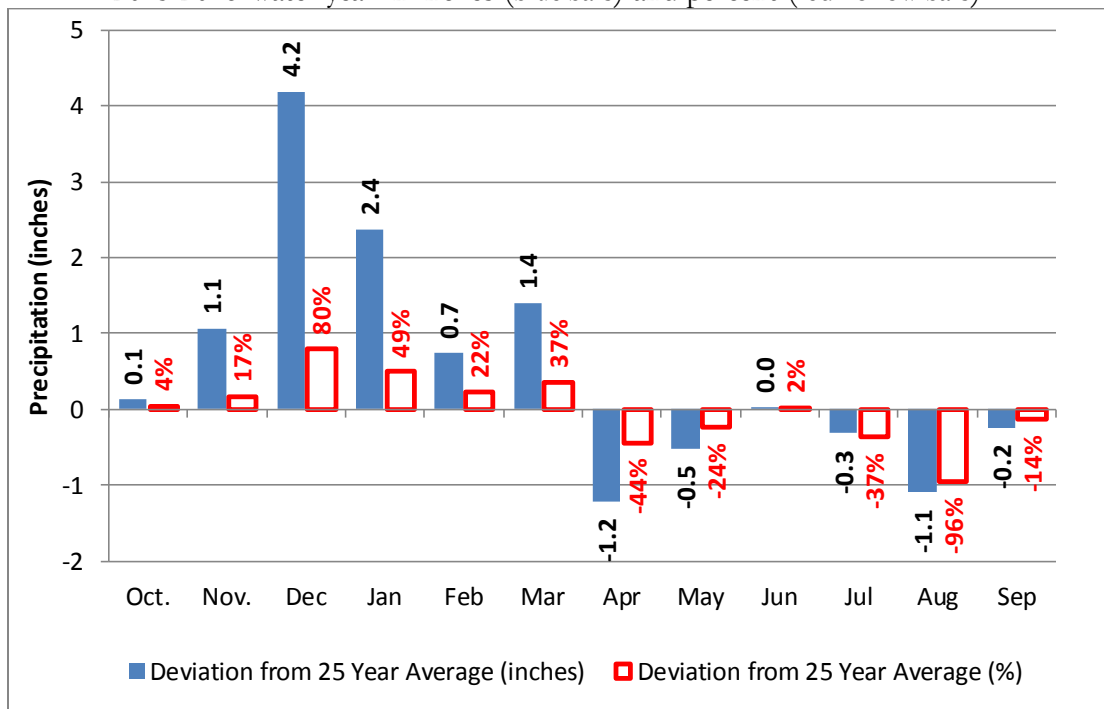
Figure E-2. Histogram showing deviation from 25-year average monthly precipitation values for 2015-2016 water year in inches (blue bars) and percent (red hollow bars).

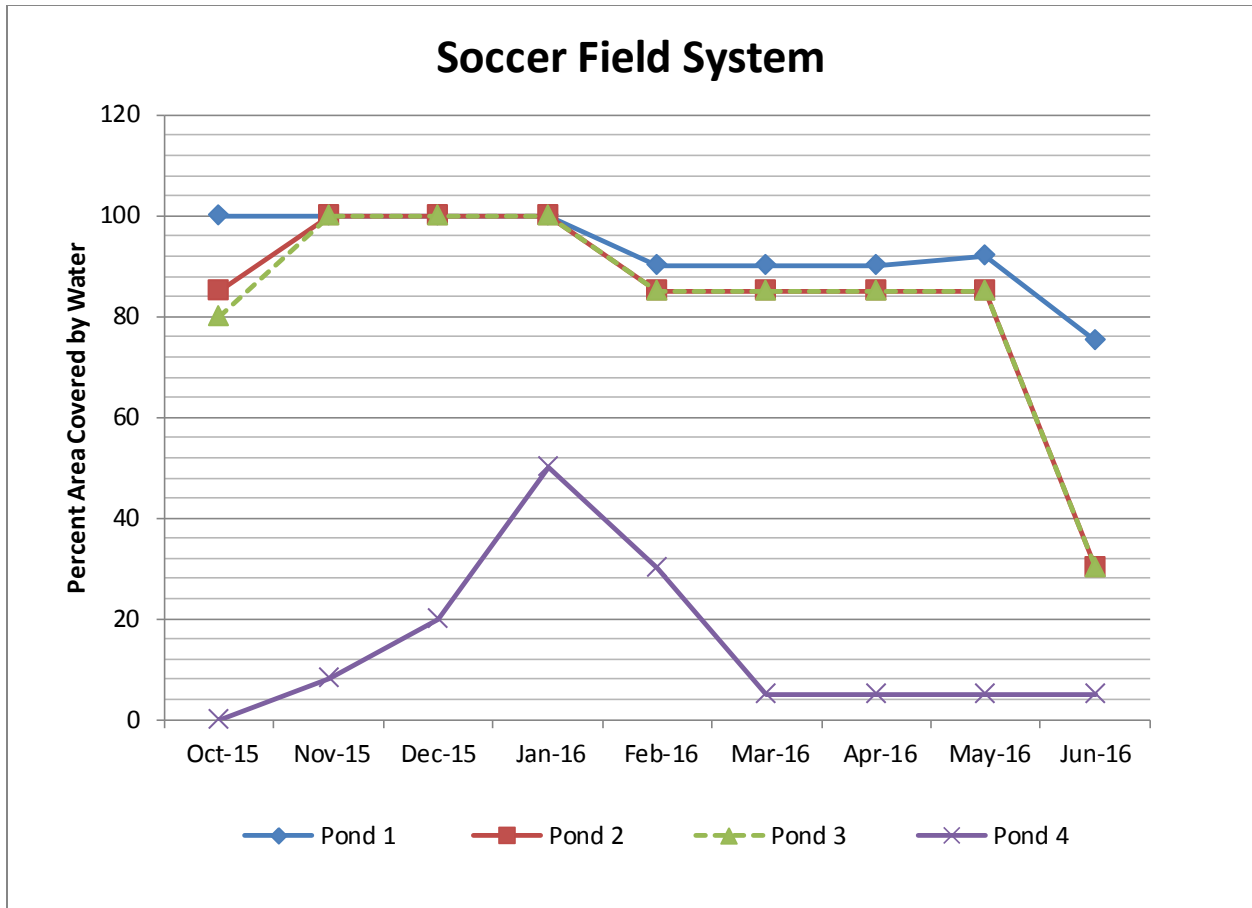
Figure E-7. Change in percent area covered with standing water at ponds in the Soccer Field System during the monitoring period (October 2015 through June 2016).

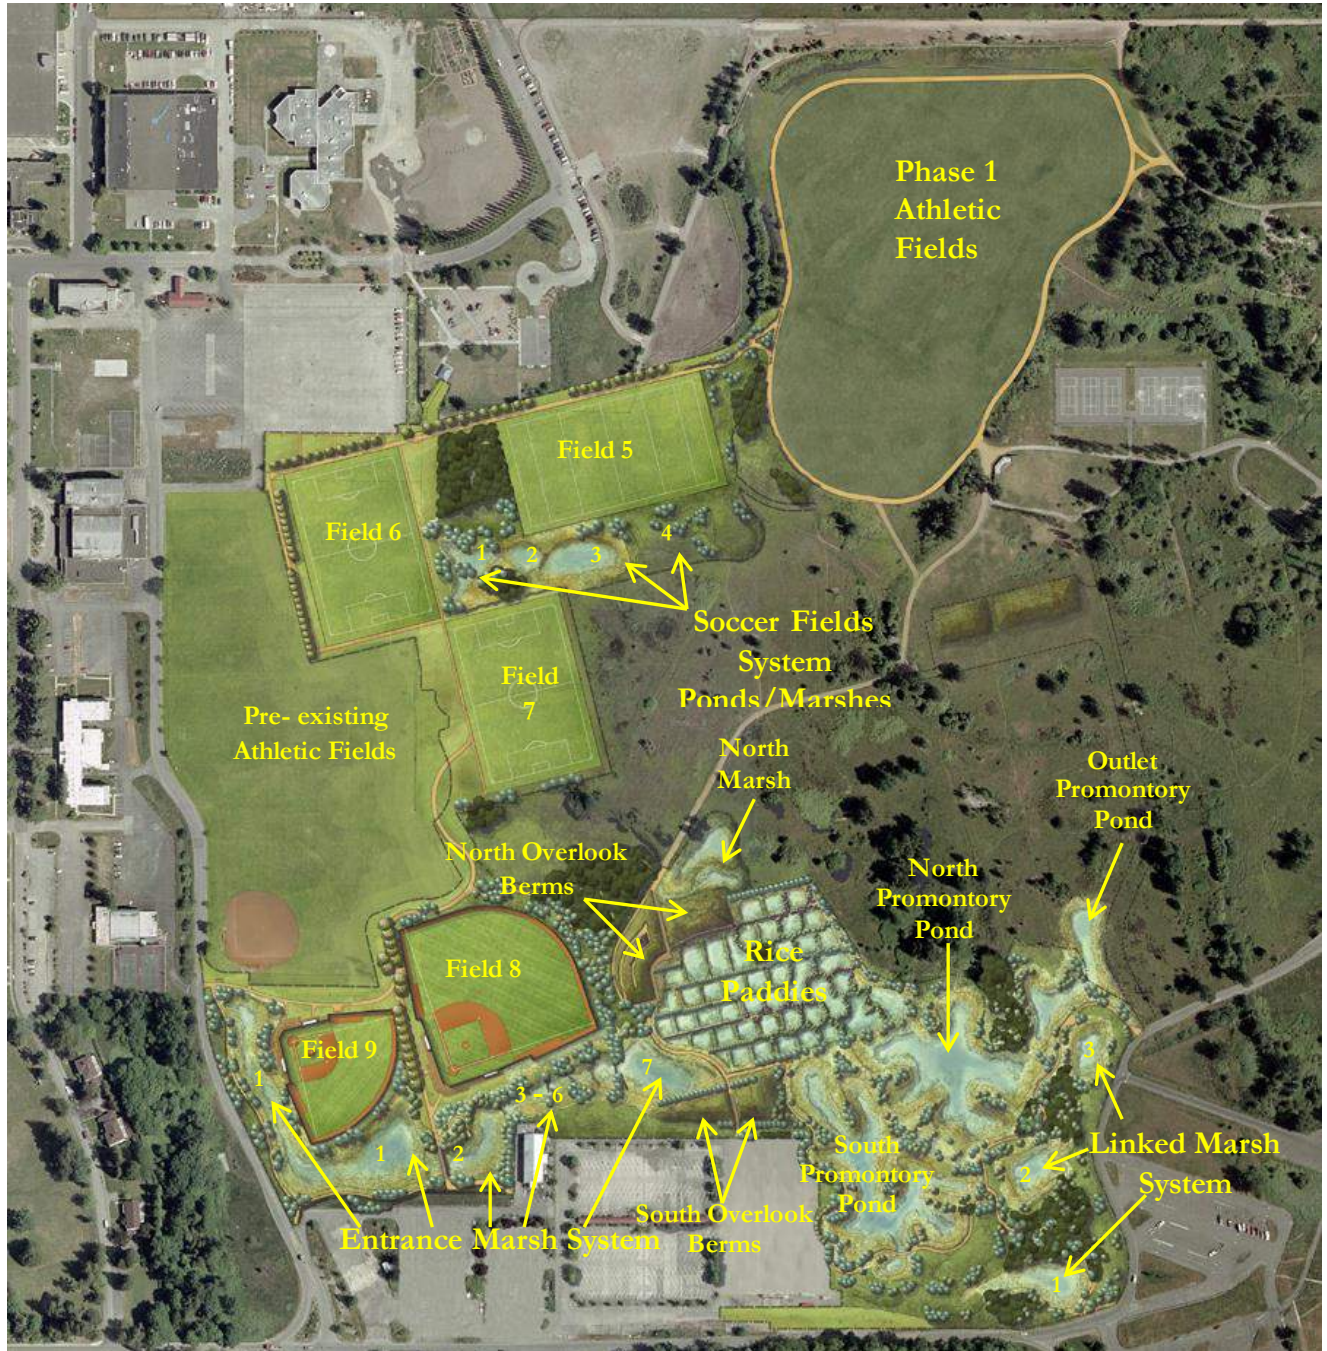
Figure E-8. Hydrologic systems located within the mitigation area.
