# Burke-Gilman Trail Missing Link

## 10/2 Driveway Refinement Field Test Overview and Outcomes

# Burke-Gilman Trail Missing Link Design Advisory Committee

## Driveway Refinement Field Test Summary

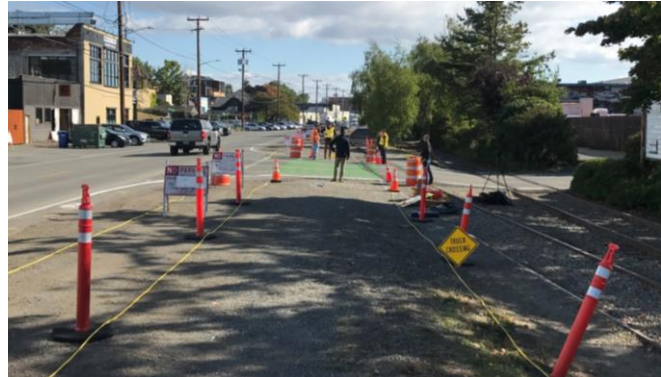
The purpose of the field test was to test corridor visibility and accessibility of the trail from various perspectives at the Schematic Design milestone. Project staff simulated a driveway crossing of the Missing Link design along Shilshole Ave NW with paint, traffic cones and barrels, and trail signs at a test driveway. A large tractor-trailer truck was driven across the simulated driveway to test a variety of turning motions and verify that driveway design specifications can accommodate these truck movements.

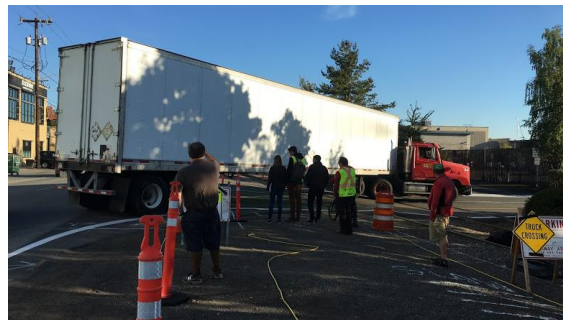
- 1. Driveway Width: Does the proposed design accommodate the trucks anticipated to use the driveways?**
  - The large tractor-trailer truck was capable of safely executing turns in and out of driveways within the proposed driveway design width (i.e., driveway and apron)

- **Field test verified the following:**
  - Driveway design accommodates the design vehicle
  - Driveway is visible for trail users
  - Sufficient sight distance for exiting vehicles
- **Design enhancements because of the field test:**
  - Taper the trail at driveway crossings from 12 feet to 8 – 10 feet to further slowdown trail users and define extent of turning paths, especially for trucks
  - Extend the green painted driveways to include the truck aprons to define the waiting area for trial users
  - Revisit the location of the LED warning signs to inform trail users of the driveway locations
  - Improve predictability for trail users and trucks making **right-turns** into driveways by:
    - Maintaining offsets from the roadway for increased visibility, and
    - implementing additional vehicle detection in the travel lane to trigger the flashing LED lights on the trail.

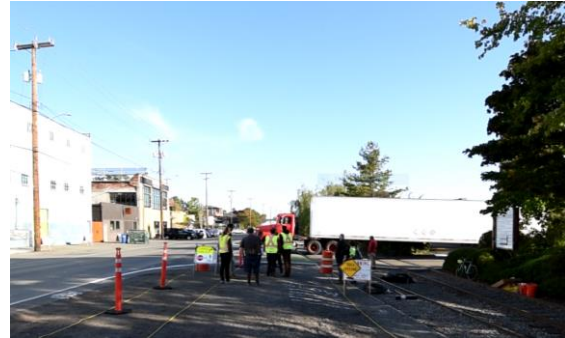
**2. Driveway Crossings for Trail Users: Does the design clearly communicate to trail users the location of the driveways and where they should be positioned when yielding to driveway traffic?**

- The green painted driveways was clearly visible for trail users
- The trail did not clearly define a waiting area for trail users to in stay while large vehicles maneuver in and out of driveways
- The best locations for advanced warning signage (particularly for cyclists to slow down and stop as they approach driveway crossings) was unclear.

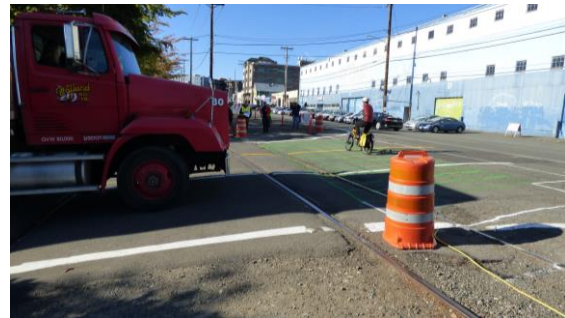
**3. Traffic Exiting from Driveway: How do vehicles exiting the driveways interact with trail users?**

- Vehicles exiting the driveways had sufficient sight distances of the trail
- Trail users had visibility of vehicles moving out of the driveway

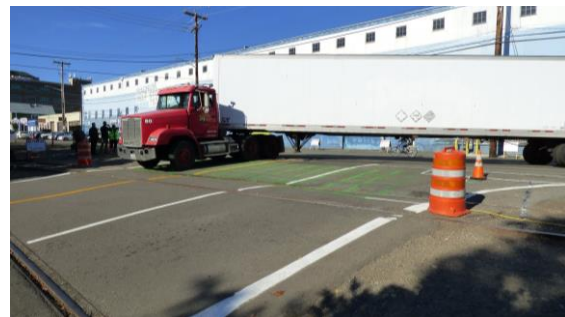
**4. Left-Turns into Driveway: Can trucks safely make a left-turn into the driveway?**

- Trucks were capable of safely making left turns into the driveways

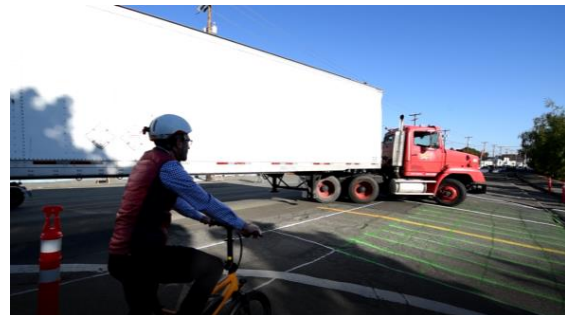
**5. Right-Turns into Driveway: Can trucks safely make a right-turn into the driveway?**

- Trucks were capable of making right turns into driveways; however, they had difficulty identifying trail users due to blind spots and trail user predictability
- Trail users might need additional prompts to make them aware of the need to yield to trucks

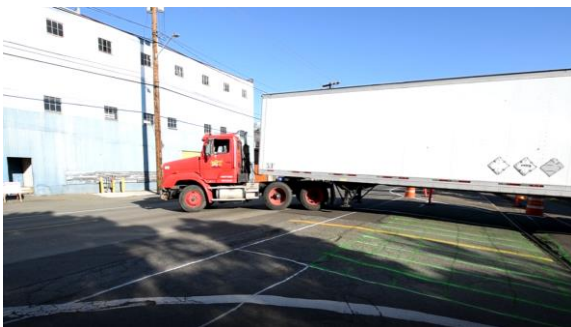
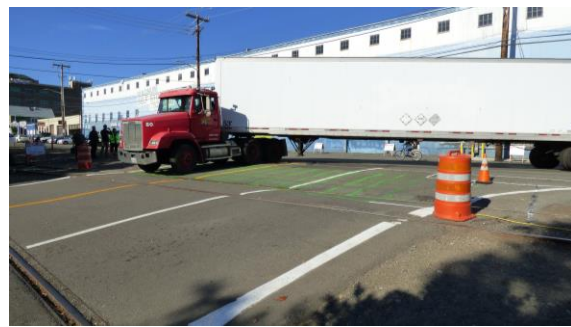
### Left Turns

*A large tractor-trailer initiates a left-turn and exits the driveway.*

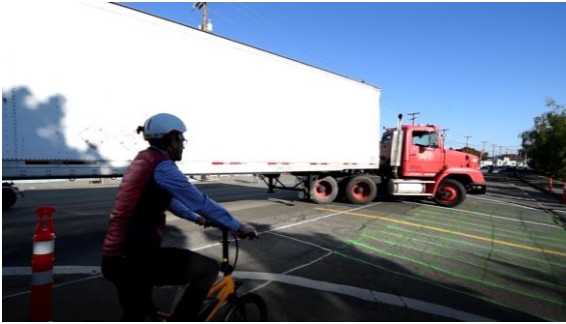
*A large tractor-trailer initiates a right-turn into the driveway. A trail-user is seen waiting for the truck to complete its turn.*

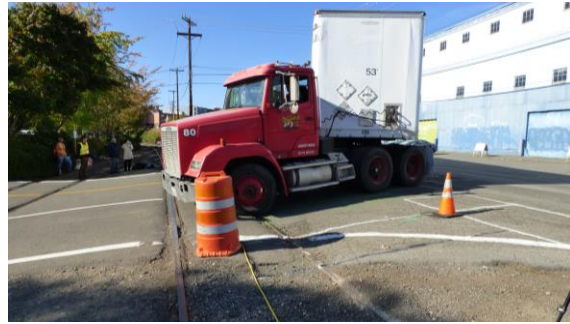
*An alternate angle of the tractor-trailer completing a right-turn into the driveway. There is sufficient space in the driveway crossing for the truck to complete this maneuver.*

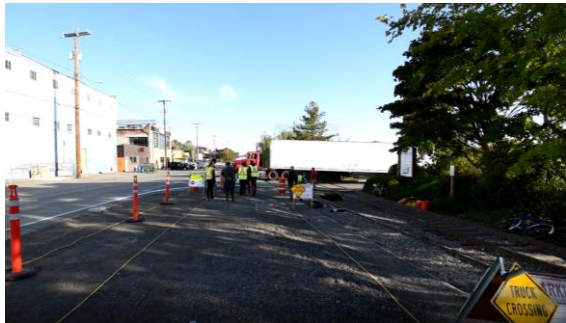
*"Truck Crossing" signs are placed along the trail.*

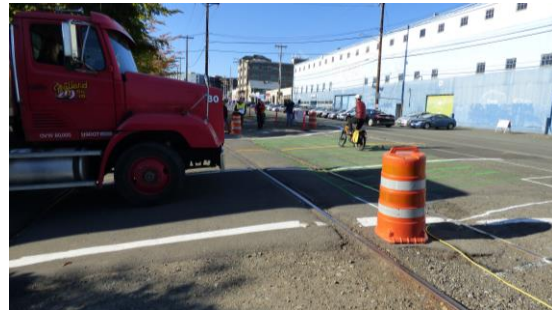
*A large-tractor trailer waits for the driveway crossing to clear before initiating a turn.*
