CPTED Site Survey

Date: July 06, 2018

Property Address: 9600 College WY N

Property Name: North Seattle College

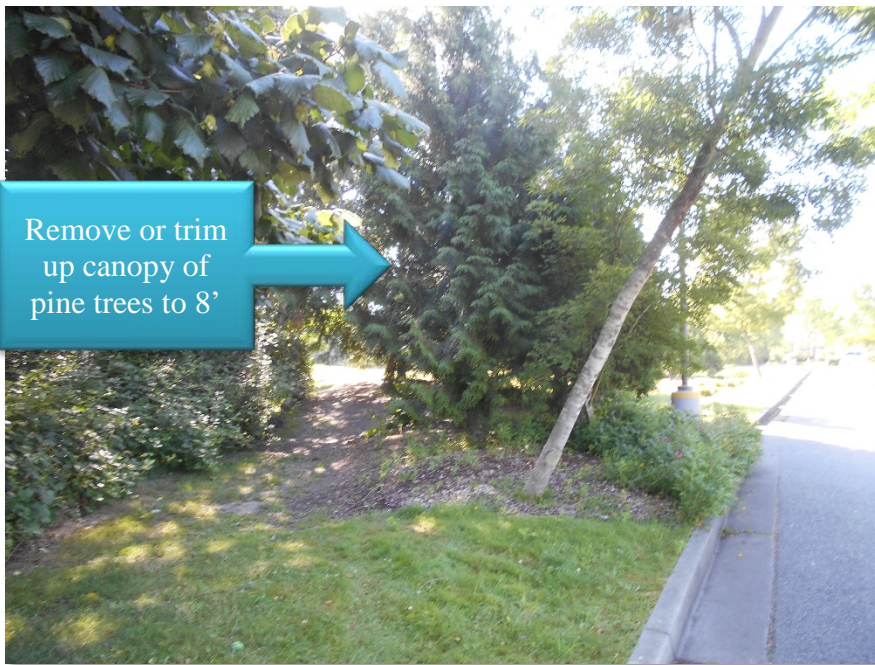
Pine trees along the South side of the bridge in-between sight line A and B are very full and have a low canopy. These trees would provide areas of concealment for abnormal users of the bridge.

- Remove the south west side pine tree group between sight line A and B or trim up canopy to eight feet.
- To improve sight line A to C remove trees that fall within the red circles or drastically trim up tree canopy. The height the trees are trimmed to will have to be decided once the bridge is built.
- Trees that are within the blue circle, canopies should be trimmed up from the ground to at least eight feet and should have branches trimmed away from the sides of the bridge.
- If the trees are kept all sight lines should be reevaluated in later stages of construction.
- Remove black berry bushes and trim the rest of the ground cover to two feet in height.

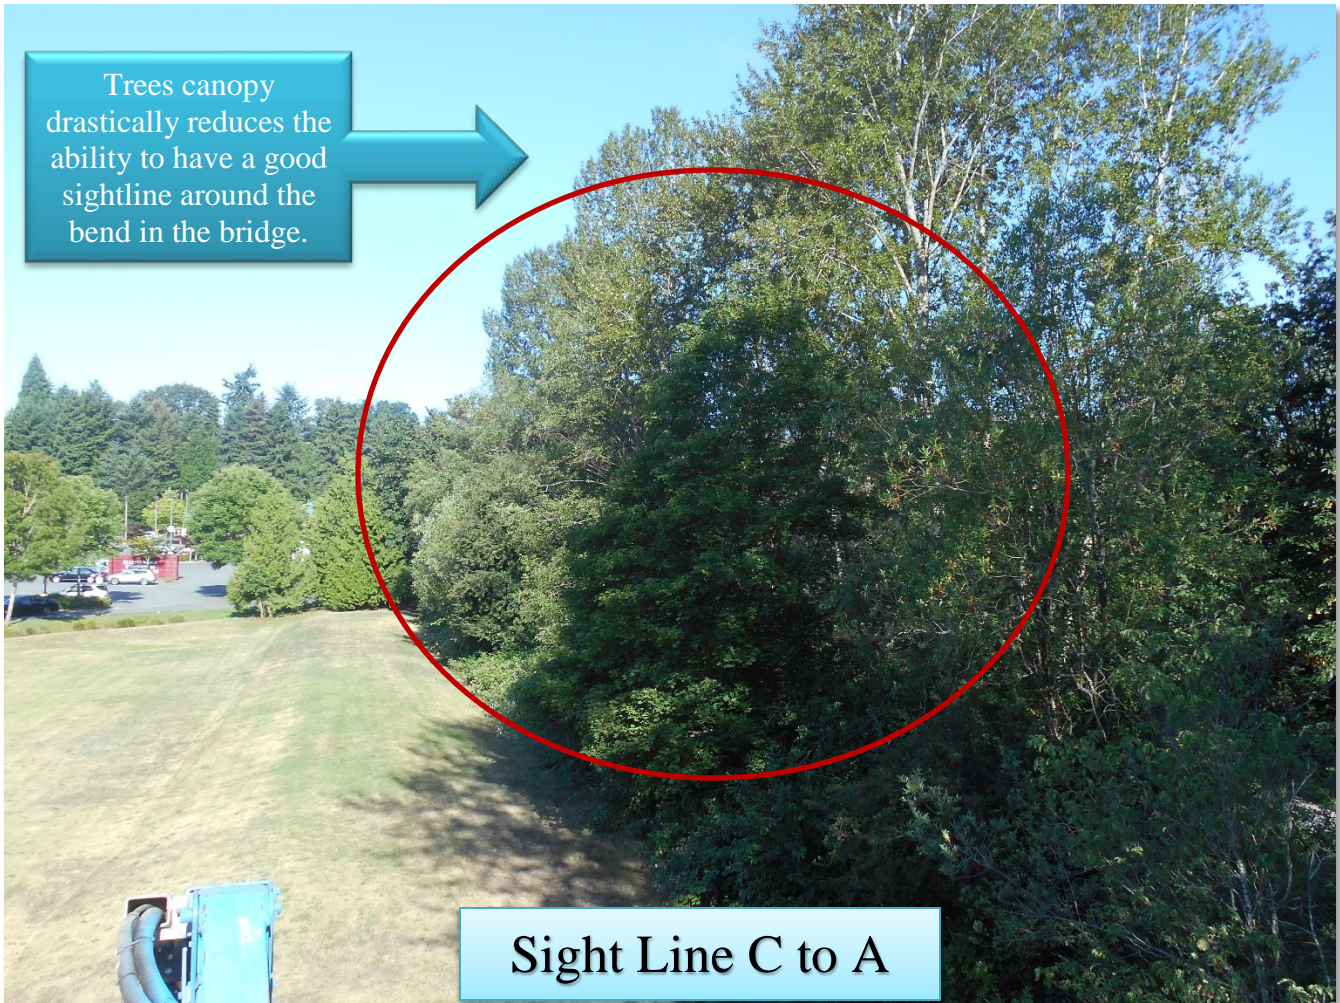
The blackberry bushes and natural vegetation that line the tree floor will be close to the bridge and should be considered when thinking about safety. The blackberry bushes should be removed or cut down to two feet and the other ground cover should be trimmed to two to three feet in height. Blackberry bushes can be hard to maintain and commonly go too large and provide good areas of concealment. The bushes should be cut back at least fifteen feet from the bridge.

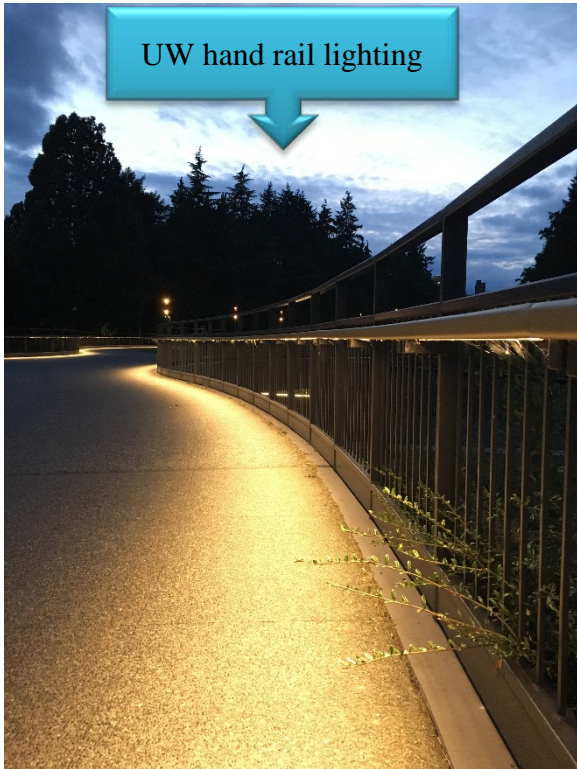
The lighting on the bridge will be handrail lighting and lighting on the multi-use path (from bridge touchdown to College Way N) will be street lighting on poles. Pedestrian scale poles (14ft tall with hinged base) with cutoff distribution lighting luminaires (consistent with SCL Material Standards) will be used to illuminate the pathway along the north side of N. 100th St., near College Way N.

- Continue pedestrian scale lighting from touchdown until the part of the bridge that goes over the freeway. Then continue with handrail lighting over the freeway.

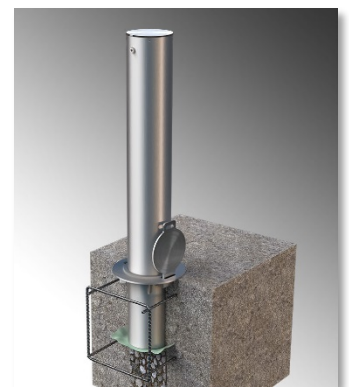
The pedestrian bridge would be large enough for a small vehicle to drive on it. Bollards can help prevent vehicles from entering the bridge while still allowing for bicycle and pedestrian traffic.

- Install bollards in front of both entrances to prevent someone from driving onto the bridge. The area is multi-use, consider using a removable style bollard (see image on right).

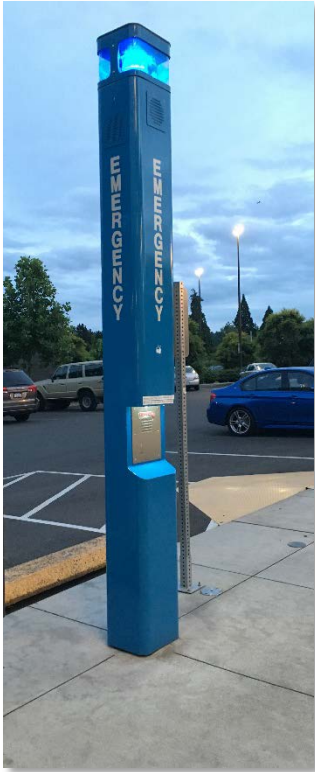
The path from the transit center to the campus will be long and should have an adequate amount of camera coverage for the entirety of the bridge. The Northgate area has issues with robberies that could spill over to the pedestrian bridge. There should be at least four cameras on the bridge, to capture the entrances on both sides and the middle.

Every transit center should have multiple locations for Emergency Call Stations. One or possibly two, solar powered, Emergency Call Stations will be included with the project with priority for the west side of the structure, but if a second Emergency Call Station may be provided, it would be in the eastern part. Due to the long length of the pedestrian bridge there is a desire for at least three phones along the pathway.

- Four cameras should be installed along the bridge. One at each entrance and two in the center. Cameras should have good high quality resolution and be placed low enough to get a good face shot and high enough that it will not be tampered with.
- Install three blue light Emergency Call Stations. One at each entrance and one in the center of the bridge.
