# Madison Valley Stormwater Project Phase 2 60% Design

Seattle Design Commission Meeting  
September 3, 2009

## NW Diversion and Washington Park Storage Project

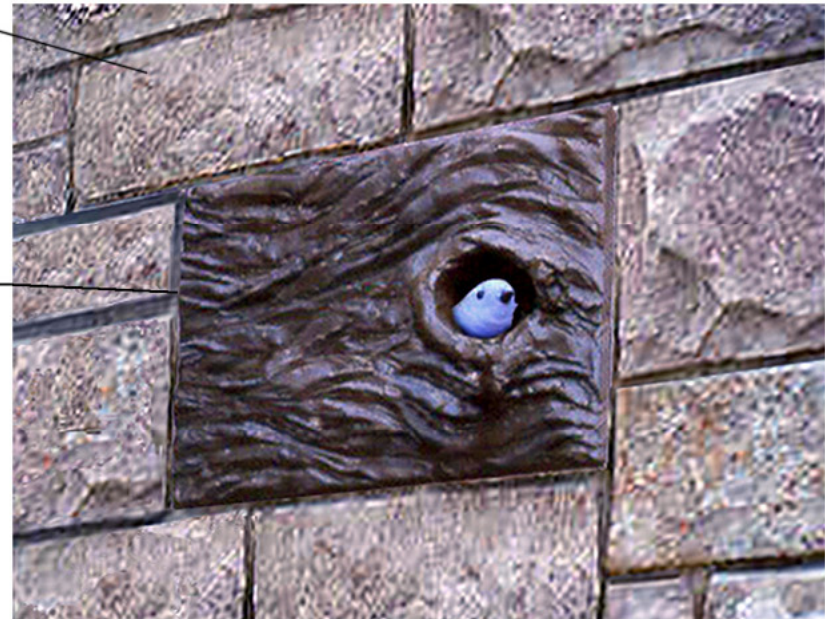
## Bird Nest

**Hydrology:** Storm runoff from the top of the tank, the upper lawn and possibly the access road is captured and directed to a gutter at the top of the wall. Captured runoff flows down the wall creating 3 moss zones of the tank into the rain garden below.

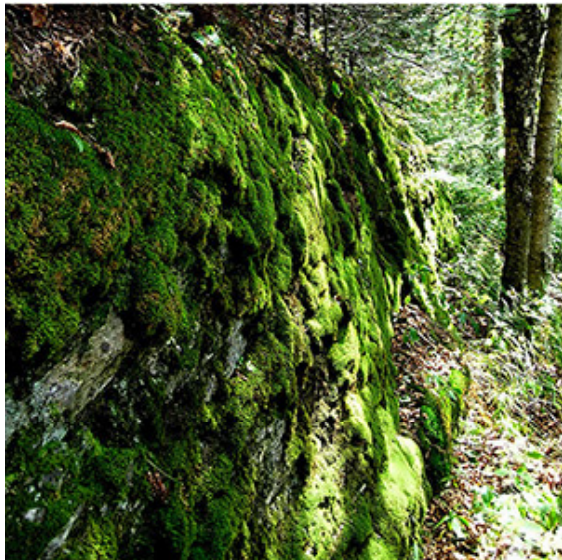
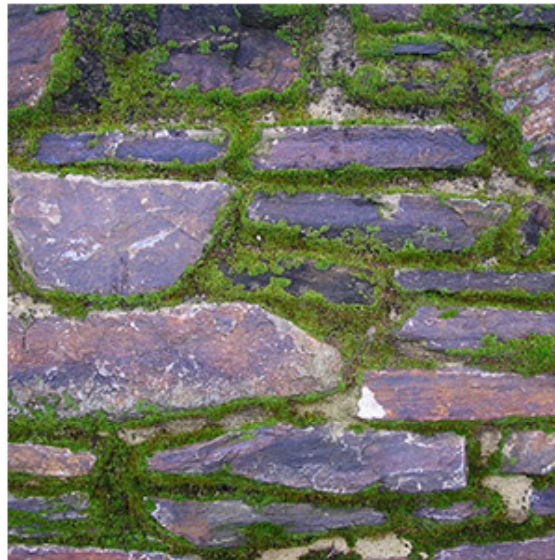
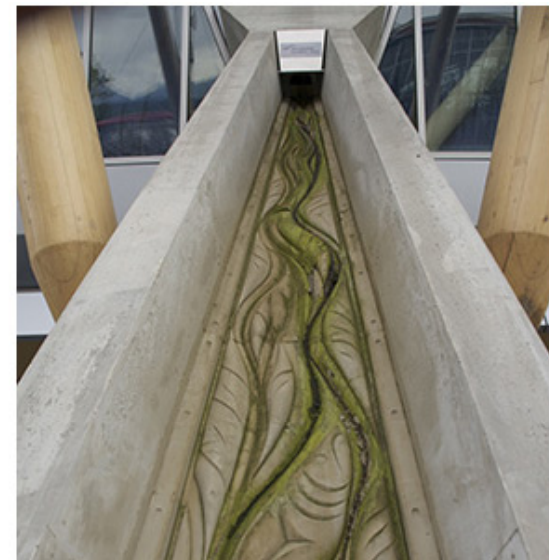
**Moss Wall Zones:** The mossy wall zones located on the northeast side of the tank, an easy place for moss to grow. In addition to moss, ferns can also grow on the wall.
