CULTURAL RESOURCES ASSESSMENT OF THE POST AVENUE BRIDGE REPLACEMENT PROJECT, SEATTLE, KING COUNTY, WASHINGTON

Report Prepared for

Seattle Department of Transportation 700 Fifth Avenue, Suite 3900 P.O. Box 34996 Seattle, WA 98124-4996

Project Number 37240 Report Number 16-322

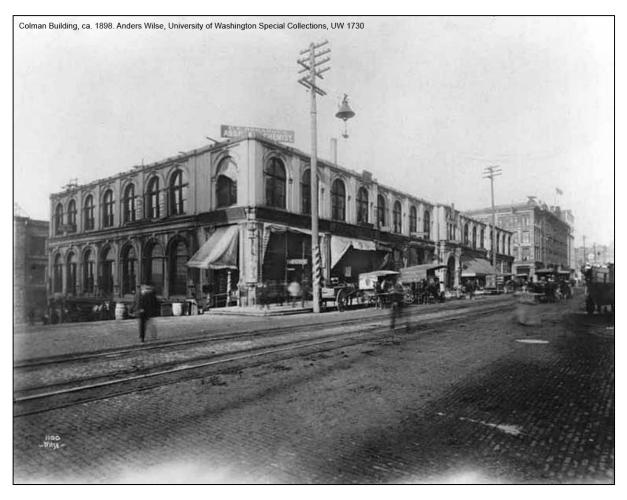
Figure 7. The Colman Block on First Avenue, rebuilt after the 1889 fire, was an important centerpiece of Seattle's downtown core for a number of years.

There was money to be made as the reconstruction of the city continued, and over the next year, in addition to his wharf, Colman also constructed new buildings on his First Avenue and Western Avenue blocks. He had already planned a more substantial business building on First Avenue before the fire, so he was ready to proceed quickly. Colman's new two-story block was built of stone on the First Avenue and Marion Street sides, with the rest constructed of brick (Figure 7). Colman vowed to add more floors when business conditions merited expansion. Perhaps because of haste or the projected \$250,000 cost of the Colman Building, Colman chose to replace the charred remains along West Street (Western Avenue) with a series of less expensive corrugated iron and frame buildings. Ten stores occupied the first floor of these new iron buildings and the second floor housed the West Street House, a hotel that likely catered to local workers as well as SLS&E passengers (Polk 1889, 1890; Sanborn Fire Insurance Map 1893; Seattle PI, Feb. 17, 1894) (Figure 8; Figure A-12).

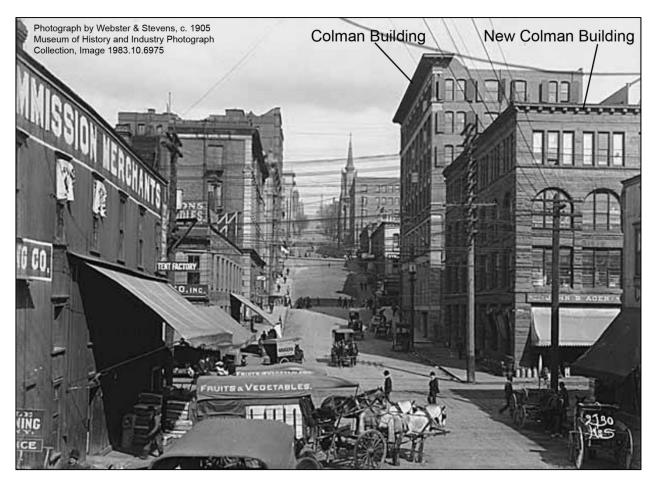
Figure 9. Freight wagons lined Marion looking east from Railroad Avenue in 1905; the Colman Buildings are to the right.

The building was in the heart of what had become known as the Commission District of Seattle, as brokers and wholesalers dealing in a variety of commercial goods enabled the city to supply all the needs of the Klondike miners as well as the residents of small towns throughout the Puget Sound region. At least one historian of Seattle's waterfront has suggested that by this time, the corner of Marion Street and Western Avenue (the name had changed from West Street by this time) was among the busiest in all of Seattle. Sidewalks were crowded with goods of all kinds, wagons jostled for space to load and unload crates and passengers bound for the West Seattle Ferry dock struggled to cross Railroad Avenue, "its planked surfaces a maze of railroad tracks, spurs, freight wagons and horse droppings" (Faber 1985:158)(Figure 9).

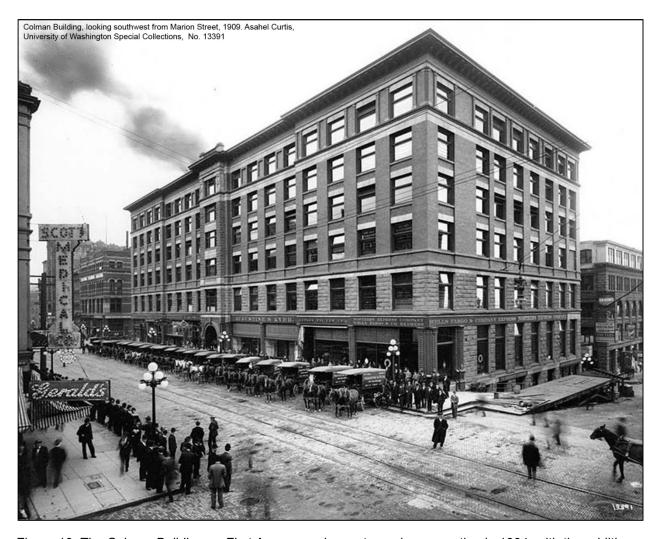
Figure 10. The Colman Building on First Avenue underwent a major renovation in 1904, with the addition of four floors.

A major expansion of the Colman Block on First Avenue followed in 1904. As James Colman had originally planned, his company added four more floors to the building and resurfaced portions of the main façade with stone. The design by architect August Tideman also included a complete remodeling of the original two floors (Figure 10). At the same time, a pedestrian bridge was also constructed across Post Street to allow tenants to cross between Colman's two buildings. The city's commercial core had moved to the north, but the Colman Building remained an important business center, with the Northwest Trust and Safe Deposit Company along First Avenue as well as a number of restaurants and stores. The western side of the building along Post Street also accommodated entrances to a few businesses, including an assay office and a hardware store (Corley 1969a; Hergert 1978; Property History Cards, Department of Planning and Development, Seattle; Sanborn 1904) (Figure B-4).

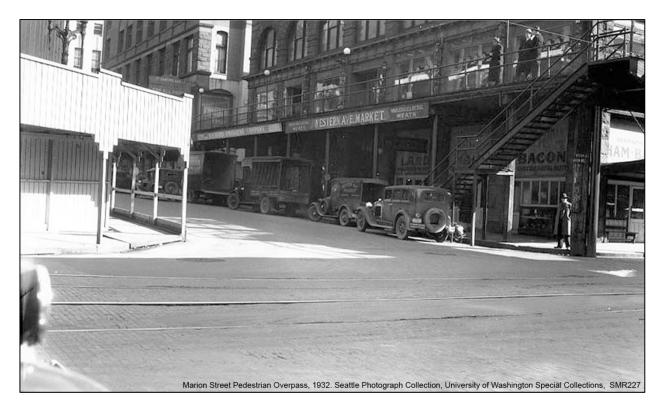
Figure 12. The Marion Street Pedestrian Overpass, shown ca.1932, provided a safe means to cross busy Railroad Avenue from the Colman Dock.

In 1897, the city vacated the portion of Marion Street between Western and Railroad Avenue for use by the Northern Pacific Railroad, but reserved the right to build an overhead walkway at Marion Street for pedestrians to cross over the busy and dangerous Railroad Avenue and safely access the waterfront. Funding for the walkway ultimately came from the Great Northern Railway Company rather than the

city. In 1908 the Board of Public Works granted the railroad a permit to construct what was then called the Marion Street Viaduct. The footbridge linked to the Colman Dock, which was located at the foot of Marion Street and was one of the primary facilities serving Seattle's so-called Mosquito Fleet. During this period as many as 2,500 different steamers were part of the commercial fleet of boats that were given that name because they "buzzed around" the inland waterways, carrying passengers as well as food, construction materials, and other products to outlying communities. Wooden boats, most often stern-or side-wheelers, made up the bulk of the Mosquito Fleet, but they were later replaced by propeller-driven vessels, which ranged from 30 to more than 200 feet in length (Hershman et al. 1981:38).

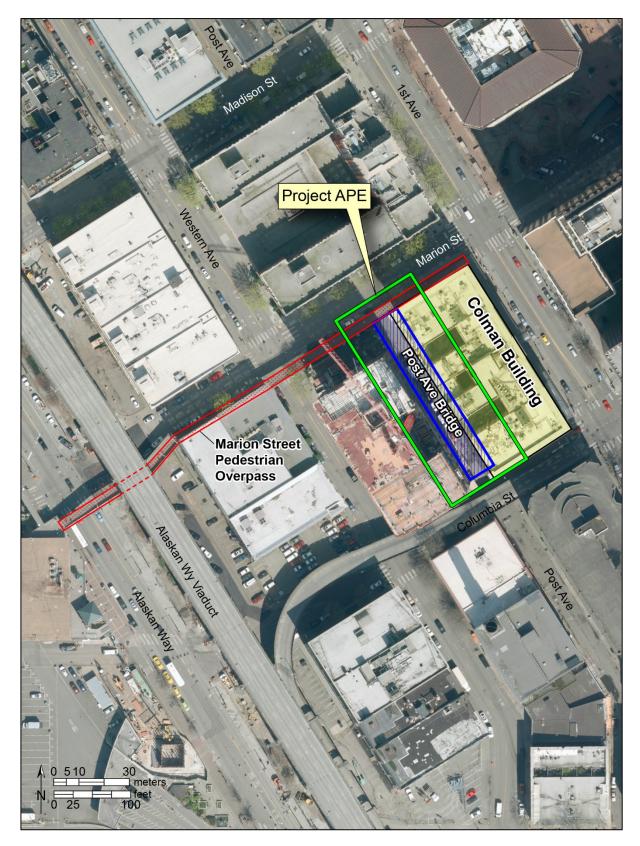
Figure 16. Built environment resources within the project APE.

Three built-environment resources, the Post Avenue Bridge, the Marion Street Pedestrian Overpass, and the Colman Building, are located within the project area (Figure 16). The Colman Building is currently listed in the NRHP and the other two resources were recorded and evaluated as part of this assessment.

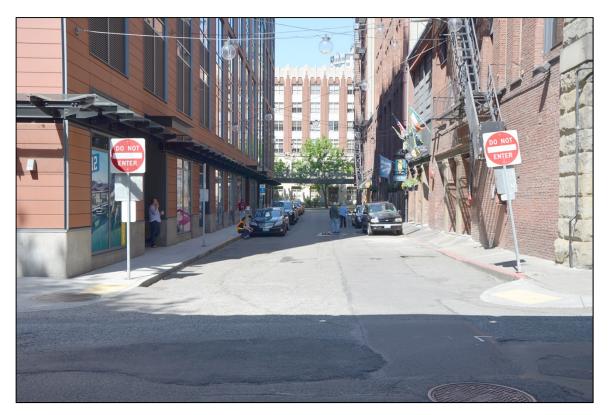
Figure 17. Post Avenue Bridge, view to the north.

Paving plans for the street in 1911 show that each trestle bent consists of three creosoted wood piles 13 feet apart (on center) with a 12×12 –foot wood pile bent cap that extends 2 feet beyond the outside piles. Each bent stands 7 feet 3 inches apart (on center). The road bed was constructed of concrete with granite curb sections measuring 23 x 6 inches. These paving plans call for a 20-inch sand cushion with 4-inch wood blocks as a wear surface. Concrete sidewalks with a 2.5% slope were built from each curb to the buildings on either side. Plans show that the original sidewalk on the west side of the bridge rested on the bent caps and iron dowels that protruded every 18 inches from mortar joints in the adjacent building (see Figure 11). This sidewalk was replaced as part of the construction of the Post Apartments. Plans for the east sidewalk do not specify exactly how this portion of the structure is attached to the Colman Building, but indicate that the poured concrete ties directly into the brick wall in some manner (Thompson 2011).

Like many other roadways near the Seattle waterfront, Post Avenue was originally graded, filled in some places, and then planked, with large segments built on trestles to cross over remaining tidal areas. While the city repaved most of Post Avenue with brick or wood blocks in the first years of the twentieth century, the portion between Marion and Columbia Streets that intersected the two blocks owned by the J.M. Colman Company was apparently not included in these projects. The Colmans paid for new paving of this part of Post Avenue in 1911, based on plans developed by R.H. Thomson and other employees of the Seattle Engineering Department. The company chose to use creosoted wood blocks as the paving surface. Likely because private funds paid for these improvements, the city did not make
