72 - Stormwater Monitoring or Stormwater-Related Studies

430 Pipeline Inspection Work 2017

Dewatering Pipeline to Ship Canal Tunnel and then to Ship Canal after Dichlorination

March 14, 2018

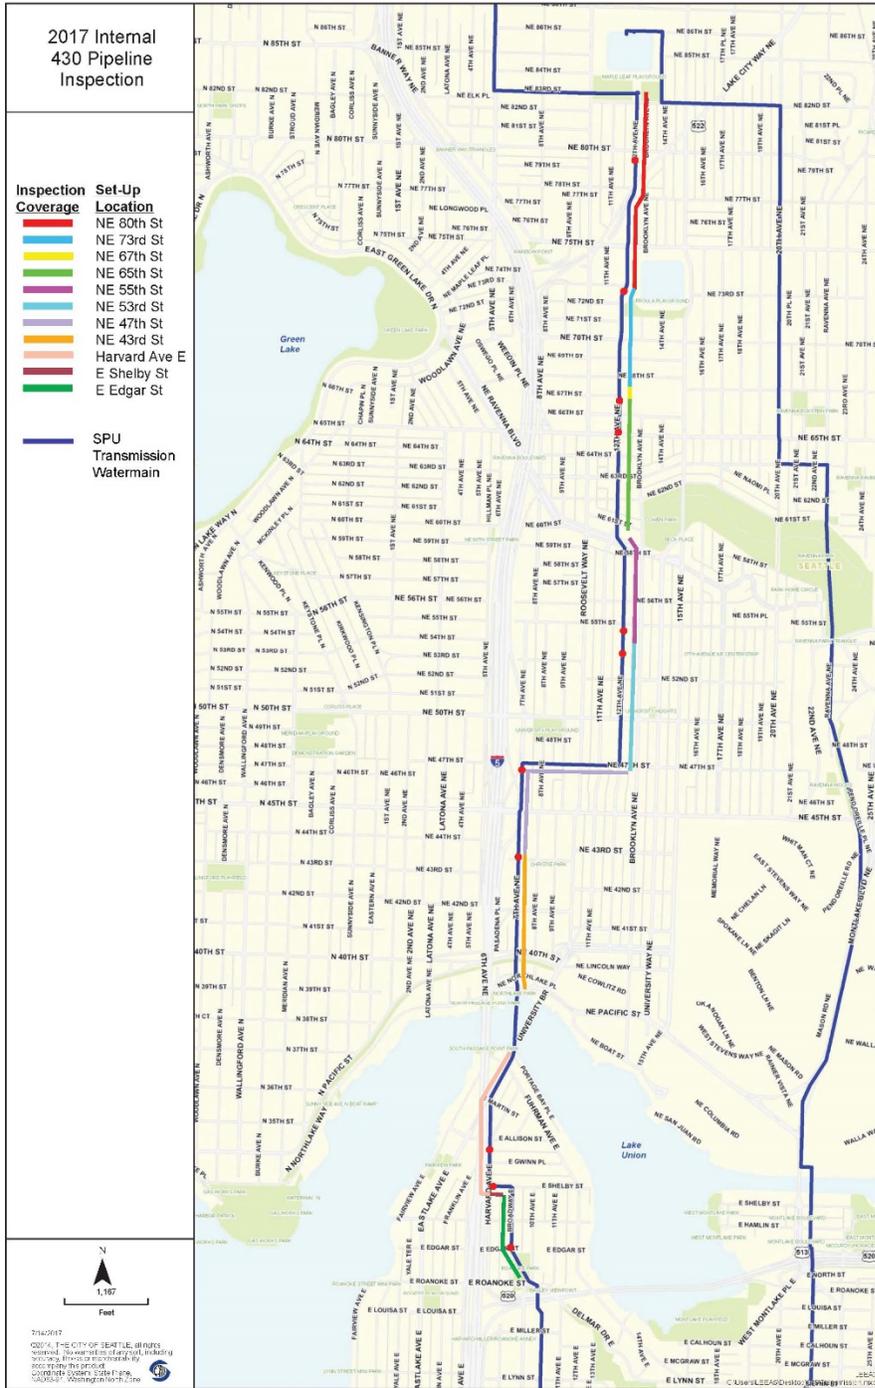
The map below shows the pipeline segment that was inspected:

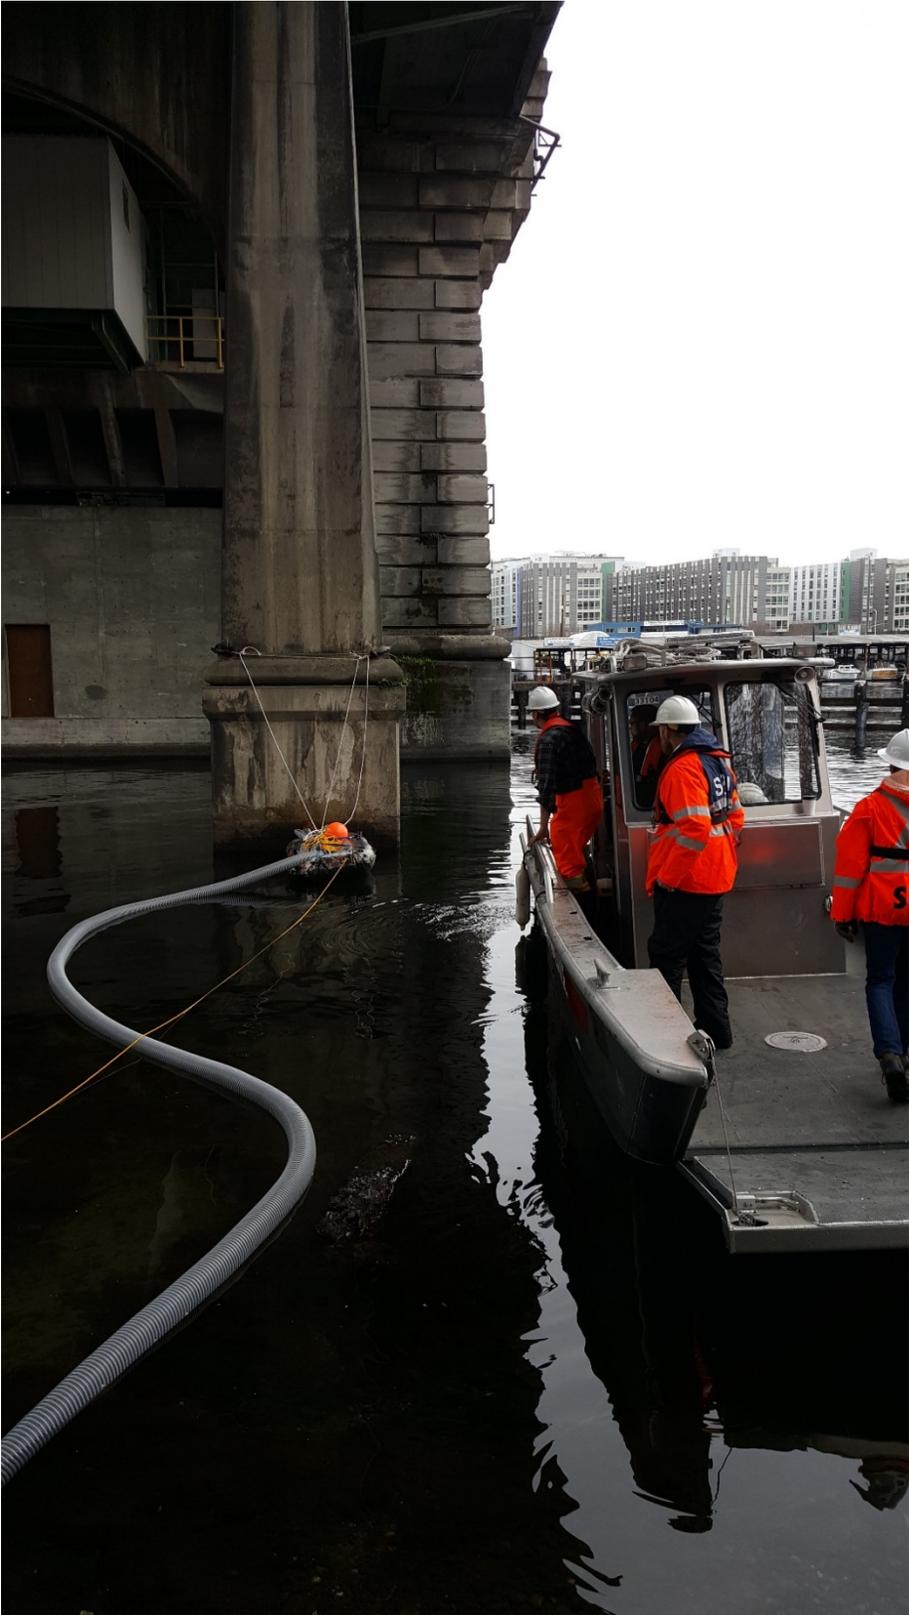
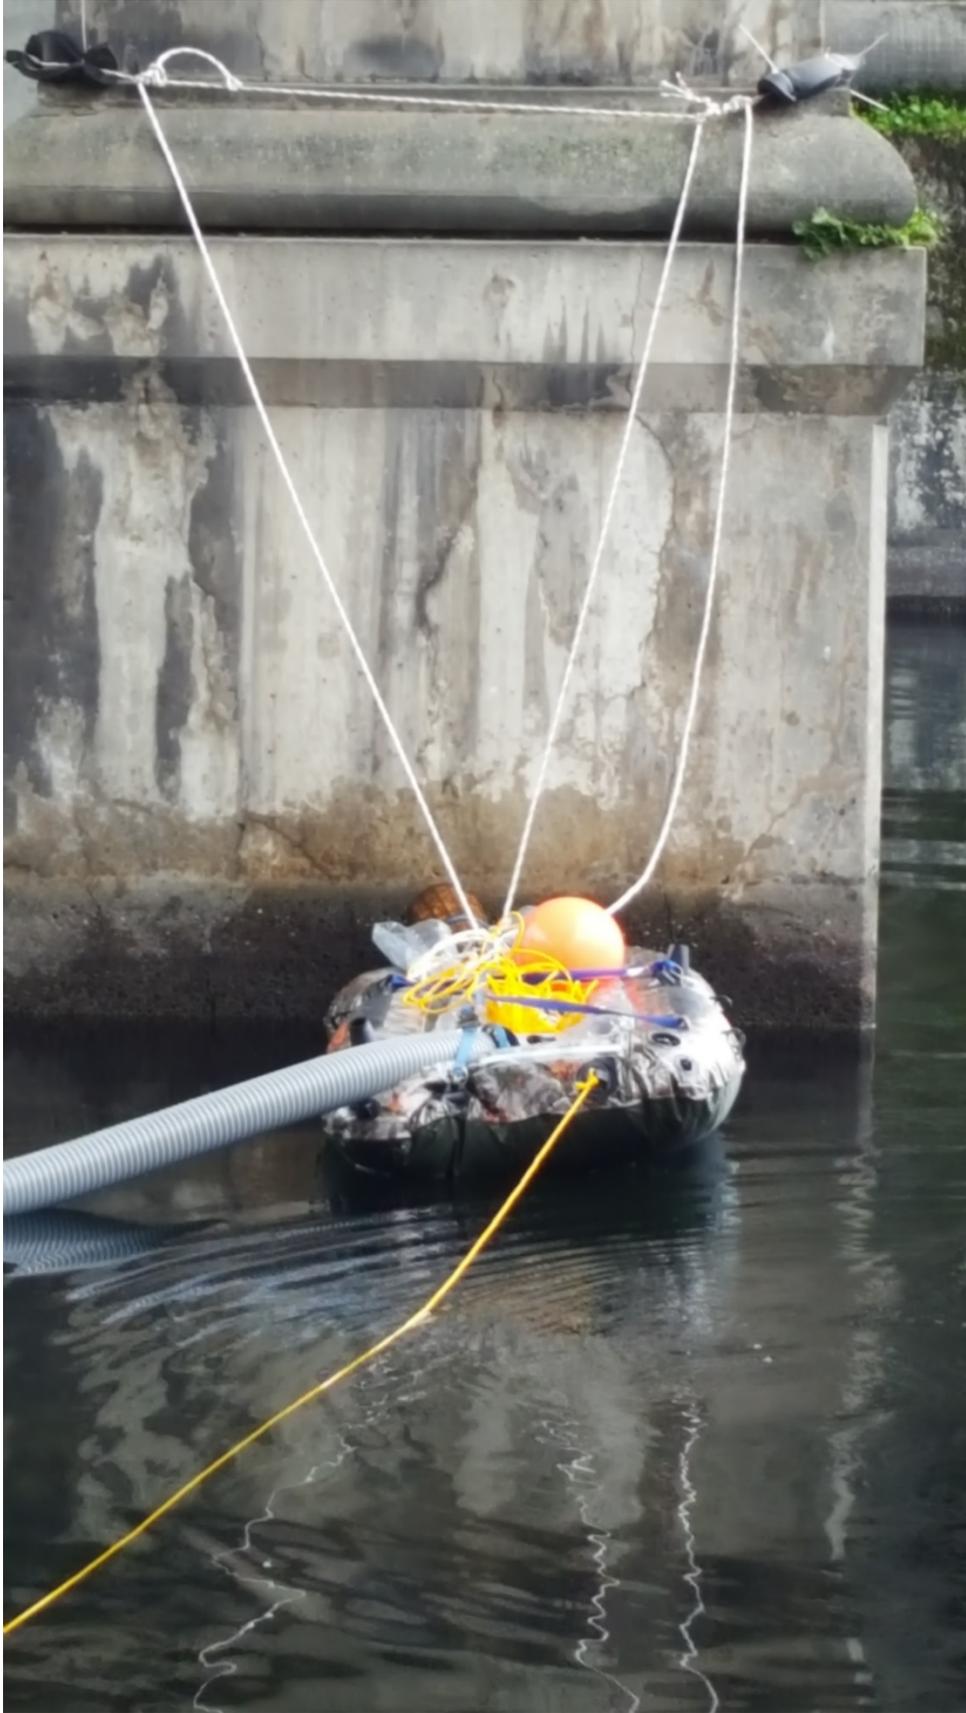
Pump Discharge Pipe Photos and site photos:

Tunnel Doghouse – Column behind center of doghouse is where discharge raft was located.

was clear of debris. The diffuser was set to spray the water up at about a 30-degree angle onto the column. While discharging no sediment was observed to be stirred up by the pumping.

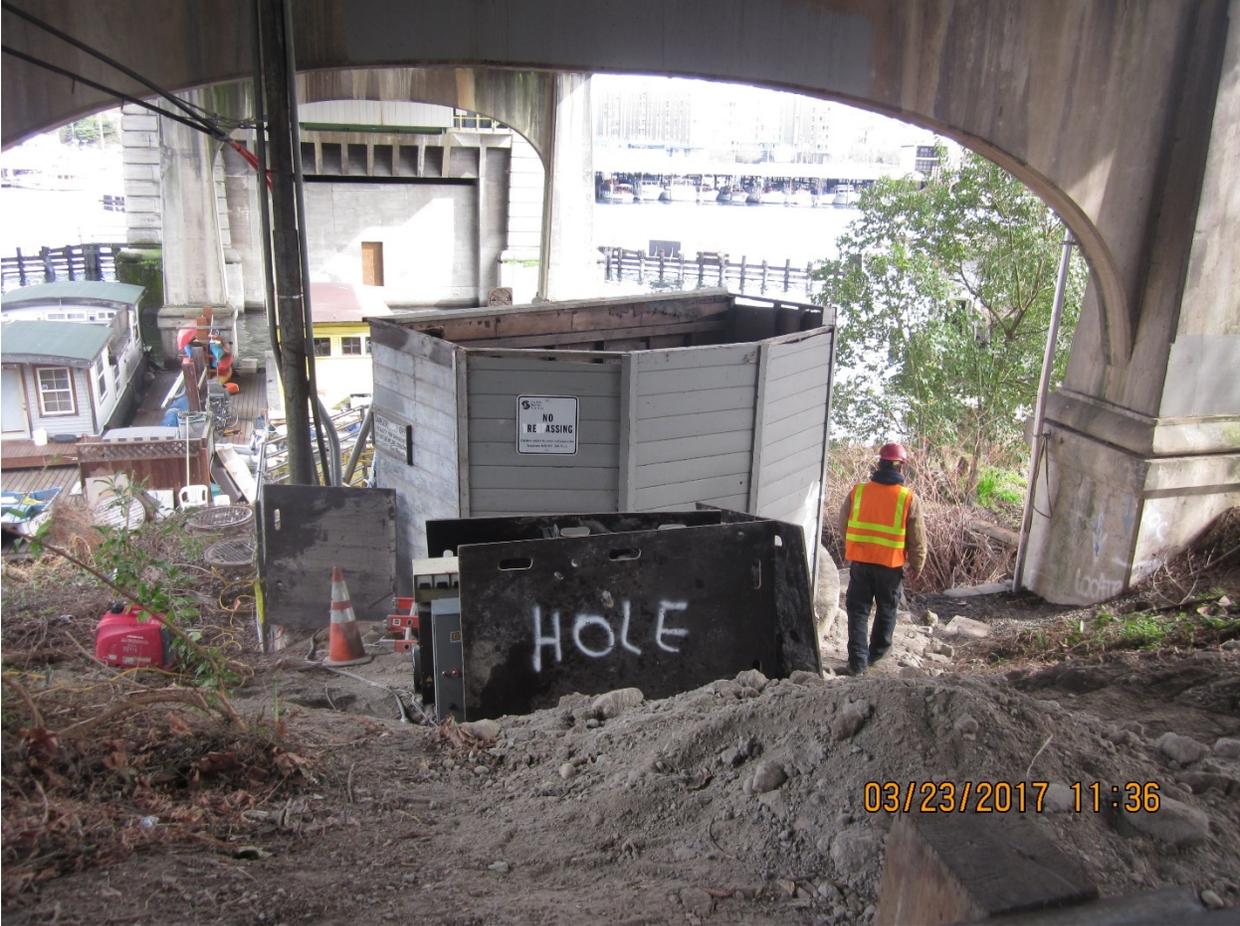
Tunnel Inspection picture showing leakage from tunnel walls and inspection team

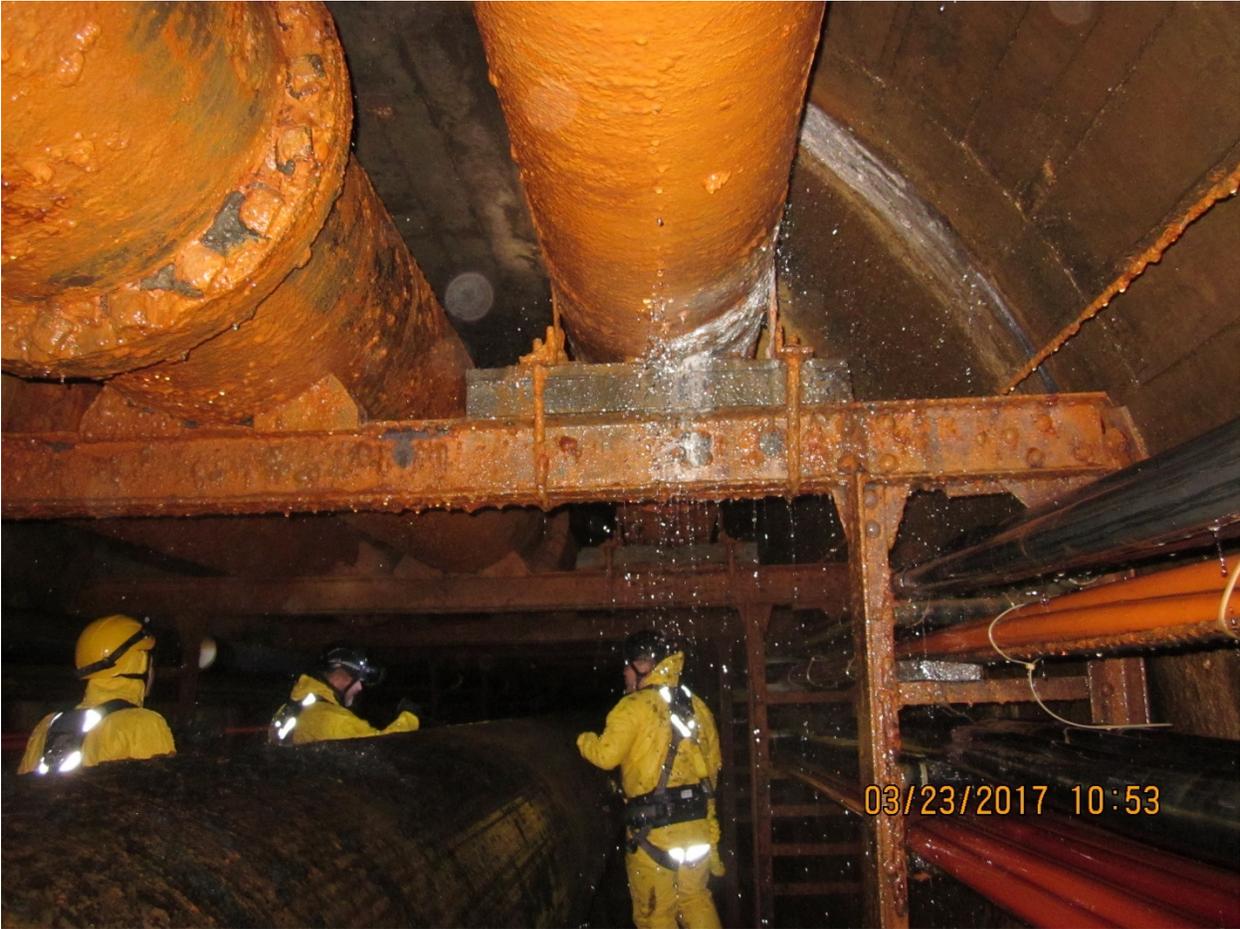
The tunnel is normally full of ground water, most of which we believe comes from the ship canal. During the inspection of the tunnel it was estimated that water infiltrates into the tunnel through seams in the tunnel wall at a rate of approximately 50-60 GPM, estimated by observation and time to fill tunnel sump. This water was tested to be sure there was no chlorine present, test reading was non-detect (to be noted as 0 ppm in our testing). A sample testing of chlorinated water was done from a hydrant to show that the test equipment was working correctly, before testing the ground water in the tunnel.

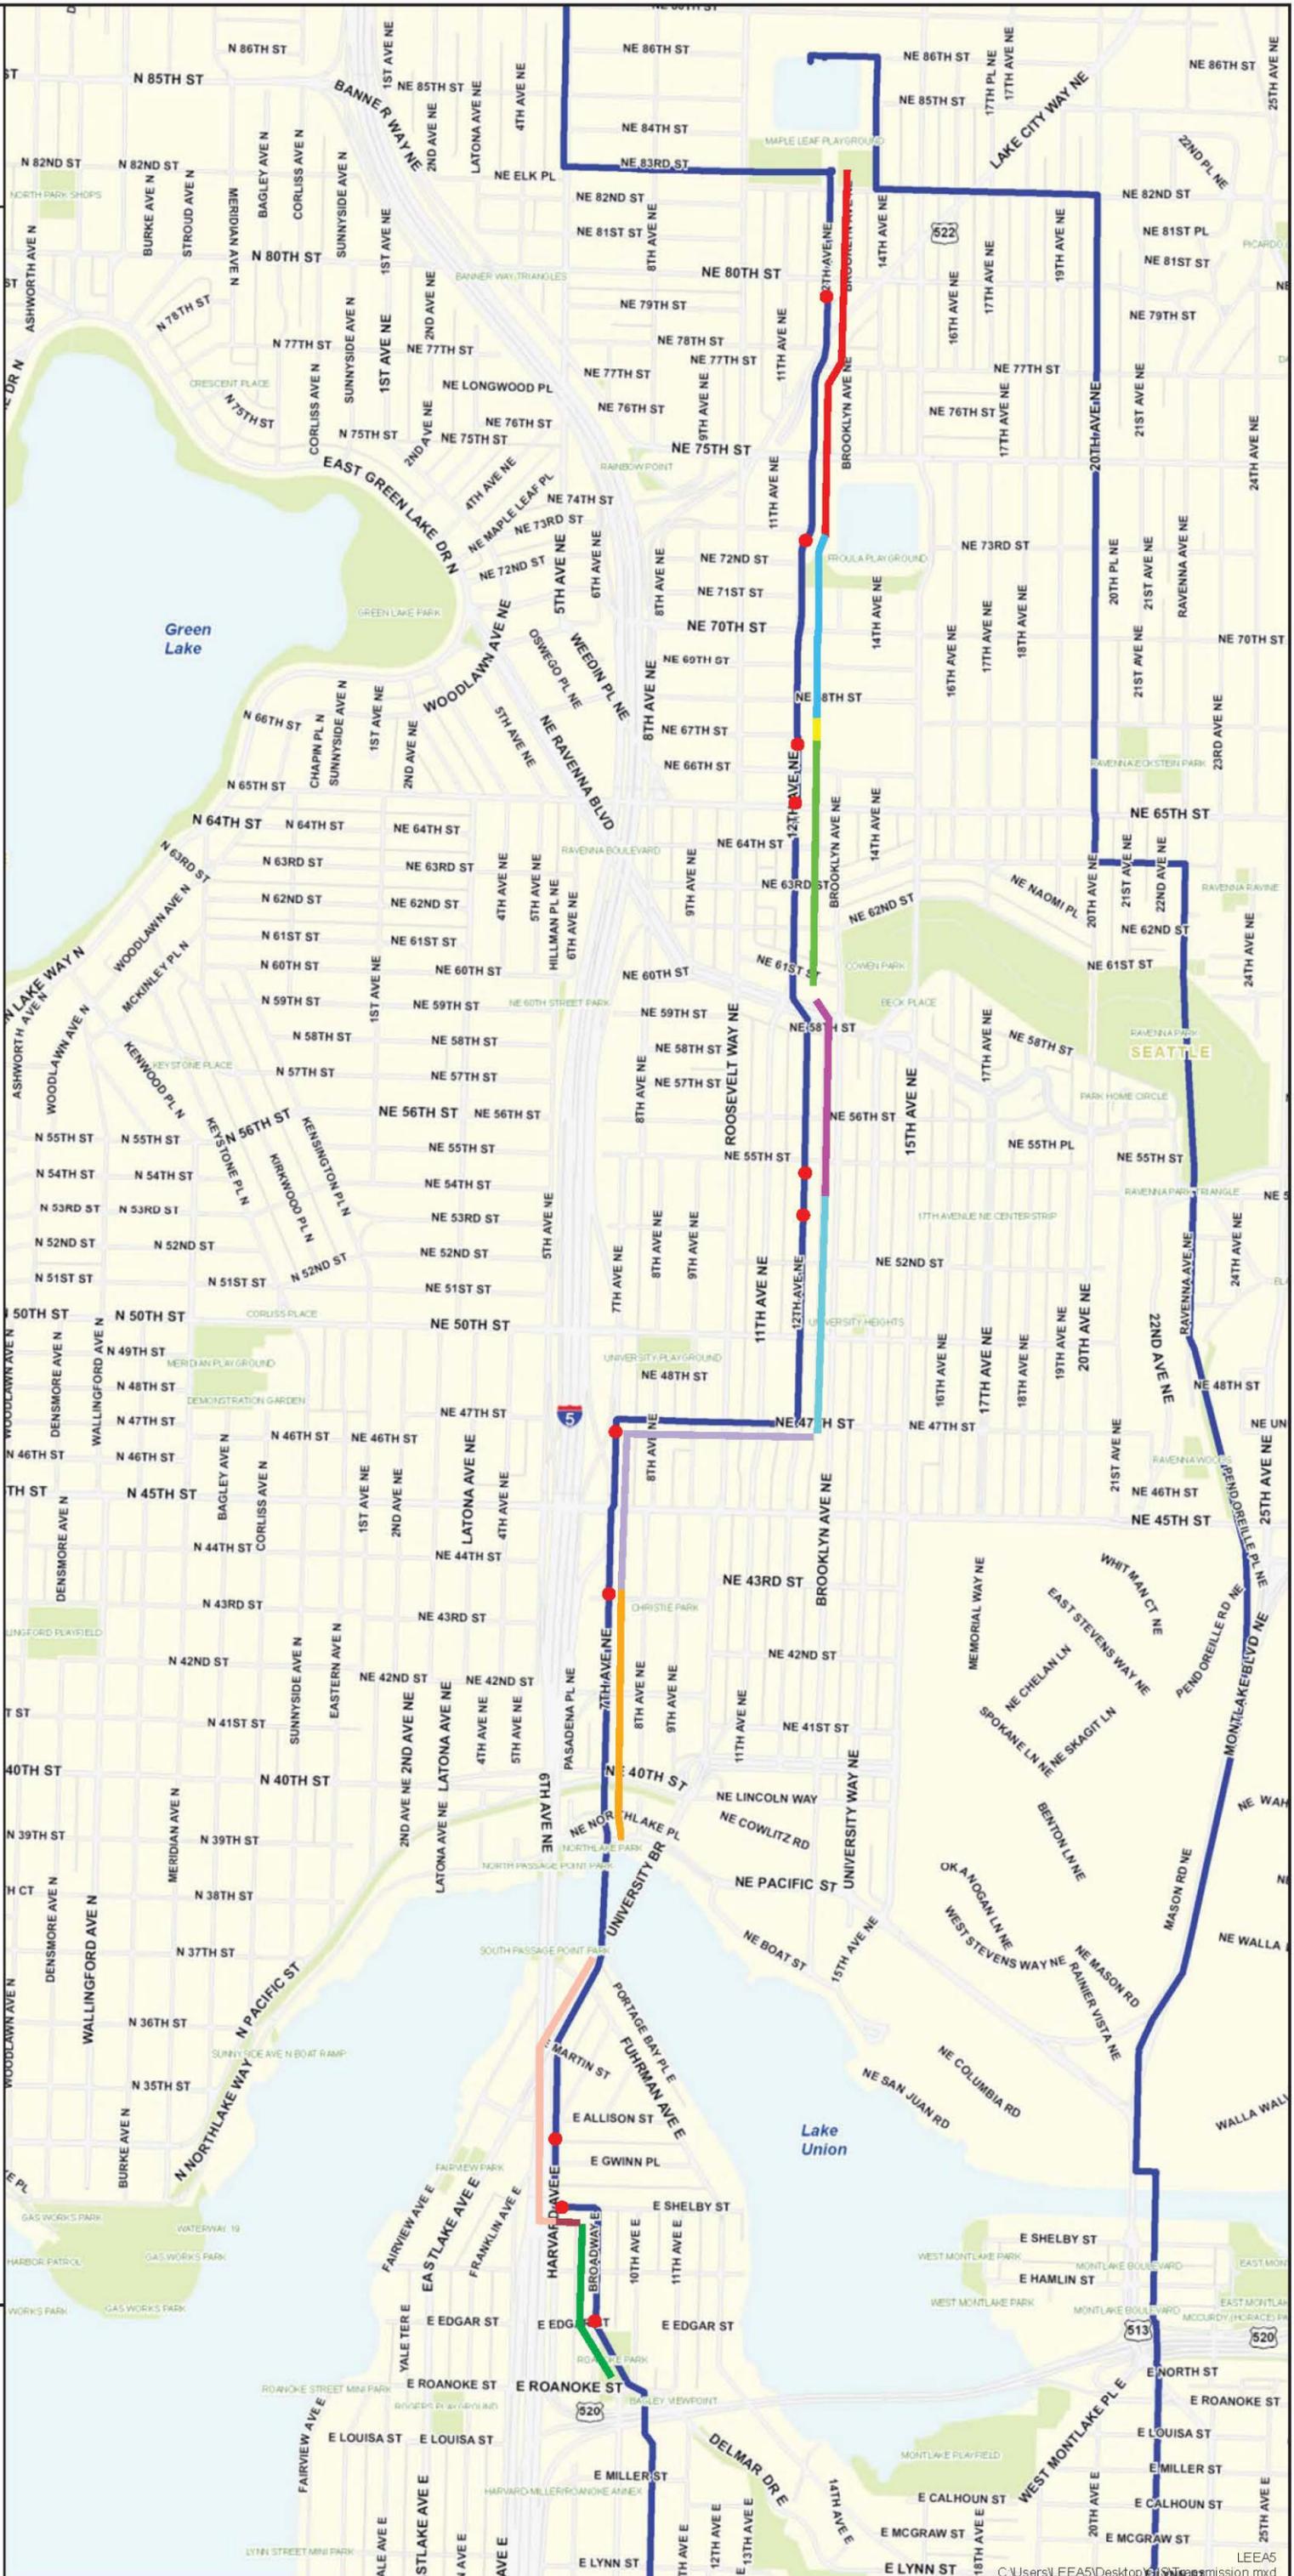
Appendix A – 2017 – 430 PL Inspection Map

2017 Internal 430 Pipeline Inspection

Inspection Coverage

- NE 80th St
- NE 73rd St
- NE 67th St
- NE 65th St
- NE 55th St
- NE 53rd St
- NE 47th St
- NE 43rd St
- Harvard Ave E
- E Shelby St
- E Edgar St
