Appendix A:

Description of business inspection, source tracing, and line cleaning programs in the Lower Duwamish Waterway

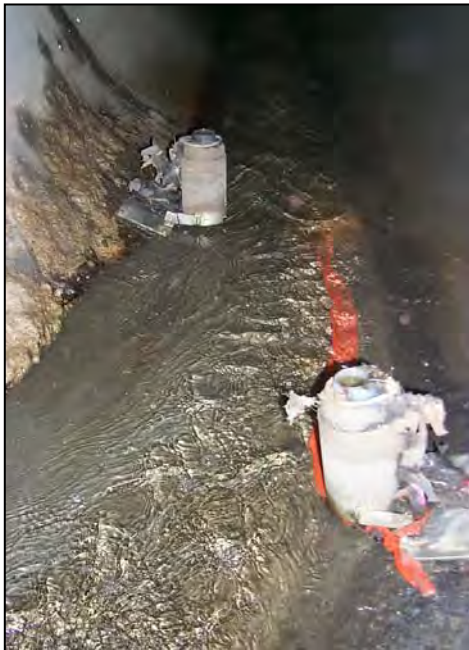
Figure 3: Modified-Norton style trap that has been used by SPU.

1. Inline Sediment Traps. Sediment traps consist of a device mounted inside the conveyance system that passively collects suspended particulate material that passes by the sampling station. SPU has primarily used the modified-Norton style trap which consists of 1 L Teflon® bottle held in sleeve held in a stainless-steel sleeve/bracket that attaches to the pipe or vault structure where they are typically deployed (Figure 3). The bottle is approximately 8 inches tall. As a result, these traps are only used in pipes that are 18-inches or larger in diameter². Using a grant from Ecology, SPU developed a lower profile, bowl-style trap that could be installed in smaller diameter pipe (Figure 4).

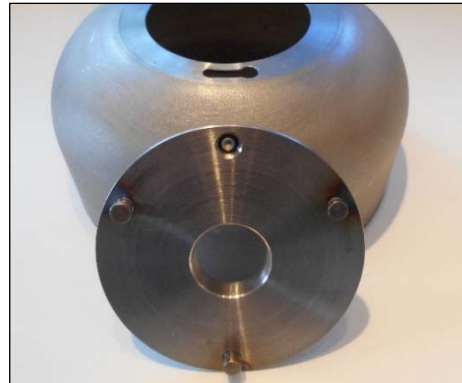
Figure 4: New bowl-style trap.

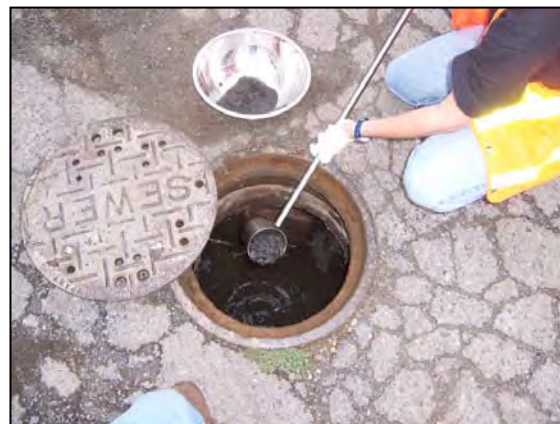
Figure 5: Inline grab sampling

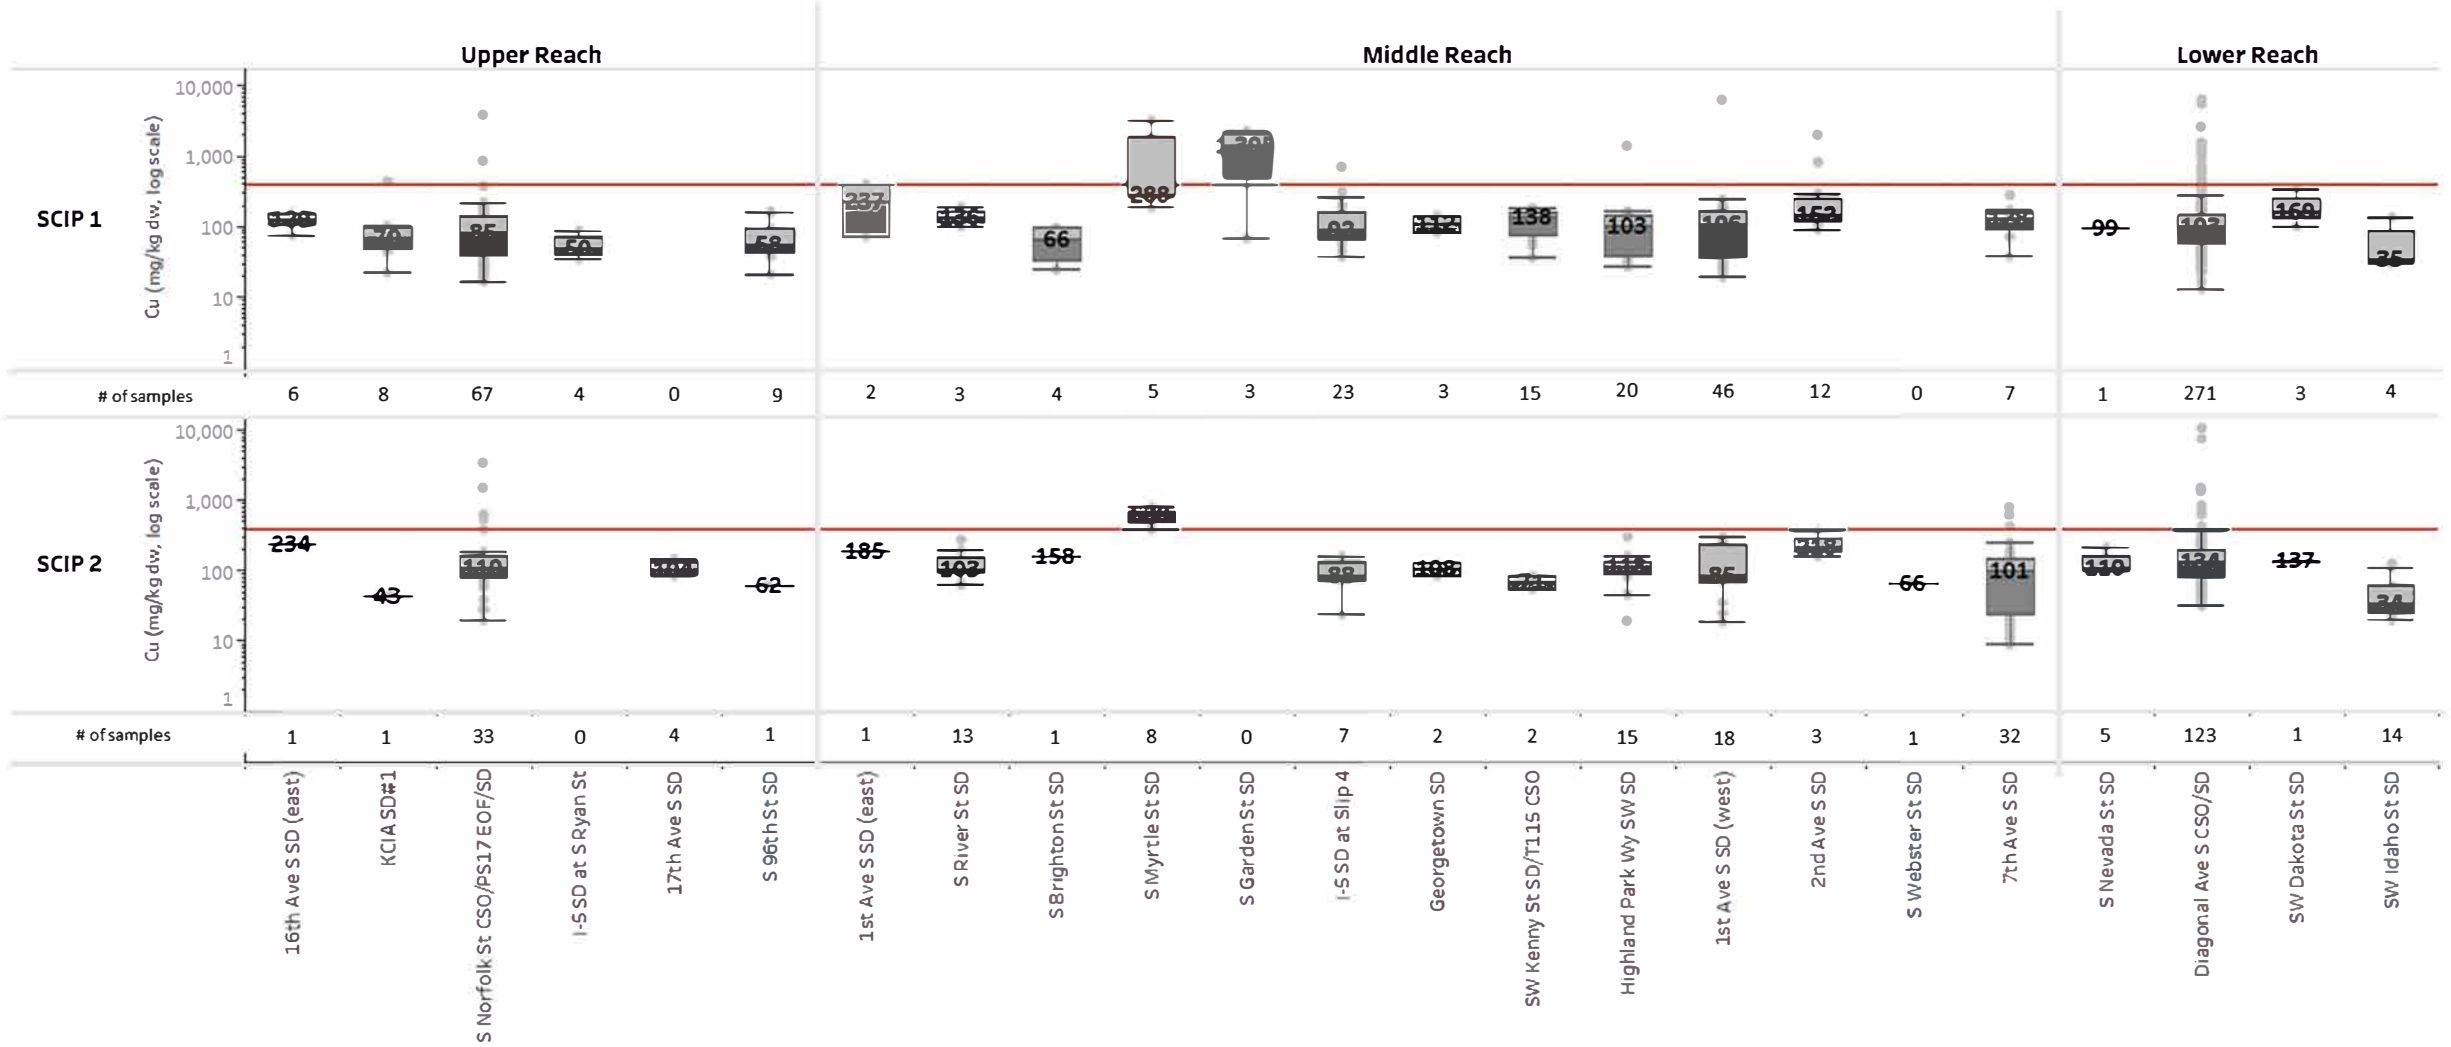
- * Red line= SCO/CSL (390 mg/kg dw)
- * Median concentrations by outfall are shown in bolded text.
- * SCIP 1 = August 18, 2003 - June 30, 2014 (all samples).
- * SCIP 2 = July 1, 2014 - June 30, 2019. If the storm drain has been cleaned, only the most recent post-cleaning samples are included.

Figure B-3: Lead (Pb) Box Plots

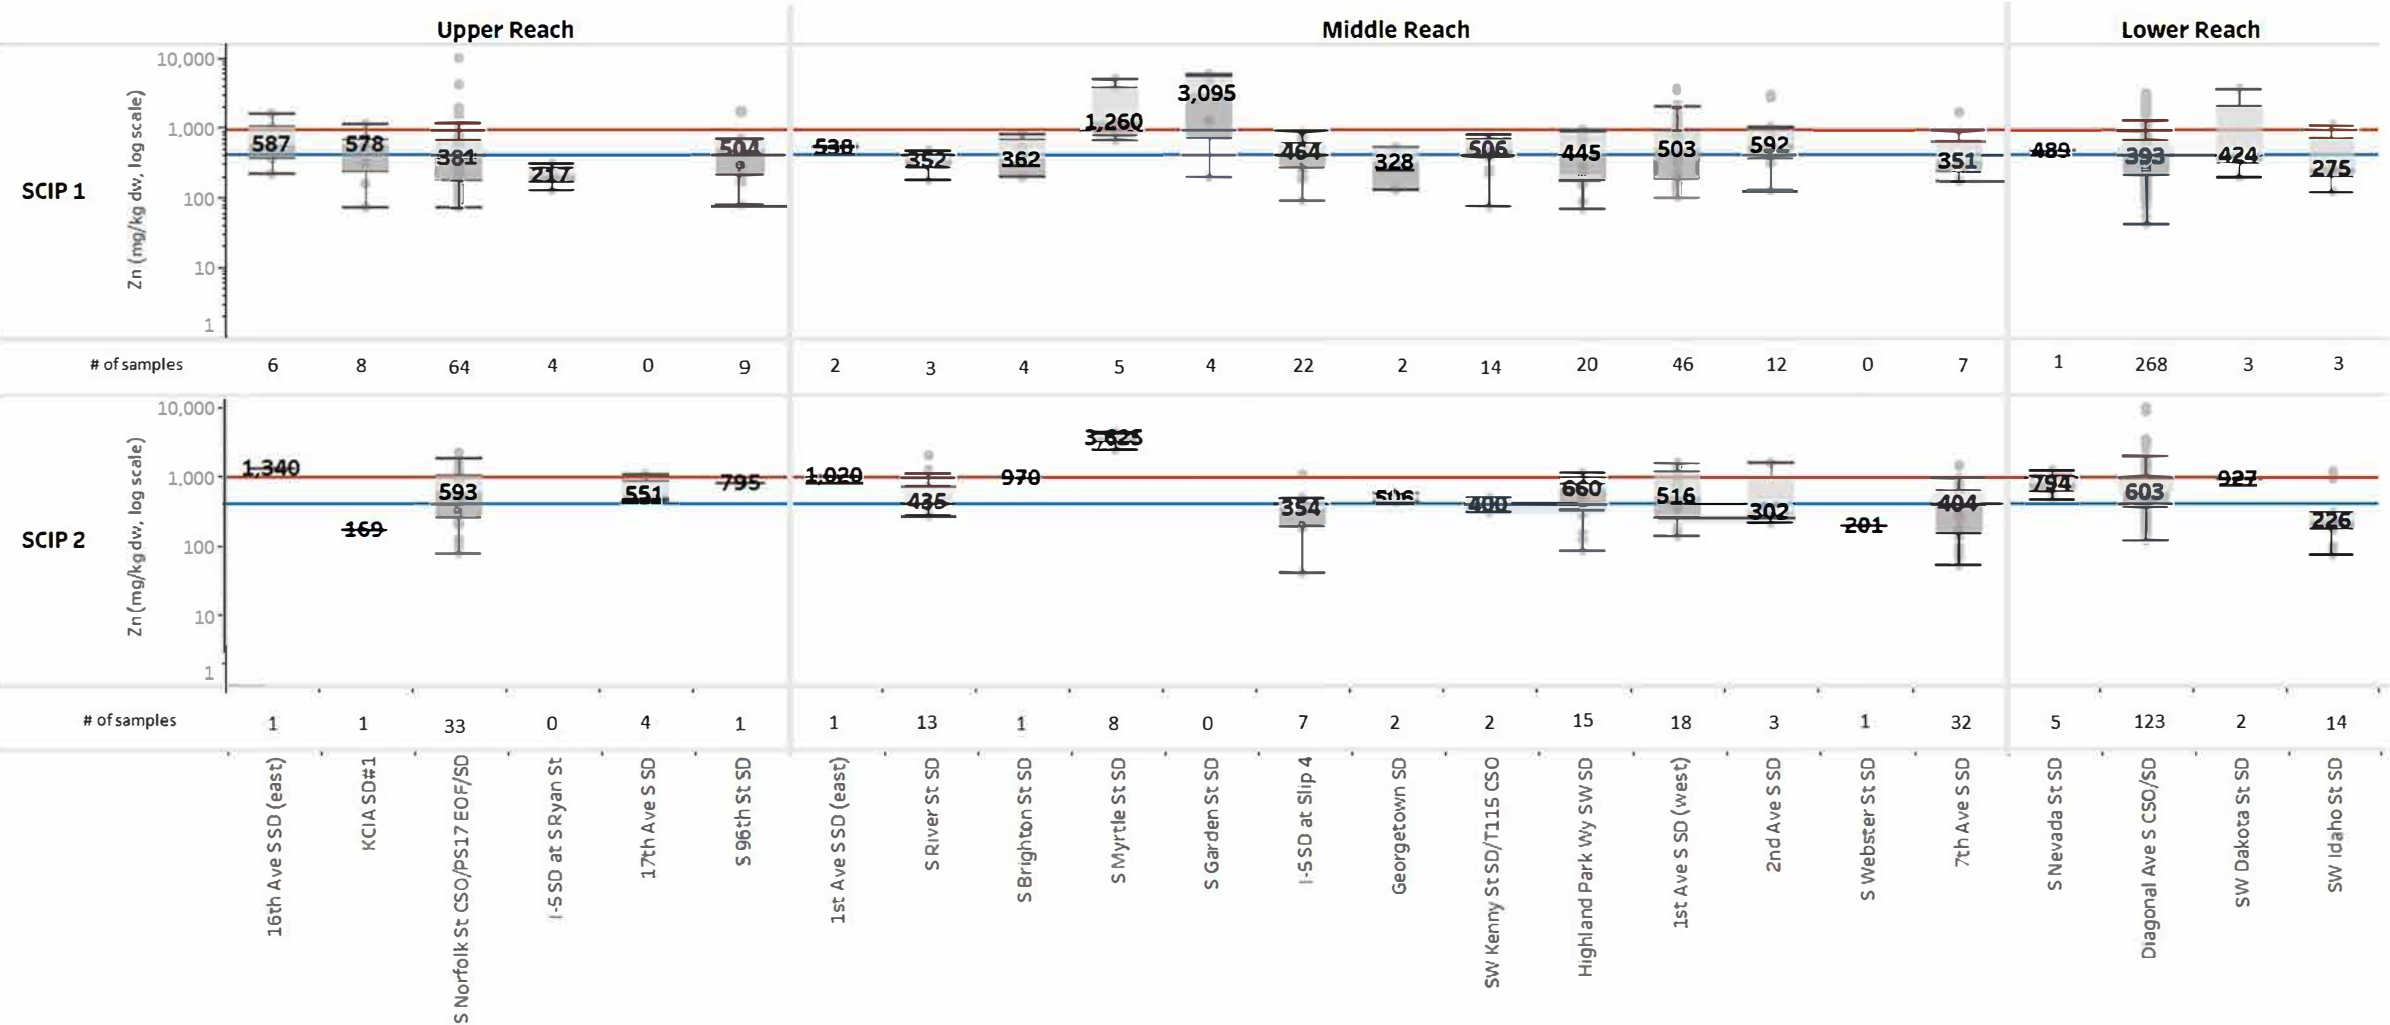
- * Blue line = SCO (410 mg/kg), Red line= CSL (960 mg/kg dw)
- * Median concentrations by outfall are shown in bolded text.
- * SCIP 1 = August 18, 2003 - June 30, 2014 (all samples).
- * SCIP 2 = July 1, 2014 - June 30, 2019. If the storm drain has been cleaned, only the most recent post-cleaning samples are included.

Figure B-6: LPAH Box Plots
Storm drain solids samples collected in Seattle’s MS4 between August 13, 2003 and June 30, 2019

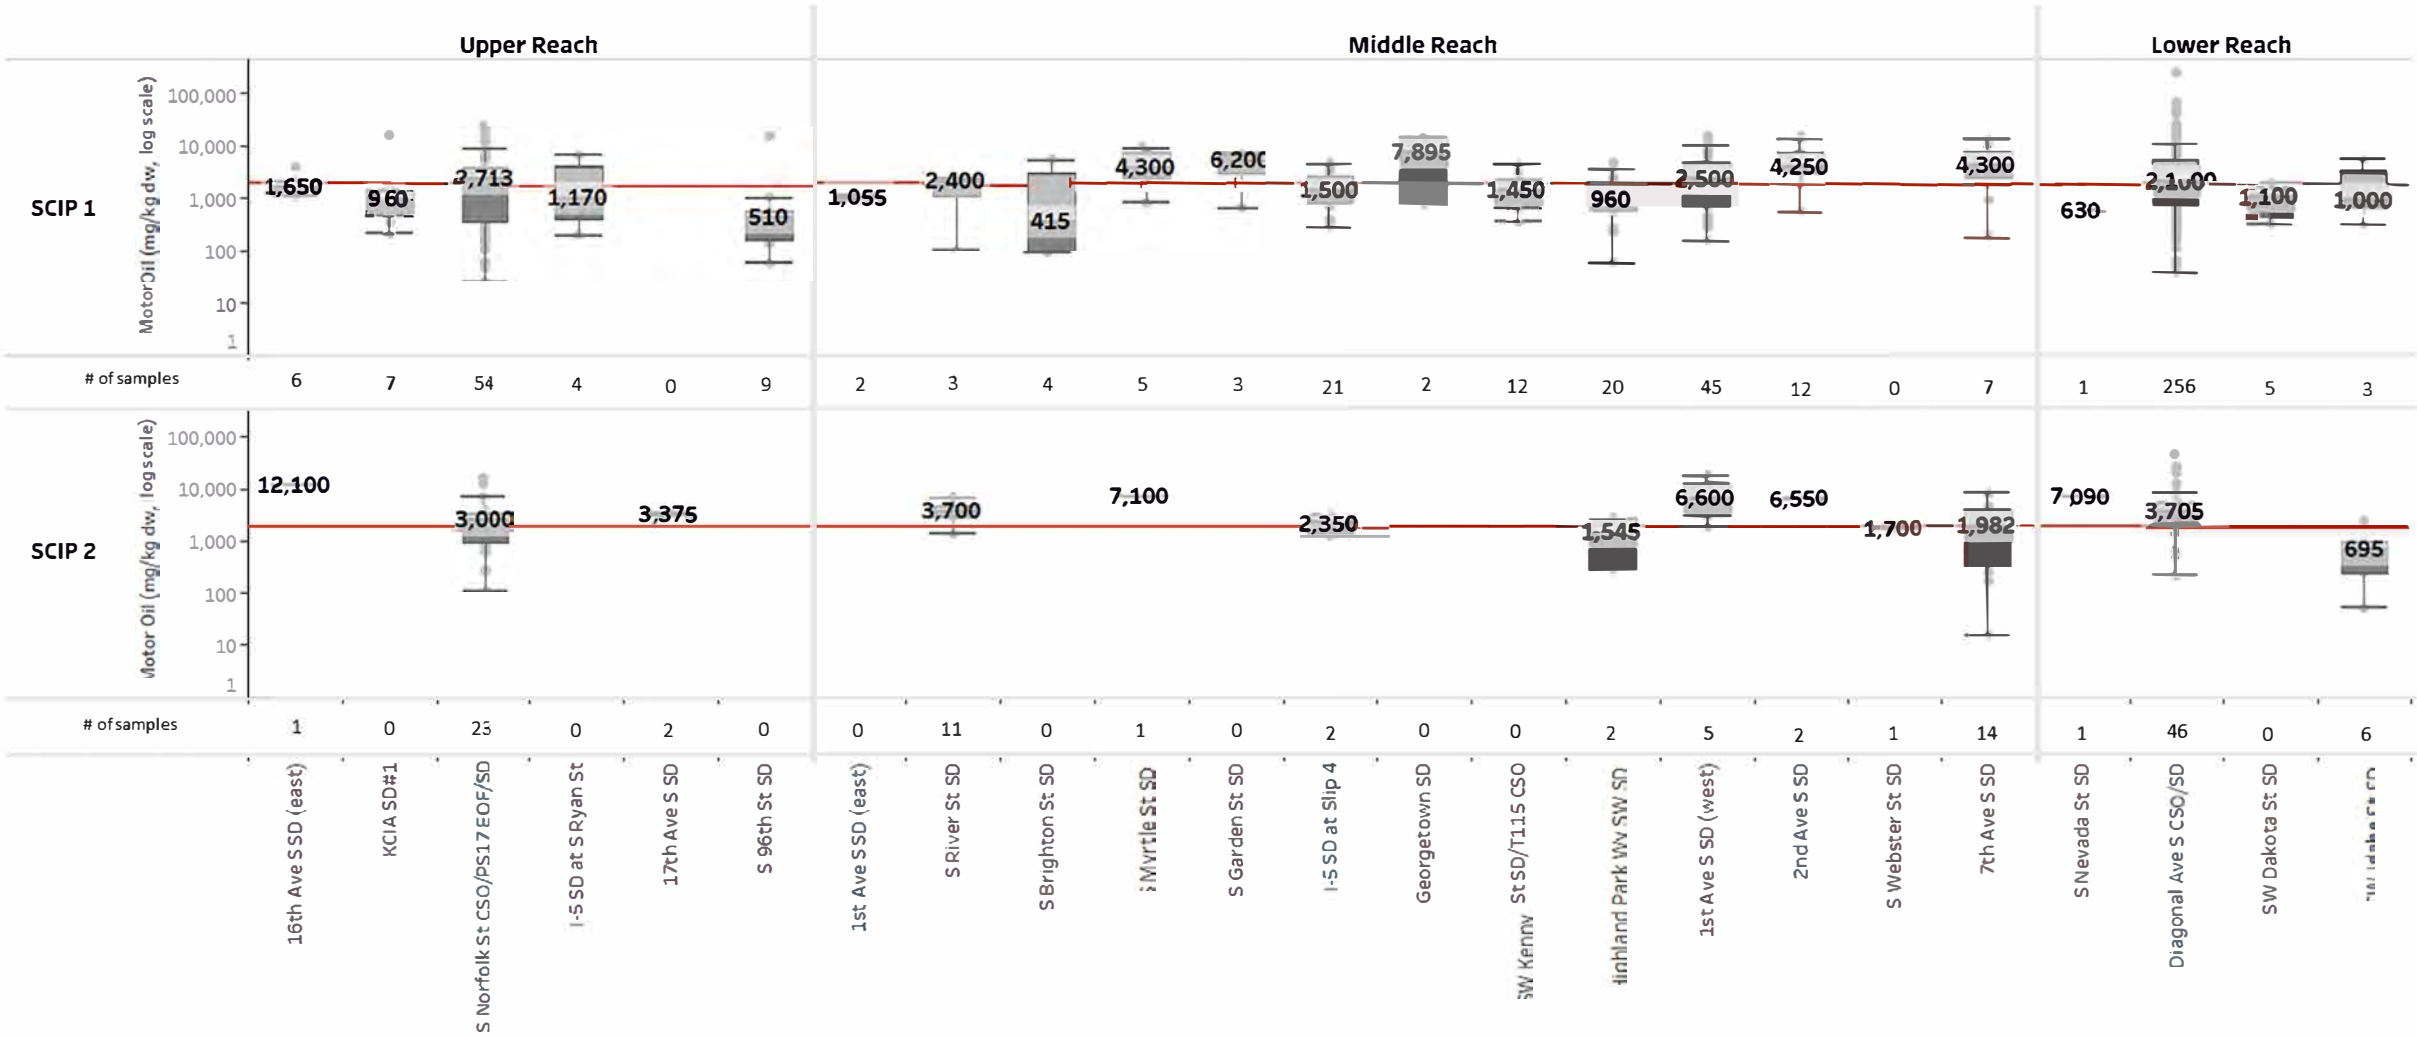
- * Red line= LAET/2LAET (2,000 mg/kg dw)
- * Median concentrations by outfall are shown in bolded text.
- * SCIP 1 = August 18, 2003 - June 30, 2014 (all samples)
- * SCIP 2 = July 1, 2014 - June 30, 2019. If the storm drain has been cleaned, only the most recent post-cleaning samples are included.

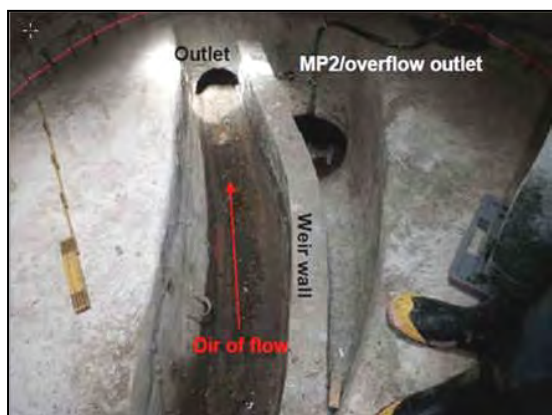
Figure 1: S Brighton CSO before sealing.

The S Brighton St SD serves an 18.6-acre industrial basin located between Slip 3 and Slip 4 (Map 15). SPU plugged the overflow from the combined sewer that had been connected to this outfall in 2012 (Figure 1 and Figure 2).

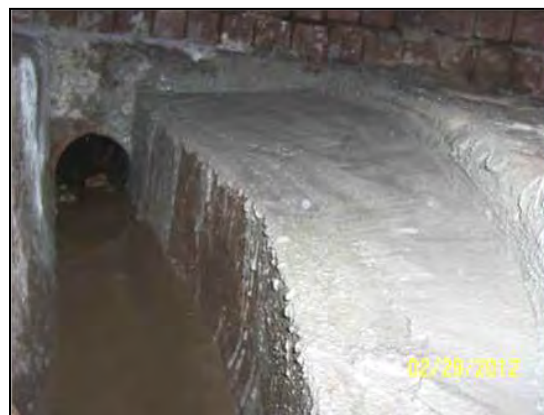
Figure 2: S Brighton CSO after sealing.

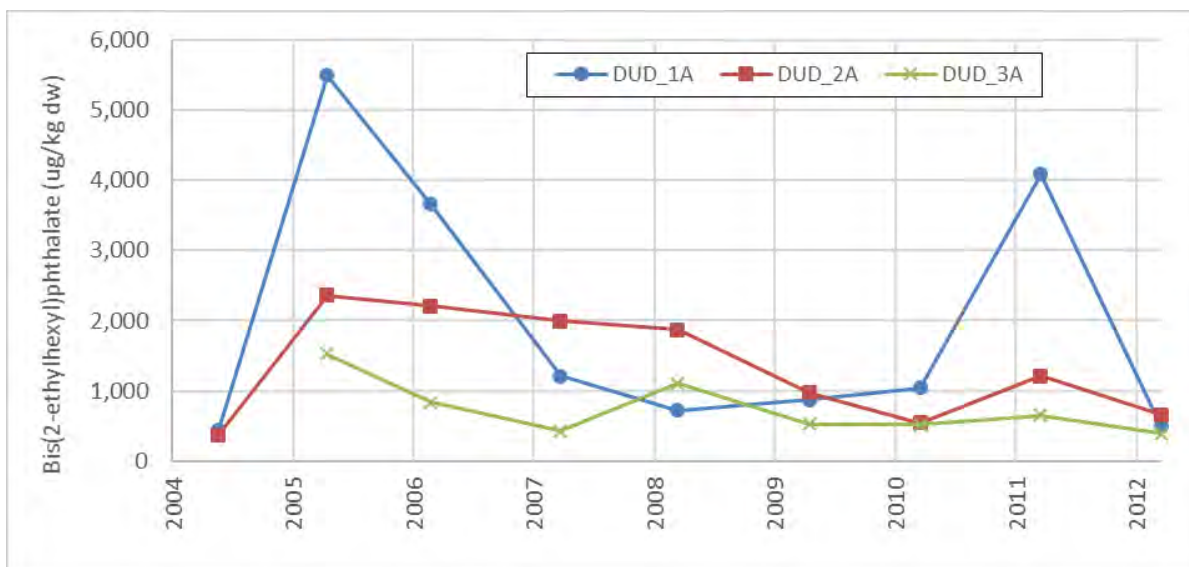
Figure C-8: BEHP in samples collected offshore of the Diagonal Ave S CSO/SD outfall post cleanup.

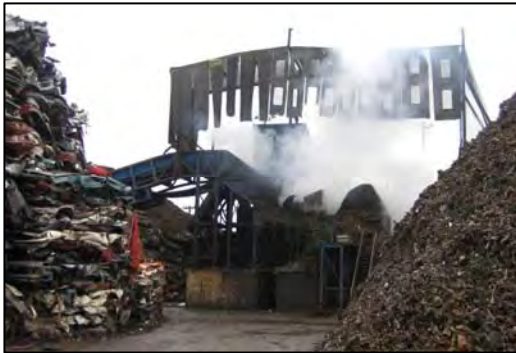
Figure 1: Metal shredder
