Historic Report / 652 S. Dearborn Street, Seattle

April 10, 2025

Introduction

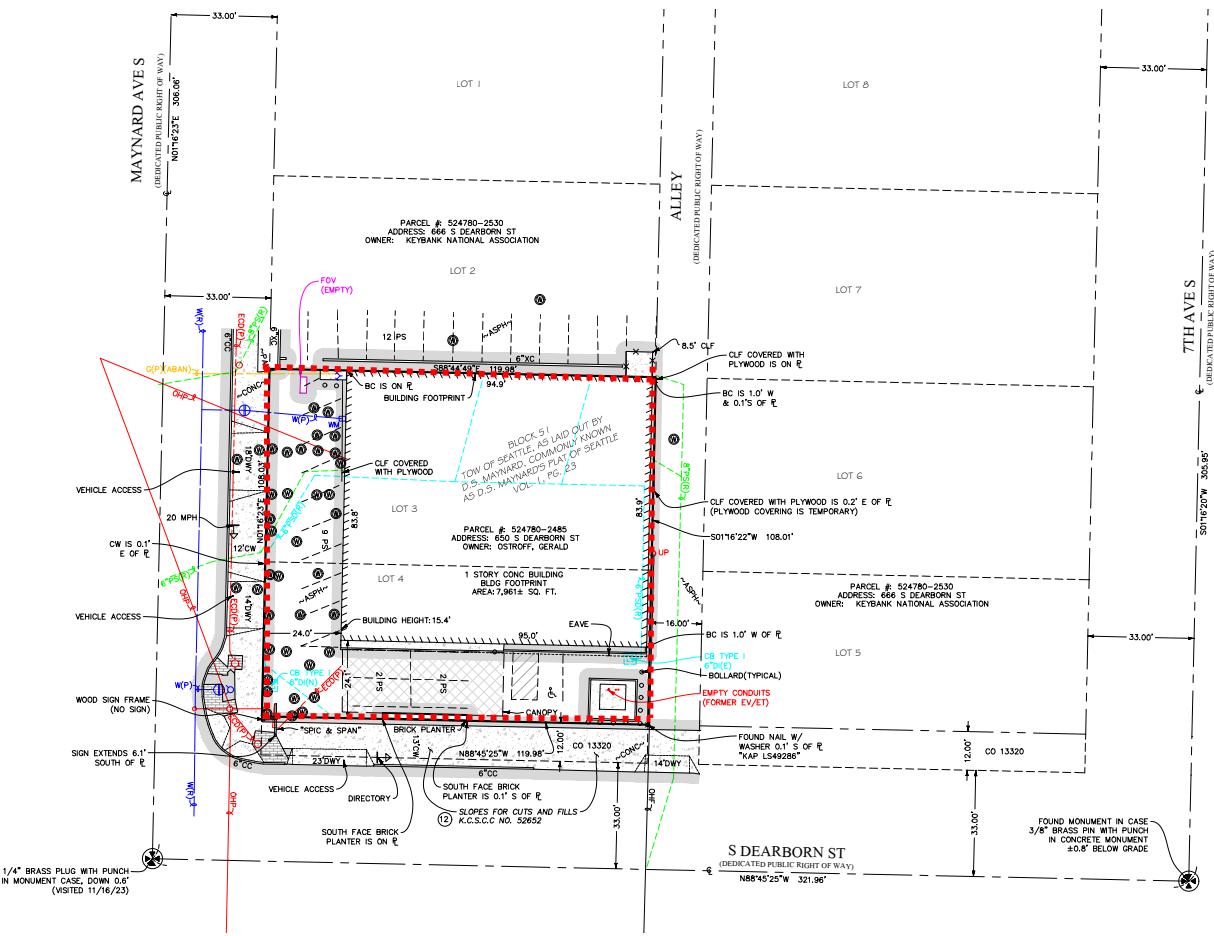
Excerpt from a 2023 survey, property shown with a dashed red outline. North is up. (Bush, Roed & Hitchings)

The parcel is approximately 120' (east-west) by 108' (north-south), for a total of 12,960 square feet. The site is relatively level. The 95' by 84' overall building footprint is situated at the northeast portion of the property, with 24' setbacks on the south (Dearborn) and west (Maynard) sides. The balance of the lot is paved, with angled surface parking along the west side. Three driveways—two from Maynard Ave S. and one from S. Dearborn Street—provide vehicular access. A large, free-standing sign is located at the southwest corner.

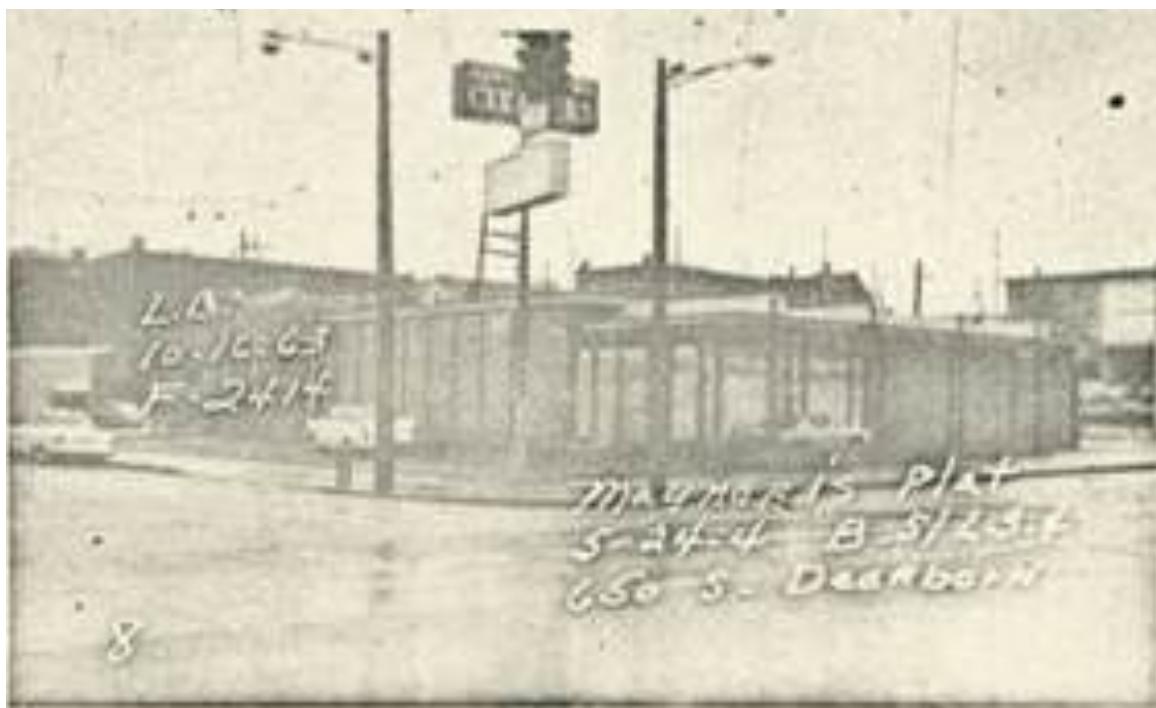
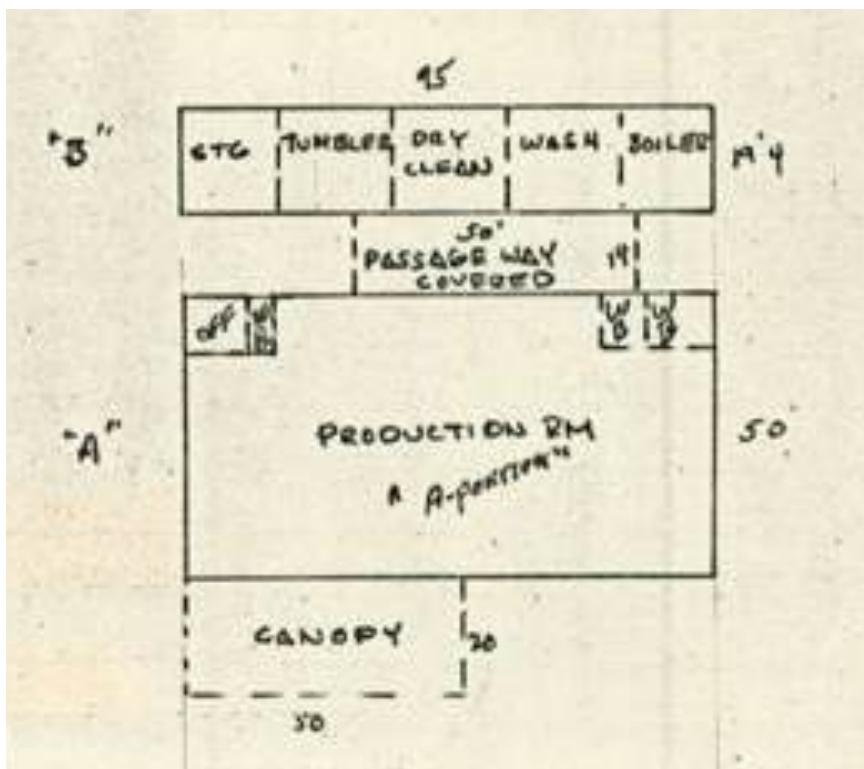
A 1963 view looking northeast toward the south and west façades of the building. Below is a sketch of the building plan from the property record card. (King County Tax Assessor property record, Puget Sound Regional Archives)

While it appears as a single building, the original drawings as well as the Tax Assessor records identify the property as having two buildings connected by an arcade. The 95' (east-west) by 50' (north-south) "production room" comprised the southern building, and behind it to the north was a 95' by roughly 14' linear building that was divided into five rooms: storage, tumbler room, dry cleaning room, shirt wash room, and boiler room. The archival property record card notes a concrete and pile foundation. Both buildings are flat-roofed, with tilt-up precast concrete exterior walls. The exterior panels have a rough-textured finish. The larger, southern building has a roof structure of glu-lam beams, which continue and project out beyond the face of the south façade, supporting a slight roof overhang. A substantial, 50' wide by 20' deep, flat entry canopy projects from the western portion of the south façade. Emergency structural repairs to the canopy element in 1991 replaced original glu lam beams with steel. Aluminum-framed entry doors were located near the west end of the south façade, with additional glazing to the east of the entry assembly. Clerestory windows along the south façade also allowed natural light into the production room. Most of the east, north, and west sides had no windows. The building has been vacant since 2019 and all glazed openings are now infilled or boarded up. The original covered passage between the front and back buildings was altered with an extension of its roof. Additional visible changes to the building include extensive painting of the textured concrete exterior walls, likely to cover over repeated graffiti.

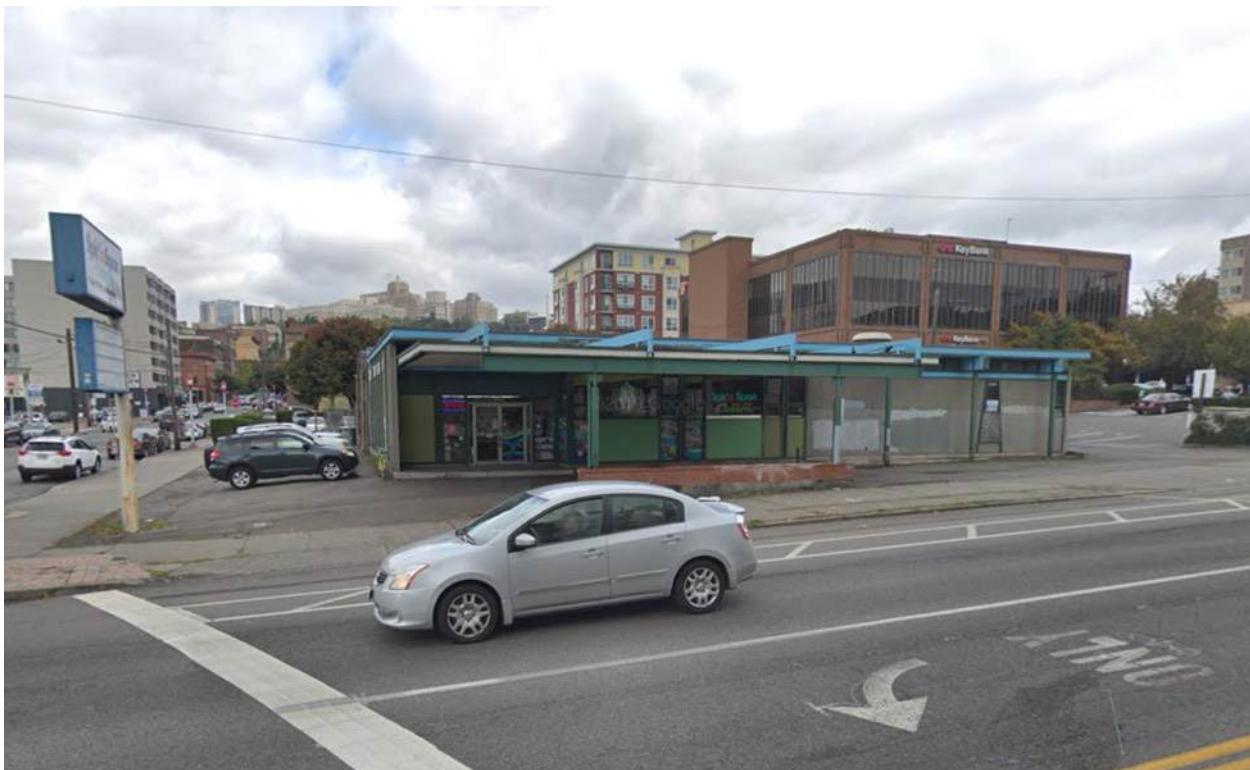
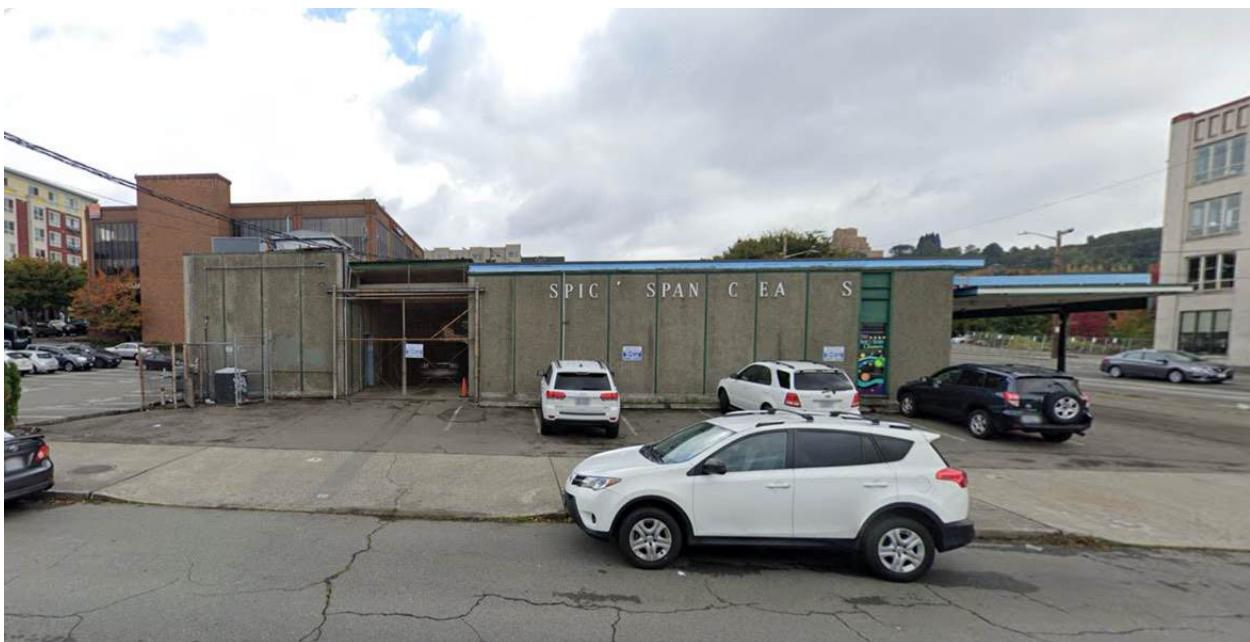
Views of the building from 2018, while it was still operating as Spic'N Span Cleaners. Top view is looking northeast toward the primary south façade on S. Dearborn Street; bottom view is looking east from Maynard Ave S. toward the west façade. (Google street view, both images)

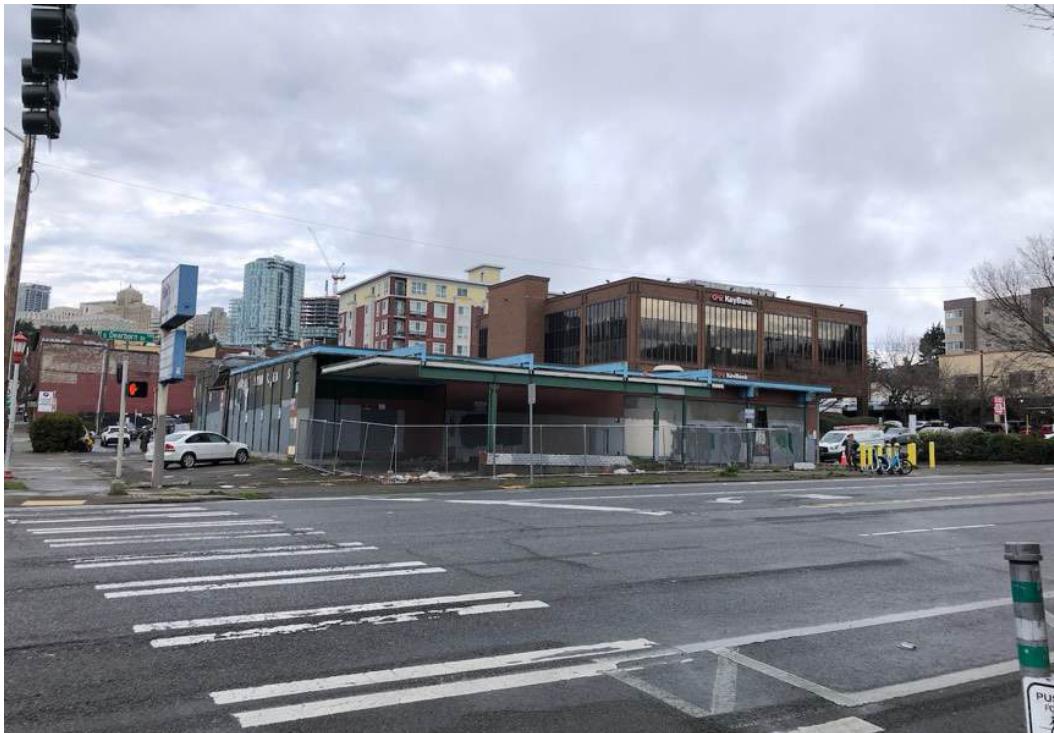
Looking northeast across S. Dearborn Street, toward the primary south and east façades of the building.

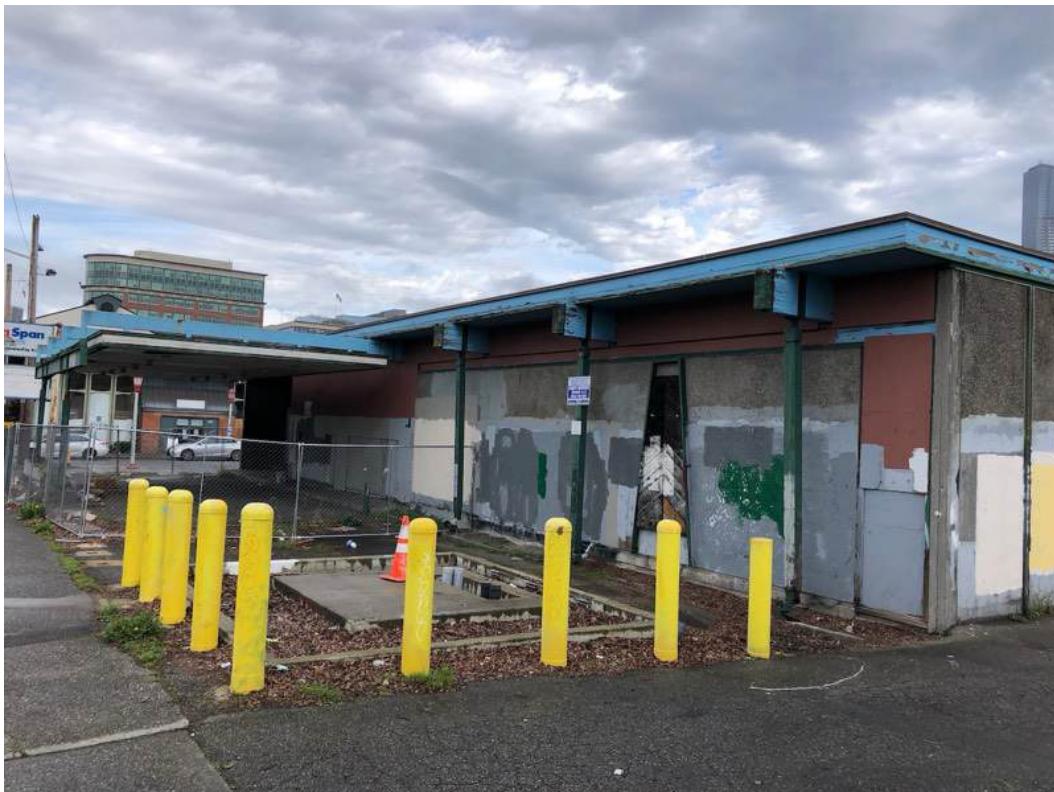
Looking northwest along the primary south (Dearborn) façade of the building.

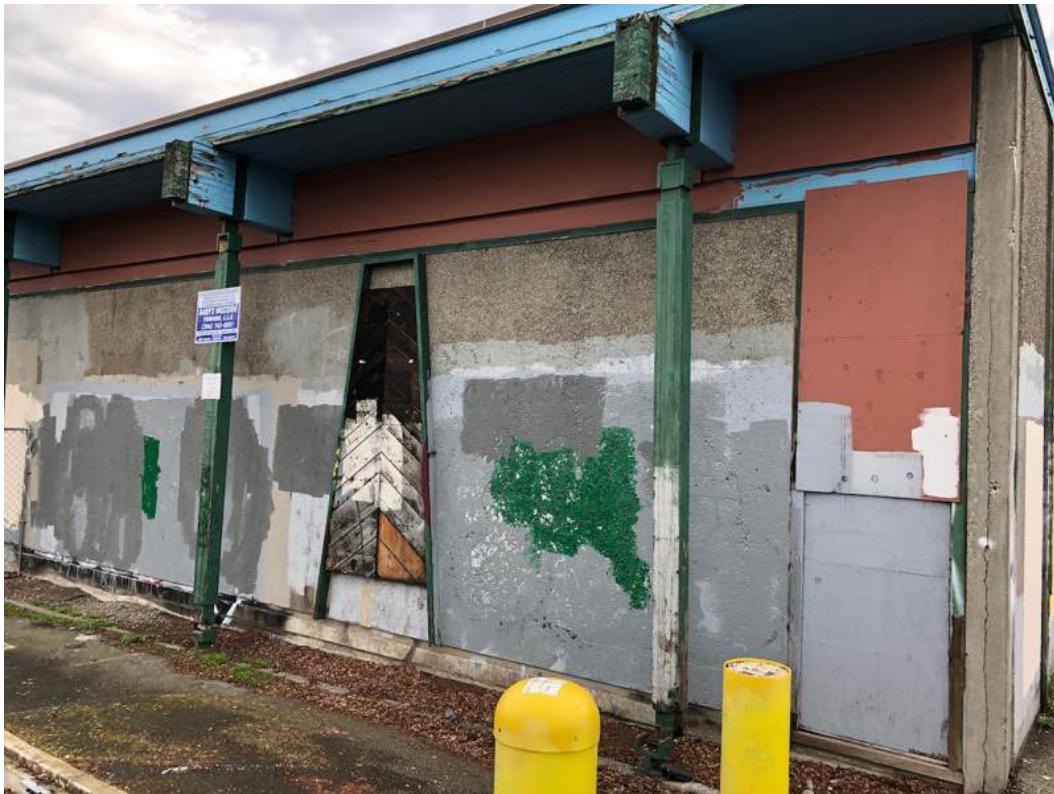
A closer view at the eastern end of the south (Dearborn) façade of the building.

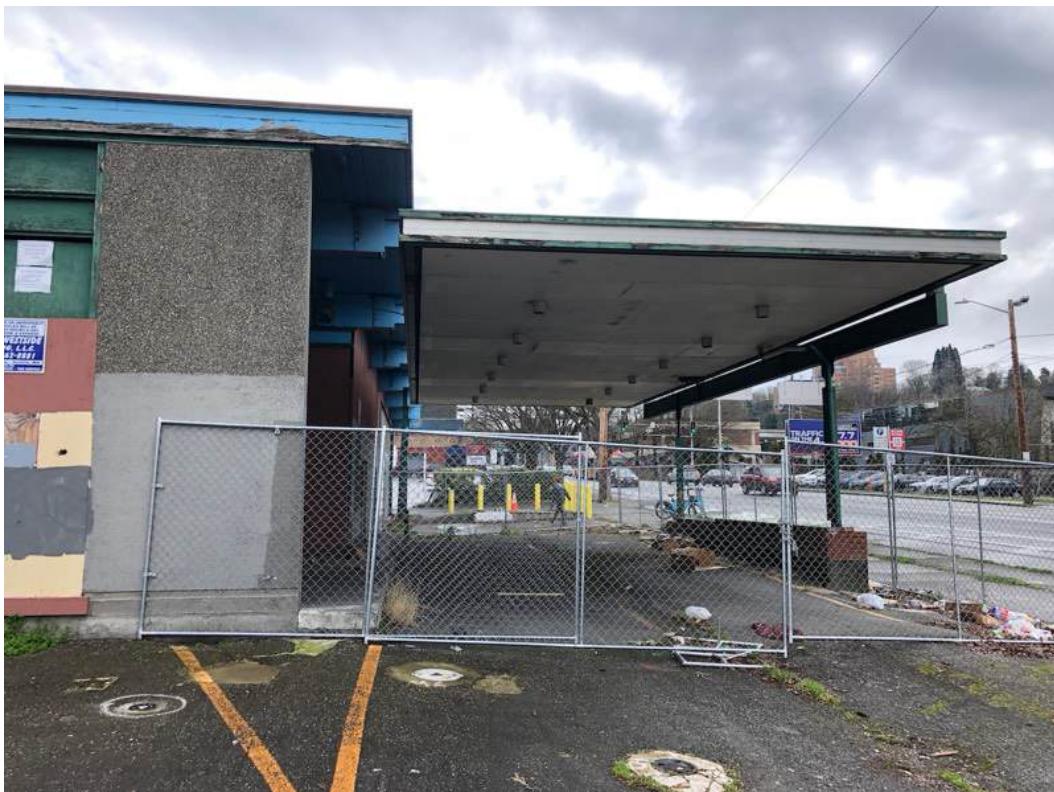
Looking east at the south end of the building, where the canopy extends over the former customer drop-off area.

- 1947 (#384315) Build store bldg. per plan [never built]
- 1963 (#502315) Construct buildings (2), \$80,000, dry cleaning workshop
- 1963 (#502766) Install underground storage tank
- 1963 (#504338) Erect & maintain sign, \$3,000
- 1964 (#505683) Extend existing cov. passageway arcade between (2) exist. bldgs.
- 1965 (#513852) Canopy support remodel / install new steel beam to support ex. Canopy
- 1967 (#520950) Erect & maintain 2 dual-faced electric signs
- 1991 (#658351) Emergency structural repair to canopy located over customer pick-up area

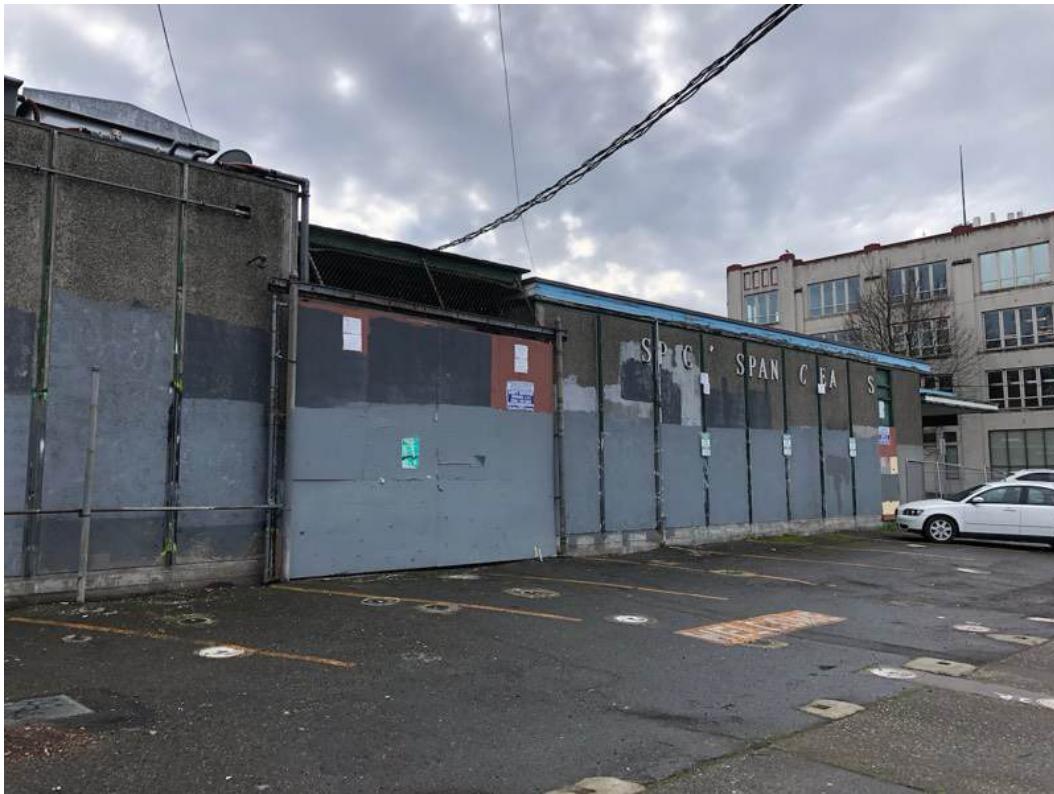
Looking southeast along the west (Maynard) façade of the building.

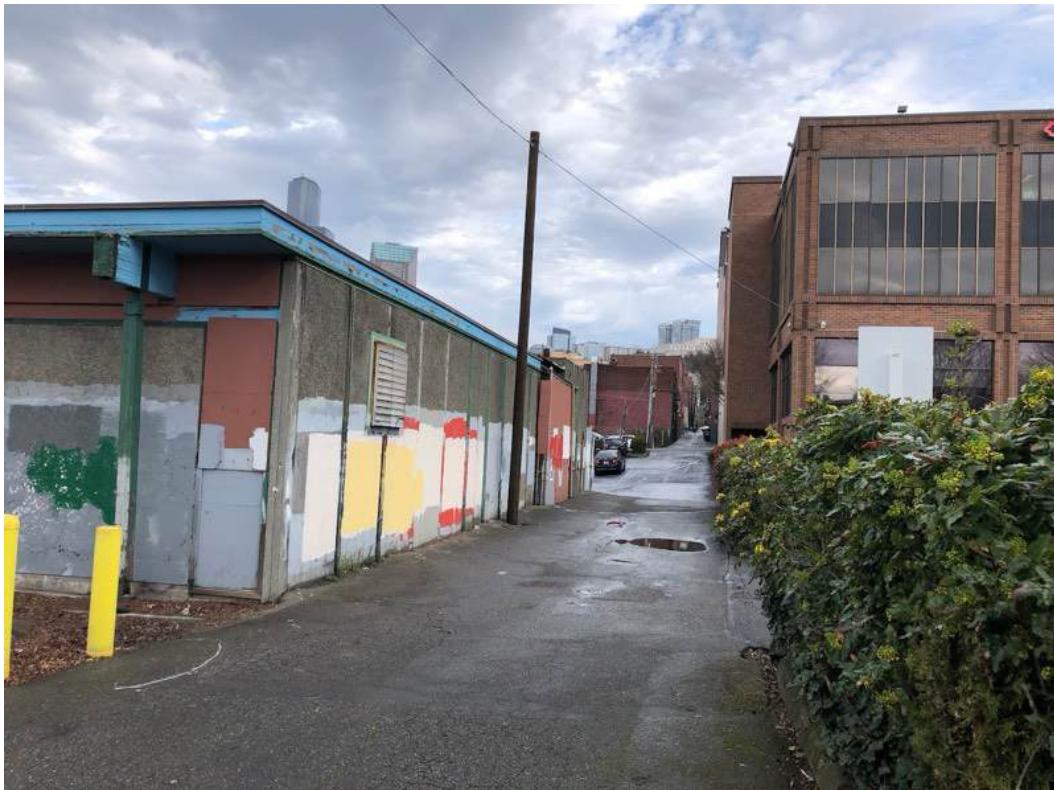
Looking northwest in the alley, along the east façade of the building.

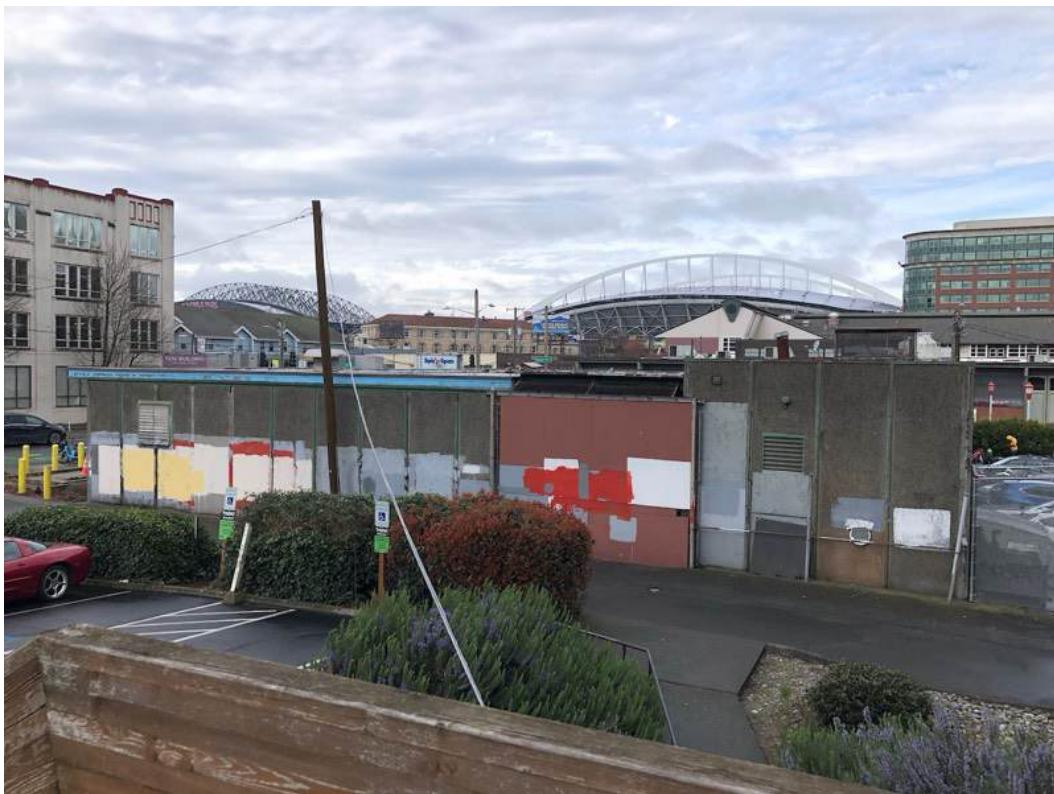
Looking southwest from the porch of the neighboring Key Bank building, toward the east façade of the subject building.

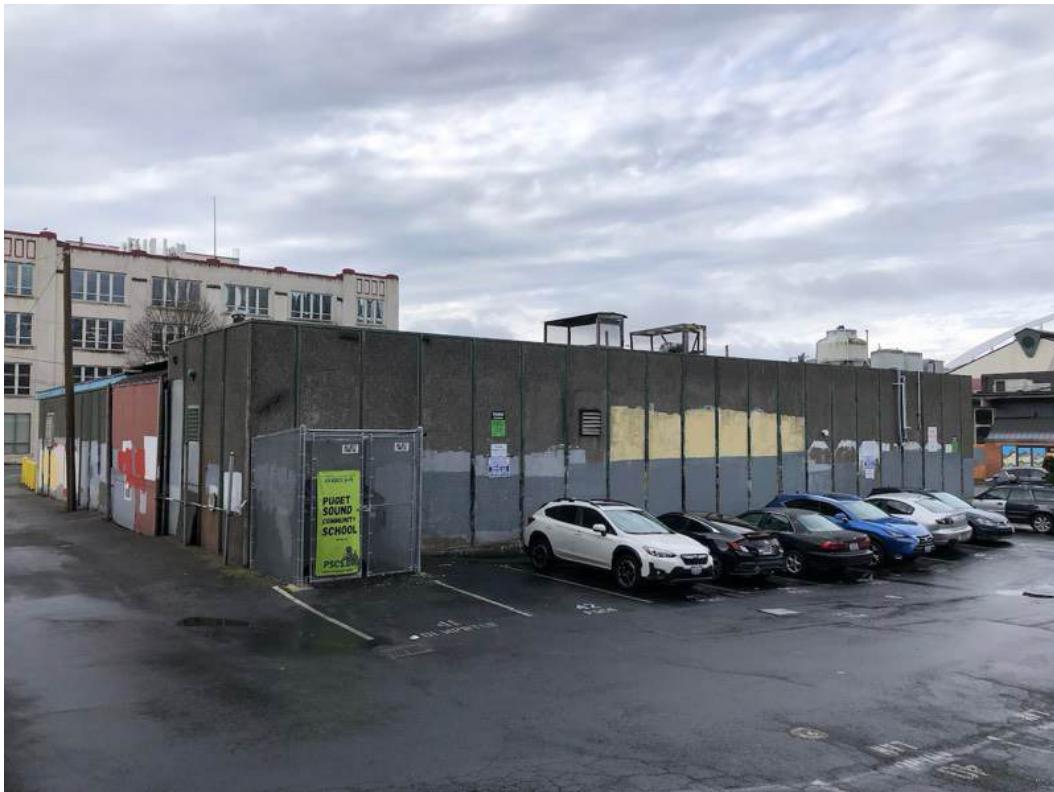
Looking southwest from the alley, toward the north (rear) façade of the building.
