JANUARY 2023
HISTORIC RESOURCES REPORT

1265 S KING STREET

1265 S KING STREET HISTORIC RESOURCES REPORT

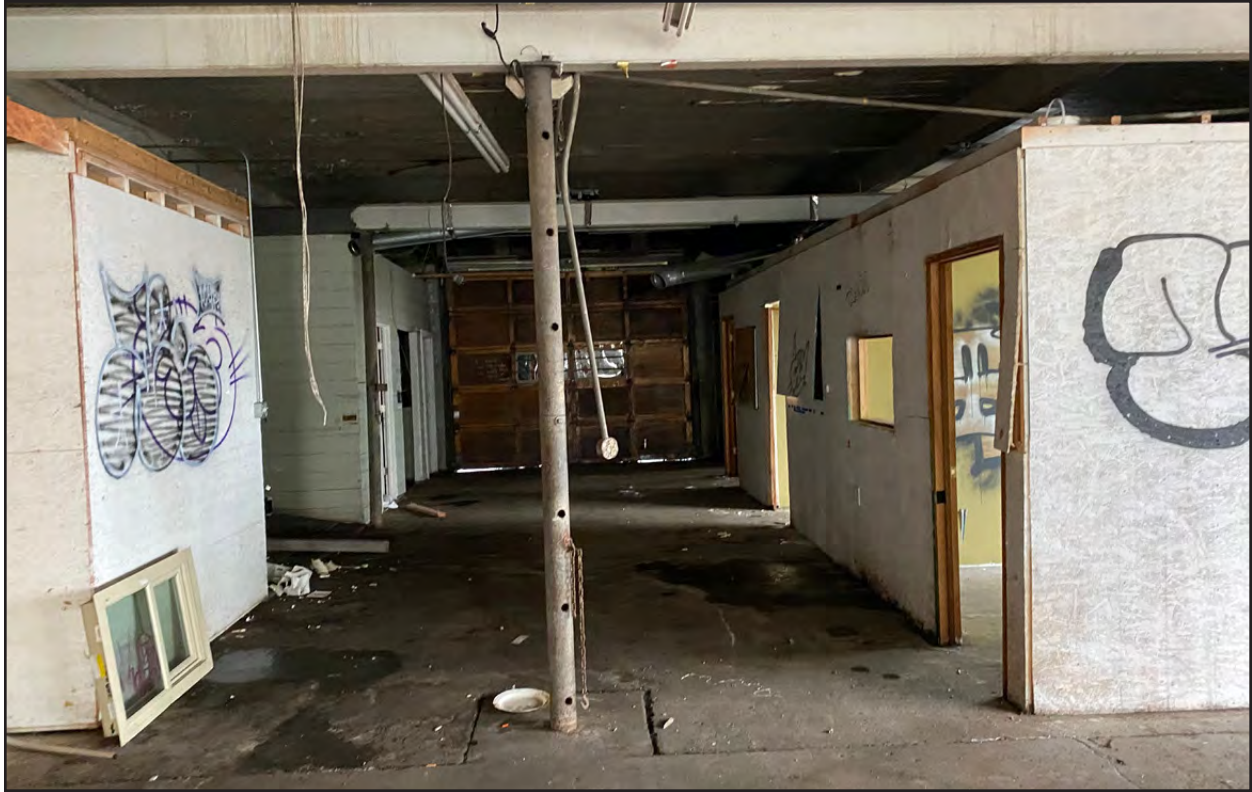
Figure 14 • 1265 S King Street, detail of hollow CMU and CMU condition

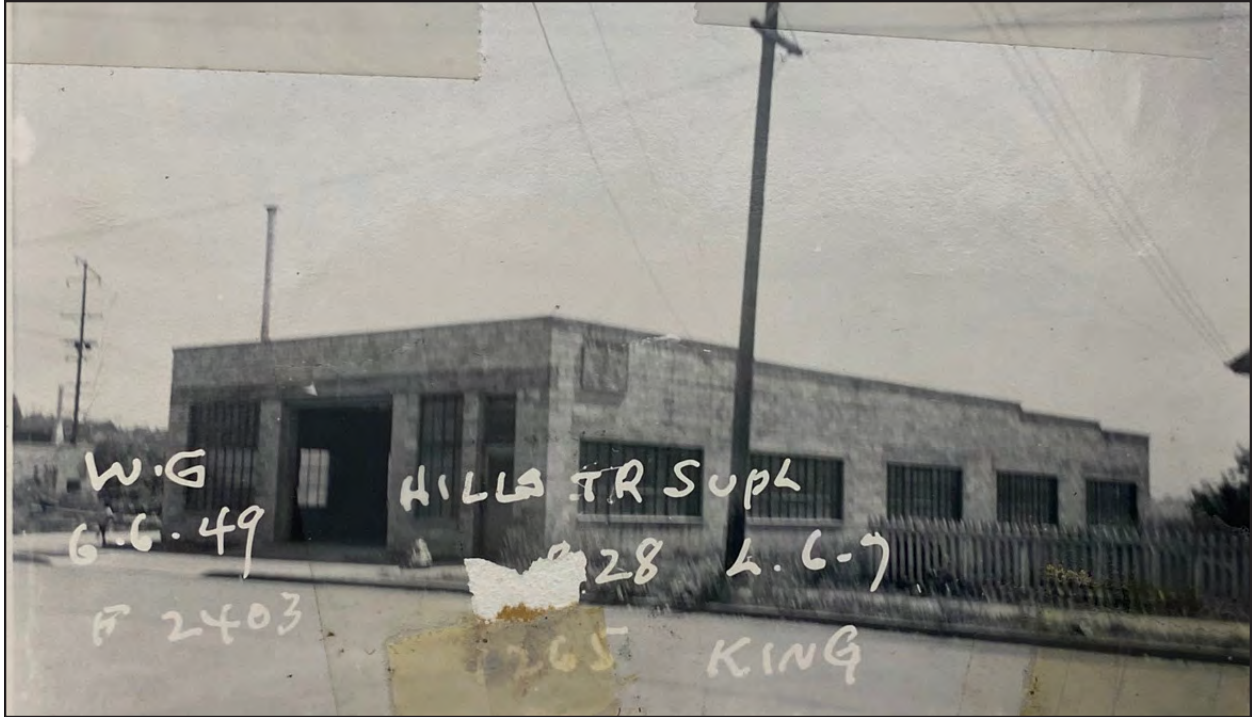
Figure 19 • City of Seattle Permit no. 388412 for 1265 S King Street

Date:	Build OM Repair Garage per plan filed. Owner contractor	Permit No.
1948	and architect James McCray	388412
