Prefontaine Fountain

Schematic Design Options for Rehabilitation

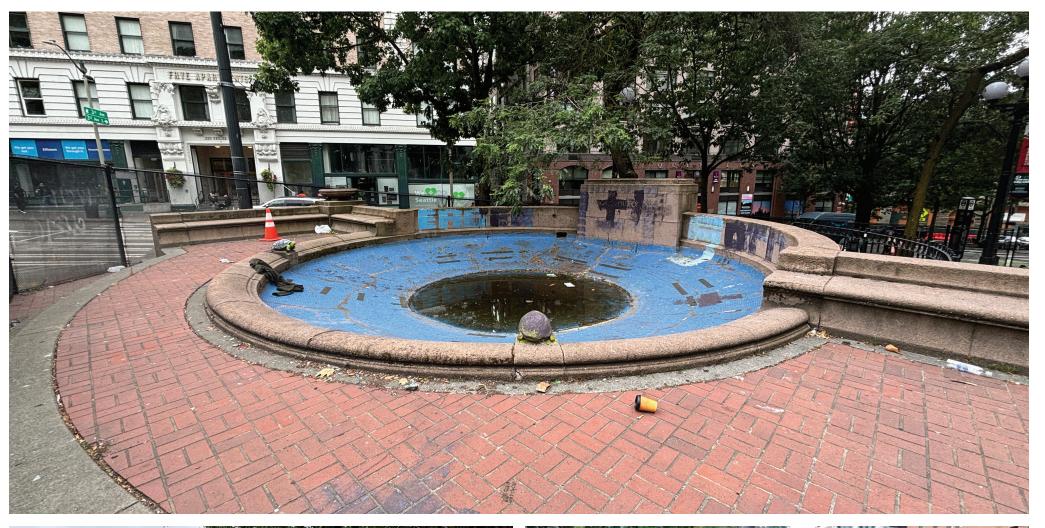
1. New electrical and plumbing services.

- 2. Wall heights in combination with street slopes create hiding spots and lack of visibility.
- 3. Fountain bowl feature encourages garbage accumulation.
- 4. Fountain in its current position is most susceptible for vandalism and vagrancy.

- 5. Existing structure blocks access through the site, causing users to avoid the area.
- 6. Re-establish community investment in the space.
- 7. Turtles are broken and are not suitable vandal-resistant elements.
- 8. Opportunity for new commemorative plaque.
- 9. Three trees internal to the Prefontaine Place property are in poor health condition and must be removed. Opportunity for one new tree(TBD). Street trees to remain.

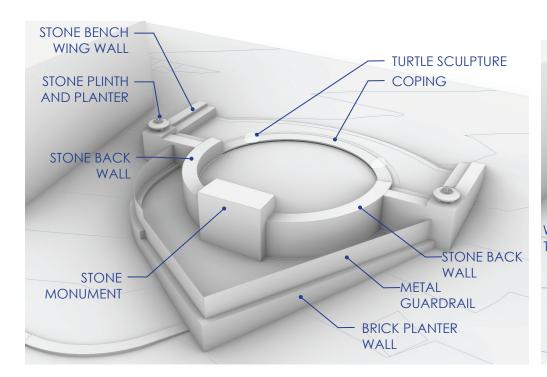
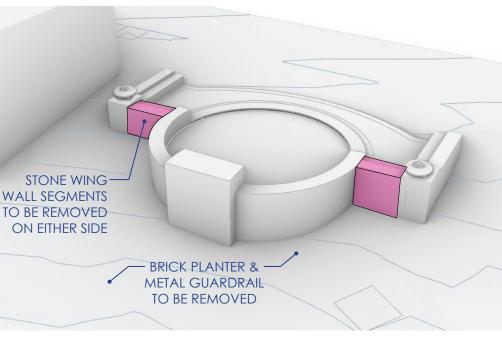
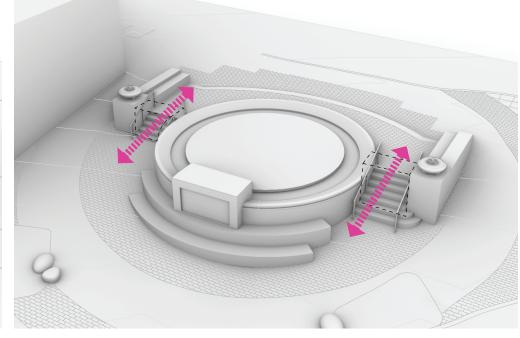
PROPOSED CONCEPT:
STAIR ACCESS THROUGH THE FOUNTAIN AREA

Studies on this page compare existing architectural features that make up Prefontaine Fountain, identifying a strategic removal of two short wall segments to increase mobility in and around the fountain.

These modifications respond to high priority recommendations identified by SDOT in the 2019 Public Life Action Plan to improve safety, mobility and circulation around the Sound Transit head house. By removing the wall segments and installing stairs two additional pathways are created, effectively doubling the amount of space to move through the area.

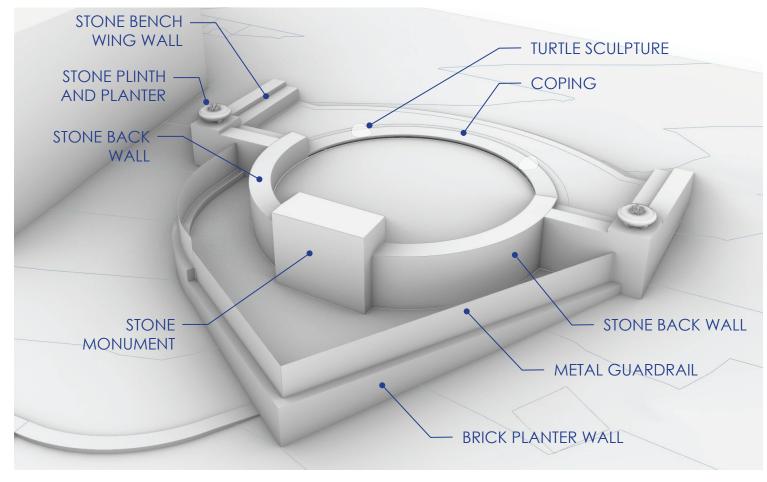
EXISTING CONDITIONS

In order to improve sight lines through the area to remove blind spots where people hide, we are also exploring reducing the height of the main monument and shoulder walls as depicted below.

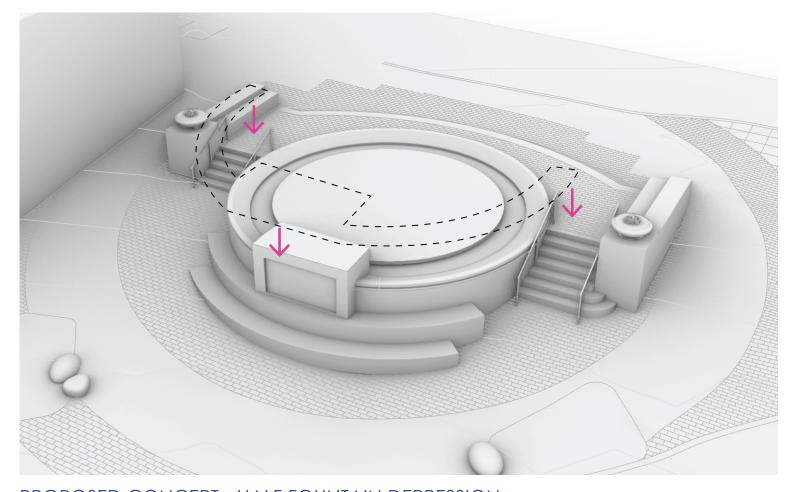
PROPOSED CONCEPT - HALF FOUNTAIN DEPRESSION

The diagram to the right proposes to reduce the main monument and wall heights to align with the existing coping elevation around the pool. This creates transparency and awareness of surroundings while you are passing through the area.

Back portion of fountain moves down to align with coping (about 2') engraved monument stone to be relocated and incorporated into lowered final monument. Future engraving or commemorative plaque to be incorporated onto the backside of the lowered stone monument facing out towards the lower plaza space. Turtle sculptures to be salvaged and returned to the original donor.

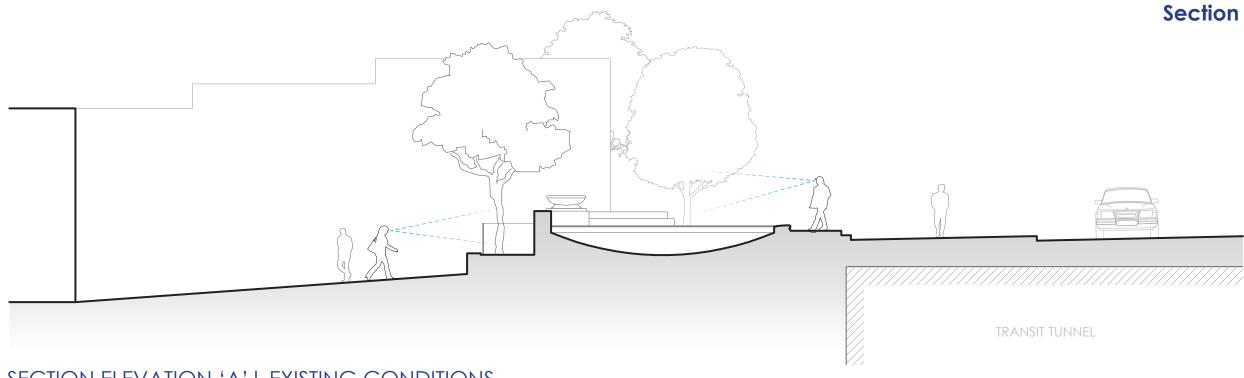
SECTION ELEVATION 'A' | EXISTING CONDITIONS

SITE SECTION COMPARISON WITH VIEWSHEDS | Section Elevation 'A'
