**The J&M Hotel and Annex**  
**Historic Review**  
**201-205 1<sup>st</sup> Avenue South**

**October 15, 2015**

**BOLA Architecture + Planning  
October 15, 2015**

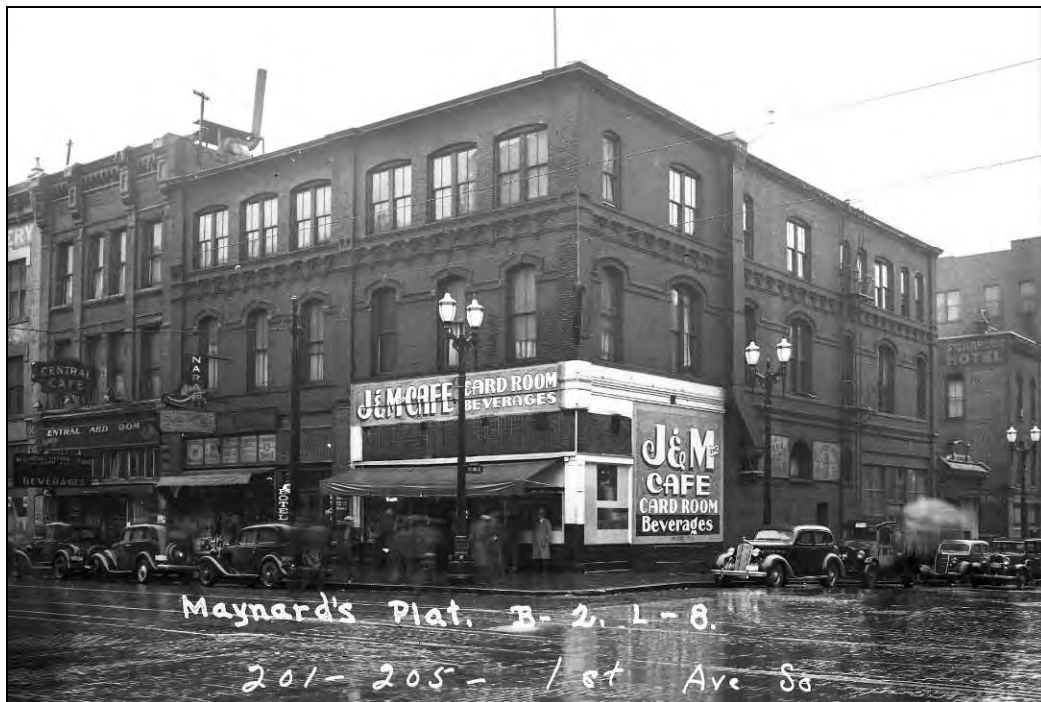
**Figure 24.** Above the 1937 Tax Assessor's photo (King County Assessor's Office, Puget Sound Regional Archives). The J&M Cafe became the occupant of the northeast 1<sup>st</sup> floor space in 1923. As shown in this image, portions of the exterior masonry were painted. The other tenants were the NARA Store, at 205 1<sup>st</sup> Avenue S, and the hotel with its entry in at 203 1<sup>st</sup> Avenue S. Also shown is the one-story building to the west (far right) facing S Washington Street, known as "the Annex." The two buildings were assembled later as a single tax parcel.

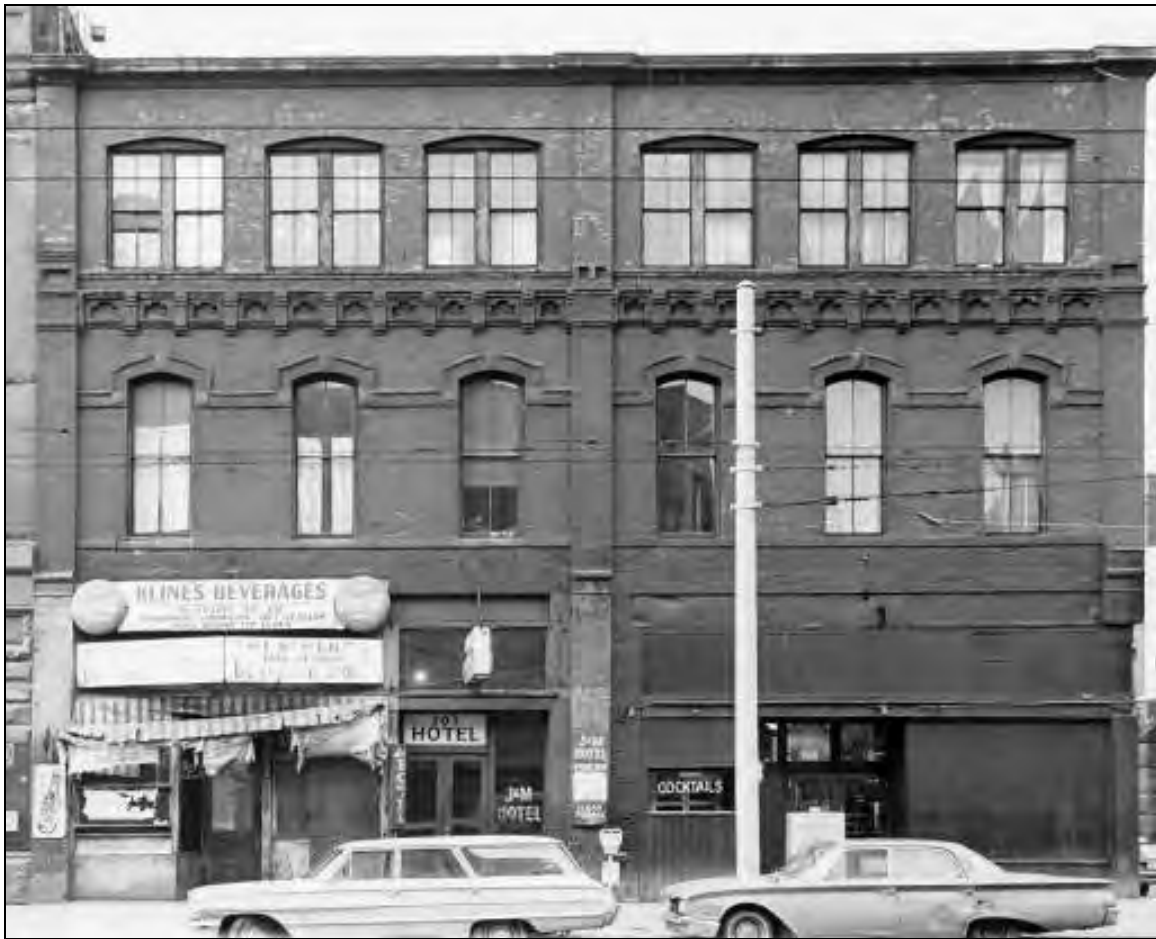
**Figure 26.** Above, the building in 1969. By this date, the J&M Cardroom, at 201 1<sup>st</sup> Avenue S, had become a cocktail lounge, with plywood covering the original display windows to comply with State liquor laws. The J&M Hotel, at 203, had its lobby accessible through storefront doors. A small grocery store was in the retail space to the south (left) at 205 1<sup>st</sup> Avenue S (Victor Steinbrueck photograph, UWLCS Order SEA3055).

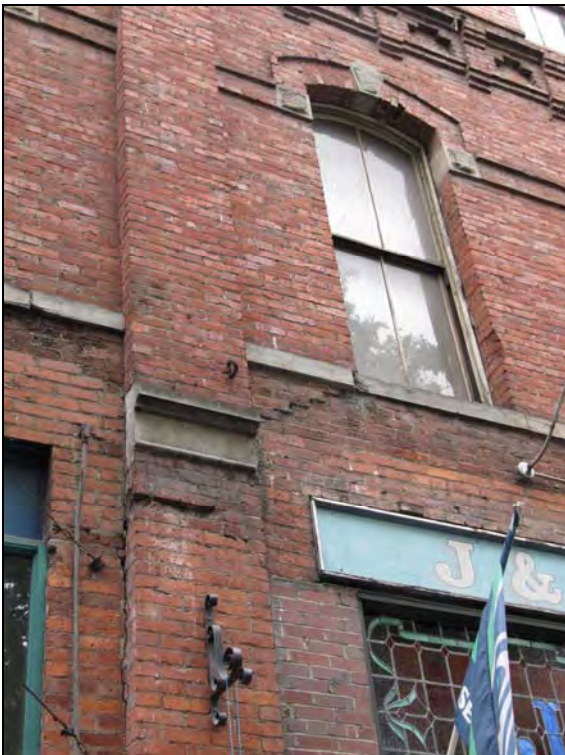
Figure 39. Below, detail view of the masonry pilaster, first floor sign band and second floor window, east facade.

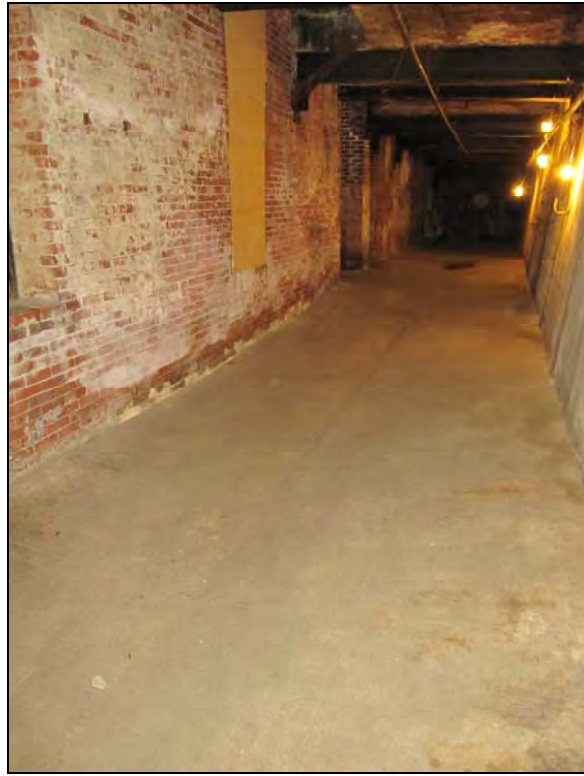
Figure 42. Below, infilled arched head opening between the basement and areaway.

double-coursed segmental arched brick headers and projecting brick sills. Lacking glass and some missing sash, these windows presumably had 1:1 glazing. Below these there are three equally spaced infilled windows with arched head openings, which presently are below the alley grade.

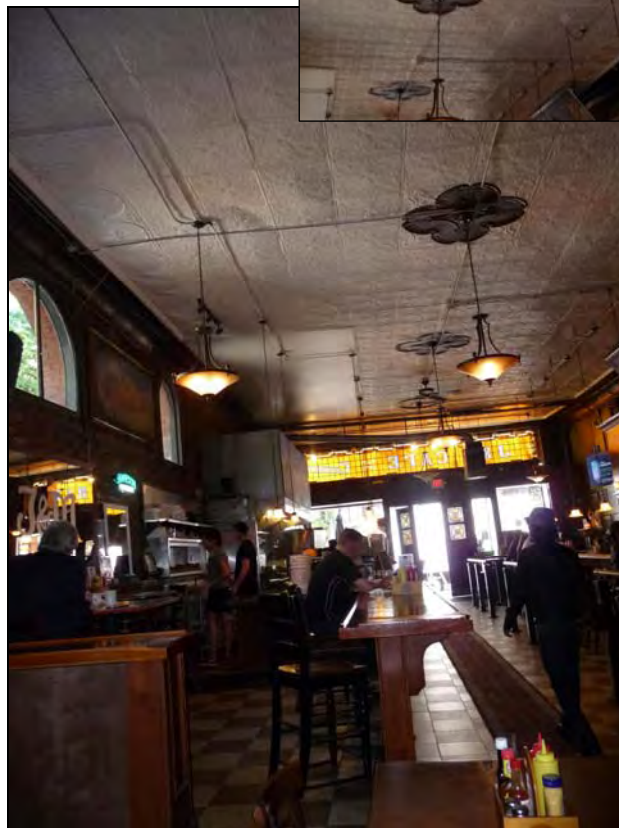
**Figure 47.** Below, interior view looking northeast in the same space toward the original hotel entry and lobby space. Note the original ceramic floor tile pattern.

At the first floor, the hotel entry lobby space retains some of its hexagonal-shaped and 1-inch square glazed ceramic mosaic, and portions of the early Greek Key perimeter pattern in the white and green tiles. This former lobby space also features stained wood column capitals with shaped trim.

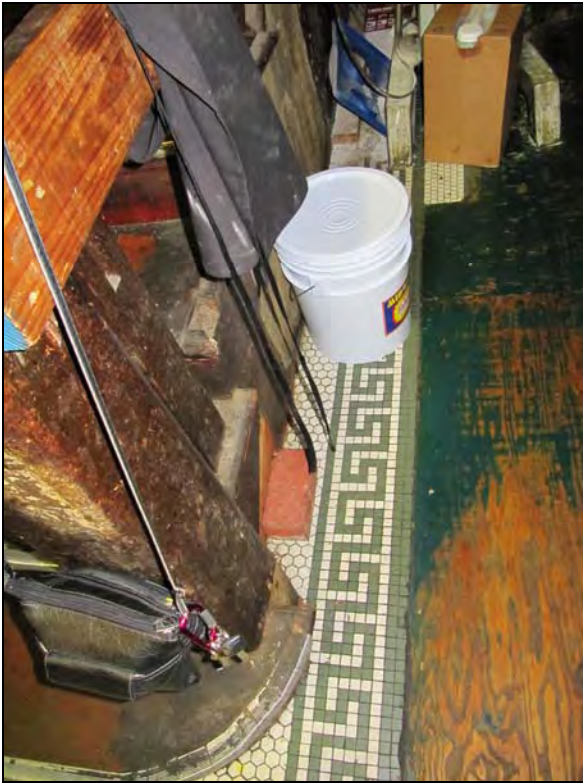
Figure 48. Above left, edge detail in the ceramic tile floor.

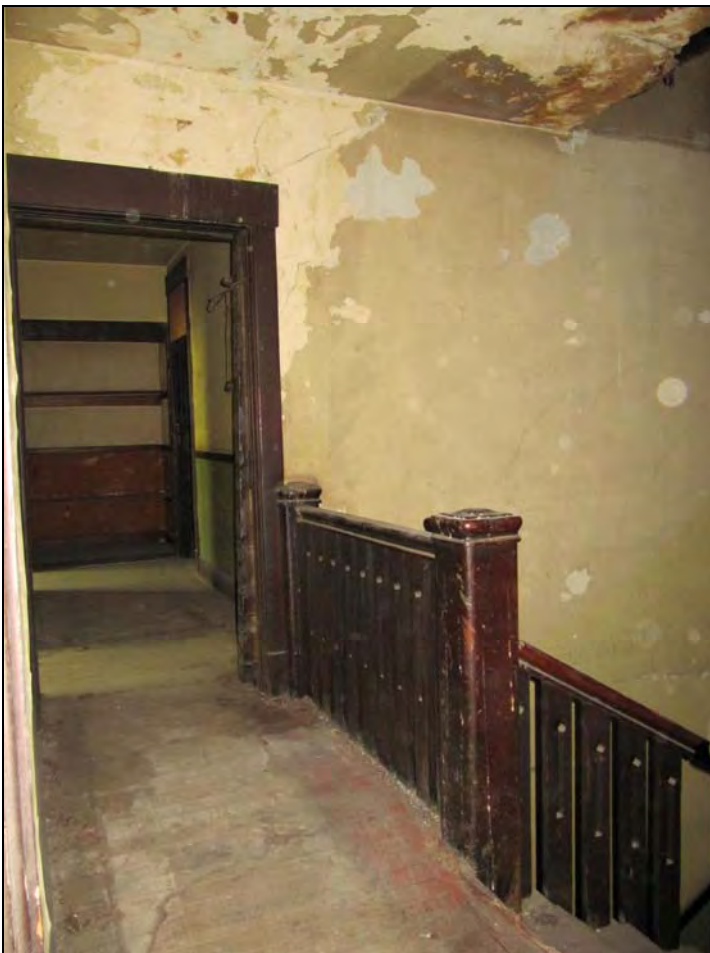
**Figure 52.** Left, view looking southwest at the stairwell and balustrade at the third floor.

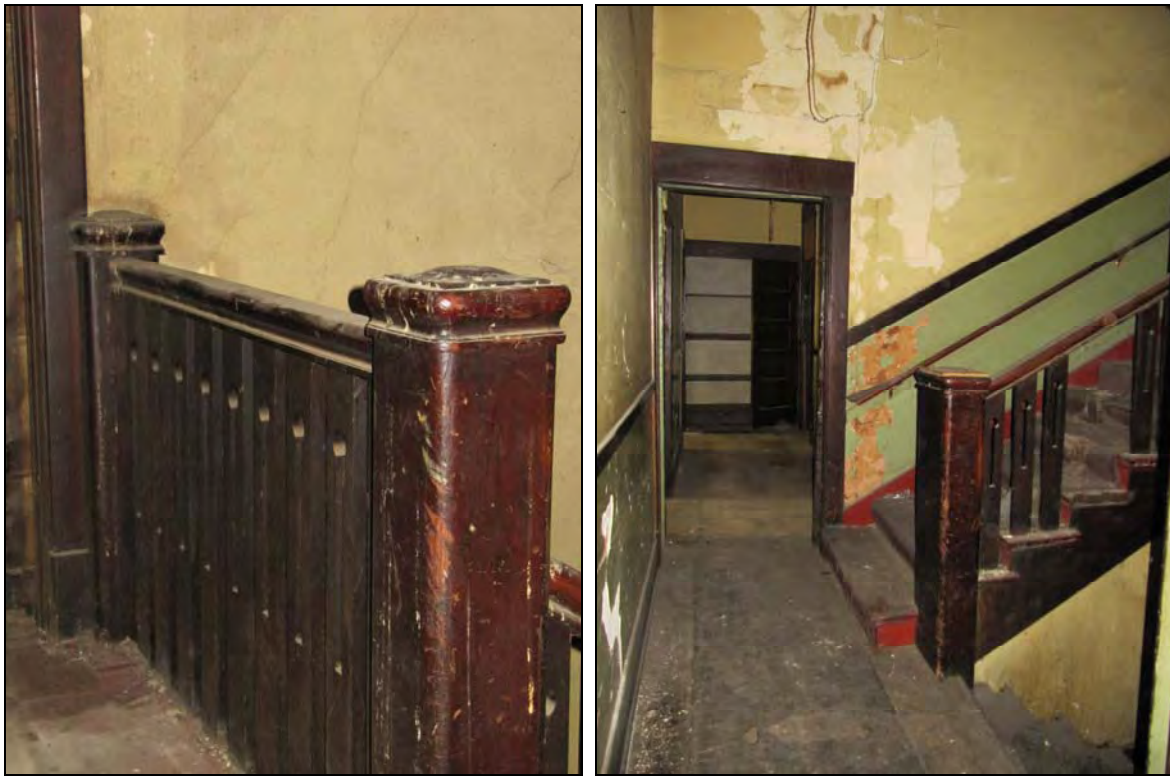
Figure 53. Above left, detail view of the primary stairwell balustrade.

Figure 54. Above right, view of the intermediate hall and primary stair at the second floor.

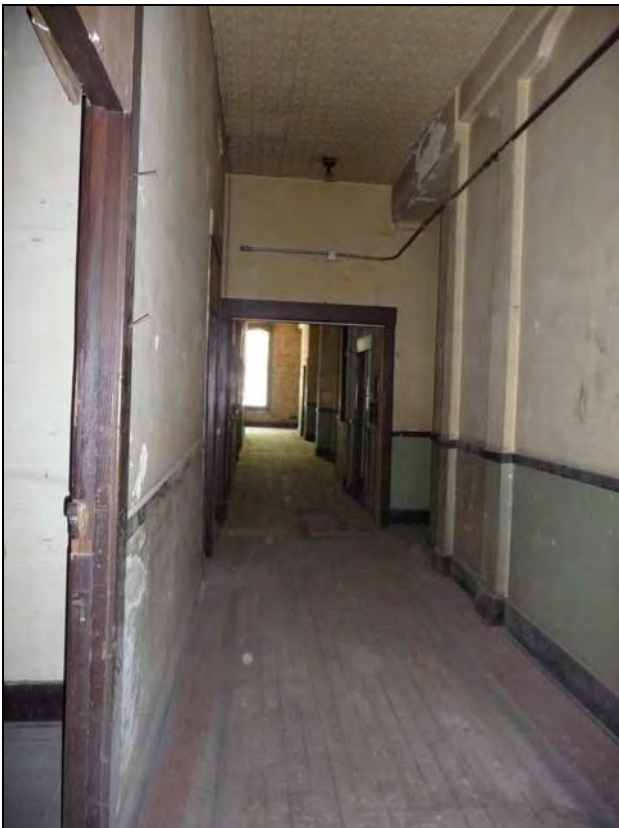
**Figure 59.** Below, typical five-panel wood door. Note the glazed transom window above the door, which has been infilled and painted.

Interior doors are typically five-panel types, made of fir, with stained and painted finishes. Transom windows along the corridors were originally glazed to bring additional light into the guest room and corridor spaces. These doors feature painted flat trim, and jambs on plinth blocks at the floor. In addition to these, there are metal-paneled fire doors in concealed pockets, held on fusible links that would separate the spaces in case of a fire.

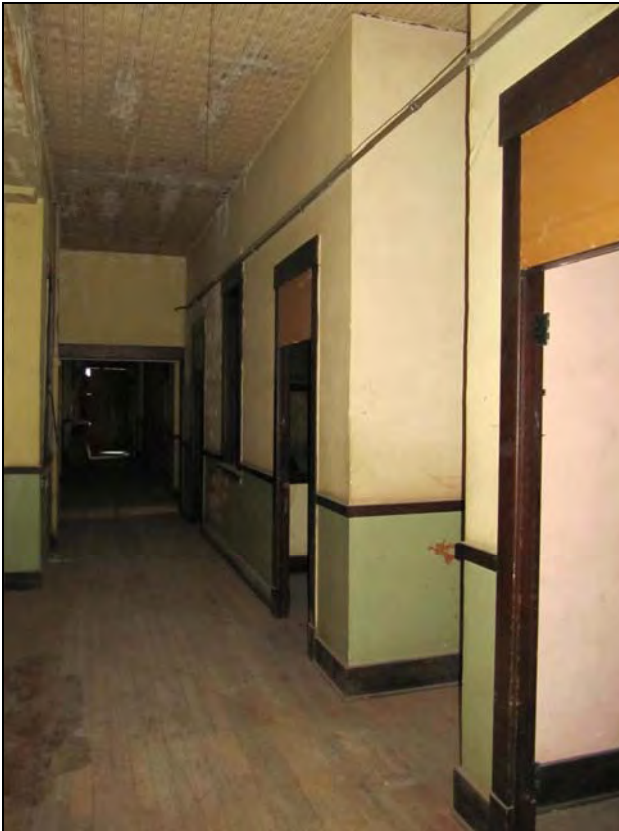
**Figure 58.** Left, view of the corridors showing typical finishes.

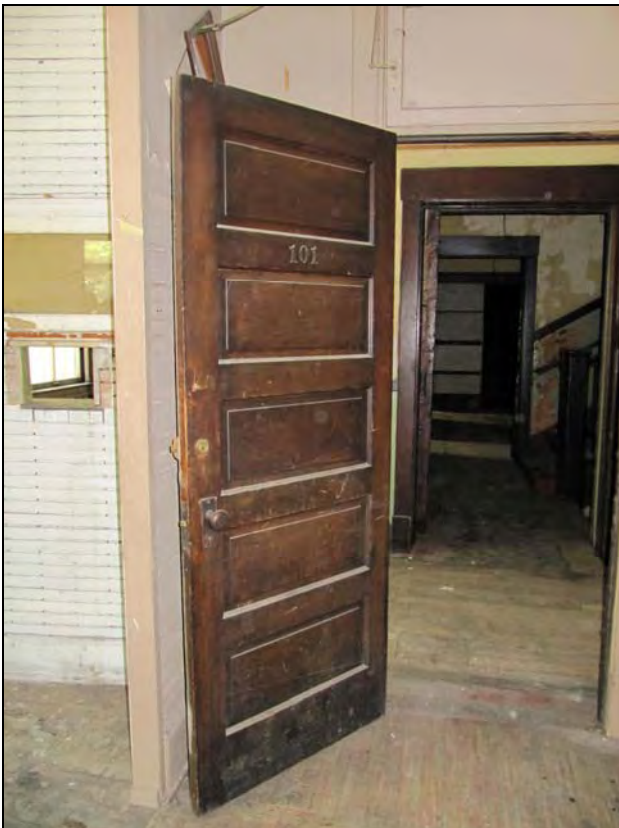
Figure 60. Below, painted metal ceiling panel.

Figure 61. Right, view within a perimeter guestroom showing the window, original radiator, and sink. Partitions suggest the space was subdivided at a later date.

Cast iron radiators speak to the original steam heating system, with a Barker oil burner and auxiliary boiler providing the heat, as do ceiling-mounted electrical lights of the building's early electrification. Light fixtures in the retail spaces appear to be non-original, although some could be vintage fixtures, or of vintage character. On the upper floors some of the fixtures consist of an exposed wire and bare bulb.

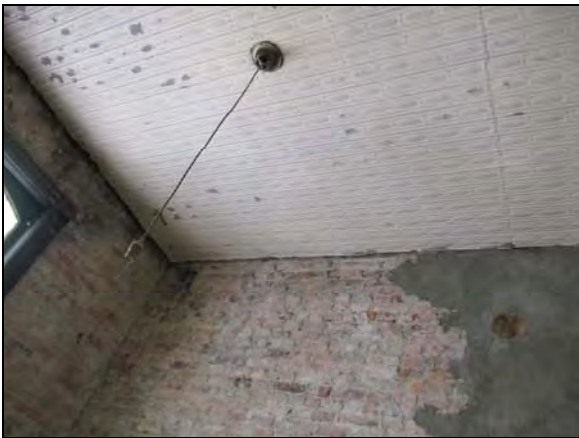
Figure 62. Bottom left, detail view of a ceiling fixture and ceiling panel.

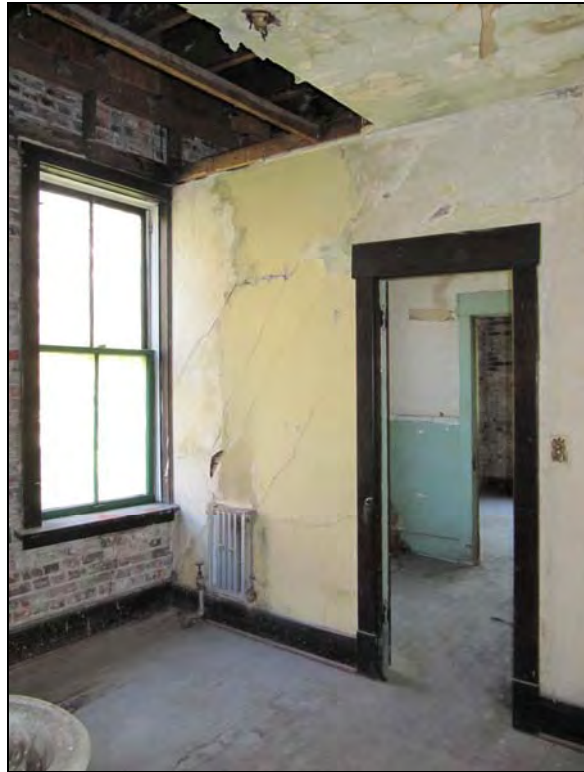
Figure 63. Bottom right, detail of a corner guestroom where plaster has been removed from walls, and the ceiling removed to access framing.

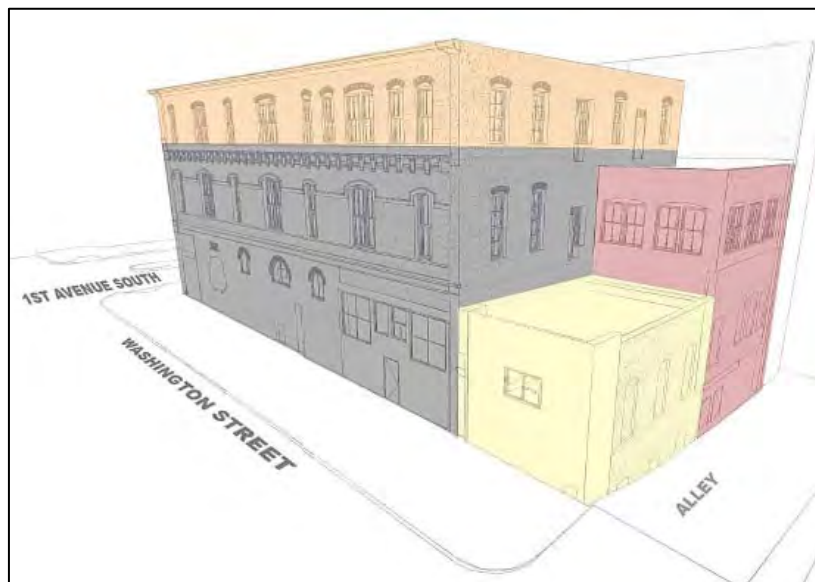
**Figure 65.** Below, a rendering of building's construction phases, in a view looking southeast on S Washington Street (by Weinstein A+U):

- The primary building (shown in dark gray) was built in ca. 1889-1900 as two-stories with a basement, and areaways on the north and east sides.
- The northern, one-story Annex section (shown in pale yellow) followed ca. 1893, also constructed with a basement and areaway. The original annex structure was setback from the street, with a slightly recessed north façade.
- A third floor (shown in pale orange), had been added to the original building by 1905 with the two-story southern portion of the Annex some time between 1900 and 1905 (shown in pink).

The 1905 Sanborn Map indicates that, by that date, the building had three stories along with a two-story section constructed to fill the back southwest portion of the property, south of a saloon in a one-story structure (the Annex) in the northwest corner of the property. This saloon structure had its height noted as 18', and it had a basement, but no access stairs. All three floors were occupied with bar fixture sales and cabinet shop with varnish room on upper floors, above a saloon/lunch café and store. (If the third floor of the building was constructed after early 1891, its design may have been undertaken by a different architect or by a contractor, as architects Comstock and Trotsche had by then left Seattle.)

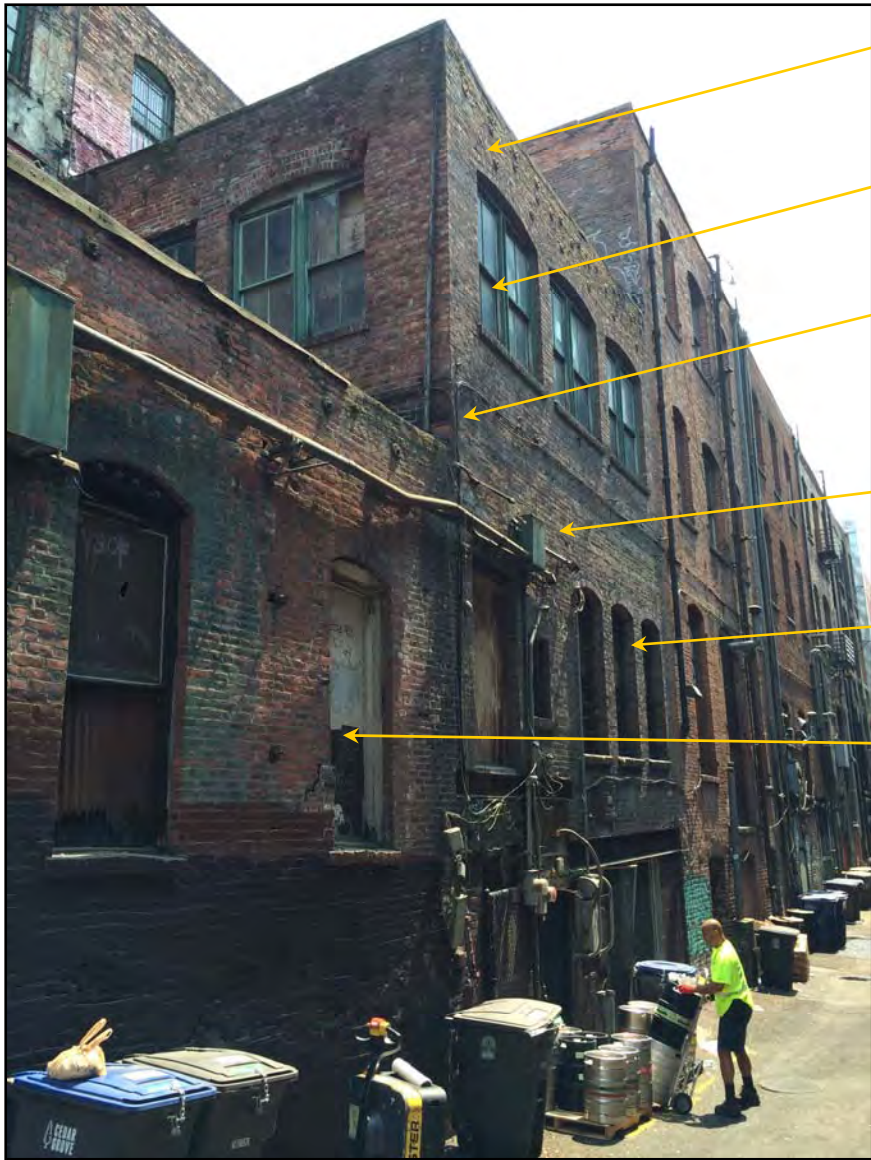
## J & M Annex Historic Character-Defining Features – Secondary West Façade

- Two-story flat roof mass at South Section, comprised of load-bearing brick masonry, approximately 12" thick, laid in a running bond with a header course every 7<sup>th</sup> course

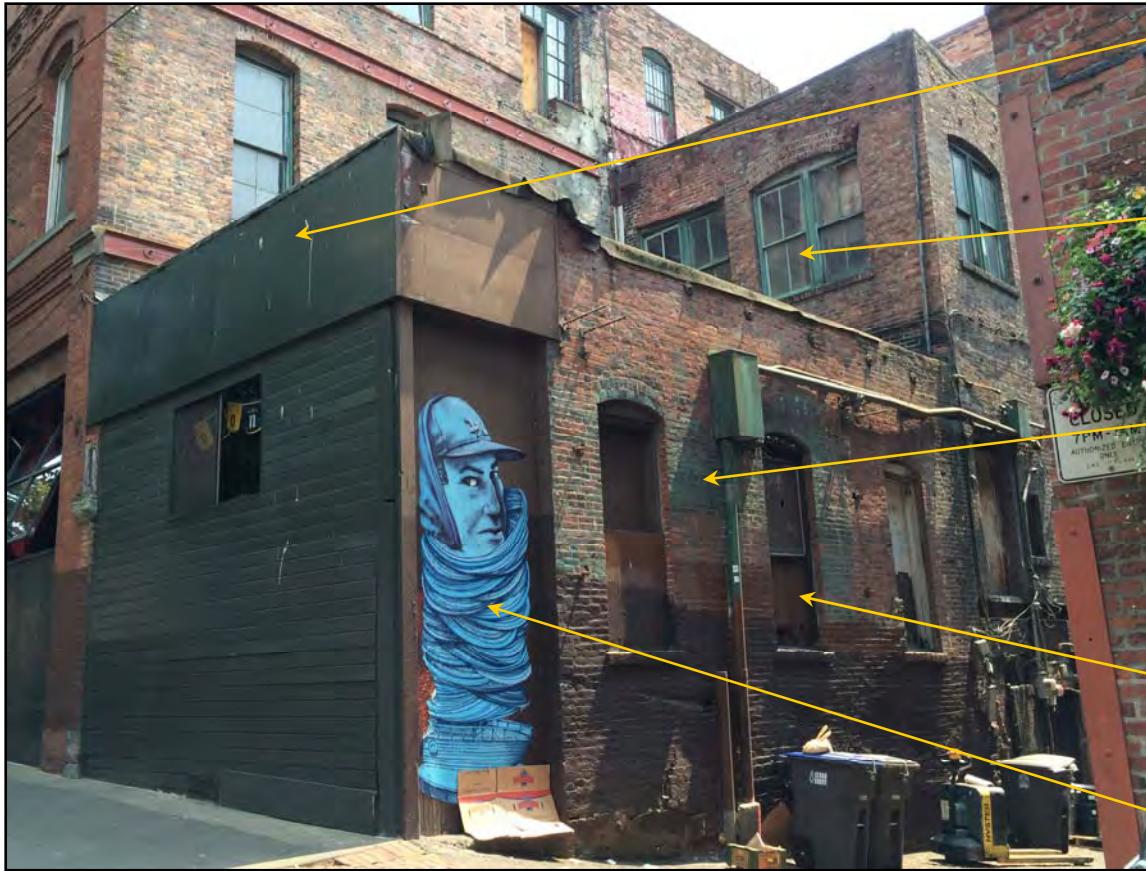
## J & M Annex Historic Character-Defining Features – Secondary West & North Façades

- Previous parapet and projecting sign board maybe revealed below existing north wall cladding (partly visible on west façade; requires exploratory selective demo)
- Two (2) pairs of double-hung 2:2 wood windows at 2nd floor north facade with triple coursed segmental row-lock arched brick header and projecting brick sills
- One-story flat roof mass at North Section, vertically separated from the two-story section with original masonry party wall at south end, comprised of load-bearing brick masonry, approximately 12" thick, laid in a running bond with a header course every 6th course
- Three (3) equally spaced infilled arched top openings on west façade at and below alley grade
- Masonry setback  $\pm 5'$  from north property line (identified by wood infill wall)

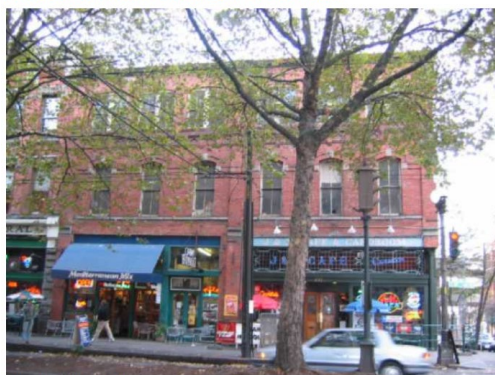
Photo collection for 201 1st AVE / Parcel ID / Inv #

This is a three story brick clad building with a small amount of stone trim. It is located on the southwest corner of First Avenue South and Washington Street. The plan of the building is rectangular. Its roof is not visible and it has a parapet, enhanced by a thin projecting cornice. The main elevation on First Avenue has a storefront with stained glass windows in the clerestory. On the second floor, the First Avenue facade consists of six single double-hung windows topped by segmental arches. The arches are further emphasized by ornamental keystone shapes in stone and small stone rectangular trim pieces on each side of the window opening. Thin raised bands link these rectangles visually and also follow the upper contours of the segmental shapes of the windows. Above the second floor, is a band of arched corbelled forms, topped by a series of slightly projecting bands. This was probably the original cornice of the 1889 portion of the building. Surmounting this, is a third level with six paired double-hung windows, surmounted by flatter segmental arches. The Washington Street elevation has similar window configuration and detailing in its eastern bay, but then has mainly paired windows with flat segmental arches on the second and third levels. The composition of this elevation is less regular. The ground level has several irregularly placed arched openings and two large trabeated openings toward the west. The interior of the café is known for its period metal ceiling.

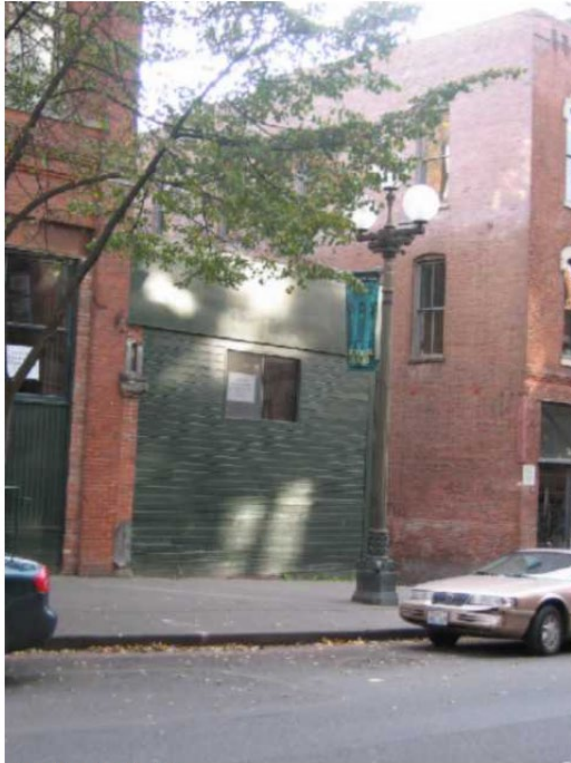
## Photo collection for 89 S Washington ST S / Parcel ID 5247800130 / Inv #

This small building adjoins the J & M Building and is currently considered part of the same parcel. It faces north on Washington Street and has an alley elevation facing west. The northern half of the building is one story, while the southern portion of the building, because of a grade change is three stories. The one story portion of the west elevation has three segmental window openings. The southern three story portion of the west elevation has segmental openings on its two upper stories and is filled in with new concrete block at the ground level. Currently, the north elevation is covered with horizontal tongue and groove siding and has a remnant of an original brick pier with a stone capital and a cast-iron base.
