# Cragin & Company/Mac's Smokehouse

Historic and Cultural Resources Report  
1006 1st Avenue South, Seattle, WA  
March 2009

Prepared by:  
The Johnson Partnership  
1212 NE 65th Street  
Seattle, WA 98115-6724  
206-523-1618, [www.tjp.us](http://www.tjp.us)

# **Cragin & Company/Mac's Smokehouse Historic and Cultural Resources Report**

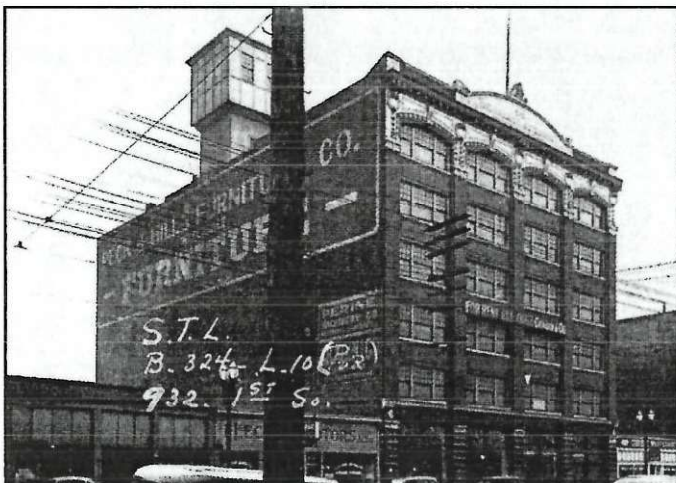
The 1937 tax photo shows a western façade with five bays of large glass storefront windows and a row of clerestory windows below a parapet advertising the West Coast Machinery Company, Incorporated. The northern third of the second bay from the north end of the façade contains a double door entrance to the building. *See Figure 15*

Figure 15 • 1000 1<sup>st</sup> Avenue S Tax Record Photos, 1937

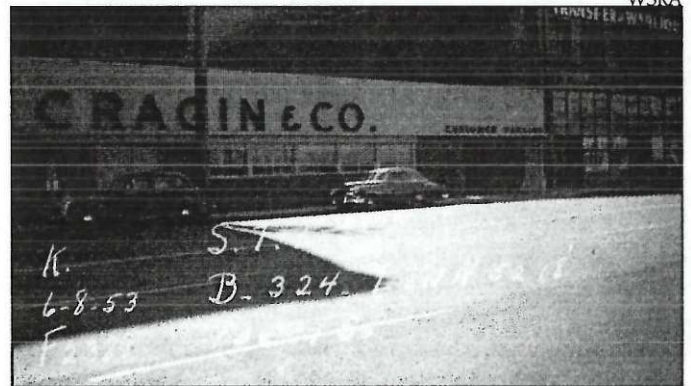
The 1953 tax photo shows the building had been remodeled and reduced in size to allow customers to access parking at the rear of the building, passing under the protection of a roof, approximately eight feet clear. A brick masonry veneer was added to the building at the lower level, and the storefront system was replaced with higher, but smaller linear openings below a metal siding parapet advertising Cragin & Company. The entrance remained in the same location as the 1937 photo. *See Figure 16*

The porte cochere feature was removed at some period between the 1953 photo and the most recent remodel of the building for Mac's Smokehouse. The red metal siding parapet covering and the brick masonry veneer were likely remodels that occurred at the same time.

Figure 16 • 1006 1<sup>st</sup> Avenue S Tax Record Photos, 1953
