# **MONTLAKE ELEMENTARY SCHOOL**

Certificate of Approval

Exterior Historic Stair Replacement and Revised Flag Pole Location

Revisions to the approved C of A scope for in-kind replacement of original entry stairs and modification of the proposed flagpole location.

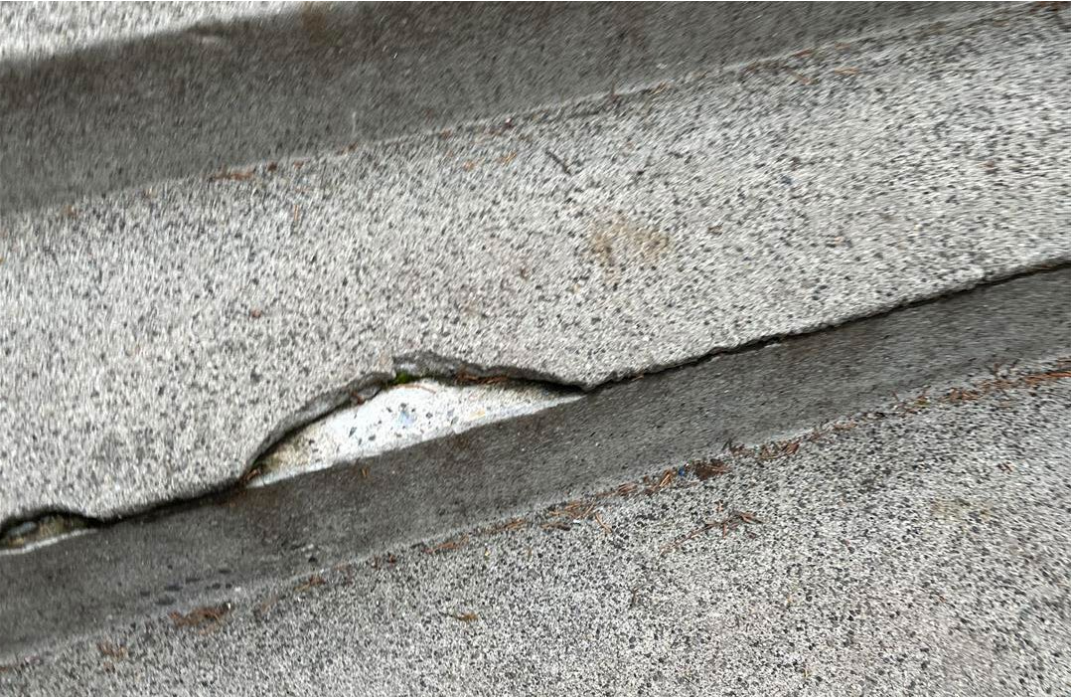
The concrete stairs were in fair condition prior to construction. Some areas of cracking and spalling were noted, but the preferred approach was to patch and repair the existing. DLR Group did note in their initial survey that these stairs had been re-surfaced in the past with a concrete topping over the original steps. The topping appeared to be holding in place for the most part with some areas of delamination noted at edges and nosings.

The existing wrought iron railings were in fair condition with the primary issues being weathered coatings in need of replacement. Some locations of localized oxidation were noted, but generally the railings appeared sound.

Stair photos taken before construction by DLR Group. November 2021

As construction progressed, regular foot traffic on the stairs exacerbated the delamination of the topping material. The decision was made to remove the existing stairs and replace them in-kind with new concrete steps. The existing railing was salvaged and re-installed per the details of this package and restored per the originally submitted "Metal Restoration" specifications.

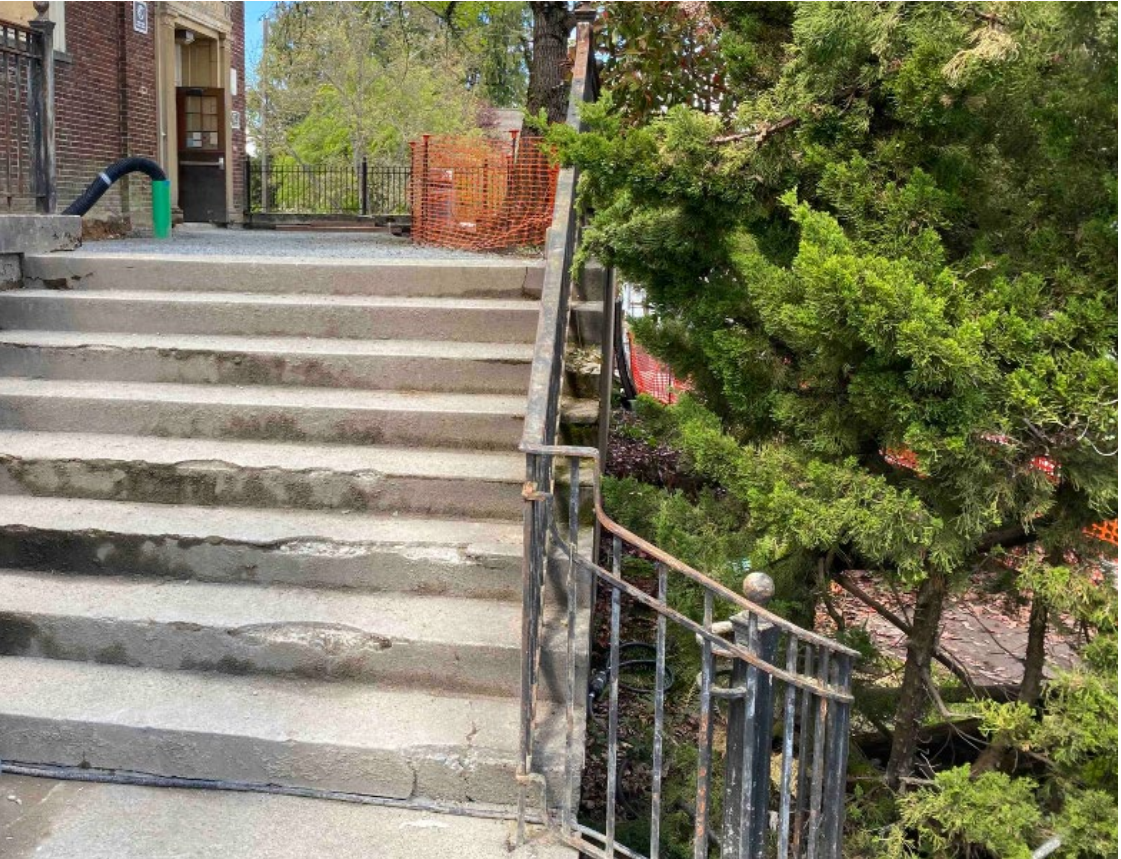
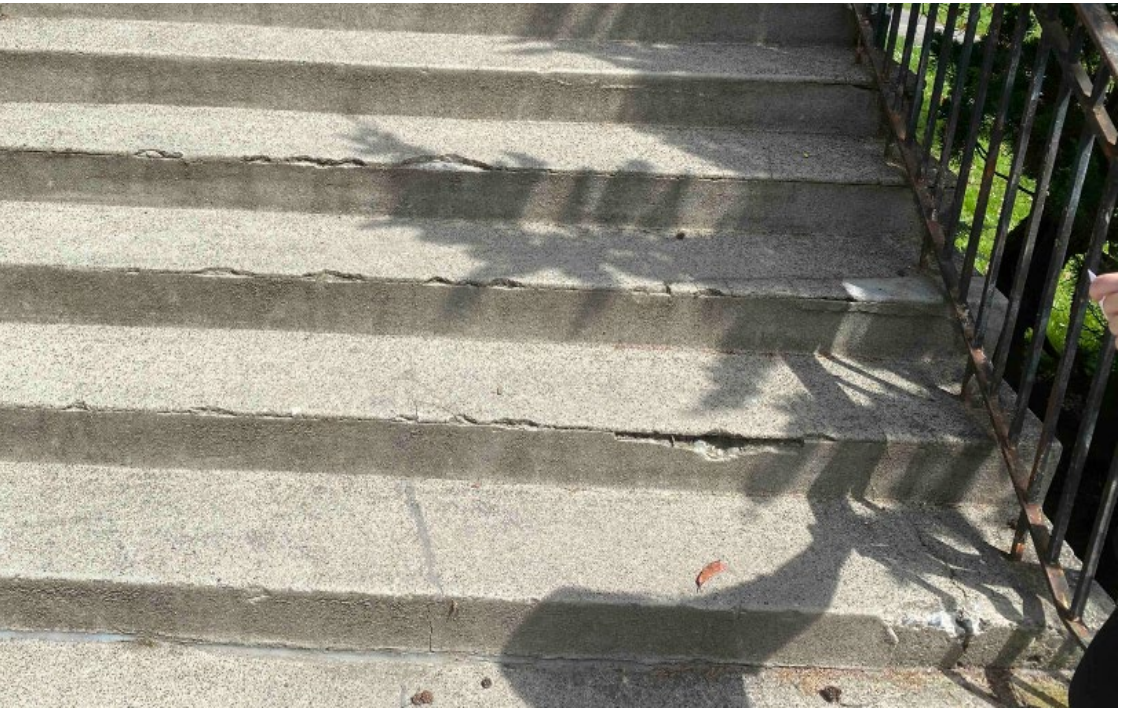
Stair photos taken during construction by DLR Group, April 2024

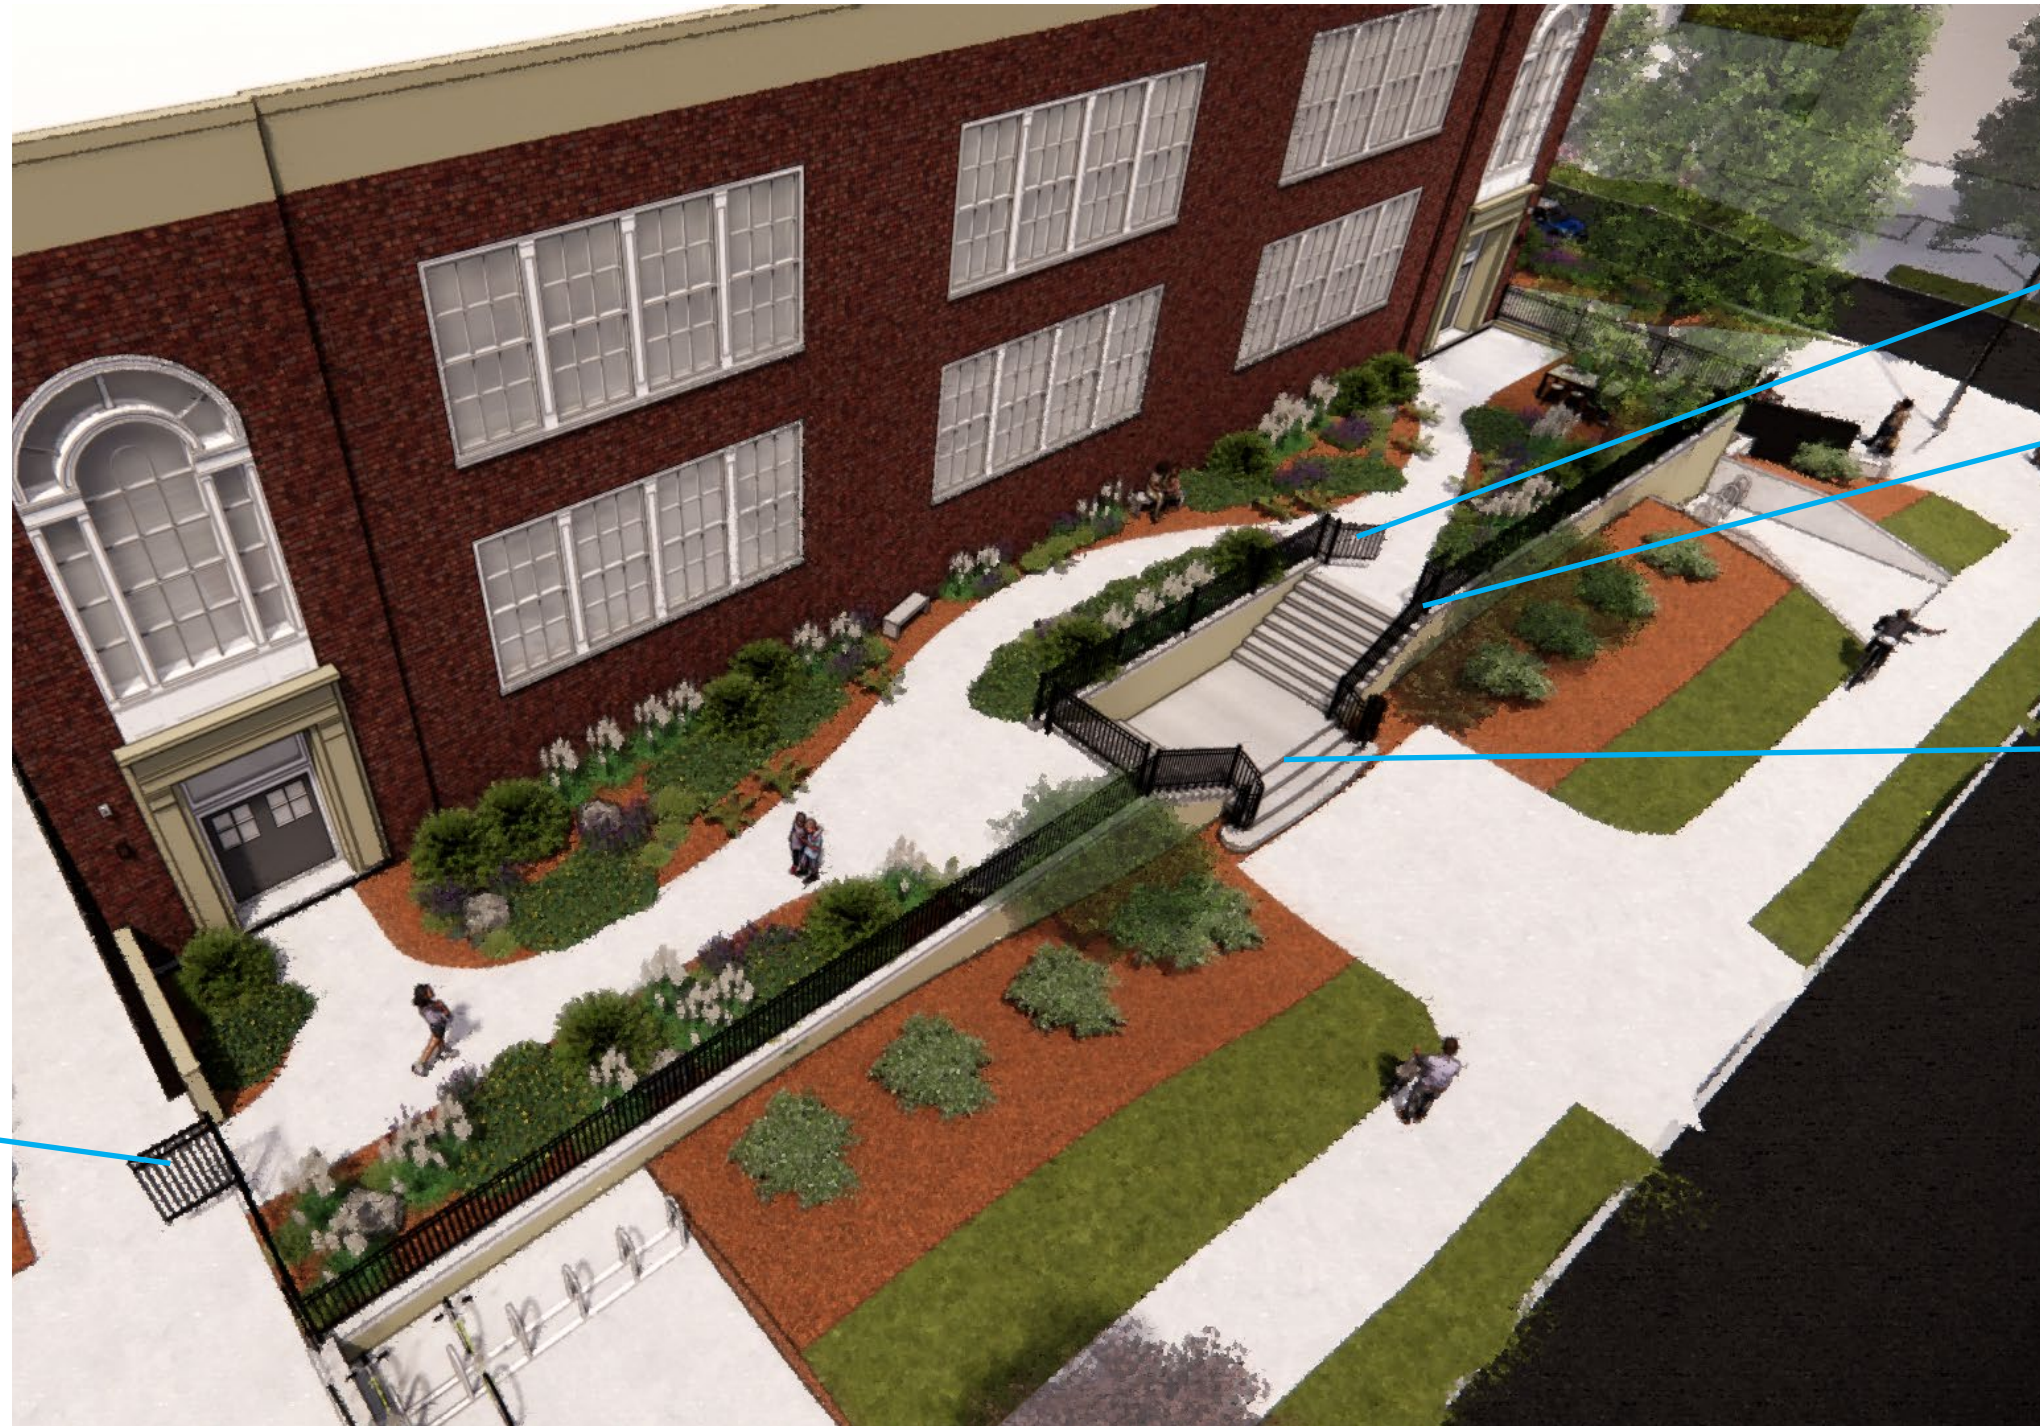
*Aerial view from northeast corner of site*

NEW SWING GATE IN SIMILAR  
STYLE OF EXISTING RAILINGS

EXISTING RAILING TO BE  
CLEANED AND RE-PAINTED PER  
SUBMITTED METAL RESTORATION  
SPEC

EXISTING STAIRS TO REMAIN.  
PATCH AND REPAIR CRACKS  
PER SUBMITTED CONCRETE  
RESTORATION SPEC

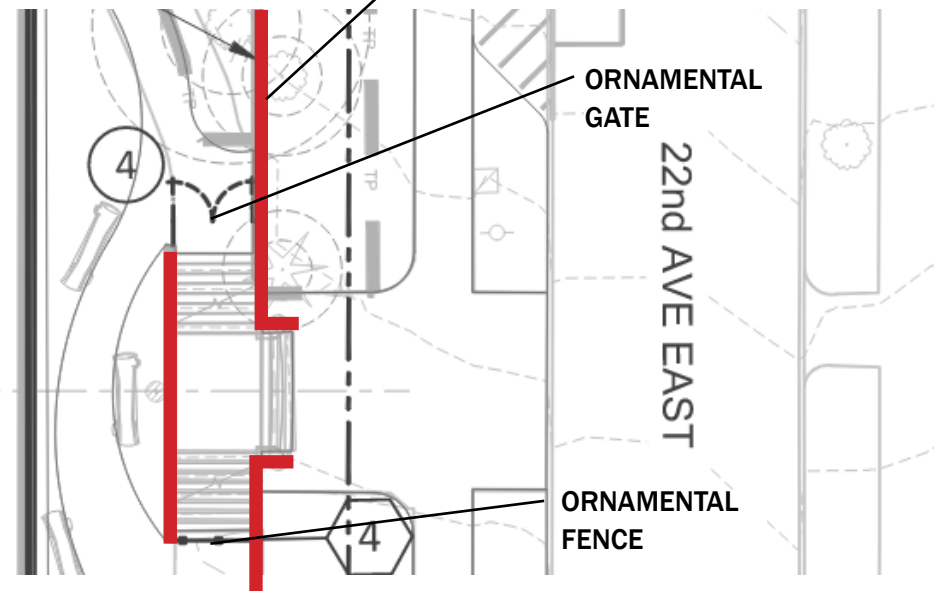
Previously approved C of A configuration - for reference

1. PICKET FENCE AND GATE, SEE SEC 323119
2. GATE LATCH, ATTACH PER MANUF RECOMMENDATION
3. 1" DIA. CANE BOLT MOUNTED ON ORN. FENCE.
4. 1½" I.D. STEEL PIPE CAST INTO CONC. PAVING.
5. FINISHED GRADE
6. EXISTING ORNAMENTAL FENCE TO REMAIN AND TO BE PROTECTED.

NOTE:  
ALL PARTS TO BE HOT-DIPPED GALVANIZED PRIMED AND PAINTED, WITH NO BURRS OR SHARP EDGES.  
WELD TO BE TYPE II QUALITY PER NAAMM

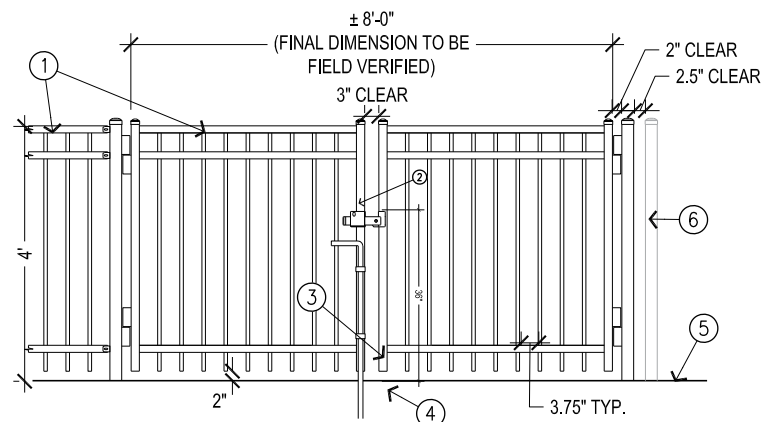
Proposed Ornamental gate at areas noted: Ameristar Montage II  
No change from previous C of A.

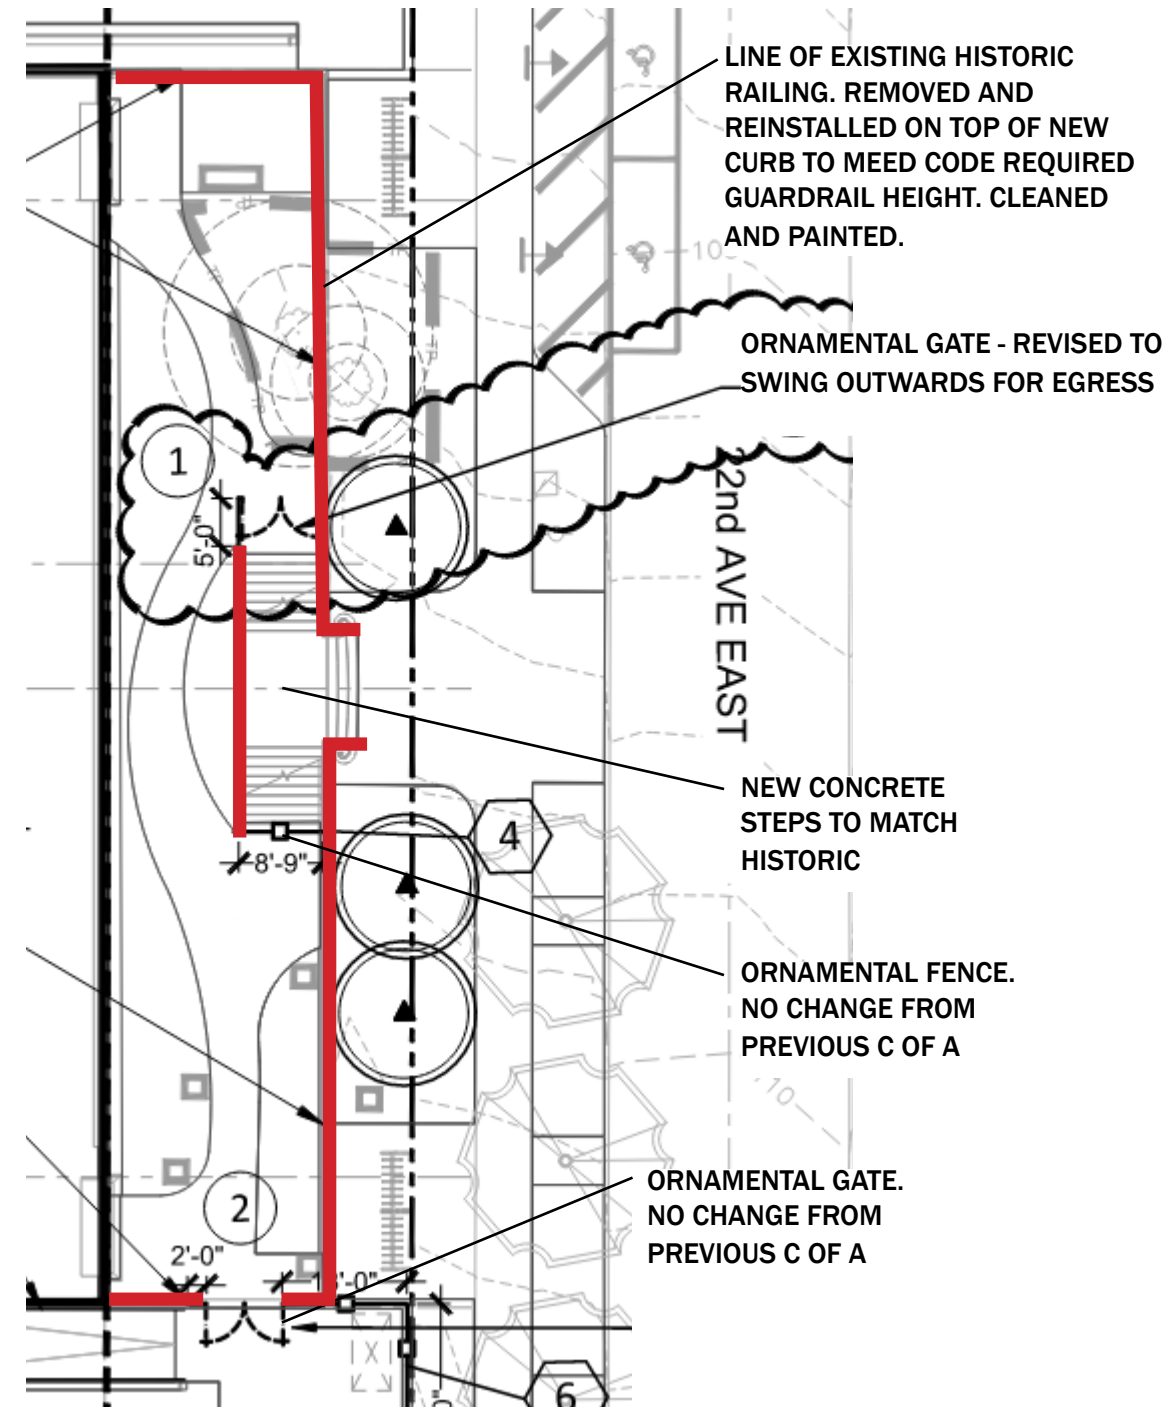
LINE OF EXISTING HISTORIC RAILING. CLEAN TO REMOVE LOOSE PAINT AND RUST. PAINT WITH RUST INHIBITIVE COATING

Revised gate configuration and railing scope

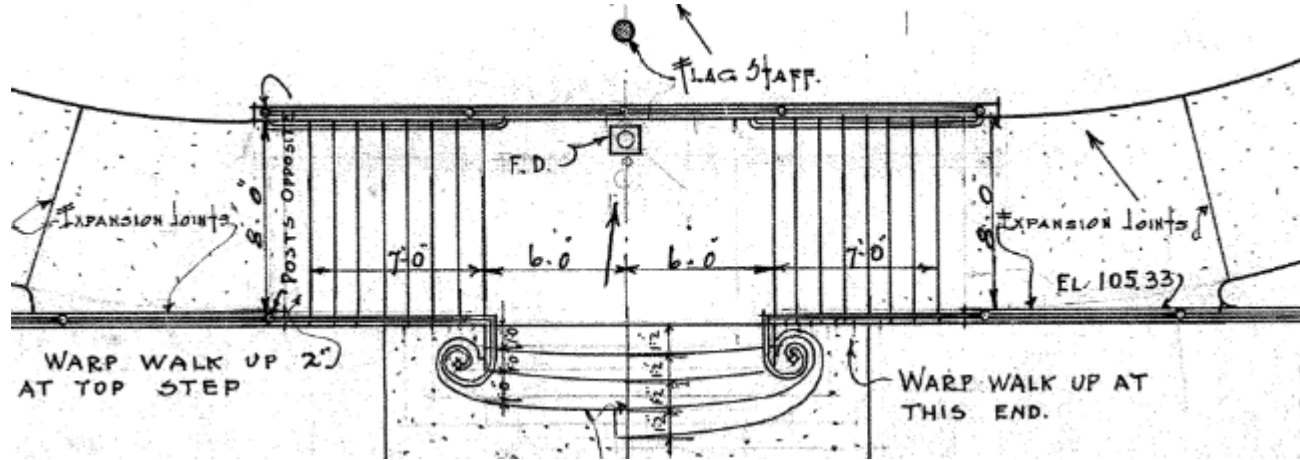
Original stair plan from 1924 drawings

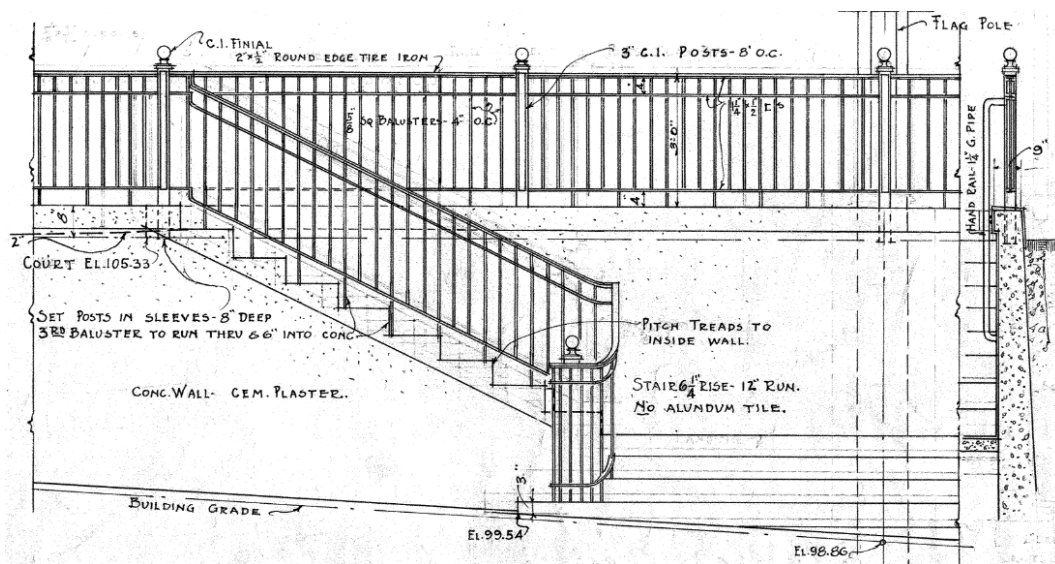
Original stair elevation from 1924 drawings

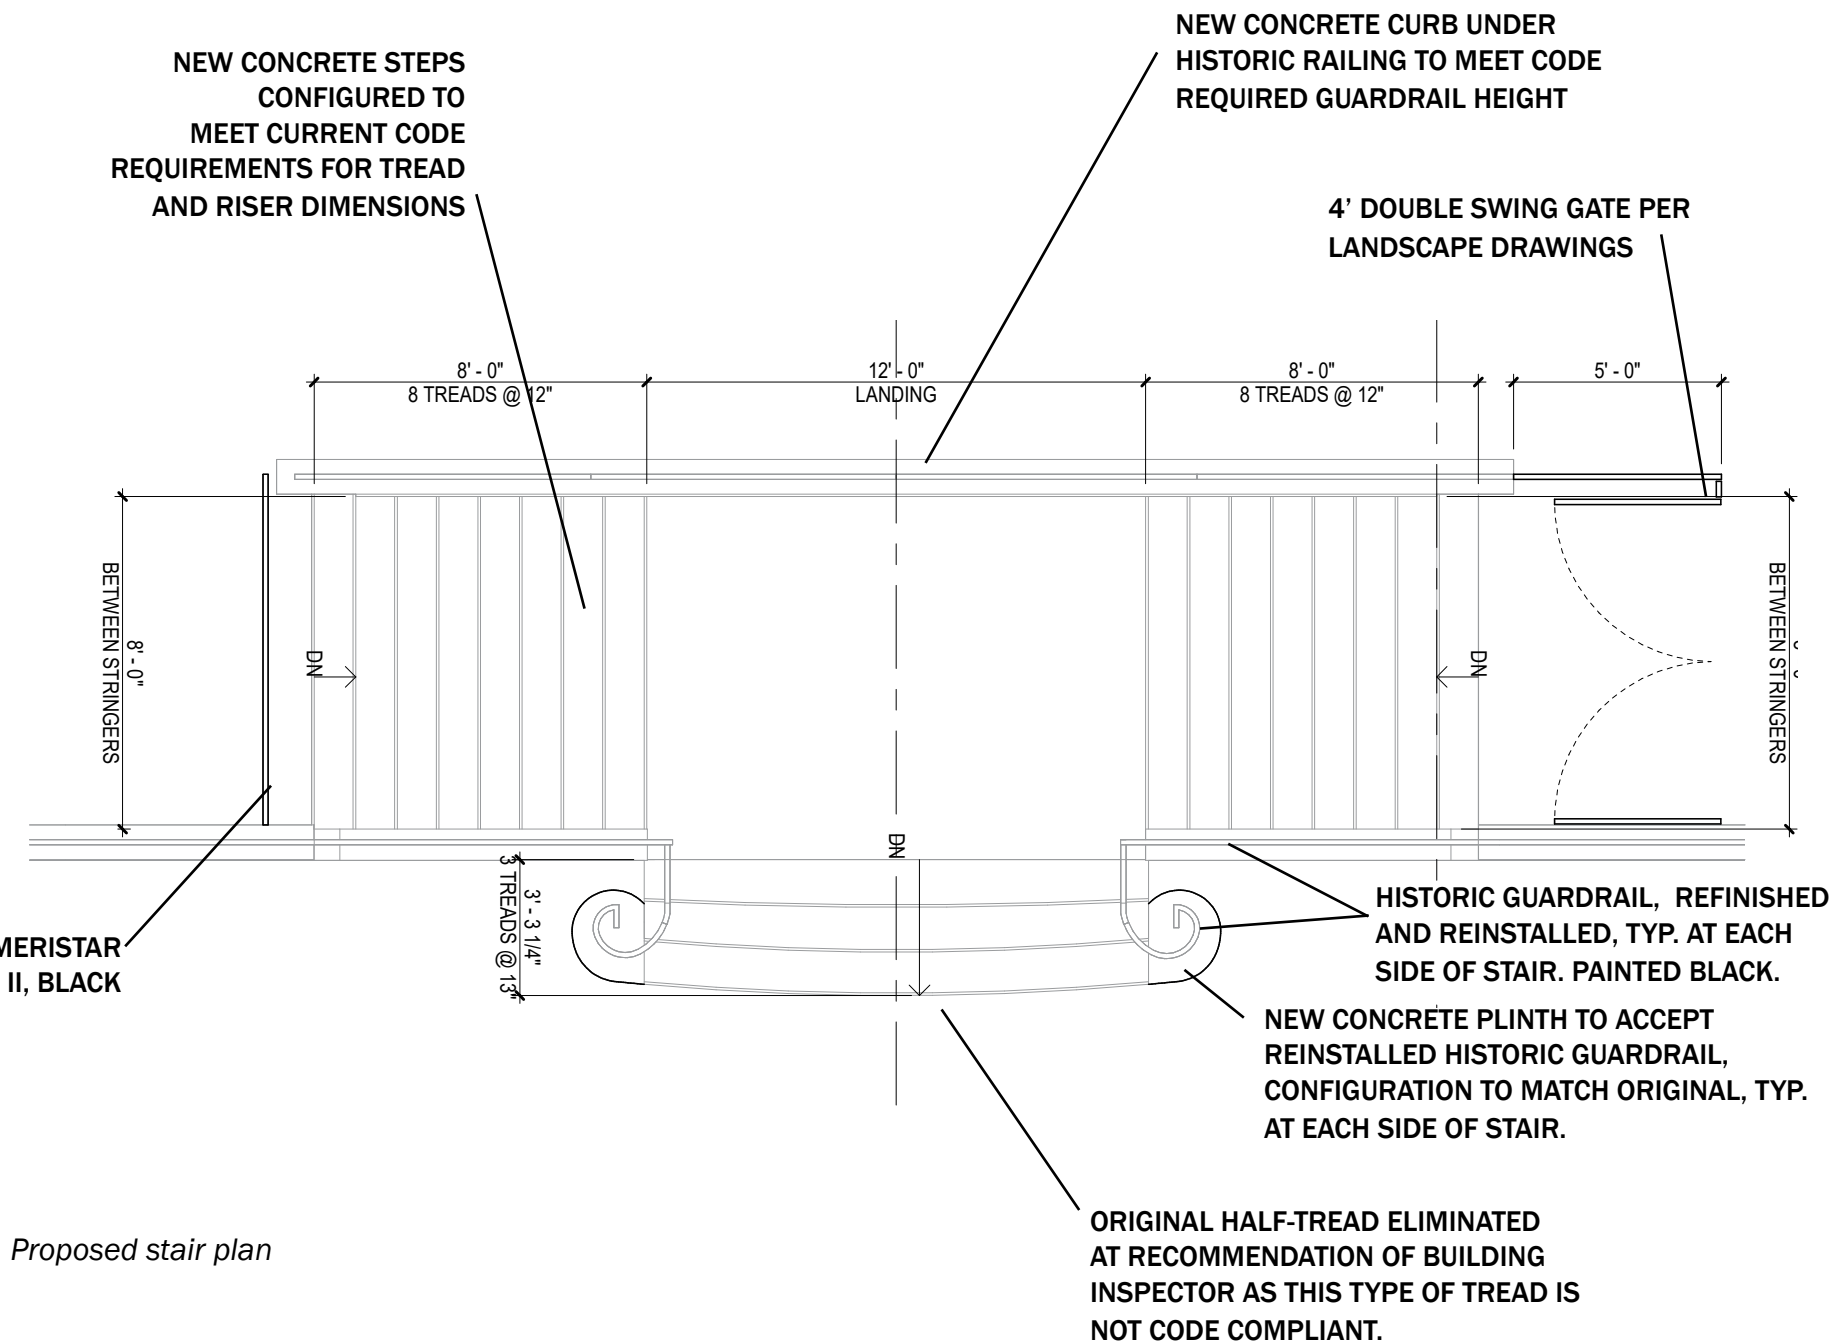
Proposed stair plan

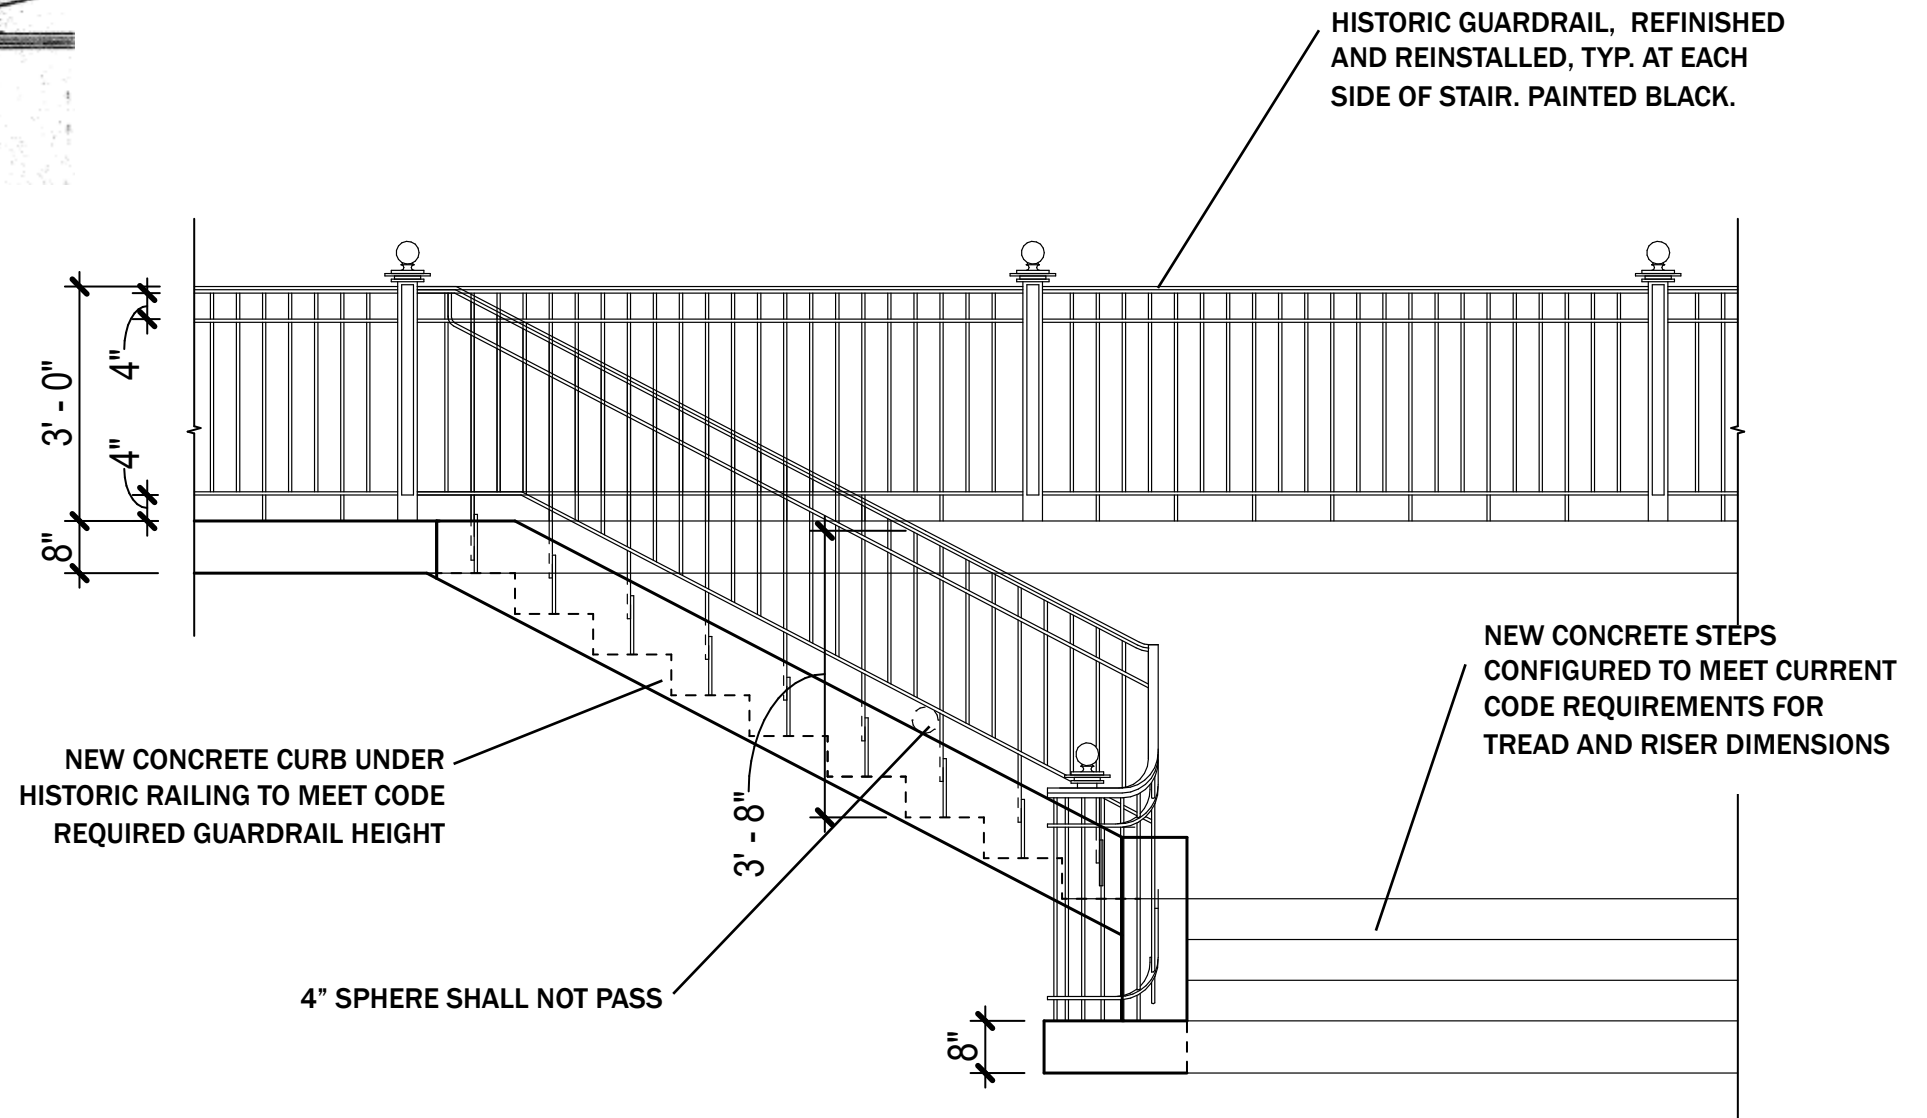
Proposed stair and railing elevation

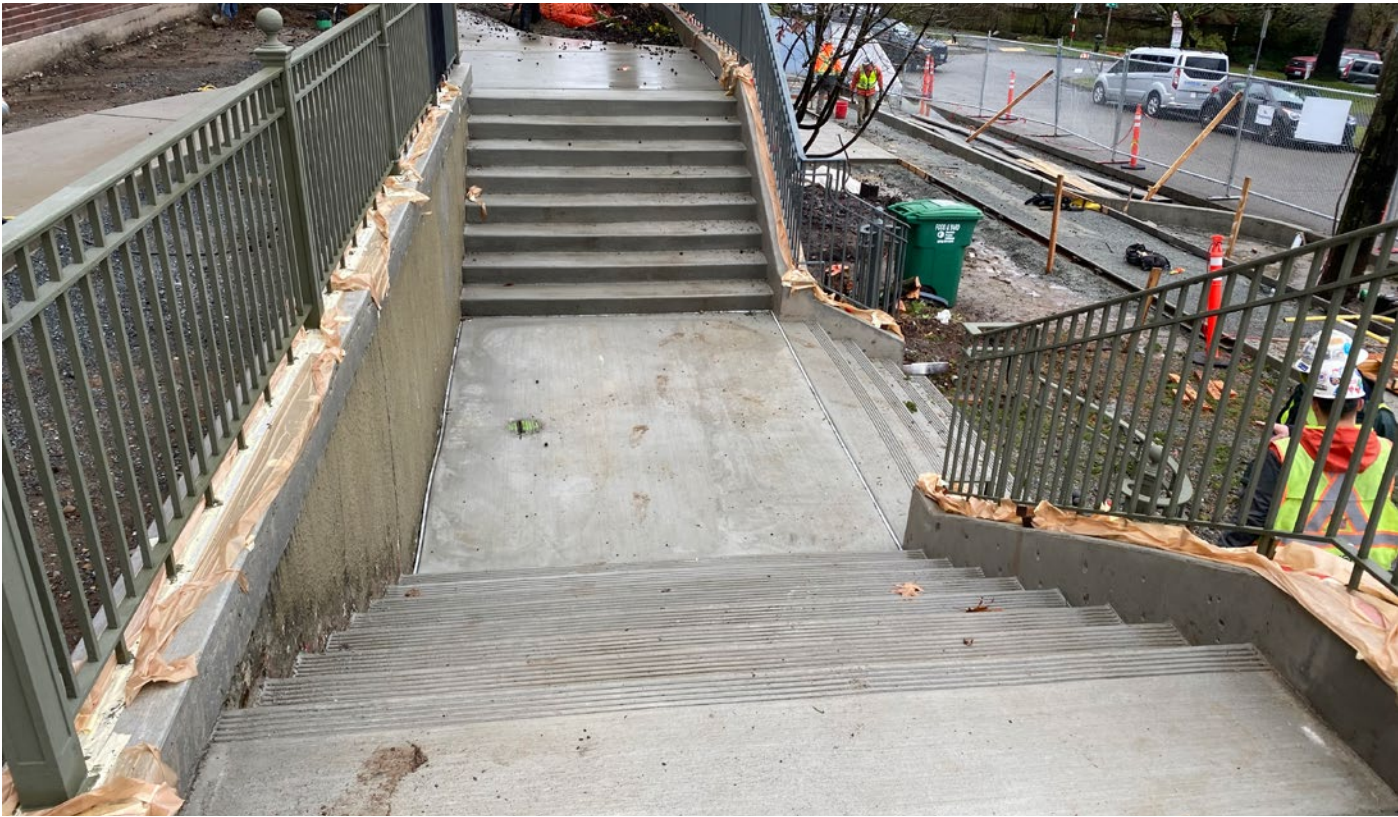
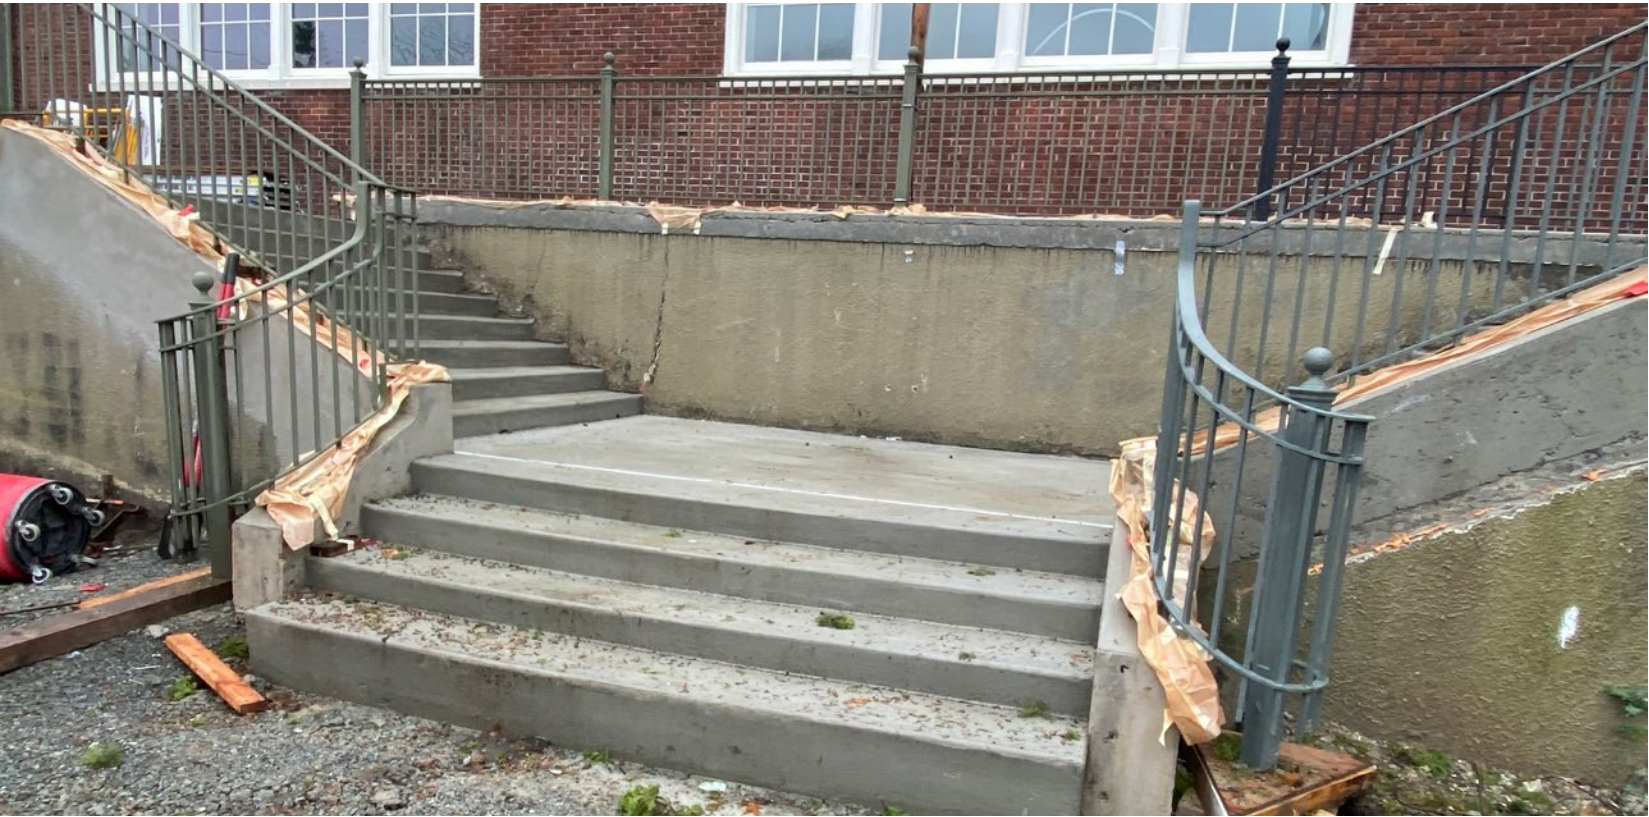
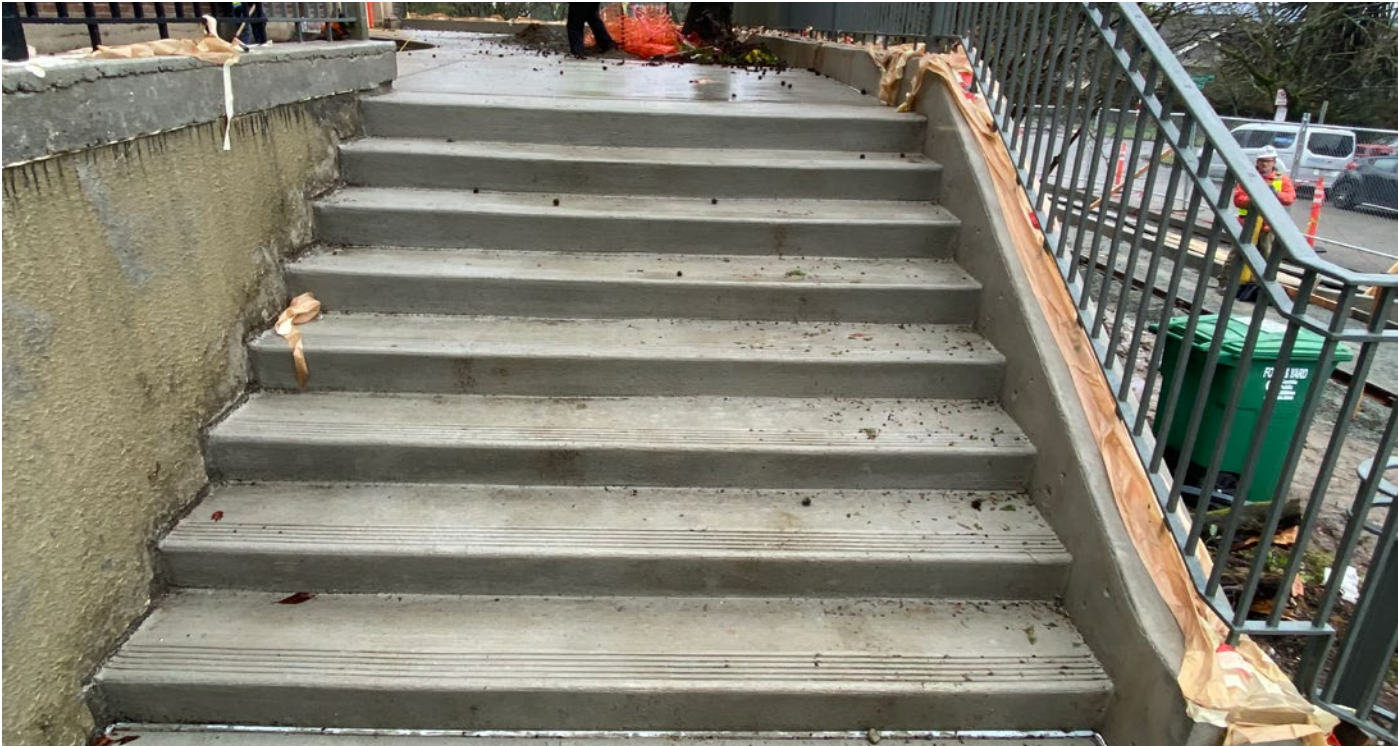
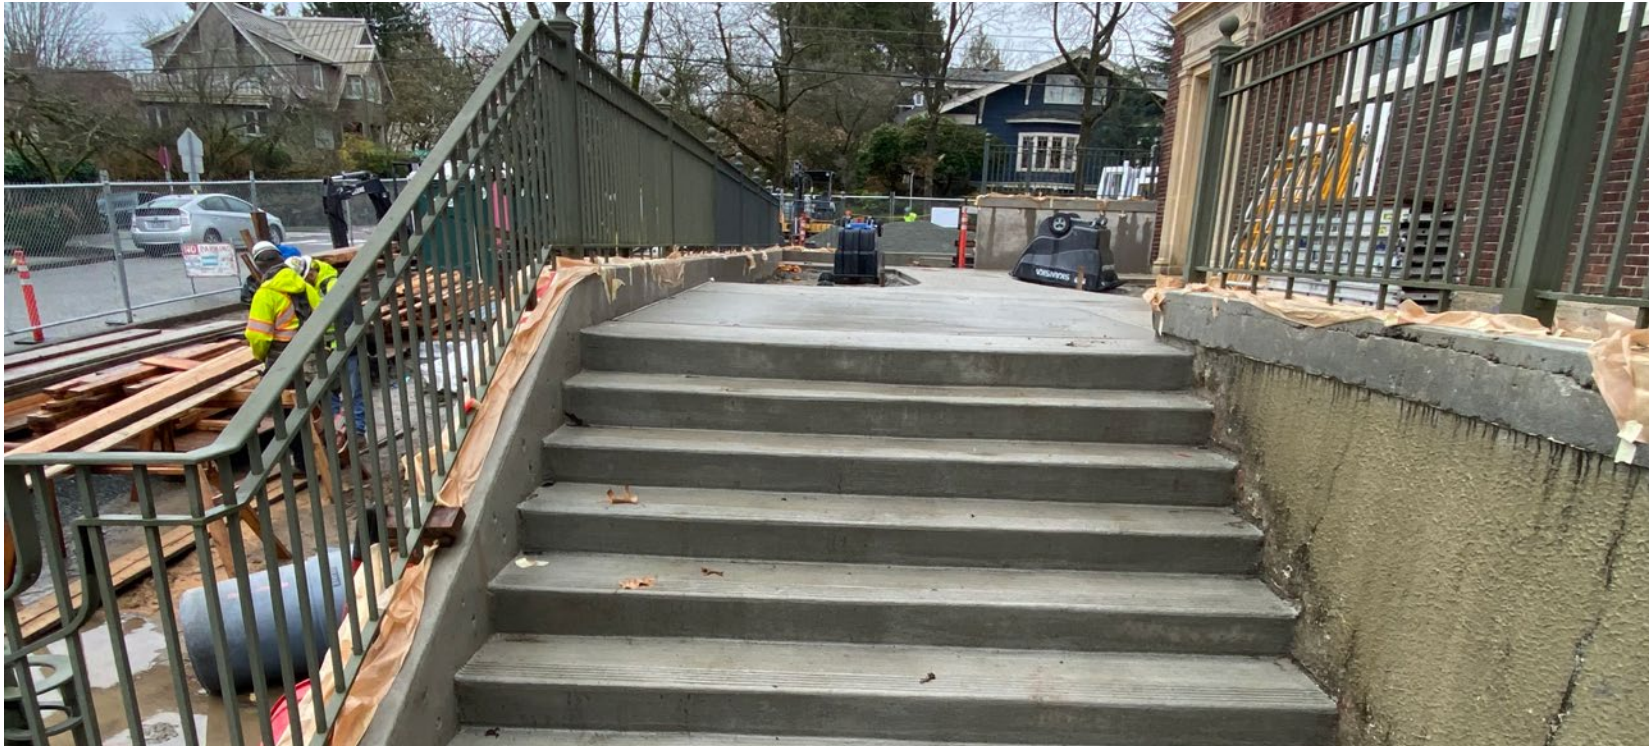
Stair photos taken by DLR Group. November 2024

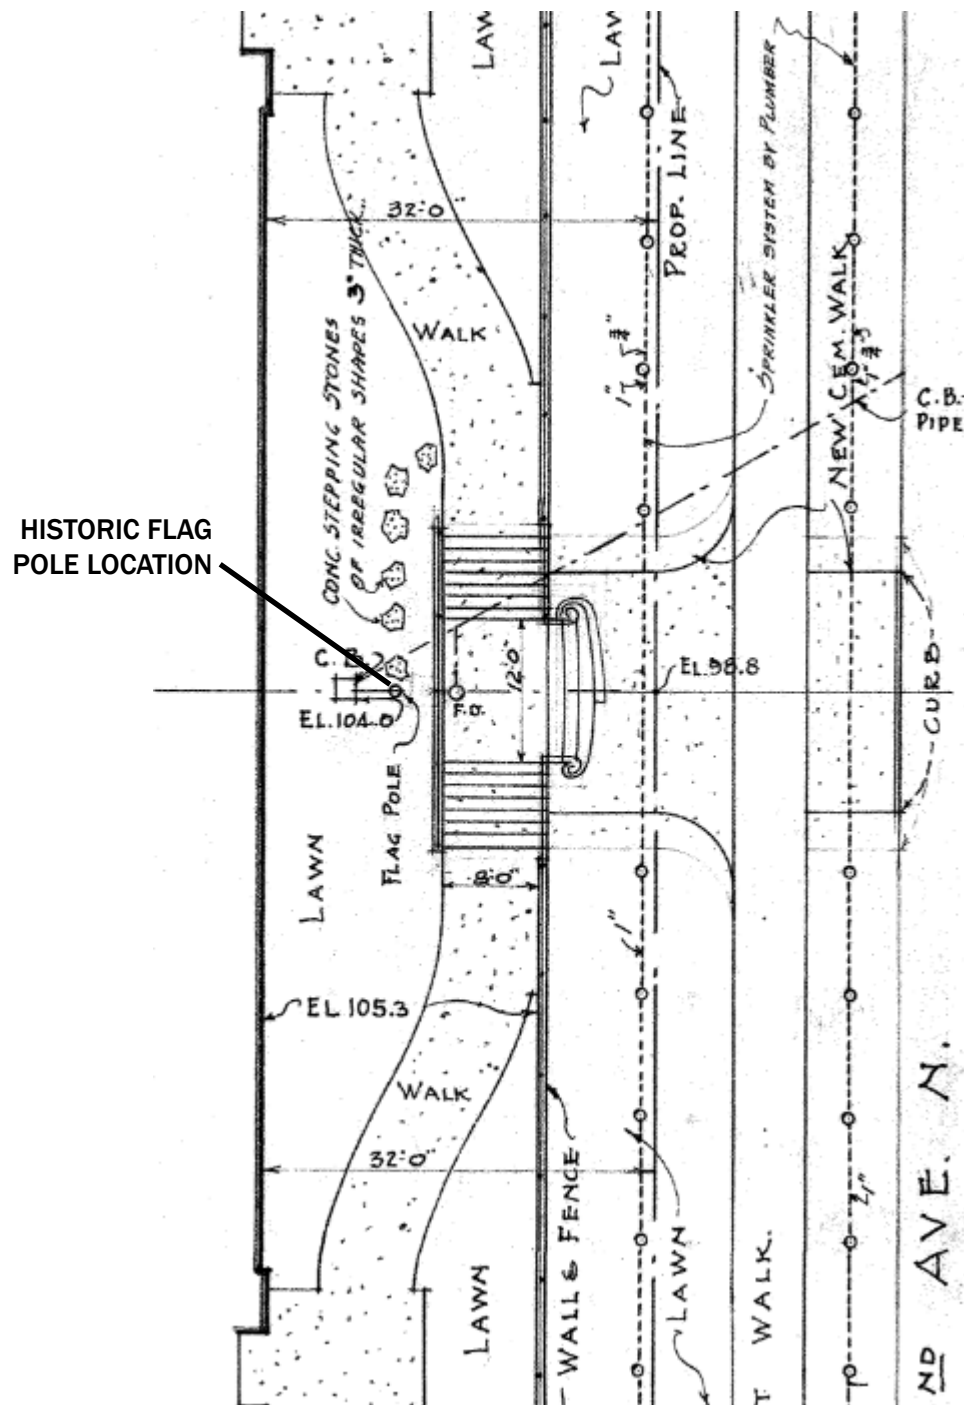
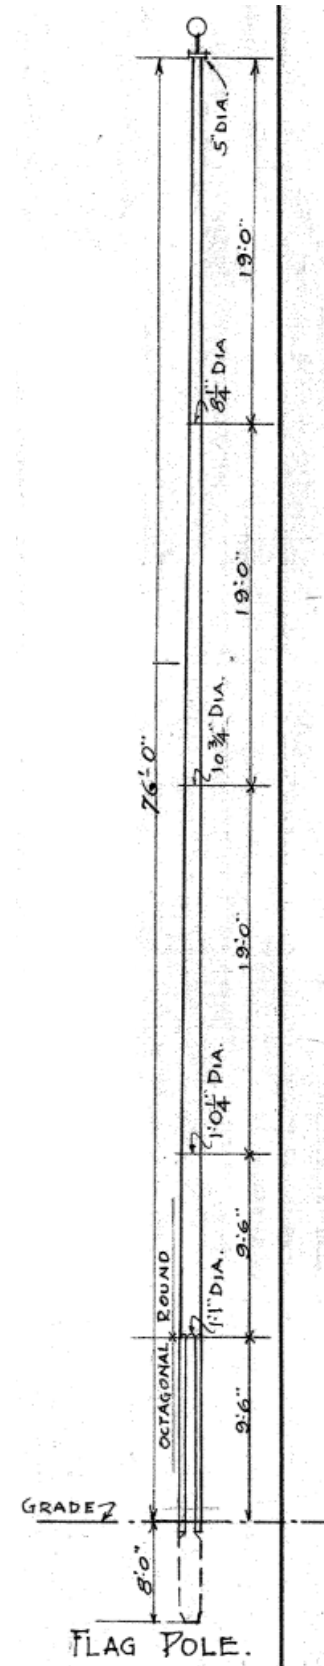
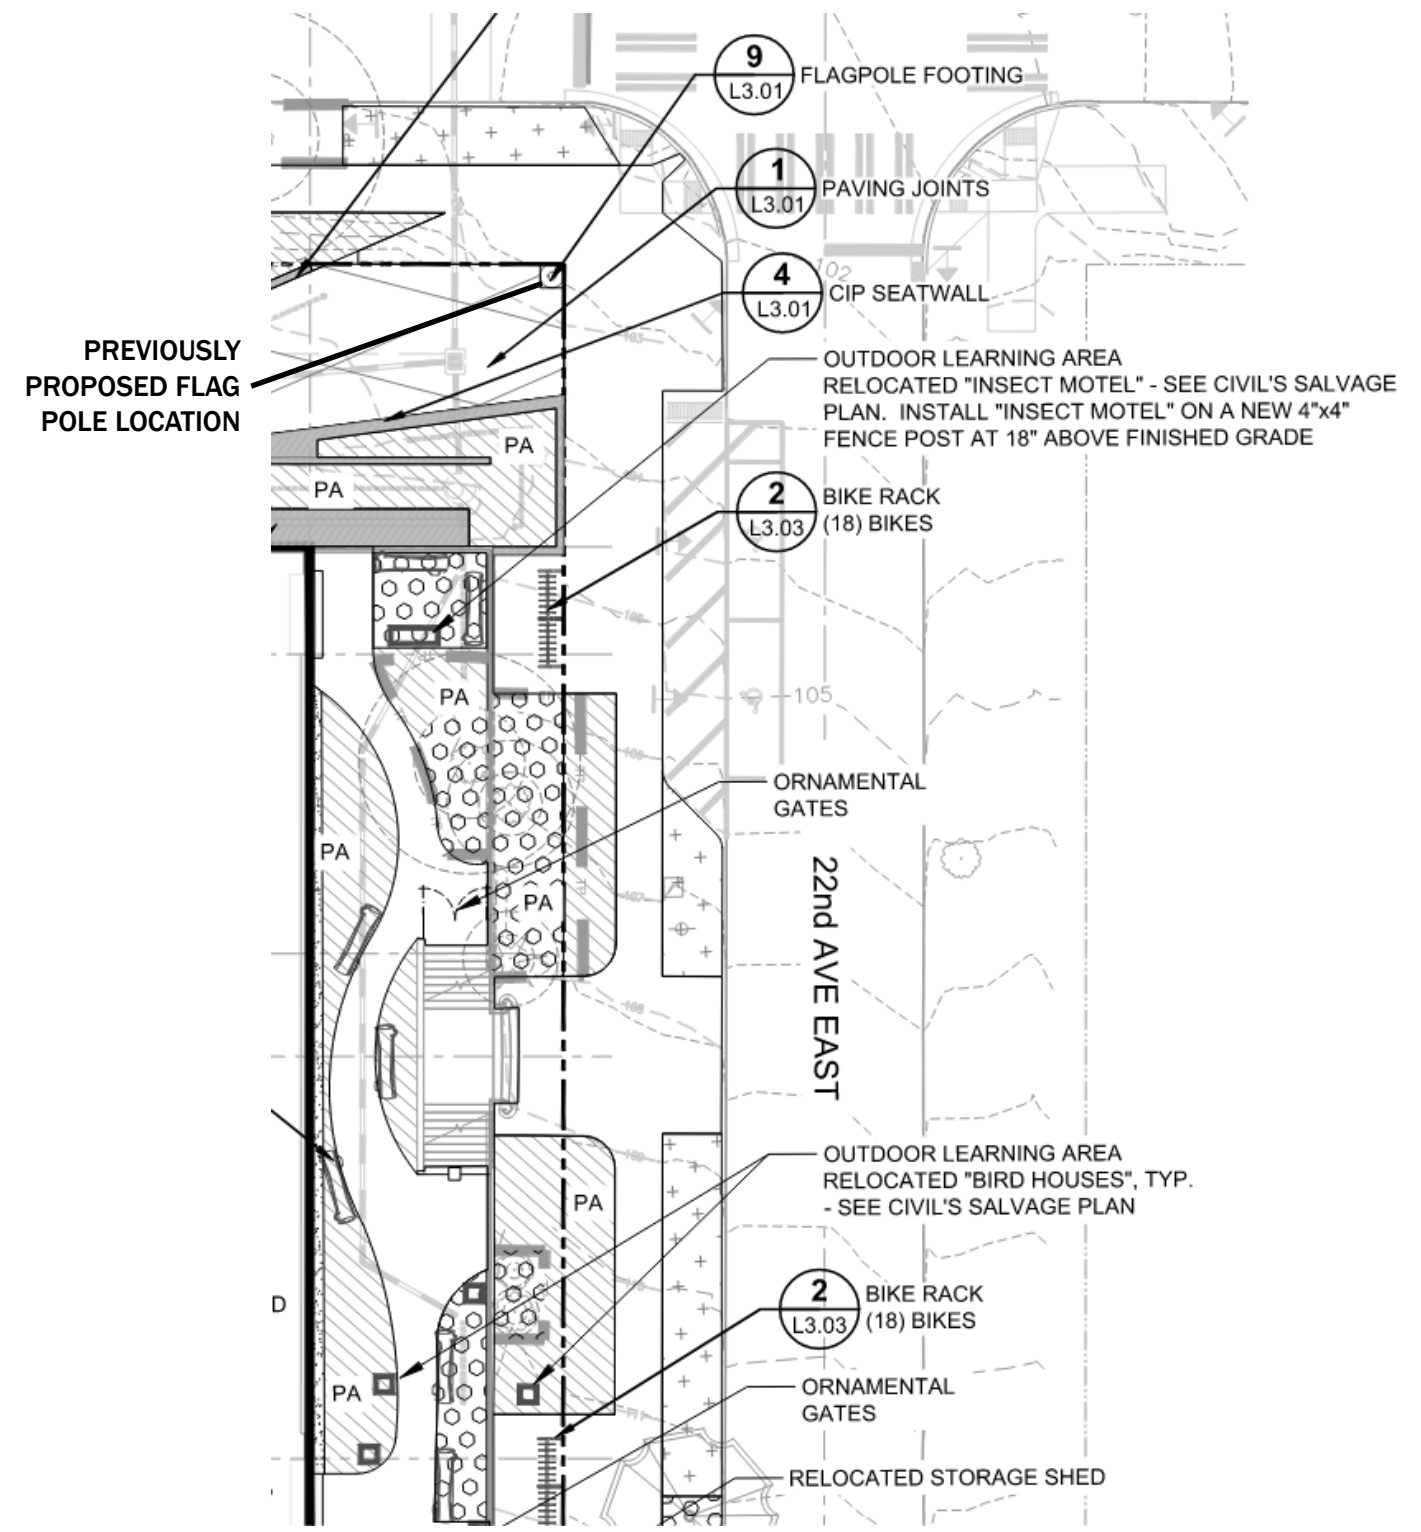
Previous proposed flag pole location per landscape drawings
